Fatigue and Strength Tests of Heat-Straightened Ferry Loading Bridge Hanger Bars

WA-RD 813.1

WSDOT Research Report

Research Report
Agreement T4118, Task 92
WSF Bearings Tests

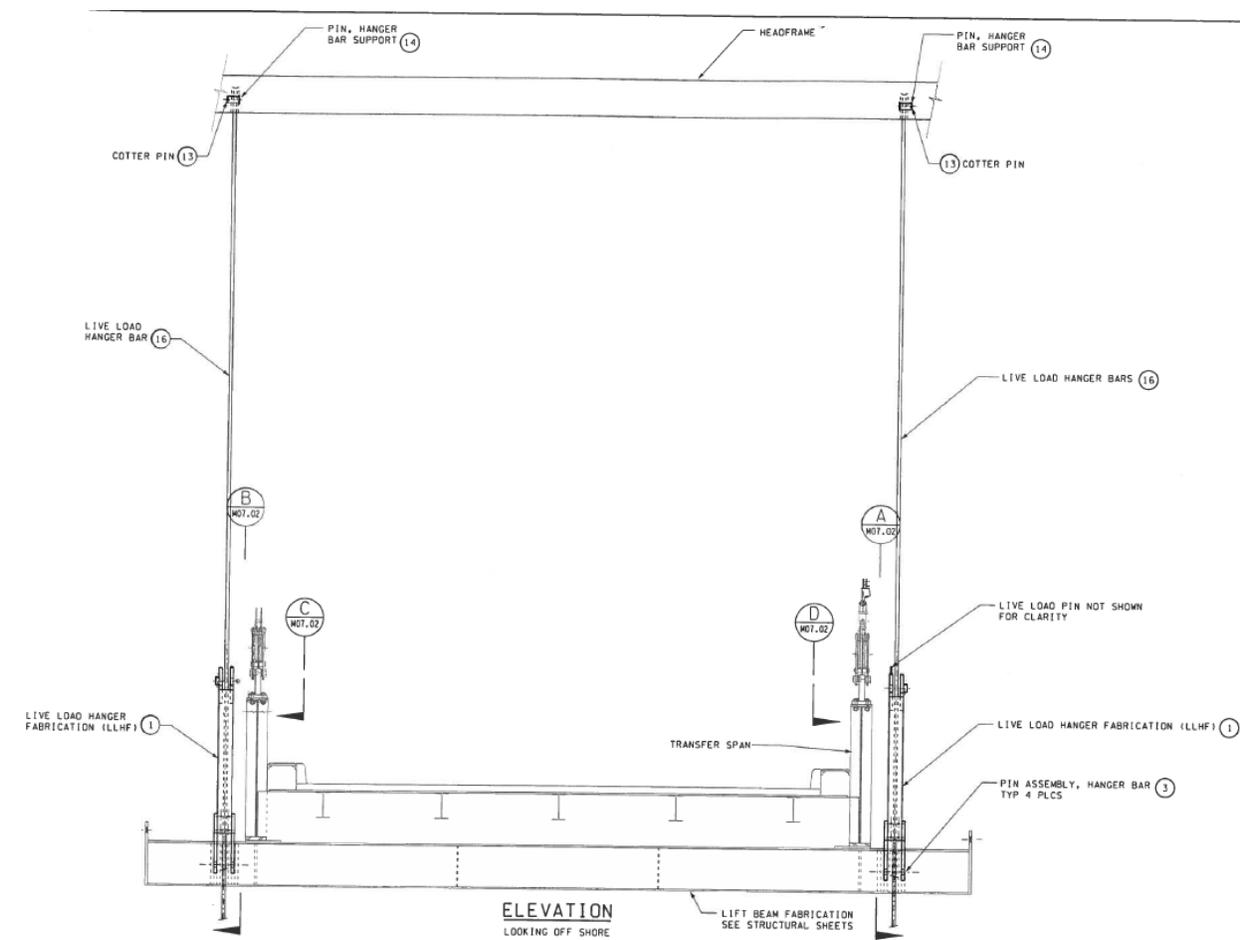
Figure 1. Loading Bridge Cross-Section with Hanger Bars Labeled.

The bridges used to load vehicles onto Washington State ferries are supported on one end by hanger bars. Figures 1, 2, and 3 show a typical loading bridge and hanger bar. These bars carry bridge loads in tension, but they can buckle in compression as the ferry rises with rising tides while at the dock or when workers adjust the bridge without removing the pins. Washington State Ferries (WSF) engineers then heat-straighten the bars and return them to service. However, it is unclear whether the bars can be heat-straightened three times and safely reused.

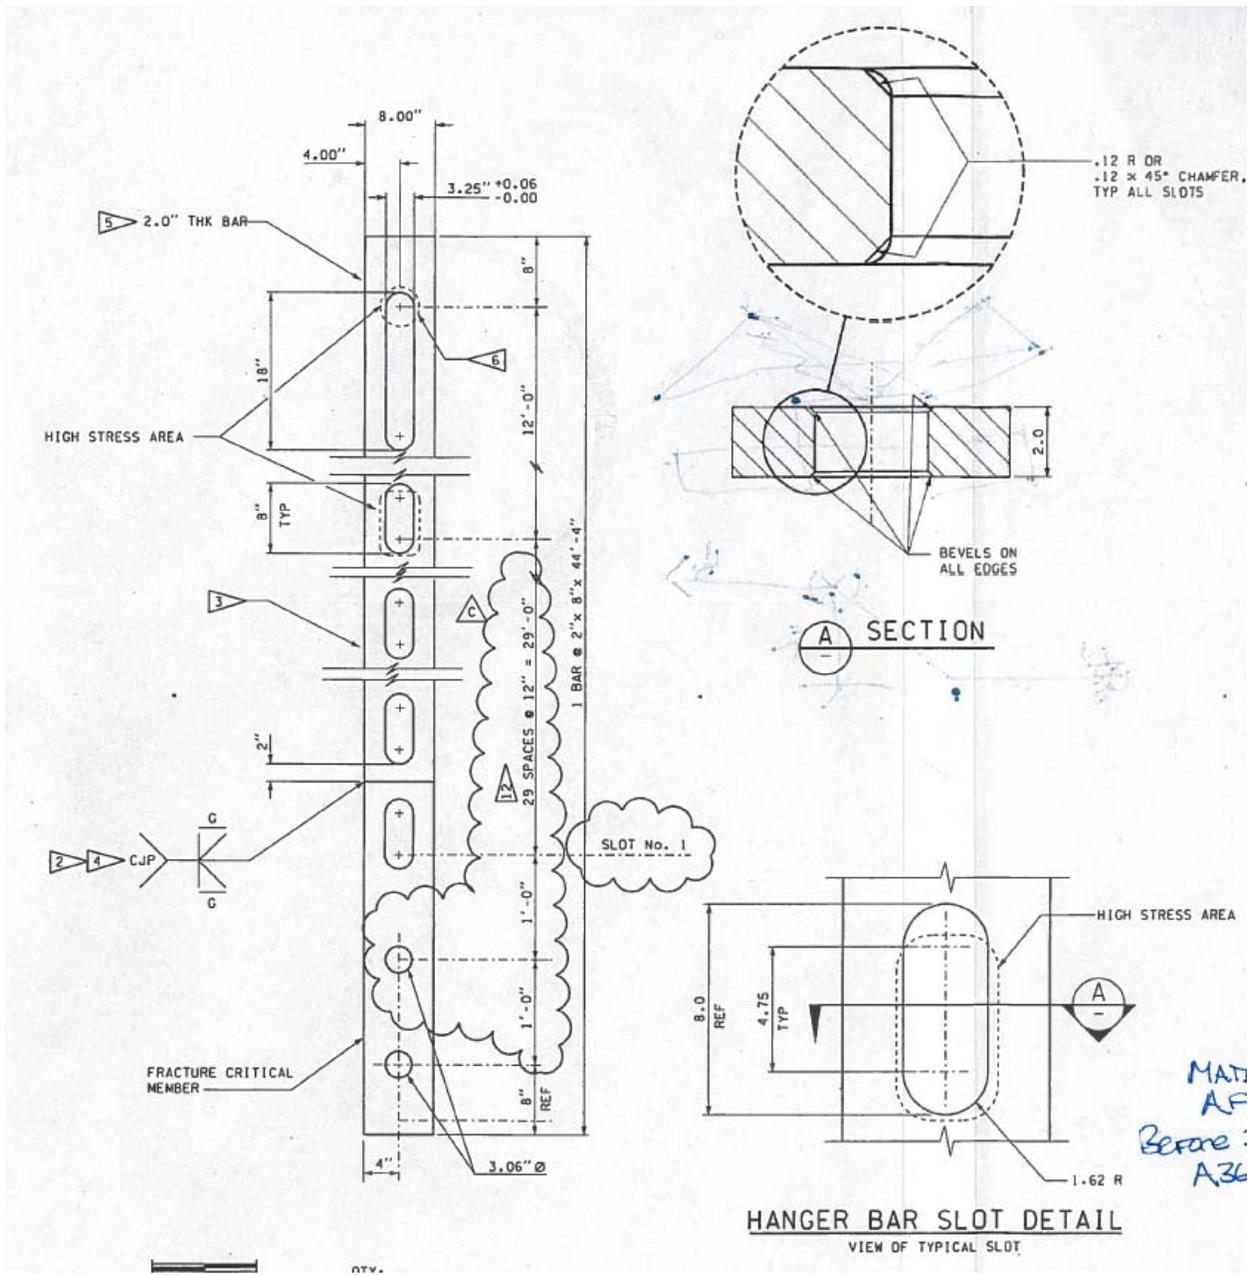
Figure 3. Hanger Bar Detail

Two hanger bar specimens were tested under fatigue loading in a 110-kip fatigue test frame in the SRL. The test set-up is shown in Figure 4a. The specimens were 40 in. long and had three of the oval shaped holes shown in Figure 3, with 4 in. of overhang on each end. A typical specimen is shown in Figure 4b. Each specimen had been heat-straightened three times, and they were named 3A and 3B. The specimens were connected to the test frames by using a series of plates and pins. The pins that were used in bearing against the hanger bars were identical to those used in the ferry loading bridges to ensure that the stress distribution in the tests closely matched that expected in the field.

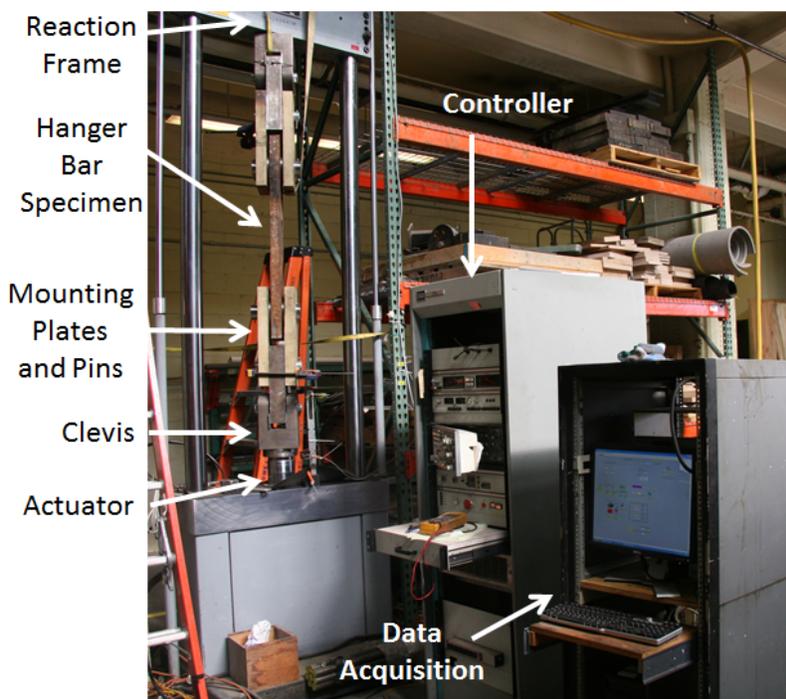
Figure 4. (a) Fatigue Test Setup (b) Fatigue Specimen

Both specimens were subjected to sinusoidal cyclic fatigue loading with peaks at 60 kips and 10 kips of tension at a rate of 3 Hz. The loading was conducted around the clock, and emergency switches were utilized to sense a failure and stop the hydraulic system. This loading protocol was agreed to by the SRL staff and the WSF engineers. They determined that the specimens should be subjected to 3 million cycles of loading, at which point the tests would be stopped if no failure occurred.

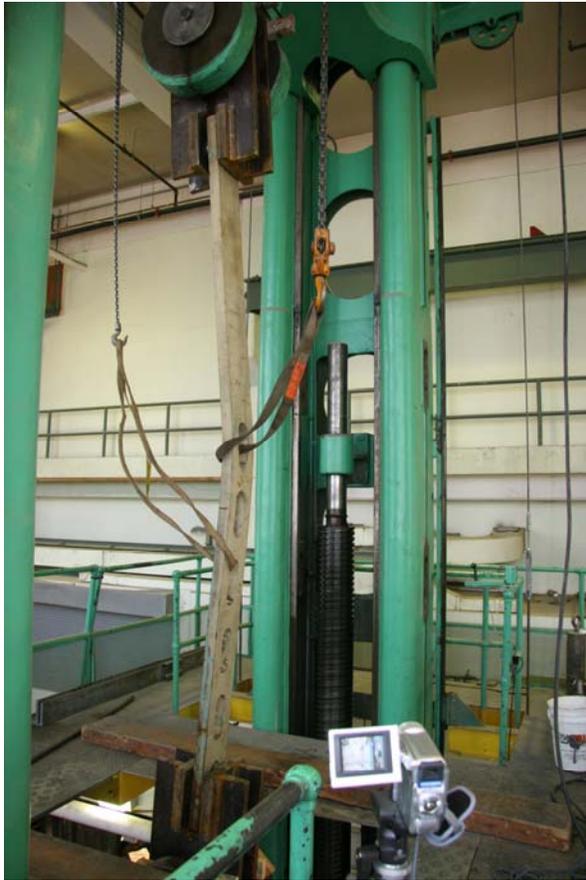
Ultimate strength tests were conducted at the top of the SRL's 2.4-million-pound capacity Universal Testing Machine (UTM). Two lengths of specimens were tested: (1) nominally 10-ft-long bars, one that had been heat-straightened multiple times and two that were installed bent to simulate their condition after buckling, and (2) 40-in.-long bars that were used (or designed to be used) in the fatigue test set-up. Figure 5 shows the two types of specimens installed in the UTM. The material for all bars was either A36 or an unknown older steel.

Figure 5. Ultimate Strength Test Setup (a) Nominal 10 ft Specimen (b) 40 in. Specimen

The set-up utilized pin connections at each end of the hanger bars, and the pins used were identical to those used in the field. Loading was applied slowly to each specimen and continued

Table 6 lists the details of each specimen. Specimens Ult1 and Ult2 were 10 ft long and were tested after being bent (Figure 5a). Specimen Ult3 had been heat-straightened three times. Specimens F3A and F3B were 40 in. long and had been subjected to 3 million cycles of fatigue loading as described above. Specimens F2A and F2B were 40 in. long and had been heat-straightened twice. As noted above, all specimens exhibited ductile behavior, and the two bent specimens did not fracture at the bend but rather at a different net section (at the pin connection or one slotted hole away from the pin connection).

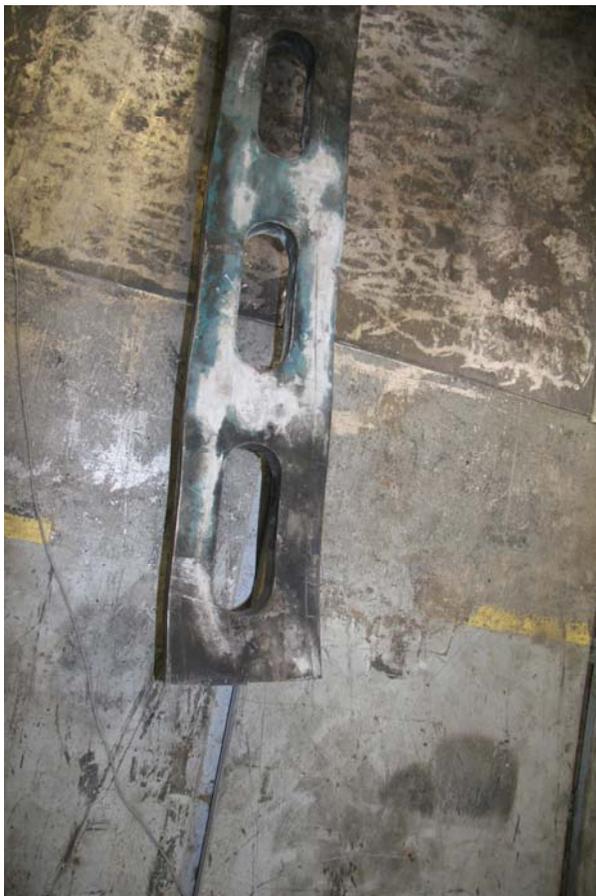
Each specimen exhibited reasonable ductility before fracturing either at a net section area adjacent to a slotted hole within the length of the specimen or at the net section where the pins connected to the specimens. After the tests, signs of yielding at all net section areas adjacent to the slotted holes were visible. An example is shown in Figure 6a. An example of the typical net section fracture that occurred after significant inelastic deformation is shown in Figure 6b.

Figure 6. (a) Example of typical slotted hole yielding and deformation. (b) Example of typical net section fracture.

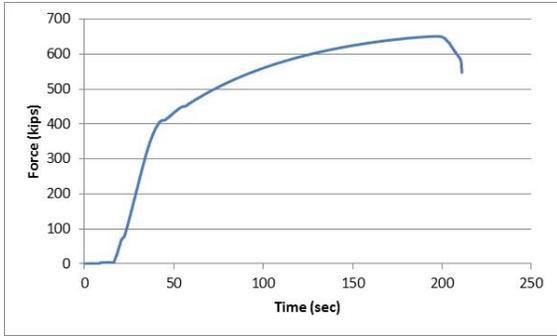
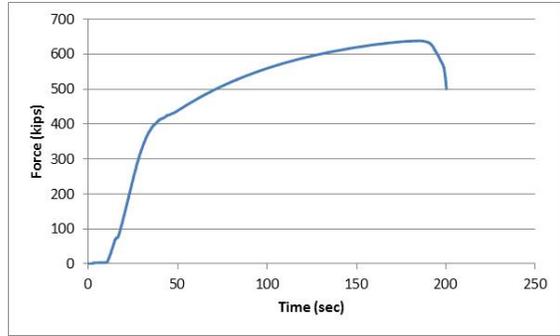
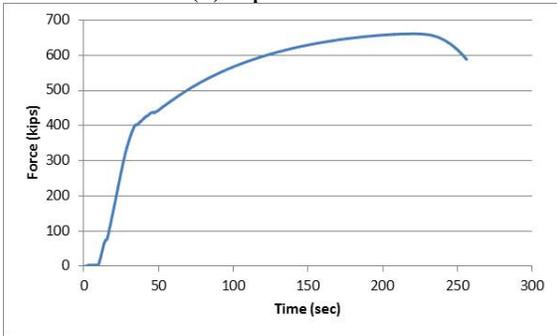
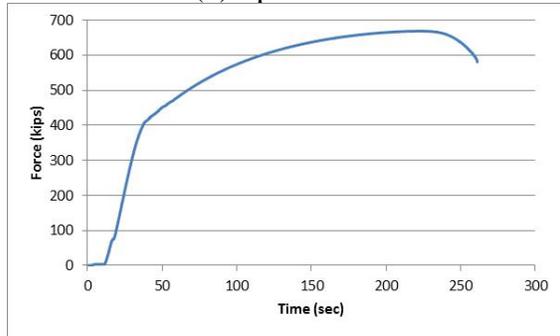
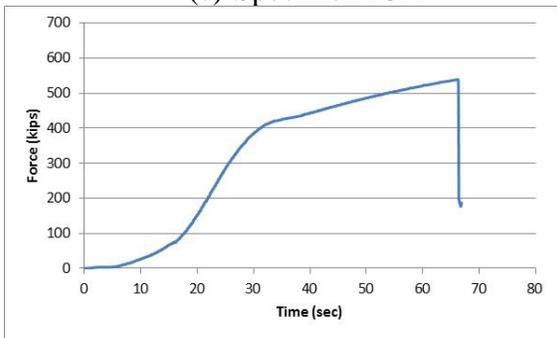
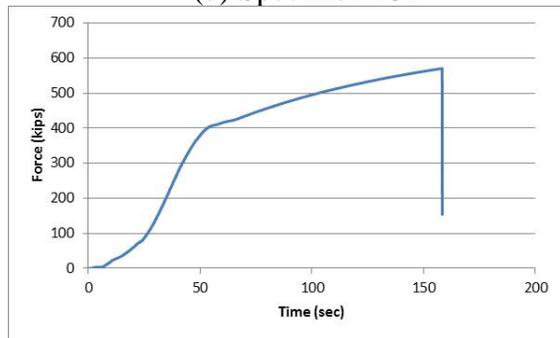
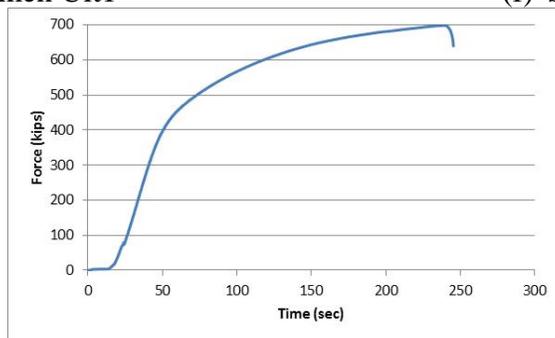
Figure 7. Load vs. Time Curves for Ultimate Strength Tests

Figure 7 shows the force versus time curves for each tested specimen, where the names correspond to the information in Table 1. As noted above, a constant rate of crosshead displacement was used to control the test so that the load versus time curves would be similar to load deformation curves. Figure 7 shows that each specimen had a clear yield point at which the slope of the curve changed. This was followed by ductile inelastic deformation and eventual fracture at a net section adjacent to a slotted hole. Note that the two long bent specimens showed a smaller initial stiffness as the bend in the bar was straightened. Also note that those two specimens had slightly lower ultimate strengths than the other specimens, although the yield strength was similar.

By using the curves of Figure 7, the yield and ultimate strengths of each specimen were determined, and the results are given in Table 1. The table also shows the nominal yield and ultimate strengths, assuming a yield stress of 36 ksi and an ultimate stress of 58 ksi each, times the net area at a long slotted hole of 9.5 in². A comparison of the nominal and experimentally obtained values indicated that the inelastic buckling deformation, heat-straightening (up to three times), and fatigue loading generally did not affect the yield strengths of the bars. The data in Table 1 do indicate that the bars tested in the bent configuration had somewhat lower ultimate strengths, producing effective ultimate stresses of 56.7 for Specimen Ult1 and 60 ksi for Specimen Ult2. The former was slightly lower than the minimum ultimate stress for A36 of 58 ksi. It is unclear why these specimens exhibited a lower ultimate strength, especially given that the fractures occurred far from the bends. Heat-straightening and fatigue loading were not found to affect the ultimate strength.

¹ Yield strength estimated as point of significant change in slope in Figure 7 plots.

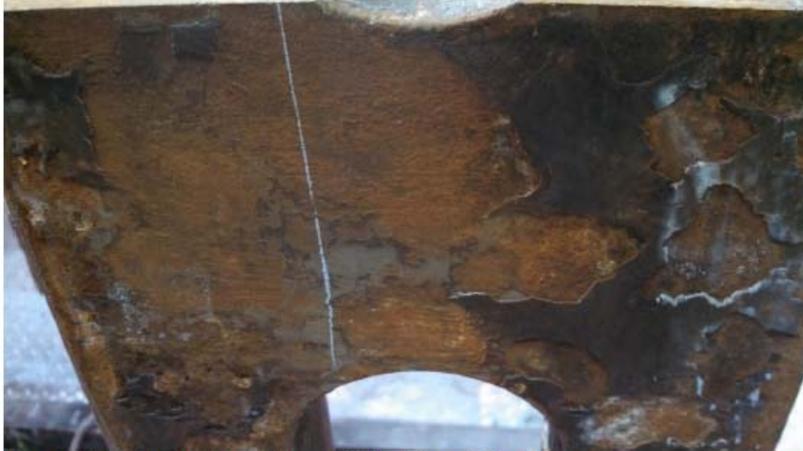
Performed magnetic particle examination of four load bar plates, 2A, 2B, 3A, and 3B. This inspection was performed to determine if there were any flaws prior to fatigue testing. Noted flaw in bottom of plate 3A at X end. Notified Jeff Berman and Vince with UW.

Fig. 1. Crack noted in bottom of 3A plate at X end

Below are inspection reports from Mayes Testing Engineers, Inc. They performed magnetic particle testing on the hanger bars before fatigue loading (inspection on April 2, 2013) to check for initial cracks and following fatigue loading (inspection on May 17, 2013) for Specimen F3A and F3B (denoted 3A and 3B in the inspections reports). As shown, no indications of significance were found. Small indications parallel to the direction of the applied load were found, but they were not due to the fatigue loading applied but instead may have been related to corrosion or material imperfections.

Weld or Part No.	Location	Accept	Reject	Remarks
2A	four sides of plate	X		informational inspection
2B	four sides of plate	X		informational inspection
3A	top and both sides	X		informational inspection
	bottom		X	5" longitudinal crack at X end
3B	four sides of plate	X		informational inspection
