Kwik Bond Polymers® High Friction Surface Treatment

WA-RD 851.1

Experimental Feature Report

QE9982
I-5 and I-90 High Friction Surface Treatment
SR 526 EB to I-5 SB and 148th Avenue SE to I-90 WB

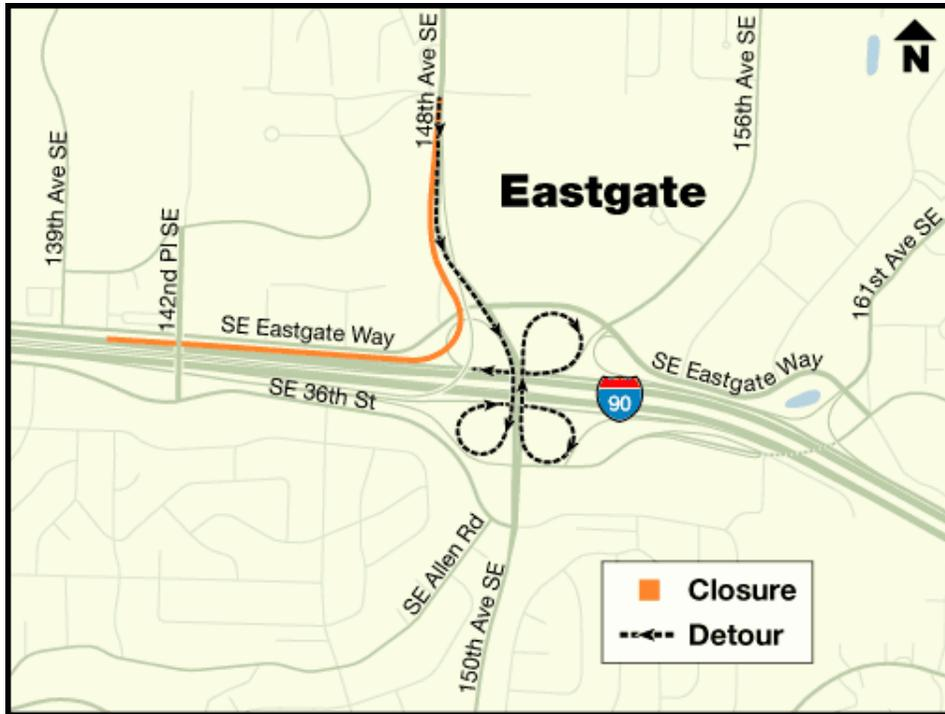
Figure 1. HFST installation on SB 148th Avenue SE on-ramp to WB I-90.

The two ramps are located on I-90 and I-5. The I-90 HFST was applied to the on-ramp from 148th Avenue SE to westbound I-90 in Eastgate (Figure 1). The I-5 HFST was applied to the on-ramp from SR 526 eastbound to I-5 southbound south of Everett (Figure 2).

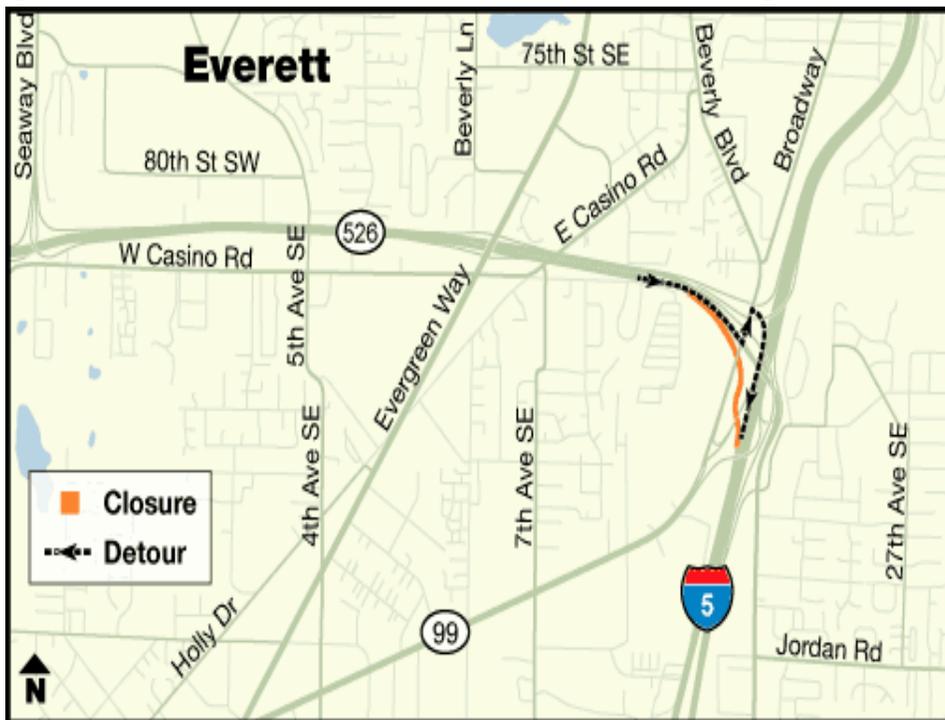
Figure 2. HFST installation on EB SR 526 on-ramp to SB I-5.

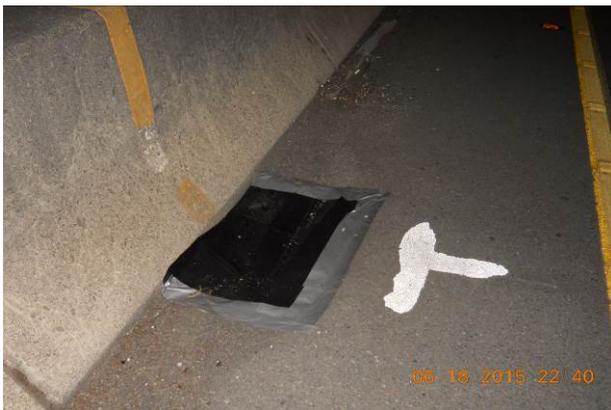
Figure 3. Inlet covered prior to HFST.

The HFST was installed on the two ramps in the last two weeks of June, 2015. The process is captured in a series of photographs. Figures 3-6 show the preparation prior to the application of the HFST. The pavement receiving the HFST was cleaned to remove all dirt, sand, oils and other debris using a combination of street sweepers and brooms. The paint stripes were removed by diamond grinding if they were in the center of the roadway, or if they were the edge stripes they were left in place or covered with duct tape. If the stripes were of the thermal variety with raised lane marker bumps, duct tape was applied to prevent covering by the HFST.

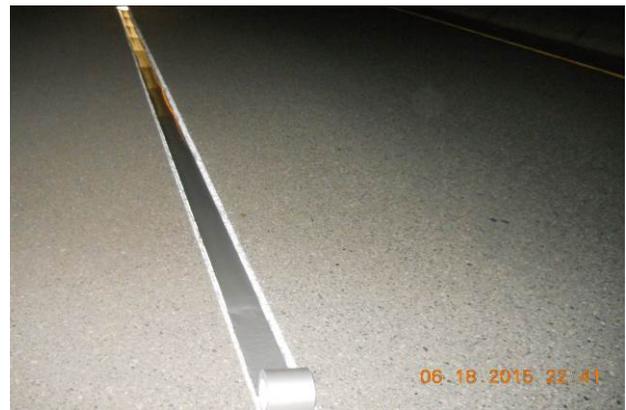
Figure 4. Lane line taped prior to HFST.

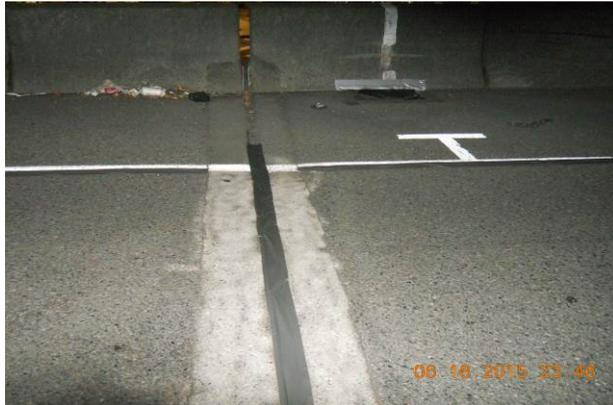
Figure 5. Taped expansion joint.

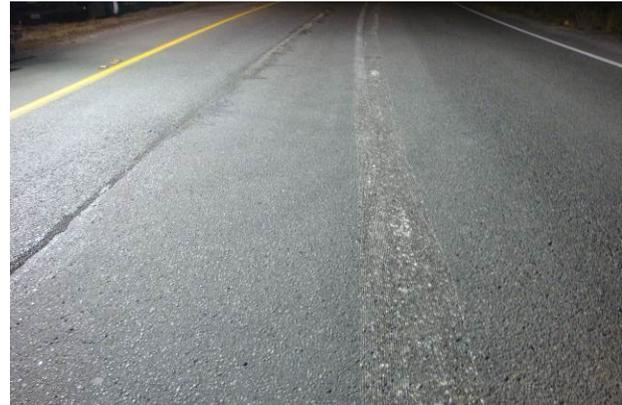
Figure 6. Diamond grinding to remove centerline stripe.

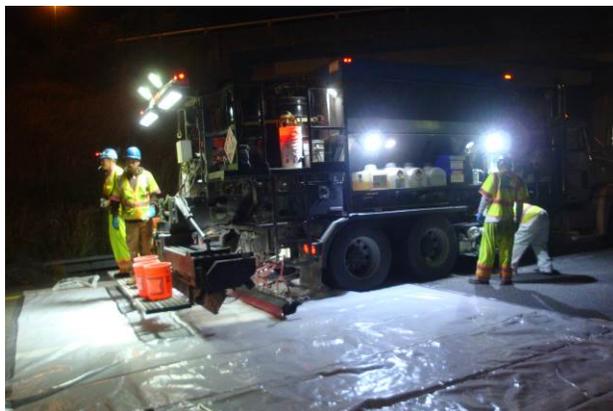
Figure 7. Application vehicle.

The application process is shown in Figures 7-18. The starting area is covered with plastic to prevent spills from contaminating the existing pavement and to provide a starting point for the HFST. The aggregate from the storage tank on the application vehicle is fed by a conveyor to a central bucket (Figure 9). Augers distribute the aggregate across the width of the paver (Figure 10). The two part binder, also carried on the paver (Figure 11), is distributed through a series of hoses to a ribbed plate (Figure 12). The ribbing on the plate distributes the liquid binder evenly across its width. A replaceable plastic squeegee is attached to the bottom of the ribbed plate to prevent wear on the plate (Figure 13). The binder is distributed onto the pavement followed by a curtain of aggregate (Figure 13). Additional aggregate is broadcast by hand onto the HRST to cover any wet spots of binder (Figure 14).

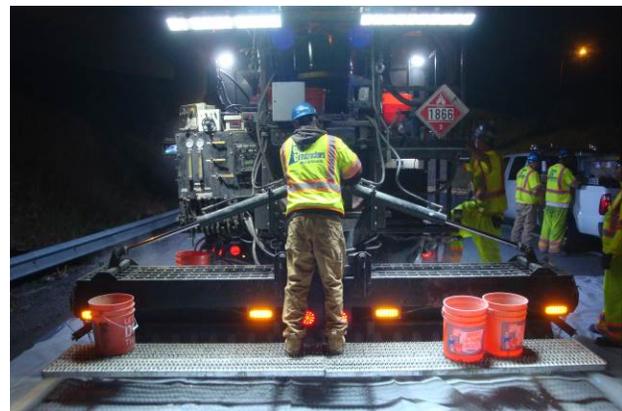
Figure 8. Application vehicle, rear view.

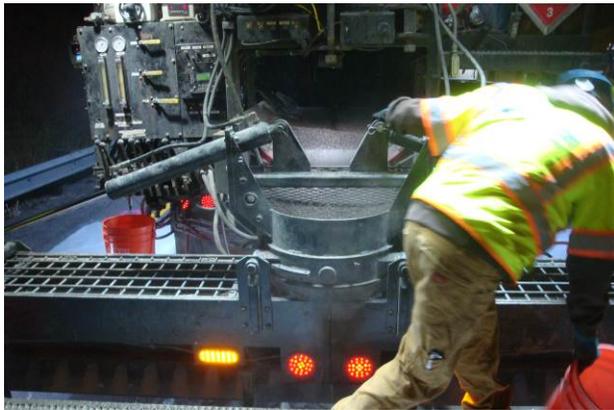
Figure 9. Aggregate bin and circular bucket that service as the source for the augers which distribute the aggregate.

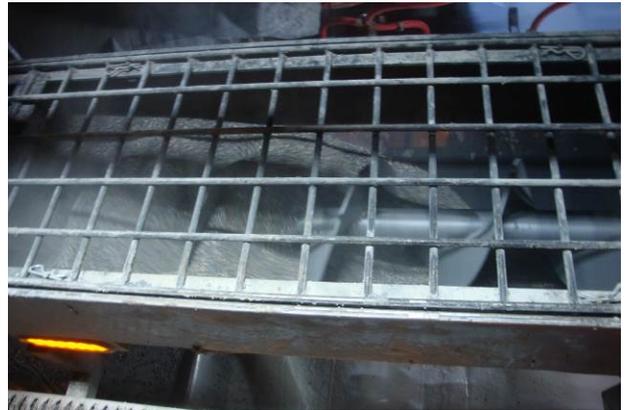
Figure 10. Augers distributing aggregate across the width of the machine.

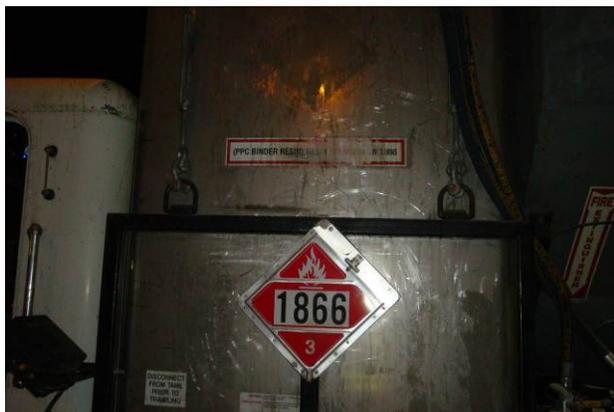
Figure 11. Binder storage tanks.

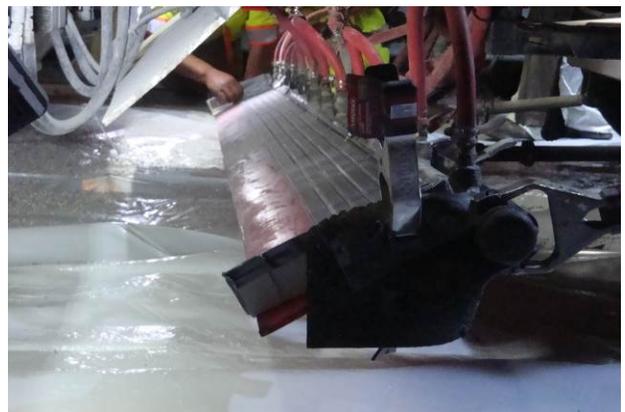
Figure 12. Binder is distributed through a number of rubber hoses to a ribbed plate.

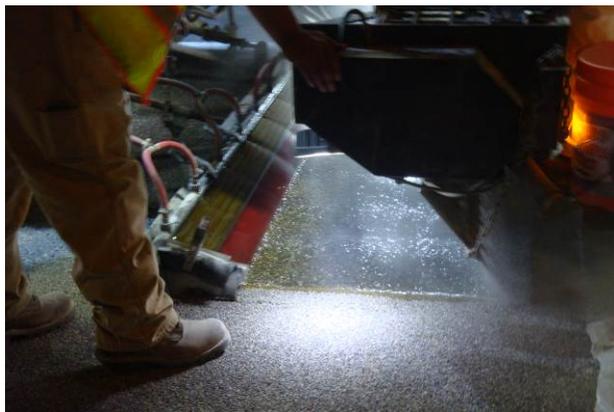
Figure 13. Red plastic squeegee protects ribbed plate from wear. Binder is spread on the pavement followed by a curtain of aggregate.

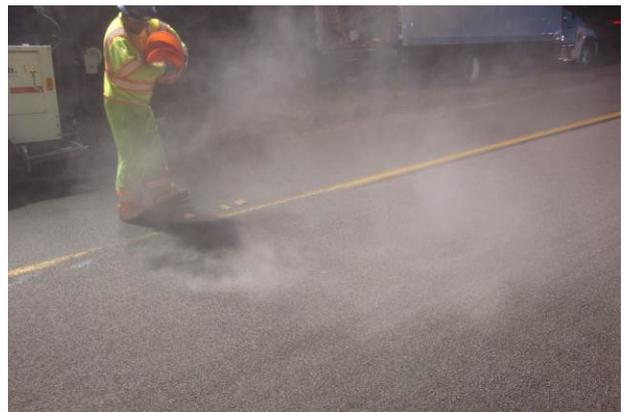
Figure 14. Casting of aggregate onto wet spots to make sure of full coverage of the pavement.

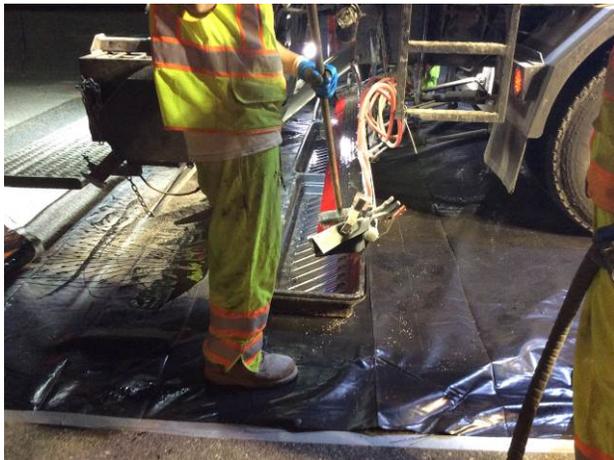
Figure 15. Clean-up operation, brushing excess binder and solvent into plastic trays.

The clean-up operation is shown in Figures 15 and 16. Organic peroxide is circulated through the hoses to remove the binder. Brushes are used to clean the ribbed plate and plastic squeegee (Figure 15). The peroxide and binder residue is collected in trays and then suctioned into a 55 gallon drum for disposal (Figure 16).

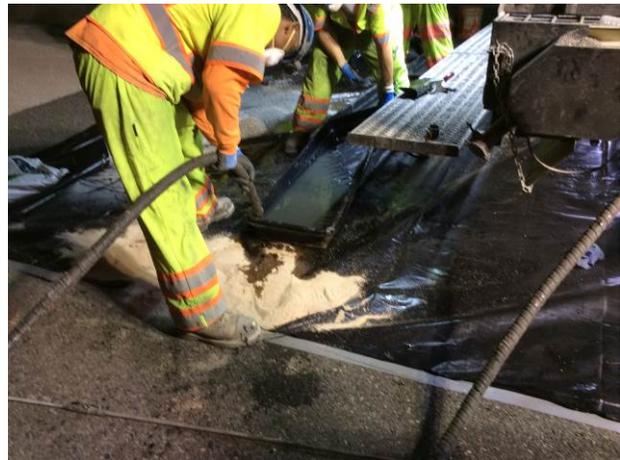
Figure 16. Suctioning excess binder and solvent from the trays.

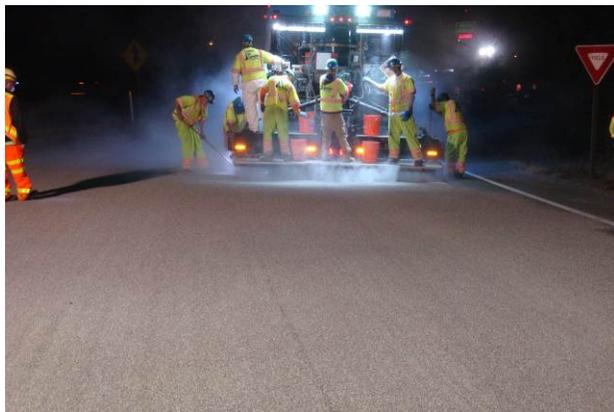
Figure 17. View of the HRST behind the paver on the I-5 section.

The finished HFST from the on-ramp to I-5 is shown in Figures 17-19 and the I-90 section in Figure 20. Note the excellent coverage with no streaking. Table 3 lists important facts concerning the installation.

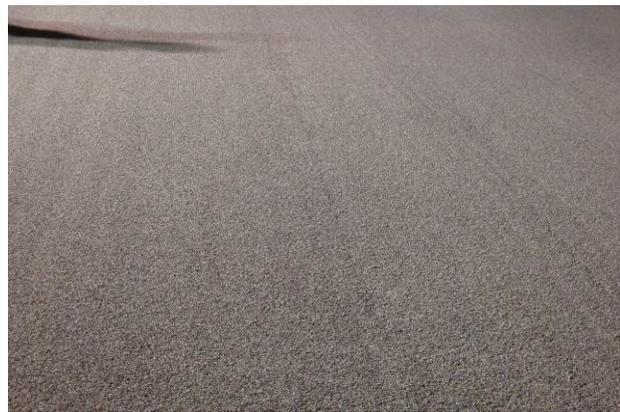
Figure 18. Completed HFST, on-ramp to I-5.

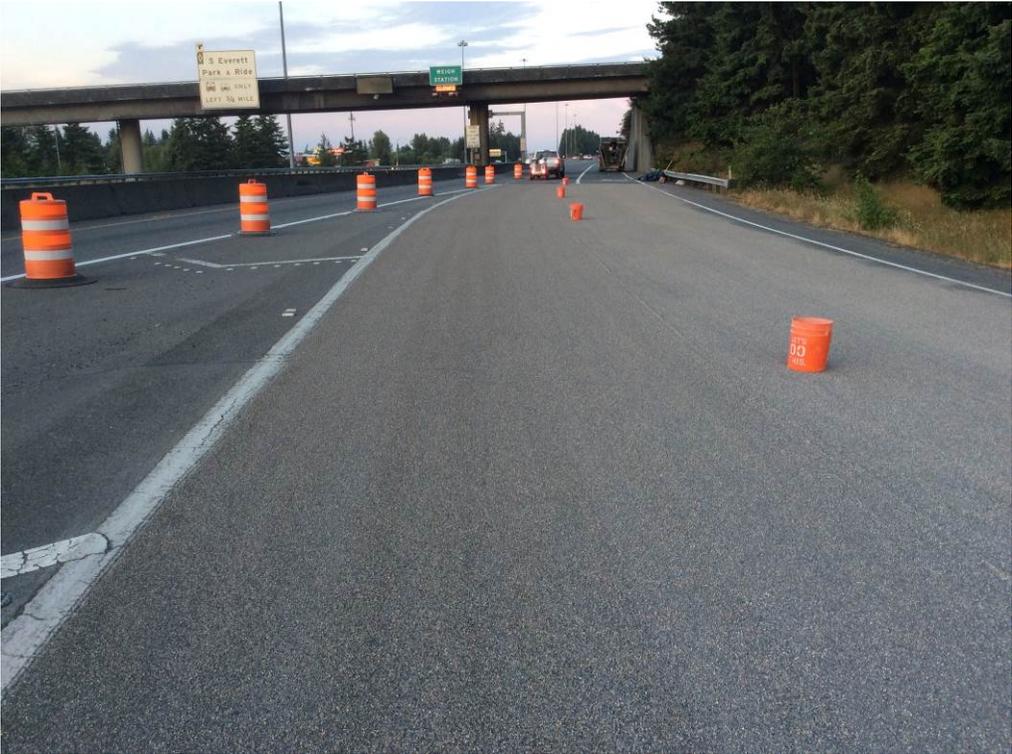
Figure 19. Completed HFST on the ramp to I-5.

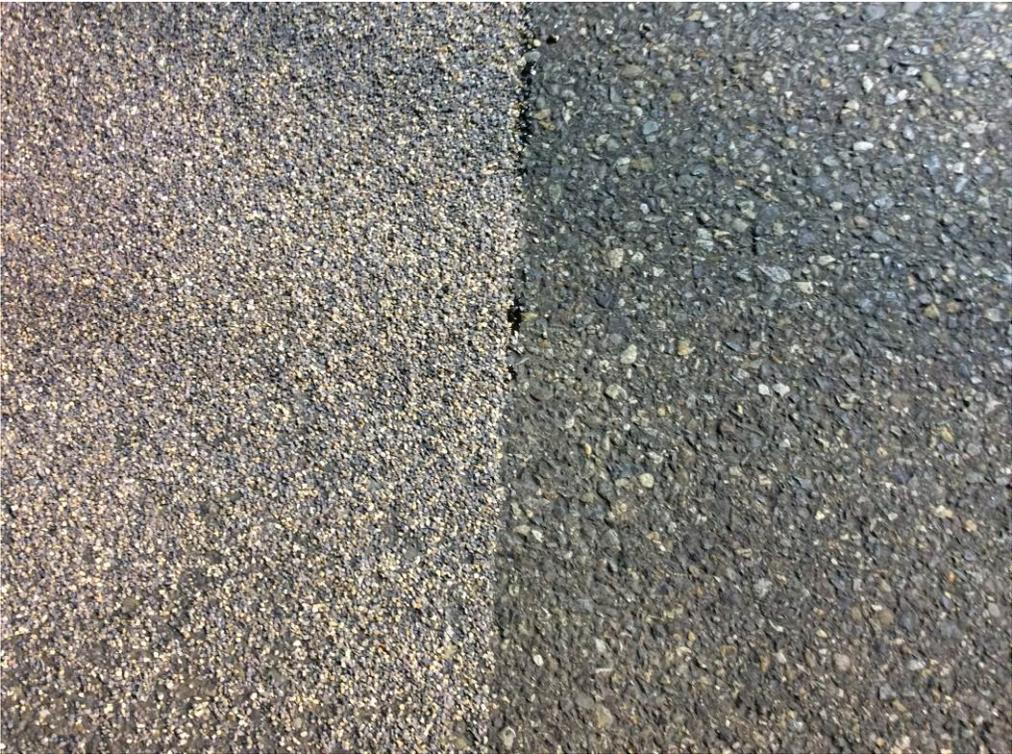
Figure 20. HFST on the left, original HMA on the right, on-ramp to I-90.

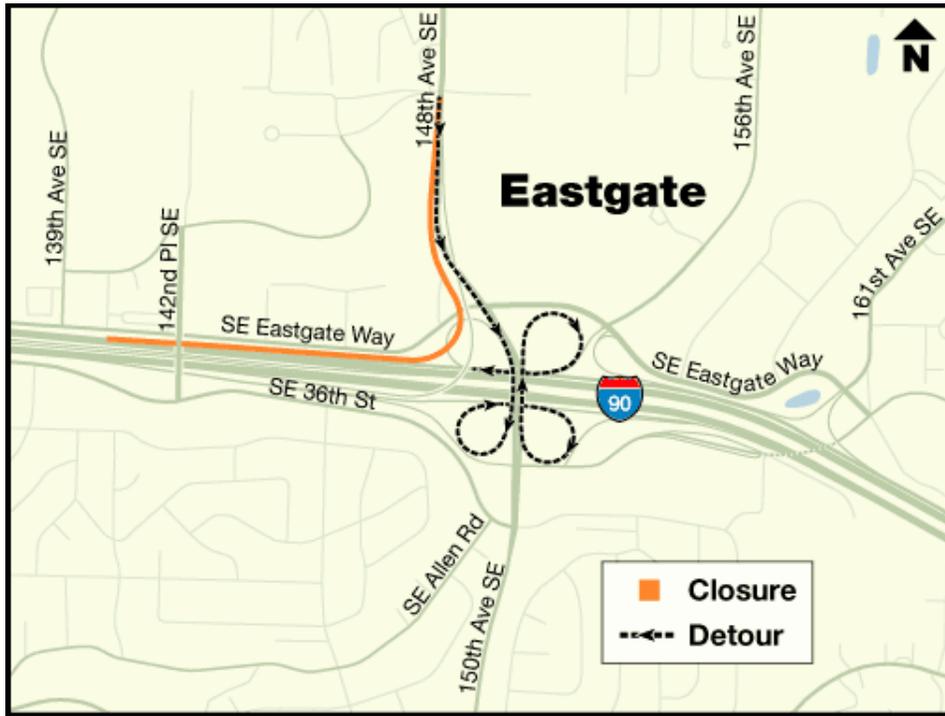
Figure 1. HFST installation on SB 148th Avenue SE on-ramp to I-90 WB.

Two ramps, one on I-90 and one on I-5, will have a High Friction Surface (HFS) applied to the ramps to improve the frictional properties of the pavement. The I-90 section is the on-ramp from 148th Avenue SE to westbound I-90 in Eastgate (Figure 1). The I-5 section is the on-ramp from SR 526 eastbound to I-5 southbound south of Everett (Figure 2). Both on-ramps are high accident locations. WSDOT installed warning signs to alert motorists to the hazard but there is still a high occurrence of accidents. The ramp geometry and type of accidents indicate that increasing the pavement friction may reduce the number of accidents.

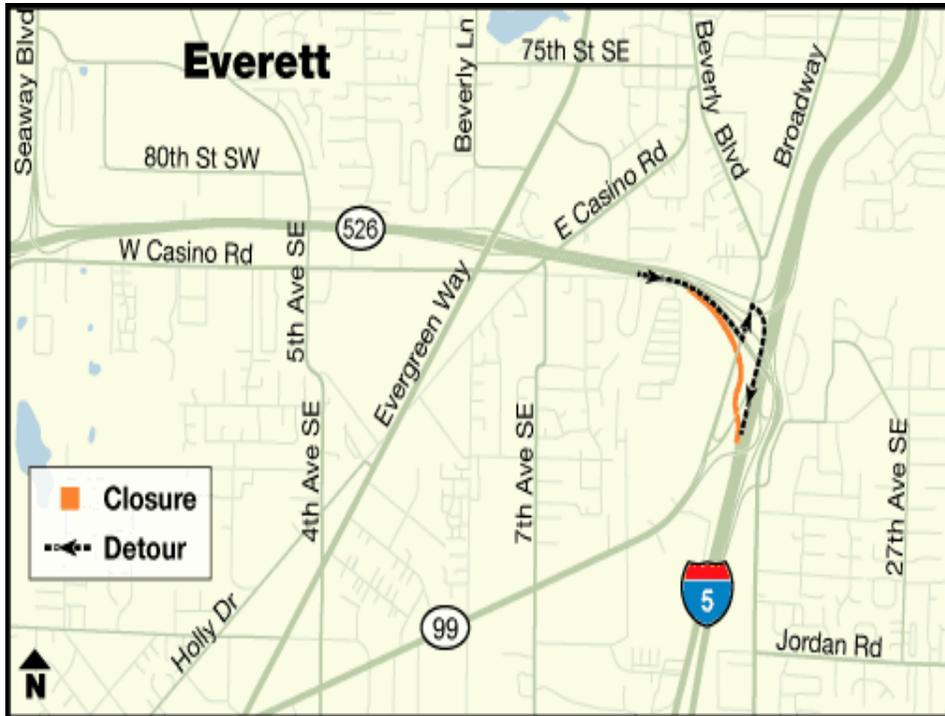
Figure 2. HFST installation on SR 526 eastbound to I-5 SB.
