**SR 532 North Leque Island Slope Protection  
MP 2.96 to MP 3.27 Mitigation Site**

**USACE NWP (13) NWS-2010-968**

**2015 MONITORING REPORT**

# **WETLAND DELINEATION REPORT**

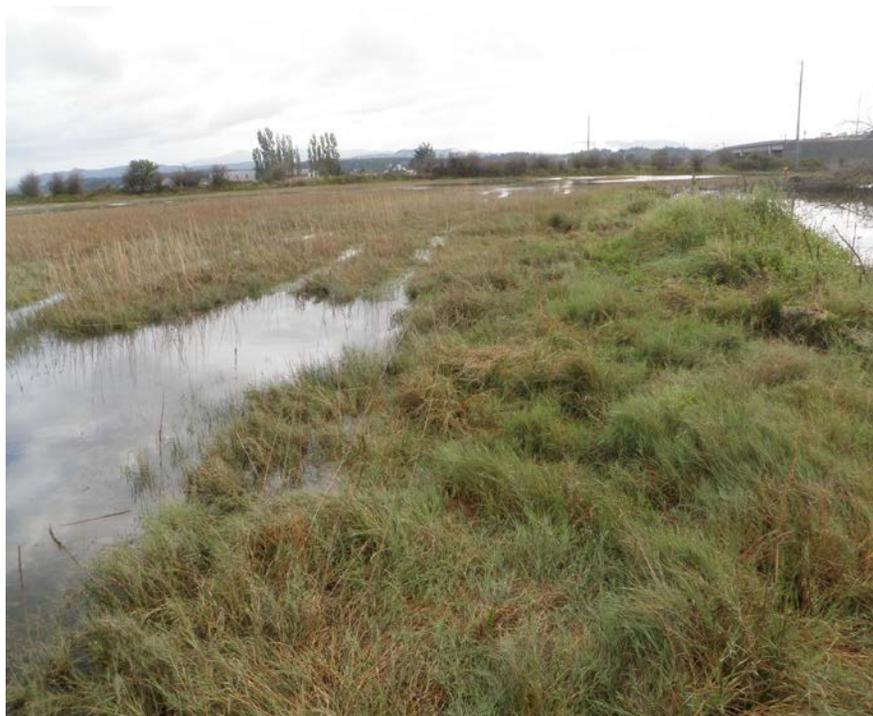
**Figure 1 Site Sketch**

This re-established wetland (Figure 1) is located west of the Mark Clark Bridge along the West Pass of the Stillaguamish River. It is part of the 39 acre Skagit Wildlife Area Refuge owned by the Washington State Department of Fish and Wildlife. This site intended to provide 0.62 acre of mitigation that includes 0.40 acre of wetland re-establishment and 0.22 acre of stream restoration, which included 0.08 acre of stream restoration in lieu of buffer mitigation. Currently, 0.28 acres of wetland re-establishment has occurred. The stream restoration has not occurred to date. The mitigation includes removal of an access road, installation of large woody debris (LWD), and removal of segments of a levee along the perimeter of North Leque Island. The levee removal has been put on hold pending further analysis regarding the Camano Island sole source aquifer.

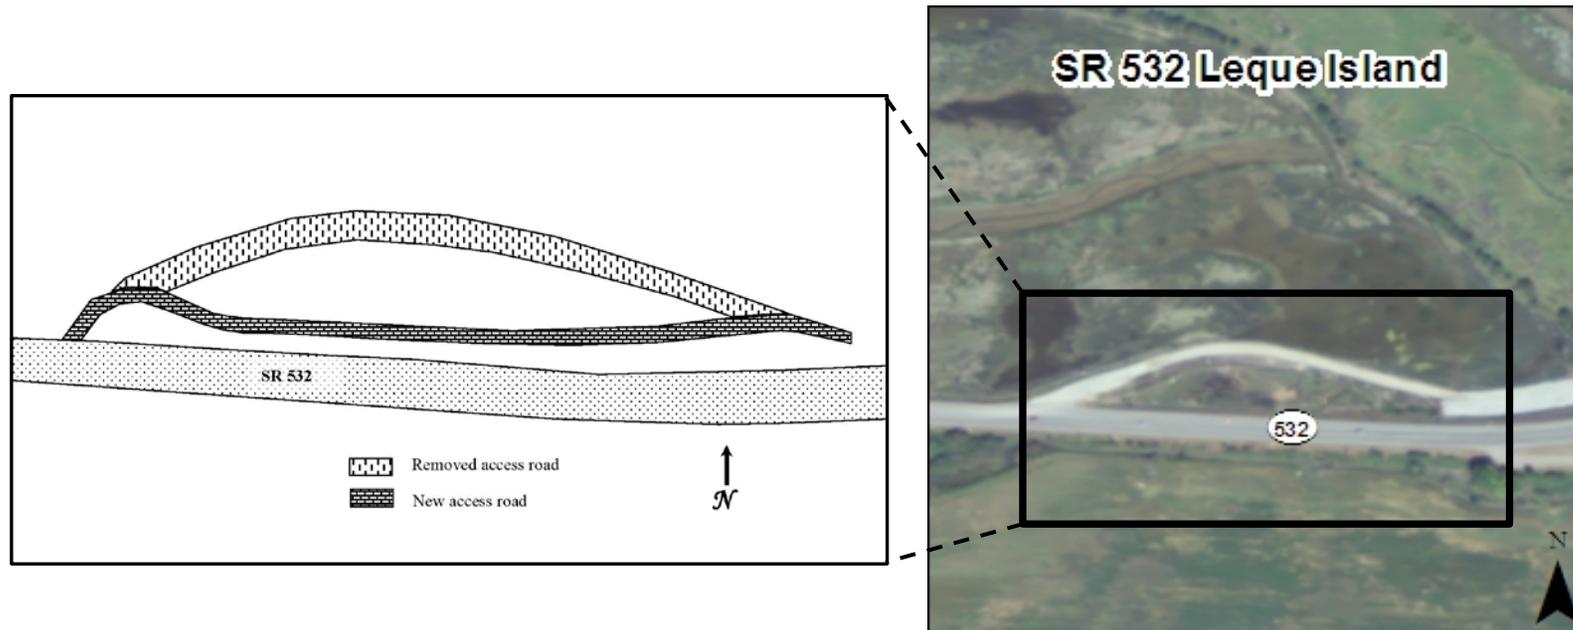
The SR 532 Leque Island Mitigation Site currently consists of the removed access road which will rely on natural recruitment from the large adjacent seed source of native estuarine emergent vegetation to fill in the excavated area over time. Appendix 2 includes site directions.

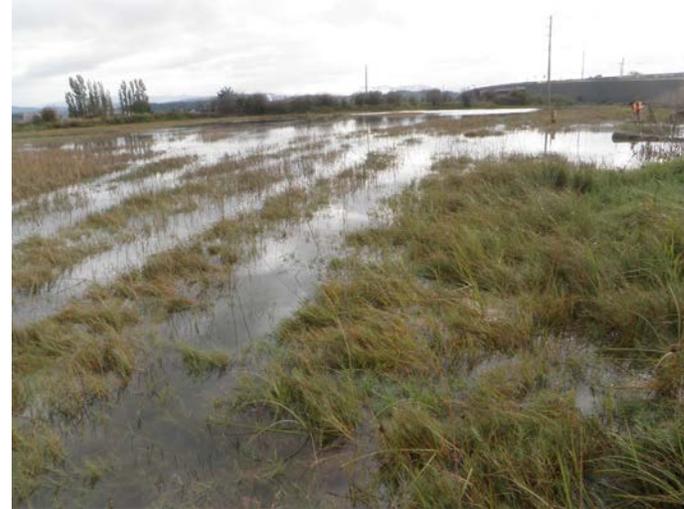
Conductivity was measured just after high tide (Photo 1). Two measurements were taken in different locations. Point 1 was taken in the middle of the restored road and the result was 20 ppt. Point 2 was taken on the west side of the site and the result was 19 ppt. This indicates a mixohaline environment.

**Photo 1**  
**Site just after high tide(Sept 2015)**

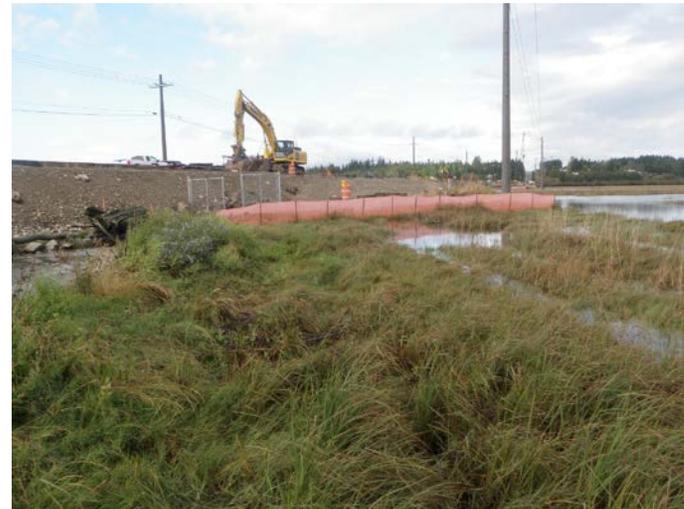
Herbaceous cover is qualitatively estimated at 85 percent (Photo 2). The existing species in the area have recolonized the old road bed and appear to be thriving. Dominant species include inland saltgrass (*Distichlis spicata*) and Lyngbye's sedge (*Carex lyngbyei*).

**Photo 2**  
**Emergent cover in the wetland (Sept 2015)**

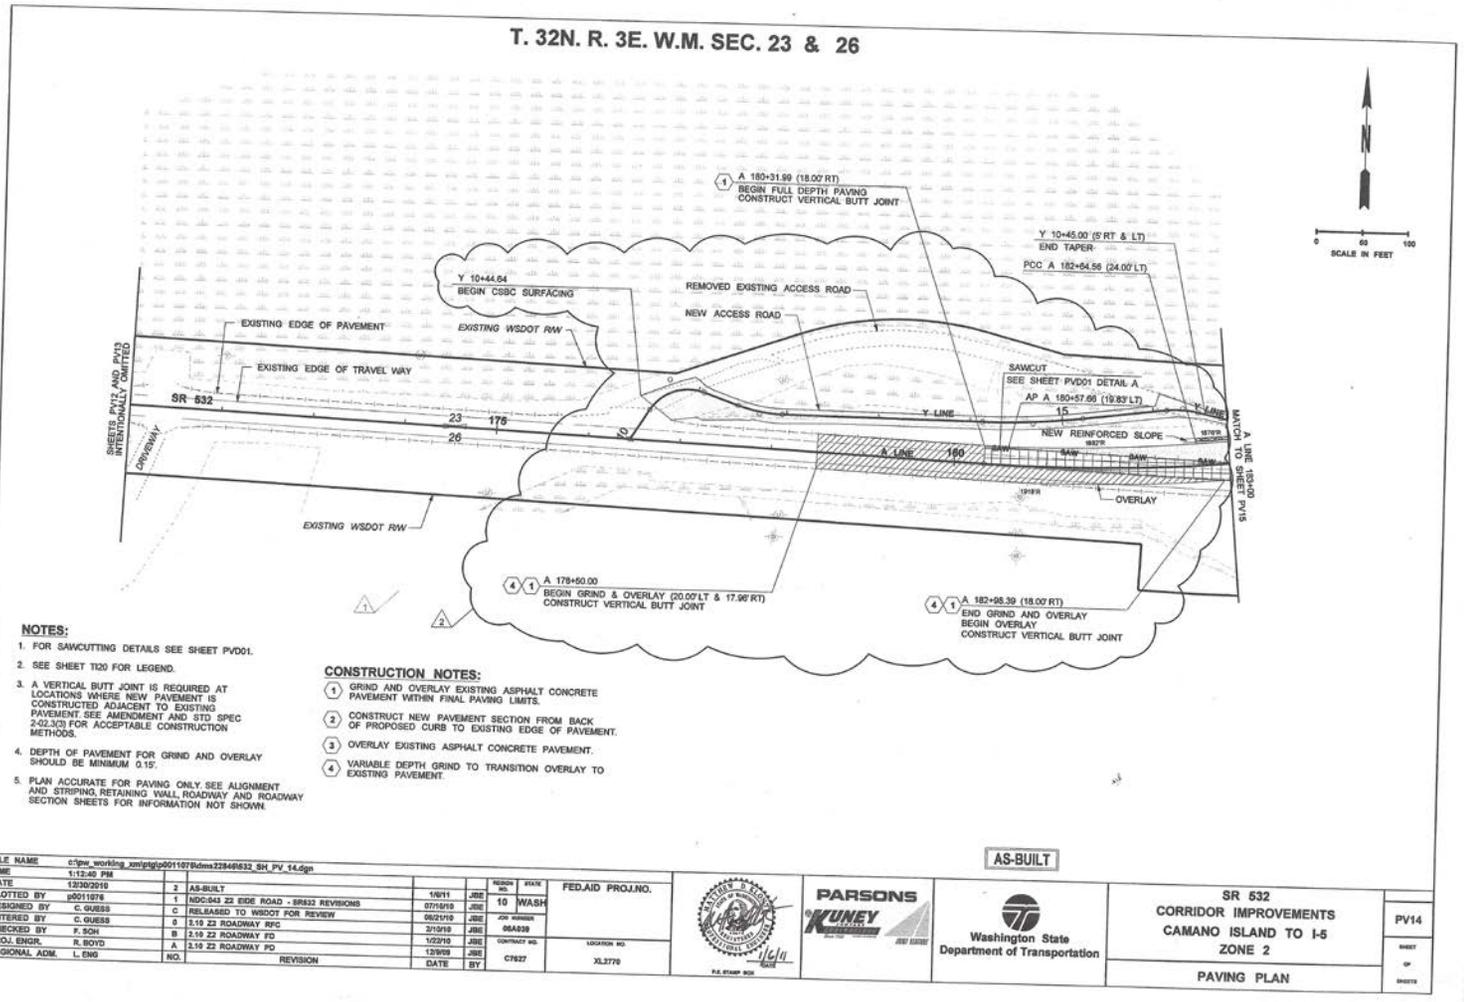
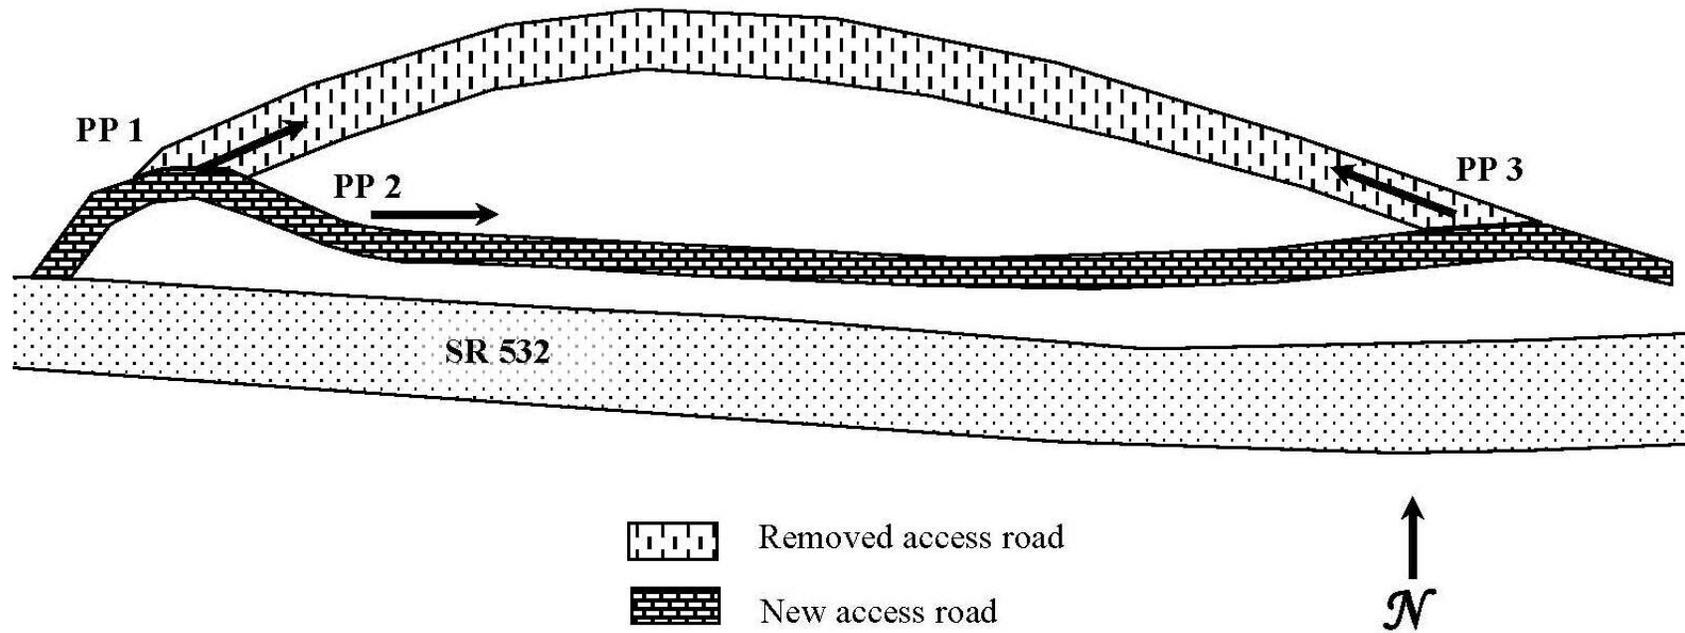
# Appendix 1 – As-Built and Photo Point Map

Appendix 1 shows the As Built (WSDOT 2010).

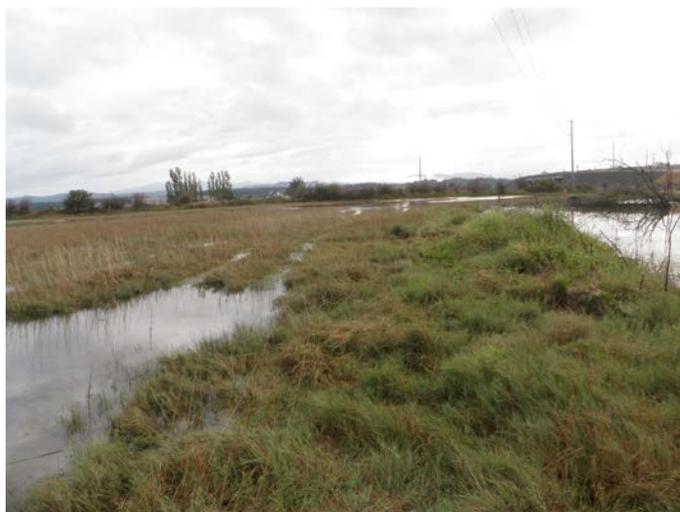
**Photo Point 1**

The photographs below were taken from permanent photo-points on September 2, 2015 and document current site development.

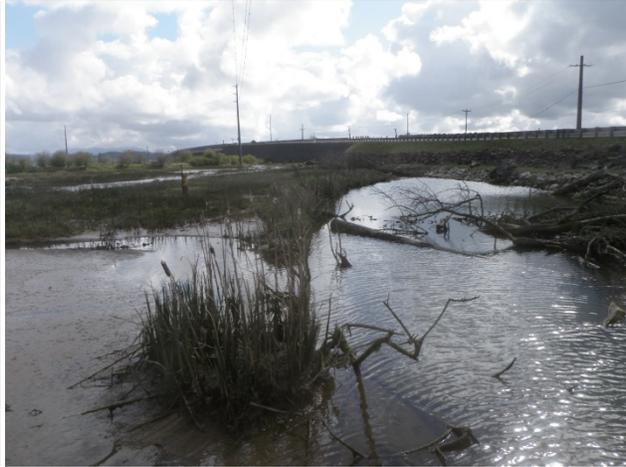
Figure 1. Vicinity Map

| General Information for the SR 532 Leque Island Mitigation Site | | |
|--|--|---|
| <b>Location:</b> | S23, T32N, R3E. Snohomish County. (Vicinity map, Figure 1) | |

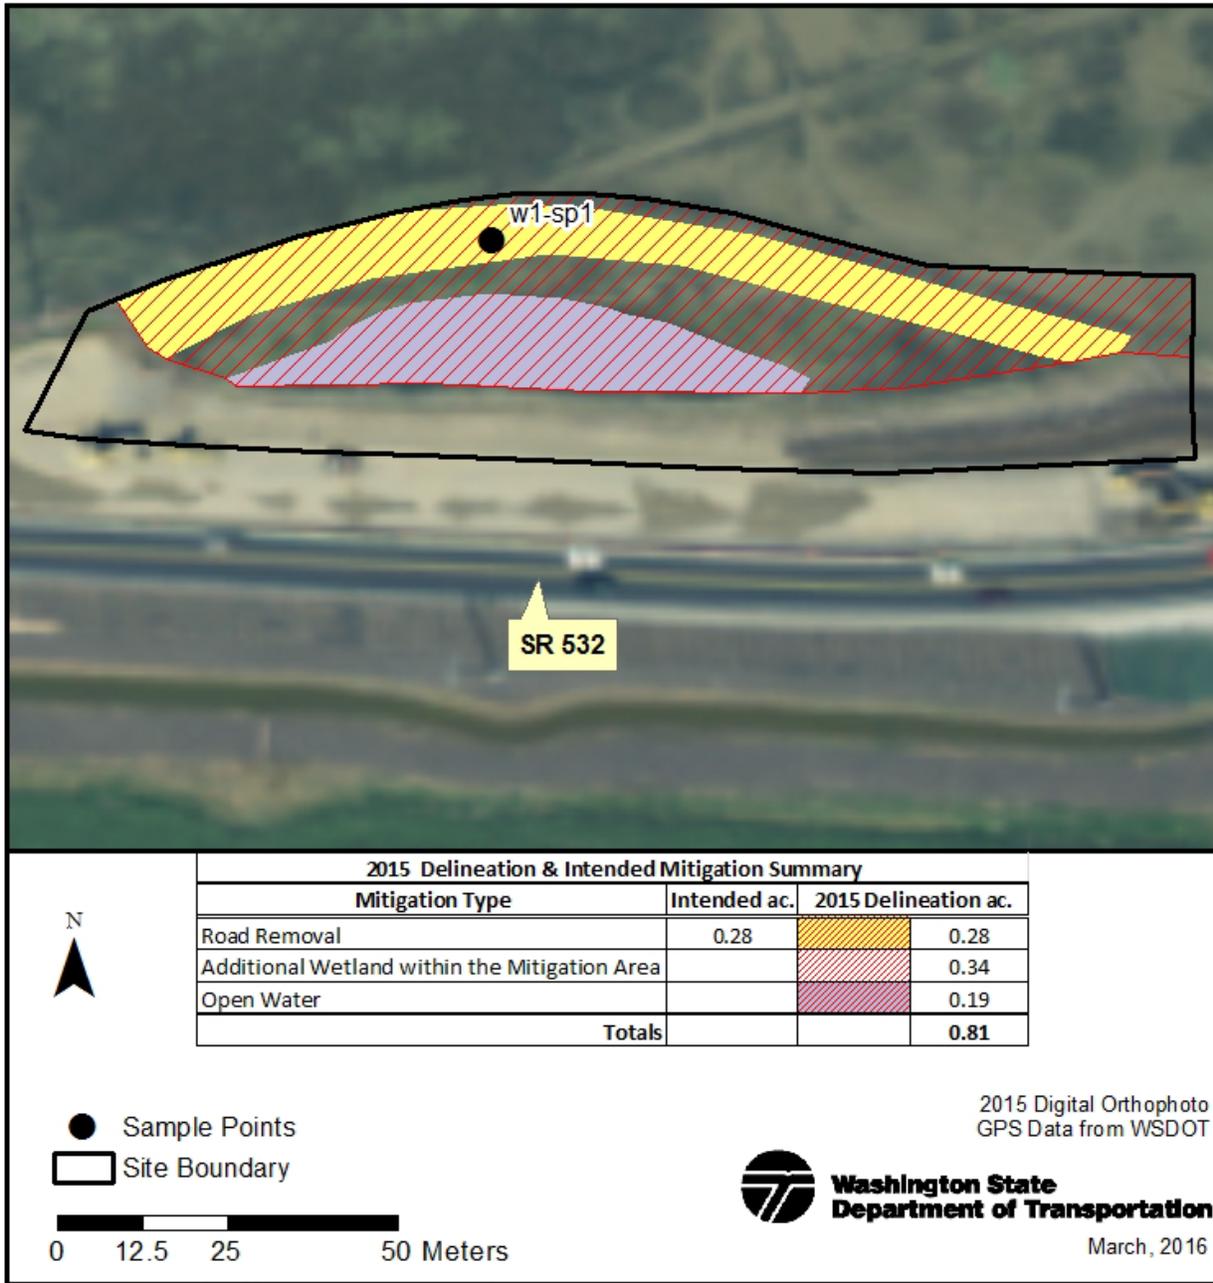
The delineation determined 0.62 acre of estuarine emergent wetland and an additional 0.19 acre of estuarine open water wetland were present within the SR 532 Leque Island Mitigation Site. Delineation data was collected at one sampling point and recorded on a wetland determination data form (Appendix A). A single wetland data point was collected. Typical paired wetland and upland sample points were not collected because the wetland mitigation area is contiguous with adjacent wetlands and is not directly adjacent to upland areas. Data recorded on the wetland determination data form characterizes typical wetland conditions observed on site. Vegetation, soils, and hydrology were examined in several additional sampling locations to determine that the entire site is wetland.

Figure 2. Study area/site boundary in black, wetland boundary in red, and sampling point locations in black.
