# **WETLAND DELINEATION REPORT**

## **SR 502 CORRIDOR WIDENING / I-5 TO BATTLEGROUND**

Clark County, WA

Washington State  
Department of Transportation

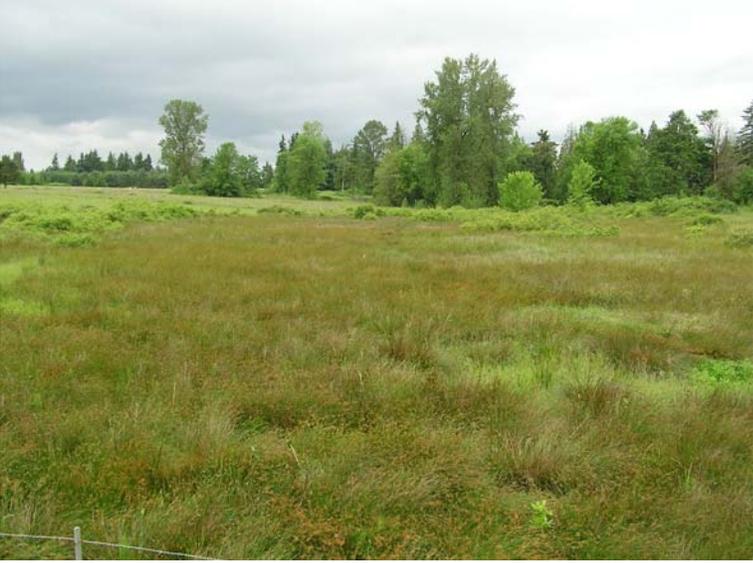
<b>Ecology Rating</b>	II	<b>Clark Co. Rating</b>	II	<b>Cowardin Classification</b>	PEM	<b>HGM Classification</b>	RIV	<b>WRIA</b>	27
	<b>Ecology Rating</b>	II									
	<b>Clark Co. Rating</b>	II									
	<b>Cowardin Classification</b>	PEM									
	<b>HGM Classification</b>	RIV									
<b>WRIA</b>	27										
<p><b>Dominant Vegetation</b></p> <p><i>Agrostis capillaris</i> (colonial bentgrass) FAC  <i>Juncus effusus</i> (soft rush) FACW</p>											
<p>Percent of Dominant Species that are OBL, FACW or FAC (excluding FAC-)</p>	100%										
<p><b>Wetland NA, looking north</b></p>											
<p><b>Description/Vegetation</b></p> <p>Wetland NA is a palustrine, emergent (PEM) wetland located north of SR 502 and west of 21<sup>st</sup> Avenue. The wetland is in a headwater position within the watershed and supports an intermittent, unnamed tributary that flows north to Gee Creek. Wetland NA extends beyond the project boundaries to the north and is part of a larger wetland complex that has palustrine, forested (PFO), palustrine scrub-shrub (PSS), and palustrine emergent vegetation (PEM) classes. Historically Wetland NA and SA were one wetland complex, but the construction of SR 502 bisected the wetland and disrupted the hydrologic connection. Heavy grazing was observed in and adjacent to the wetland, and was responsible for the composition of the vegetation community.</p>											
<p><b>Soils</b></p> <p>The soil sampled in Wetland NA exhibited a low chroma matrix and redoximorphic features within 10 inches of the surface. These characteristics are evidence that the soils in the wetland are saturated and/or inundated for a duration sufficient to promote anaerobic conditions, therefore meeting the hydric soil criterion.</p>											
<p><b>Hydrology</b></p> <p>Wetland hydrology was provided by overland flow from adjacent uplands, a seasonally shallow water table, precipitation, and from a culvert carrying surface water from Wetland SA. At the time of field investigation, areas of the wetland were inundated and/or saturated to the surface and free water was observed in the soil pit at a depth of 13 inches. These findings demonstrate the area has sufficient saturation and/or ponding during the growing season to satisfy the wetland hydrology criterion. An intermittent creek was observed flowing from south to north through the wetland, eventually discharging into Gee Creek.</p>											
<p><b>Rating/Functions</b></p> <p>Wetland NA ranked as a Category II under Ecology's 4-tier rating system (Appendix C). Water Quality Functions scored much lower than the scores for Hydrologic Functions and Habitat Functions. This is largely due to the continuous cattle grazing in the wetland, which periodically removes a significant portion of the vegetation allowing surface water to flow across the wetland into the intermittent creek with minimal frictional resistance. Wetland NA has considerable floodwater storage capacity due to its overall width and size in comparison to the intermittent creek system, although heavy grazing does limit the ability of the wetland to slow down water velocities, and reduce the potential for erosive flows. Therefore, the wetland only provides a moderate level of Hydrologic Functions. The interspersed habitats, variety of water regimes, richness of plant species, connectivity to other undisturbed areas, and overall size of the wetland provide considerable Habitat Functions. Wetland NA and Wetland SA were historically one wetland, but were bisected by the construction of SR 502. The wetlands are not rated as one wetland because a level surface water connection between the two does not exist. The culvert connecting the wetlands appears to have an elevation gradient of greater than 6 inches and water flows through the culvert in one direction, from south to the north.</p>

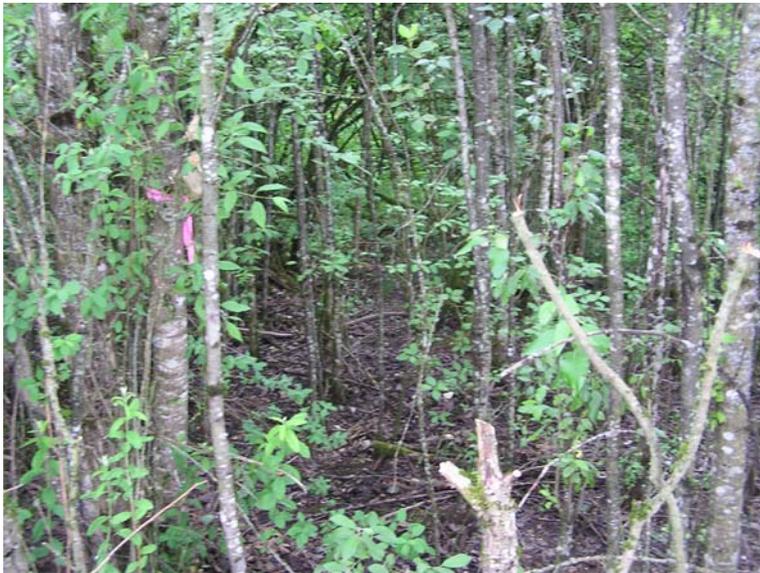
**Wetland NB**

<b>Ecology Rating</b>	III
<b>Clark Co. Rating</b>	III
<b>Cowardin Classification</b>	PFO
<b>HGM Classification</b>	DEP
<b>WRIA</b>	27

The soil sampled in Wetland NB exhibited a low chroma matrix and redoximorphic features within 10 inches of the surface. These characteristics are evidence that the soils in the wetland are saturated and/or inundated for a duration sufficient to promote anaerobic conditions, therefore meeting the hydric soil criterion.

Hydrology was principally provided by groundwater, precipitation, and localized overland flow. Field investigations suggest the wetland is seasonally saturated to the soil surface and rarely inundated. Wetland NB was hydrologically isolated from other nearby wetlands. All areas of the wetland were saturated to the surface during the March 9, 2005 site visit. Standing water was observed 6 inches below the surface in the soil pit, suggesting that this site has sufficient saturation during the growing season to satisfy the wetland hydrology criterion.

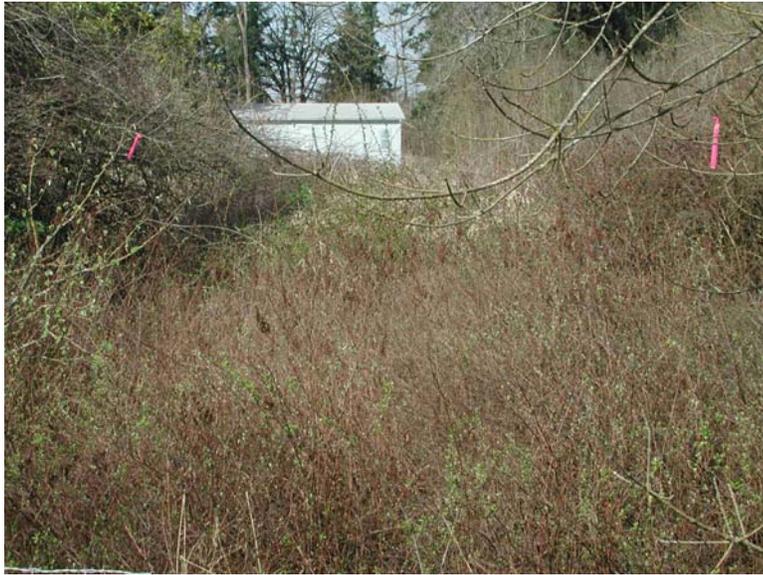
**Wetland NC**

Wetland NC, looking north

Soils were assumed to be hydric based on indications provided by the wetland vegetation community, topography, and saturated soil conditions at this location.

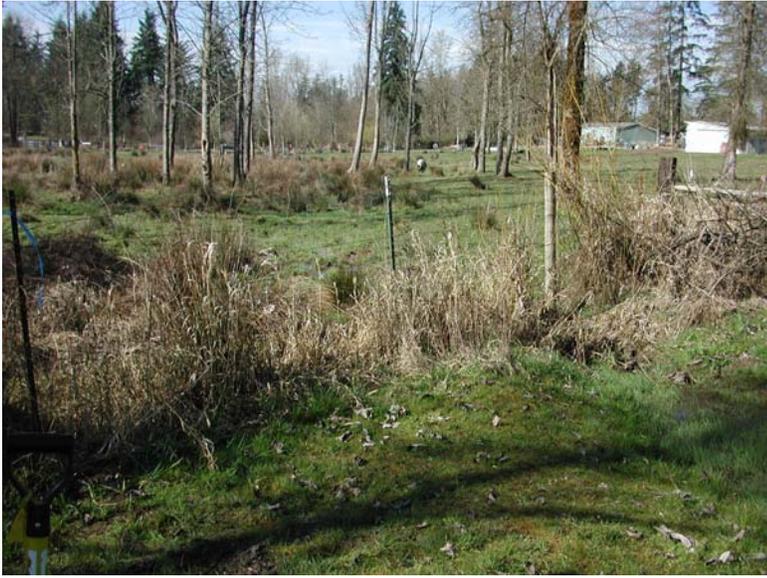
**Wetland ND & NE**

Wetland ND and NE, looking northwest

The soil sampled in Wetlands ND and NE exhibited a low chroma matrix and redoximorphic features within 10 inches of the surface. These characteristics are evidence that the soils in the wetland are saturated and/or inundated for a duration sufficient to promote anaerobic conditions, therefore meeting the hydric soil criterion.

Wetland hydrology was provided by overland flow from adjacent uplands, precipitation, a seasonally shallow water table, and from roadside ditch discharge. At the time of field investigation, areas of the wetland were inundated and/or saturated to the surface and free water was observed in the soil pit at a depth of 10 inches at ND-DW1 and at a depth of 14 inches at NE-DW1. These findings demonstrate the area has sufficient saturation and/or ponding during the growing season to satisfy the wetland hydrology criterion. An intermittent creek was observed flowing from south to north through the wetland, eventually discharging into Gee Creek.

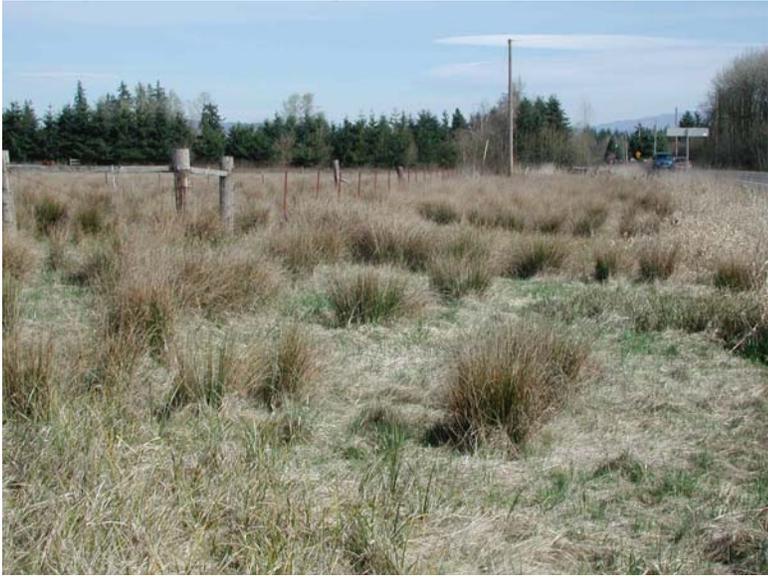
Wetland NF and SI

<b>Ecology Rating</b>	III	<b>Clark Co. Rating</b>	II	<b>Cowardin Classification</b>	PEM&PFO	<b>HGM Classification</b>	DEP	<b>WRIA</b>	27
	<b>Ecology Rating</b>	III									
	<b>Clark Co. Rating</b>	II									
	<b>Cowardin Classification</b>	PEM&PFO									
	<b>HGM Classification</b>	DEP									
<b>WRIA</b>	27										
<p><b>Dominant Vegetation</b></p> <p><u>Wetland NF (PEM)</u>  <i>Juncus effusus</i> (soft rush) FACW  <i>Agrostis capillaris</i> (colonial bentgrass) FAC  <i>Lolium arundinaceum</i> (tall fescue) FAC-</p> <p><u>Wetland SI (PFO)</u>  <i>Fraxinus latifolia</i> (Oregon ash) FACW  <i>Betula papyrifera</i> (paper birch) FAC  <i>Cornus sericea</i> (red-osier dogwood) FACW  <i>Lonicera involucrata</i> (twinberry) FAC+  <i>Carex obnupta</i> (slough sedge) OBL</p>											
Percent of Dominant Species that are OBL, FACW or FAC (excluding FAC-)	88%										
Wetland NF, looking east											
<p><b>Description/Vegetation</b></p> <p>Wetland NF is a palustrine, emergent (PEM) wetland and wetland SI is a palustrine, forested (PFO) wetland located north and south of SR 502 respectively and east of 29<sup>th</sup> Avenue. The wetlands were historically one wetland complex and are connected by a culvert that provides a level surface water connection between the two parts. Wetland NF was intensively grazed at the time of field investigation. A <i>Trillium</i> sp. was observed in Wetland SI, but was unable to be identified to the species level due to the time of the growing season. A follow up investigation is recommended in order to determine if the specie observed was the state sensitive <i>Trillium parviflorum</i>.</p>											
<p><b>Soils</b></p> <p>The soil sampled in Wetlands NF and SI exhibited a low chroma matrix and redoximorphic features within 10 inches of the surface. These characteristics are evidence that the soils in the wetlands are saturated and/or inundated for a duration sufficient to promote anaerobic conditions, therefore meeting the hydric soil criterion.</p>											
<p><b>Hydrology</b></p> <p>Wetland hydrology was provided by overland flow from adjacent uplands, precipitation, a seasonally shallow water table, and from roadside ditch discharge. At the time of field investigation, drainage patterns were observed in Wetland SI, areas of both wetlands were inundated and/or saturated to the surface and free water was observed in the soil pit at a depth of 3 inches in Wetland SI and 13 inches in NF. These findings demonstrate the areas have sufficient saturation and/or ponding during the growing season to satisfy the wetland hydrology criterion. A culvert provides a level surface water connection between the two wetlands.</p>											
<p><b>Rating/Functions</b></p> <p>Wetlands NF and SI were scored as one wetland, and ranked as a Category III wetland under Ecology's 4-tier rating system (Appendix C). Scores for the broad categories of Water Quality Functions, Hydrologic Functions, and Habitat Functions were relatively even. Although onsite grazing provides ample opportunity for Water Quality Function, potential is limited due to the relatively low cover of ungrazed vegetation, and low degree to which the site impounds water. Hydrologic Functions are low to moderate due to the shallow depth of water storage and the wetlands connectivity to roadside ditches. Habitat Functions are limited due to the proximity of the wetlands to residential developments and roadways. The various water regimes of Wetland NF and the structural complexity of the vegetation in Wetland SI contribute some Habitat Functions to the overall wetland complex.</p>

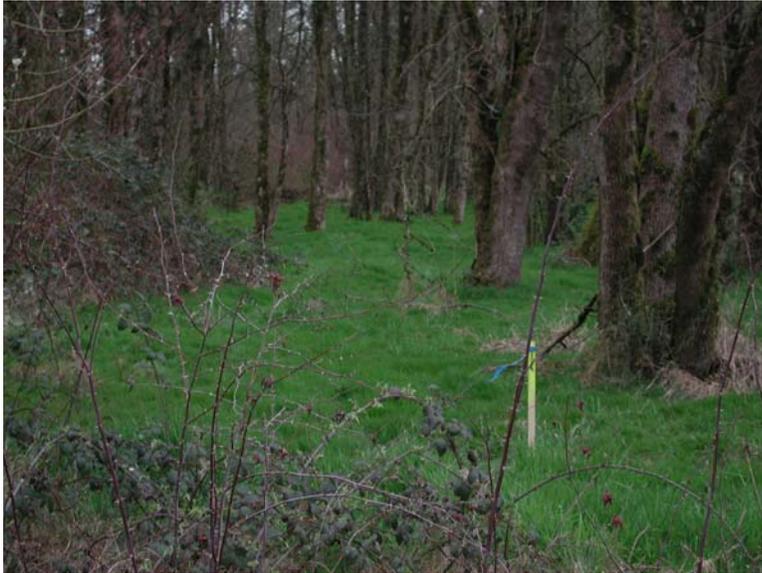
**Wetland NG & NH**

Wetland NH, looking north

The soil sampled in Wetlands NG and NH exhibited a low chroma matrix and redoximorphic features within 10 inches of the surface. These characteristics are evidence that the soils in the wetland are saturated and/or inundated for a duration sufficient to promote anaerobic conditions, therefore meeting the hydric soil criterion.

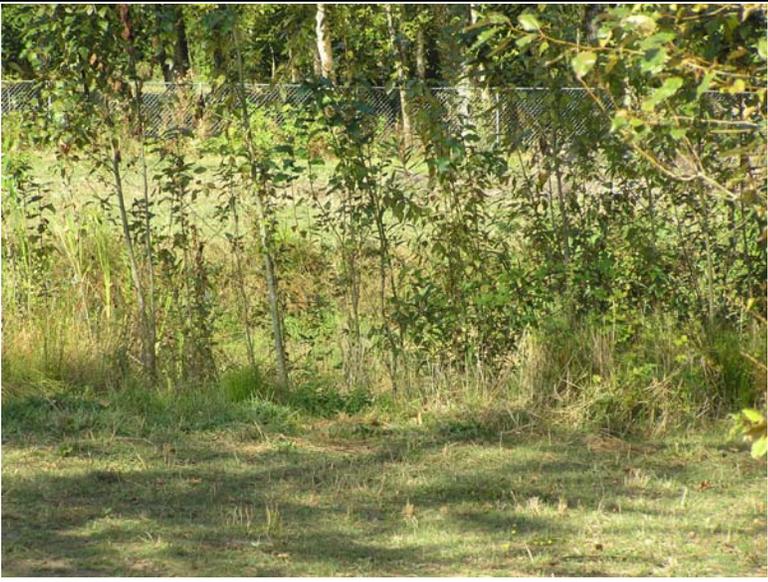
<b>Ecology Rating</b>	IV
	<b>Clark Co. Rating</b>	IV
	<b>Cowardin Classification</b>	PEM
	<b>HGM Classification</b>	DEP
	<b>WRIA</b>	27
<p><b><u>Dominant Vegetation</u></b></p> <p><i>Phalaris arundinacea</i> (reed canary grass) FACW  <i>Populus balsamifera</i> (black cottonwood) FAC</p>		
<p>Percent of Dominant Species that are OBL, FACW or FAC (excluding FAC-)</p>		100%
<p>Wetland NGG, looking north</p>		
<p><b>Description/Vegetation</b></p> <p>Wetland NGG is a small, isolated, palustrine emergent (PEM) fringe wetland located north of SR 502, west of 29<sup>th</sup> Avenue, and just south of Wetland NG. The wetland encircles an excavated, permanently inundated pond. The landscape surrounding the wetland has been graded/disturbed through earth moving activity and was heavily grazed by Pygmy goats.</p>		
<p><b>Soils</b></p> <p>The soil sampled in Wetland NGG exhibited a low chroma matrix and redoximorphic features within 10 inches of the surface. These characteristics are evidence that the soils in the wetland are saturated and/or inundated for a duration sufficient to promote anaerobic conditions, therefore meeting the hydric soil criterion.</p>

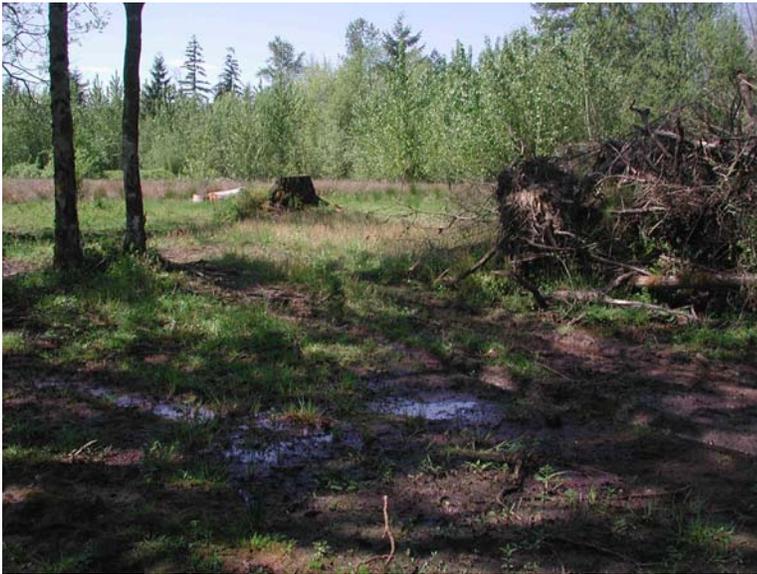
**Wetland NI & NJ**

Wetland NJ, looking northwest

Wetlands NI and NJ are located north of SR 502 and east of 37th Avenue. They are both part of a large wetland complex that extends beyond the project boundary to the north. Wetland NI is a palustrine, emergent (PEM) wetland that is bordered to the west by a single-family residence. Wetland NJ is a palustrine, forested (PFO) and palustrine, emergent (PEM) wetland complex that has recently been cleared/disturbed, and large debris piles were observed throughout the wetland. The wetland delineation was conducted using notes from a previous wetland report.

The soil sampled in Wetlands NI and NJ exhibited a low chroma matrix and redoximorphic features within 10 inches of the surface. These characteristics are evidence that the soils in the wetland are saturated and/or inundated for a duration sufficient to promote anaerobic conditions, therefore meeting the hydric soil criterion.

Wetland hydrology was provided by overland flow from adjacent uplands, precipitation, and a seasonally shallow water table. Areas of inundation and/or surface saturation were observed throughout the wetlands on March 21, 2005. The presence of drainage patterns and sediment deposits in the wetland were primary indicators of wetland hydrology; water-stained leaves were noted as a secondary indicator. These findings suggest there is sufficient saturation and/or ponding during the growing season to satisfy the wetland hydrology criterion.

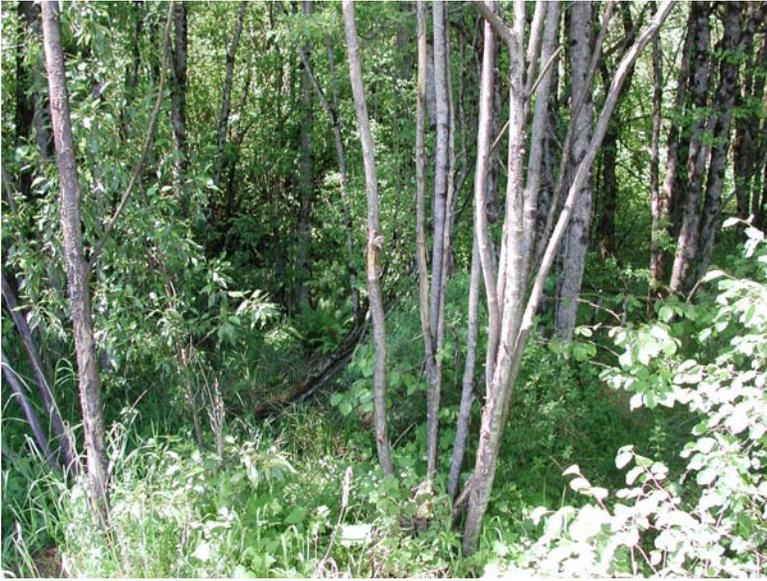
<b>Ecology Rating</b>	III	<b>Clark Co. Rating</b>	II	<b>Cowardin Classification</b>	PFO & PEM	<b>HGM Classification</b>	DEP	<b>WRIA</b>	27
	<b>Ecology Rating</b>	III									
	<b>Clark Co. Rating</b>	II									
	<b>Cowardin Classification</b>	PFO & PEM									
	<b>HGM Classification</b>	DEP									
<b>WRIA</b>	27										
<p><b>Dominant Vegetation</b></p> <p>Wetland NK-DW1 (PFO)  <i>Carex obnupta</i> (slough sedge) OBL  <i>Lysichiton americanus</i> (skunkcabbage) OBL  <i>Fraxinus latifolia</i> (Oregon Ash) FACW  <i>Cornus sericea</i> (red-osier dogwood) FACW  <i>Physocarpus capitatus</i> (Pacific ninebark) FACW</p> <p>Wetland NK-DW2 (PEM)  <i>Veronica americana</i> (American speedwell) OBL  <i>Ranunculus repens</i> (creeping buttercup) FACW  Unidentifiable grass</p>											
Percent of Dominant Species that are OBL, FACW or FAC (excluding FAC-)	100%										
Wetland NK, looking south											
<p><b>Description/Vegetation</b></p> <p>Wetland NK is a palustrine, forested (PFO) and emergent vegetation (PEM) wetland complex located north of SR 502 and west of 50th Avenue. The wetland is in a headwater position within the watershed with an intermittent stream running within its boundaries to the north. The area has been heavily disturbed through grazing and land clearing, and a large manure pile is situated within the wetland boundaries. Historically Wetland NK and SN were one wetland complex, but the construction of SR 502 bisected the wetland.</p>											
<p><b>Soils</b></p> <p>The soil sampled in Wetland NK exhibited a low chroma matrix and redoximorphic features within 10 inches of the surface. These characteristics are evidence that the soils in the wetland are saturated and/or inundated for a duration sufficient to promote anaerobic conditions, therefore meeting the hydric soil criterion.</p>											
<p><b>Hydrology</b></p> <p>Wetland hydrology is provided by overland flow from adjacent uplands, precipitation, and a seasonally shallow water table. Hydrology also enters the site from Wetland SN via a culvert beneath SR 502. At the time of field investigation, all areas of the wetland were inundated or saturated within 12 inches of the soil surface. Free water was observed in the soil pit at NK-DW1 12 inches below the surface. Drainage patterns provided another primary indicator of wetland hydrology. These findings demonstrate the area has sufficient saturation and/or ponding during the growing season to satisfy the wetland hydrology criterion.</p>											
<p><b>Rating/Functions</b></p> <p>Wetland NK ranked as a Category II under Ecology's 4-tier rating system (Appendix C). Water Quality Functions received a moderate score due to the prevalence of water quality improving vegetation and the relative absence of depressional areas that would assist in trapping of pollutants. This wetland received the highest possible rating for Hydrologic Functions. The dense, velocity reducing vegetation and the large amount of over bank storage relative to the stream channel are characteristics that contribute to this wetland's significant hydrologic function. Habitat Functions were rated moderately. Varied water regimes and multiple vegetation classes are elements of this wetland that contribute to habitat functions. Wetland NK and Wetland SN were historically one wetland, but were bisected by the construction of SR 502. The wetlands are not rated as one wetland because a level surface water connection between the two does not exist. The culvert connecting the wetlands appears to have an elevation gradient of greater than 6 inches and water flows in one direction, from south to the north.</p>

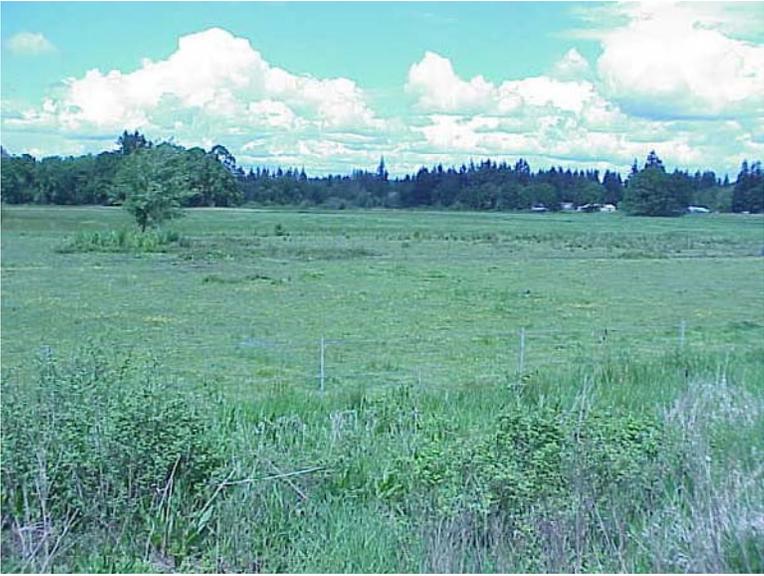
Wetland NN/SU

<b>Ecology Rating</b>	I
	<b>Clark Co. Rating</b>	I
	<b>Cowardin Classification</b>	PEM
	<b>HGM Classification</b>	RIV
	<b>WRIA</b>	27 & 28
	<p><b>Dominant Vegetation</b></p> <p><i>Poa annua</i> (annual bluegrass) FAC  <i>Ranunculus repens</i> (creeping buttercup) FACW  <i>Juncus effusus</i> (soft rush) FACW</p>	
Percent of Dominant Species that are OBL, FACW or FAC (excluding FAC-)	100%	
Wetland NN, looking northeast		
<b>Description/Vegetation</b>		
<p>Wetlands NN and SU are palustrine, emergent (PEM) wetlands located on both sides of SR 502 that begin approximately 1000' west of 72<sup>nd</sup> Avenue. The wetland complex inhabits two WRIA's (27 &amp; 28) and extends beyond the project boundaries both to the north and south, and is part of a larger wetland area. An unnamed tributary flows through the wetland and is carried under SR 502 by a gated box culvert. The water observed in the culvert appeared to be level on both sides of the road, and according to the WRIA line was flowing both to the north and the south. The northward flowing unnamed tributary eventually discharges into the East Fork of the Lewis River, and the southward flowing tributary discharges into Mill Creek. The wetland was being used as pasture for a variety of livestock, mainly horses. The eastern edge of the northern wetland has been filled to create a horse corral, and the eastern edge of the southern wetland has been filled, but was not being utilized at the time of investigation.</p>

<b>Soils</b>		
<p>The soil sampled in Wetlands NN and SU exhibited a low chroma matrix and redoximorphic features within 10 inches of the surface. These characteristics are evidence that the soils in the wetland are saturated and/or inundated for a duration sufficient to promote anaerobic conditions, therefore meeting the hydric soil criterion.</p>		
<b>Hydrology</b>		
<p>Wetland hydrology was provided by overland flow from adjacent uplands, precipitation, stormwater discharge from roadside ditches, a seasonally shallow water table, and from seasonal high flow events of the unnamed tributary and Mill Creek. Numerous culverts connect the two wetlands including a large box culvert that carries the unnamed tributary under SR 502.</p> <p>At the time of field investigation, areas of inundation up to 11 inches deep were observed throughout the wetlands, free water was observed in the soil pit at a depth of 1 inch at NN-DW1, and oxidized root channels associated with living plant material were observed within 12 inches of the surface. These findings demonstrate the area has sufficient saturation and/or ponding during the growing season to satisfy the wetland hydrology criterion.</p> <p>Conversations with local residents also confirmed wetland hydrology. They described yearly flooding events that lasted for at least 2 consecutive weeks and would infrequently submerge SR 502 for extended durations.</p>

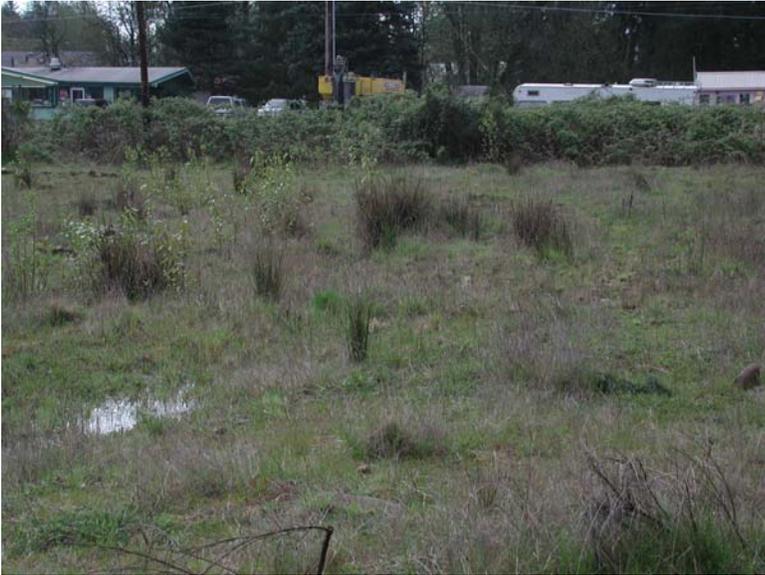
<b>Ecology Rating</b>	IV
	<b>Clark Co. Rating</b>	IV
	<b>Cowardin Classification</b>	PEM
	<b>HGM Classification</b>	DEP
	<b>WRIA</b>	27
	<p><b>Dominant Vegetation</b></p> <p><i>Populus balsamifera</i> (black cottonwood) FAC  <i>Juncus effusus</i> (soft rush) FACW  <i>Agrostis capillaris</i> (colonial bentgrass) FAC</p>	
	Percent of Dominant Species that are OBL, FACW or FAC (excluding FAC-)	100%
Wetland NO, looking north		
<b>Description/Vegetation</b>		
Wetland NO is a highly disturbed palustrine, emergent (PEM) wetland located north of SR 502 and west of 72nd Avenue. It appears as if the area the wetland occupies was graded and prepared for land development and then abandoned. Wetland NO is bordered by parking lots to the south and other impervious areas to the east. It is bordered on the west by an upland forest, and on the north by a similarly disturbed area that is dominated by upland grasses and forbs.

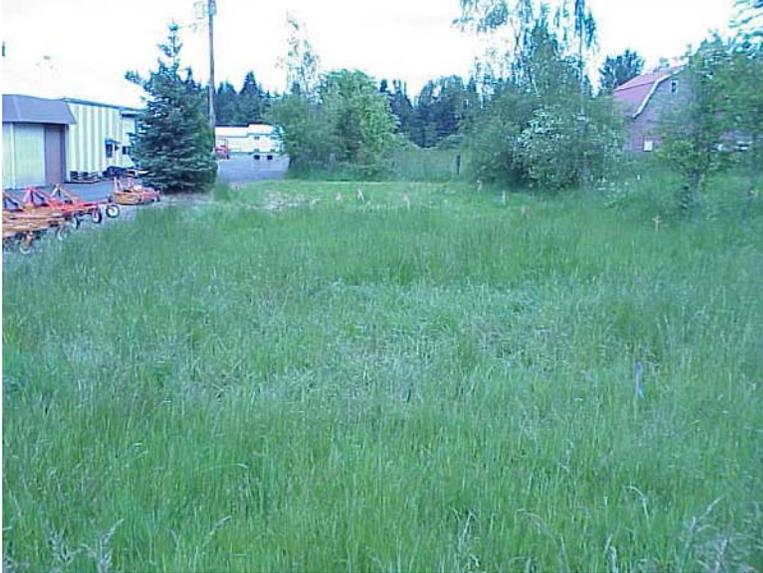
<b>Ecology Rating</b>	IV
	<b>Clark Co. Rating</b>	IV
	<b>Cowardin Classification</b>	PEM
	<b>HGM Classification</b>	DEP
	<b>WRIA</b>	28
	<p><b><u>Dominant Vegetation</u></b></p> <p><i>Alopecurus pratensis</i> (Meadow foxtail) FACW  <i>Phalaris arundinacea</i> (reed canary grass) FACW</p>	
Percent of Dominant Species that are OBL, FACW or FAC (excluding FAC-)	100%	
Wetland NQ, looking north		
<b>Description/Vegetation</b>		
<p>Wetland NQ is a palustrine, emergent (PEM) wetland located north of SR 502 and west of 82<sup>nd</sup> Avenue. A parking lot and commercial development are located directly to the west, and the wetland appears to be heavily disturbed. At the time of field investigation the area was vegetated, but during subsequent visits the area had been mowed. A large pasture area exists to the north, but is heavily fragmented by fences. The wetland is connected to a roadside ditch and may receive backflow discharge from the ditch during highflow events, and also may discharge water into the ditch during normal precipitation events.</p>

<b>Soils</b>		
<p>The soil sampled in Wetland NQ exhibited a low chroma matrix and redoximorphic features within 10 inches of the surface. These characteristics are evidence that the soils in the wetland are saturated and/or inundated for a duration sufficient to promote anaerobic conditions, therefore meeting the hydric soil criterion.</p>		
<b>Hydrology</b>		
<p>Wetland hydrology was provided by overland flow from adjacent uplands, precipitation, and a seasonally shallow water table. The wetland outlets into a roadside ditch and may receive backflow during high precipitation events. At the time of field investigation, areas of inundation up to 2 inches deep were observed throughout the wetland. The soil pit at the datapoint was saturated to the surface and oxidized root channels associated with living plant material were observed within 12 inches of the surface. These findings demonstrate that the area has sufficient saturation and/or ponding during the growing season to satisfy the wetland hydrology criterion.</p>

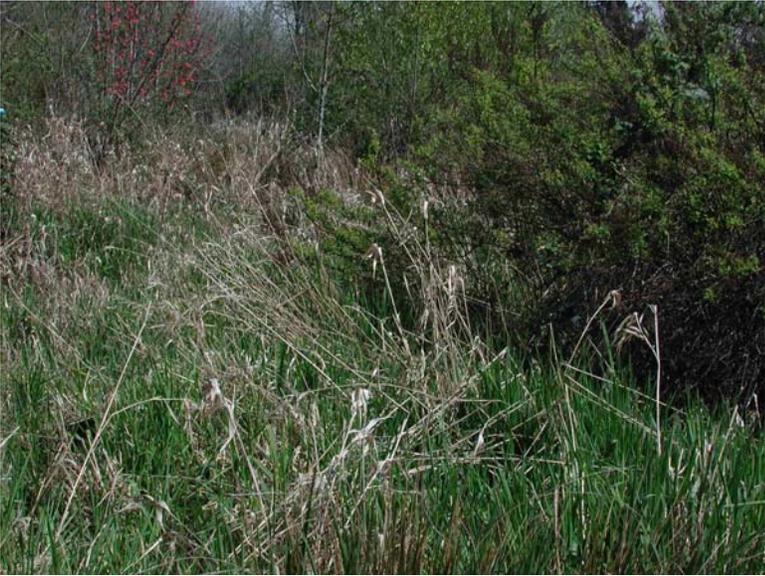
<table border="1"> <tr> <td><b>Ecology Rating</b></td> <td>II</td> </tr> <tr> <td><b>Clark Co. Rating</b></td> <td>II</td> </tr> <tr> <td><b>Cowardin Classification</b></td> <td>PEM/PSS</td> </tr> <tr> <td><b>HGM Classification</b></td> <td>DEP</td> </tr> <tr> <td><b>WRIA</b></td> <td>28</td> </tr> </table>	<b>Ecology Rating</b>	II	<b>Clark Co. Rating</b>	II	<b>Cowardin Classification</b>	PEM/PSS	<b>HGM Classification</b>	DEP	<b>WRIA</b>	28
	<b>Ecology Rating</b>	II									
	<b>Clark Co. Rating</b>	II									
	<b>Cowardin Classification</b>	PEM/PSS									
	<b>HGM Classification</b>	DEP									
<b>WRIA</b>	28										
<p><b>Dominant Vegetation</b></p> <p><i>Juncus effusus</i> (soft rush) FACW  <i>Phalaris arundinacea</i> (reed canary grass) FACW  <i>Spirea douglasii</i> (hardhack) FACW</p>											
<table border="1"> <tr> <td>Percent of Dominant Species that are OBL, FACW or FAC (excluding FAC-)</td> <td>100%</td> </tr> </table>	Percent of Dominant Species that are OBL, FACW or FAC (excluding FAC-)	100%

<p><b>Hydrology</b></p> <p>Wetland hydrology was provided by overland flow from adjacent uplands, precipitation, and a seasonally shallow water table. At the time of field investigation, areas of inundation up to 4 inches deep, water stained leaves, and wetland drainage patterns were observed throughout the wetland. The soil sampled at the datapoint was saturated to the surface, and free water was observed in the soil pit at a depth of 3 inches. These findings demonstrate the area has sufficient saturation and/or ponding during the growing season to satisfy the wetland hydrology criterion.</p>											
<p><b>Rating/Functions</b></p> <p>Wetland NS ranked as a Category II under Ecology's 4-tier rating system (Appendix C). The ability of the wetland to improve water quality can be attributed to the highly constricted outlet of the wetland, the large areas of persistent emergent vegetation, and the large areas of seasonal ponding throughout the wetland. Wetland NS is south of Mill Creek and provides significant Hydrologic Functions by storing surface water that would otherwise be a source of flooding and erosive flows. The interspersed habitats, richness of plant species, variety of water regimes, relatively undisturbed buffer, and overall size of the wetland provide considerable Habitat Functions.</p>

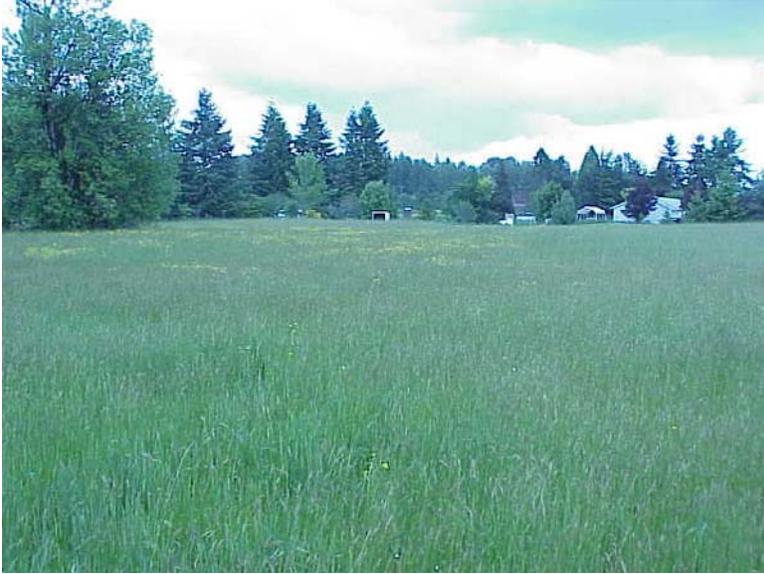
<table border="1"> <tr> <td><b>Ecology Rating</b></td> <td>III</td> </tr> <tr> <td><b>Clark Co. Rating</b></td> <td>III</td> </tr> <tr> <td><b>Cowardin Classification</b></td> <td>PEM</td> </tr> <tr> <td><b>HGM Classification</b></td> <td>DEP</td> </tr> <tr> <td><b>WRIA</b></td> <td>28</td> </tr> </table>	<b>Ecology Rating</b>	III	<b>Clark Co. Rating</b>	III	<b>Cowardin Classification</b>	PEM	<b>HGM Classification</b>	DEP	<b>WRIA</b>	28
	<b>Ecology Rating</b>	III									
<b>Clark Co. Rating</b>	III										
<b>Cowardin Classification</b>	PEM										
<b>HGM Classification</b>	DEP										
<b>WRIA</b>	28										
	<p><b><u>Dominant Vegetation</u></b></p> <p><i>Anthoxanthum odoratum</i> (sweet vernal grass) FACU  <i>Holcus lanatus</i> (common velvetgrass) FAC  <i>Juncus effusus</i> (soft rush) FACW  <i>Lotus corniculatus</i> (bird's-foot trefoil) FAC  <i>Ranunculus acris</i> (tall buttercup) FACW-</p> <table border="1"> <tr> <td>Percent of Dominant Species that are OBL, FACW or FAC (excluding FAC-)</td> <td>80%</td> </tr> </table>	Percent of Dominant Species that are OBL, FACW or FAC (excluding FAC-)	80%

<b>Hydrology</b>											
Wetland hydrology was provided by overland flow from adjacent uplands, precipitation, and a seasonally shallow water table. At the time of field investigation, areas of inundation up to 3 inches deep and wetland drainage patterns were observed throughout the wetland. The soil sampled at the datapoint was saturated to the surface. These findings demonstrate the area has sufficient saturation and/or ponding during the growing season to satisfy the wetland hydrology criterion.											
<b>Rating/Functions</b>											
Wetland NU ranked as a Category III under Ecology's 4-tier rating system (Appendix C). The ability of the wetland to improve water quality can be attributed to the highly constricted outlet of the wetland, the large area of persistent emergent vegetation and the areas of seasonal ponding throughout the wetland. Wetland NU is south of Mill Creek and provides Hydrologic Functions by storing surface water that would otherwise be a source of flooding and erosive flow. The interspersed habitats, richness of plant species, variety of water regimes, relatively undisturbed buffer, proximity to other wetlands, and overall size of the wetland provide considerable Habitat Functions.

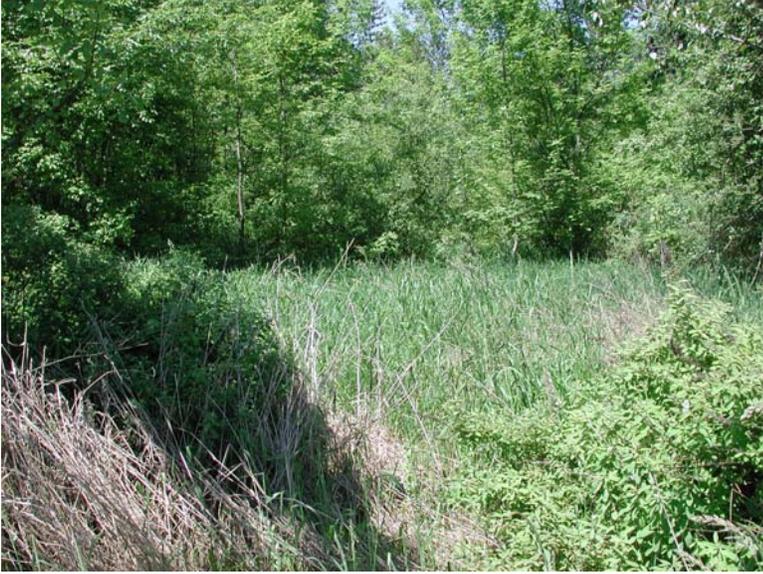
<b>Ecology Rating</b>	II
	<b>Clark Co. Rating</b>	II
	<b>Cowardin Classification</b>	PFO & PEM
	<b>HGM Classification</b>	DEP
	<b>WRIA</b>	28
	<b>Dominant Vegetation</b>	
	<p><u>NX-DW1 (PEM)</u></p> <p><i>Rumex crispus</i> (curly dock) FAC+  <i>Montia linearis</i> (narrowleaf minerslettuce) NL  <i>Lolium arundinaceum</i> (tall fescue) FAC-  <i>Myosotis laxa</i> (bay forget-me-not) OBL</p> <p><u>NX-DW2 (PFO)</u></p> <p><i>Fraxinus latifolia</i> (Oregon ash) FACW  <i>Spiraea douglasii</i> (hardhack) FACW  <i>Rosa nutkana</i> (Nootka rose) FAC  <i>Phalaris arundinacea</i> (reed canary grass) FACW</p>	
Percent of Dominant Species that are OBL, FACW or FAC (excluding FAC-)	75%	
Wetland NX looking north		
<b>Description/Vegetation</b>		
Wetland NX is a palustrine, emergent (PEM) and palustrine, forested (PFO) wetland complex located north of SR 502 and just east of 97th Avenue. The western PEM portion of the wetland appears to have been cleared/disturbed through earth moving activities. A single family residence, apparently established on fill material, is surrounded by this wetland on the west, north, and east. The wetland extends beyond the property boundaries to the north.

<b>Soils</b>		
The soil sampled in Wetland NX exhibited a low chroma matrix and redoximorphic features within 10 inches of the surface. These characteristics are evidence that the soils in the wetland are saturated and/or inundated for a duration sufficient to promote anaerobic conditions, therefore meeting the hydric soil criterion.		
<b>Hydrology</b>		
Wetland hydrology is provided by precipitation, overland flow from adjacent wetlands, roadside ditch discharge, and a seasonally shallow water table. Portions of the wetland showed shallow inundation on May 2, 2005. Other locations showed saturation to the soil surface or within 12 inches of the surface. These findings demonstrate that Wetland NX has sufficient saturation and/or ponding during the growing season to satisfy the wetland hydrology criterion.		
<b>Rating/Functions</b>		
Wetland NX ranked as a Category II under Ecology's 4-tier rating system (Appendix C). Water Quality Functions are provided by the following characteristics of the wetland: greater than 95% cover of persistent ungrazed vegetation, seasonal ponding over more than half the total area of the wetland, and the proximity of the wetland to residential areas and roadways. The amount of water storage observed in the wetland is evidence that the area reduces flooding and erosion, providing a significant Hydrologic Function to the watershed. The habitat functions provided by the wetland can be attributed to the complexity of the vegetation structure, the various water regimes, richness of plant species, interspersed habitats, relatively undisturbed buffers, and connectivity to other undisturbed areas.

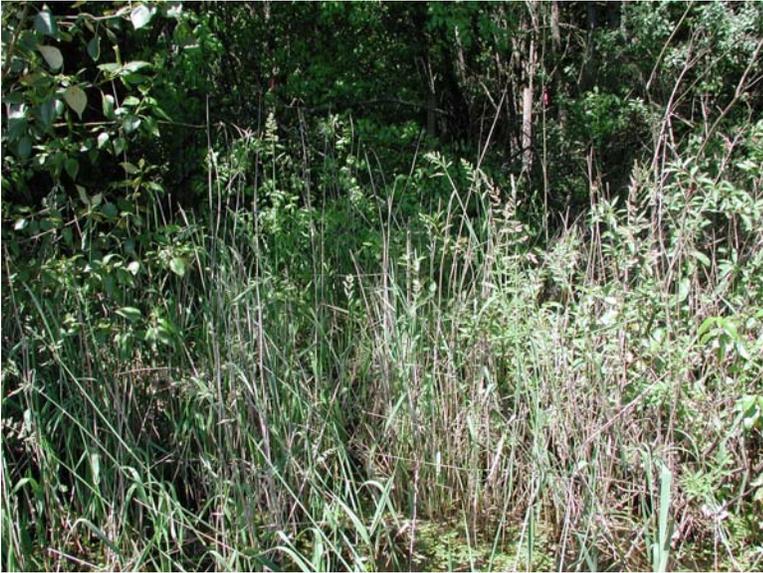
<b>Ecology Rating</b>	III
	<b>Clark Co. Rating</b>	III
	<b>Cowardin Classification</b>	PFO & PEM
	<b>HGM Classification</b>	DEP
	<b>WRIA</b>	28
<p><b><u>Dominant Vegetation</u></b></p> <p><i>Fraxinus latifolia</i> (Oregon ash) FACW  <i>Populus balsamifera</i> (black cottonwood) FAC  <i>Phalaris arundinacea</i> (reed canarygrass) FACW</p>		
<p>Percent of Dominant Species that are OBL, FACW or FAC (excluding FAC-)</p>		100%
<p>Wetland NY looking north</p>		
<p><b>Description/Vegetation</b></p> <p>Wetland NY is a palustrine, emergent (PEM) and palustrine, forested (PFO) wetland complex located north of SR 502 and east of 92nd Avenue. It is located in a topographic depression adjacent to SR 502.</p>		
<p><b>Soils</b></p> <p>The soil sampled in Wetland NY exhibited a low chroma matrix and redoximorphic features within 10 inches of the surface. These characteristics are evidence that the soils in the wetland are saturated and/or inundated for a duration sufficient to promote anaerobic conditions, therefore meeting the hydric soil criterion.</p>

<p><b>Hydrology</b></p> <p>Groundwater and precipitation are considered to be the principal sources of hydrology. On May 2, 2005 all of Wetland NY was either inundated or saturated to the surface. Water-stained leaves were also present providing a secondary indicator that Wetland NY has saturation or ponding for sufficient duration during the growing season to meet wetland hydrology criterion.</p>		
<p><b>Rating/Functions</b></p> <p>Wetland NY ranked as a Category III under Ecology's 4-tier rating system (Appendix C). The Water Quality Functions of this wetland were rated relatively high. This residentially located wetland is heavily vegetated and has a distinct anoxic smell indicating the wetland can remove a wide range of pollutants from surface water. The hydrologic functions of this wetland were rated low partially due to the connection of the wetland to a roadside ditch. To a lesser degree this wetland performs Habitat Functions. Although this wetland is relatively small, it has structural diversity, species diversity, and multiple hydrologic regimes present, all of which provide habitat value.</p>

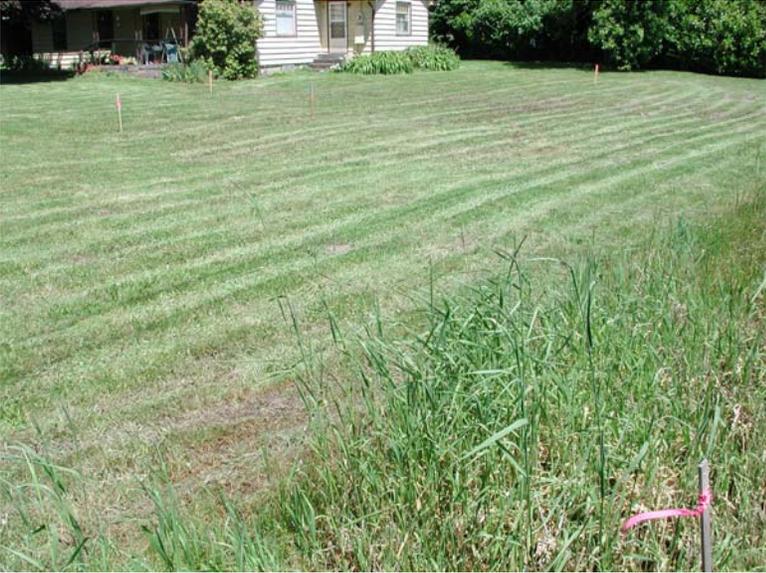
Wetland NZ

<table border="1"> <tr> <td><b>Ecology Rating</b></td> <td>IV</td> </tr> <tr> <td><b>Clark Co. Rating</b></td> <td>IV</td> </tr> <tr> <td><b>Cowardin Classification</b></td> <td>PEM</td> </tr> <tr> <td><b>HGM Classification</b></td> <td>DEP</td> </tr> <tr> <td><b>WRIA</b></td> <td>28</td> </tr> </table>	<b>Ecology Rating</b>	IV	<b>Clark Co. Rating</b>	IV	<b>Cowardin Classification</b>	PEM	<b>HGM Classification</b>	DEP	<b>WRIA</b>	28
	<b>Ecology Rating</b>	IV									
	<b>Clark Co. Rating</b>	IV									
	<b>Cowardin Classification</b>	PEM									
	<b>HGM Classification</b>	DEP									
<b>WRIA</b>	28										
<p><b>Dominant Vegetation</b></p> <p><i>Poa trivialis</i> (rough bluegrass) FACW  <i>Leontodon taraxacoides</i>            (lesser hawkbit) NL  <i>Ranunculus repens</i> (creeping buttercup)            FACW</p>											
<table border="1"> <tr> <td>Percent of Dominant Species that are OBL, FACW or FAC (excluding FAC-)</td> <td>67%</td> </tr> </table>	Percent of Dominant Species that are OBL, FACW or FAC (excluding FAC-)	67%

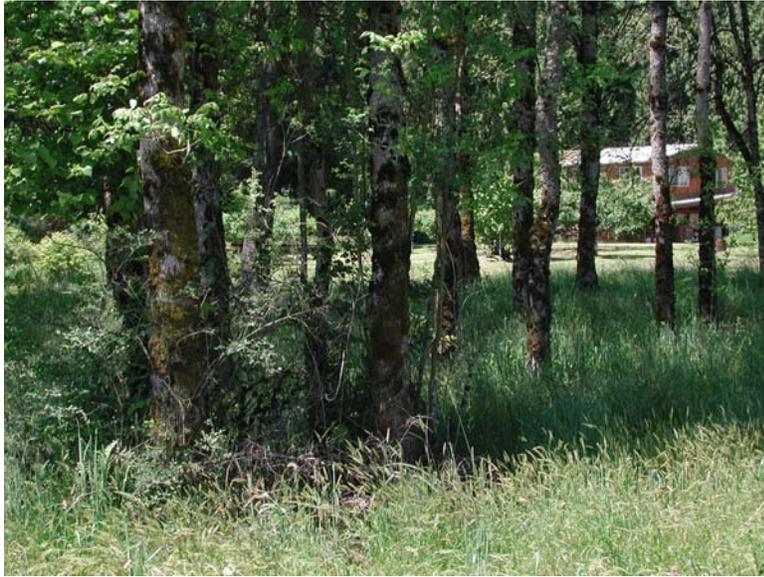
Wetland NAB looking west and south

The soil sampled in Wetland NAB exhibited a low chroma matrix and redoximorphic features within 10 inches of the surface. These characteristics are evidence that the soils in the wetland are saturated and/or inundated for a duration sufficient to promote anaerobic conditions, therefore meeting the hydric soil criterion.

Wetland hydrology was provided by overland flow from adjacent uplands, precipitation, and a shallow water table. At the time of field investigation, the soil sampled at the datapoint was saturated at the surface and free water was observed at the surface of the pit. Areas of the wetland were inundated with 4 inches of water. These findings demonstrate the area has sufficient saturation and/or ponding during the growing season to satisfy the wetland hydrology criterion.

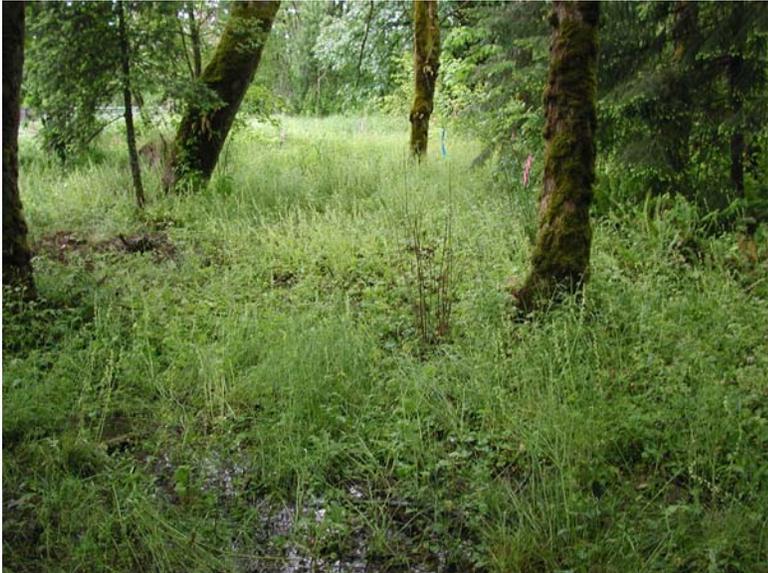
<b>Ecology Rating</b>	III
	<b>Clark Co. Rating</b>	III
	<b>Cowardin Classification</b>	PFO
	<b>HGM Classification</b>	DEP
	<b>WRIA</b>	28
	<p><b>Dominant Vegetation</b></p> <p><i>Fraxinus latifolia</i> (Oregon ash) FACW  <i>Claytonia sibirica</i> (siberian springbeauty) FAC  <i>Maianthemum dilatatum</i> (false-lily-of-the-valley) FACU-  <i>Tellima grandiflora</i> (bigflower tellima)  NL  <i>Ranunculus sp.</i> (buttercups) N/A</p>	
Wetland NAC, looking west	Percent of Dominant Species that are OBL, FACW or FAC (excluding FAC-)	60%
<b>Description/Vegetation</b>		
<p>Wetland NAC is a palustrine, forested (PFO) wetland located north of SR 502 and east of 97th street. The Battle Ground Animal Hospital borders Wetland NAC to the west and a paved driveway borders the wetland to the east. A very small upland hummock dominated by <i>Corylus cornuta</i> (beaked hazelnut) and <i>Polystichum munitum</i> (western swordfern) is completely enclosed within the wetland.</p>

<b>Soils</b>		
<p>The soil sampled in Wetland NAC exhibited a low chroma matrix and redoximorphic features within 10 inches of the surface. These characteristics are evidence that the soils in the wetland are saturated and/or inundated for a duration sufficient to promote anaerobic conditions, therefore meeting the hydric soil criterion.</p>		
<b>Hydrology</b>		
<p>Wetland hydrology was provided by overland flow from adjacent uplands, precipitation, and a seasonally shallow water table. All wetland areas showed saturation at or near the surface on May 18, 2005, and free water was observed in the soil pit at a depth of 4 inches. These findings suggest that Wetland NAC has sufficient saturation and/or ponding during the growing season to satisfy the wetland hydrology criterion.</p>		
<b>Rating/Functions</b>		
<p>Wetland NAC ranked as a low Category III under Ecology's 4-tier rating system (Appendix C). Scores for the broad categories of Water Quality Functions and Habitat Functions were relatively even, with Hydrologic Functions being provided to a slightly lesser degree. Although this is a forested wetland with three vegetative layers, its inability to impound water or maintain significant levels of inundation, and lack of interspersed habitat types are factors that kept it from achieving an Ecology Category II rating.</p>

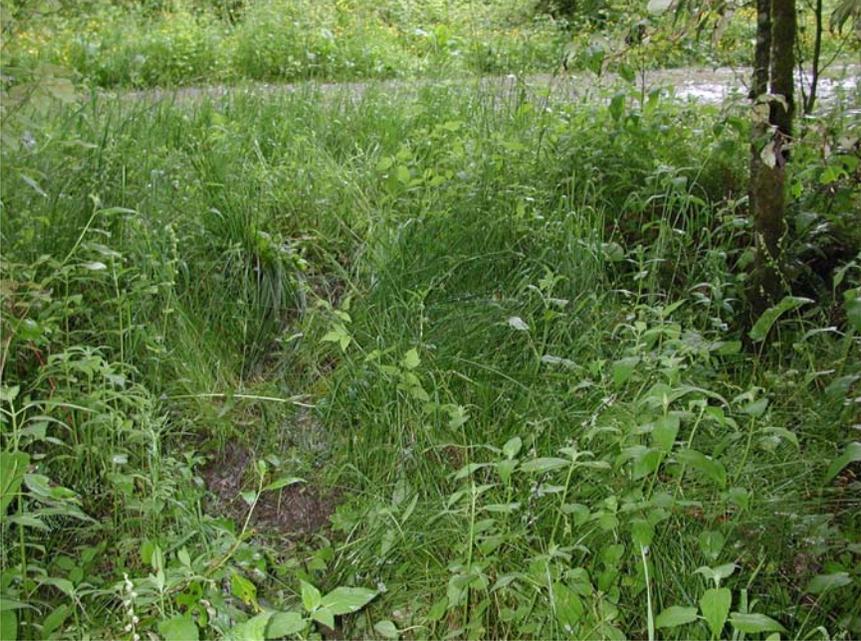
<table border="1"> <tr> <td><b>Ecology Rating</b></td> <td>IV</td> </tr> <tr> <td><b>Clark Co. Rating</b></td> <td>III</td> </tr> <tr> <td><b>Cowardin Classification</b></td> <td>PFO</td> </tr> <tr> <td><b>HGM Classification</b></td> <td>DEP</td> </tr> <tr> <td><b>WRIA</b></td> <td>28</td> </tr> </table>	<b>Ecology Rating</b>	IV	<b>Clark Co. Rating</b>	III	<b>Cowardin Classification</b>	PFO	<b>HGM Classification</b>	DEP	<b>WRIA</b>	28
	<b>Ecology Rating</b>	IV									
	<b>Clark Co. Rating</b>	III									
	<b>Cowardin Classification</b>	PFO									
	<b>HGM Classification</b>	DEP									
	<b>WRIA</b>	28									
<p><b>Dominant Vegetation</b></p> <p><i>Populus balsamifera</i> (black cottonwood) FACW  <i>Juncus</i> sp. (rushes)  <i>Carex</i> sp. (sedges)  <i>Acer circinatum</i> (vine maple) FAC-</p>											
<table border="1"> <tr> <td>Percent of Dominant Species that are OBL, FACW or FAC (excluding FAC-)</td> <td>100%</td> </tr> </table>	Percent of Dominant Species that are OBL, FACW or FAC (excluding FAC-)	100%

Percent of Dominant Species that are OBL, FACW or FAC (excluding FAC-)	100%										
Wetland NAD, looking west											
<p><b>Description/Vegetation</b></p> <p>This very small isolated palustrine, emergent wetland (PEM) is located in a topographic depression north of SR 502 and east of 92nd Avenue between Wetlands NC and NE. The <i>Carex</i> and <i>Juncus spp.</i> observed are most likely one of the more common hydrophytes known to occur in the area.</p>											
<p><b>Soils</b></p> <p>The soil sampled in Wetland NAD exhibited a low chroma matrix and redoximorphic features within 10 inches of the surface. These characteristics are evidence that the soils in the wetland are saturated and/or inundated for a duration sufficient to promote anaerobic conditions, therefore meeting the hydric soil criterion.</p>											
<p><b>Hydrology</b></p> <p>Wetland hydrology is provided by overland flow, precipitation, and by a seasonally shallow water table. On May 18, 2005 all areas of the site were saturated to the surface or inundated to less than 2 inches. At NAD-DW1, free water was observed in the soil pit at a depth of 4.0 inches. These findings demonstrate the area has sufficient saturation and/or ponding during the growing season to satisfy the wetland hydrology criterion.</p>

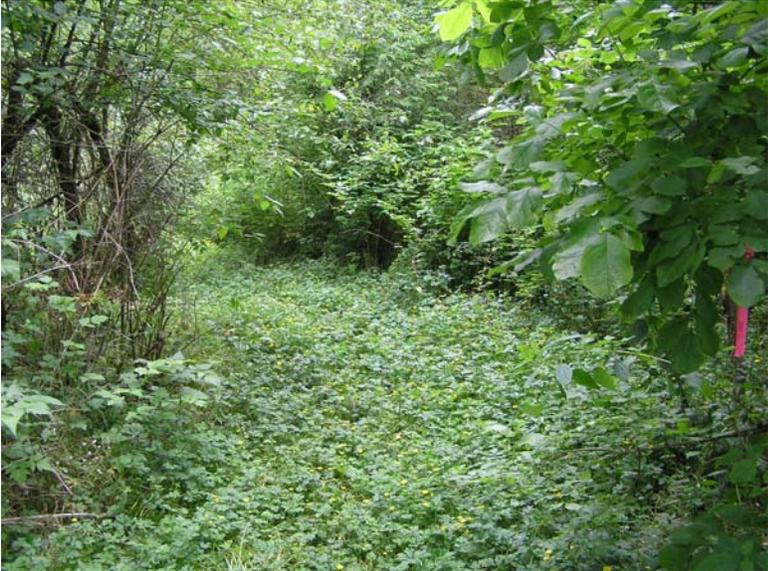
<b>Ecology Rating</b>	III
	<b>Clark Co. Rating</b>	III
	<b>Cowardin Classification</b>	PFO
	<b>HGM Classification</b>	DEP
	<b>WRIA</b>	28
	<p><b><u>Dominant Vegetation</u></b></p> <p><i>Cornus sericea</i> (redosier dogwood) FACW  <i>Claytonia sibirica</i> (siberian springbeauty) FAC  <i>Ranunculus repens</i> (creeping buttercup) FACW</p>	
	Percent of Dominant Species that are OBL, FACW or FAC (excluding FAC-)	100%
<p>Wetland NAF, looking west</p>		
<p><b>Description/Vegetation</b></p> <p>Wetland NAF is a palustrine, forested (PFO) wetland located about 200 feet north of SR 502 near the project boundary at its eastern extent. The wetland extends to the north beyond the project boundary, and appears to be isolated and topographically positioned in a closed depression.</p>		
<p><b>Soils</b></p> <p>The soil sampled in Wetland NAF exhibited a low chroma matrix and redoximorphic features within 10 inches of the surface. These characteristics are evidence that the soils in the wetland are saturated and/or inundated for a duration sufficient to promote anaerobic conditions, therefore meeting the hydric soil criterion.</p>

<p><b>Hydrology</b></p> <p>Wetland hydrology was provided by precipitation, a seasonally shallow water table, and overland flow from adjacent uplands. At the time of field investigation, areas of the wetland were saturated to the surface, and free water was observed in the soil pit at a depth of 4 inches. These findings demonstrate the area has sufficient saturation and/or ponding during the growing season to satisfy the wetland hydrology criterion.</p>		
<p><b>Rating/Functions</b></p> <p>Wetland NAF ranked as a Category III under Ecology's 4-tier rating system (Appendix C). Water Quality Functions were rated higher than Hydrologic Functions and Habitat Functions. Seasonal ponding, the wetland's depressional nature, and lack of surface water outlet contribute to the performance of Water Quality Functions. Wetland NA does not have much potential for reducing flooding and erosion due to its small size and isolated location. Habitat Function was limited due to this site's lack of complexity and special habitat features.</p>

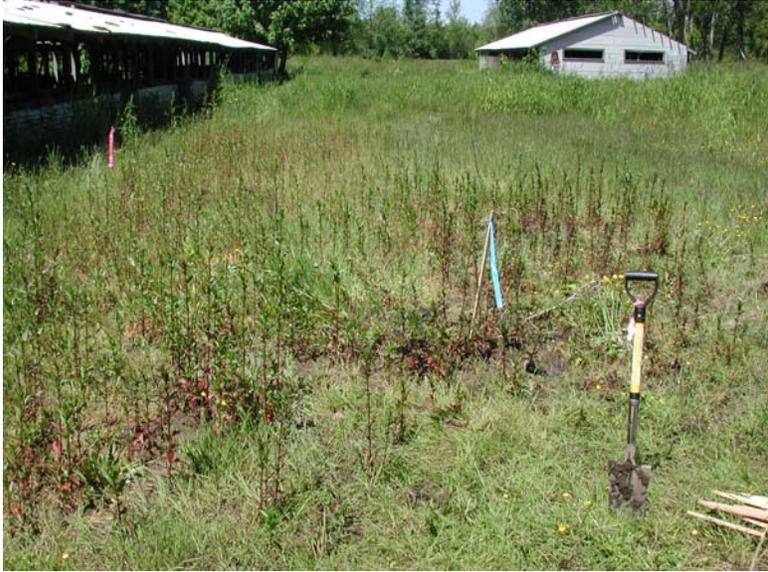
<b>Ecology Rating</b>	III
	<b>Clark Co. Rating</b>	III
	<b>Cowardin Classification</b>	PEM
	<b>HGM Classification</b>	DEP
	<b>WRIA</b>	28
	<b><u>Dominant Vegetation</u></b>	
	<u>NAG-DW1</u> <i>Alopecurus geniculatus</i> (water foxtail) OBL <i>Epilobium ciliatum</i> (fringed willowherb) FACW- <i>Ranunculus repens</i> (creeping buttercup) FACW	
	<u>NAG-DW2</u> <i>Phalaris arundinacea</i> (reed canarygrass) FACW	
	Percent of Dominant Species that are OBL, FACW or FAC (excluding FAC-)	100%
<b>Description/Vegetation</b>		
Wetland NAG is a palustrine, emergent (PEM) wetland, and is the eastern most wetland within the project boundary on the north side of SR 502. The wetland extends beyond the project boundaries to the northeast and is connected to a larger wetland complex. Multiple buildings surround the wetland and historical disturbance/modification of the wetland is likely.		
<b>Soils</b>

The soil sampled in Wetland NAG exhibited a low chroma matrix and redoximorphic features within 10 inches of the surface. These characteristics are evidence that the soils in the wetland are saturated and/or inundated for a duration sufficient to promote anaerobic conditions, therefore meeting the hydric soil criterion.		
<b>Hydrology</b>		
Wetland hydrology was provided by precipitation, a seasonally shallow water table, and overland flow from adjacent uplands. At the time of field investigation, areas of the wetland were saturated to the surface or inundated, and free water was observed in the soil pit at a depth of 7 inches in NAG-DW1, and a depth of 4 inches in NAG-DW2. These findings demonstrate the area has sufficient saturation and/or ponding during the growing season to satisfy the wetland hydrology criterion.		
<b>Rating/Functions</b>		
Wetland NAG ranked as a Category III under Ecology's 4-tier rating system (Appendix C). Water Quality Functions were rated higher than Hydrologic Functions and Habitat Functions. Seasonal ponding from 2 to 3 feet deep, this wetland's depressional nature, and the highly constricted outlet contribute to the performance of Water Quality Functions. These same physical features, in combination with this wetland's water storage potential in the watershed provide moderate Hydrologic Functions through flood and erosion control. Habitat Functions were limited due to this site's lack of complexity and special habitat features.
