# **WETLAND DELINEATION REPORT**

## **SR 502 CORRIDOR WIDENING / I-5 TO BATTLEGROUND**

Clark County, WA

Washington State  
Department of Transportation

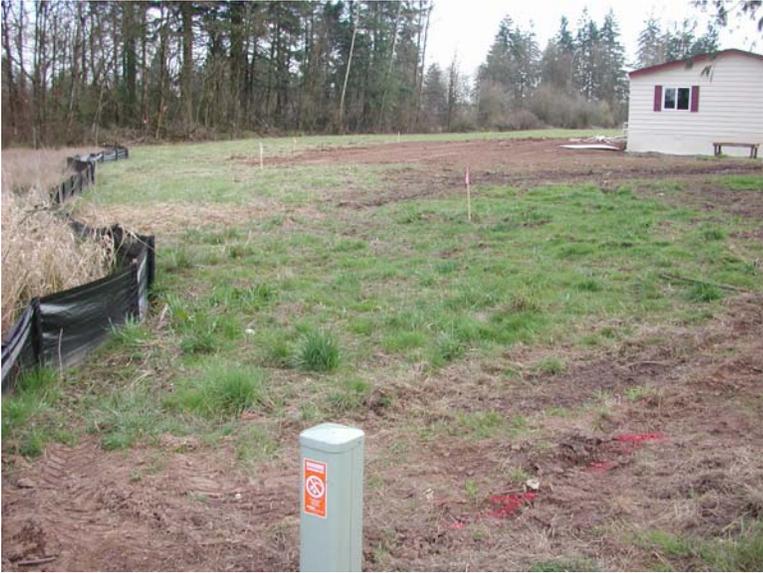
<b>Ecology Rating</b>	II
	<b>Clark Co. Rating</b>	II
	<b>Cowardin Classification</b>	PFO & PEM
	<b>HGM Classification</b>	DEP
	<b>WRIA</b>	27
	<p><b>Dominant Vegetation</b></p> <p><i>Juncus effusus</i> (soft rush) FACW  <i>Phalaris arundinacea</i> (reed canarygrass) FACW</p>	
Wetland SA, looking south	Percent of Dominant Species that are OBL, FACW or FAC (excluding FAC-)	100%
<p><b>Description/Vegetation</b></p> <p>Wetland SA is a palustrine, forested (PFO) and palustrine, emergent vegetation (PEM) wetland complex located south of SR 502 and west of 22<sup>nd</sup> Avenue. The wetland is in a headwater position within the watershed and discharges water into wetland NA via a culvert beneath SR 502. Historically Wetlands NA and SA were one wetland complex, but the construction of SR 502 bisected the wetland. At the time of field investigation, the wetland had been partially filled/disturbed by the development and construction of a single-family residence located directly to the west.</p>

<p><b>Soils</b></p> <p>The soil sampled in Wetland SA exhibited a low chroma matrix and redoximorphic features within 10 inches of the surface. These characteristics are evidence that the soils in the wetland are saturated and/or inundated for a duration sufficient to promote anaerobic conditions, therefore meeting the hydric soil criterion.</p>		
<p><b>Hydrology</b></p> <p>Wetland hydrology is provided by overland flow from adjacent uplands, precipitation, and a seasonally shallow water table. At the time of field investigation, all areas of the wetland were saturated to the surface or within 12 inches of the soil surface, and free water was observed in the soil pit at a depth of 3 inches. Drainage patterns provided another primary indicator of wetland hydrology. These findings demonstrate the area has sufficient saturation and/or ponding during the growing season to satisfy the wetland hydrology criterion.</p>

<p><b>Rating/Functions</b></p> <p>Wetland SA ranked as a Category II under Ecology's 4-tier rating system (Appendix C). Water Quality Functions scored lower than the scores for Hydrologic Functions and Habitat Functions. Water Quality Functions are limited since the wetland has a culvert for an outlet and lacks seasonally ponded areas. The area provides significant Hydrologic Functions due to its headwater position within the watershed and its ability to store surface water that would otherwise be a source of flooding and erosive flows. There are numerous habitat features that provide considerable Habitat Functions, including the interspersed of habitat types, varied water regimes, richness of plant species, connectivity to other undisturbed areas, downed large woody debris, thinned stemmed vegetation, and the overall size of the wetland. Wetland SA and Wetland NA were historically one wetland, but were bisected by the construction of SR 502. The wetlands are not rated as one wetland because a level surface water connection between the two does not exist. The culvert connecting the wetlands appears to have an elevation gradient of greater than 6 inches and water flows in one direction, from south to the north.</p>

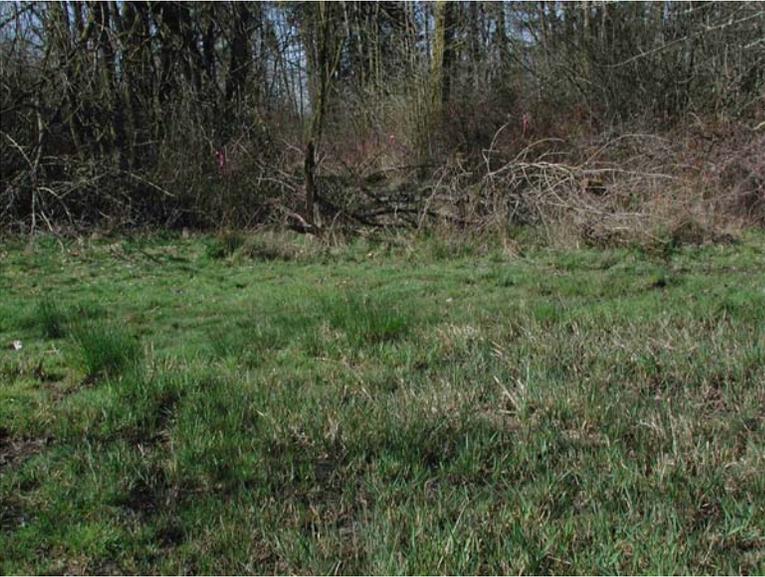
<b>Wetland SB</b>

<b>Ecology Rating</b>	III	<b>Clark Co. Rating</b>	III	<b>Cowardin Classification</b>	PEM/PFO	<b>HGM Classification</b>	DEP	<b>WRIA</b>	28
	<b>Ecology Rating</b>	III									
	<b>Clark Co. Rating</b>	III									
	<b>Cowardin Classification</b>	PEM/PFO									
	<b>HGM Classification</b>	DEP									
	<b>WRIA</b>	28									
<p><b><u>Dominant Vegetation</u></b></p> <p><i>Juncus effusus</i> (soft rush) FACW  <i>Phalaris arundinacea</i> (reed canary grass) FACW</p>											
Percent of Dominant Species that are OBL, FACW or FAC (excluding FAC-)	100%										
Wetland SB, looking west											
<b>Description/Vegetation</b>											
<p>Wetland SB is a palustrine, emergent (PEM) and palustrine, forested (PFO) wetland complex located south of SR 502 and west of 22nd Avenue behind an abandoned residence. Species dominating the PFO include <i>Spirea douglasii</i> (hardhack), <i>Rosa nutkana</i> (Nootka rose), and <i>Fraxinus latifolia</i> (Oregon ash). The wetland may have historically covered more area and might have been used as a septic field. The PEM portion of the wetland appears to be infrequently mowed and may be used as a debris/yard waste storage area.</p>											
<b>Soils</b>											
<p>The soil sampled in Wetland SB exhibited a low chroma matrix and redoximorphic features within 10 inches of the surface. These characteristics are evidence that the soils in the wetland are saturated and/or inundated for a duration sufficient to promote anaerobic conditions, therefore meeting the hydric soil criterion.</p>											
<b>Hydrology</b>											
<p>Wetland hydrology was provided by overland flow from adjacent uplands, precipitation, and a seasonally shallow water table. At the time of field investigation, areas of the wetland were saturated to the surface, free water was detected in the soil pit at a depth of 10 inches, and wetland drainage patterns were observed throughout the wetland. These findings demonstrate the area has sufficient saturation and/or ponding during the growing season to satisfy the wetland hydrology criterion. Wetland SB is located in back of an abandoned residential property and may have historically been used as a septic field.</p>											
<b>Rating/Functions</b>											
<p>Wetland SB ranked as a Category III under Ecology's 4-tier rating system (Appendix C). The ability of the wetland to improve water quality can be attributed to the fact that the wetland occupies a depression with no apparent outlet and is covered by persistent ungrazed vegetation. Wetland SB has the potential to store surface water that would otherwise be a source of flooding and erosive flows, thereby providing significant Hydrologic Functions. The interspersed habitats, structural complexity associated with the different vegetation types, richness of plant species, variety of water regimes, and connectivity to other undisturbed areas provide considerable Habitat Functions.</p>

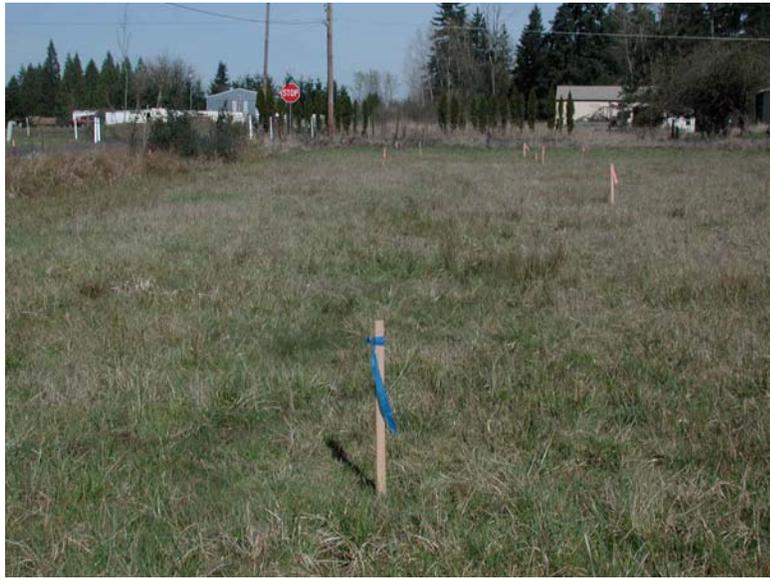
Percent of Dominant Species that are OBL, FACW or FAC (excluding FAC-)	67%										
Wetland SC, looking north											
<p><b>Description/Vegetation</b>  Wetland SC is a palustrine, emergent (PEM) wetland located south of SR 502 and east of 22nd Avenue. The wetland is in a pasture that extends to the south beyond the project boundaries and appears to be mowed/grazed frequently. The wetland is connected to a roadside ditch, and is located less than 75 feet west of a single family residence</p>											
<p><b>Soils</b>  The soil sampled in Wetland SC exhibited a low chroma matrix and redoximorphic features within 10 inches of the surface. These characteristics are evidence that the soils in the wetland are saturated and/or inundated for a duration sufficient to promote anaerobic conditions, therefore meeting the hydric soil criterion.</p>											
<p><b>Hydrology</b>  Wetland hydrology was provided by overland flow from adjacent uplands, precipitation, discharge from roadside ditches, and a seasonally shallow water table. At the time of field investigation, areas of the wetland were saturated to the surface, and free water was observed in the soil pit at a depth of 10 inches. These findings demonstrate the area has sufficient saturation and/or ponding during the growing season to satisfy the wetland hydrology criterion.</p>

<p><b>Rating/Functions</b>  Wetland SC ranked as a Category IV under Ecology's 4-tier rating system (Appendix C). The ability of the wetland to improve water quality is very limited, due to the frequent mowing/grazing of the wetland. Wetland SC is located in a headwater position of the watershed and protects downstream resources from flooding and/or excessive flows, thereby providing significant Hydrologic Functions. The lack of connectivity to other undisturbed areas and proximity to residential areas and roadways limits the Habitat Functions of the wetland.</p>

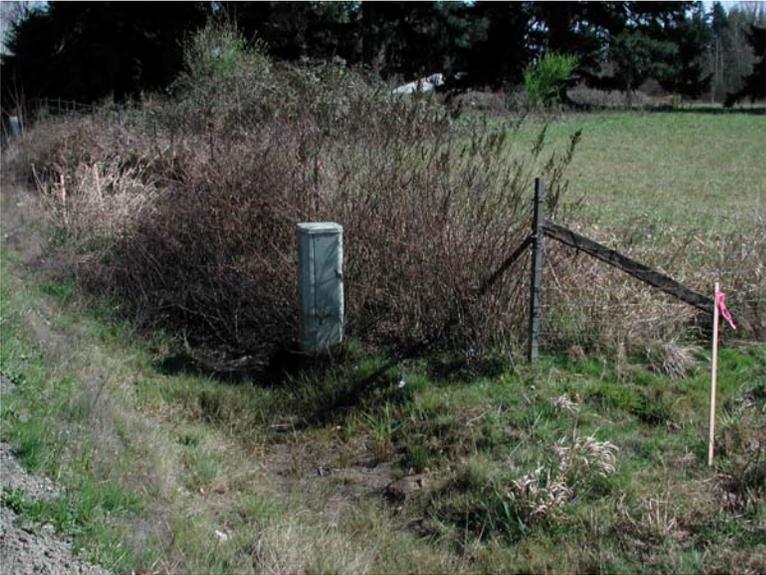
<b>Ecology Rating</b>	IV
	<b>Clark Co. Rating</b>	IV
	<b>Cowardin Classification</b>	PEM
	<b>HGM Classification</b>	DEP
	<b>WRIA</b>	28
	<p><b><u>Dominant Vegetation</u></b></p> <p><i>Phalaris arundinacea</i> (reed canarygrass) FACW</p>	
	Percent of Dominant Species that are OBL, FACW or FAC (excluding FAC-)	100%
Wetland SD, looking south		
<b>Description/Vegetation</b>		
Wetland SD is a palustrine, emergent (PEM) wetland located south of SR 502 and east of 22nd Avenue. The wetland appears to function as a swale that drains a pasture to the south. There is no longer a surface water connection between Wetland SD and Wetland NC, which were likely one wetland feature prior to the construction of SR 502.		
<b>Soils</b>		
The soil sampled in Wetland SD exhibited a low chroma matrix and redoximorphic features within 10 inches of the surface. These characteristics are evidence that the soils in the wetland are saturated and/or inundated for a duration sufficient to promote anaerobic conditions, therefore meeting the hydric soil criterion.

<b>Hydrology</b>		
Wetland hydrology is provided by overland flow, precipitation, and a seasonally shallow water table. At the time of the field investigation, all areas of the wetland showed saturation within 12 inches of the soil surface, and wetland drainage patterns were observed. These findings demonstrate the area has sufficient saturation and/or ponding during the growing season to satisfy the wetland hydrology criterion.		
<b>Rating/Functions</b>		
Wetland SD ranked as a Category IV under Ecology's 4-tier rating system (Appendix C). The functions provided by this wetland are minimal, limited by the lack of opportunity to improve water quality, the inability to impound water, and the lack of habitat features.

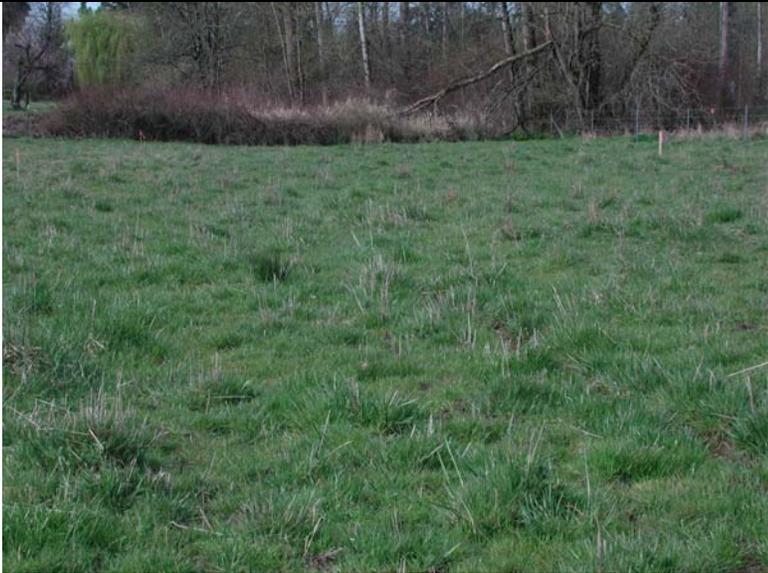
Wetland SE & SF

<b>Ecology Rating</b>	III
	<b>Clark Co. Rating</b>	III
	<b>Cowardin Classification</b>	PEM/PFO
	<b>HGM Classification</b>	DEP
	<b>WRIA</b>	27
<p><b><u>Dominant Vegetation</u></b></p> <p><u>Wetland SE</u>  <i>Fraxinus latifolia</i> (Oregon ash) FACW  <i>Cornus sericea</i> (redosier dogwood) FACW  <i>Phalaris arundinacea</i> (reed canarygrass) FACW</p> <p><u>Wetland SF</u>  <i>Phalaris arundinacea</i> (reed canarygrass) FACW</p>		
Wetland SE, looking west	Percent of Dominant Species that are OBL, FACW or FAC (excluding FAC-)	100%
<p><b>Description/Vegetation</b></p> <p>Wetlands SE and SF are located south of SR 502 and west and east of 29th Avenue, respectively. Wetland SF is a small topographic depression that is the remnant of a larger wetland complex that was filled during the development of a single-family residential site. Wetland SE is connected to Wetland SF via a culvert under 29th Avenue. Wetland SE is a swale-like, depressional wetland that carries water away from 29th Avenue in an east to west direction. Surface water then flows in one direction, south to north, through a culvert beneath SR 502, providing hydrologic support for Wetlands ND and NE and an associated unnamed tributary. Wetlands SE and SF have palustrine, forested (PFO) and palustrine, emergent wetland (PEM) classes.</p>

<p><b>Soils</b></p> <p>The soils sampled in Wetlands SE and SF exhibited low chroma matrices and redoximorphic features within 10 inches of the surface. These characteristics are evidence that the soils in the wetland are saturated and/or inundated for a duration sufficient to promote anaerobic conditions, therefore meeting the hydric soil criterion.</p>		
<p><b>Hydrology</b></p> <p>Wetland SF is a small feature that is hydrologically connected to Wetland SE via a culvert beneath 29th Avenue. The wetland is classified as a depressional, semi-permanently flooded/saturated palustrine emergent wetland. All wetland areas were inundated or saturated within 12 inches of the surface on March 21, 2005. Free water was observed 2 inches below the surface in the soil pit at SE-DW1, and at a depth of 12 inches at datapoint SF-DW1. Drainage patterns were noted as another primary indicator of hydrology. These findings suggest there is sufficient saturation and/or ponding during the growing season to satisfy the wetland hydrology criterion.</p>

<p><b>Rating/Functions</b></p> <p>Wetland SE &amp; SF ranked as Category III under Ecology's 4-tier rating system (Appendix C). Water Quality Functions were scored much lower than Hydrologic Functions and Habitat Functions. This is largely due to factors that limit water quality functions such as lack of ponded water, low cover of ungrazed vegetation, and the ditch outlet. This wetland is considered a headwater wetland, which increases its potential to help reduce flooding and erosion, thereby providing significant Hydrologic Function. Habitat Functions are moderately supported by the multiple canopy layers, the relatively undisturbed buffers, and the proximity of the wetland complex to other wetlands.</p>

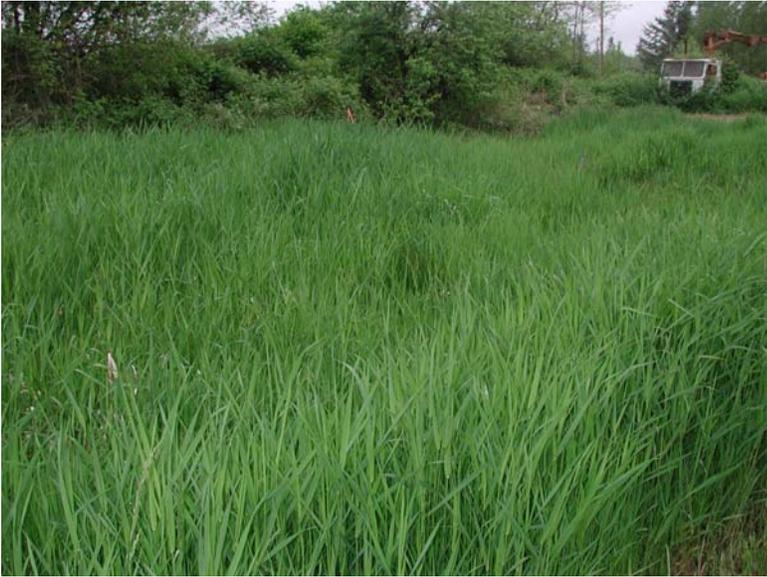
<b>Ecology Rating</b>	IV
	<b>Clark Co. Rating</b>	IV
	<b>Cowardin Classification</b>	PEM
	<b>HGM Classification</b>	DEP
	<b>WRIA</b>	27
	<p><b>Dominant Vegetation</b></p> <p><i>Phalaris arundinacea</i> (reed canary grass) FACW</p>	
Percent of Dominant Species that are OBL, FACW or FAC (excluding FAC-)	100%	
Wetland SJ, looking southeast		
<b>Description/Vegetation</b>		
<p>Wetland SJ is a palustrine, emergent (PEM) wetland located south of SR 502, west of 37th Avenue and east of an unnamed driveway. The wetland is small in size and is being used to store abandoned vehicles. The wetland was historically part of Wetland SI, but was bisected by the construction of the driveway. There is no hydrologic connection between Wetlands SI and SJ, so the wetlands were rated separately.</p>		
<b>Soils</b>		
<p>The soil sampled in Wetland SJ exhibited a low chroma matrix and redoximorphic features within 10 inches of the surface. These characteristics are evidence that the soils in the wetland are saturated and/or inundated for a duration sufficient to promote anaerobic conditions, therefore meeting the hydric soil criterion.</p>

<b>Hydrology</b>		
<p>Wetland hydrology was provided by overland flow from adjacent uplands, precipitation and a seasonally shallow water table. At the time of field investigation, areas of the wetland were saturated to the surface and free water was observed in the soil pit at a depth of 10 inches. These findings demonstrate the area has sufficient saturation and/or ponding during the growing season to satisfy the wetland hydrology criterion.</p>		
<b>Rating/Functions</b>		
<p>Wetland SJ ranked as a Category IV under Ecology's 4-tier rating system (Appendix C). Due to the lack of structural diversity and frequent mowing, the functions of the wetland are minimal.</p>

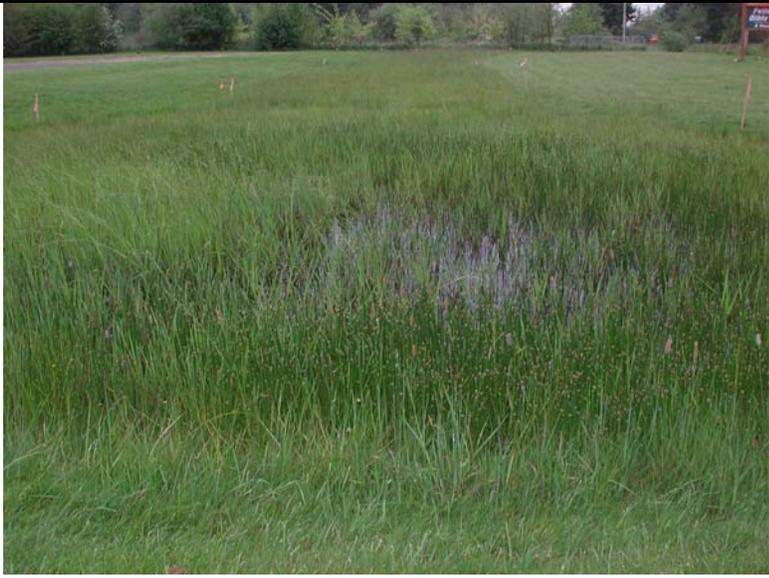
Wetland SKK, SL, & SLL

<b>Ecology Rating</b>	IV
	<b>Clark Co. Rating</b>	IV
	<b>Cowardin Classification</b>	PEM
	<b>HGM Classification</b>	DEP
	<b>WRIA</b>	27
<p><b><u>Dominant Vegetation</u></b></p> <p><i>Alopecurus pratensis</i> (meadow foxtail) FACW  <i>Alopecurus geniculatus</i> (water foxtail) OBL  <i>Holcus lanatus</i> (common velvetgrass) FAC</p>		
<p>Percent of Dominant Species that are OBL, FACW or FAC (excluding FAC-)</p>		100%
<p>Wetland SL, looking west</p>		
<p><b>Description/Vegetation</b></p> <p>Wetland SL is a linear-shaped topographic depression running parallel to and just south of SR 502. Wetlands SKK and SLL are smaller features to the west and east of Wetland SL respectively. The entire wetland complex begins directly west of 37th Avenue. All of the wetlands have hydrologic connections and are separated by narrow upland burms. All three features are considered palustrine, emergent (PEM) wetlands. Wetlands SL and SLL appear to have been created/alterd during the development and landscaping of the church buildings to the south, and appear to be mowed on a regular basis.</p>

<p><b>Soils</b></p> <p>The soils sampled in Wetlands SKK, SL, and SLL exhibited low chroma matrices and redoximorphic features within 10 inches of the surface. These characteristics are evidence that the soils in the wetland are saturated and/or inundated for a duration sufficient to promote anaerobic conditions, therefore meeting the hydric soil criterion.</p>		
<p><b>Hydrology</b></p> <p>Wetland SL is the largest wetland of the three, and is separated from Wetland SKK by a driveway to the west, and from Wetland SLL by a berm to the east. Wetland SLL is connected hydrologically to Wetland SL by a 6 inch corrugated pipe. Alteration of Wetland SL and SLL's topography in the recent past is apparent, perhaps for ease of grounds maintenance and/or to limit areas of saturation to a restricted area. The contours are symmetrical and have a landscaped appearance. On March 16, March 24, and April 19 of 2005 all wetland areas were inundated or saturated to the soil surface. These findings demonstrate that these wetlands have sufficient saturation and/or ponding during the growing season to satisfy the wetland hydrology criterion.</p>

<p><b>Rating/Functions</b></p> <p>Wetlands SKK, SL, and SLL rank as Category IV under Ecology's 4-tier rating system (Appendix C). Scores for Hydrologic Functions, Water Quality Functions, and Habitat Functions were all generally low. The lack of structural and species diversity, lack of the ability to impound water, lack of significant levels of inundation, and the lack of habitat features are all factors contributing to the overall low level of functions provided by these wetlands.</p>

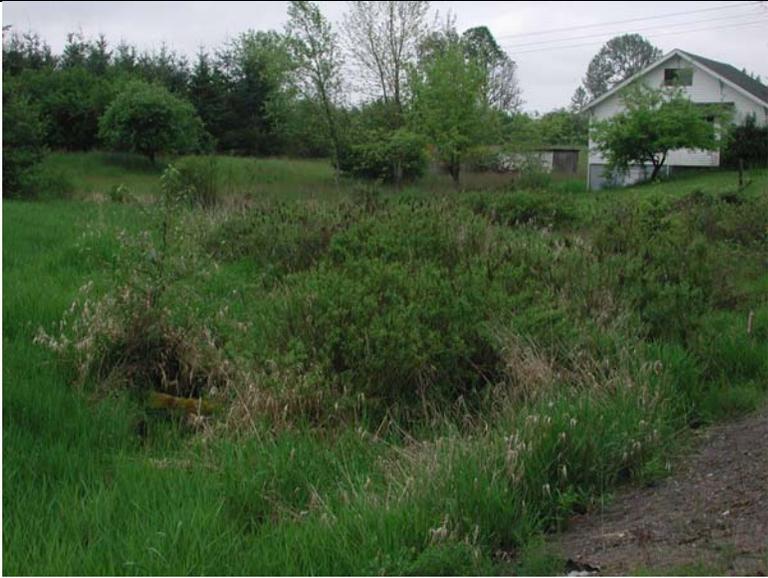
<b>Ecology Rating</b>	III
	<b>Clark Co. Rating</b>	III
	<b>Cowardin Classification</b>	PEM
	<b>HGM Classification</b>	DEP
	<b>WRIA</b>	27
<p><b><u>Dominant Vegetation</u></b></p> <p><u>SN-DW1</u> <i>Poa sp.</i> (bluegrasses)</p> <p><u>SN-DW2</u> <i>Phalaris arundinacea</i> (reed canarygrass) FACW <i>Alopecurus geniculatus</i> (water foxtail) OBL</p>		
Percent of Dominant Species that are OBL, FACW or FAC (excluding FAC-)		100%
Wetland SN, looking west		
<b>Description/Vegetation</b>		
<p>Wetland SN is a palustrine, emergent (PEM) Wetland located south of SR 502 and west of 42nd Avenue. The wetland is in a headwater position in the watershed providing hydrological support to Wetland NK (north of SR 502) and an associated unnamed tributary via a culvert passing beneath SR 502. Although Wetlands SN and NK were historically one wetland complex, the construction of SR 502 bisected the wetland, and a level surface water connection no longer exists. The western part of the wetland represented by SN-DW1, was a mowed lawn dominated by an unidentifiable <i>Poa</i> species. Most of the possible candidates in this genus are FAC or wetter species. Based on this information and the strength of the indicators for the other 2 parameters, it was assumed that more than 50% of the dominant species would normally have an indicator status of OBL, FACW, and/or FAC, thus meeting the hydrophytic vegetation criterion.</p>

<b>Soils</b>		
<p>The soils sampled in Wetland SN exhibited low chroma matrices and redoximorphic features within 10 inches of the surface. These characteristics are evidence that the soils in the wetland are saturated and/or inundated for a duration sufficient to promote anaerobic conditions, therefore meeting the hydric soil criterion.</p>		
<b>Hydrology</b>		
<p>Wetland hydrology was provided by overland flow from adjacent uplands, a seasonally shallow water table, roadside ditch discharge, and precipitation. On March 24, 2005 portions of the wetland were inundated or saturated to the soil surface, and wetland drainage patterns were observed. A landowner living directly adjacent to the wetland stated that he observes prolonged periods of inundation in his backyard, the eastern portion of the wetland, every spring. These findings demonstrate that Wetland SN has sufficient saturation and/or ponding during the growing season to satisfy the wetland hydrology criterion.</p>

<b>Rating/Functions</b>		
<p>Wetland SN ranked as a Category III under Ecology's 4-tier rating system (Appendix C). This wetland, at the western end, is a headwater wetland of a system that has flooding problems, which gave it a higher score for Hydrologic Function. Wetland SN scored relatively low for Water Quality Functions and Habitat Functions due in part to its lack of ungrazed vegetation, lack of complexity, and lack of habitat types and features.</p>

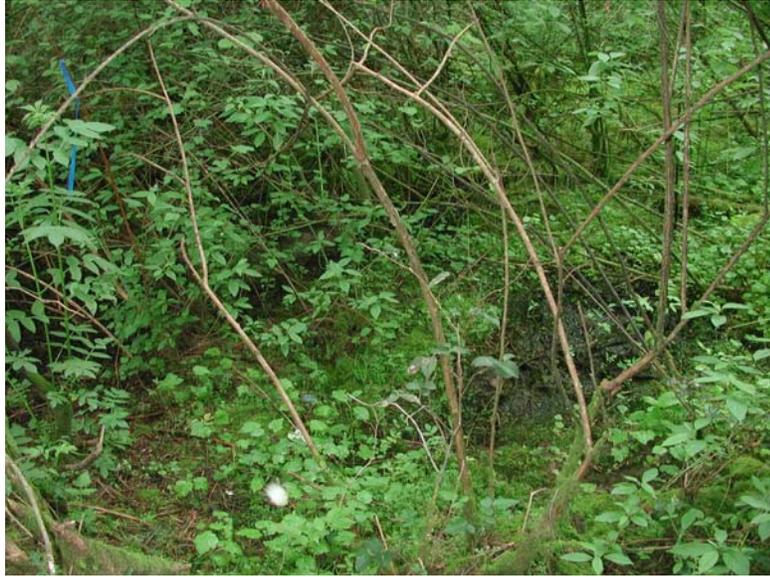
<b>Ecology Rating</b>	III	<b>Clark Co. Rating</b>	III	<b>Cowardin Classification</b>	PFO	<b>HGM Classification</b>	DEP	<b>WRIA</b>	28
	<b>Ecology Rating</b>	III									
	<b>Clark Co. Rating</b>	III									
	<b>Cowardin Classification</b>	PFO									
	<b>HGM Classification</b>	DEP									
<b>WRIA</b>	28										
<p><b>Dominant Vegetation</b></p> <p><i>Cornus sericea</i> (red-osier dogwood) FACW  <i>Lonicera involucrata</i> (twinberry) FAC+  <i>Pseudotsuga menziesii</i> (Douglas-fir) FACU  <i>Tolmeia menziesii</i> (youth on age) FAC+</p>											
<p>Percent of Dominant Species that are OBL, FACW or FAC (excluding FAC-)</p>	75%										
<p>Wetland SO, looking west</p>											
<p><b>Description/Vegetation</b></p> <p>Wetland SO is a palustrine, forested (PFO) wetland located south of SR 502 and west of 50th Avenue. The wetland was inundated at the time of field investigation and extended south beyond the project boundaries.</p>											
<p><b>Soils</b></p> <p>The soil sampled in Wetland SO exhibited a low chroma matrix and redoximorphic features within 10 inches of the surface. These characteristics are evidence that the soils in the wetland are saturated and/or inundated for a duration sufficient to promote anaerobic conditions, therefore meeting the hydric soil criterion.</p>											
<p><b>Hydrology</b></p> <p>Wetland hydrology is provided by overland flow from adjacent uplands, precipitation, and a seasonally shallow water table. At the time of field investigation, areas of the wetland were saturated to the surface and free water was observed in the soil pit at a depth of 2 inches. Wetland drainage patterns were also observed in the wetland, as were areas of inundation up to 14 inches in depth. These findings demonstrate the area has sufficient saturation and/or ponding during the growing season to satisfy the wetland hydrology criterion.</p>											
<p><b>Rating/Functions</b></p> <p>Wetland SO ranked as a Category III under Ecology's 4-tier rating system (Appendix C). The ability of the wetland to improve water quality can be attributed to the following facts: the wetland is a depression with no apparent surface outlet, is seasonally inundated over half the total area, and is covered by persistent ungrazed vegetation. Wetland SO provides limited Hydrologic Function because it is in an isolated landscape position within the watershed, and does not have the opportunity to store water that would otherwise be a source of flooding and erosive flows. Wetland SO provides significant Habitat Functions due to the various water regimes present, the large downed, woody debris, the large relatively undisturbed buffer, and the connectivity of the wetland to other undisturbed areas.</p>

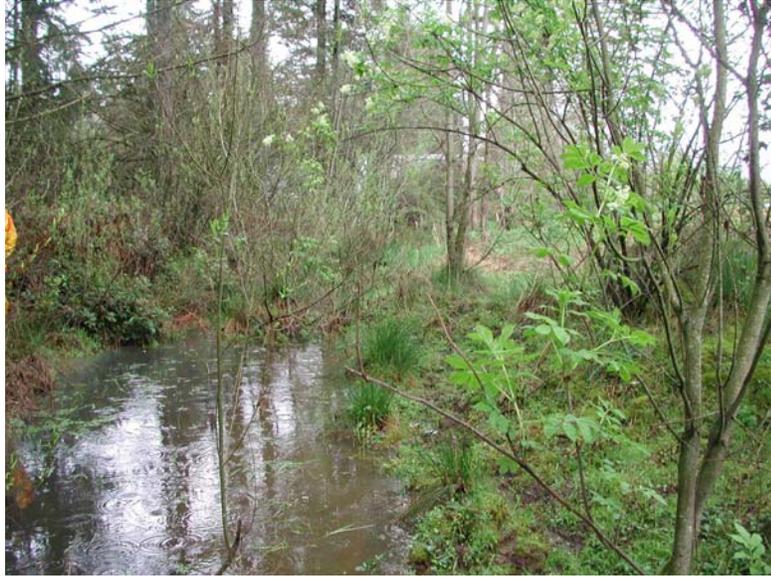
<b>Ecology Rating</b>	III	<b>Clark Co. Rating</b>	IV	<b>Cowardin Classification</b>	PEM	<b>HGM Classification</b>	DEP	<b>WRIA</b>	28
	<b>Ecology Rating</b>	III									
	<b>Clark Co. Rating</b>	IV									
	<b>Cowardin Classification</b>	PEM									
	<b>HGM Classification</b>	DEP									
<b>WRIA</b>	28										
<p><b><u>Dominant Vegetation</u></b></p> <p><i>Juncus effusus</i> (soft rush) FACW  <i>Oenanthe sarmentosa</i> (water parsley) OBL  <i>Phalaris arundinacea</i> (reed canary grass) FACW</p>											
<p>Percent of Dominant Species that are OBL, FACW or FAC (excluding FAC-)</p>	<p>100%</p>										
<p>Wetland SP, looking north</p>											
<p><b>Description/Vegetation</b></p> <p>Wetland SP is a palustrine, emergent (PEM) wetland located south of SR 502 and west of 50th Avenue. The area appears to have been created/disturbed through earth moving activities. A large ditch was dug through the middle of the wetland and the soil from the excavation was stockpiled on the east side of the wetland. A large pile of manure was located directly north of the wetland, and appeared to discharge runoff into the wetland.</p>											
<p><b>Soils</b></p> <p>The soil sampled in Wetland SP exhibited a low chroma matrix and redoximorphic features within 10 inches of the surface. These characteristics are evidence that the soils in the wetland are saturated and/or inundated for a duration sufficient to promote anaerobic conditions, therefore meeting the hydric soil criterion.</p>											
<p><b>Hydrology</b></p> <p>Wetland hydrology was provided by overland flow from adjacent uplands, precipitation, and a seasonally shallow water table. At the time of field investigation, areas of the wetland were saturated to the surface, inundated to a maximum depth of 12 inches, and free water was observed in the soil pit at a depth of 4 inches. These findings demonstrate the area has sufficient saturation and/or ponding during the growing season to satisfy the wetland hydrology criterion.</p>											
<p><b>Rating/Functions</b></p> <p>Wetland SP ranked as a Category III under Ecology's 4-tier rating system (Appendix C). The ability of the wetland to improve water quality can be attributed to the following facts: the wetland has a intermittently flowing outlet, is seasonally inundated over 25% of the total area, and is covered by persistent ungrazed vegetation. The wetland is adjacent to a large manure storage pile, which furnishes the wetland with the opportunity to provide Water Quality Functions. Wetland SP provides limited Hydrologic Function because it was in an isolated landscape position within the watershed, and does not receive surface water that would otherwise be a source of flooding and erosive flows. Wetland SP provides significant Habitat Functions due to the various water regimes present, the large relatively undisturbed buffer, and the connectivity of the wetland to other undisturbed areas.</p>

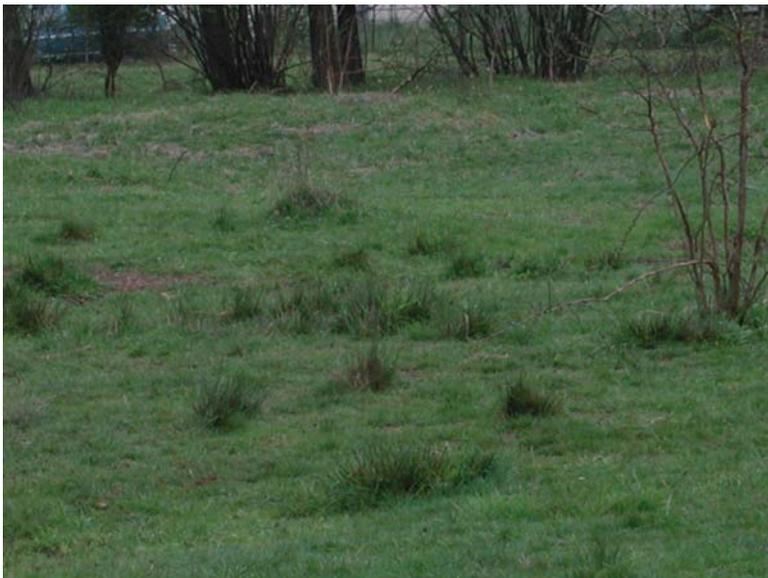
<b>Ecology Rating</b>	IV
	<b>Clark Co. Rating</b>	IV
	<b>Cowardin Classification</b>	PEM
	<b>HGM Classification</b>	DEP
	<b>WRIA</b>	28
	<p><b><u>Dominant Vegetation</u></b></p> <p><i>Agrostis capillaris</i> (colonial bentgrass) FAC  <i>Juncus effuses</i> (soft rush) FACW</p>	
Percent of Dominant Species that are OBL, FACW or FAC (excluding FAC-)	100%	
Wetland SQ, looking west		
<b>Description/Vegetation</b>		
Wetland SQ is a very small palustrine, emergent (PEM) wetland that is located in a pasture south of SR 502 and just west of 50 <sup>th</sup> Avenue. The pasture appeared to be heavily grazed by livestock, mainly goats.		
<b>Soils</b>		
The soil sampled in Wetland SQ exhibited a low chroma matrix and redoximorphic features within 10 inches of the surface. These characteristics are evidence that the soils in the wetland are saturated and/or inundated for a duration sufficient to promote anaerobic conditions, therefore meeting the hydric soil criterion.

<b>Hydrology</b>		
Wetland hydrology was provided by overland flow from adjacent uplands, precipitation, and a seasonally shallow water table. On March 28, 2005 all areas of the site were saturated to the surface or inundated to a maximum depth of 1 inch. These findings demonstrate the area has sufficient saturation and/or ponding during the growing season to satisfy the wetland hydrology criterion.		
<b>Rating/Functions</b>		
Wetland SQ ranked as a Category IV under Ecology's 4-tier rating system (Appendix C). This wetland is very small and rated very low in each of the broad categories of Water Quality Functions, Hydrological Functions, and Habitat Functions.

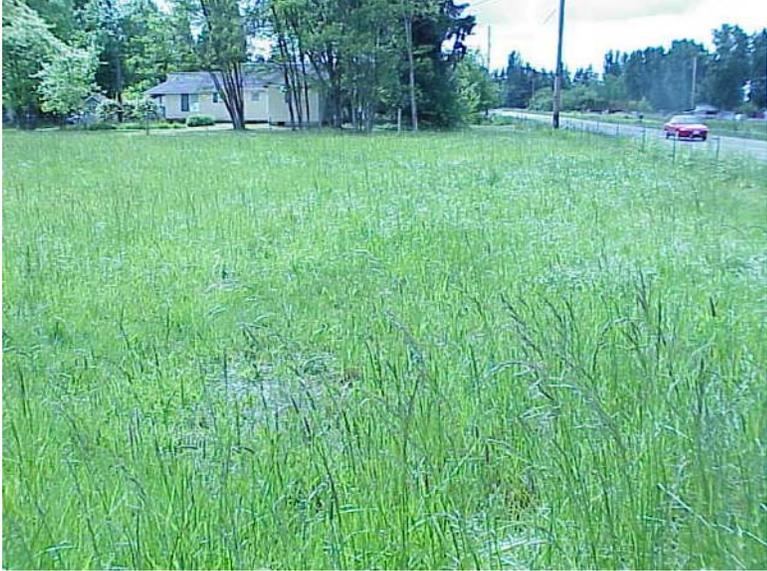
Wetland ST

<b>Ecology Rating</b>	IV	<b>Clark Co. Rating</b>	IV	<b>Cowardin Classification</b>	PEM	<b>HGM Classification</b>	DEP	<b>WRIA</b>	28
	<b>Ecology Rating</b>	IV										
	<b>Clark Co. Rating</b>	IV										
	<b>Cowardin Classification</b>	PEM										
	<b>HGM Classification</b>	DEP										
<b>WRIA</b>	28											
<p><b>Dominant Vegetation</b>  <i>Agrostis capillaris</i> (colonial bentgrass) FAC  <i>Poa</i> sp. (bluegrass)  <i>Ranunculus repens</i> (creeping buttercup)            FACW</p>												
Percent of Dominant Species that are OBL, FACW or FAC (excluding FAC-)	≥67%											
Wetland SR, looking southeast												
<p><b>Description/Vegetation</b></p> <p>Wetland SR was a palustrine, emergent (PEM) wetland that was located south of SR 502 and just west of 50th Avenue. It may serve as grazing area for goats that were occupying an adjacent parcel to the west. Field observations indicated it had been grazed or mowed recently. The wetland was connected to a roadside ditch that provided a hydrologic connection to other wetlands. The <i>Poa</i> sp. was unidentifiable at the time of investigation, although most of the possible candidates in this genus are FAC or wetter species.</p>												
<p><b>Soils</b></p> <p>The soil sampled in Wetland SR exhibited a low chroma matrix and redoximorphic features within 10 inches of the surface. These characteristics are evidence that the soils in the wetland are saturated and/or inundated for a duration sufficient to promote anaerobic conditions, therefore meeting the hydric soil criterion.</p>												
<p><b>Hydrology</b></p> <p>Wetland hydrology was provided by overland flow from adjacent uplands, precipitation, discharge from roadside ditches during high flow events, and a seasonally shallow water table. At the time of the site visit Wetland SR had less than one inch of inundation with free water standing at the soil surface in the soil pit. These findings demonstrate the area has sufficient saturation and/or ponding during the growing season to satisfy the wetland hydrology criterion.</p>												
<p><b>Rating/Functions</b></p> <p>Wetland SR ranked as a Category IV under Ecology's 4-tier rating system (Appendix C). This wetland rated relatively low in nearly all respects, however, an important water quality function is likely being provided by this wetland that is down slope from a goat pen. Other functions were limited by the wetlands landscape position, lack of complexity and structure, and its inability to impound water.</p>

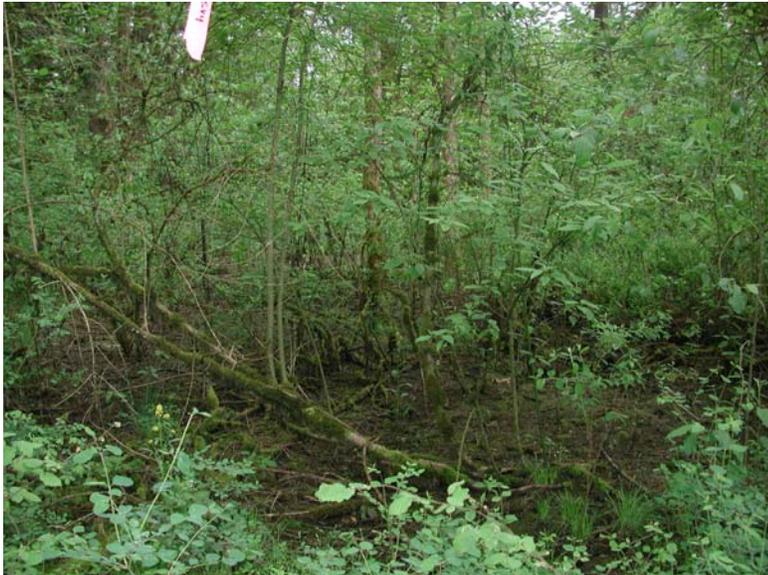
<b>Ecology Rating</b>	III
	<b>Clark Co. Rating</b>	III
	<b>Cowardin Classification</b>	PFO
	<b>HGM Classification</b>	DEP
	<b>WRIA</b>	28
<p><b>Dominant Vegetation</b></p> <p><i>Carex obnupta</i> (slough sedge) OBL  <i>Fraxinus latifolia</i> (Oregon ash) FACW  <i>Spirea douglasii</i> (hardhack) FACW  <i>Symphoricarpos albus</i> (snowberry) FACU</p>		
Percent of Dominant Species that are OBL, FACW or FAC (excluding FAC-)		75%
Wetland SV, looking south		
<b>Description/Vegetation</b>		
Wetland SV is a palustrine, forested (PFO) wetland located south of SR 502 and west of 72 <sup>nd</sup> Avenue. The wetland was inundated at the time of investigation and appeared to store a significant amount of surface water. The wetland was not connected to the roadside ditch and appeared to be isolated.		
<b>Soils</b>		
Permission to dig was not granted for the site, although it was assumed that the soils were hydric due to the fact that the area appeared to be inundated and/or saturated for a duration sufficient to promote anaerobic conditions. The strength of the hydrology and vegetation indicators were further evidence the wetland criterion were met, therefore, aiding in the assumption that the hydric soil criteria was satisfied.

<b>Hydrology</b>		
Wetland hydrology is provided by overland flow from adjacent uplands, precipitation, and a seasonally shallow water table. At the time of field investigation, water marks on trees were observed, areas of the wetland were saturated to the surface, and inundation to a depth of 12 inches was observed. The area of inundation covered more than ¾ of the wetland and permanent inundation was assumed to occur in a portion of the wetland. These findings demonstrate the area has sufficient saturation and/or ponding during the growing season to satisfy the wetland hydrology criterion.		
<b>Rating/Functions</b>		
Wetland SV ranked as a Category III under Ecology's 4-tier rating system (Appendix C). The ability of the wetland to improve water quality can be attributed to the following facts: over half of the total area is seasonally inundated and >95% of the area is covered by persistent ungrazed vegetation. Wetland SV provides Hydrologic Function through the storage of surface water during high precipitation events. Marks of ponding were observed 2 feet from the surface, indicating regular, prolonged durations of surface water storage. Wetland SV provides significant Habitat Functions due to the various water regimes present, the large relatively undisturbed buffer, and the connectivity of the wetland to other wetland areas.

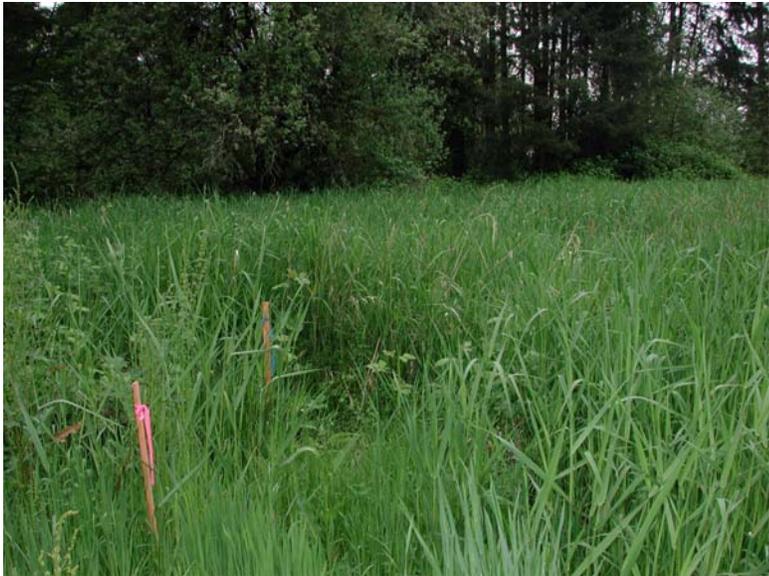
<b>Ecology Rating</b>	IV
	<b>Clark Co. Rating</b>	III
	<b>Cowardin Classification</b>	PEM
	<b>HGM Classification</b>	DEP
	<b>WRIA</b>	28
	<p><b>Dominant Vegetation</b></p> <p><i>Phalaris arundinacea</i> (reed canary grass) FACW</p>	
	Percent of Dominant Species that are OBL, FACW or FAC (excluding FAC-)	100%
Wetland SVV, looking southeast		
<b>Description/Vegetation</b>		
Wetland SVV is a palustrine, emergent (PEM) wetland located south of SR 502, west of 72nd Avenue, and directly west of Julie's Restaurant. The wetland is just upslope of Mill Creek and may contribute baseflow to the system. Subsequent visits to the area indicated that personnel from the restaurant frequently mowed the wetland.		
<b>Soils</b>		
Permission to dig was not granted for site, although it was assumed that the soils were hydric due to the fact that the area appeared to be inundated and/or saturated for a duration sufficient to promote anaerobic conditions.

<b>Hydrology</b>		
Wetland hydrology was provided by overland flow from adjacent uplands, precipitation and a seasonally shallow water table. At the time of field investigation, areas of the wetland were saturated to the surface and wetland drainage patterns were observed throughout the wetland. These findings demonstrate the area has sufficient saturation and/or ponding during the growing season to satisfy the wetland hydrology criterion.		
<b>Rating/Functions</b>		
Wetland SVV ranked as a Category IV under Ecology's 4-tier rating system (Appendix C). Due to the lack of structural diversity and frequent mowing, the functions of the wetland are minimal.

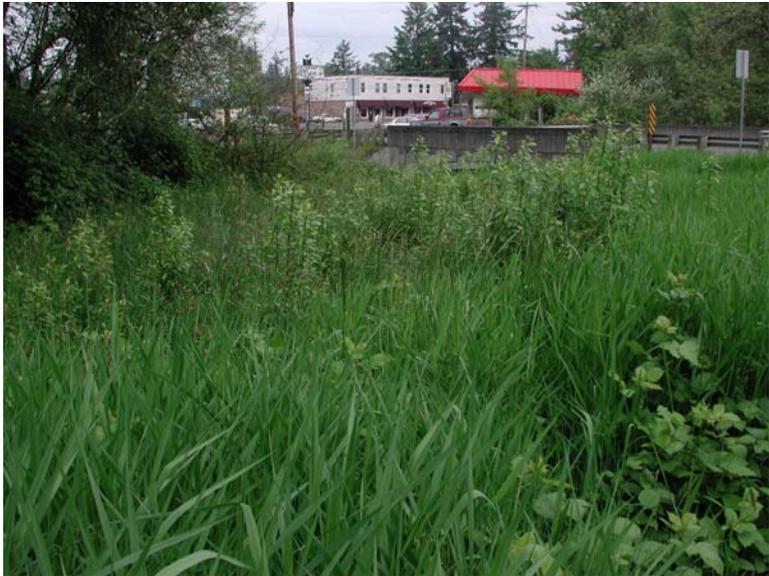
<b>Ecology Rating</b>	IV
	<b>Clark Co. Rating</b>	III
	<b>Cowardin Classification</b>	PEM
	<b>HGM Classification</b>	DEP
	<b>WRIA</b>	28
	<p><b>Dominant Vegetation</b></p> <p><i>Alopecurus pratensis</i> (Meadow foxtail) FACW  <i>Phalaris arundinacea</i> (reed canary grass) FACW  <i>Populus balsamifera</i> (black cottonwood) FAC</p>	
	Percent of Dominant Species that are OBL, FACW or FAC (excluding FAC-)	100%
Wetland SVW, looking northeast		
<b>Description/Vegetation</b>		
Wetland SVW is a palustrine, emergent (PEM) wetland located south of SR 502, west of 72nd Avenue, and directly north Julie's Restaurant. The wetland area is elevated approximately 8 feet above Mill Creek and appeared to contribute minimal base flow to the creek. Subsequent visits to the area indicated that personnel from the restaurant frequently mowed the wetland.		
<b>Soils</b>		
Permission to dig was not granted for the site, although it was assumed that the soils were hydric due to the fact that the area appeared to be inundated and/or saturated for a duration sufficient to promote anaerobic conditions and the strength of the hydrology and vegetation indicators.

<b>Hydrology</b>		
Wetland hydrology is provided by overland flow from adjacent uplands, precipitation and a seasonally shallow water table. At the time of field investigation, areas of the wetland were saturated to the surface. The wetland was situated in a topographical depression, suggesting that frequent saturation and/or inundation occurs following precipitation events. These findings demonstrate the area has sufficient saturation and/or ponding during the growing season to satisfy the wetland hydrology criterion.		
<b>Rating/Functions</b>		
Wetland SVW ranked as a Category IV under Ecology's 4-tier rating system (Appendix C). Due to the lack of structural diversity and frequent mowing, the functions of the wetland are minimal.

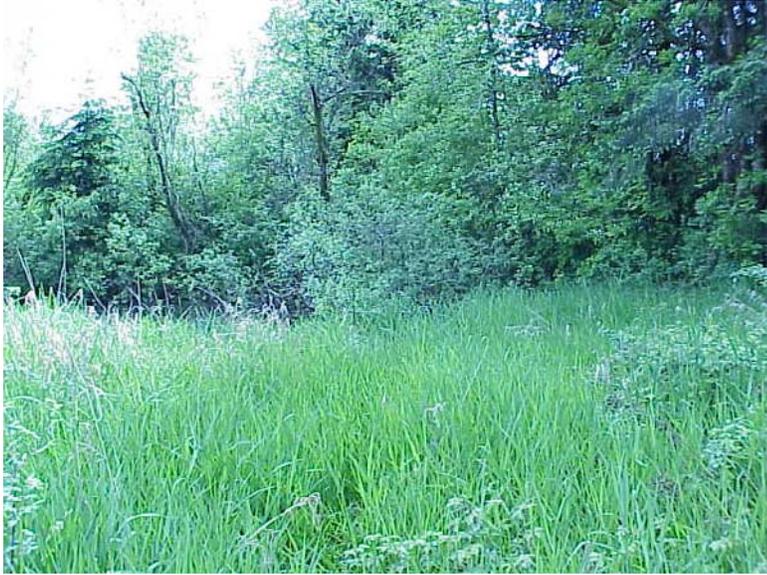
<b>Ecology Rating</b>	II
	<b>Clark Co. Rating</b>	II
	<b>Cowardin Classification</b>	PEM/PSS
	<b>HGM Classification</b>	DEP
	<b>WRIA</b>	28
	<p><b>Dominant Vegetation</b></p> <p>SX-DW1 (PSS)  <i>Cornus sericea</i> (red-osier dogwood) FACW  <i>Phalaris arundinacea</i> (reed canary grass) FACW</p> <p>SX-DW2 (PEM)  <i>Phalaris arundinacea</i> (reed canary grass) FACW</p>	
Percent of Dominant Species that are OBL, FACW or FAC (excluding FAC-)	100%	
Wetland SX, looking southeast		
<b>Description/Vegetation</b>		
Wetland SX is a palustrine, emergent (PEM) and palustrine, scrub-shrub (PSS) wetland complex located south of SR 502, east of 72nd Avenue, and behind First Independent Bank. The wetland extends beyond the project limits to the east and consists of several Cowardin classes, including: palustrine, emergent (PEM); palustrine, forested (PFO); and palustrine, scrub-shrub (PSS).		
<b>Soils</b>

The soil sampled in Wetland SX exhibited a low chroma matrix and redoximorphic features within 10 inches of the surface. These characteristics are evidence that the soils in the wetland are saturated and/or inundated for a duration sufficient to promote anaerobic conditions, therefore meeting the hydric soil criterion.		
<b>Hydrology</b>		
Wetland hydrology was provided by overland flow from adjacent uplands, precipitation, a seasonally shallow water table, and from overflow of the adjacent pond. At the time of field investigation, areas of the wetland were inundated and/or saturated to the surface. Free water was observed in the soil pit at a depth of 12 inches in SX-DW1 and 10 inches in SX-DW2. These findings demonstrate the area has sufficient saturation and/or ponding during the growing season to satisfy the wetland hydrology criterion.		
<b>Rating/Functions</b>		
Wetland SX ranked as a Category II under Ecology's 4-tier rating system (Appendix C). The ability of Wetland SX to improve water quality is attributed mainly to the fact that the wetland is a depression with no apparent outlet and has persistent, emergent vegetation for greater than half of the total area. Wetland SX has considerable floodwater storage capacity due to the fact that no surface outlet was observed, allowing the wetland to store surface water that would otherwise be a source of erosive flows and/or floodwater. The numerous vegetation classes, variety of water regimes, moderate interspersions of habitats, relatively undisturbed buffer, and overall size of the wetland provide considerable Habitat Functions.

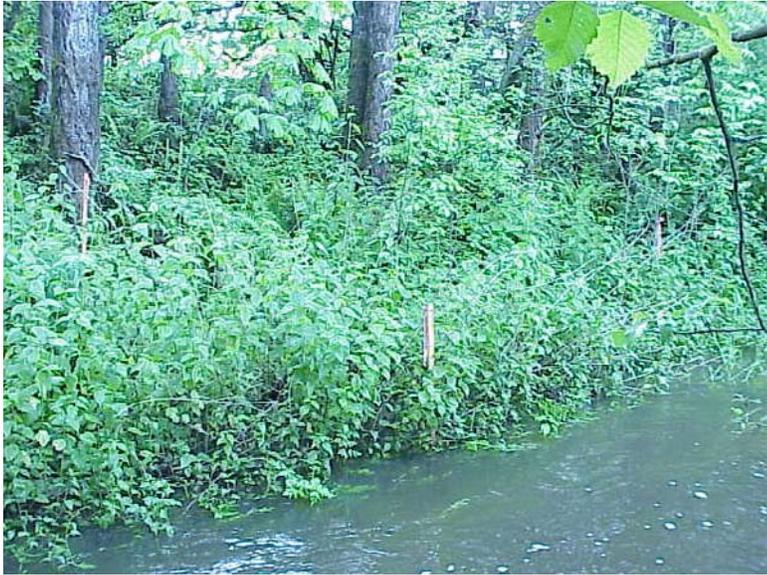
Percent of Dominant Species that are OBL, FACW or FAC (excluding FAC-)	100%										
<p>Wetland SY, looking south</p>											
<p><b>Description/Vegetation</b></p> <p>Wetland SY is a palustrine, emergent (PEM) wetland located along the southern bank of Mill Creek, south of SR 502 and east of 72nd Avenue. The drift lines and water marks observed were evidence that the wetland was seasonally inundated during high flow events of Mill Creek. The wetland was on an approximately 10% slope and was dominated by <i>U. dioica</i>. The small size of the wetland limited the functions it provided.</p>											
<p><b>Soils</b></p> <p>No soil pit was dug in the wetland due to the dominance of <i>Urtica dioica</i> (stinging nettle) and coarse nature of the substrate. The wetland experiences extended durations of inundation and/or saturation due to its proximity to Mill Creek and therefore meets the hydric soil criterion.</p>

<p><b>Hydrology</b></p> <p>Wetland hydrology was provided by overland flow from adjacent uplands, seasonal flood events of Mill Creek, and a shallow water table. At the time of field investigation, areas of the wetland were inundated, drift lines, water marks on trees, and flowing water was observed on the creek side of the wetland. These findings demonstrate the area has sufficient saturation and/or ponding during the growing season to satisfy the wetland hydrology criterion.</p>											
<p><b>Rating/Functions</b></p> <p>Wetland SY ranked as a Category III under Ecology's 4-tier rating system (Appendix C). The ability of Wetland SY to improve water quality is due to its proximity to Mill Creek and the presence of persistent, ungrazed vegetation. The dense vegetation has the ability to slow down water velocities and trap sediment. Wetland SY has considerable floodwater storage capacity due to its proximity to Mill Creek and its dense vegetative covering. The interspersed habitats and connectivity to other undisturbed areas, and overall size of the wetland provide considerable Habitat Functions.</p>

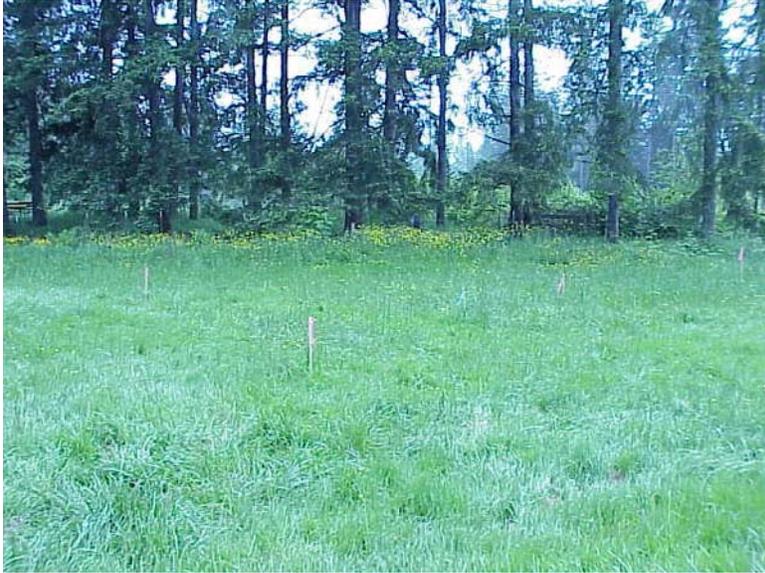
<b>Ecology Rating</b>	IV
	<b>Clark Co. Rating</b>	IV
	<b>Cowardin Classification</b>	PEM
	<b>HGM Classification</b>	DEP
	<b>WRIA</b>	28
	<b>Dominant Vegetation</b>	
<i>Ranunculus repens</i> (creeping buttercup) FACW Unidentified pasture grass		
Percent of Dominant Species that are OBL, FACW or FAC (excluding FAC-)		≥50%
Wetland SZ, looking south		
<b>Description/Vegetation</b>		
<p>Wetland SZ is a small palustrine, emergent (PEM) wetland located south of SR 502 and east of 72nd Avenue in a mowed field. The wetland is located in a topographic depression at the northern edge of a large stand of upland forest.</p>		
<b>Soils</b>		
<p>The soil sampled in Wetland SZ exhibited a low chroma matrix and redoximorphic features within 10 inches of the surface. These characteristics are evidence that the soils in the wetland are saturated and/or inundated for a duration sufficient to promote anaerobic conditions, therefore meeting the hydric soil criterion.</p>

<b>Hydrology</b>		
<p>Wetland hydrology is provided by overland flow, precipitation, and by a seasonally shallow water table. On April 18, 2005 all areas of the site were saturated within 12 inches of the soil surface. At SZ-DW1, free water was observed in the pit at a depth of 12 inches with saturation occurring at 10 inches. These findings demonstrate the area has sufficient saturation and/or ponding during the growing season to satisfy the wetland hydrology criterion.</p>		
<b>Rating/Functions</b>		
<p>Wetland SZ ranked as a Category IV under Ecology's 4-tier rating system (Appendix C). Due to the site's small size, landscape position, and lack of complexity it rated low in the three broad categories of Water Quality Functions, Hydrologic Functions, and Habitat Functions. This wetland may provide some habitat value due to its relatively undisturbed buffer and proximity in relation to an expanse of quality upland habitat.</p>

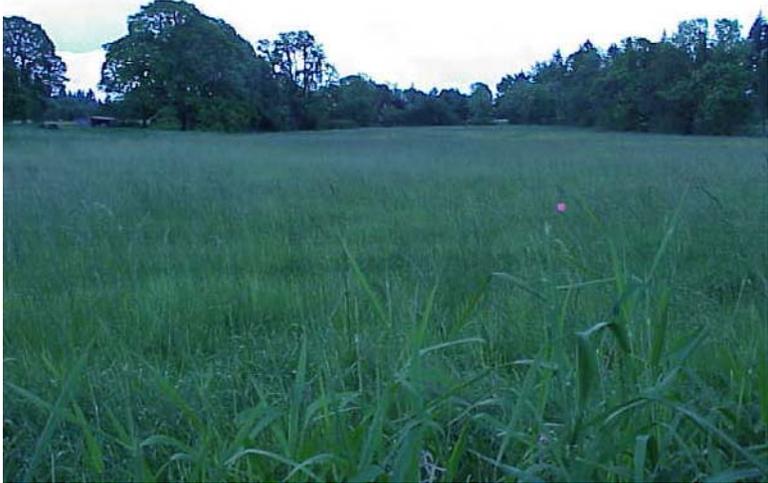
<b>Ecology Rating</b>	III
	<b>Clark Co. Rating</b>	IV
	<b>Cowardin Classification</b>	PEM
	<b>HGM Classification</b>	DEP
	<b>WRIA</b>	28
	<b>Dominant Vegetation</b>	
<i>Alopecurus geniculatus</i> (water foxtail) OBL <i>Holcus lanatus</i> (common velvetgrass) FAC		
Percent of Dominant Species that are OBL, FACW or FAC (excluding FAC-)		100%
Wetland SAA, looking south		
<b>Description/Vegetation</b>		
Wetland SAA is a palustrine, emergent (PEM) wetland located south of SR 502 and east of 50 <sup>th</sup> Avenue in a field between two single-family residences. The wetland extends beyond the project boundaries to the south and is part of a larger PEM complex.		
<b>Soils</b>		
The soil sampled in Wetland SAA exhibited a low chroma matrix and redoximorphic features within 10 inches of the surface. These characteristics are evidence that the soils in the wetland are saturated and/or inundated for a duration sufficient to promote anaerobic conditions, therefore meeting the hydric soil criterion.

<b>Hydrology</b>		
Wetland hydrology is provided by overland flow, precipitation, and by a seasonally shallow water table. On April 21, 2005 all areas of the site were inundated or saturated to the surface and wetland drainage patterns were observed throughout the wetland. At SAA-DW1, free water was observed in the pit at the soil surface. These findings demonstrate the area has sufficient saturation and/or ponding during the growing season to satisfy the wetland hydrology criterion.		
<b>Rating/Functions</b>		
Wetland SAA ranked as a Category III under Ecology's 4-tier rating system (Appendix C). The site's landscape position, dense and ungrazed vegetation, and constricted outlet help trap pollutants and therefore support Water Quality Functions. The constricted outlet and depressed topography also allows this wetland to provide the Hydrologic Function of retaining water. Although this wetland does have varied hydroperiods, habitat value is generally limited due to its lack of various vegetative classes, or other special habitat features.

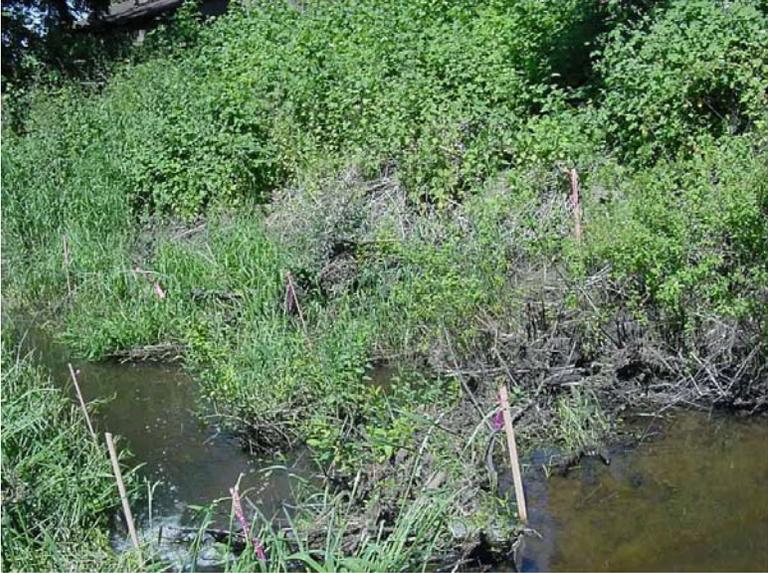
Wetland SAB, NV, & NW

Percent of Dominant Species that are OBL, FACW or FAC (excluding FAC-)	100%										
<p>Wetland NW, looking northeast</p>											
<p><b>Description/Vegetation</b></p> <p>Wetlands NV, NW, and SAB are small palustrine, emergent wetlands (PEM) located along Mill Creek in the vicinity of where it crosses beneath SR 502, west of 72 Avenue (Dollar Corner). Wetlands NV and NW are just north of SR 502, and Wetland SAB is just south of SR 502. The wetlands were assessed as one wetland complex because they existed within a stretch of Mill Creek that had a constant water regime.</p>											
<p><b>Soils</b></p> <p>The soil sampled in Wetlands NV, NW, and SAB exhibited a low chroma matrices and redoximorphic features within 10 inches of the surface. These characteristics are evidence that the soils in the wetland are saturated and/or inundated for a duration sufficient to promote anaerobic conditions, therefore meeting the hydric soil criterion.</p>

<p><b>Hydrology</b></p> <p>Wetland hydrology was provided by seasonal flooding events of Mill Creek, overland flow from adjacent uplands, precipitation, and a shallow water table. At the time of field investigation, drift lines approximately 2 feet above the present stream level were observed throughout the wetland, as were wetland drainage patterns. The soil was saturated within 6 inches of the surface at each datapoint, and various depths of inundation were observed throughout the wetlands. These findings demonstrate the area has sufficient saturation and/or ponding during the growing season to satisfy the wetland hydrology criterion.</p>											
<p><b>Rating/Functions</b></p> <p>Wetland NV, NW, and SAB rank as a Category IV under Ecology's 4-tier rating system (Appendix C). Scores for the broad categories of Water Quality Functions, Hydrologic Functions, and Habitat Functions were all relatively low largely due to the wetland's very small size and monotypic invasive vegetation.</p>
