# **WETLAND DELINEATION REPORT**

## **SR 502 CORRIDOR WIDENING / I-5 TO BATTLEGROUND**

Clark County, WA

Washington State  
Department of Transportation

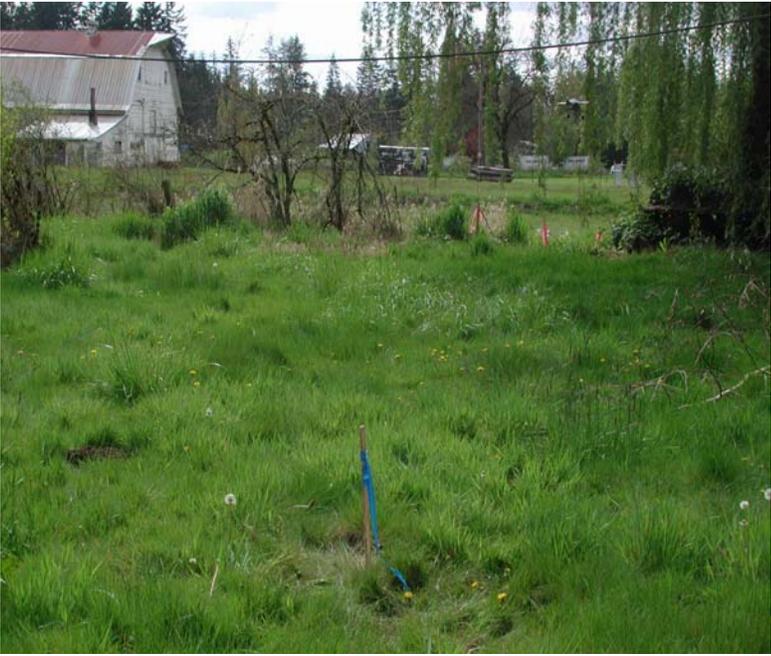
Percent of Dominant Species that are OBL, FACW or FAC (excluding FAC-)	83%										
Wetland SAD, looking west											
<b>Description/Vegetation</b>											
Wetland SAD is a palustrine, emergent (PEM) wetland located south of SR 502, behind an abandoned single-family residence, and begins approximately 1700 feet west of 87th Avenue. The wetland extends beyond the project boundaries to the south and was part of a larger PEM complex.											
<b>Soils</b>											
The soil sampled in Wetland SAD exhibited a low chroma matrix and redoximorphic features within 10 inches of the surface. These characteristics are evidence that the soils in the wetland are saturated and/or inundated for a duration sufficient to promote anaerobic conditions, therefore meeting the hydric soil criterion.											
<b>Hydrology</b>											
Wetland hydrology is provided by overland flow, precipitation, and by a seasonally shallow water table. On April 21, 2005 all areas of the site were inundated or saturated to the surface. At SAD-DW1, free water was observed in the soil pit at a depth of 6.5 inches. At SAD-DW2, free water was observed at the surface of the soil pit (saturated to the surface). Oxidized root channels associated with living plant material were observed, providing a secondary indicator of wetland hydrology. These findings demonstrate the area has sufficient saturation and/or ponding during the growing season to satisfy the wetland hydrology criterion.

<b>Rating/Functions</b>											
Wetland SAD ranked as a low Category III under Ecology's 4-tier rating system (Appendix C). Water Quality and Hydrologic functions are limited in this wetland because it does not impound water and therefore is unlikely to retain pollutants or reduce flooding. Varied hydroperiods, a relatively undisturbed buffer, and close proximity to other wetlands are characteristics that contribute to Habitat Functions. Habitat value is generally limited in this wetland due to its lack of vegetative structure or other special habitat features.

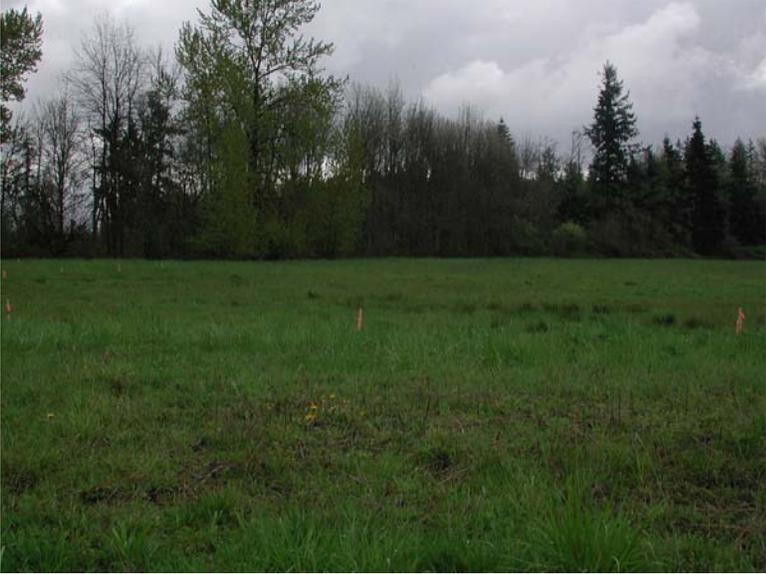
<b>Ecology Rating</b>	III
	<b>Clark Co. Rating</b>	IV
	<b>Cowardin Classification</b>	PEM
	<b>HGM Classification</b>	DEP
	<b>WRIA</b>	28
	<p><b>Dominant Vegetation</b></p> <p><i>Alopecurus pratensis</i> (meadow foxtail) FACW  <i>Lupinus polyphyllus</i>            (bigleaf lupine) FAC+</p>	
Wetland SAE, looking south	Percent of Dominant Species that are OBL, FACW or FAC (excluding FAC-)	100%
<b>Description/Vegetation</b>		
<p>Wetland SAE is a palustrine, emergent (PEM) wetland that was located south of SR 502 and approximately 1500 feet west of 87th Avenue. The wetland extends beyond the project boundary to the south and was situated within a berm-like structure that was storing surface water. According to the property owner, the berm-like structure is the remnant of a former horse-racing track. A drainage feature was located in the western portion of the berm and appeared to drain excess surface water into wetland SAD.</p>

<b>Soils</b>		
<p>The soil sampled in Wetland SAE exhibited a low chroma matrix and redoximorphic features within 10 inches of the surface. These characteristics are evidence that the soils in the wetland are saturated and/or inundated for a duration sufficient to promote anaerobic conditions, therefore meeting the hydric soil criterion.</p>		
<b>Hydrology</b>		
<p>Wetland hydrology is provided by overland flow, precipitation, and by a seasonally shallow water table. On April 14, 2005 all areas of the site were inundated or saturated to the surface. Free water was observed in the soil pit at a depth of 12 inches and drainage patterns provided another primary indicator of wetland hydrology. These findings demonstrate the area has sufficient saturation and/or ponding during the growing season to satisfy the wetland hydrology criterion.</p>		
<b>Rating/Functions</b>		
<p>Wetland SAE ranked as a Category III under Ecology's 4-tier rating system (Appendix C). This wetland provides moderate Hydrological and Habitat Functions and minimal Water Quality Functions. Water Quality Functions are limited by the lack of pollutant sources in the vicinity. The wetland's constricted outlet and areas of inundation throughout the wetland provide significant Hydrologic Functions by storing surface water that would otherwise be a source of flooding and erosive flows. Varied hydroperiods and a relatively undisturbed buffer are the only habitat features in a wetland that otherwise provides little Habitat Functions, due to its lack of vegetative complexity, structure, and overall size.</p>

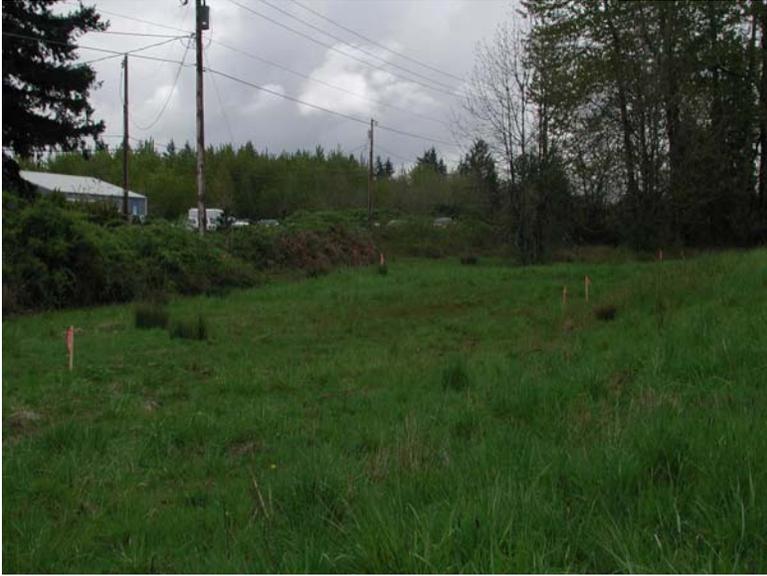
Wetland SAF and SAG

<b>Ecology Rating</b>	III
	<b>Clark Co. Rating</b>	III
	<b>Cowardin Classification</b>	PFO,PSS, PEM
	<b>HGM Classification</b>	DEP
	<b>WRIA</b>	28
<p><b><u>Dominant Vegetation</u></b></p> <p><u>Wetland SAF (PSS)</u>  <i>Alopecurus geniculatus</i> (water foxtail)  OBL  <i>Holcus lanatus</i> (common velvetgrass)  FAC  <i>Rosa nutkana</i> (nutka rose) FAC</p> <p><u>Wetland SAG (PEM)</u>  <i>Epilobium ciliatum</i> (FACW-)</p>		
Wetland SAF, looking east	Percent of Dominant Species that are OBL, FACW or FAC (excluding FAC-)	100%
<b>Description/Vegetation</b>		
<p>Wetland SAF and SAG are located south of SR 502 and east of 72nd Avenue. They contain palustrine, forested (PFO), scrub-shrub (PSS), and emergent (PEM) vegetation classes. The smaller wetland, SAG, is to the east of a driveway that separates the two wetlands, and is located in a deeply incised channel. Water runs east to west through wetland SAG into Wetland SAF through a culvert beneath the driveway. A drainage swale carries water north through Wetland SAF into a ditch on SR 502.</p>

<b>Soils</b>		
<p>The soil sampled in Wetlands SAF and SAG exhibited a low chroma matrix and redoximorphic features within 10 inches of the surface. These characteristics are evidence that the soils in the wetland are saturated and/or inundated for a duration sufficient to promote anaerobic conditions, therefore meeting the hydric soil criterion.</p>		
<b>Hydrology</b>		
<p>Wetland hydrology is provided by overland flow, precipitation, and by a seasonally shallow water table. On April 18, 2005 all areas of the site were saturated to the surface or inundated to a maximum depth of 12 inches. At SAF-DW1, free water was observed in the pit at 12 inches with the soil saturated to 8 inches. At SAG-DW1, free water was observed in the pit at the soil surface. These findings demonstrate the area has sufficient saturation and/or ponding during the growing season to satisfy the wetland hydrology criterion.</p>

<b>Rating/Functions</b>		
<p>Wetland SAF and SAG ranked as Category III wetlands under Ecology's 4-tier rating system (Appendix C). These wetlands were rated relatively low for water quality and hydrologic functions. Their landscape position, topography, and unconstricted outlet into a roadside ditch make these wetlands ineffective at impounding water or trapping pollutants. Wetlands SAF and SAG received a somewhat higher rating for habitat functions due to the various hydrologic regimes present, the presence of multiple vegetation classes, their complexity and interspersed habitats, and their relatively undisturbed buffers.</p>

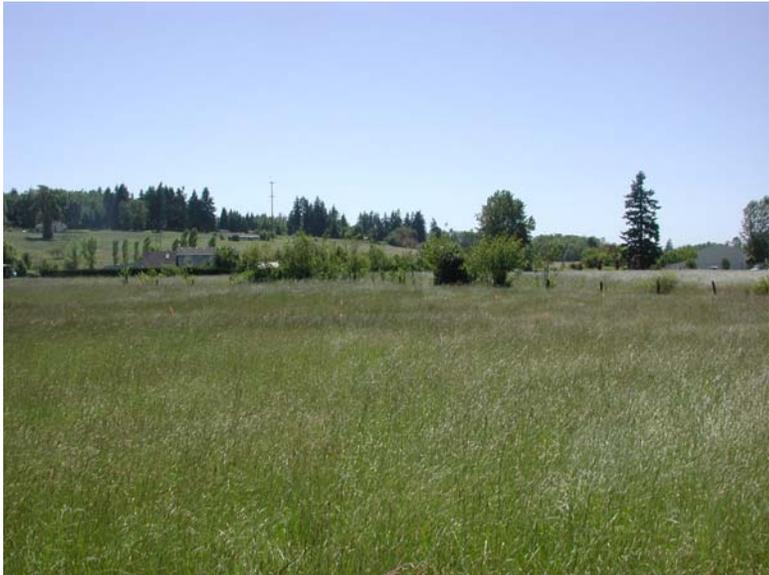
<b>Ecology Rating</b> <b>Clark Co. Rating</b> <b>Cowardin Classification</b> <b>HGM Classification</b> <b>WRIA</b>	IV IV PEM DEP 28	
	<b>Dominant Vegetation</b>		
	<b>SAI-DW1</b> <i>Myosotis laxa</i> (bay forget-me-not) OBL <i>Ranunculus repens</i> (creeping buttercup) FACW <i>Rosa pisocarpa</i> (clustered rose) FAC <i>Rubus ursinus</i> (California blackberry) FACU		
	<b>SAI-DW2</b> <i>Anthoxanthum odoratum</i> (sweet vernal grass) FACU		
	<b>SAI-DW3</b> <i>Anthoxanthum odoratum</i> (sweet vernal grass) FACU		
	<b>SAI-DW4</b> <i>Juncus bufonius</i> (toad rush) FACW		
	Percent of Dominant Species that are OBL, FACW or FAC (excluding FAC-)	67%	
	<b>Description/Vegetation</b>		
	<p>Wetland SAI is a palustrine, emergent (PEM) wetland located south of SR 502 and east of 87th Avenue. The wetland is in an active hayfield and is regularly harvested. A ditch ran from south to north through the wetland and connected with the roadside ditch on the south side of SR 502. The ditch through the wetland occurred along a fence line, was dominated by shrubs, and can be seen in the picture above. The roadside ditch provided a hydrologic connection between SAI and other wetlands, but the wetlands were rated separately since the wetlands were historically separate units. In some portions of the wetland, the plant community was dominated by annuals that developed during an uncharacteristically dry spring, and were not believed to be an accurate representation of site conditions.</p>

<b>Soils</b>		
<p>The soil sampled at each datapoint in Wetland SAI exhibited a low chroma matrix and redoximorphic features within 10 inches of the surface. These characteristics are evidence that the soils in the wetland are saturated and/or inundated for a duration sufficient to promote anaerobic conditions, therefore meeting the hydric soil criterion.</p>			
<b>Hydrology</b>			
<p>Wetland hydrology is provided by overland flow from adjacent uplands, precipitation, and a seasonally shallow water table. At the time of field investigation, areas of the wetland were inundated or saturated to the surface, with free water observed at various depths in each of the soil pits, with a maximum depth of 14 inches observed at SAI-DW1 and SAI-DW2. These findings demonstrate the area has sufficient saturation and/or ponding during the growing season to satisfy the wetland hydrology criterion.</p>			
<b>Rating/Functions</b>

<p>Wetland SAI ranked as a Category IV under Ecology's 4-tier rating system (Appendix C). Due to the lack of structural diversity and agricultural land use, the functions of the wetland are minimal and limited largely to water quality improvement.</p>

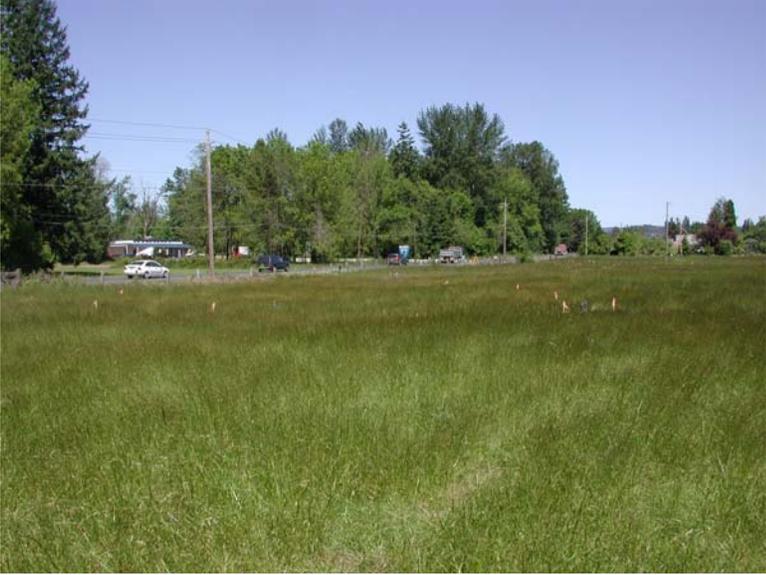
Wetland SAJ

<table><tr> <td><b>Ecology Rating</b></td> <td>IV</td> </tr><tr> <td><b>Clark Co. Rating</b></td> <td>IV</td> </tr></table>

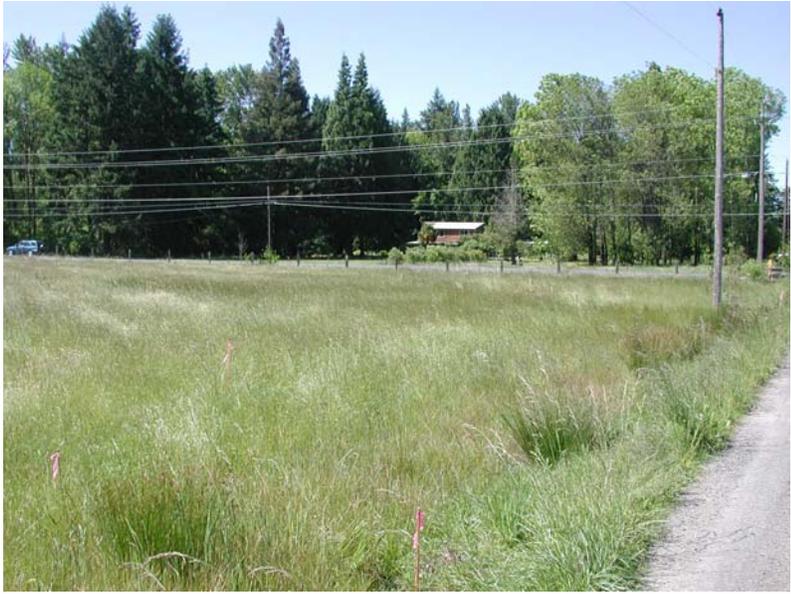
Percent of Dominant Species that are OBL, FACW or FAC (excluding FAC-)	33.3%										
Wetland SAK, looking northeast											
<p><b>Description/Vegetation</b></p> <p>Wetland SAK is a palustrine, emergent (PEM) wetland that was located south of SR 502 and east of 87th Avenue. The wetland is in an active hayfield and is regularly harvested. The wetland is connected to a roadside ditch that provided a hydrologic connection to other wetlands, but the wetlands were rated separately since the wetlands were historically separate units. Although the wetland vegetation criterion was not technically met for this wetland, the wetland determination is justified by the strength of the soil and hydrology parameters.</p>											
<p><b>Soils</b></p> <p>The soil sampled in Wetland SAK exhibited a low chroma (10 YR 4/1) matrix and redoximorphic features within 10 inches of the surface. These characteristics are evidence that the soils in the wetland are saturated and/or inundated for a duration sufficient to promote anaerobic conditions, therefore meeting the hydric soil criterion.</p>

<p><b>Hydrology</b></p> <p>Wetland hydrology was provided by overland flow from adjacent uplands, precipitation, discharge from roadside ditches during high flow events, and a seasonally shallow water table. For a period in excess of 30 days in April and May 2005, areas of the wetland were saturated to the surface, inundated to a depth of 2 inches, and free water was observed in the soil pit at a depth of 5 inches (May 11, 2005). These findings demonstrate the area has sufficient saturation and/or ponding during the growing season to satisfy the wetland hydrology criterion.</p>											
<p><b>Rating/Functions</b></p> <p>Wetland SAK ranked as a Category IV under Ecology's 4-tier rating system (Appendix C). This wetland rated relatively low in nearly all respects, with functions largely limited to a modest water quality function supported by dense herbaceous vegetation. Active agricultural use, small size, landscape position, and lack of habitat features are limiting factors with regard to overall functions provided.</p>

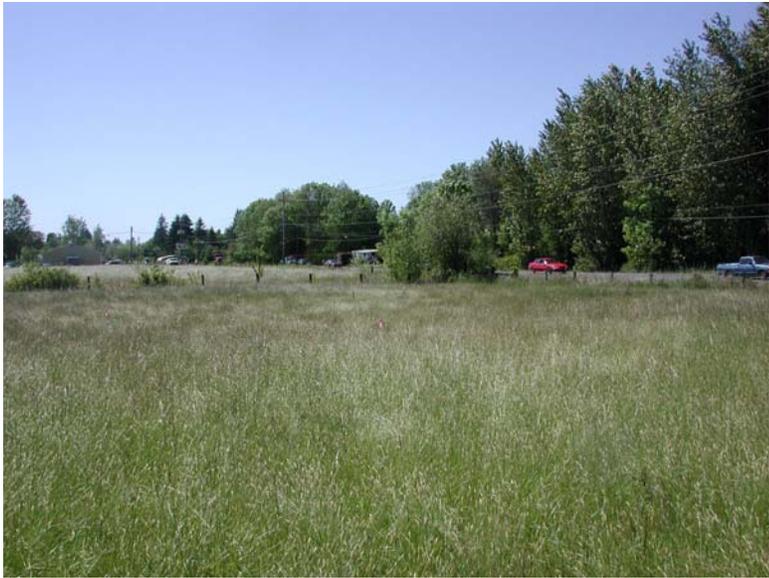
<b>Ecology Rating</b>	IV
	<b>Clark Co. Rating</b>	IV
	<b>Cowardin Classification</b>	PEM
	<b>HGM Classification</b>	DEP
	<b>WRIA</b>	28
	<p><b>Dominant Vegetation</b></p> <p><i>Anthoxanthum odoratum</i> (sweet vernal grass) FACU  <i>Holcus lanatus</i> (common velvetgrass) FAC  <i>Phalaris arundinacea</i> (reed canary grass) FACW</p>	
Percent of Dominant Species that are OBL, FACW or FAC (excluding FAC-)	67%	
Wetland SAM, looking northwest		
<b>Description/Vegetation</b>		
Wetland SAM is a palustrine, emergent (PEM) wetland located south of SR 502 directly east of an unnamed street, and east of 87th Avenue. The wetland extends beyond the property boundaries to the south, is connected to a roadside ditch, and is in a hayfield that is actively harvested.		
<b>Soils</b>		
The soil sampled in Wetland SAM exhibited a low chroma matrix and redoximorphic features within 10 inches of the surface, and emitted a Sulfidic odor. These characteristics are evidence that the soils in the wetland are saturated and/or inundated for a duration sufficient to promote anaerobic conditions, therefore meeting the hydric soil criterion.

<b>Hydrology</b>		
Wetland hydrology is provided by overland flow from adjacent uplands, precipitation, and a seasonally shallow water table. At the time of field investigation, the wetland was saturated to the surface, inundated to a depth of 2 inches, and free water was observed at the surface of the soil pit. These findings demonstrate the area has sufficient saturation and/or ponding during the growing season to satisfy the wetland hydrology criterion. A culvert was observed on the eastern border of the wetland, and it appeared to discharge runoff from Wetland SAN during high precipitation events.		
<b>Rating</b>		
Wetland SAM ranked as a Category IV under Ecology's 4-tier rating system (Appendix C). Due to the lack of structural diversity and agricultural land use, the functions of the wetland are minimal and limited largely to water quality improvement.

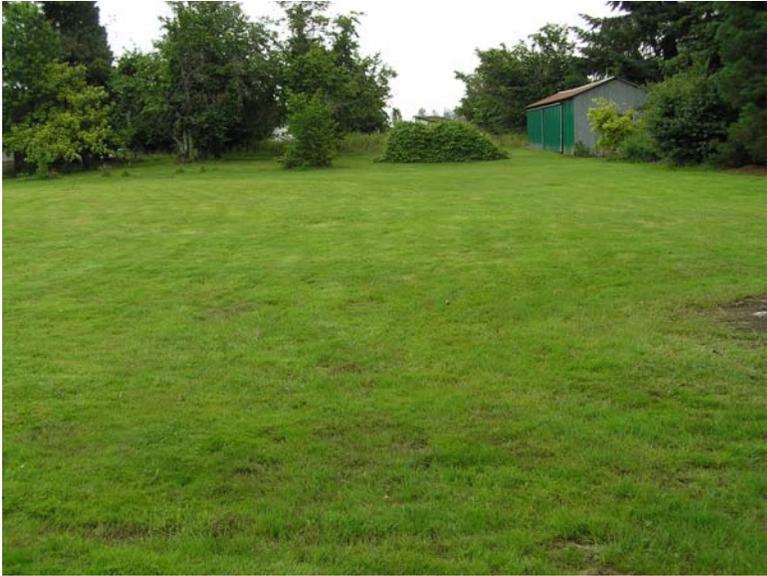
<b>Ecology Rating</b>	IV
	<b>Clark Co. Rating</b>	IV
	<b>Cowardin Classification</b>	PEM
	<b>HGM Classification</b>	DEP
	<b>WRIA</b>	28
	<p><b>Dominant Vegetation</b></p> <p><i>Poa pratensis</i> (Kentucky bluegrass) FAC  <i>Ranunculus repens</i> (creeping buttercup) FACW</p>	
Percent of Dominant Species that are OBL, FACW or FAC (excluding FAC-)	100%	
Wetland SAN, looking east		
<b>Description/Vegetation</b>		
<p>Wetland SAN is a palustrine, emergent (PEM) wetland located south of SR 502, east of an unnamed driveway, and east of 87th Avenue. The wetland is in a maintained residential backyard and is periodically mowed. The area was being used for a debris/yard waste storage area. A drainage swale extended north from the wetland and crossed under the driveway in an approximately 6 inch culvert, and appeared to discharge into wetland SAM.</p>		
<b>Soils</b>		
<p>The soil sampled in Wetland SAN exhibited a low chroma matrix and redoximorphic features within 10 inches of the surface. These characteristics are evidence that the soils in the wetland are saturated and/or inundated for a duration sufficient to promote anaerobic conditions, therefore meeting the hydric soil criterion.</p>

<b>Hydrology</b>		
<p>Wetland hydrology was provided by overland flow from adjacent uplands, precipitation and a seasonally shallow water table. At the time of field investigation, areas of the wetland were saturated to the surface, inundated to a depth of 4 inches, and free water was observed at the surface of the soil pit. These findings demonstrate the area has sufficient saturation and/or ponding during the growing season to satisfy the wetland hydrology criterion. Wetland SAN appeared to drain into Wetland SAM. A ditch extended north from Wetland SAN and connected to a culvert that crossed under a gravel road and discharged into Wetland SAM.</p>		
<b>Rating/Functions</b>		
<p>Wetland SAN ranked as a Category IV under Ecology's 4-tier rating system (Appendix C). Due to the lack of structural diversity and residential land use (mowed backyard), the functions of the wetland are minimal.</p>

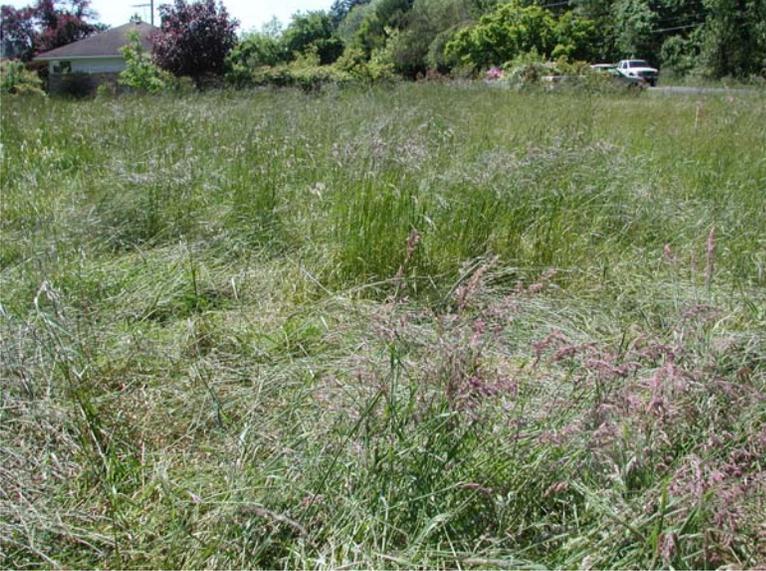
<b>Ecology Rating</b>	IV
	<b>Clark Co. Rating</b>	IV
	<b>Cowardin Classification</b>	PEM
	<b>HGM Classification</b>	DEP
	<b>WRIA</b>	28
	<p><b>Dominant Vegetation</b></p> <p><i>Alopecurus pratensis</i> (Meadow foxtail) FACW  <i>Holcus lanatus</i> (common velvetgrass) FAC  <i>Lolium arundinaceum</i> (tall fescue) FAC-</p>	
Percent of Dominant Species that are OBL, FACW or FAC (excluding FAC-)	67%	
Wetland SAO, looking northwest		
<b>Description/Vegetation</b>		
Wetland SAO is a palustrine, emergent (PEM) wetland located south of SR 502 and east of 87th Avenue. The wetland was surrounded by single-family residences and may have historically been used as a septic field.		
<b>Soils</b>		
The soil sampled in wetland SAO exhibited a low chroma matrix and redoximorphic features within 10 inches of the surface. These characteristics are evidence that the soils in the wetland are saturated and/or inundated for a duration sufficient to promote anaerobic conditions, therefore meeting the hydric soil criterion.

<b>Hydrology</b>		
Wetland hydrology is provided by overland flow from adjacent uplands, precipitation, discharge from a roadside ditch during periods of high flow, and a seasonally shallow water table. At the time of field investigation, areas of the wetland were saturated to the surface and free water was observed in the soil pit at a depth of 2 inches. These findings demonstrate the area has sufficient saturation and/or ponding during the growing season to satisfy the wetland hydrology criterion. The area may have been historically used as a septic field.		
<b>Rating/Functions</b>		
Wetland SAO ranked as a Category IV under Ecology's 4-tier rating system (Appendix C). Due to the lack of structural diversity, the functions of the wetland are minimal and limited largely to improving water quality.

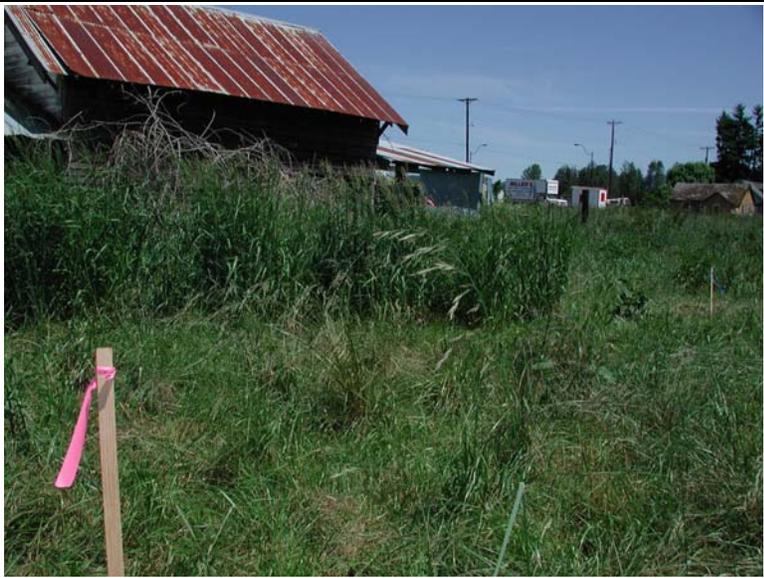
<b>Ecology Rating</b>	IV
	<b>Clark Co. Rating</b>	IV
	<b>Cowardin Classification</b>	PEM
	<b>HGM Classification</b>	DEP
	<b>WRIA</b>	28
	<p><b>Dominant Vegetation</b></p> <p><i>Alopecurus geniculatus</i> (water foxtail) OBL  <i>Alopecurus pratensis</i> (meadow foxtail) FACW  <i>Phalaris arundinacea</i> (reed canarygrass) FACW</p>	
Wetland SAP, looking north	Percent of Dominant Species that are OBL, FACW or FAC (excluding FAC-)	100%
<b>Description/Vegetation</b>		
This small isolated palustrine emergent wetland (PEM) is located in a topographic depression south of SR 502 next to a farmhouse. It is the easternmost wetland delineated in the project area south of SR 502.		
<b>Soils</b>		
The soil sampled in Wetland SAP exhibited a low chroma matrix and redoximorphic features within 10 inches of the surface. These characteristics are evidence that the soils in the wetland are saturated and/or inundated for a duration sufficient to promote anaerobic conditions, therefore meeting the hydric soil criterion.

<b>Hydrology</b>		
On May 26, 2005, all areas of the wetland were saturated or inundated to a maximum depth of 2 inches. These findings suggest that this wetland has sufficient saturation and/or ponding during the growing season to satisfy the wetland hydrology criterion.		
<b>Rating/Functions</b>		
Wetland SAP ranked as a Category IV under Ecology's 4-tier rating system (Appendix C). Scores for the broad categories of Water Quality Functions, Hydrologic Functions, and Habitat Functions were all relatively low. The wetland provides some water quality functions since it is a densely vegetated topographic depression with no outlet that has a nearby potential source of pollutants (residential and agriculture). Other functions are severely limited by its small size and lack of complexity and structure.

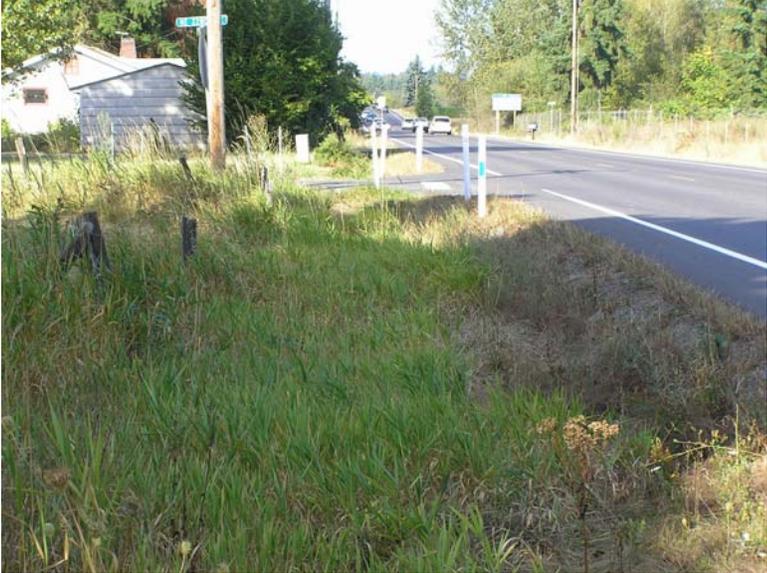
<b>Ecology Rating</b>	IV
	<b>Clark Co. Rating</b>	IV
	<b>Cowardin Classification</b>	PEM
	<b>HGM Classification</b>	DEP
	<b>WRIA</b>	27
	<p><b>Dominant Vegetation</b></p> <p><i>Phalaris arundinacea</i> (reed canarygrass) FACW</p>	
Wetland SWD1, looking west	Percent of Dominant Species that are OBL, FACW or FAC (excluding FAC-)	100%
<p><b>Description/Vegetation</b></p> <p>Wetland SWD1 is a palustrine, emergent (PEM) wetland located south of SR 502, east of 22<sup>nd</sup> Avenue and west of 29<sup>th</sup> Avenue in a roadside ditch. The wetland is adjacent to a historical wetland, Wetland SC, and conveys stormwater to other roadside ditches via culverts.</p>		
<p><b>Soils</b></p> <p>The soil sampled in Wetland SWD1 exhibited a low chroma matrix and redoximorphic features within 10 inches of the surface. These characteristics are evidence that the soils in the wetland are saturated and/or inundated for a duration sufficient to promote anaerobic conditions, therefore meeting the hydric soil criterion.</p>

<p><b>Hydrology</b></p> <p>Wetland hydrology is provided by overland flow from adjacent uplands, precipitation, roadside ditch discharge, and a seasonally shallow water table. At the time of field investigation, all areas of the wetland were saturated to the surface or within 12 inches of the soil surface, and free water was observed in the soil pit at a depth of 6 inches. These findings demonstrate the area has sufficient saturation and/or ponding during the growing season to satisfy the wetland hydrology criterion.</p>		
<p><b>Rating/Functions</b></p> <p>Wetland SWD1 ranked as a Category IV under Ecology's 4-tier rating system (Appendix C).</p> <p>Scores for the broad categories of Water Quality Functions, Hydrologic Functions, and Habitat Functions were all relatively low.</p>

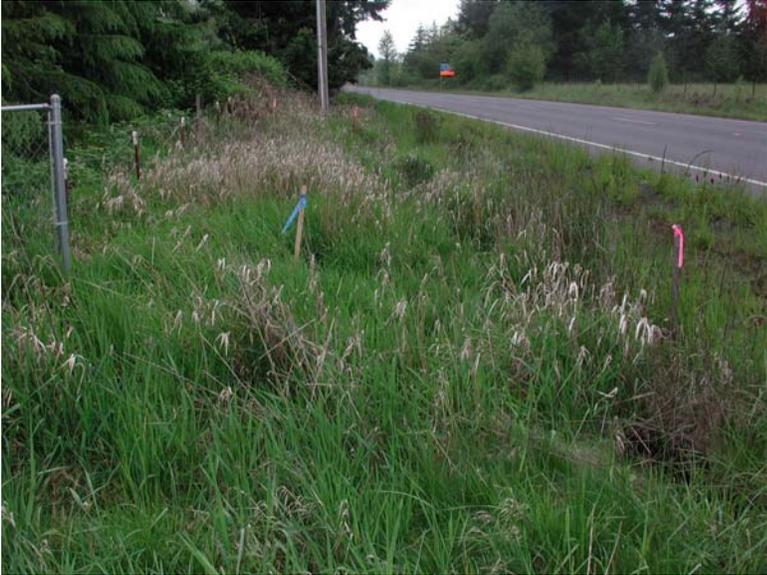
<b>Ecology Rating</b>	IV
	<b>Clark Co. Rating</b>	IV
	<b>Cowardin Classification</b>	PEM
	<b>HGM Classification</b>	DEP
	<b>WRIA</b>	27
	<p><b><u>Dominant Vegetation</u></b></p> <p><i>Phalaris arundinacea</i> (reed canarygrass) FACW</p>	
	Percent of Dominant Species that are OBL, FACW or FAC (excluding FAC-)	100%
Wetland SWD2, looking west		
<b>Description/Vegetation</b>		
Wetland SWD2 is a palustrine, emergent (PEM) wetland located south of SR 502 and east of 29 <sup>th</sup> Avenue in a roadside ditch. The wetland is adjacent to a historical wetland, Wetland SL, and conveys stormwater to other roadside ditches via culverts.		
<b>Soils</b>		
The soil sampled in Wetland SWD2 exhibited a low chroma matrix and redoximorphic features within 10 inches of the surface. These characteristics are evidence that the soils in the wetland are saturated and/or inundated for a duration sufficient to promote anaerobic conditions, therefore meeting the hydric soil criterion.

<b>Hydrology</b>		
Wetland hydrology is provided by overland flow from adjacent uplands, precipitation, roadside ditch discharge, and a seasonally shallow water table. At the time of field investigation, all areas of the wetland were saturated to the surface and free water was observed in the soil pit at a depth of 4 inches. These findings demonstrate the area has sufficient saturation and/or ponding during the growing season to satisfy the wetland hydrology criterion.		
<b>Rating/Functions</b>		
Wetland SWD2 ranked as a Category IV under Ecology's 4-tier rating system (Appendix C). Scores for the broad categories of Water Quality Functions, Hydrologic Functions, and Habitat Functions were all relatively low.

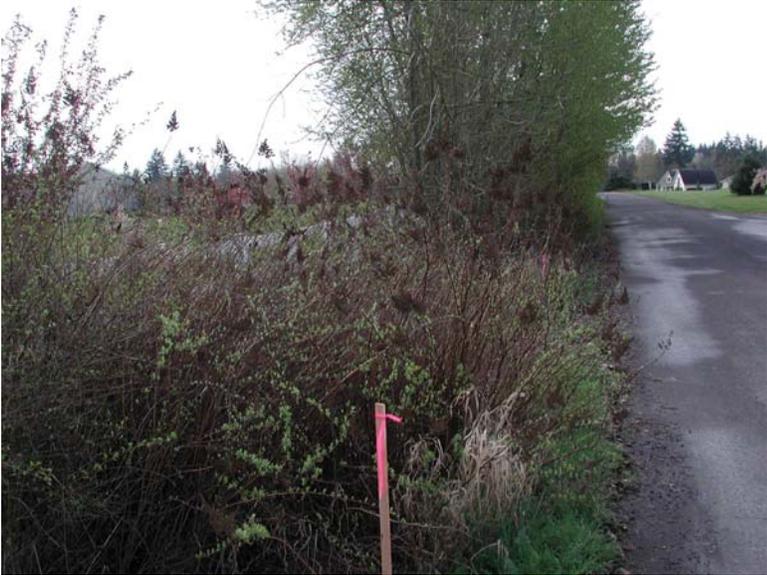
<b>Ecology Rating</b>	IV
	<b>Clark Co. Rating</b>	IV
	<b>Cowardin Classification</b>	PEM
	<b>HGM Classification</b>	DEP
	<b>WRIA</b>	27
<p><b><u>Dominant Vegetation</u></b></p> <p><i>Fraxinus latifolia</i> (Oregon ash) FACW  <i>Phalaris arundinacea</i> (reed canarygrass) FACW  <i>Populus balsamifera</i> (black cottonwood) FAC</p>		
<p>Percent of Dominant Species that are OBL, FACW or FAC (excluding FAC-)</p>		100%
<p>Wetland SWD3, looking south</p>		
<p><b>Description/Vegetation</b></p> <p>Wetland SWD3 is a palustrine, emergent (PEM) wetland located south of SR 502 and east of 29<sup>th</sup> Avenue in a roadside ditch. The wetland is adjacent to a historical wetland, Wetland SL, and conveys stormwater to other roadside ditches via culverts. The establishment of hydrophytic woody vegetation was indicative of a prolonged duration of wetland conditions.</p>		
<p><b>Soils</b></p> <p>The soil sampled in Wetland SWD3 exhibited a low chroma matrix and redoximorphic features within 10 inches of the surface. These characteristics are evidence that the soils in the wetland are saturated and/or inundated for a duration sufficient to promote anaerobic conditions, therefore meeting the hydric soil criterion.</p>

<p><b>Hydrology</b></p> <p>Wetland hydrology is provided by overland flow from adjacent uplands, precipitation, roadside ditch discharge, and a seasonally shallow water table. At the time of field investigation, all areas of the wetland were saturated to the surface, areas of inundation up to 6 inches deep were observed, and free water was observed at the surface of the soil. These findings demonstrate the area has sufficient saturation and/or ponding during the growing season to satisfy the wetland hydrology criterion.</p>		
<p><b>Rating/Functions</b></p> <p>Wetland SWD3 ranked as a Category IV under Ecology's 4-tier rating system (Appendix C). Scores for the broad categories of Water Quality Functions, Hydrologic Functions, and Habitat Functions were all relatively low.</p>

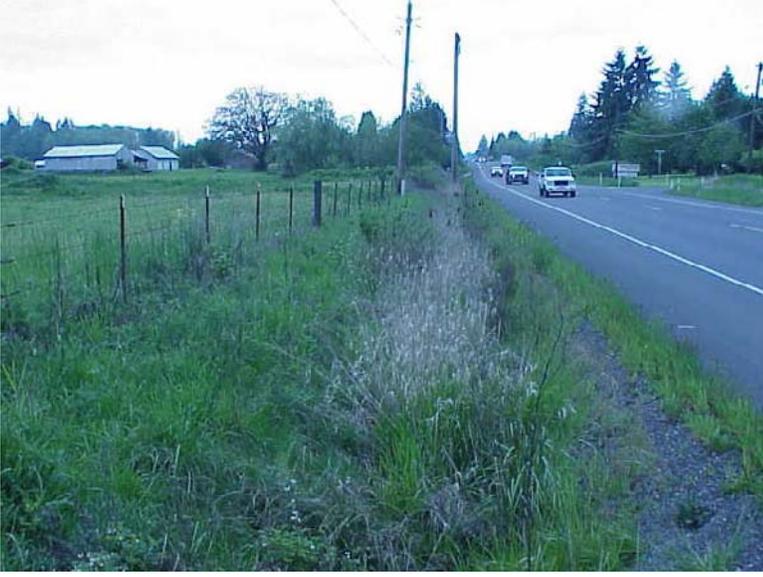
<table border="1"> <tr> <td><b>Ecology Rating</b></td> <td>IV</td> </tr> <tr> <td><b>Clark Co. Rating</b></td> <td>IV</td> </tr> <tr> <td>Cowardin Classification</td> <td>PEM</td> </tr> <tr> <td>HGM Classification</td> <td>DEP</td> </tr> <tr> <td><b>WRIA</b></td> <td>28</td> </tr> </table>	<b>Ecology Rating</b>	IV	<b>Clark Co. Rating</b>	IV	Cowardin Classification	PEM	HGM Classification	DEP	<b>WRIA</b>	28
	<b>Ecology Rating</b>	IV									
	<b>Clark Co. Rating</b>	IV									
	Cowardin Classification	PEM									
	HGM Classification	DEP									
<b>WRIA</b>	28										
<p><b>Dominant Vegetation</b></p> <p><i>Phalaris arundinacea</i> (reed canary grass) FACW  <i>Spirea douglasii</i> (hardhack) FACW</p>											
<table border="1"> <tr> <td>Percent of Dominant Species that are OBL, FACW or FAC (excluding FAC-)</td> <td>100%</td> </tr> </table>	Percent of Dominant Species that are OBL, FACW or FAC (excluding FAC-)	100%

Percent of Dominant Species that are OBL, FACW or FAC (excluding FAC-)	100%										
Wetland SWD4, looking west											
<b>Description/Vegetation</b>											
Wetland SWD4 is a palustrine, emergent (PEM) wetland located south of SR 502 and east of 87 <sup>th</sup> Avenue in a roadside ditch. The wetland is at the same elevation as adjacent wetlands, and conveys stormwater to other roadside ditches via culverts.											
<b>Soils</b>											
The soil sampled in Wetland SWD4 exhibited a low chroma matrix and redoximorphic features within 10 inches of the surface. These characteristics are evidence that the soils in the wetland are saturated and/or inundated for a duration sufficient to promote anaerobic conditions, therefore meeting the hydric soil criterion.											
<b>Hydrology</b>											
Wetland hydrology is provided by overland flow from adjacent uplands, precipitation, roadside ditch discharge, and a seasonally shallow water table. At the time of field investigation, all areas of the wetland were saturated to the surface, areas of inundation up to 4 inches deep were observed, and free water was observed at the surface of the soil. These findings demonstrate the area has sufficient saturation and/or ponding during the growing season to satisfy the wetland hydrology criterion.
