US 2 Tumwater Canyon Bridge Replacement Mitigation Site

USACE NWP (23) NWS-2010-1255

2015 MONITORING REPORT

Issued March 2016

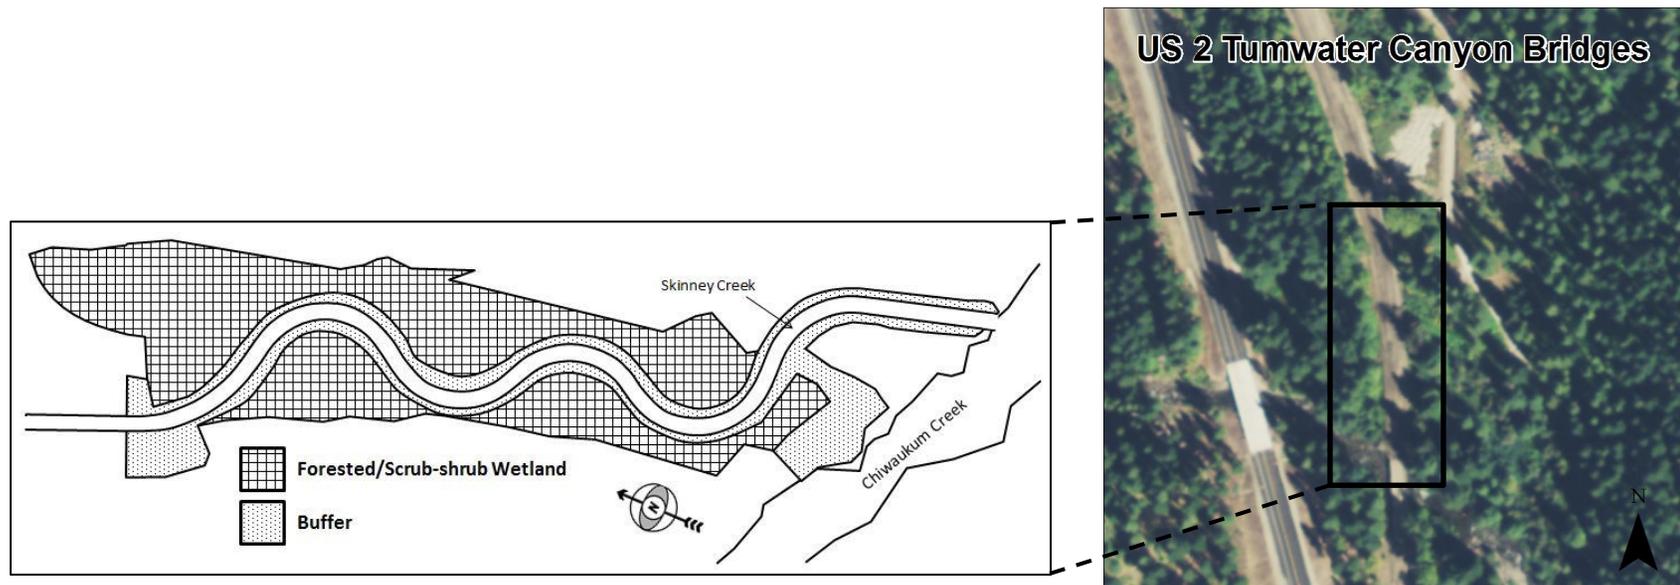
Figure 1 Site Sketch

The US 2 Tumwater Canyon Bridges Mitigation Site is built on an abandoned section of US 2, following realignment of the roadway as part of the project. It reconnects two larger wetlands that were previously bisected by the old section of highway. A section of Skinney Creek, previously a linear ditch alongside the old section of US 2, was realigned as a meandering channel through the center of the mitigation site. Appendix 2 includes site directions.

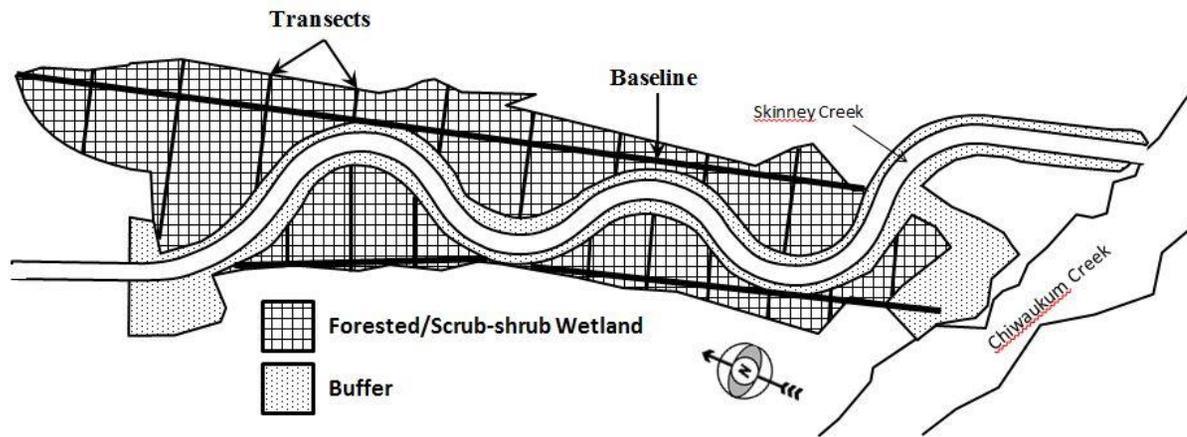
Figure 2 Site Sampling Design (2015)

Placement of Baseline: A 196-meter-long baseline was placed roughly north-south in three segments, with one segment in each fenced-off area of forested/scrub-shrub wetland.

PS 2	PS 3
Attribute	Density	Cover
Target pop.	Native woody	Invasive species
Zone	PSS/PFO	Entire site
Sample method	UBT	Visual estimates
SU width	2 m	
Total # of SU	16

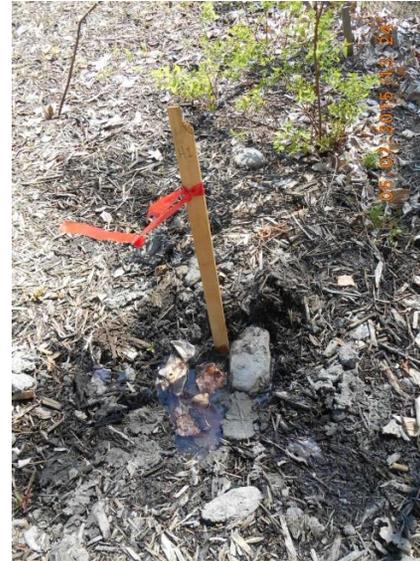
Two hydrology monitoring visits were conducted in 2015 by WSDOT region staff on April 22 and May 7. Three hydrology monitoring pit locations were established during the first visit and checked at each visit. During both visits in 2015, inundation, saturation to the soil surface, or a water table within the upper 12 inches of the soil, was observed at each of the hydrology pit locations (Photo 1).

Photo 1
Water in hydrology monitoring pit (May 2015)

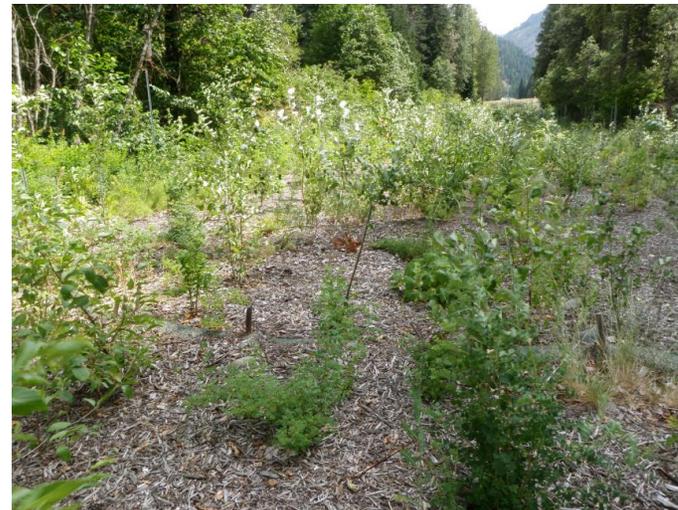
The density of native woody species in the forested and scrub-shrub wetland areas of the site (Photo 2) is estimated at 9.6 plants/100ft² (CI_{80%} = 7.7-11.5). The most abundant species are Sitka alder (*Alnus viridis*), thimbleberry (*Rubus parviflorus*), Nootka rose (*Rosa nutkana*), and hardhack (*Spiraea douglasii*).

Photo 2
Woody density in the PFO/PSS (July 2015)

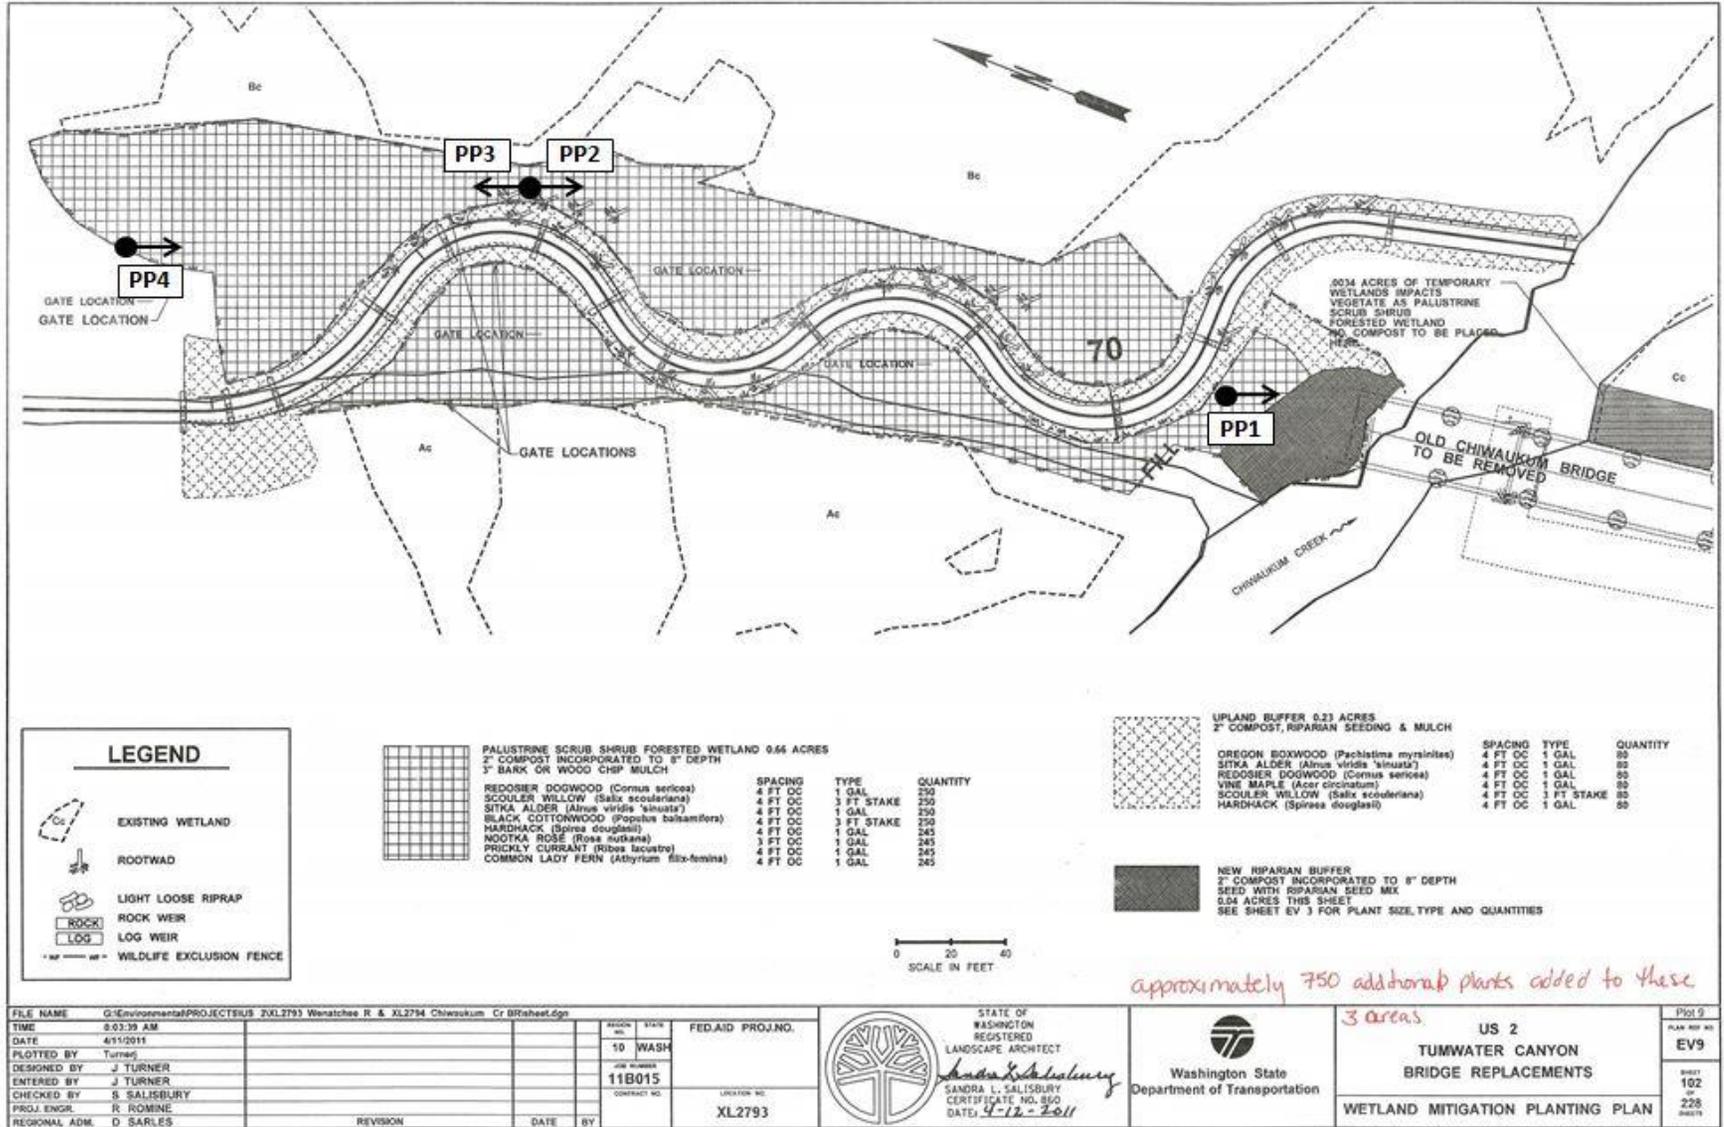
Appendix 1 – Planting Plan with Photo Point Locations

Appendix 1 shows the planting plan (WSDOT 2011).

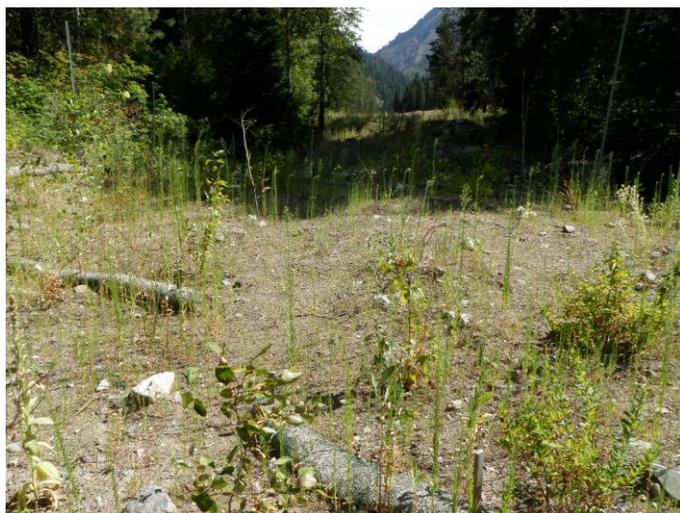
Photo Point 1

The photographs below were taken from permanent photo-points on July 21, 2015 and document current site development.
