**WSDOT and City of Renton
Springbrook Creek Wetland and Habitat Mitigation Bank
Unit C**

USACE IP 200600100

2014 MONITORING REPORT

Issued March 2015

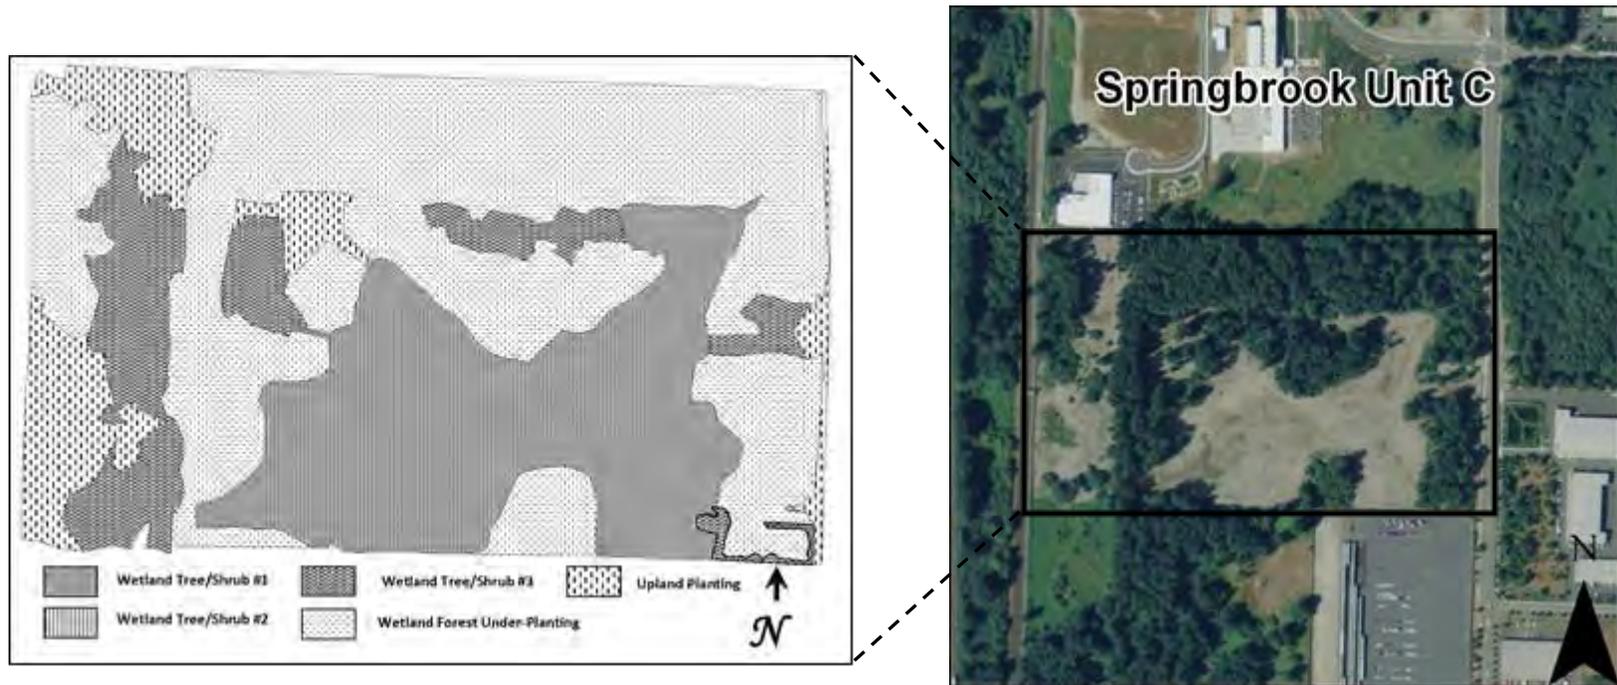
Figure 1 Site Sketch

This mitigation bank contains reestablished, rehabilitated, and enhanced wetlands as well as enhanced uplands and riparian areas adjacent to Springbrook Creek. Unit C (Figure 1) is 47.48 acres, of which 27.9 acres are pre-existing wetlands. The bank is operated and managed by WSDOT and the City of Renton. The purpose of the bank is to provide compensation for unavoidable impacts to wetlands and other aquatic resources caused by WSDOT highway construction projects and City of Renton mitigation requirements within the service area.

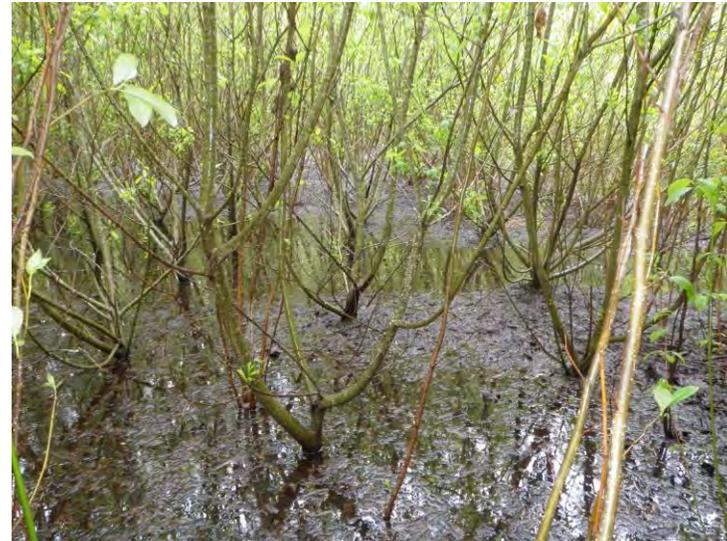
Photo 2 Shallow inundation in wetland tree/shrub planting area (April 2014)

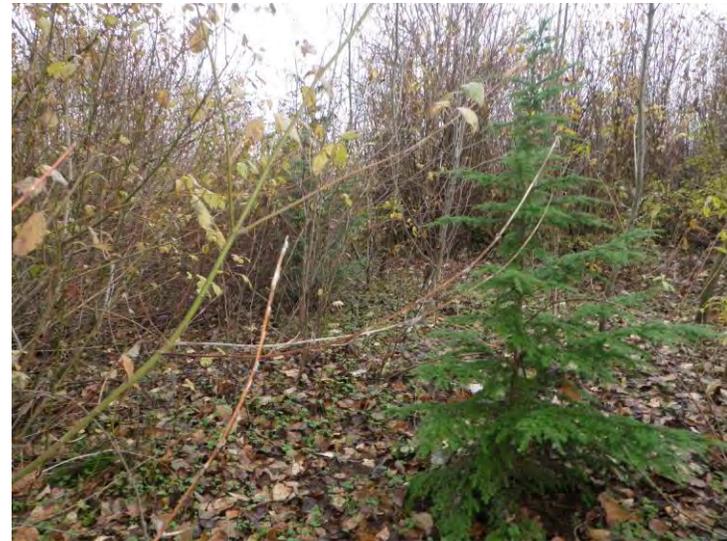
The density of conifers across the entire forested wetland enhancement areas is 65 plants/acre ($CI_{80\%} = 45-86$) (Photo 3). This density estimate is likely below the performance standard target. Targeted replanting was performed in the areas where high mortality was observed.

Photo 3 Underplanted conifer in enhanced wetland (November 2014)

Unit C will continue to receive on-going weed control on an as-needed basis. The forested enhancement area will be assessed for additional conifer planting. Additional details related to site management can be found in the Springbrook Creek Wetland and Habitat Mitigation Bank Status Report 2014.

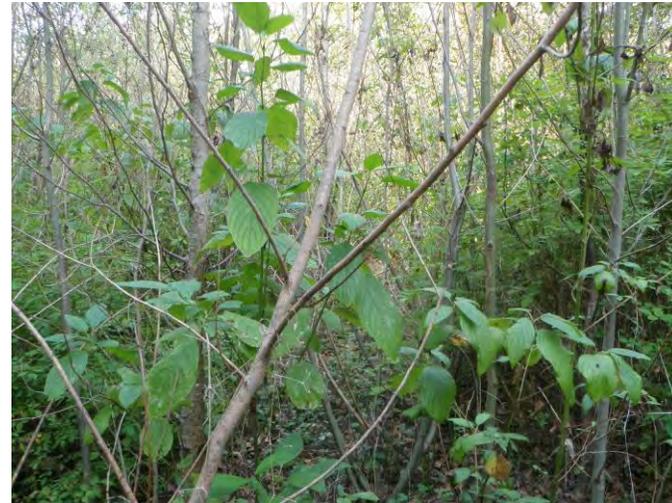
The cover of native woody vegetation within the Wetland Tree/Shrub planting areas is 98% cover (CI_{80%} = 97-99). This cover estimate exceeds the performance standard target. Dominant species observed in this zone included black cottonwood (*Populus balsamifera*), willows (*Salix spp.*), and redosier dogwood (*Cornus alba*) (Photo 4).

Photo 4
Native wetland shrubs in Tree/Shrub Planting Area (July 2014)

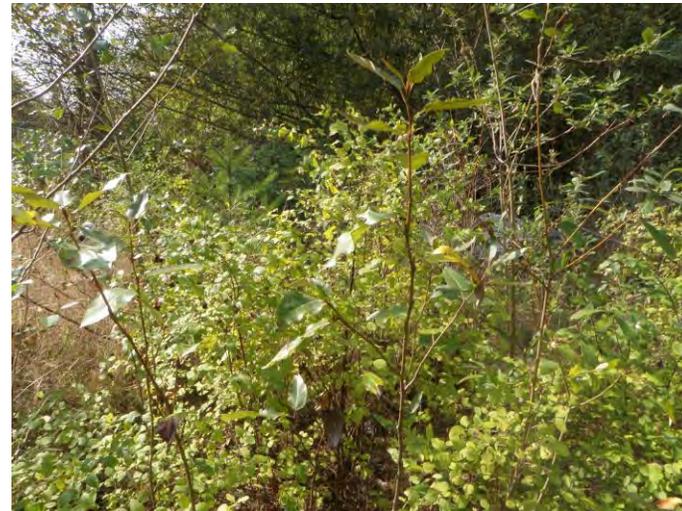
The cover of native woody vegetation in the upland buffer planting areas is 92% cover (CI_{80%} = 88-96%). This cover value exceeds the performance standard target. Dominant species observed in this zone included black cottonwood, redosier dogwood, and snowberry (*Symphoricarpos albus*) (Photo 5).

Photo 5
Native woody vegetation in Upland Buffer Planting Area (July 2014)

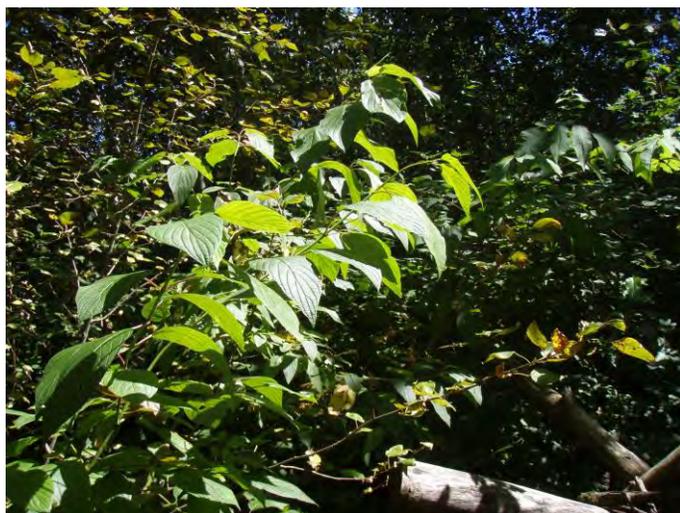
Photo Point 1a

The photographs below were taken from permanent photo-points on July 31, 2014 and document current site development.

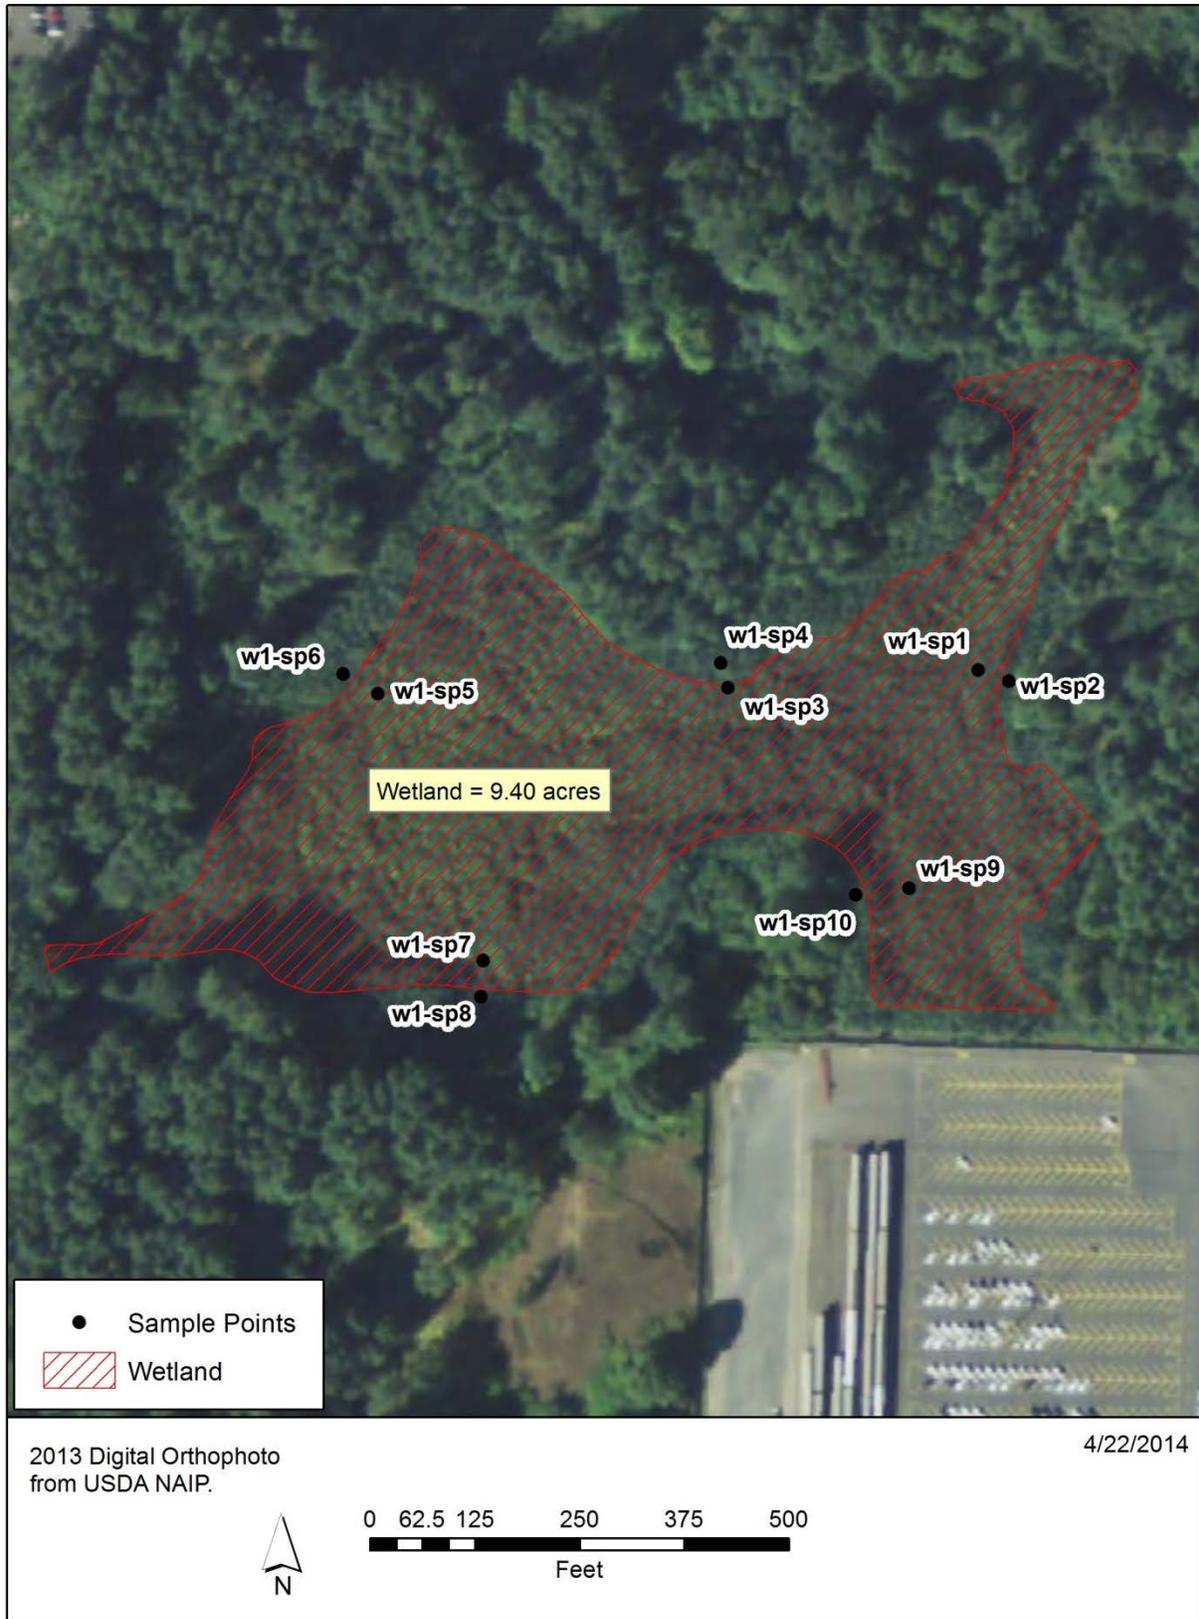
The delineation determined 9.40 acres of wetland were present within Springbrook Bank Unit C wetland establishment area. Delineation data were collected at ten sampling points and recorded on wetland determination data forms (Appendix A). Paired wetland and upland sample points were used to define the wetland edge. Upland data points occur on a relatively narrow excavated slope. Above the slope lies a preexisting wetland area not addressed in this report. Data recorded on wetland determination data forms characterize typical wetland and upland conditions observed on site. Vegetation, soils, and hydrology were examined in many additional sampling locations to determine the wetland boundary.

Figure 2. Wetland boundary/study area in red, sampling point locations in black.

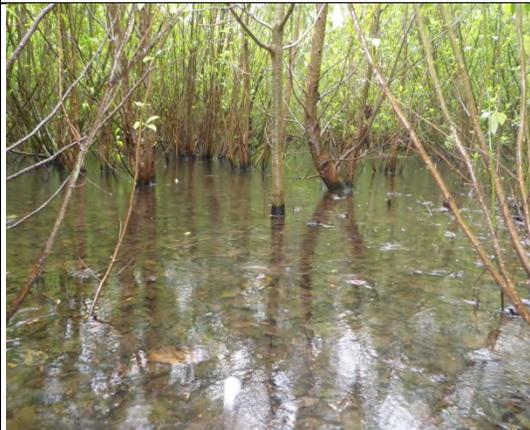
Springbrook Bank Unit C – Wetland Delineation Summary		
Total Delineated Wetland Area	9.40 acres

Wetland Determination Data Form(s)	Appendix A; Sampling Point W1-SP1, W1-SP3, W1-SP5, W1-SP7, W1-SP9
	Upland Determination Data Form(s)	Appendix A; Sampling Point W1-SP2, W1-SP4, W1-SP6, W1-SP8, W1-SP10
	Delineator(s)	Doug Littauer Tom Mohagen
	Delineation Date	April 16 and 17, 2014
Vegetation	Trees – none Shrubs – Sitka willow (<i>Salix sitchensis</i>), Pacific willow (<i>Salix lasiandra</i>), black cottonwood (<i>Populus balsamifera</i>), redosier dogwood (<i>Cornus alba</i>), Nootka rose (<i>Rosa nutkana</i>), Oregon ash (<i>Fraxinus latifolia</i>) Herbs – creeping buttercup (<i>Ranunculus repens</i>),	
Soils	Soils examined to a depth of 20 inches exhibited hydric characteristics. Matrix colors of 2.5Y 4/1 and 2.5Y 5/2 were observed. Redoximorphic concentrations were observed in some layers. Indicator Depleted Matrix (F3) met.

Hydrology	A high groundwater table associated with the Green River is the predominant source of hydrology. Surface water also contributes hydrology, flowing through an inlet and outlet, both with water control structures. Precipitation also provides hydrologic inputs. Inundation was present to 5 inches in some areas of the wetland. Other areas had water in observation pits at the soil surface. Water marks and water-stained leaves were also observed in some areas.	
Rationale for Delineation	Positive indicators of all three wetland criteria are present. Placement of boundary determined by presence/absence of wetland hydrology indicators. In many locations near the upland/wetland boundary both hydric soils and hydrophytic vegetation were present. Because the delineation occurred at an ideal time to observe primary hydrology indicators, presence/absence of hydrology indicators was a primary factor in determining placement of the wetland boundary. Soils in part of the study area are mapped hydric soils and hydric soils were observed in upland areas adjacent to the wetland boundary.

A Global Positioning System (GPS) Trimble GeoXT mapping grade unit was used to record the wetland boundaries and sampling point locations (Figure 2). Wetland boundary points were recorded at regular intervals and at any change in direction along the boundary.

Wetlands described in this report were assessed only within the wetland establishment area of Springbrook Bank Unit C (Figure 2). Wetland preservation areas are present within Springbrook Bank Unit C, however they were not included in this delineation. The delineation (Figure 2) is a smaller subset of the entire Springbrook Bank Unit C site. The wetland establishment area was determined by georeferencing plan sheets in ArcGIS. The delineation boundary and study area are the same for this delineation.

Wetland polygons, sampling point locations, and wetland names shown in Figure 2.
