2011

Duluth I-35 NGCS Open House OBSI Testing

Introduction

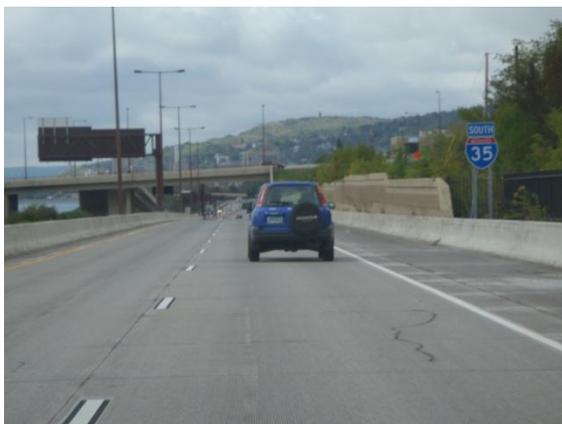
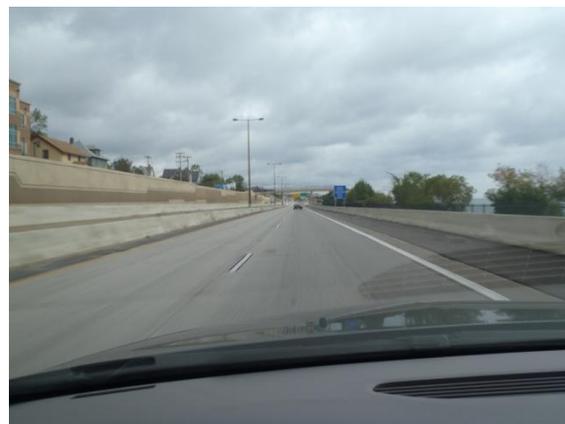
Figure 1 Location of OBSI Testing

OBSI testing was conducted on September 17th, 2010 just north of the tunnel sections as indicated in Figure 1. Testing was conducted using the ACPA 2009 SRTT tire and in general conformance to the AASHTO TP 76 specifications with the exception that the frequency range was 500 to 5000 Hz. The temperature was 55° Fahrenheit during testing. It had rained that night and testing was conducted about 10 AM after the pavement had dried.

SB I-35 OBSI Test Location

NB I-35 OBSI Test Location

The I-35 roadway consists of two as-built projects, one approximately 45 years old on the south end and one approximately 20 years old on the north end. For the OBSI testing it was decided to test the northern as-built project to provide a better representation of the texture as it was felt there were fewer slab repairs on the newer project.

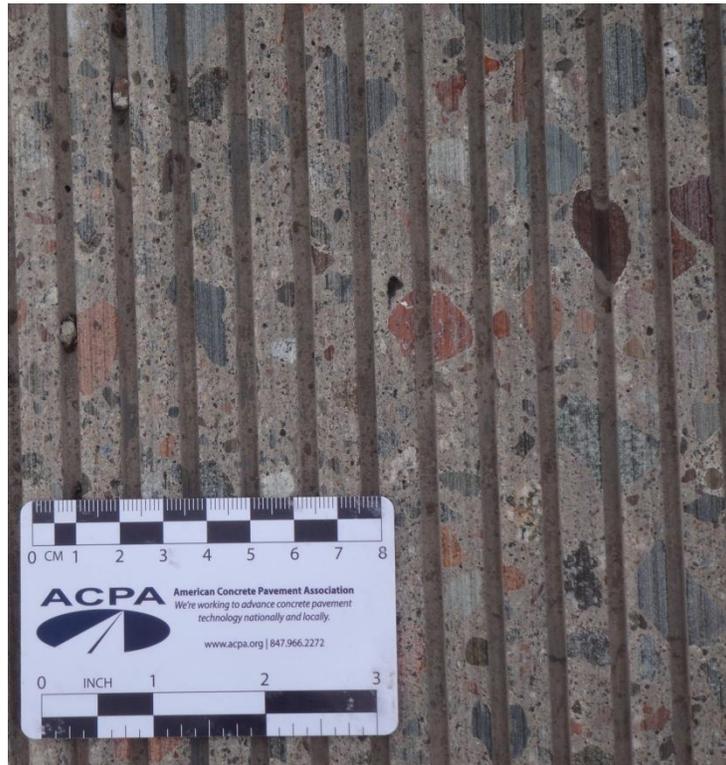
Figure 2 Duluth I-35 NGCS Texture

Figure 2 indicates a close up photo of the NGCS texture. The 1/8 inch wide grooves were spaced on approximately 5/8" centers. This texture was constructed by first profile grinding the surface using a

conventional diamond grinding process. Once the profile grinding was completed, a single pass NGCS surface was then constructed. The existing sealed joints (hot pour) remained and were not resealed.

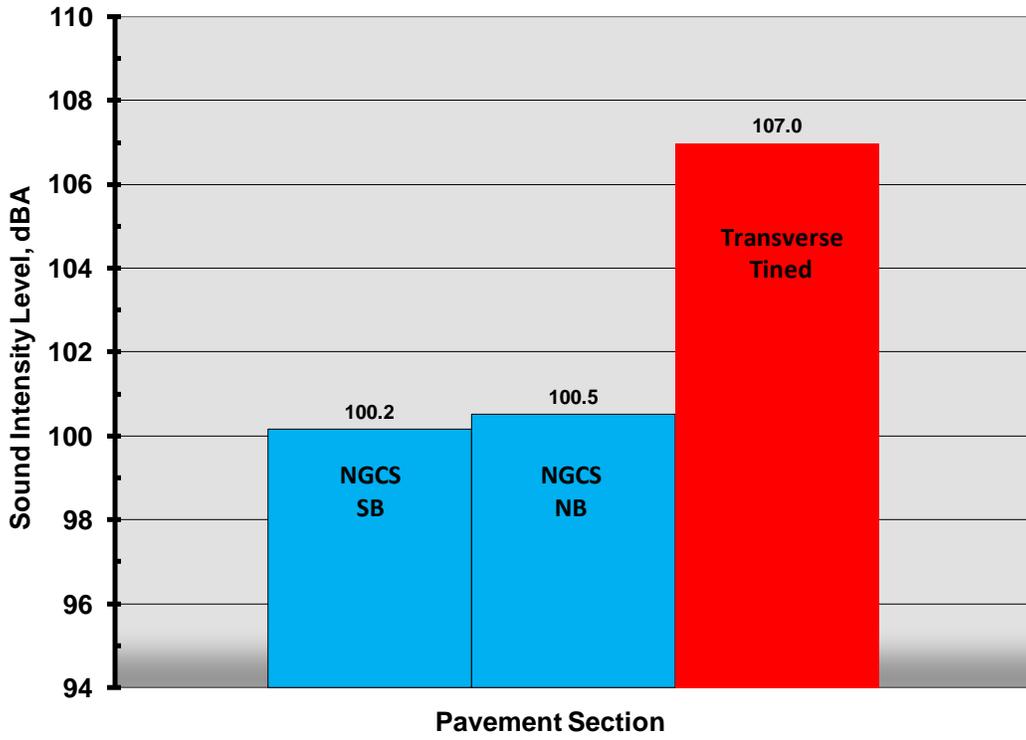
Figure 3 OBSI Level of the Duluth NGCS Surface and Existing Transverse Tined Surface

Figures 3 and 4 indicate the OBSI results for the NGCS surface. As indicated in Figure 3, the NGCS surface was almost 7 dBA quieter than the existing transverse tined texture that still existed at a couple locations on the north end of the project. The results of the NB and SB roadways for the NGCS surface were similar.

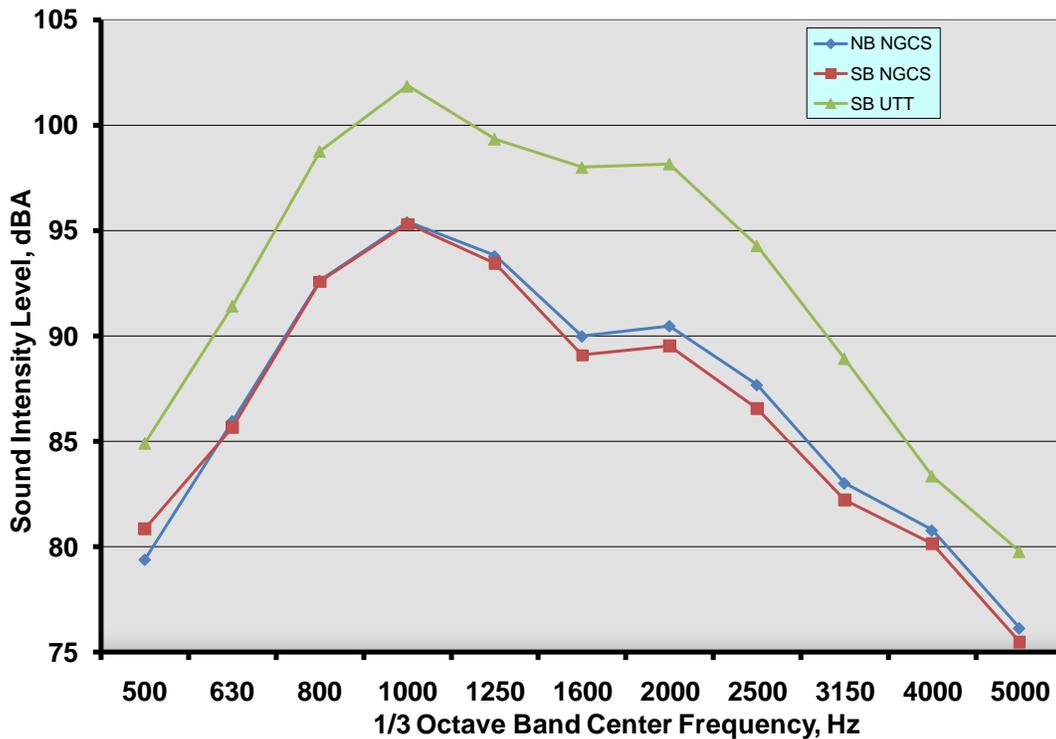
Figure 4 OBSI One-Third Octave A-Weighted Spectra Results for the NGCS Texture

Figure 4 indicates the spectra results for the three surfaces. As indicated, the transverse tined surface has higher levels at all frequency bands. The NB NGCS produced slightly higher results above 1600 Hz.

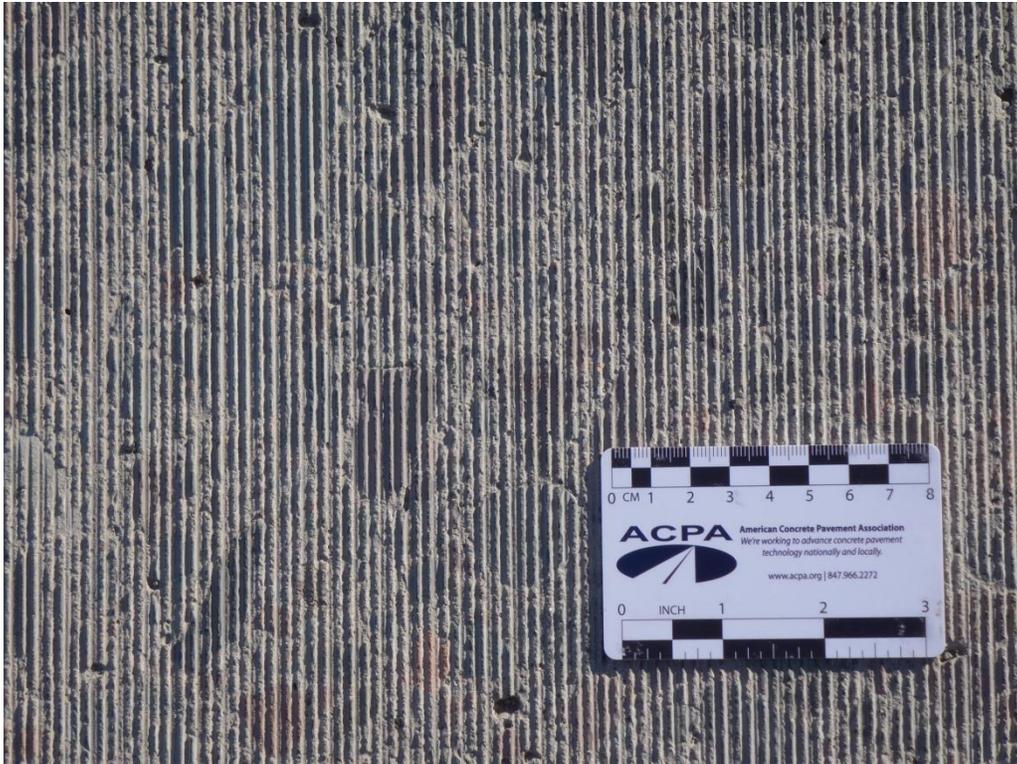
Figure 5 Close Up Photo of NGCS LITE Texture before Grooving

On September 21st, Interstate Improvement constructed a 2000 ft. long, one lane wide, NGCS LITE test section on I-35 NB just after exit 250. Recently developed Husqvarna blades were used to construct the NGCS LITE texture. Testing was conducted prior to groove construction so it represents only the flush grind condition. Figure 5 indicates the NGCS LITE texture by itself without grooves. Figure 6 indicates the NGCS LITE texture (without grooves) alongside a conventional diamond grind (CDG) texture.

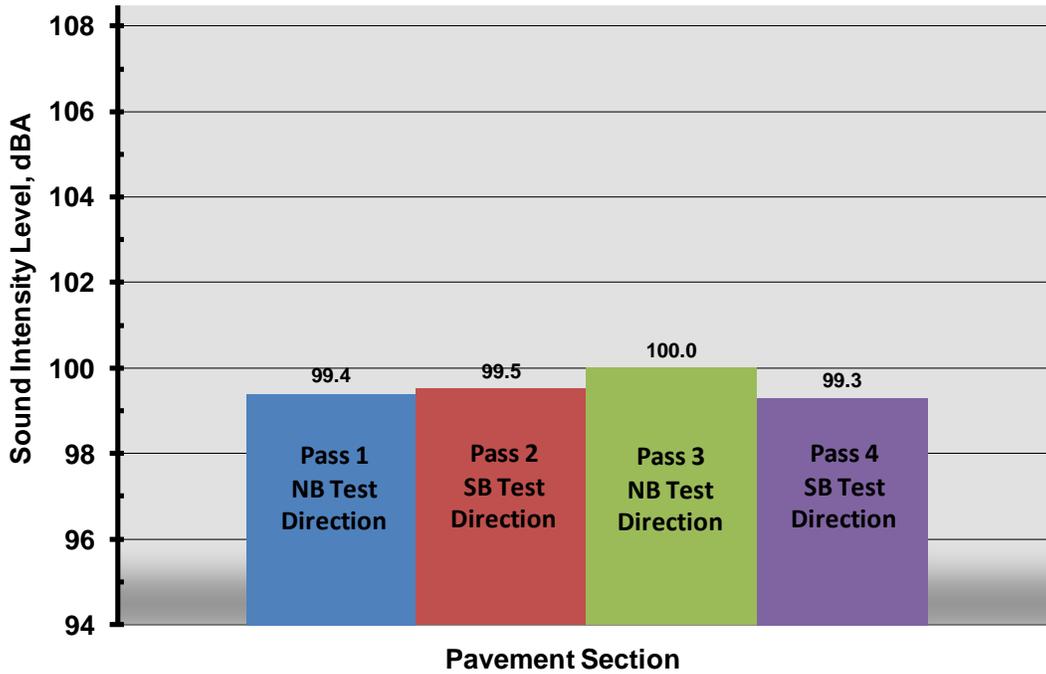
Figure 7 OBSI Levels for Each of the Four Passes Conducted for the NGCS LITE Texture (without Grooves)- NB is downhill Direction

The results of the OBSI testing are indicated in Figures 7 and 8. As indicated in Figure 7, three of the four passes provided consistent results but one pass was slightly higher.

The ACPA retested the site on September 22st and made four passes as before. Since the test section is constructed on a downgrade it presents speed control issues to maintain the test speed of 60 mph. The speed variability was somewhat of an issue on the second attempt also.

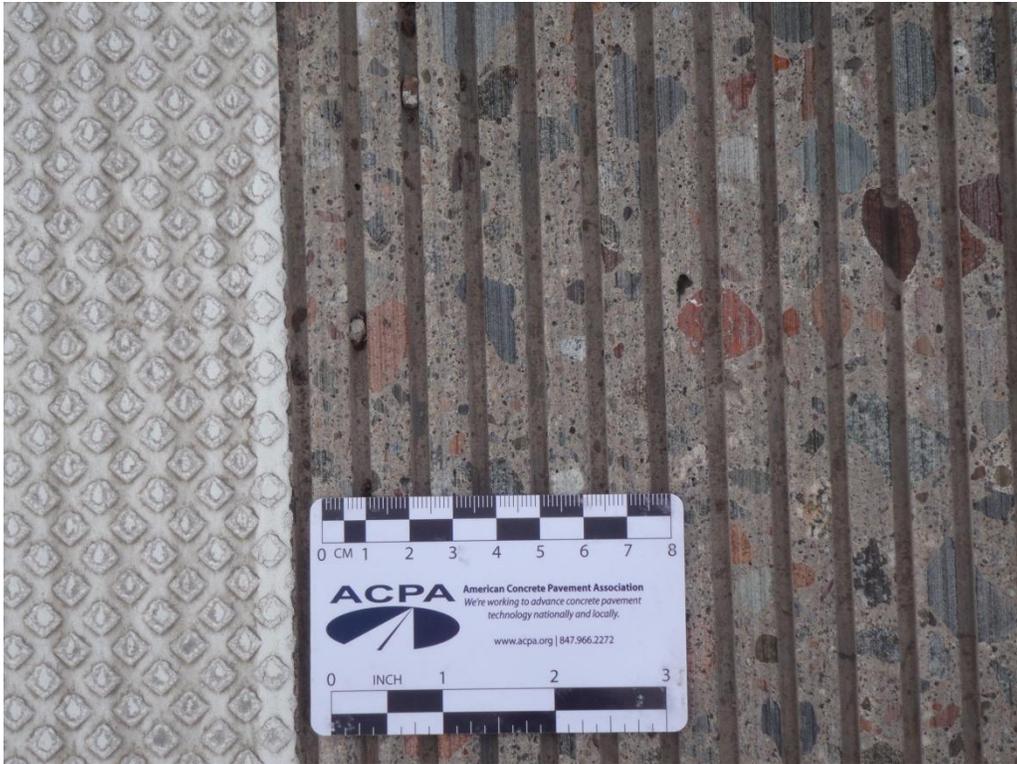
Figure 1-1 Duluth I-35 NGCS Texture

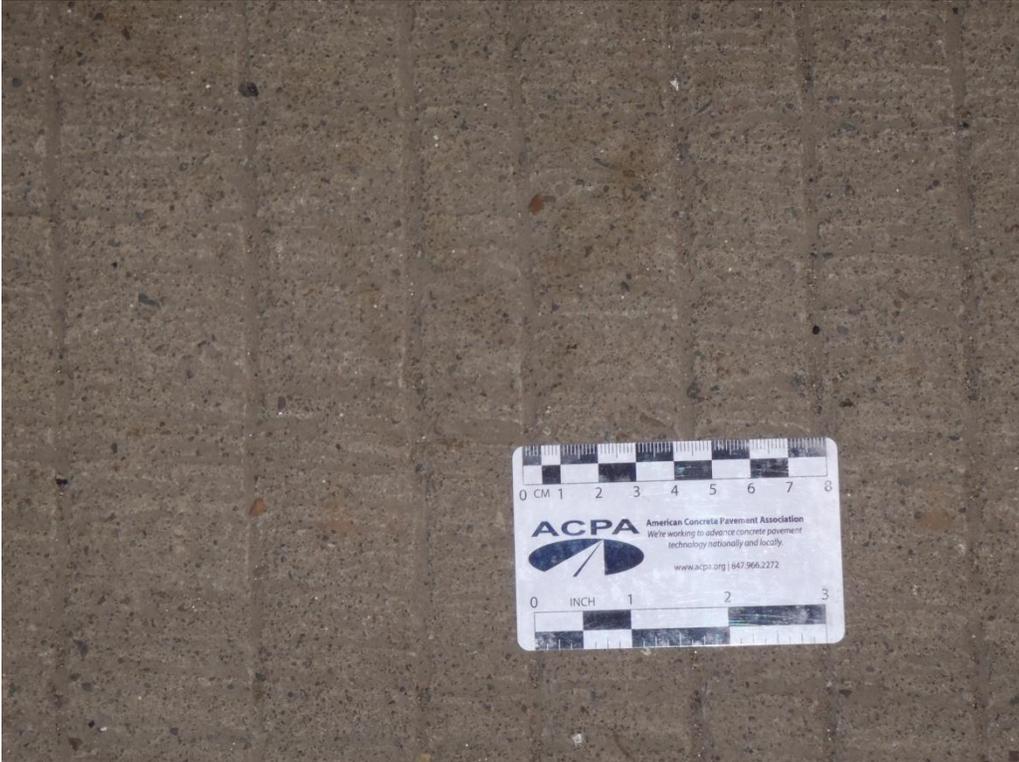
Figure 1-5 Existing Duluth I-35 Transverse Tining

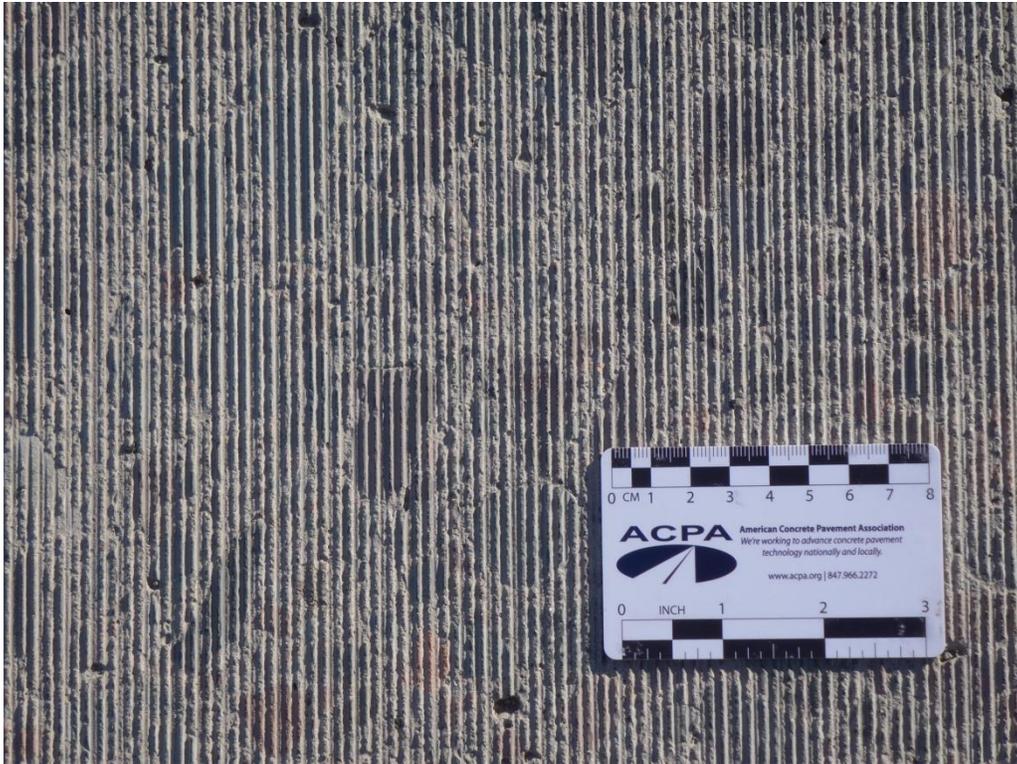
Figure 2-1 NGCS LITE Texture (without Grooves)

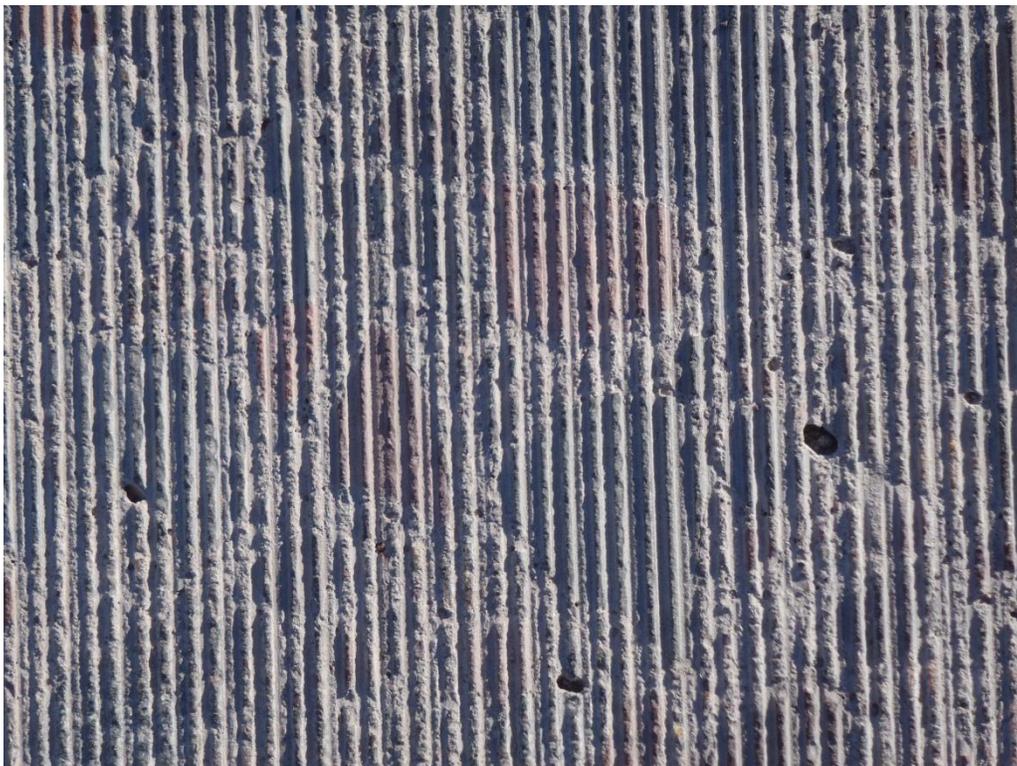
Figure 2-2 Close Up of Duluth I-35 NGCS LITE Texture (without Grooves)

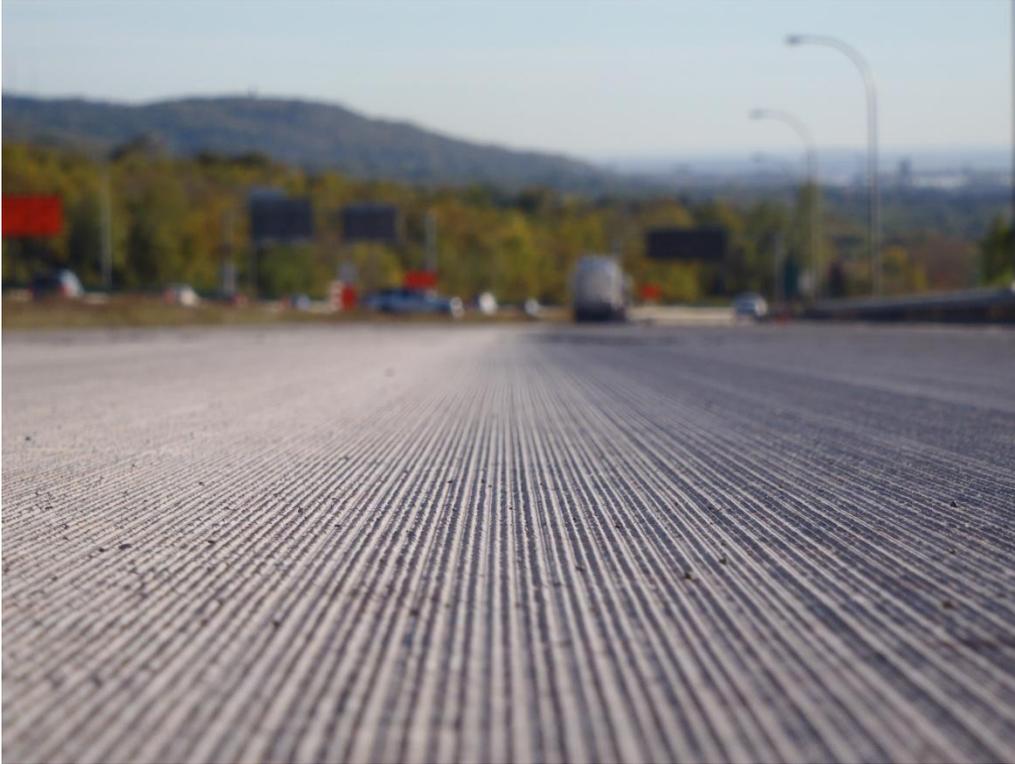
Figure 2-3 Ground View of Duluth I-35 NGCS LITE Texture (without Grooves)

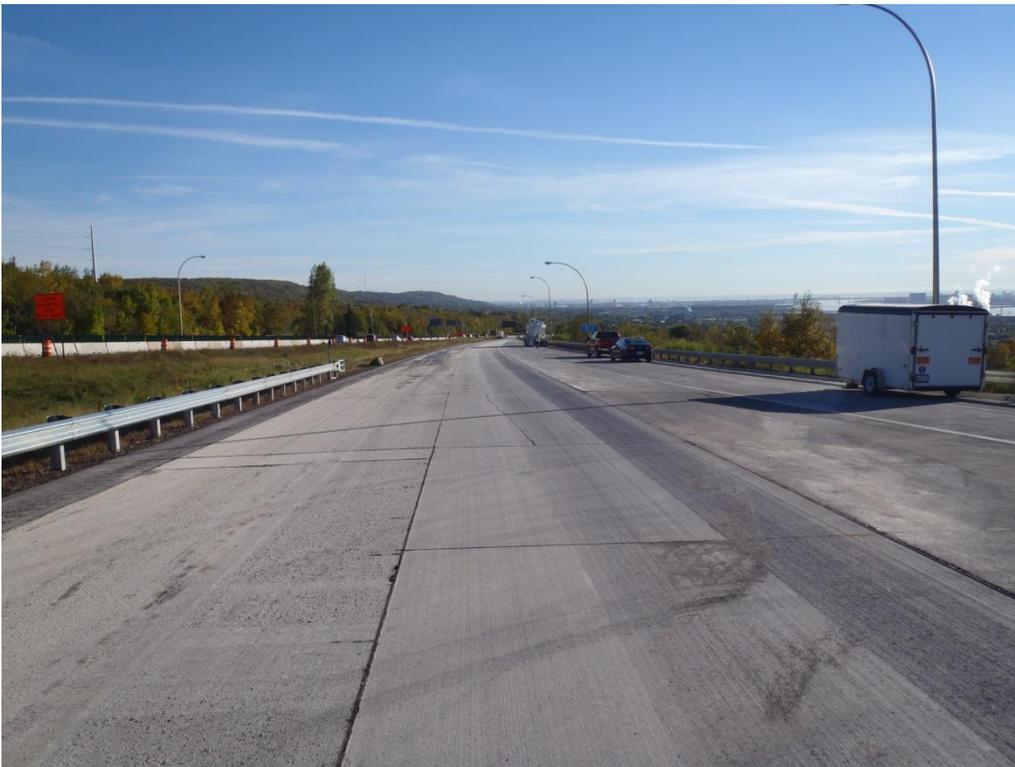
Figure 2-4 View of Duluth I-35 NB NGCS LITE Texture Alongside CDG

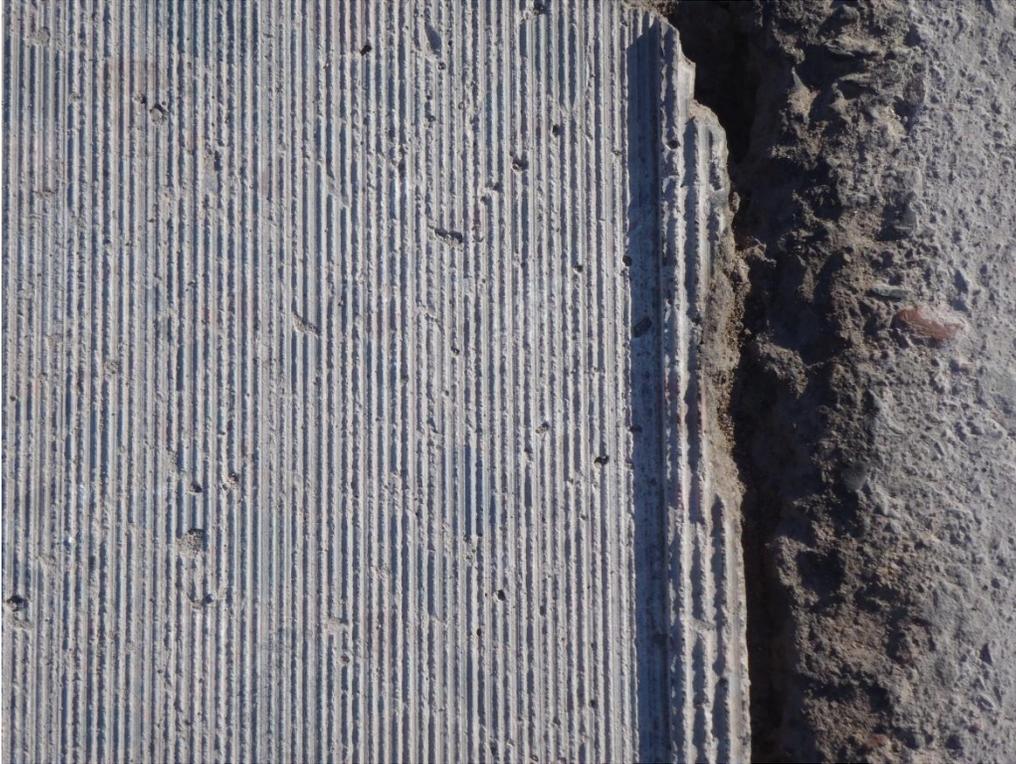
Figure 2-5 Duluth I-35 NGCS LITE Texture—Ridge at Shoulder

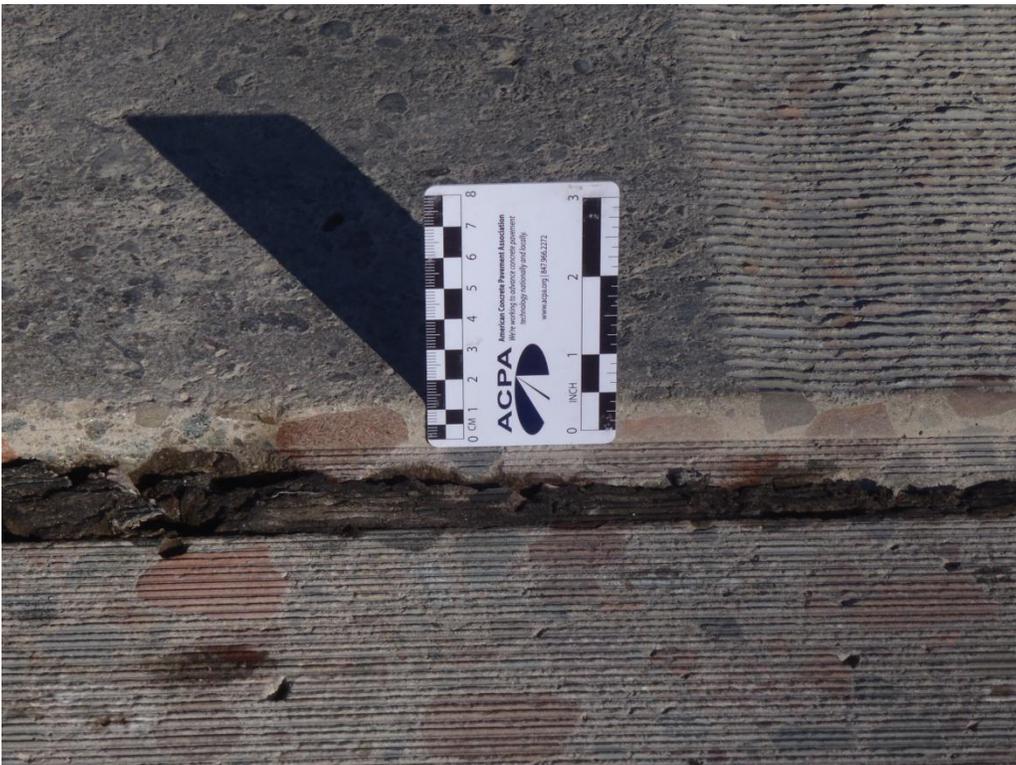
Figure 2-6 Duluth I-35 NB NGCS LITE Texture—Depth of Cut on One Slab

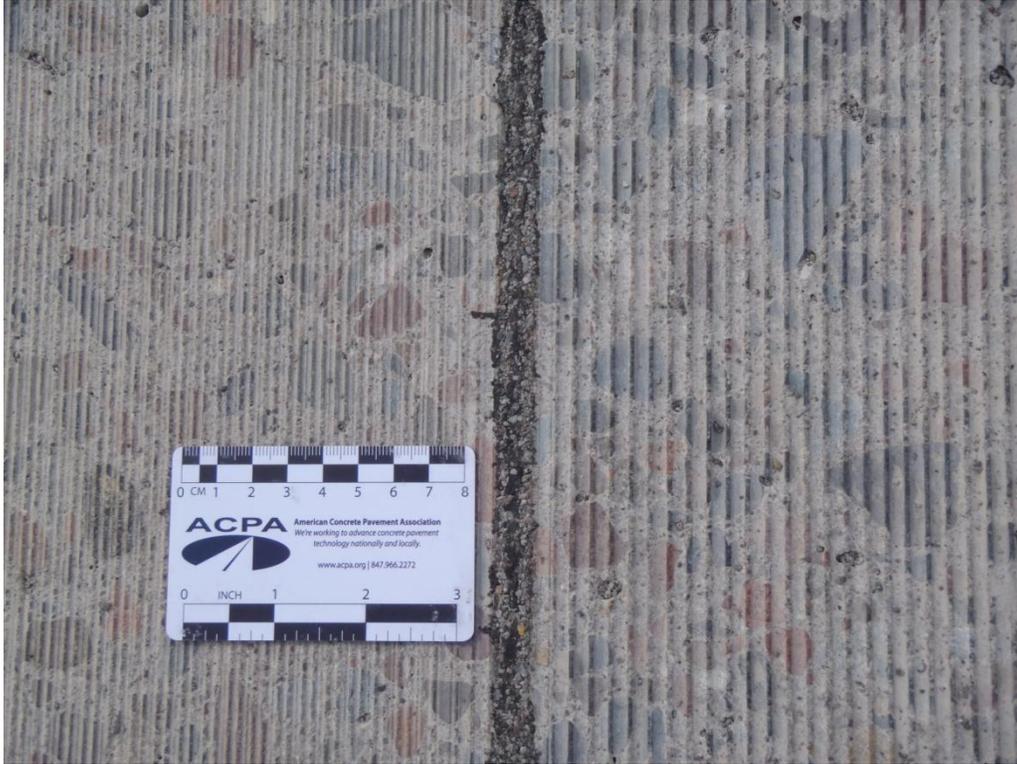
Figure 2-7 NGCS LITE Texture Alongside CDG

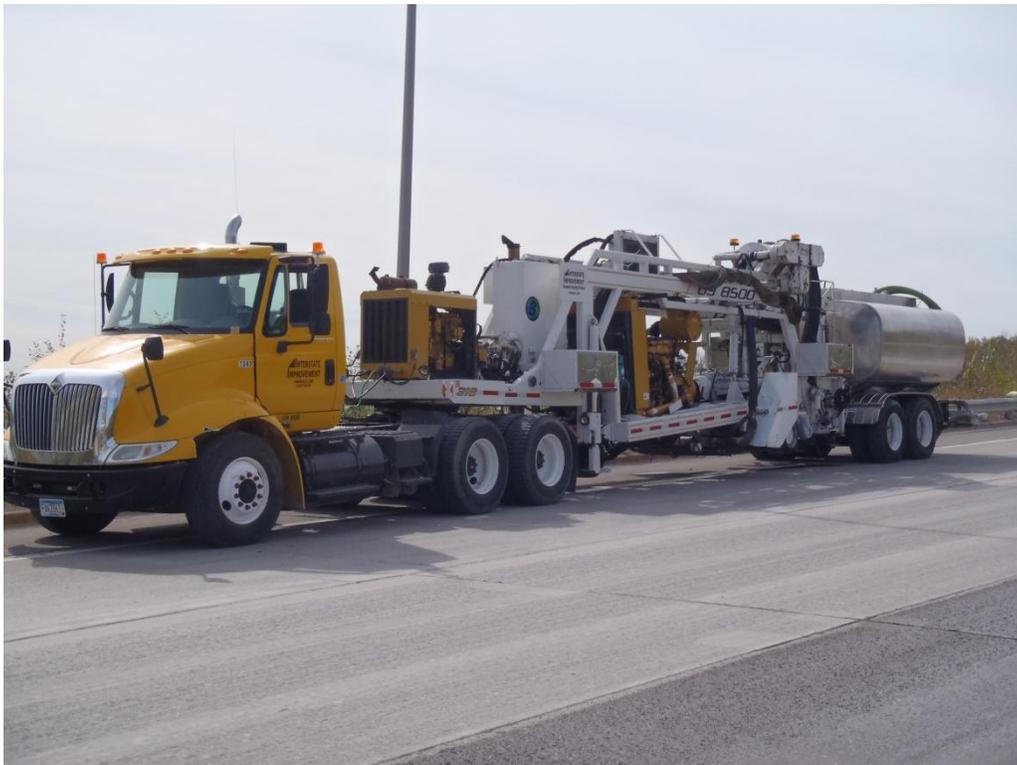
Figure 2-8 Interstate Improvement Diamond Grinding Equipment
