**I-5/SR 502 Interchange Mitigation Sites
(Johnson Farm Wetland Mitigation Site and Gee Creek Riparian Area)**

2014 MONITORING REPORT

Issued March 2015

**Washington State
Department of Transportation**

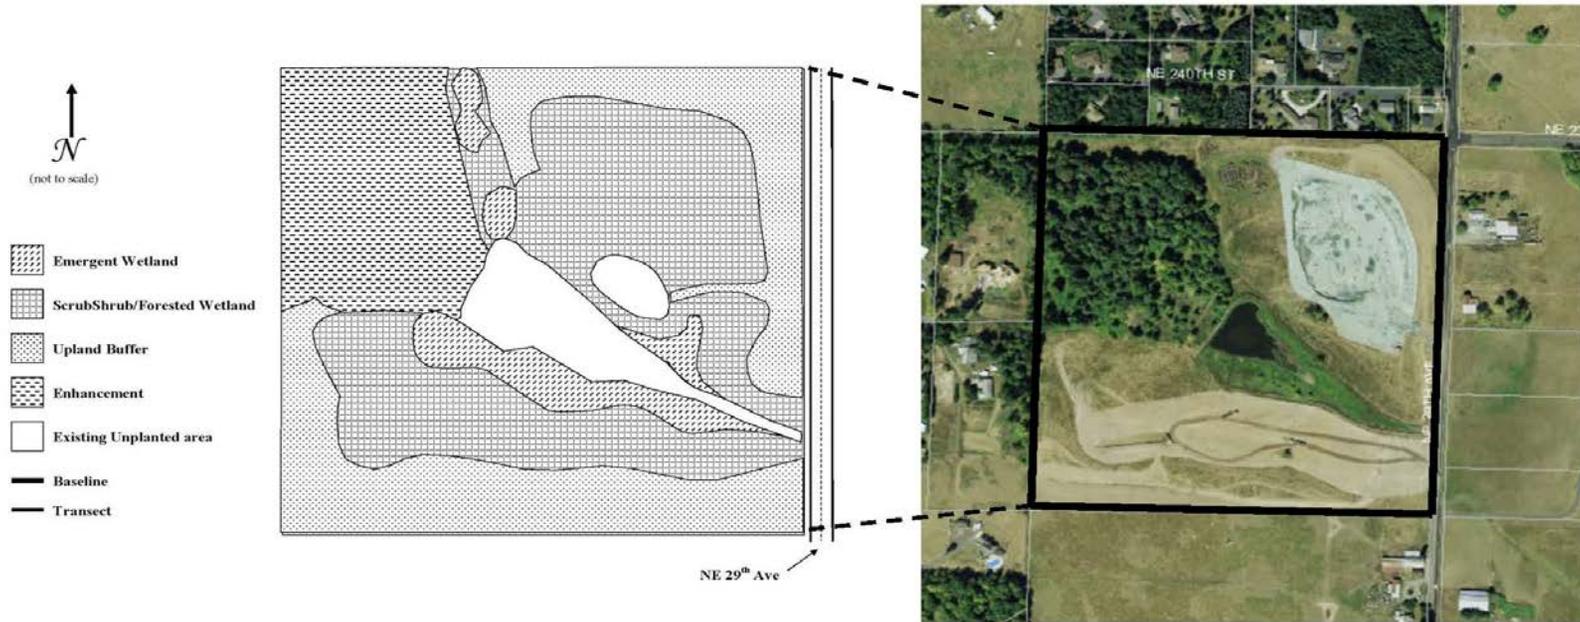
Figure 1 Johnson Site Sketch

The 39.8-acre Johnson Wetland Mitigation Site (Figure 1) consists of establishment, enhancement, and preservation areas. This site was created to compensate for the loss of 6.42 acres of wetlands due to the construction of new Interstate (I) 5 on and off ramps and a bridge that spans I-5 to connect to SR 502. This large and diverse mitigation site is designed to provide a variety of functions including wildlife habitat, water quality improvement, nutrient and sediment retention, groundwater recharge, base flow contributions to Gee Creek, and flood flow attenuation.

The Johnson Mitigation Site contains an existing pond surrounded by a mosaic of emergent, scrub-shrub, and forested wetland communities. The existing forested area in the northwestern corner of the site is under-planted with western red cedar (*Thuja plicata*). Appendix 2 includes site directions.

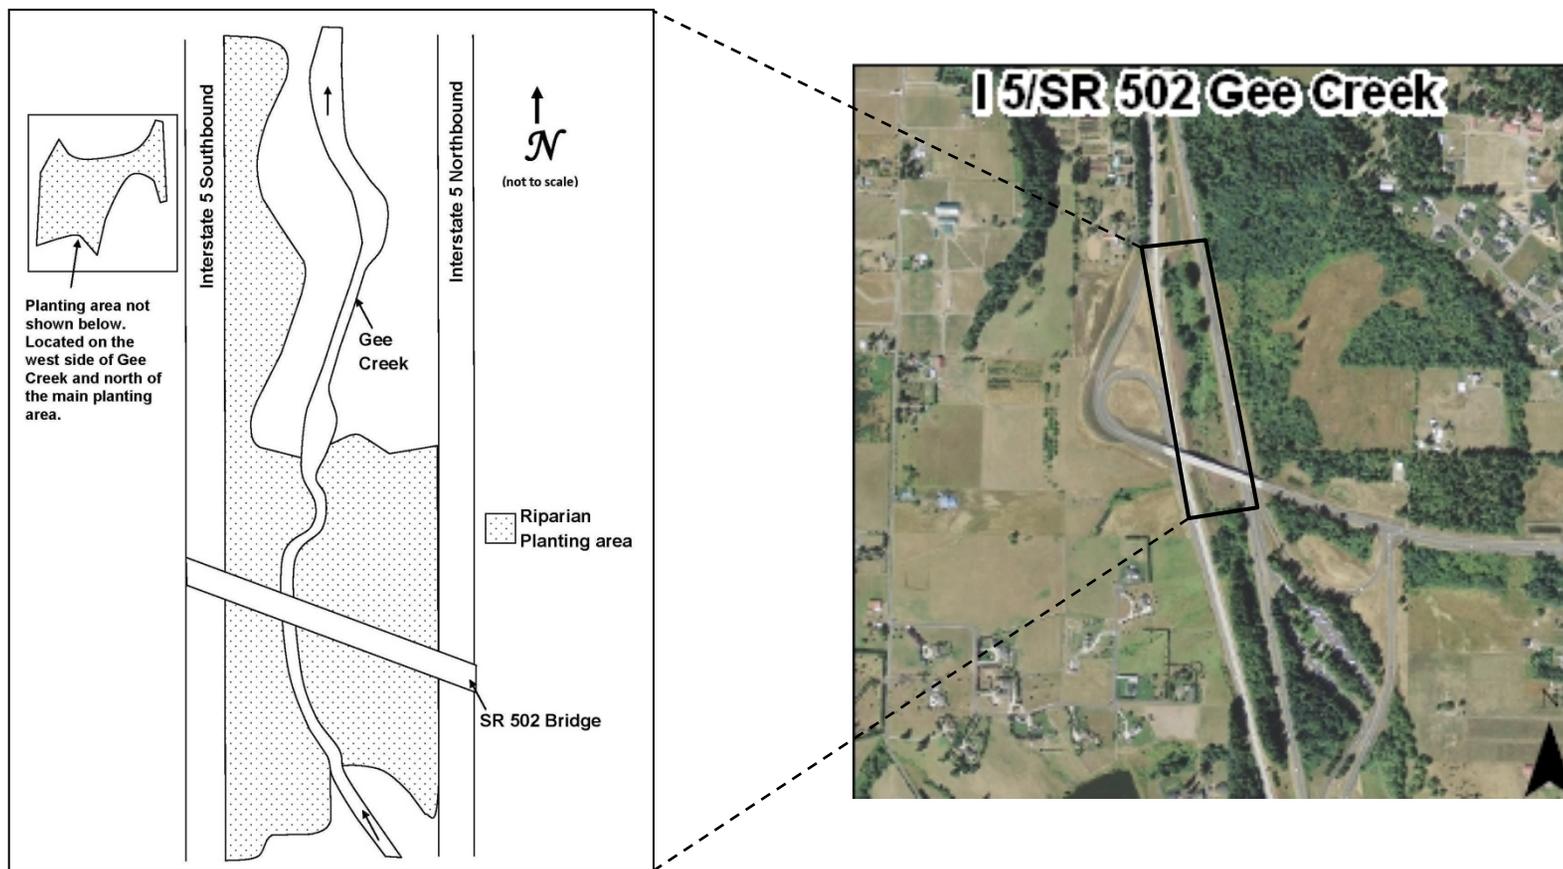
Figure 2 Gee Creek Site Sketch

The Gee Creek Riparian Area is located in the median of Interstate 5 (Figure 2). This area consists of 9.8 acres of preserved mature riparian forest and approximately 11.0 acres of riparian forest establishment. Appendix 2 includes site directions.

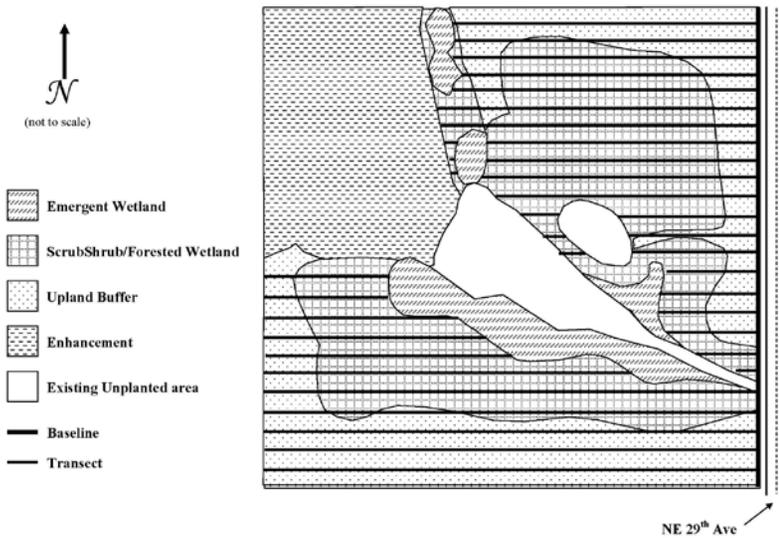
Figure 3 Johnson Site Sampling Design for Woody Species (2014)

To evaluate standards for vegetative cover at the Johnson site, a 400-meter baseline was established along the eastern edge of the site (Figure 3). Twenty-five sampling transects were placed perpendicular to the baseline segments using a systematic random sampling method. The unequal-area belt transect method was used to estimate native woody density in the forested and scrub-shrub wetland (Performance Standards 5–9), and in the buffer (Performance Standards 10–12). Twenty-one one-meter-wide belt transect sample units were positioned along the sampling transects in the scrub-shrub and forested wetland. (Four transects did not fall within the forested/scrub-shrub zone.) Twenty-five one-meter-wide belt transect sample units were positioned along the sampling transects in the buffer. The point-line method was used to estimate herbaceous cover in the emergent area (Performance Standard 13). Sixteen four-meter-long point-line sample units (20 points each) were randomly positioned along 15 sampling transects in the emergent areas (Figure 4). The cover of invasive species on-site was visually estimated (Performance Standards 17 -19).

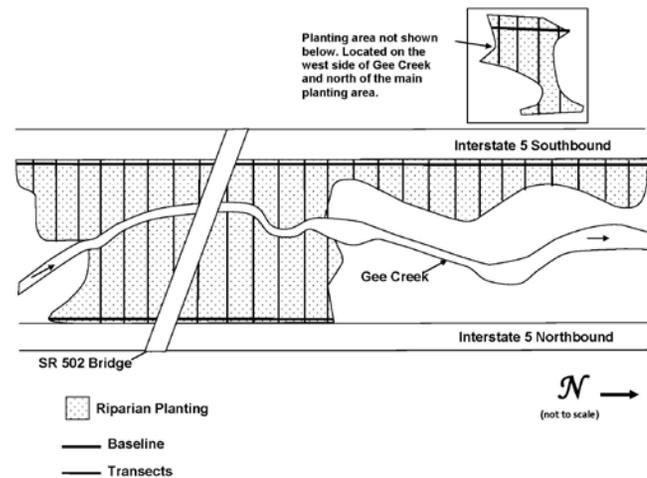
Figure 5 Gee Creek Site Sampling Design (2014)

To evaluate standards for vegetation at the Gee Creek Site, a 799-meter baseline was established in three segments: two along the western edge of the site and one along the eastern edge of the site (Figure 5). Sixteen sampling transects were placed perpendicular to the baseline segments using a systematic random sampling method. The unequal-area belt transect method was used to estimate native woody density (Performance Standards 14-16). Sixteen one-meter-wide belt transect sample units were positioned along the sampling transects.

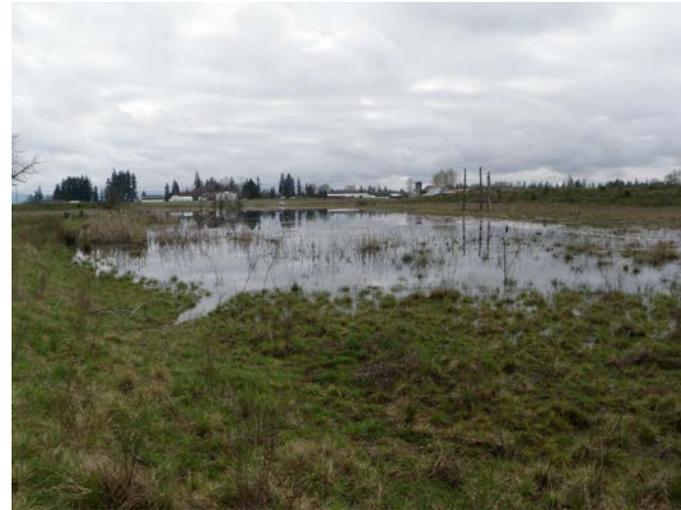
In 2014, water was present at or above the soil surface in all intended wetland areas of the site during two spring hydrology monitoring visits on March 11 and April 2 (Appendix 3, Table 2) (Photo 1). At the third visit on April 15, water was present at 12” below the soil surface in the only pit dug. Two other hydrology sites were observed at this visit and surface indicators of water were found at both.

**Photo 1
Inundation in the forested wetland (April 2014)**

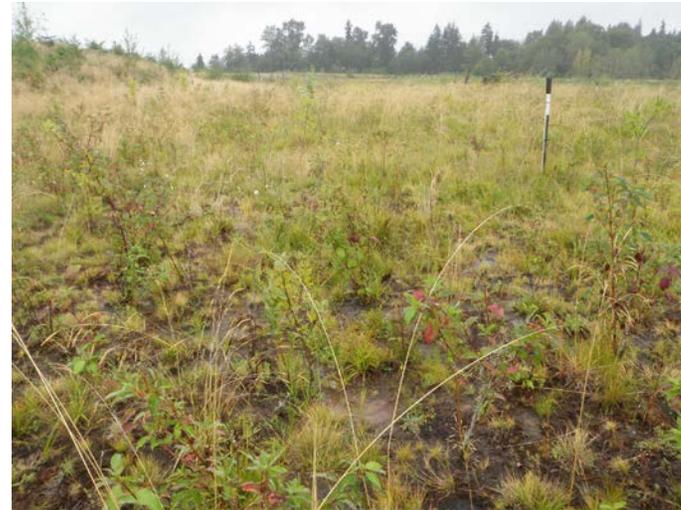
The density of native shrub species in the forested and scrub-shrub wetland areas combined (Photos 2 and 3) is estimated at 2,899 shrubs per acre ($CI_{80\%} = 2,628-3,170$). This value is below the performance standard. However, it is still fairly dense and likely adequate to achieve the objective of promoting the development of a dense native plant community in this zone. The dominant shrub species in these areas are redosier dogwood (*Cornus alba*) and willow. Overall native woody density (trees and shrubs) in the combined forested and scrub-shrub wetland areas is estimated at 3,672 plants per acre ($CI_{80\%} = 3,233-4,110$).

Photo 2
Woody density in the forested wetland (July 2014)

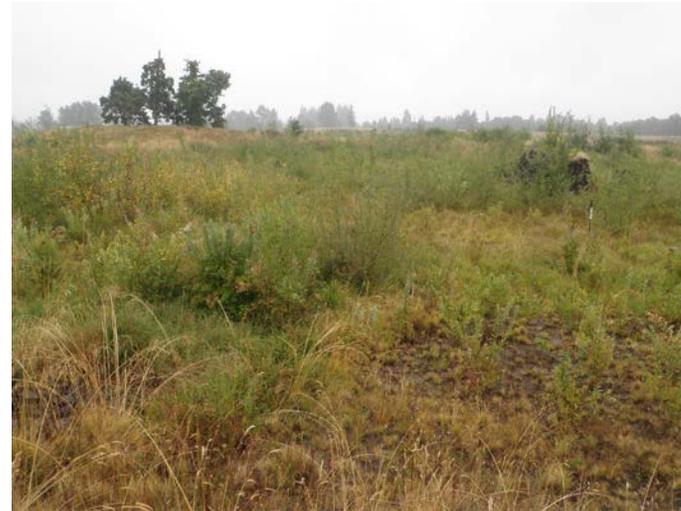
Photo 3
Woody density in the scrub-shrub wetland (July 2014)

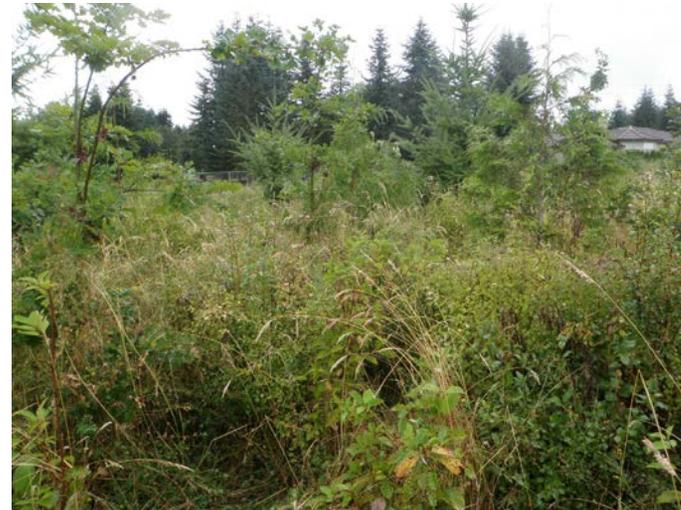
The density of native shrub species in the buffer (Photo 4) is estimated at 4,488 shrubs per acre ($CI_{80\%} = 3,937-5,039$). This value meets the performance standard.

Photo 4
Woody density in the buffer (July 2014)

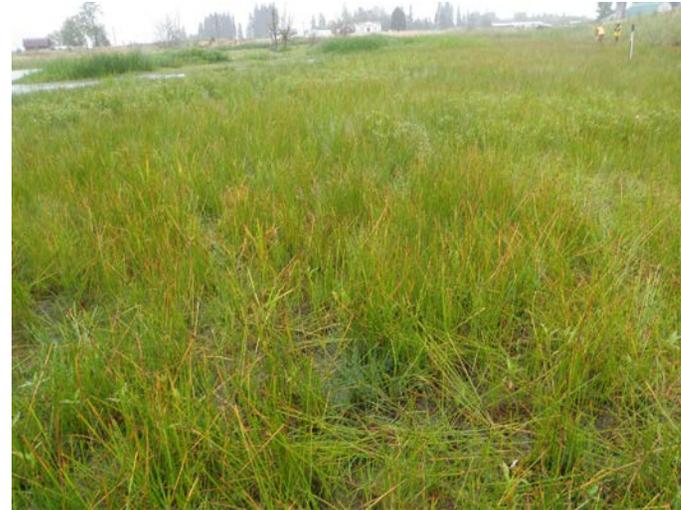
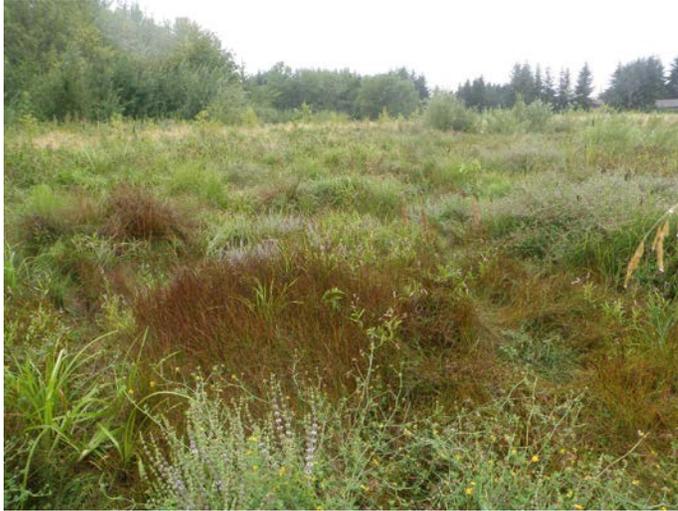
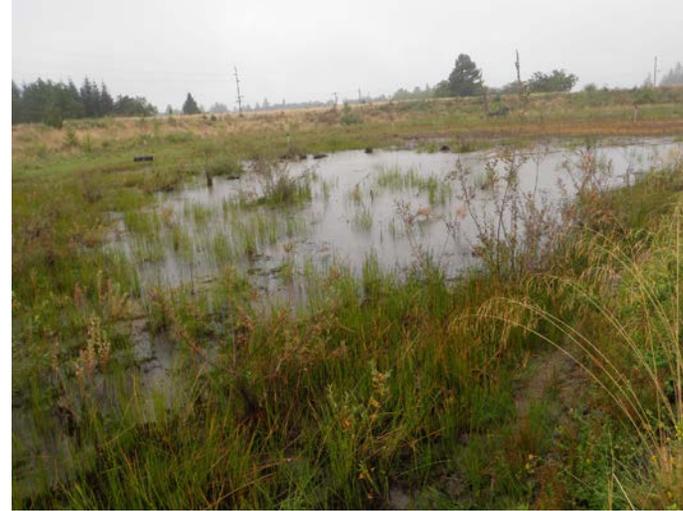
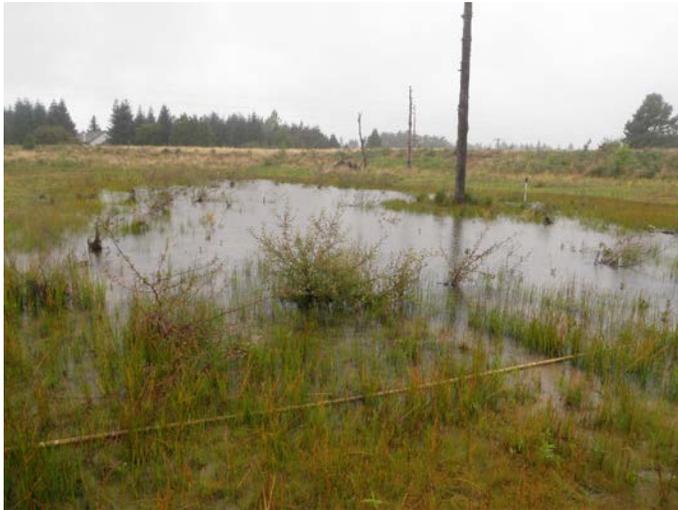
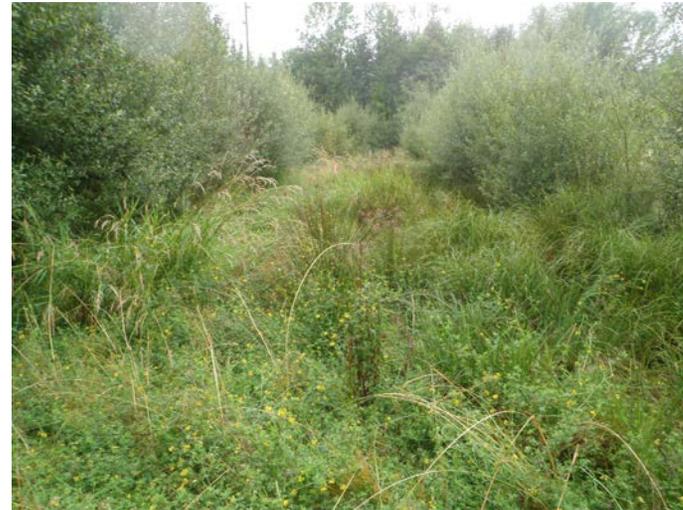
The cover of native facultative wet or wetter herbaceous species in the emergent areas is estimated at 67% ($CI_{80\%} = 56-77\%$) (Photos 5-9). The dominant species in these areas are needle spikerush (*Eleocharis acicularis*), common spikerush, and swamp smartweed (*Persicaria hydropiperoides*).

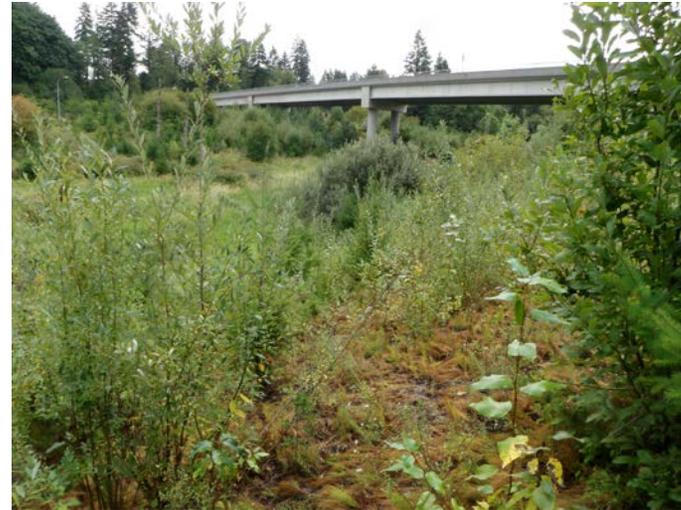
At the Gee Creek riparian enhancement area, six tree species and 16 shrub species were encountered in the sample (Photo 10). Based on visual estimates, no single species is currently approaching or exceeding 60 percent cover in these areas.

Photo 10
Native woody density at the Gee Creek riparian enhancement area (July 2014)

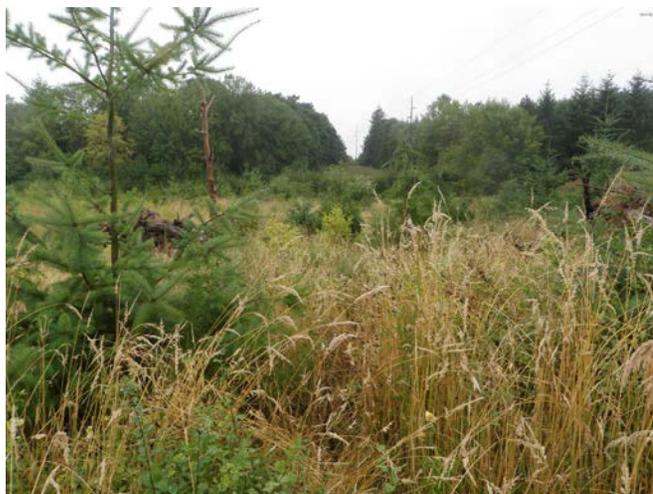
Photo Point 1a

The photographs below were taken from permanent photo-points on July 23, 2014 and document current site development.

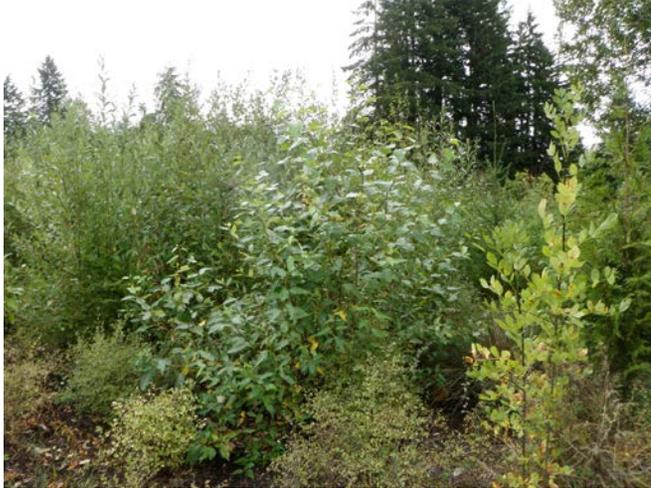
Photo Point 1

The photographs below were taken from permanent photo-points on August 13, 2014 and document current site development.

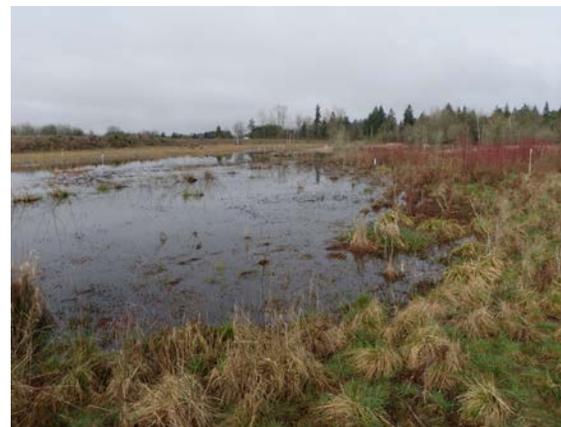
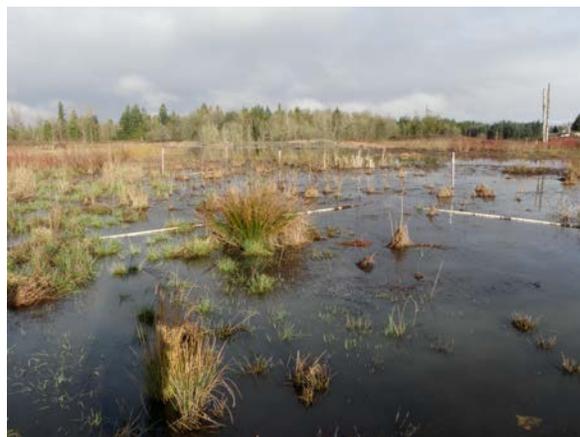
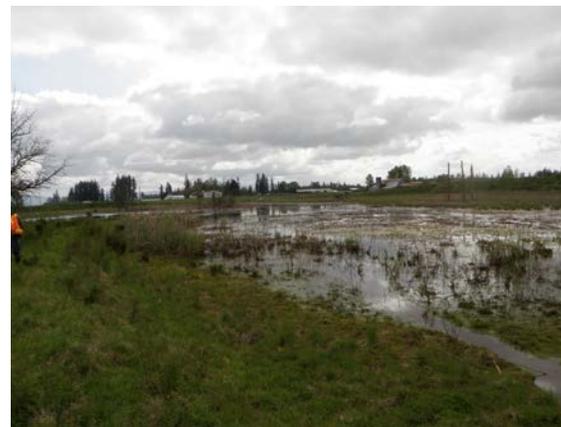
Photographic documentation shows continued headwater storage in constructed depressions and swales (Appendix 4). Photographs were taken from locations approximate to the 2012 permanent photo-points.

The photographs below were taken from locations approximate to the 2012 permanent photo-points on March 11, and April 15, 2014 and document the extent of seasonal ponding.

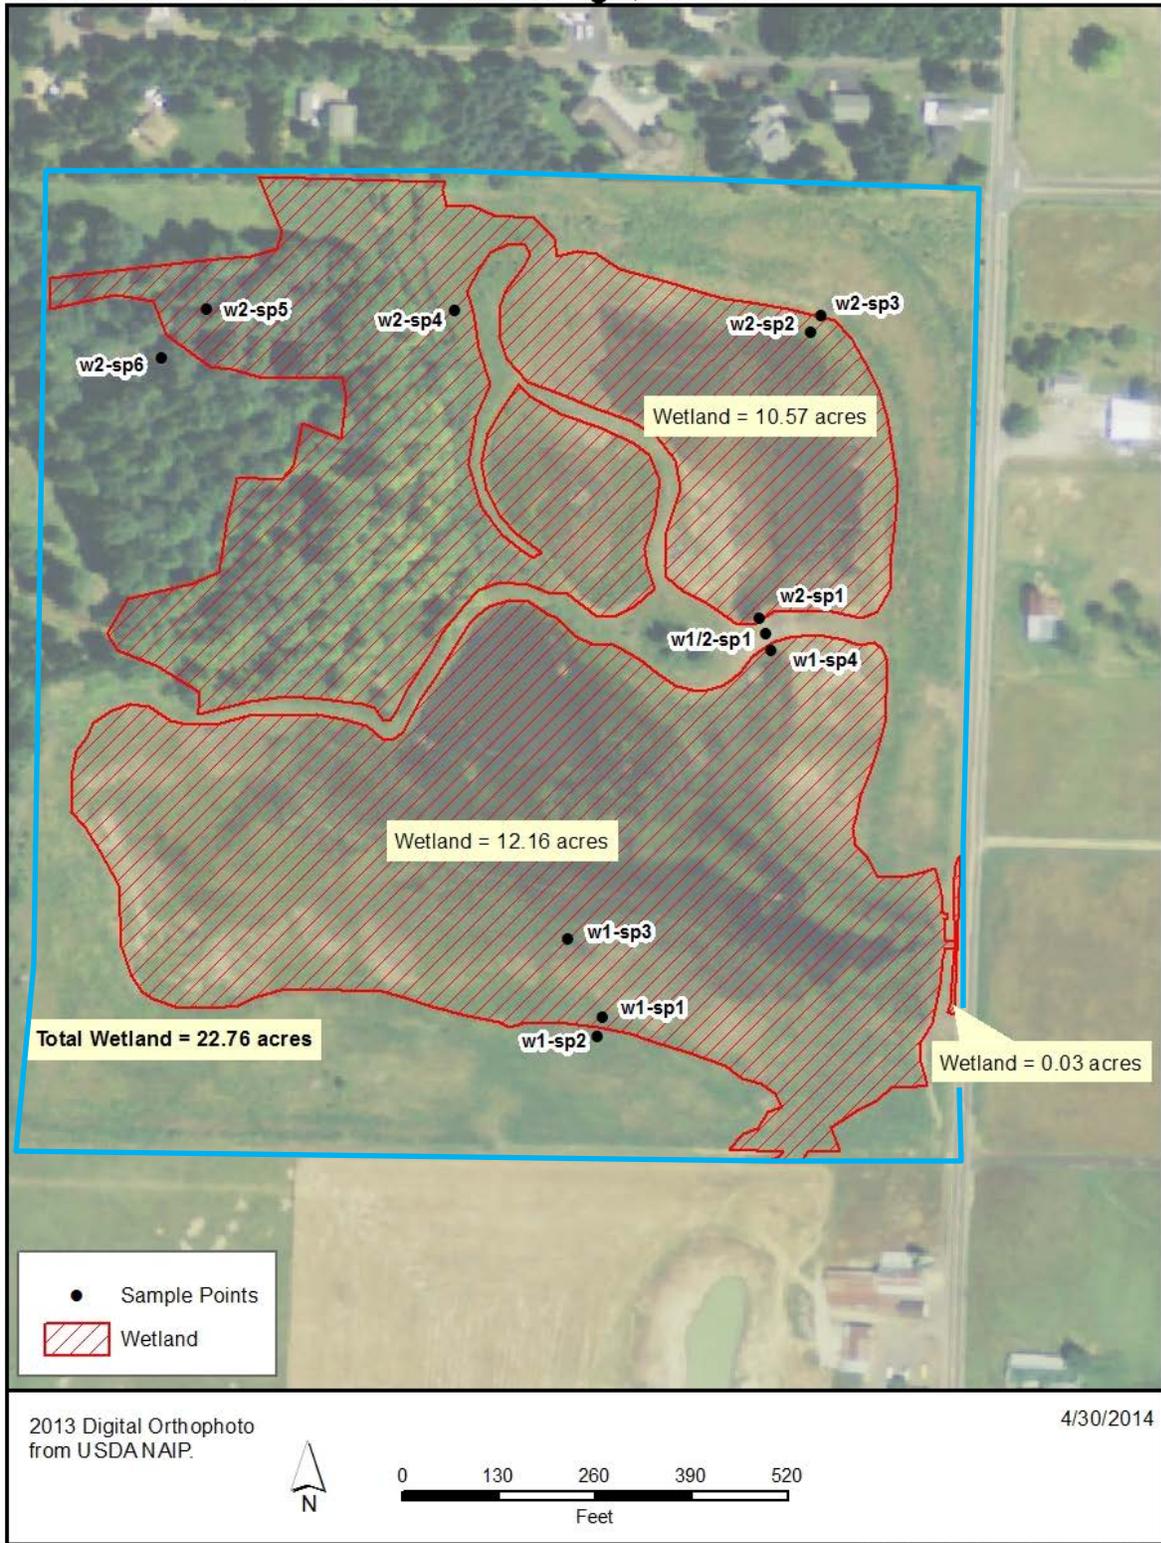
The delineation determined 22.76 acres of wetland were present within the I-5 Johnson Farm mitigation site. Delineation data were collected at eleven sampling points and recorded on wetland determination data forms (Appendix A). Paired wetland and upland sample points were used to define the wetland edge. Additional wetland sample points characterize various wetland vegetation communities. Data recorded on wetland determination data forms characterize typical wetland and upland conditions observed on site. Vegetation, soils, and hydrology were examined in many additional sampling locations to determine the wetland boundary.

Figure 2. Study area in blue, wetland boundary in red, and sampling point locations in black.
