APPENDIX H  
LABORATORY REPORTS

Strength Testing Reports  
Corrosion Testing Reports  
Atterberg Limits Testing Reports  
Petrographic Analysis Reports

# Strength and Direct Shear Testing Results

**Rock Testing  
WDOT - I90 Hyak Extension**

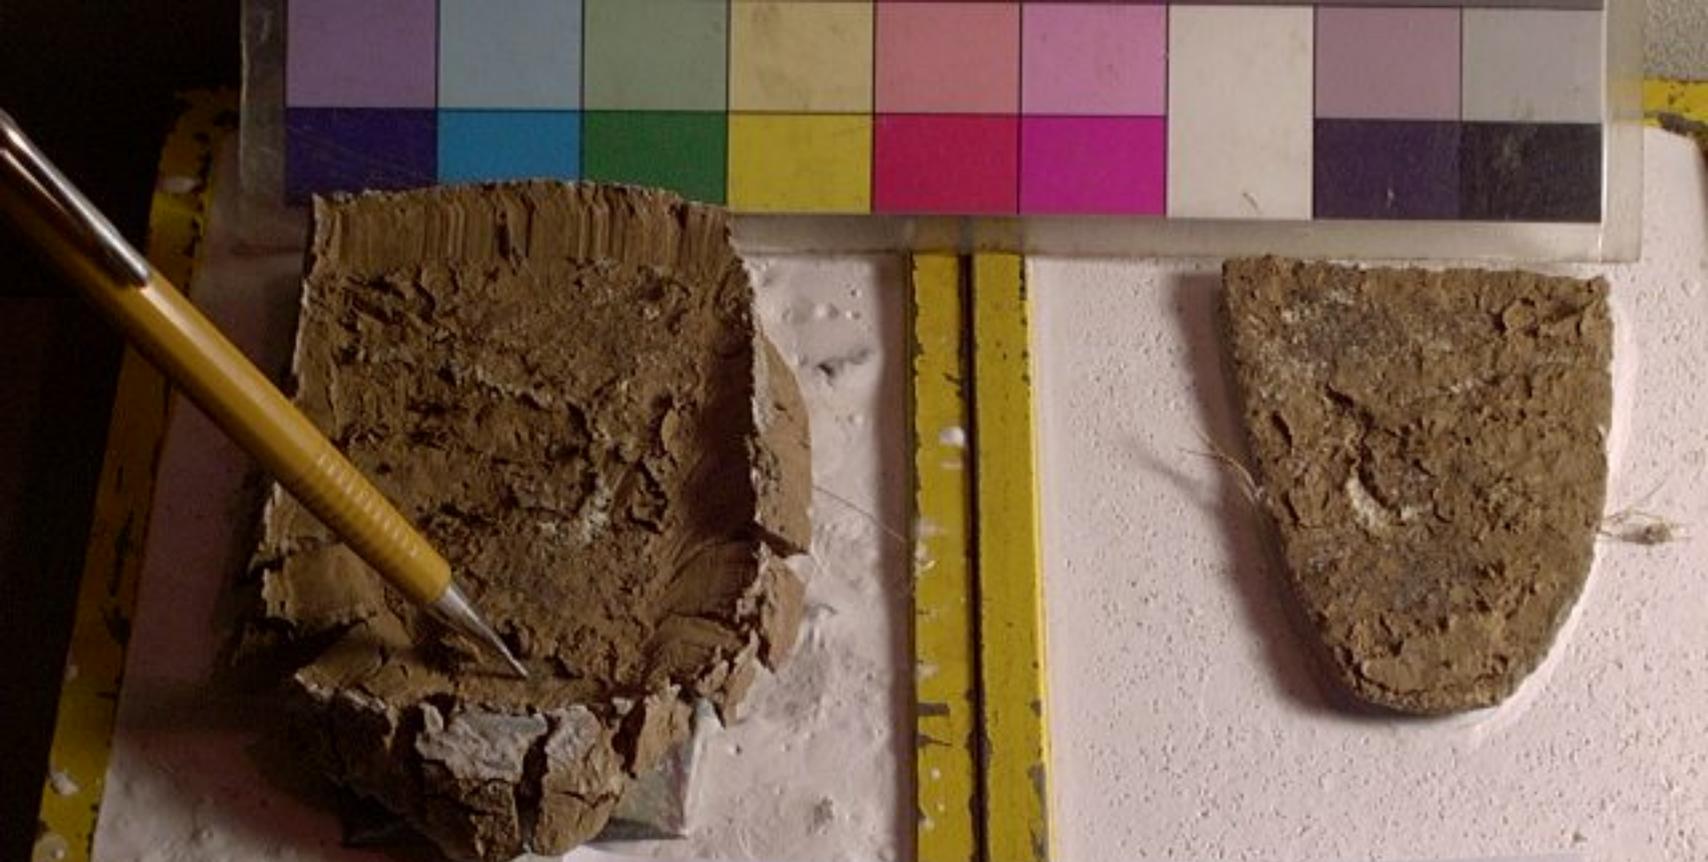
Wyllie & Noorish  
I-90 Hyak Realignment  
Direct Shear Test  
Boring: H-107-06 Depth: 84.0-84.9'  
Sample: 103(A)

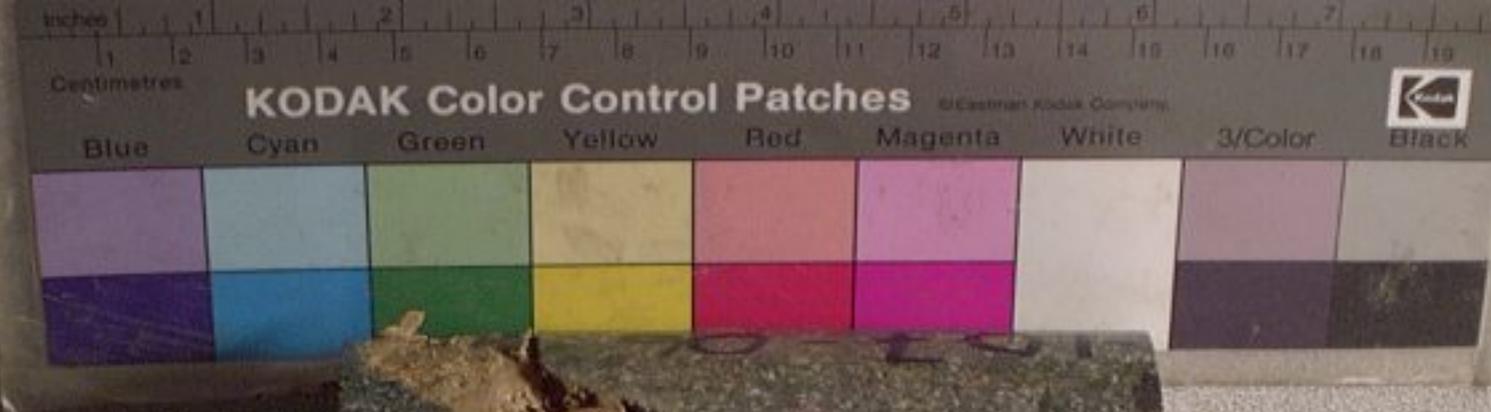
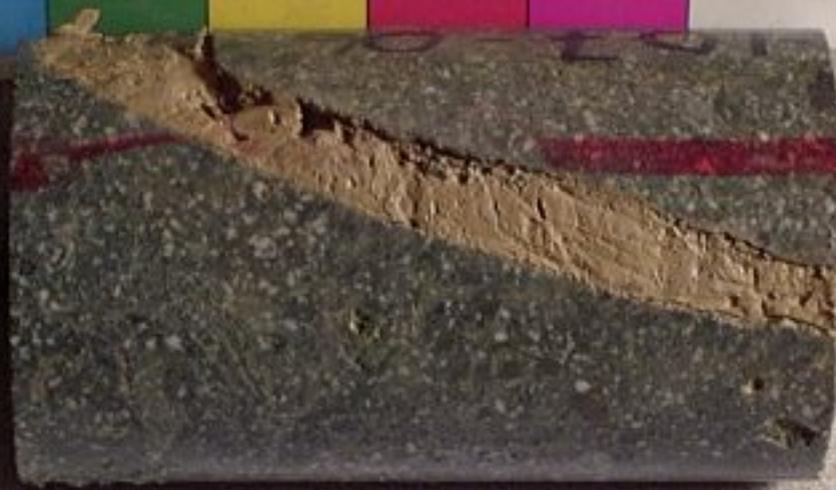
Wyllie & Noorish  
I-90 Hyak Realignment  
Direct Shear Test  
Boring: H-107-06 Depth: 84.0-84.9'  
Sample: 103(A)

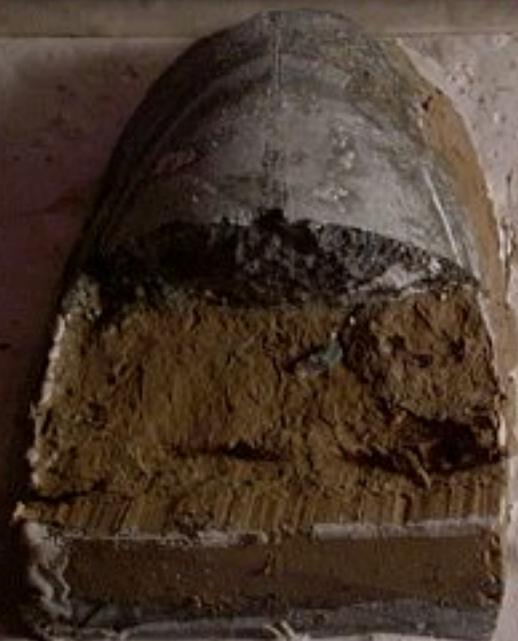
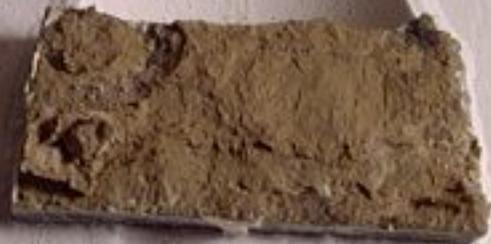
Wyllie & Noorish  
I-90 Hyak Realignment  
Direct Shear Test  
Boring: H-107-06 Depth: 84.0-84.9'  
Sample: 103(A)

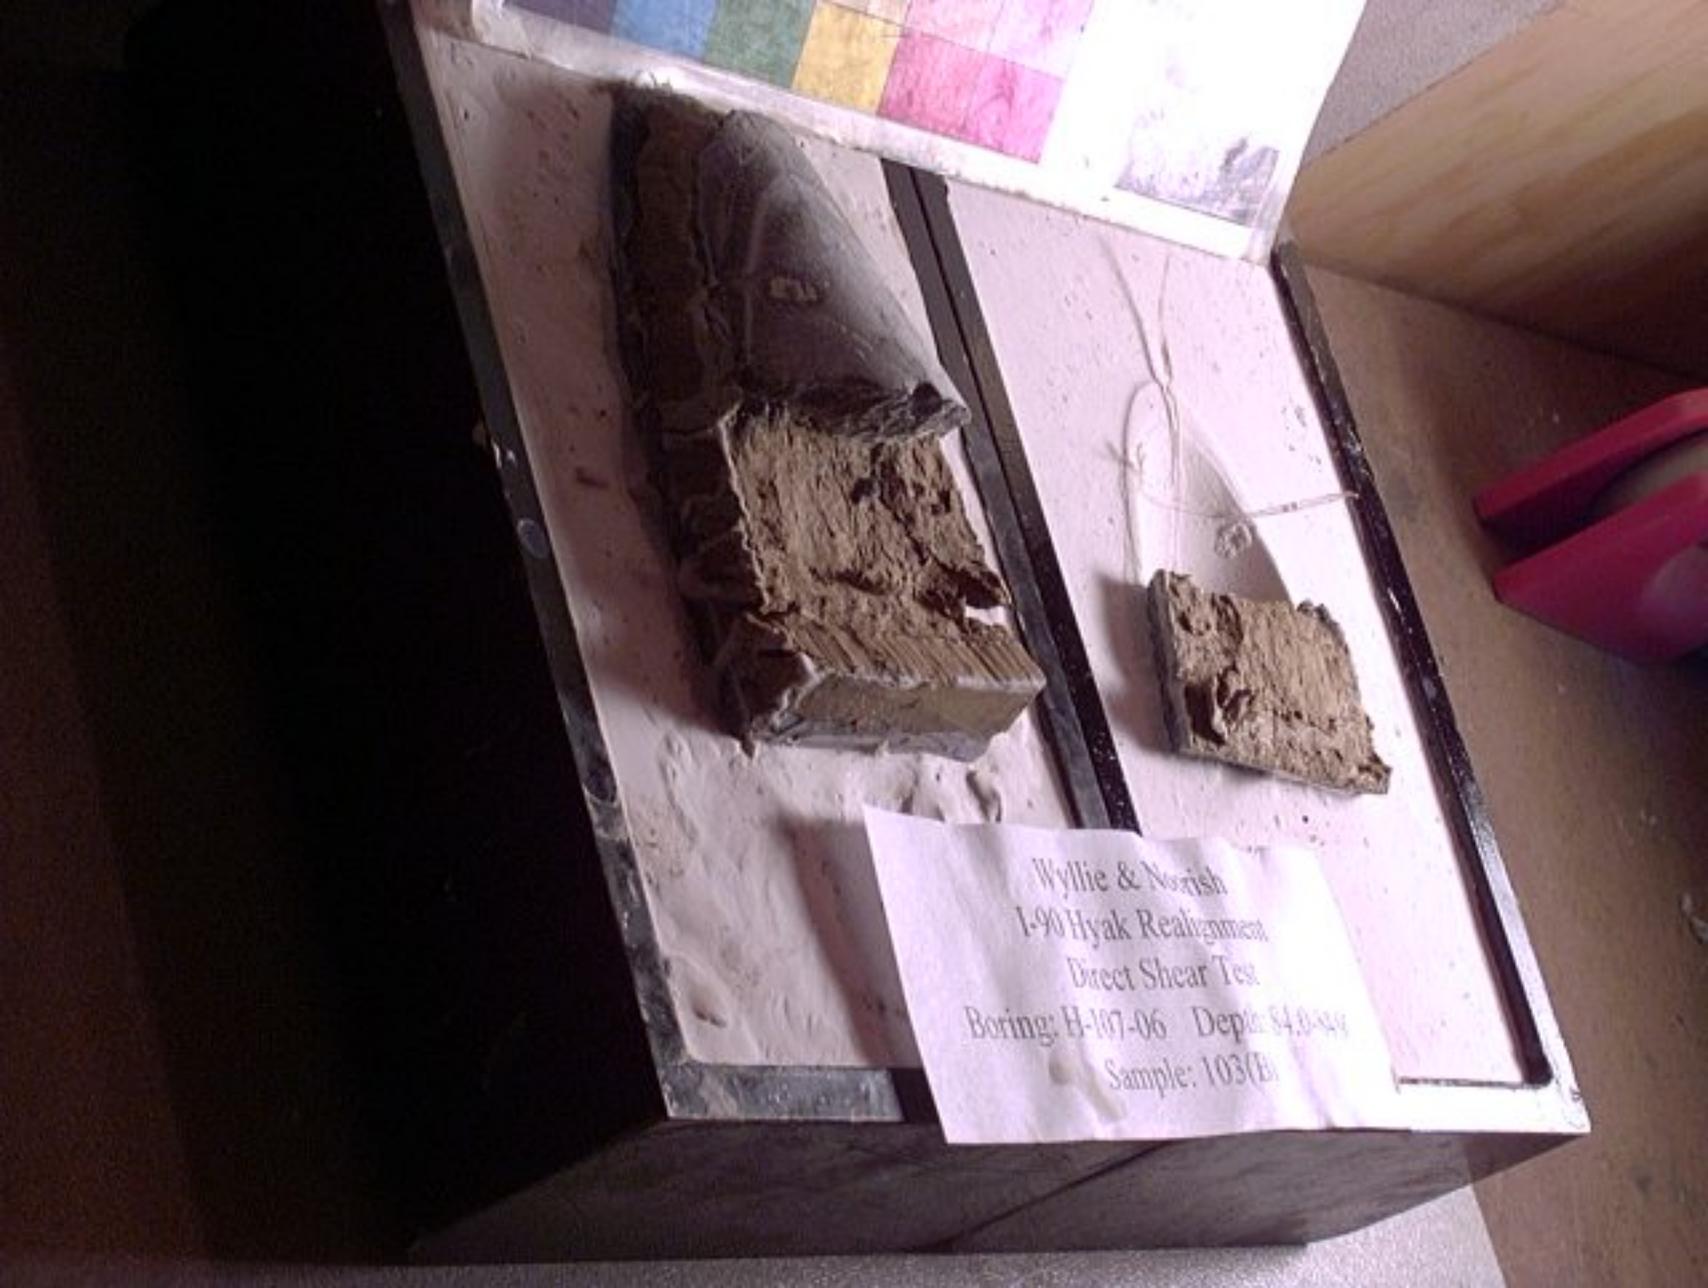
Wyllie & Noorish  
I-90 Hyak Realignment  
Direct Shear Test  
Boring: H-107-06 Depth: 84.0-84.9'  
Sample: 103(B)

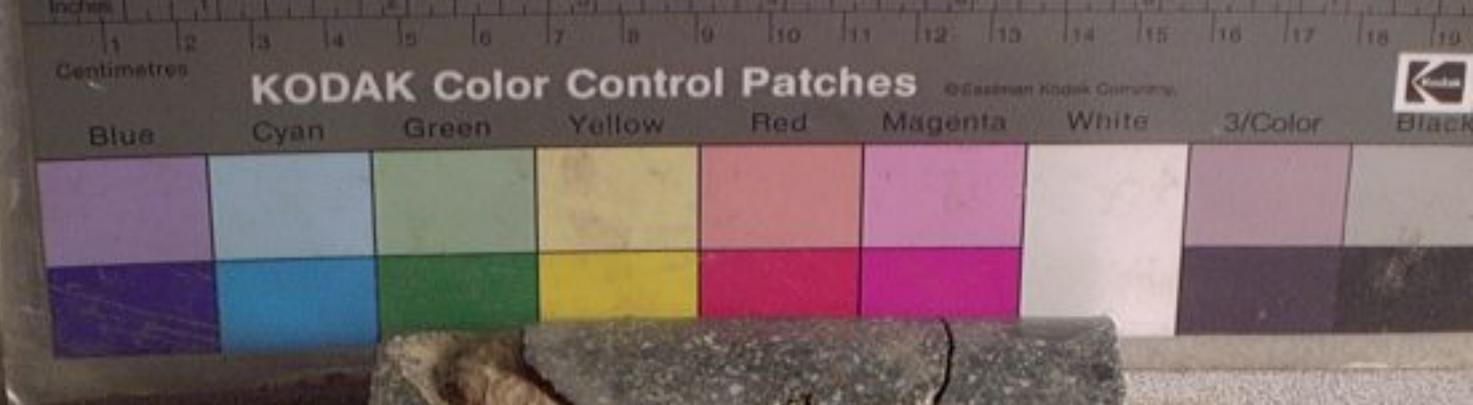
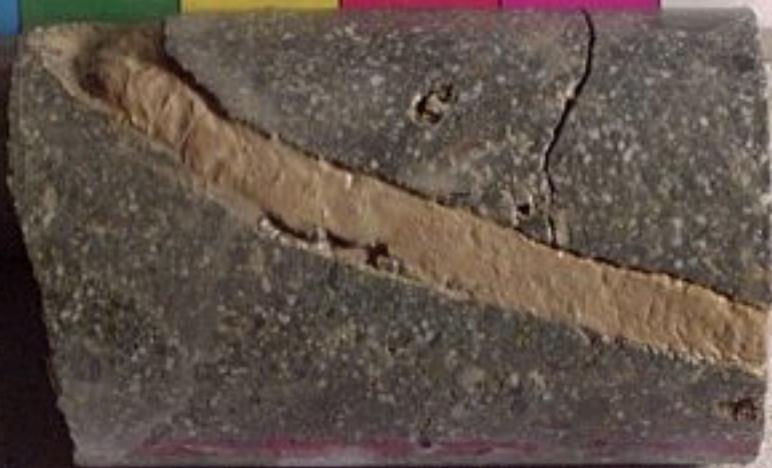
Wyllie & Norrish  
I-90 Hyak Realignment  
Direct Shear Test  
Boring: H-107-06 Depth: 84.0-84.4  
Sample: 103(B)

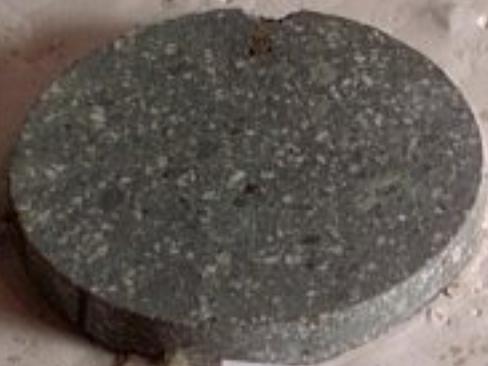
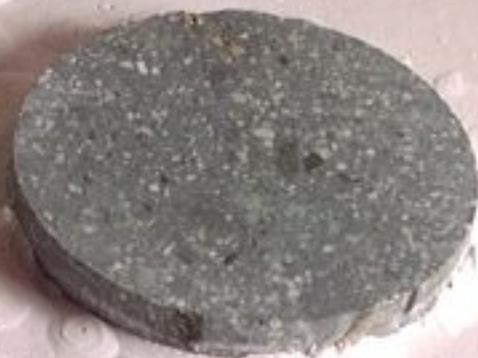
Wyllie & Noorish  
I-90 Hyak Realignment  
Direct Shear Test  
Boring: H-107-06 Depth: 84.0-84.9'  
Sample: 103(B)

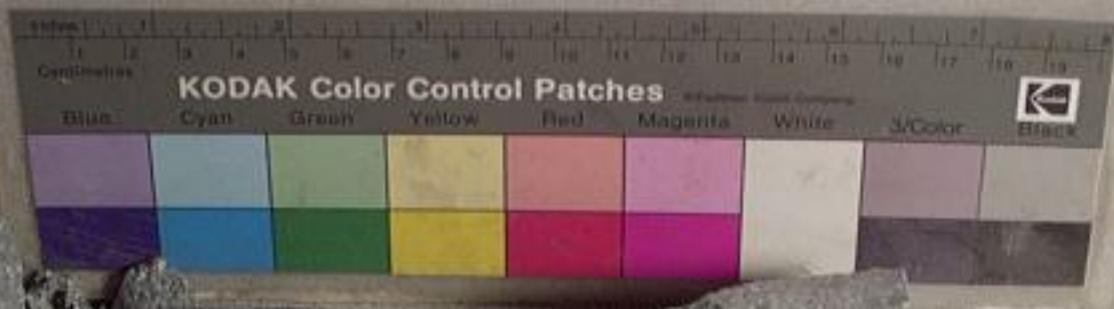
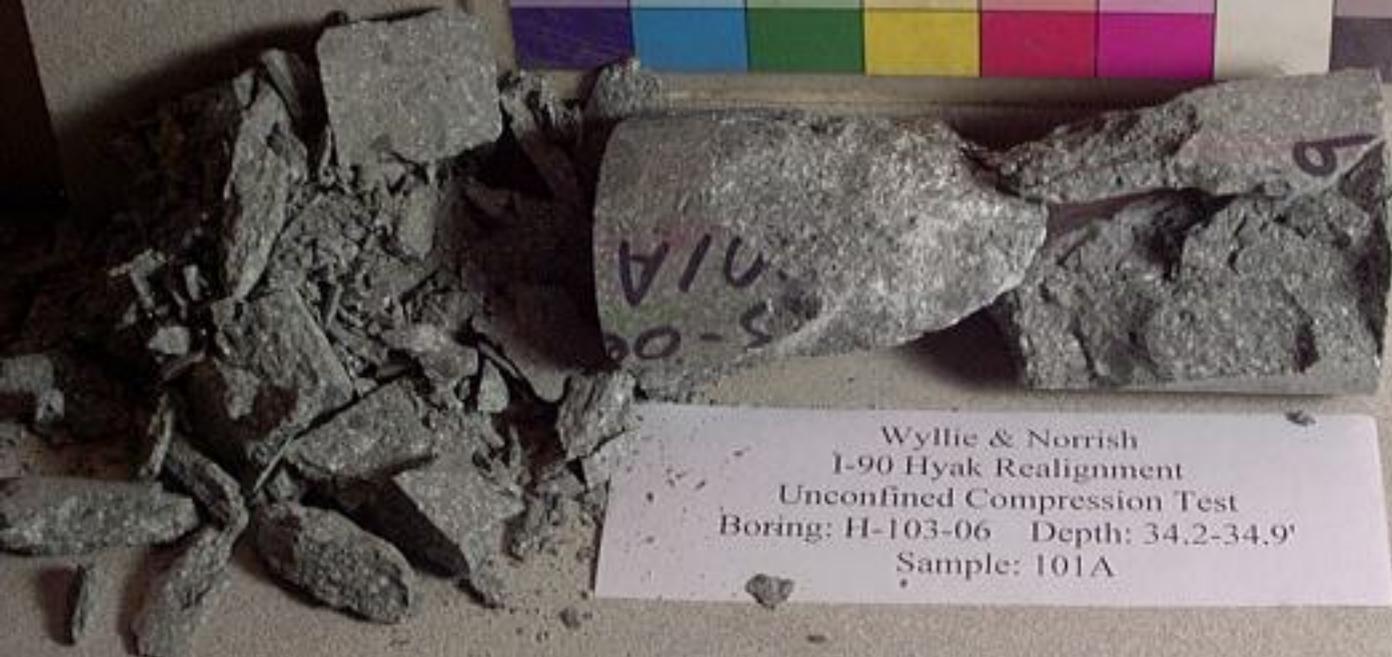
Wyllie & Norrish  
I-90 Hyak Realignment  
Unconfined Compression Test  
Boring: H-101-06 Depth: 94.0-94.7'  
Sample: 101A

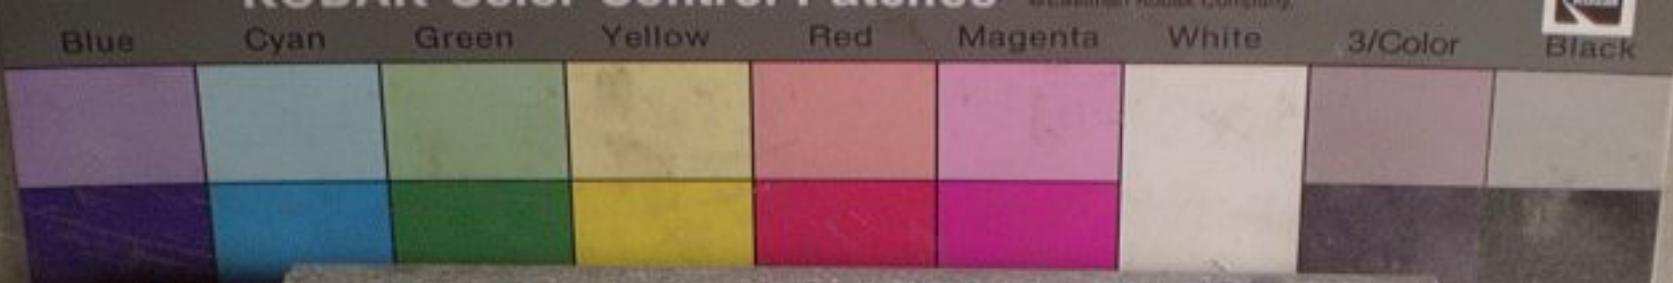
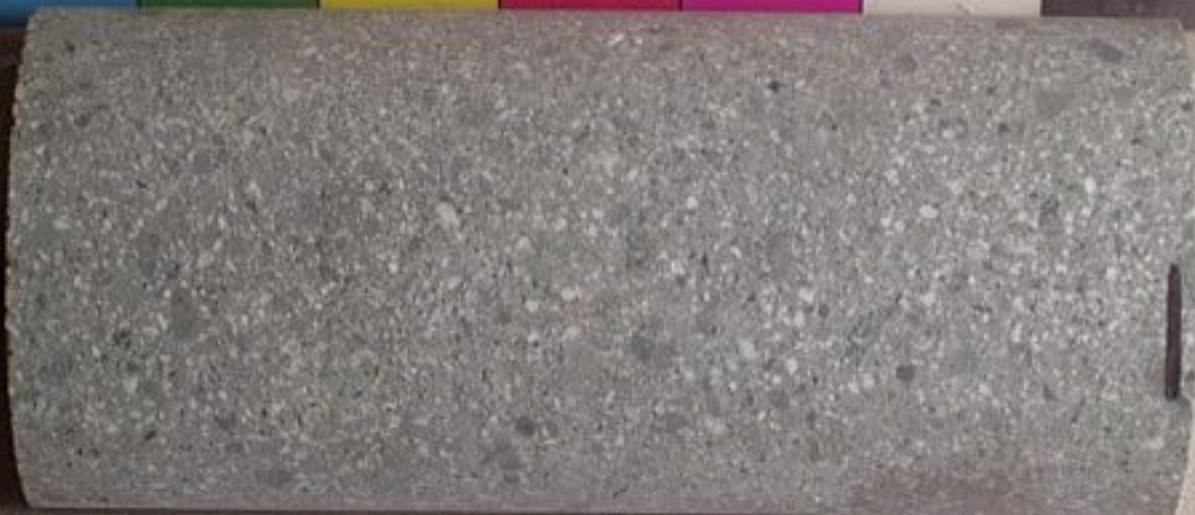
Wyllie & Norrish  
1-90 Hyak Realignment  
Unconfined Compression Test  
Boring: H-103-06 Depth: 34.2-34.9'  
Sample: 101A

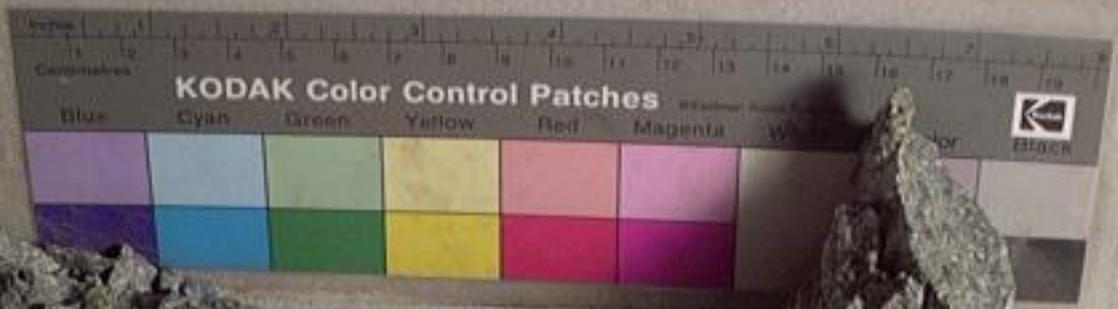
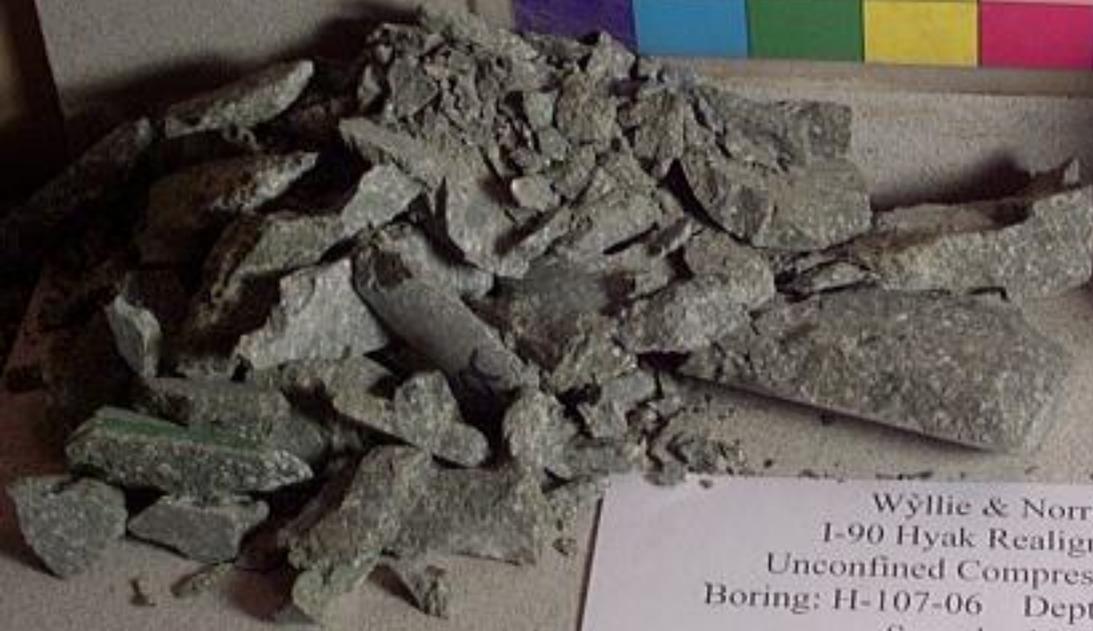
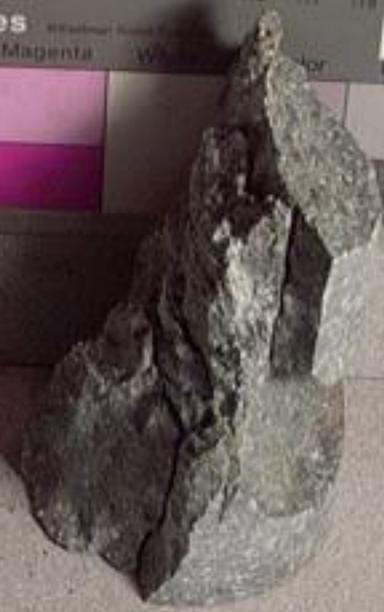
Wyllie & Norrish  
I-90 Hyak Realignment  
Unconfined Compression Test  
Boring: H-103-06 Depth: 34.2-34.9'  
Sample: 101A

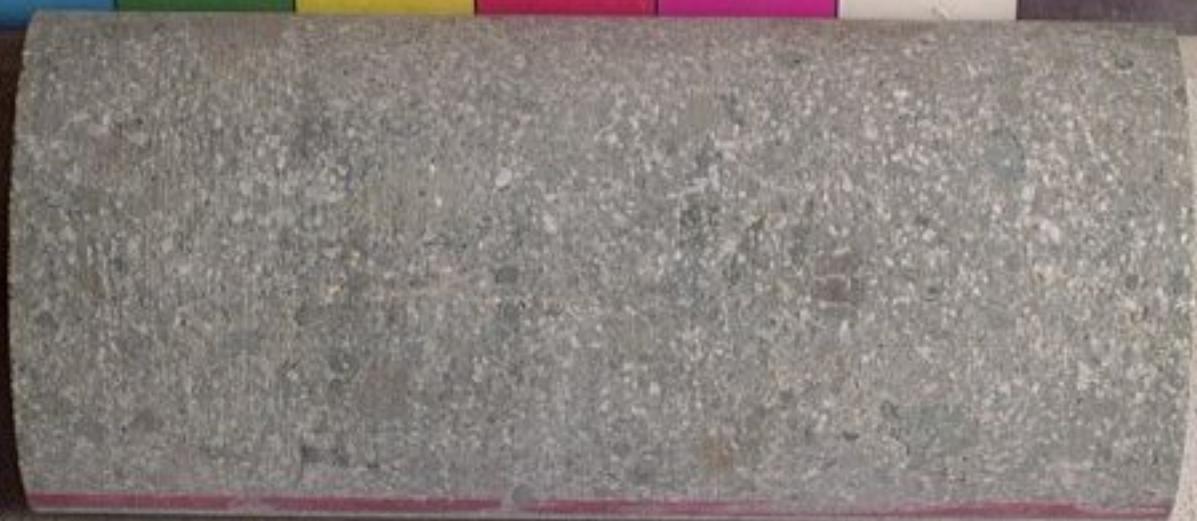
Wyllie & Norrish  
I-90 Hyak Realignment  
Unconfined Compression Test  
Boring: H-107-06    Depth: 30.6-31.2'  
Sample: 101B

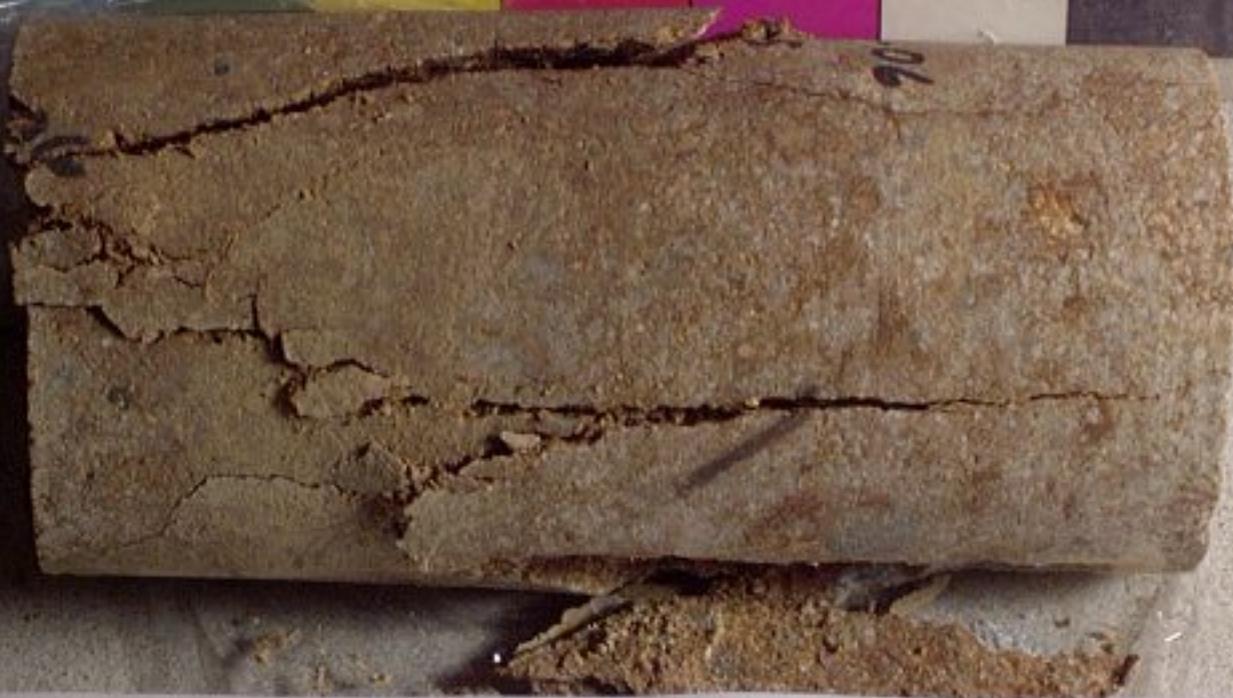
Wyllie & Norrish  
I-90 Hyak Realignment  
Unconfined Compression Test  
Boring: H-109-06 Depth: 128.9-129.8'  
Sample: 105

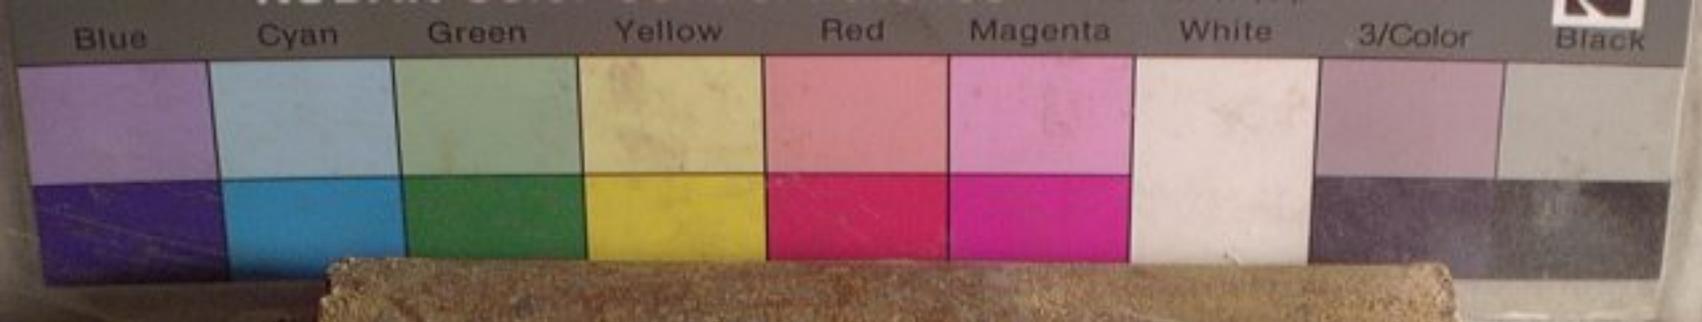
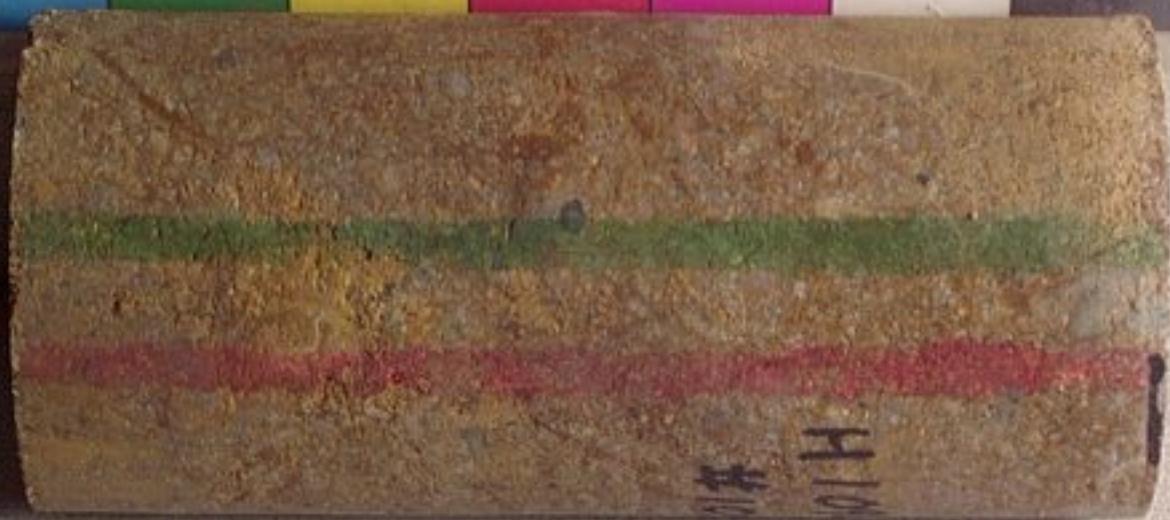
Wyllie & Norrish  
I-90 Hyak Realignment  
Unconfined Compression Test  
Boring: H-109-06 Depth: 128.9-129.8'  
Sample: 105

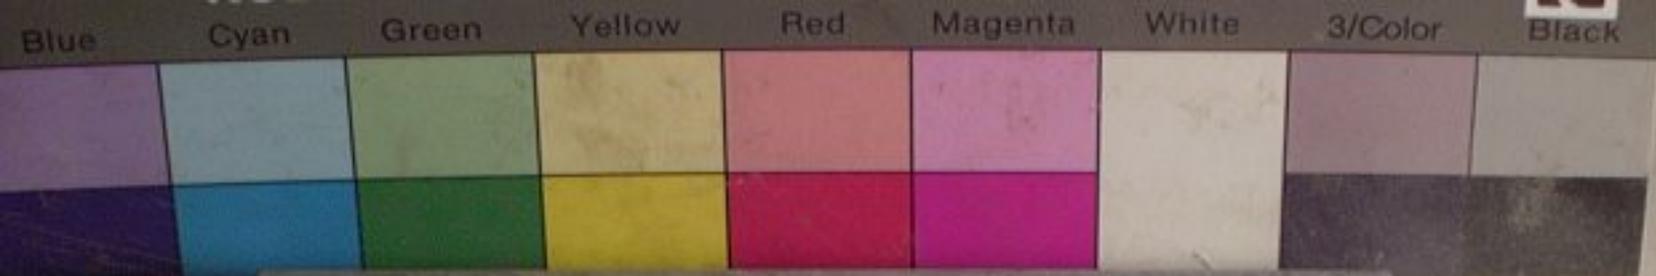
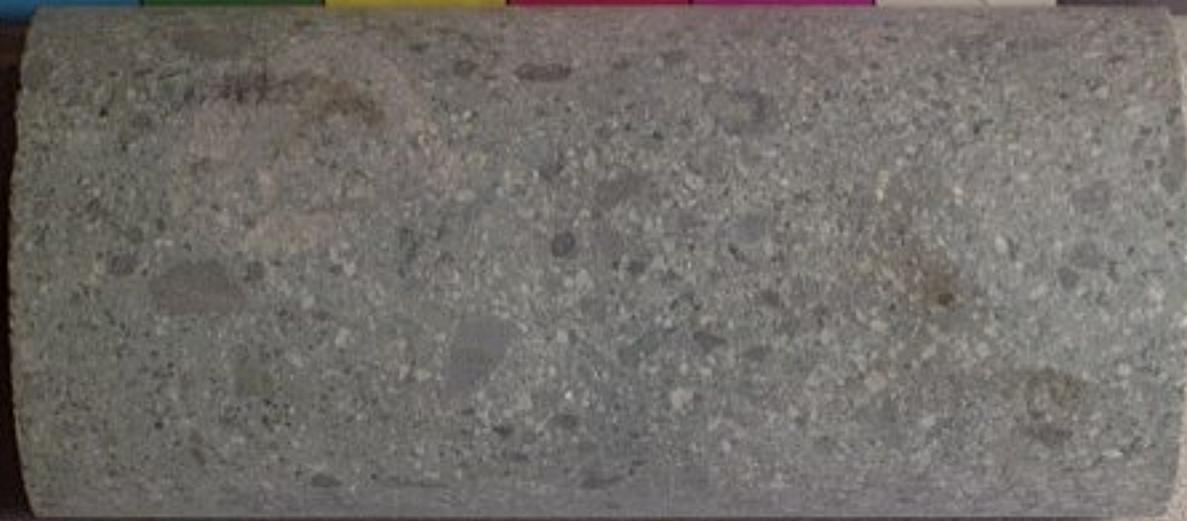
Wyllie & Norrish  
I-90 Hyak Realignment  
Unconfined Compression Test  
Boring: H-110-06    Depth: 80.1-80.6'  
Sample: 102A

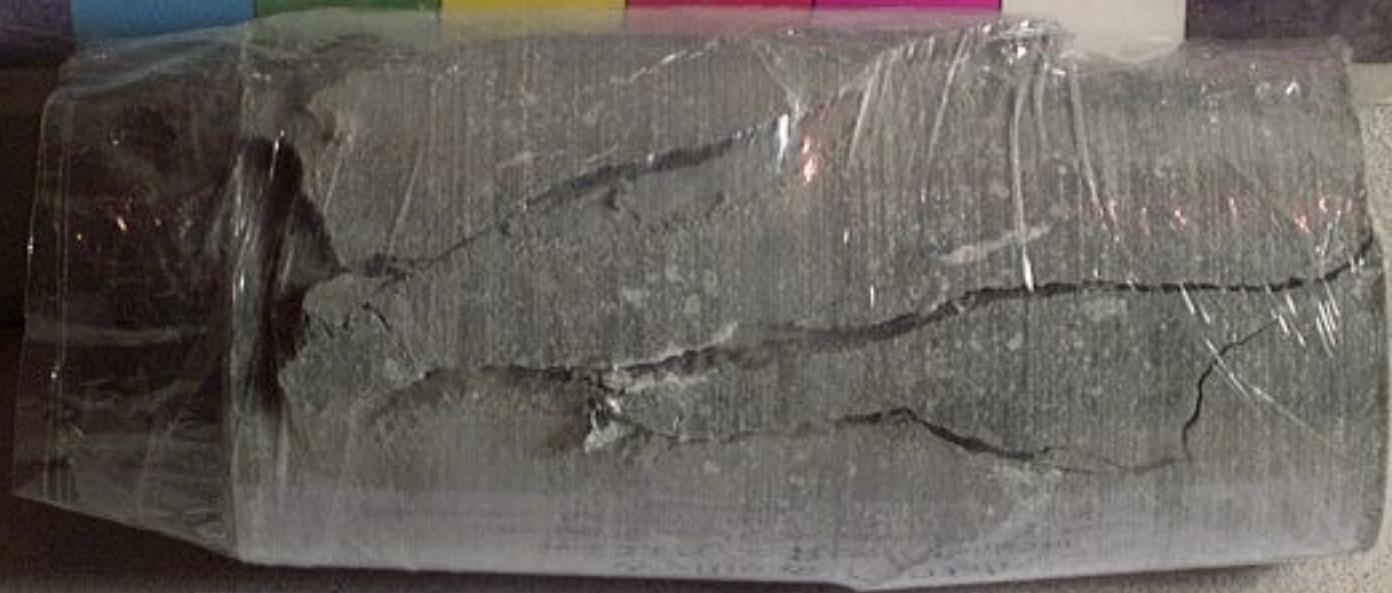
Wyllie & Norrish  
I-90 Hyak Realignment  
Unconfined Compression Test  
Boring: H-201-06    Depth: 77.9-78.7'  
Sample: 103B

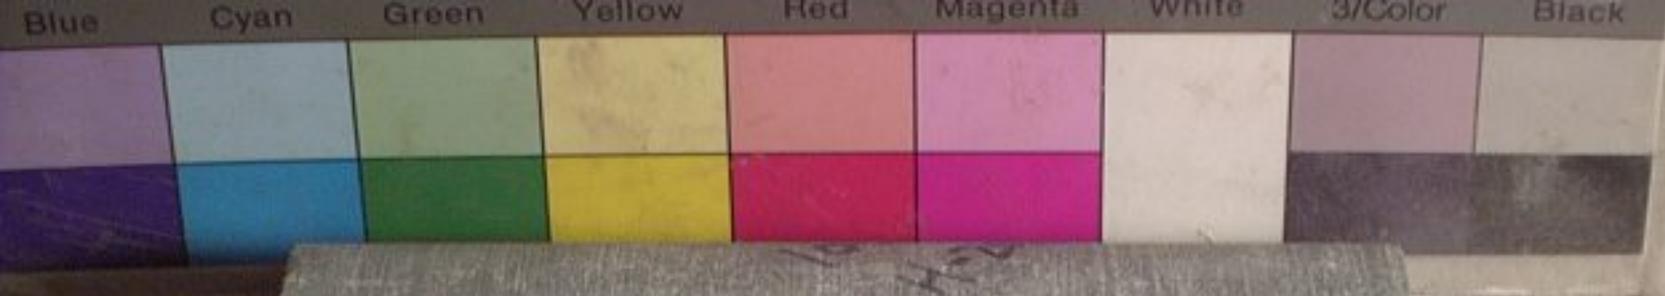
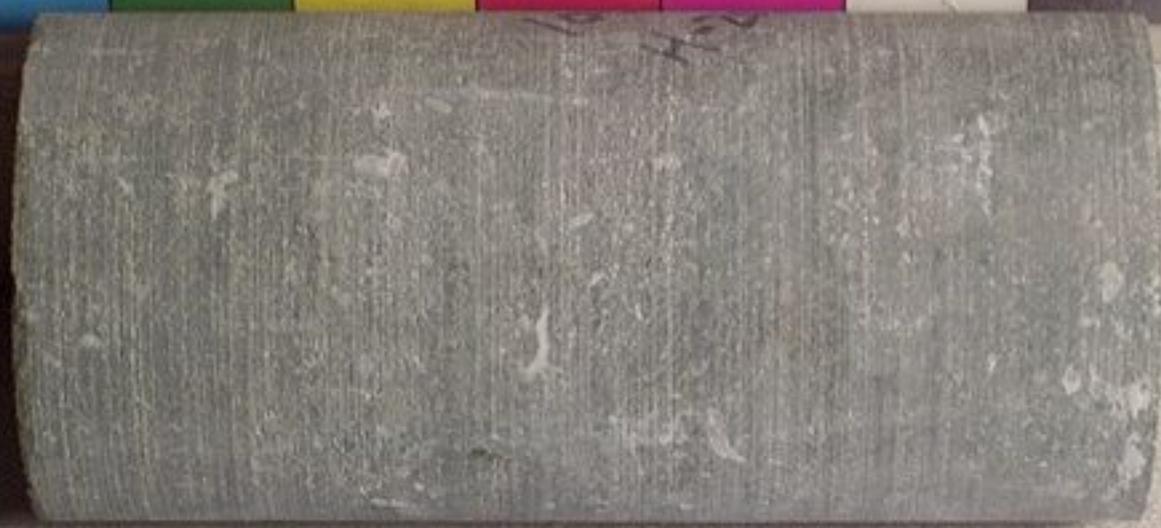
Wyllie & Norrish  
I-90 Hyak Realignment  
Unconfined Compression Test  
Boring: H-201-06    Depth: 77.9-78.7'  
Sample: 103B

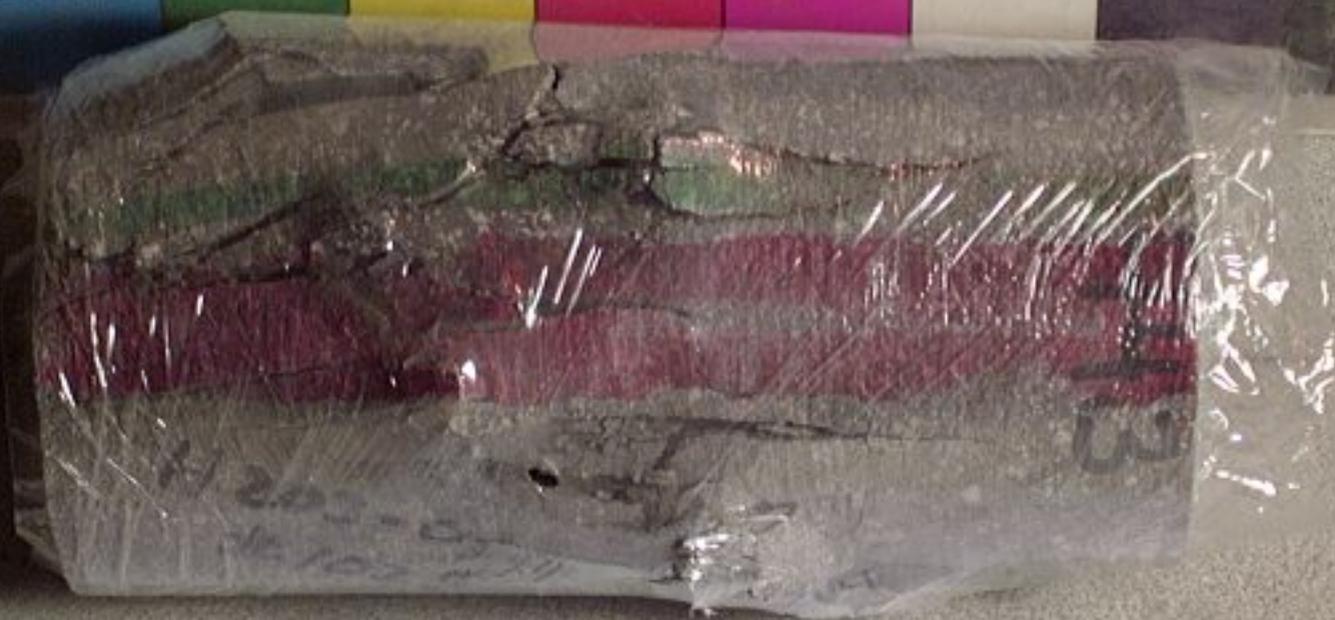
Wyllie & Norrish  
I-90 Hyak Realignment  
Unconfined Compression Test  
Boring: H-203-06 Depth: 44.3-45.0'  
Sample: 102A

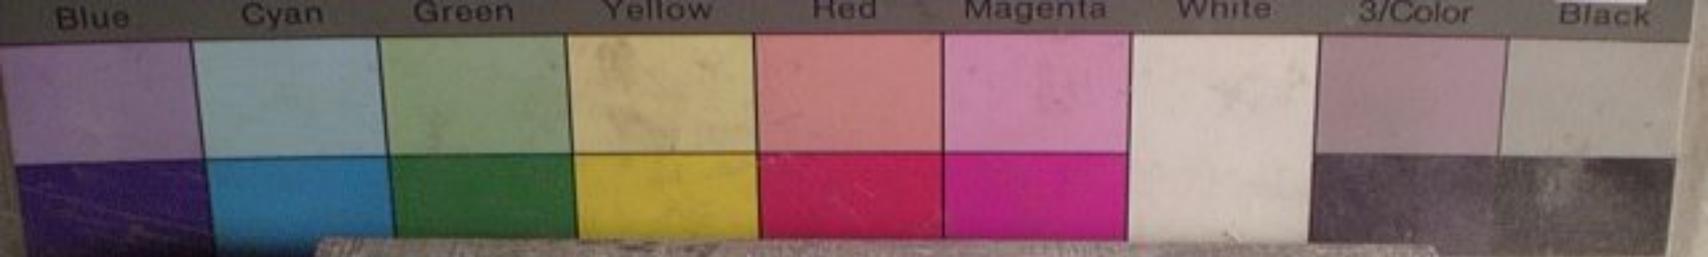
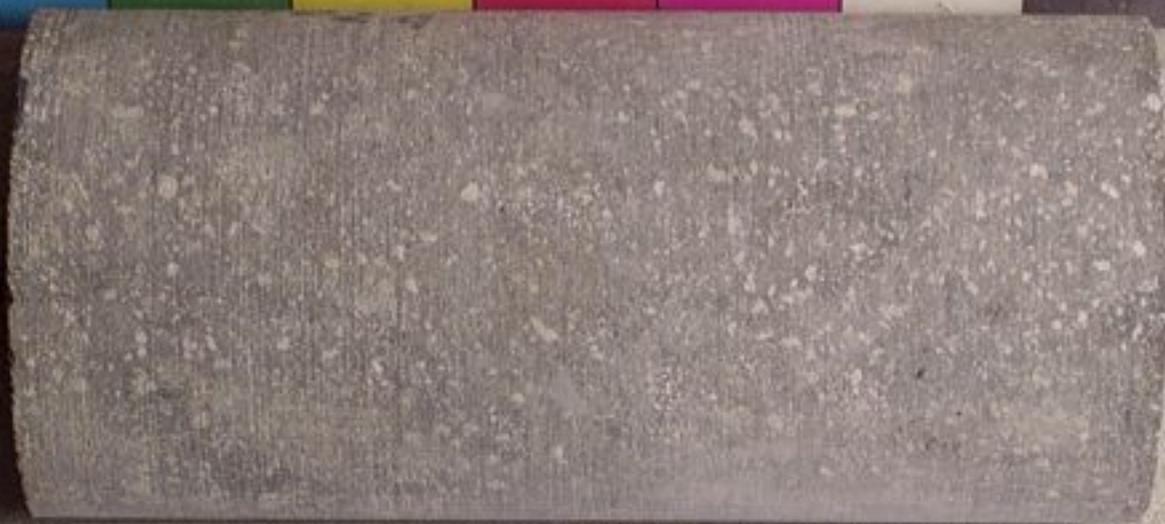
Wyllie & Norrish  
I-90 Hyak Realignment  
Unconfined Compression Test  
Boring: H-203-06    Depth: 44.3-45.0'  
Sample: 102A

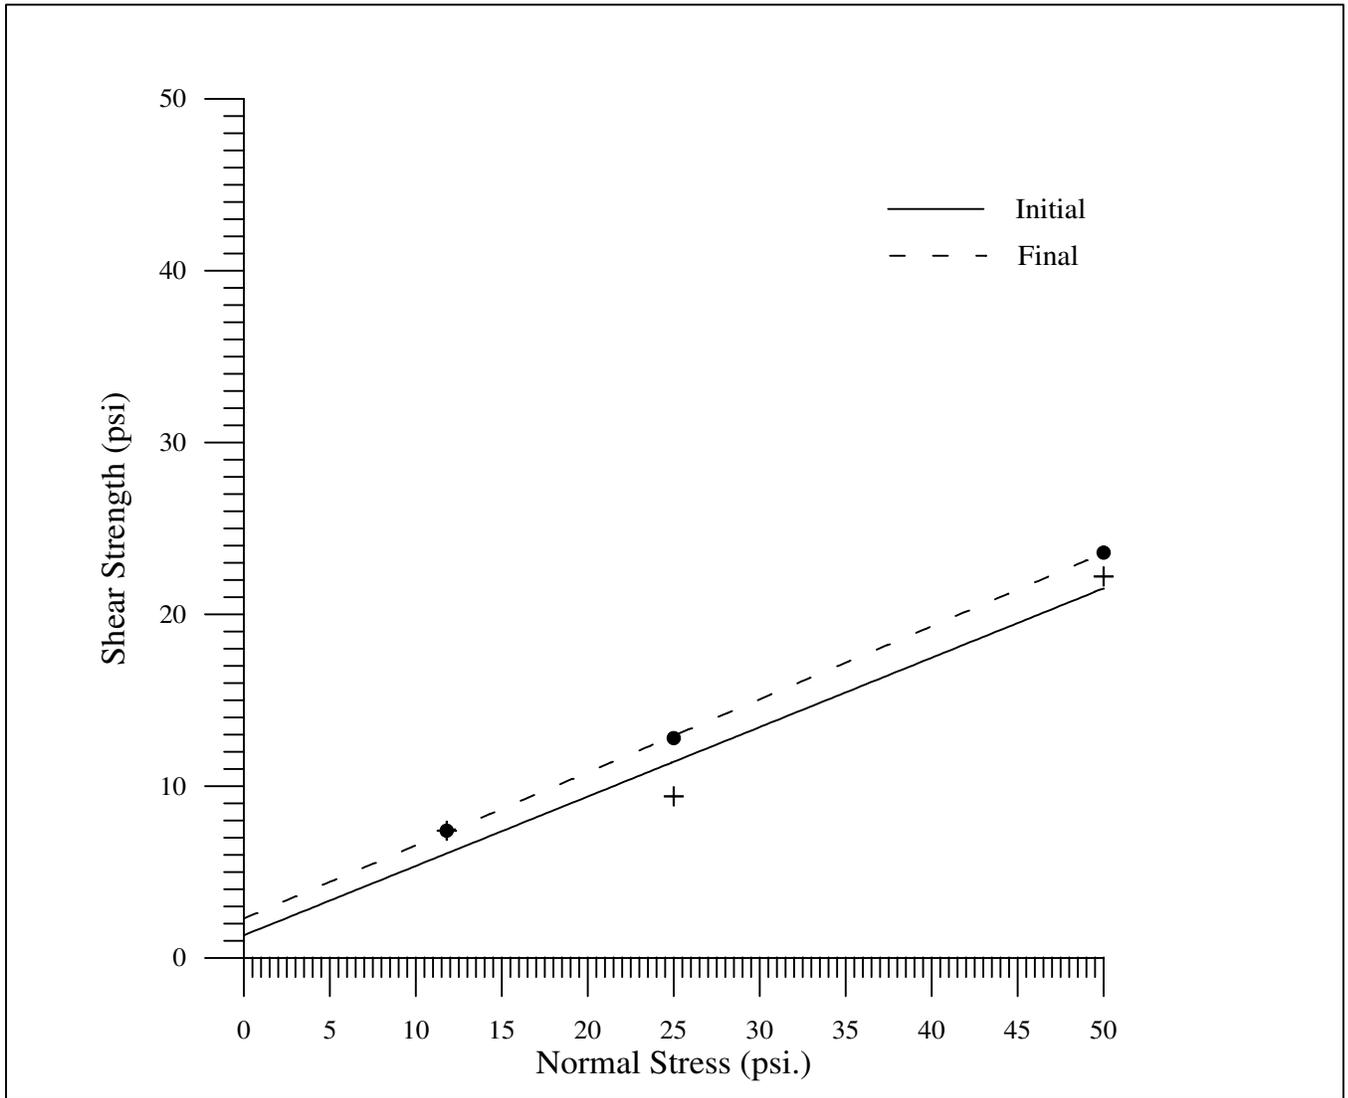
Brecciated shear zone with hard broken meta-andesite interspersed in tannish gray clay.

**DIRECT SHEAR TEST**  
**Failure Envelope Normal Stress vs. Shear Strength**

Sample 06-104 consisted of a shear zone consisting of broken rock, appearing as slabs parallel to the main shear plane, with clay separating the rock pieces. Unlike a typical filled discontinuity, the broken rock pieces could rotate and modify the interface strength as shear displacements developed. This interaction was evident during the initial second and third stages and well as the final third stage. During the initial second stage, the strength appeared to be quite low. This low strength was either due to error on my part, by not allowing the test to proceed to a large enough shear displacement (although the shear strength did start to drop just before stopping this second stage) or it did represent the shear strength of the clay without the rock blocks bridging the two sides of the shear zone. I expect that the high initial third stage strength represented a rock-to-rock contact strength that was modified by the presence of the clay. I have chosen, somewhat arbitrarily, to simply use the linear approximation of these three measured strengths to represent the failure envelope of the initial shear of the interface. This representation may be incorrect and it may be more proper to use the first and second stage initial strengths to represent the clay strength without the rock-to-rock interaction.

During the final stages, quite regular first and second stage strengths developed. However something occurred during this final third stage, possibly a major rotation of one of the rock blocks, that significantly weakened the interface. This occurrence was also accompanied by a much more extreme irregularity in the stress-displacement trace, something that would be characteristic of a rolling block within the interface. I expect that for the purposes of creating a failure envelope that this lower strength should not be used. For the purposes of constructing the final failure envelope, the third stage strength of the initial set of loadings was used. Despite the nice alignment of the failure points, it should be recognized that there is a distinct possibility that the hard rock blocks could act in the manner of ball bearings, and allow the shear interface to be quite a bit weaker than has been expressed by this failure envelope.

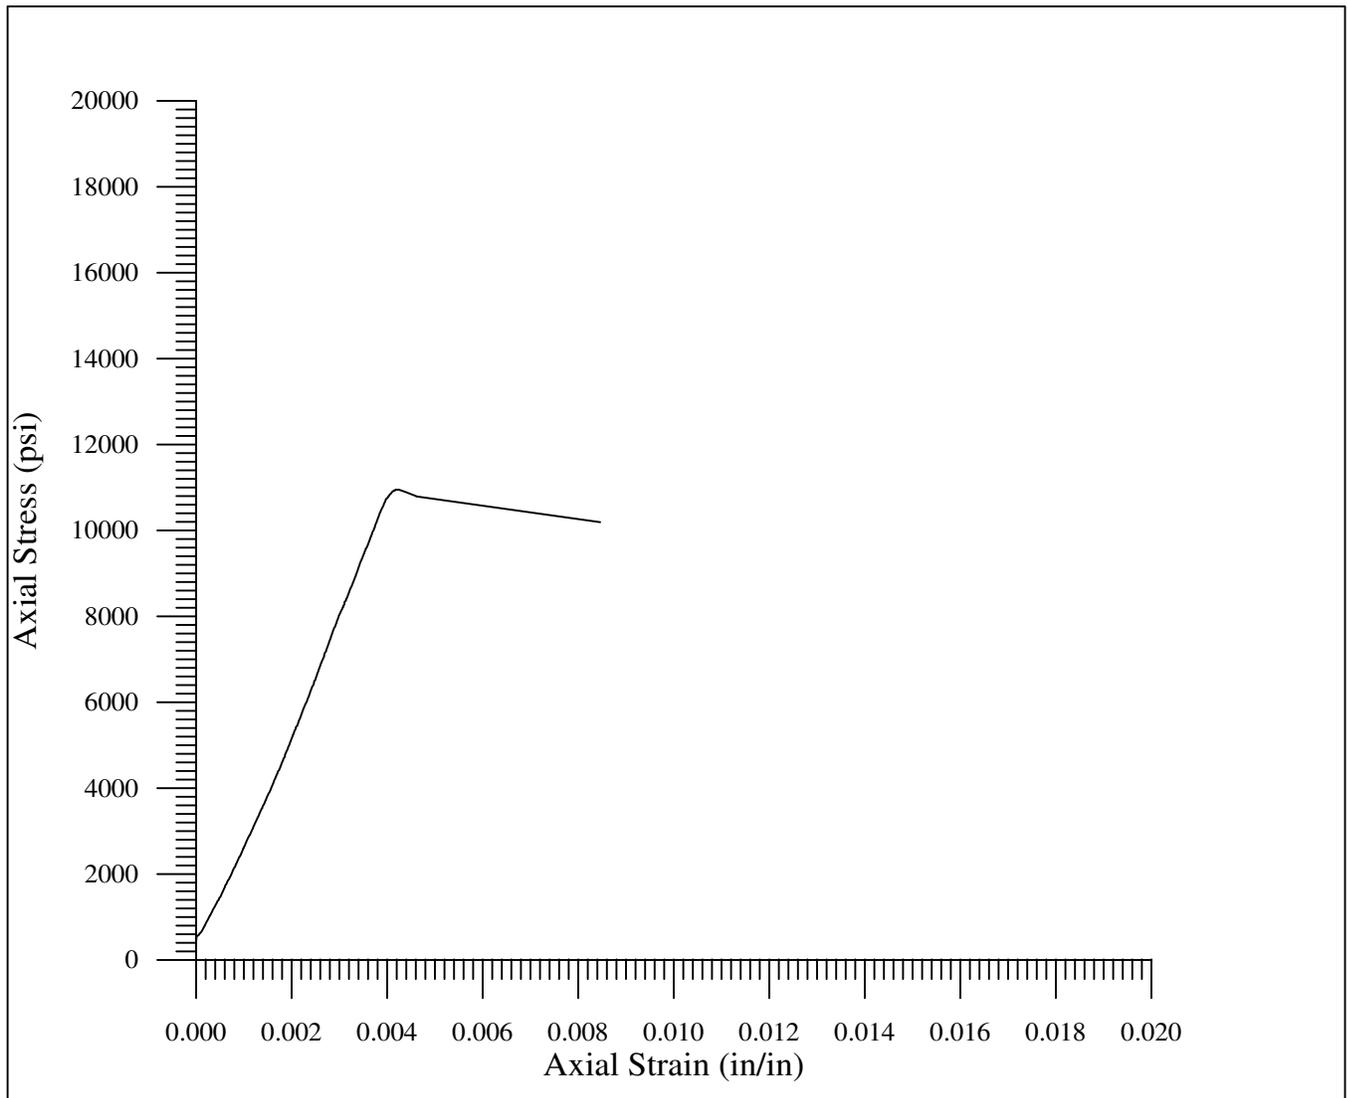
**UNCONFINED COMPRESSION TEST**  
**Axial Stress vs. Strain**

<p><b>Sample: 06-101A</b>  <b>Boring: RKS-06-07</b>  <b>Depth: 35.1-35.8'</b></p> <p style="text-align: center;"><b>DESCRIPTION</b></p> <p style="text-align: center;">Dark gray meta-andesite with quartz healed fractures and tight fractures.</p> <p><b>Density: 174.6 pcf</b>  <b>Strength: 10,946 psi</b></p>	<div style="text-align: center;">
