APPENDIX H  
LABORATORY REPORTS

Strength Testing Reports  
Corrosion Testing Reports  
Atterberg Limits Testing Reports  
Petrographic Analysis Reports

# Strength and Direct Shear Testing Results

**Rock Testing  
WDOT - I90 Hyak Extension**

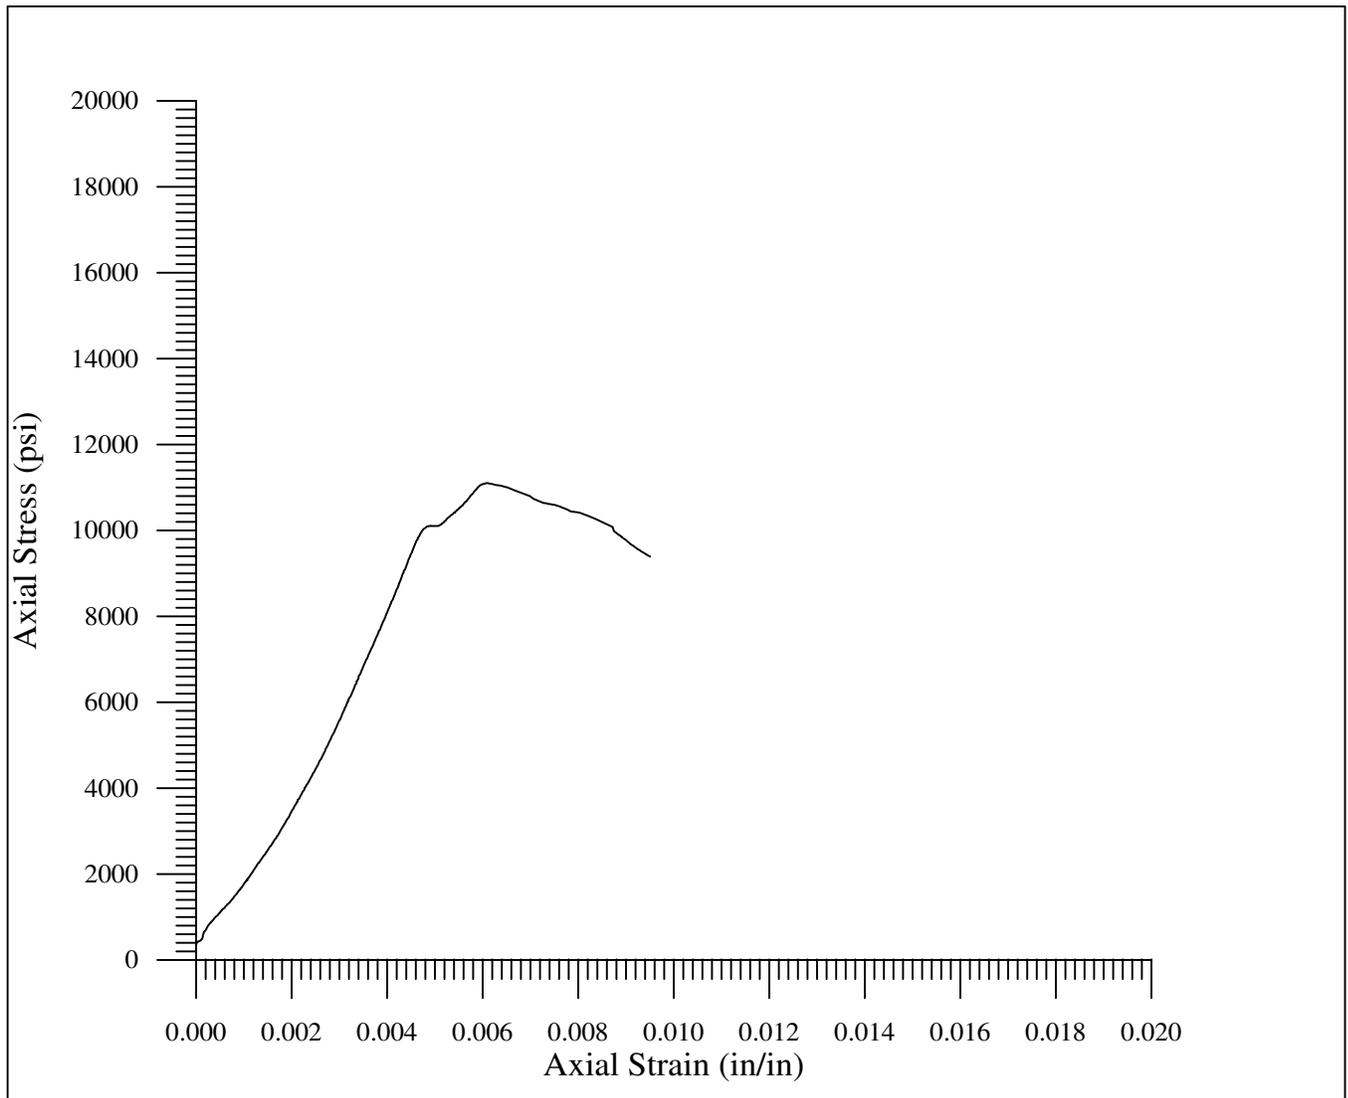
**UNCONFINED COMPRESSION TEST**  
**Axial Stress vs. Strain**

<p><b>Sample: 11-101A</b>  <b>Boring: RKS-11-07</b>  <b>Depth: 64.1-64.8'</b></p> <p style="text-align: center;"><b>DESCRIPTION</b></p> <p style="text-align: center;">Medium gray meta-welded lapilli tuff with a few tight fractures.</p> <p><b>Density: 161.3 pcf</b>  <b>Strength: 11,100 psi</b></p>	<div style="text-align: center;">

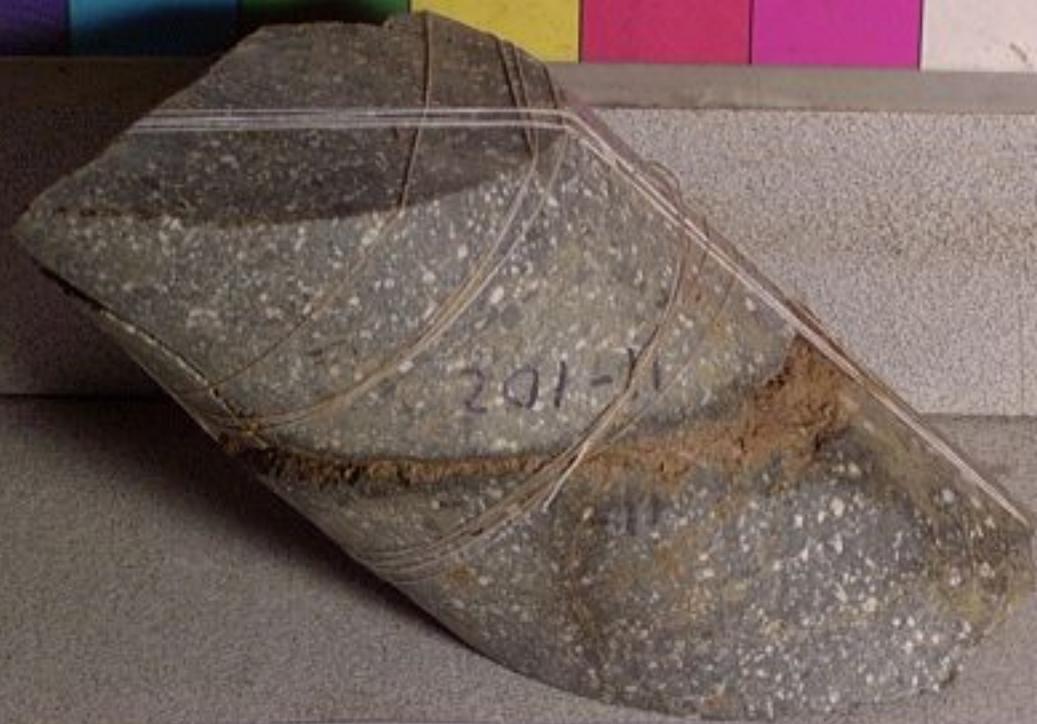
Wyllie & Norrish  
190 Hyak Realignment  
Direct Shear Test  
Boring: RKS-11-07 Depth: 107.3-107.8'  
Sample: 11-102

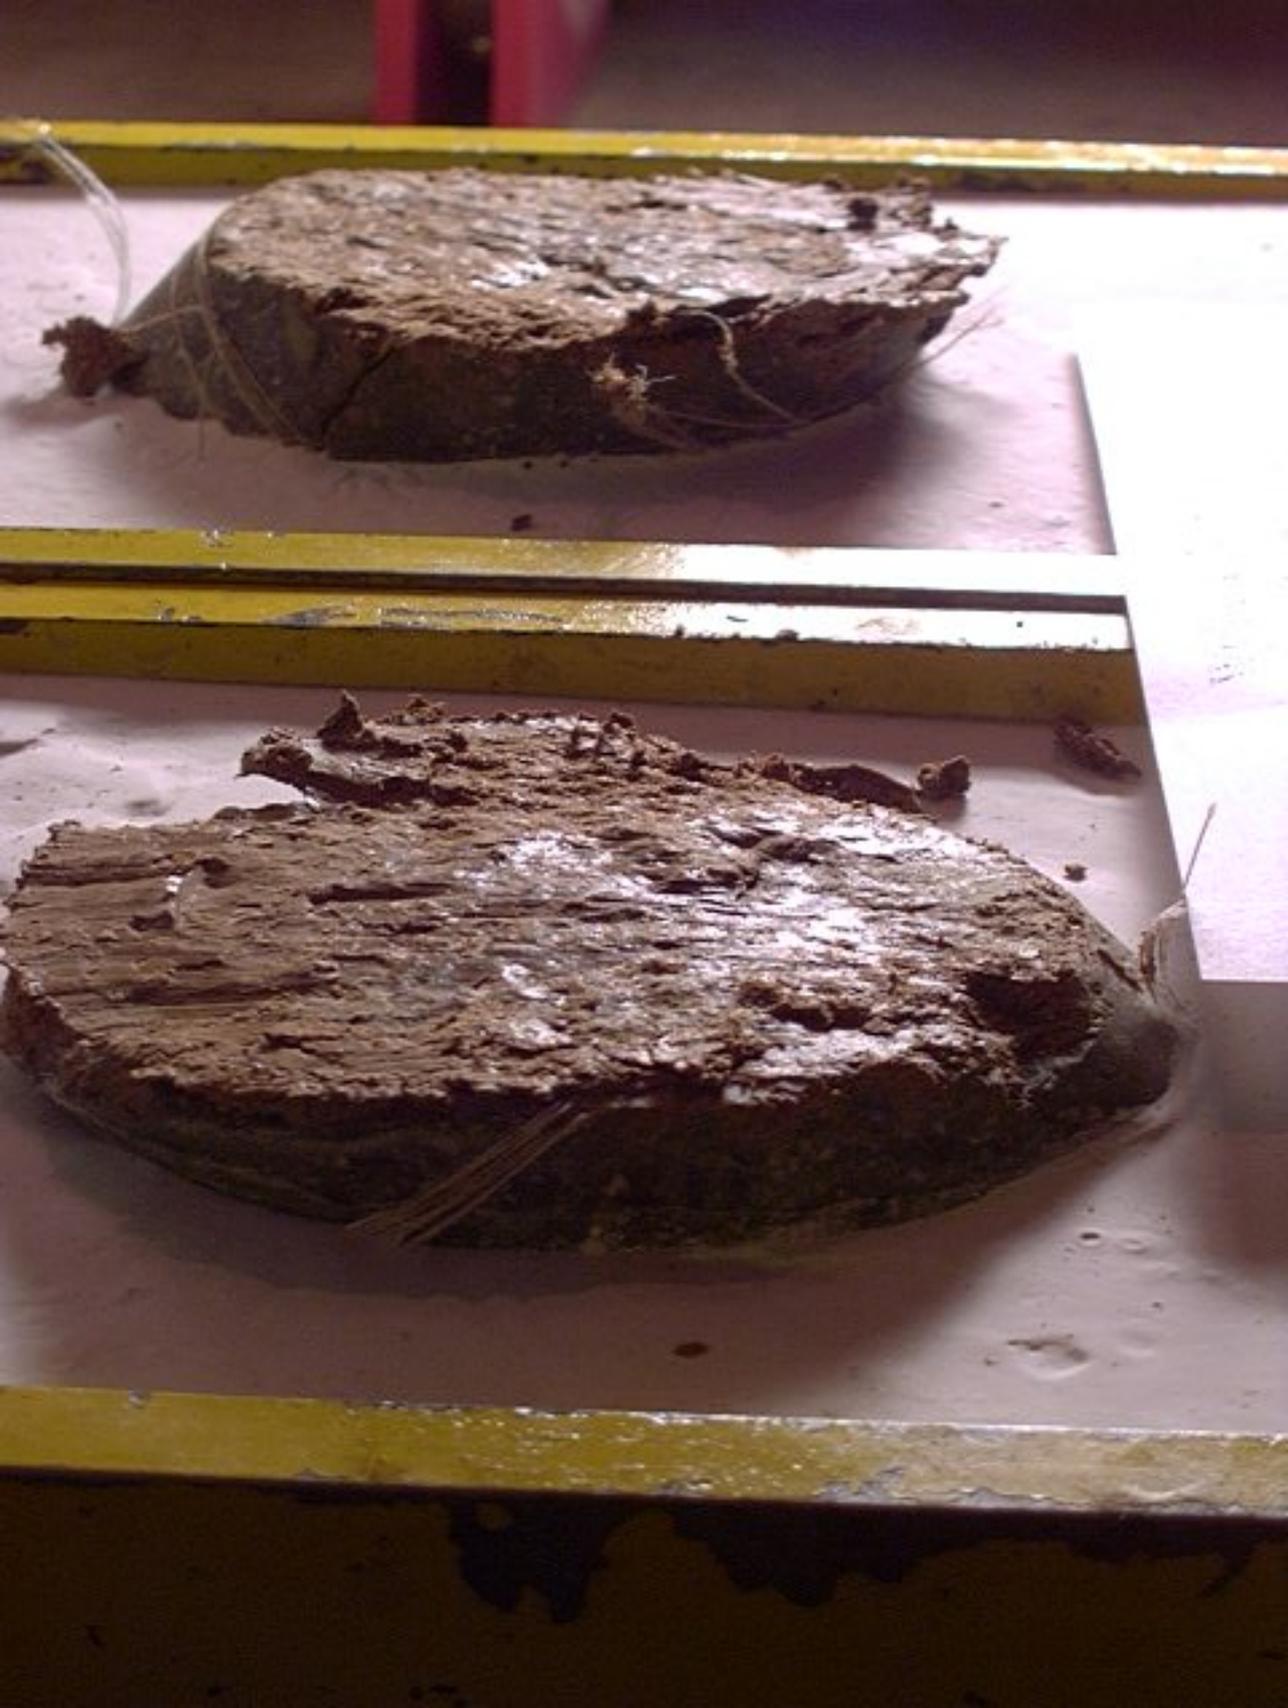
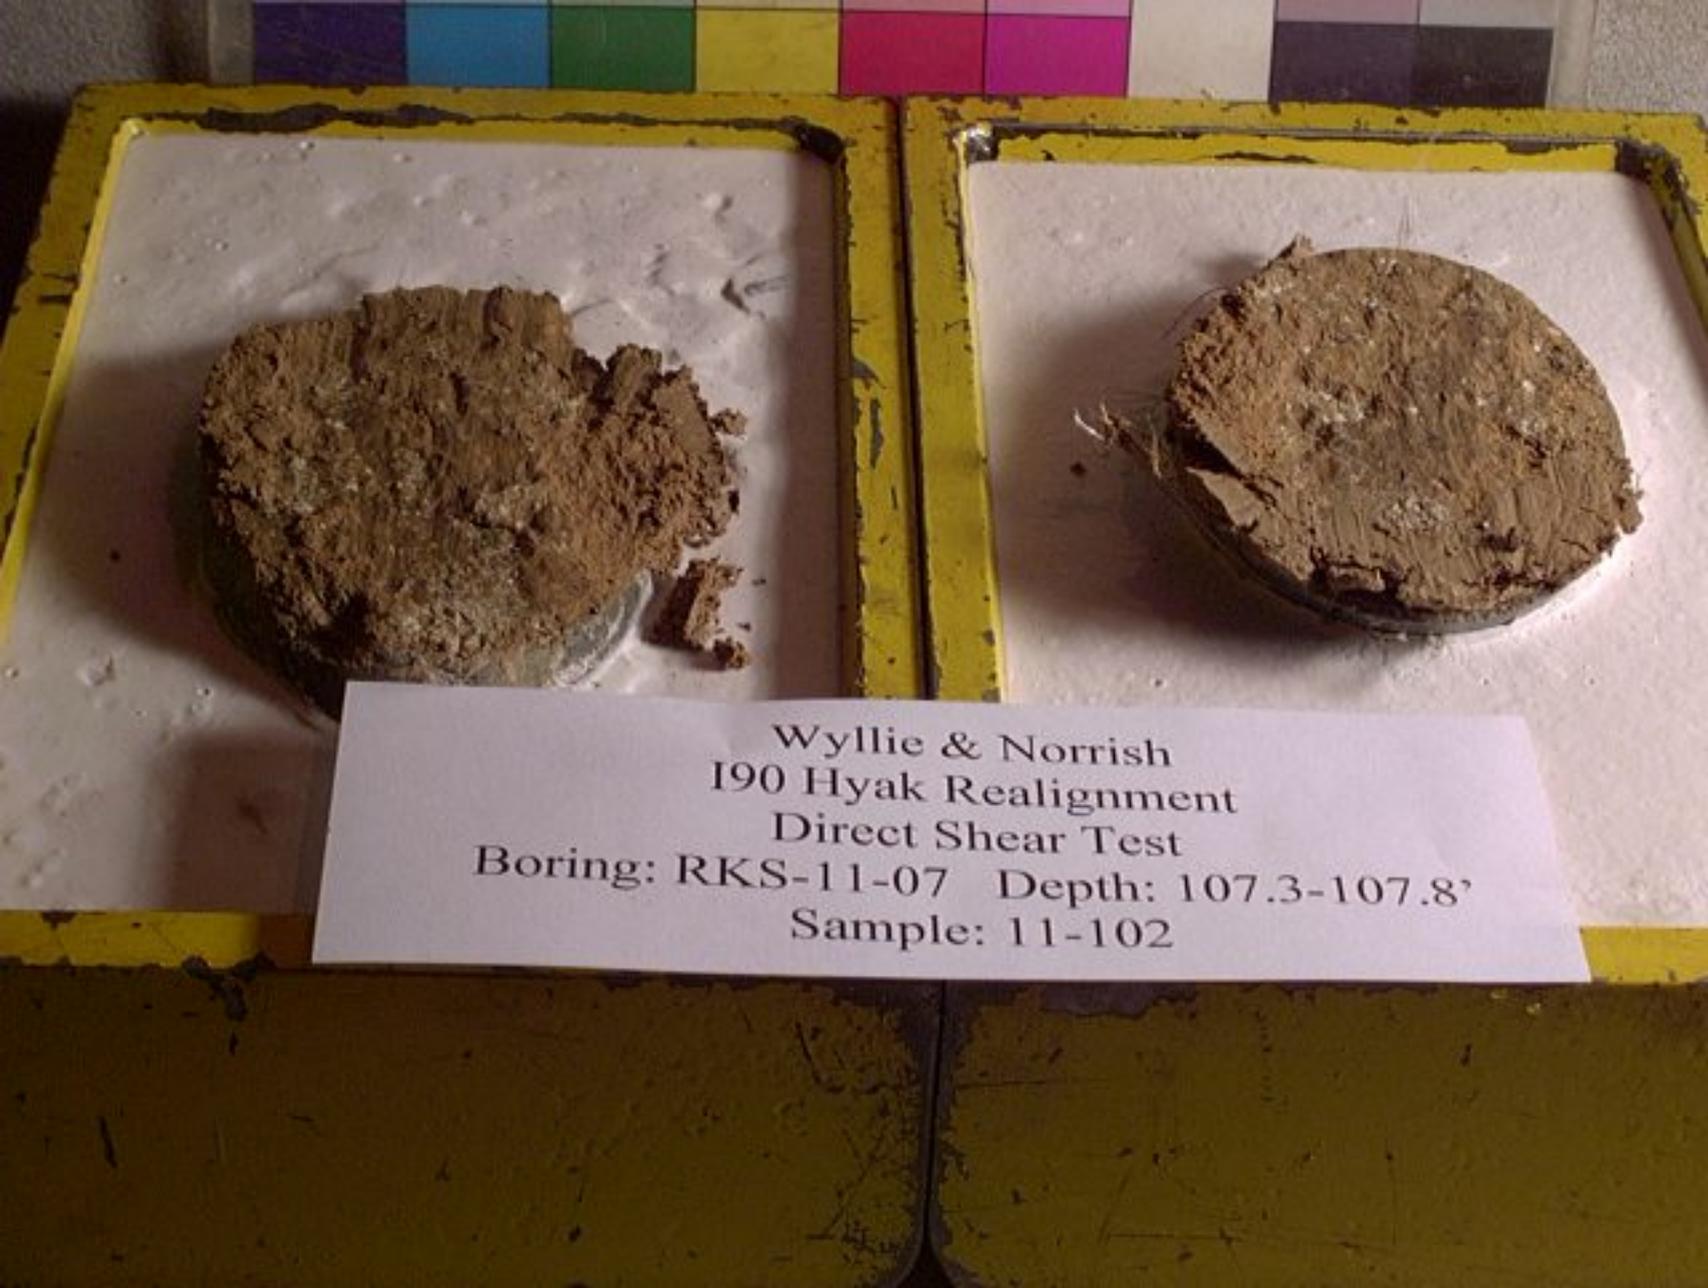
The image shows two yellow trays containing soil samples. The left tray contains a soil sample that has been partially broken apart, with some loose soil visible. The right tray contains a soil sample that is still in a single, roughly circular piece. Both samples are a light brown color and appear to be fine-grained soil. A white label is placed in front of the trays, providing details about the samples and the test.

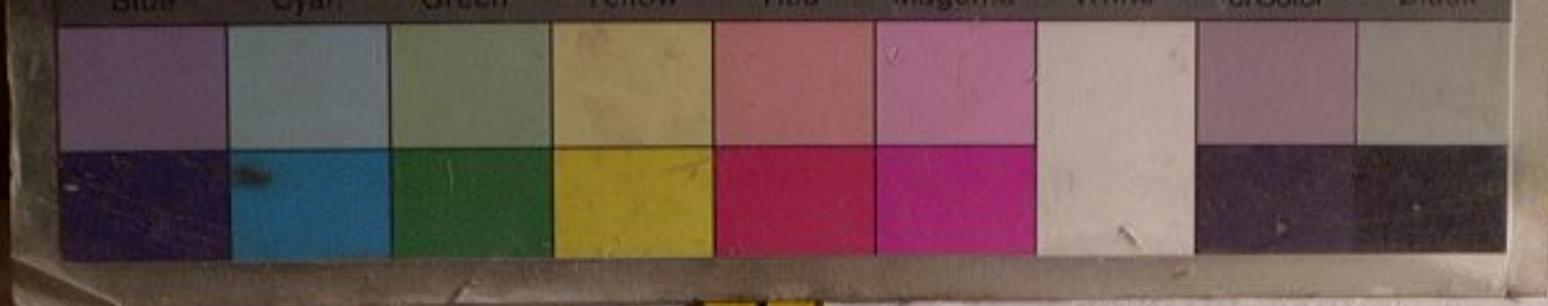
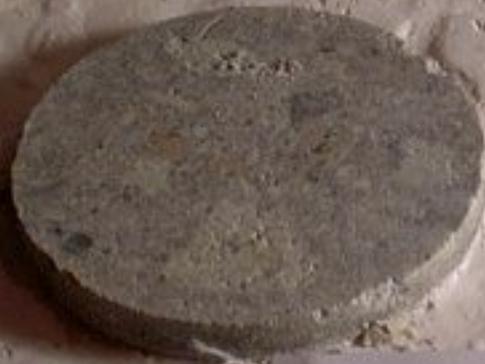
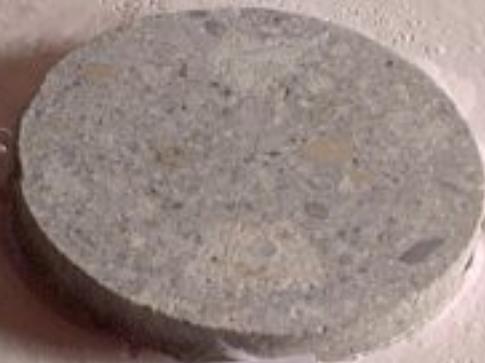
Wyllie & Norrish  
East I-90 Hyak Realignment  
Direct Shear Test  
Boring: RKS-19-07 Depth: 56.3-57.0'  
Sample: 103B

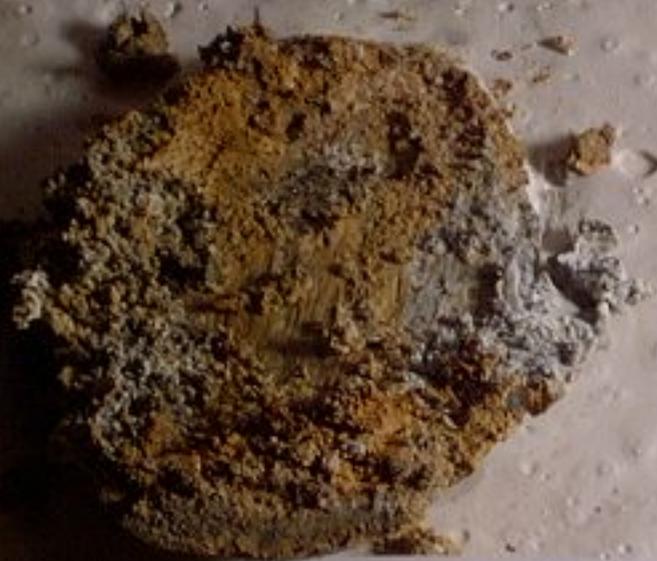
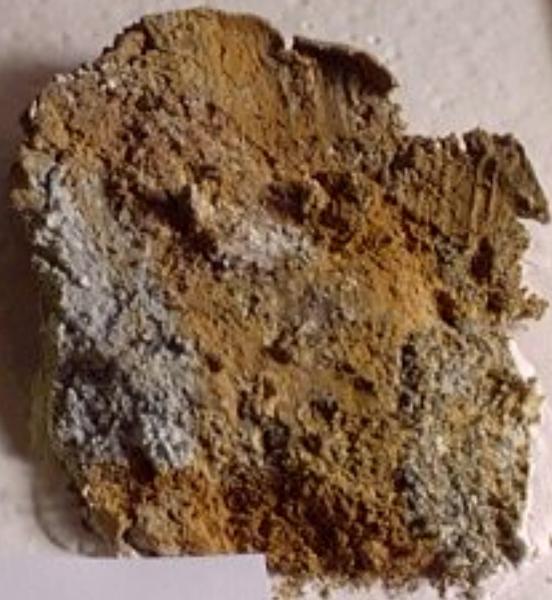
Wyllie & Norrish  
East I-90 Hyak Realignment  
Direct Shear Test  
Boring: RKS-19-07 Depth: 33.0-33.7'  
Sample: 101

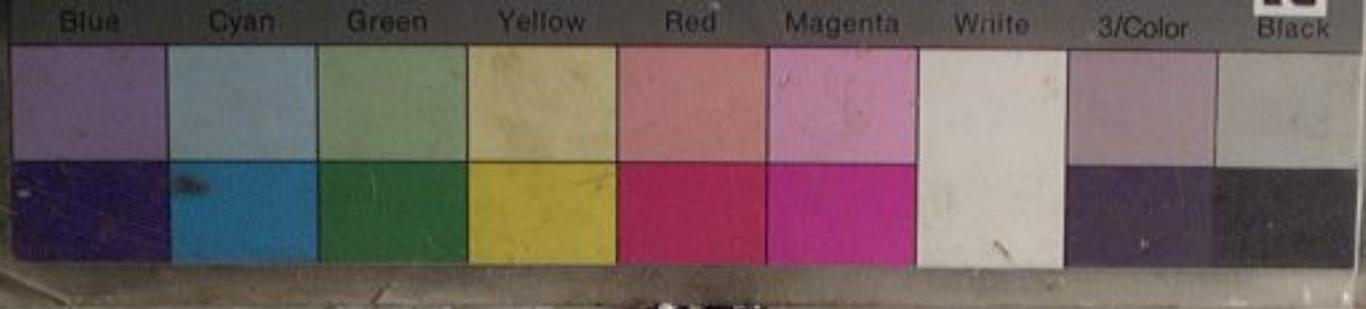
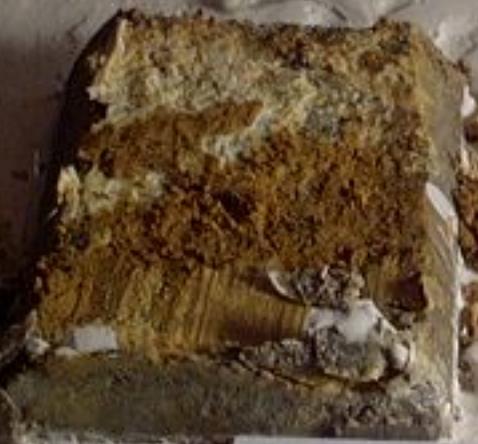
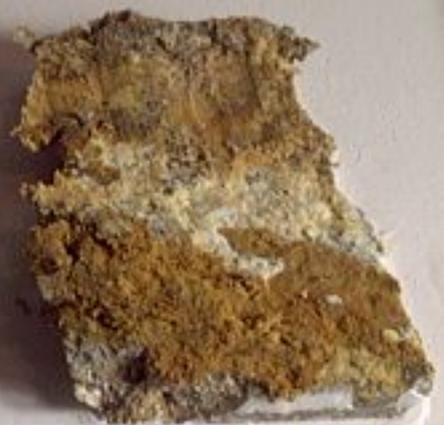
Wyllie & Norrish  
East I-90 Hyak Realignment  
Direct Shear Test  
Boring: RKS-13-07 Depth: 39.0-39.5'  
Sample: 103

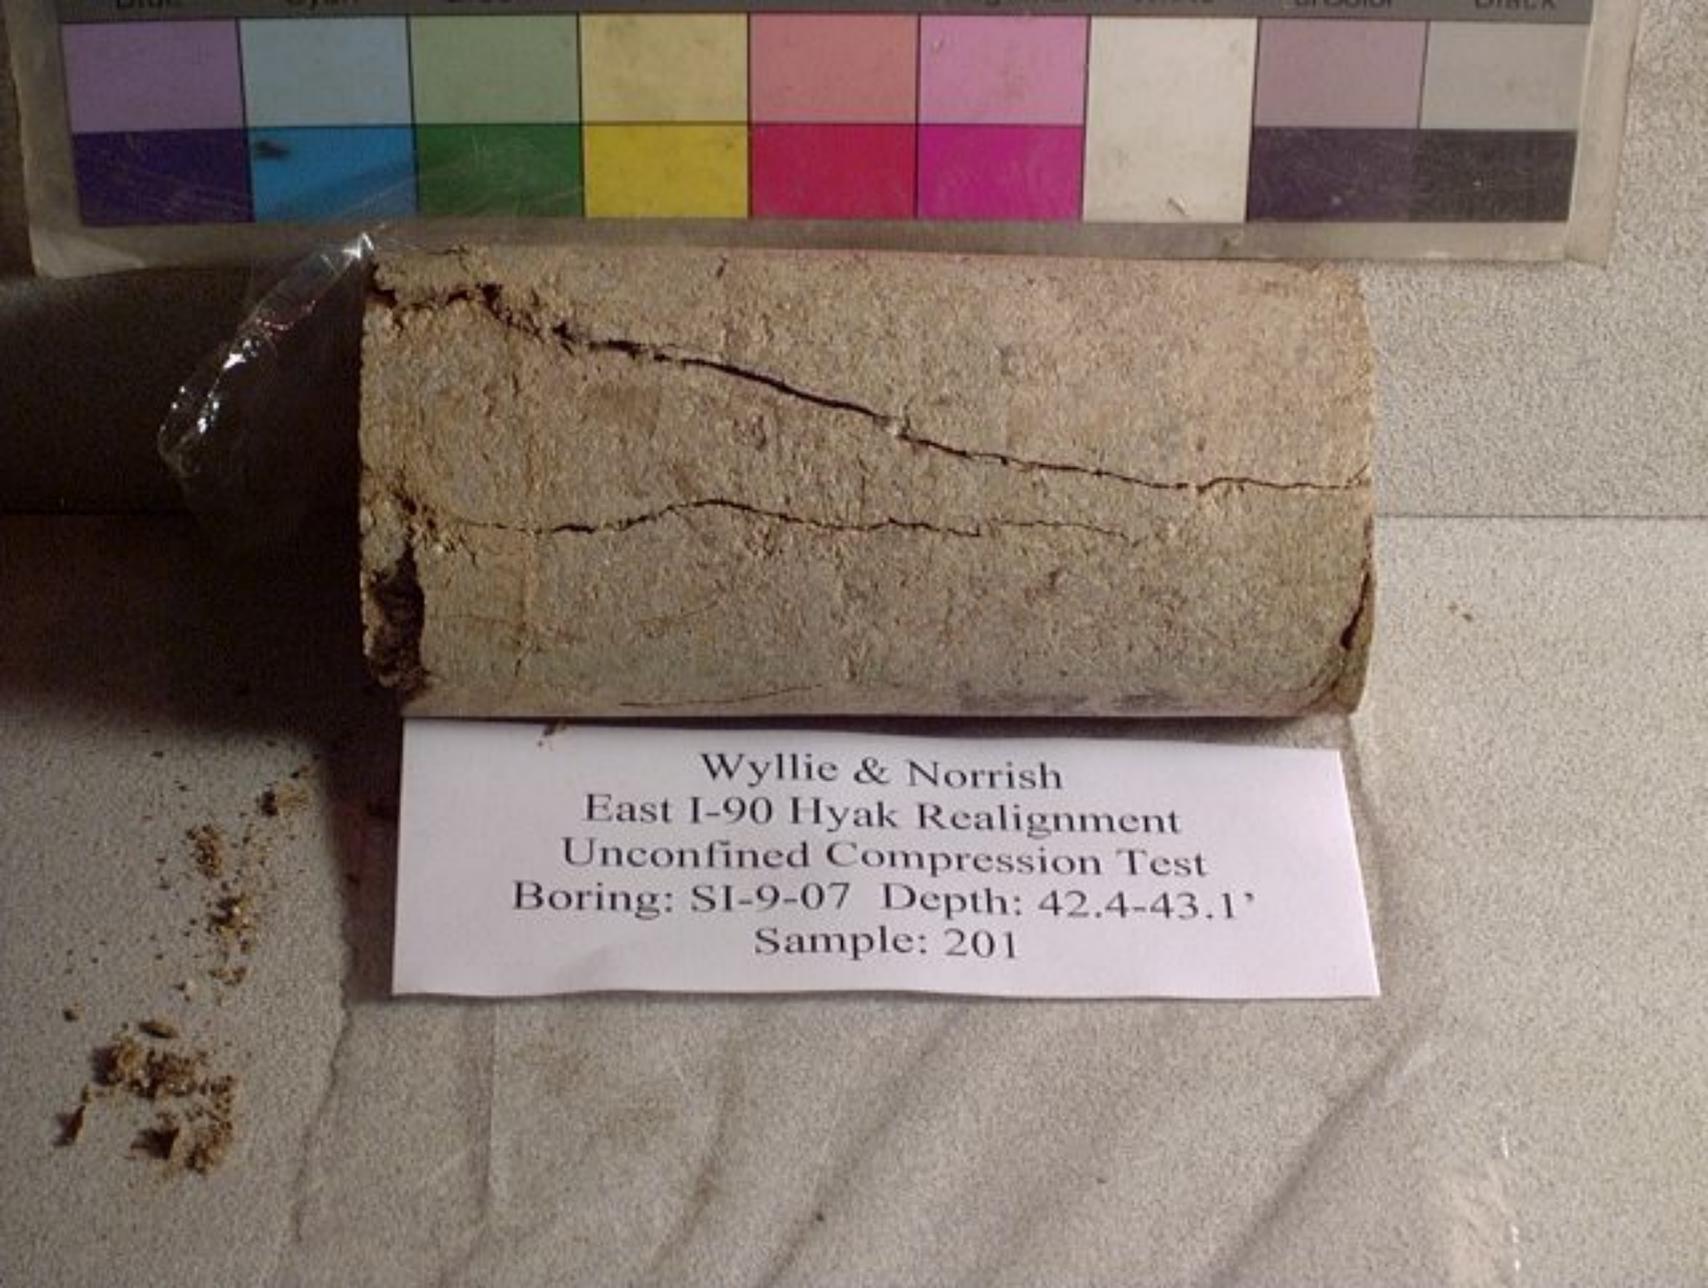
Wyllie & Norrish  
East I-90 Hyak Realignment  
Unconfined Compression Test  
Boring: SI-9-07 Depth: 42.4-43.1'  
Sample: 201

<p><b>Sample: 201</b>  <b>Boring: SI-9-07</b>  <b>Depth: 42.4-43.1'</b></p> <p style="text-align: center;"><b>DESCRIPTION</b></p> <p style="text-align: center;">Medium brown meta welded lapilli tuff, somewhat friable with several oxide stained joints.</p> <p><b>Density: 158.9 pcf</b>  <b>Strength: 3348 psi</b></p>	<div style="text-align: center;">

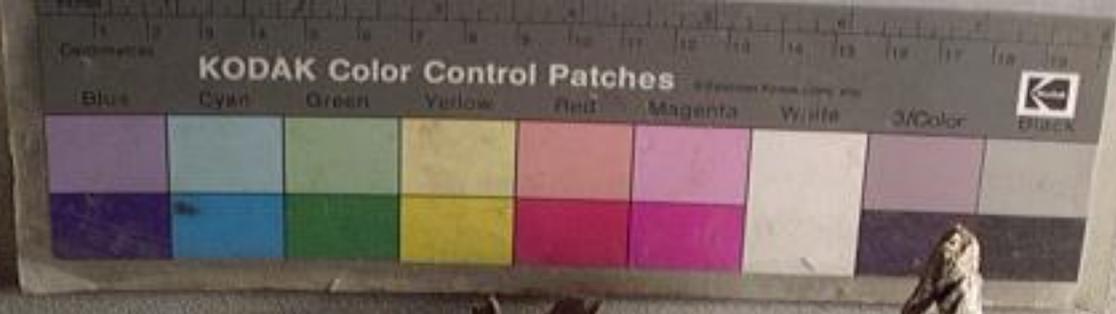
Wyllie & Norrish  
East I-90 Hyak Realignment  
Unconfined Compression Test  
Boring: SI-7-07 Depth: 36.9-37.4'  
Sample: 101B

<p><b>Sample: 101B</b>  <b>Boring: SI-7-07</b>  <b>Depth: 36.9-37.4'</b></p> <p style="text-align: center;"><b>DESCRIPTION</b></p> <p style="text-align: center;">Medium gray meta welded lapilli tuff, with slight oxide staining, but no apparent planes of weakness.</p> <p><b>Density: 163.5 pcf</b>  <b>Strength: 26,444 psi</b></p>	<div style="text-align: center;">

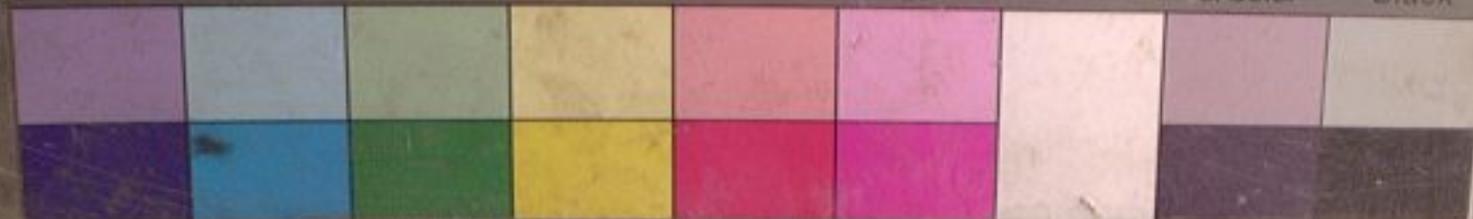
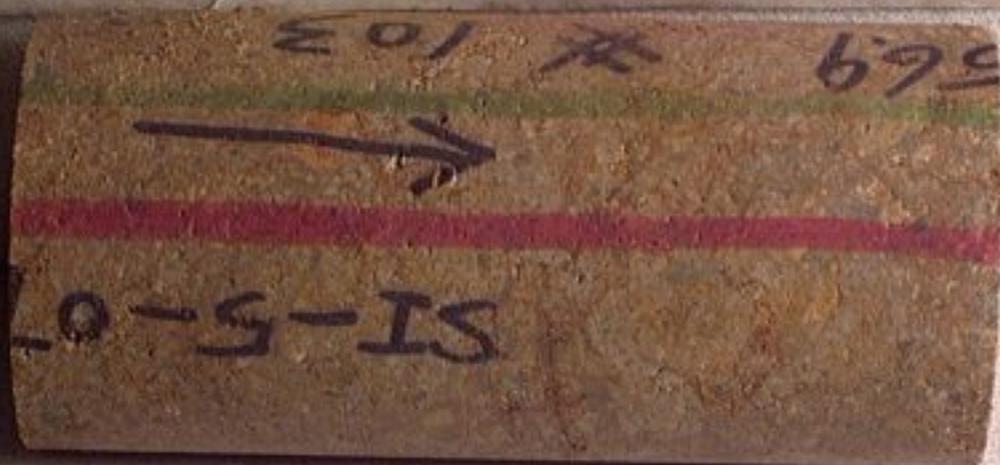
Wyllie & Norrish  
East I-90 Hyak Realignment  
Unconfined Compression Test  
Boring: SI-5-07 Depth: 56.9-57.6'  
Sample: 103

<p><b>Sample: 103</b>  <b>Boring: SI-5-07</b>  <b>Depth: 56.9-57.6'</b></p> <p style="text-align: center;"><b>DESCRIPTION</b></p> <p style="text-align: center;">Medium brown meta welded lapilli tuff,  slightly altered with two minor oxide stained  non-through-going joints.</p> <p><b>Density: 158.6 pcf</b>  <b>Strength: 3782 psi</b></p>	<div style="text-align: center;">

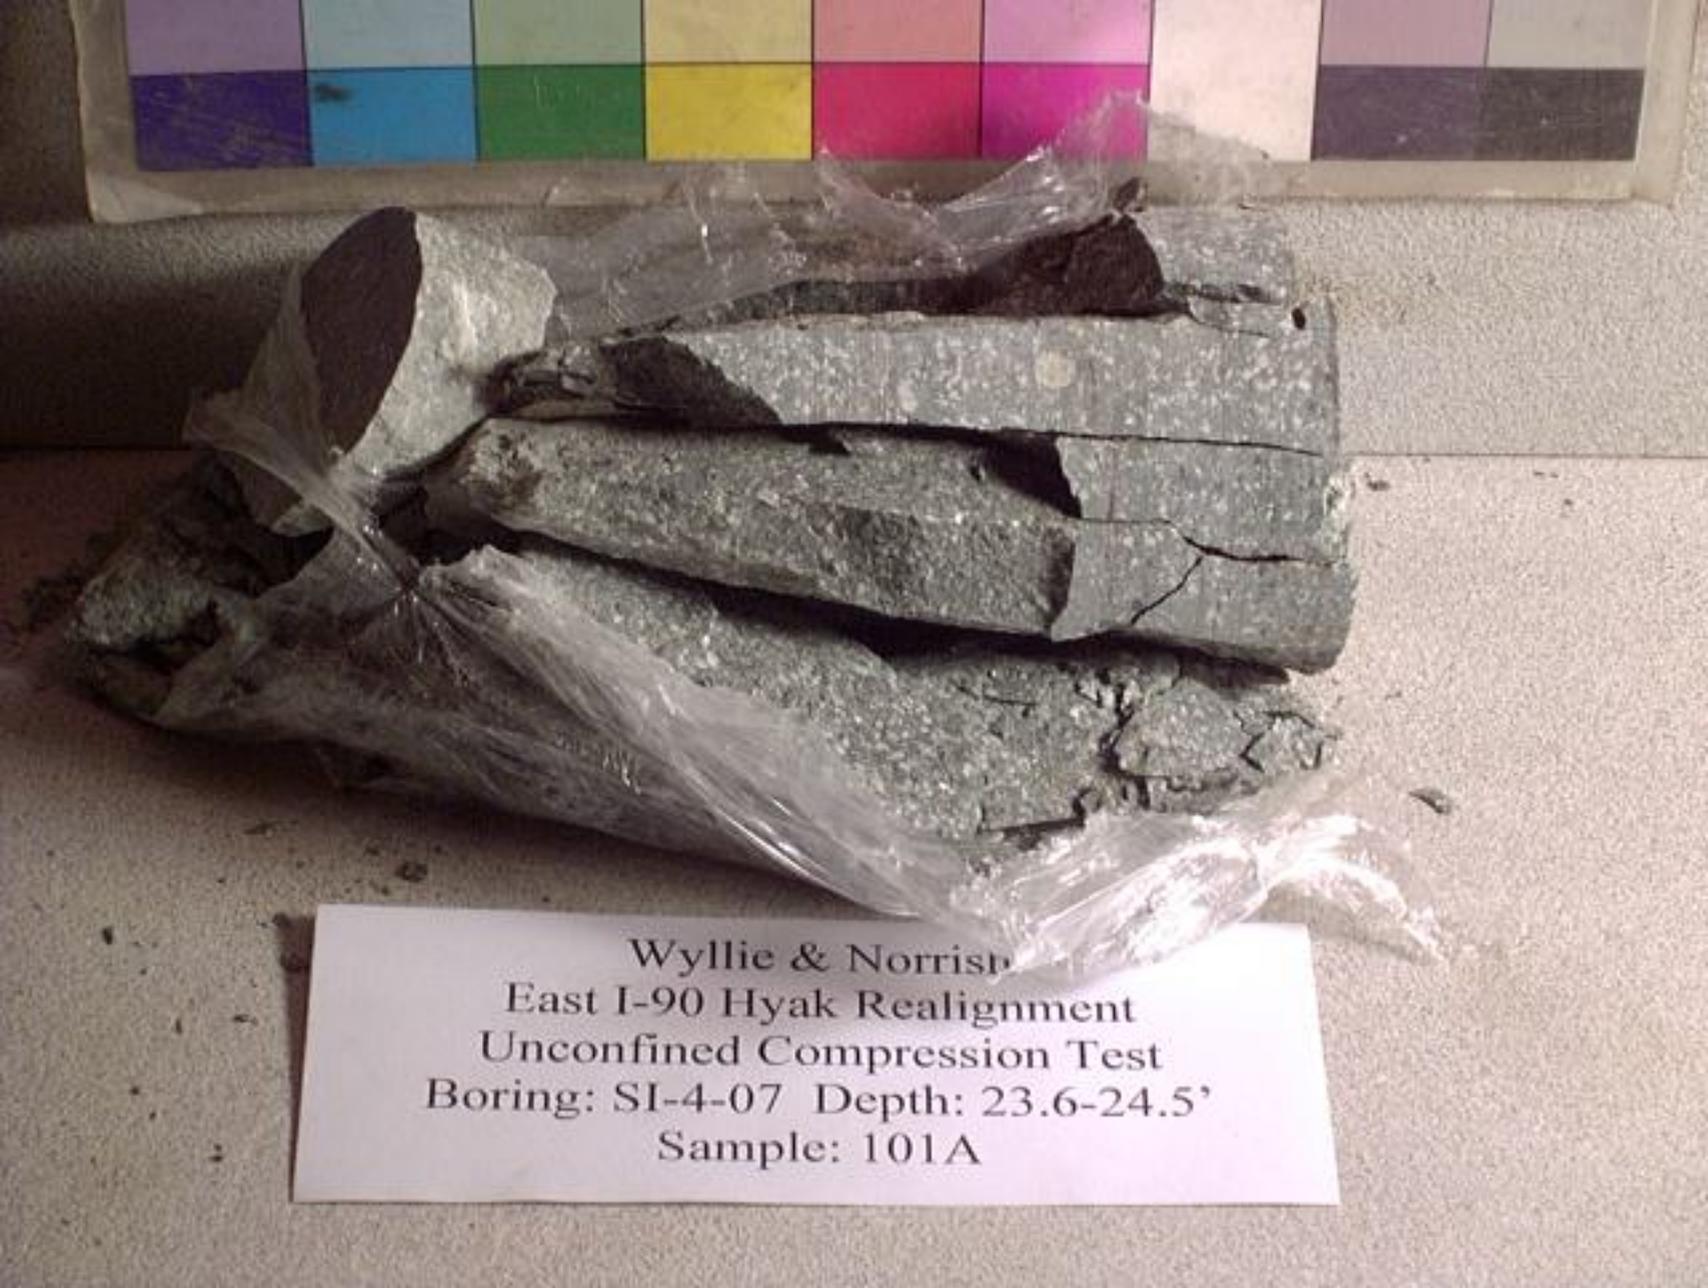
Wyllie & Norrish  
East I-90 Hyak Realignment  
Unconfined Compression Test  
Boring: SI-4-07 Depth: 23.6-24.5'  
Sample: 101A

<p><b>Sample: 101A</b>  <b>Boring: SI-4-07</b>  <b>Depth: 23.6-24.5'</b></p> <p style="text-align: center;"><b>DESCRIPTION</b></p> <p style="text-align: center;">Medium blue gray meta welded lapilli tuff, with a glued fracture at one end.</p> <p><b>Density: 162.9 pcf</b>  <b>Strength: 23,469 psi</b></p>	<div style="text-align: center;">

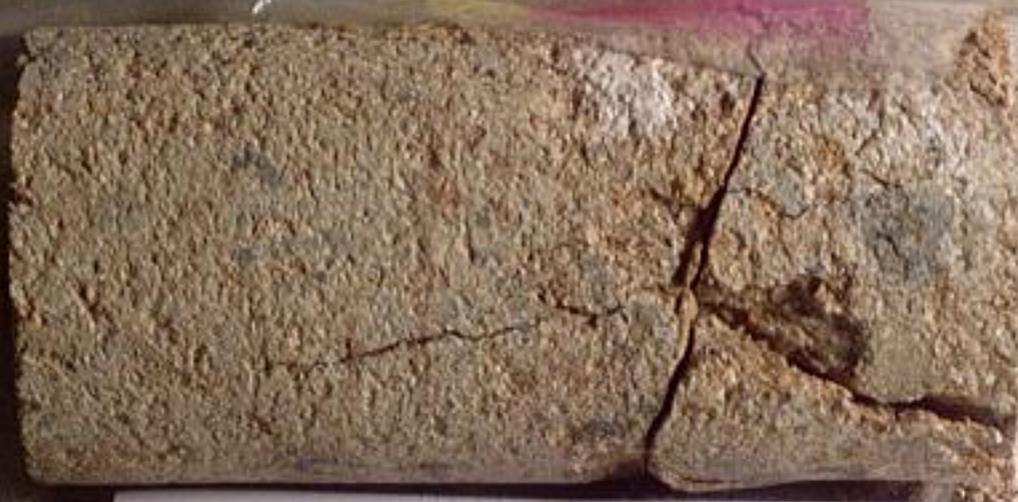
Wyllie & Norrish  
East I-90 Hyak Realignment  
Unconfined Compression Test  
Boring: SI-1-07 Depth: 32.0-32.7'  
Sample: 101

<p><b>Sample: 101</b>  <b>Boring: SI-1-07</b>  <b>Depth: 32.0-32.7'</b></p> <p style="text-align: center;"><b>DESCRIPTION</b></p> <p style="text-align: center;">Medium brown meta welded lapilli tuff,  altered and friable with an open  oxide coated fracture.</p> <p><b>Density: 155.1 pcf</b>  <b>Strength: 4680 psi</b></p>	<div style="text-align: center;">

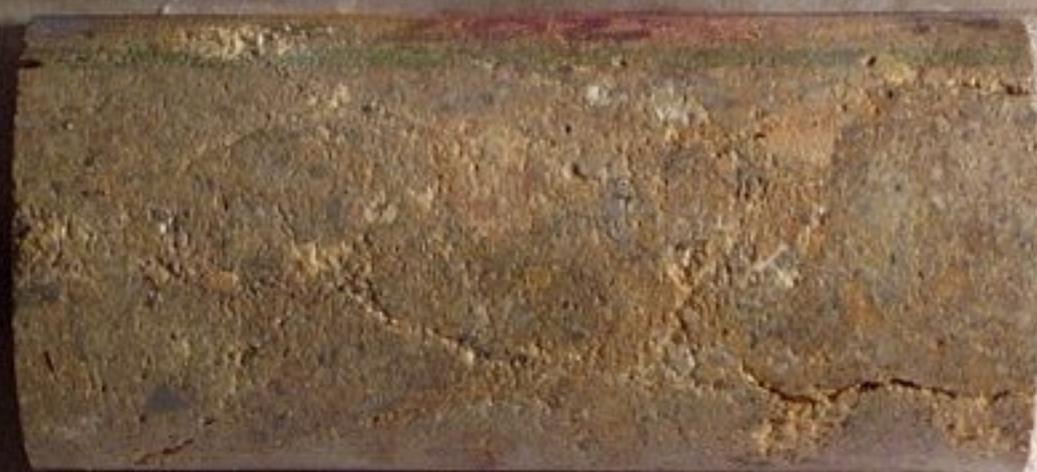
Wyllie & Norrish  
East I-90 Hyak Realignment  
Unconfined Compression Test  
Boring: RKS-28-07 Depth: 27.8-28.5'  
Sample: 202

<p><b>Sample: 202</b>  <b>Boring: RKS-28-07</b>  <b>Depth: 27.8-28.5'</b></p> <p style="text-align: center;"><b>DESCRIPTION</b></p> <p style="text-align: center;">Medium brown meta welded lapilli tuff, with two major axial fractures.</p> <p><b>Density: 156.2 pcf</b>  <b>Strength: 1970 psi</b></p>	<div style="text-align: center;">

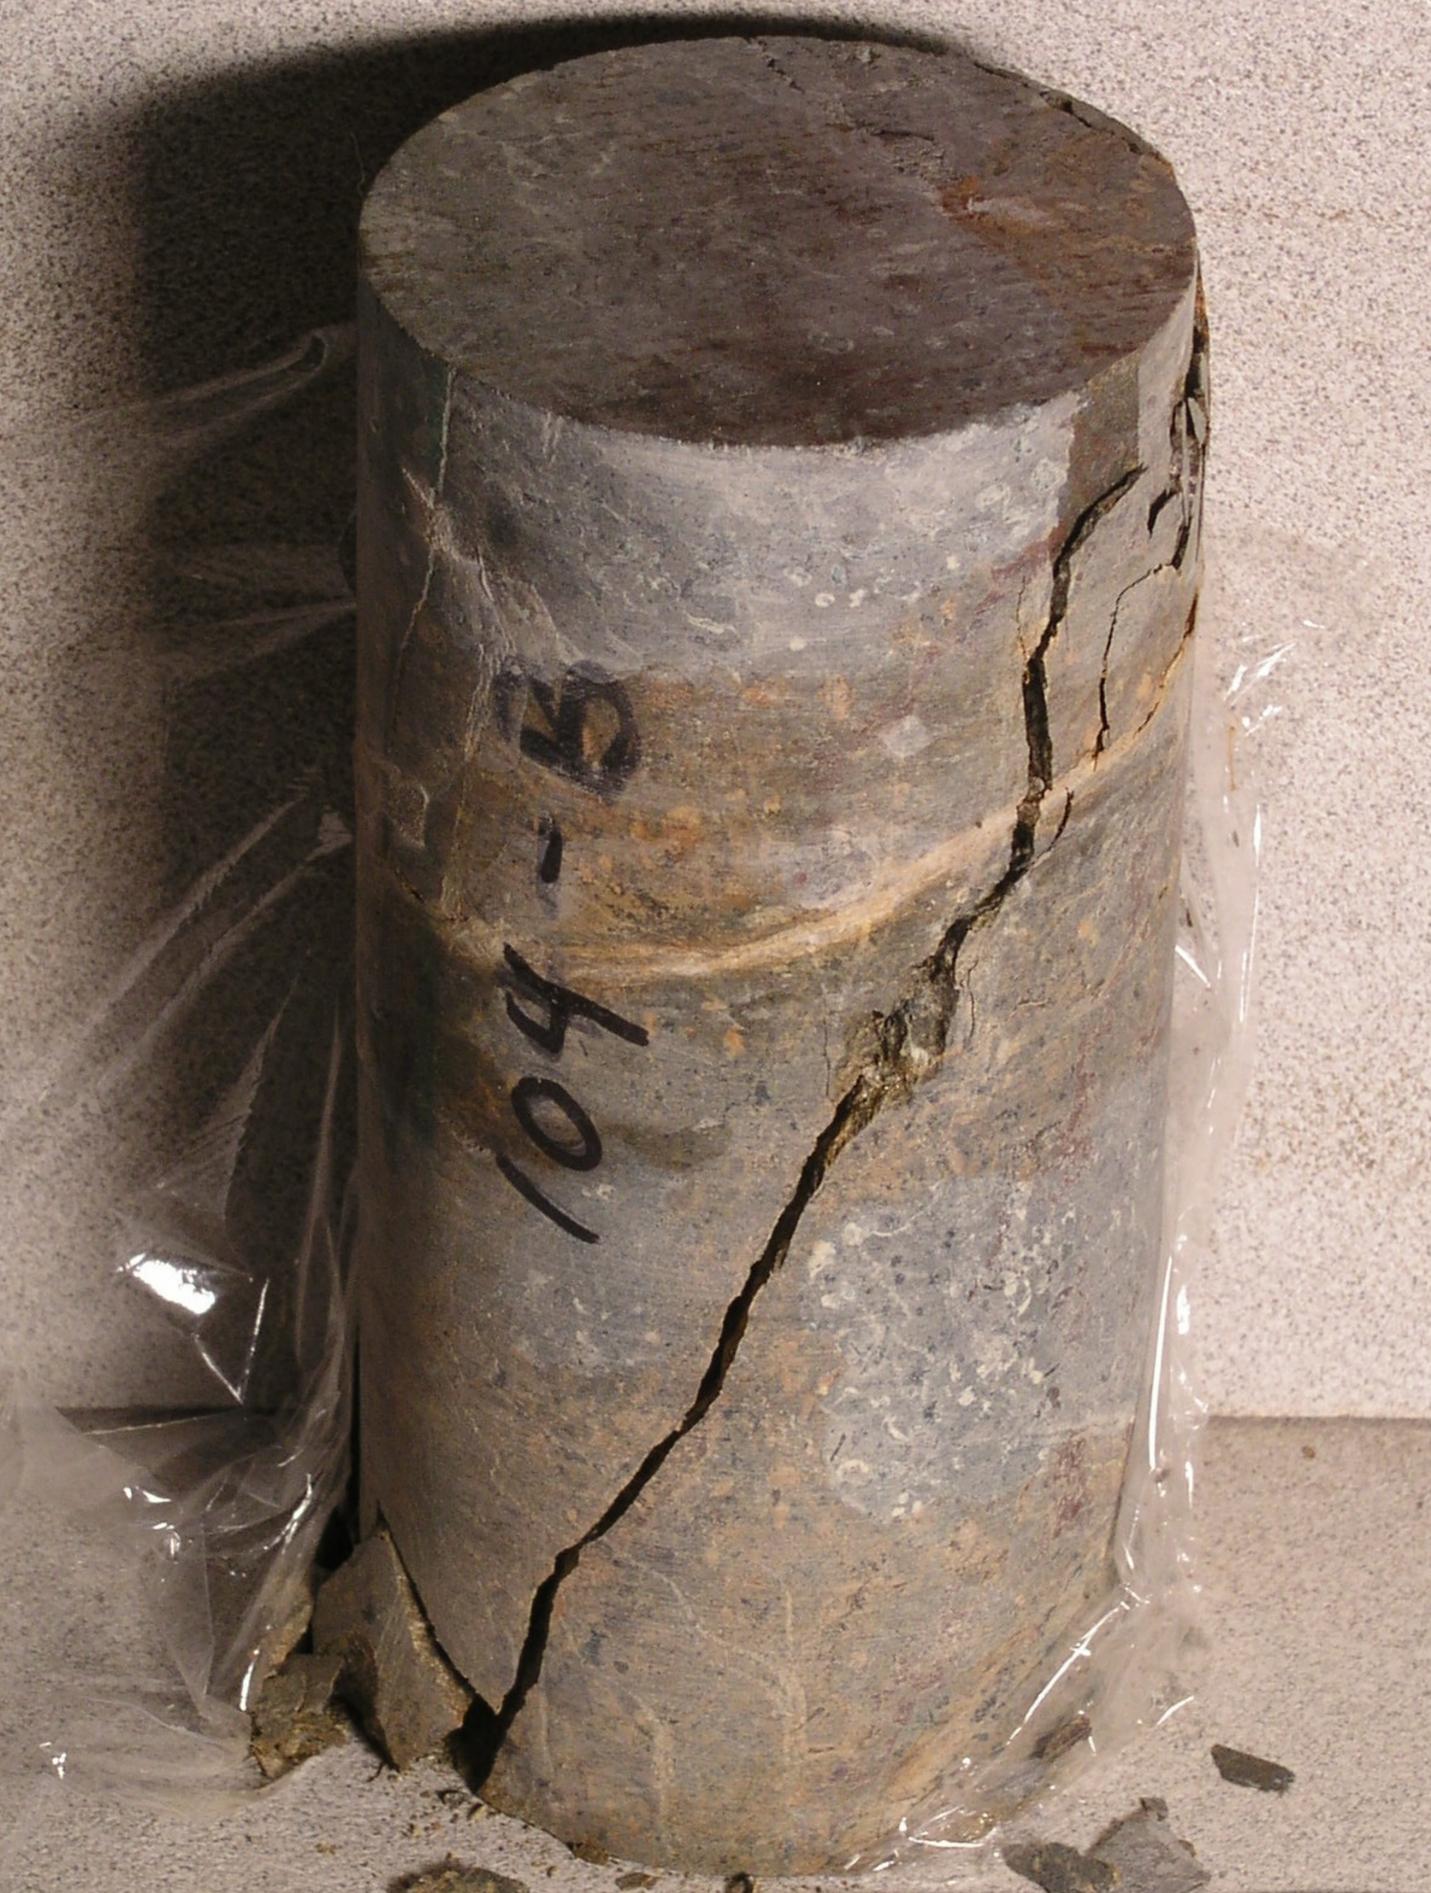
Wyllie & Norrish Rock Engineers  
East I-90 Hyak Realignment  
Unconfined Compression Test  
Boring: RKS-33-08 Depth: 64.5-65.1'  
Sample: 104-A

A cylindrical rock sample is shown, oriented vertically. The rock has a dark, weathered appearance with a prominent vertical crack running down its length. Handwritten in black ink on the side of the rock are the markings "104-A". The sample is placed on a light-colored, textured surface and is partially wrapped in clear plastic. A white label with black text is positioned below the rock sample.

A few of the unconfined compression samples with joints were "repaired" with cyanoacrylate glue. Sample 104A from Boring RKS-33-08 contained a joint that dipped at a shallow angle. This joint was still intact, but it was reinforced with glue so that it could be cut and ground without damaging the samples. The shallow dip of this joint made this a good candidate for "repair" in that any failure would pass diagonally across the glued joint and thus the glued joint would not be involved in the sample failure. On the other hand, Sample #102 from Boring RKS-46-08 was not a good candidate for joint gluing as this joint was so steeply inclined. The weak joint was intact, but it was clearly quite weak and wicked up the glue. In this case the sample failed along the pre-existing joint making this an invalid test. I had my doubts about the validity of gluing this sample, but I thought it would be interesting to verify my doubts, and so I performed the test. The strength would have been significantly lower had the joint not been glued.

<p><b>Sample: 104A</b> <b>Boring: RKS-33-08</b> <b>Depth: 64.5-65.1'</b></p> <p style="text-align: center;"><b>DESCRIPTION</b></p> <p>Dark greenish gray somewhat altered meta-basalt with clacite filled fractures. One cross joint was open and weak and "repaired" with cyanoacrylate glue. Failure did not involve the glued joint.</p> <p><b>Density: 172.0 pcf</b> <b>Strength: 6925 psi</b></p>	<div style="text-align: center;">
