APPENDIX H  
LABORATORY REPORTS

Strength Testing Reports  
Corrosion Testing Reports  
Atterberg Limits Testing Reports  
Petrographic Analysis Reports

# Strength and Direct Shear Testing Results

**Rock Testing  
WDOT - I90 Hyak Extension**

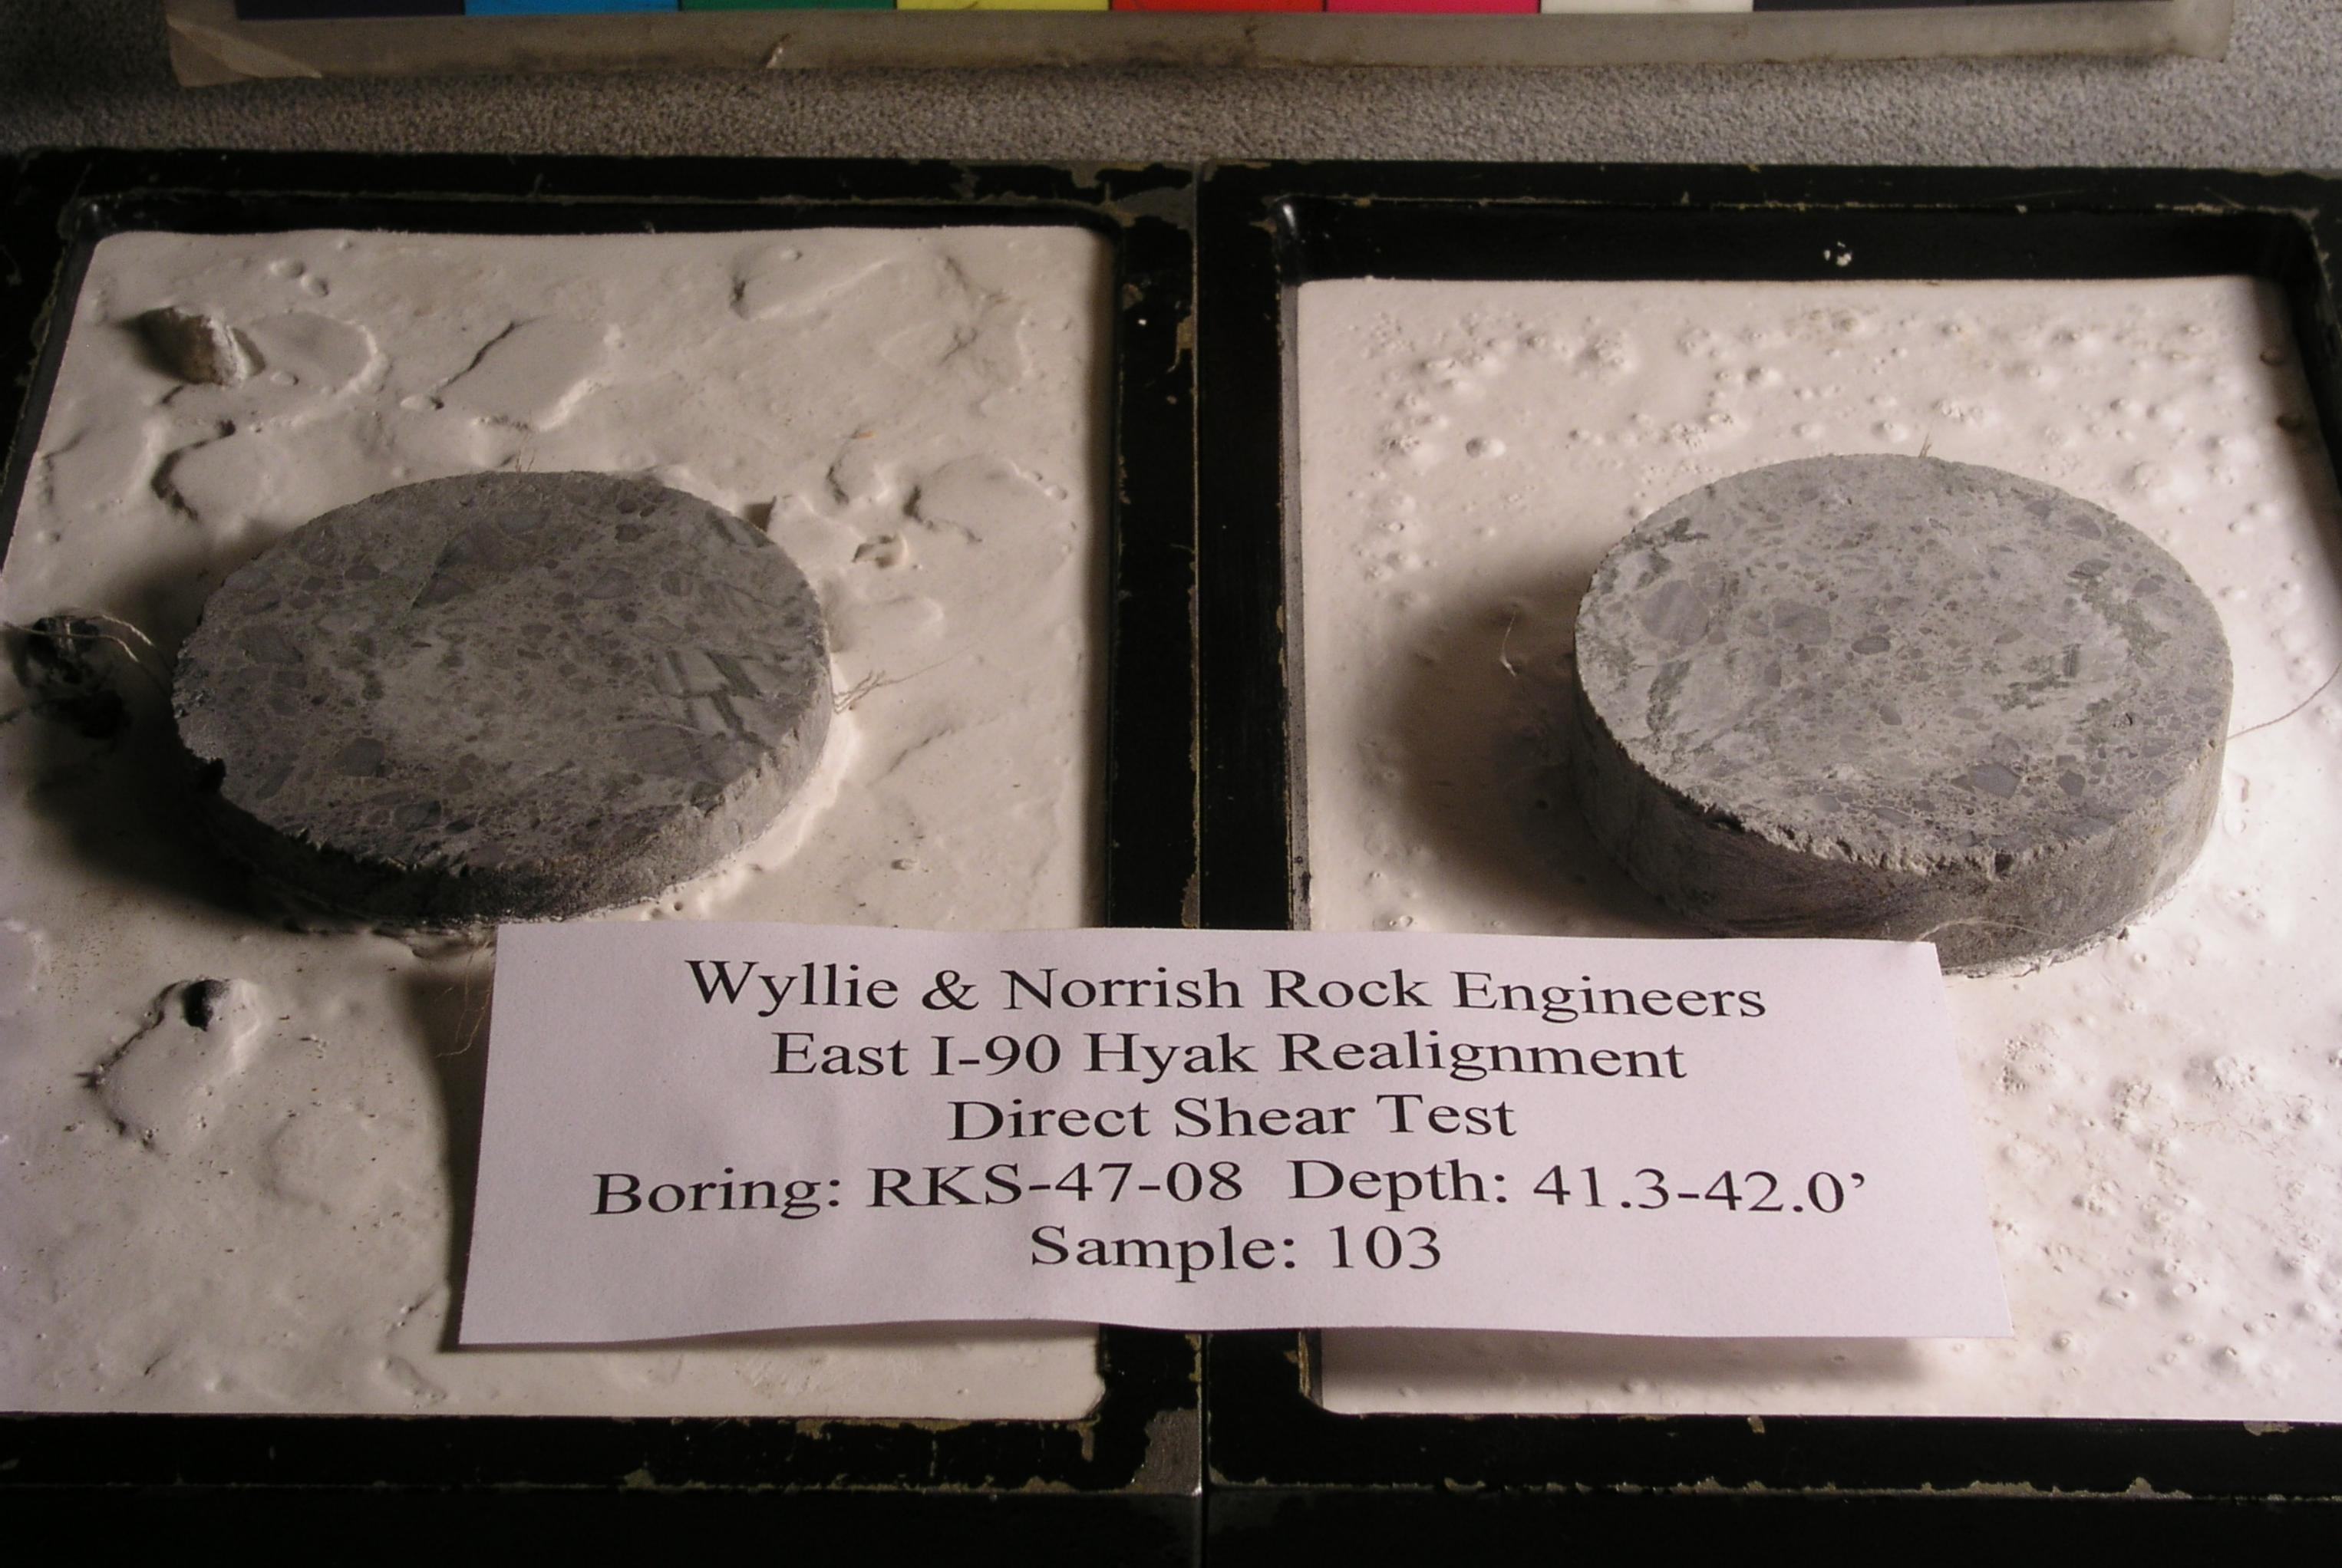
Wyllie & Norrish Rock Engineers  
East I-90 Hyak Realignment  
Direct Shear Test  
Boring: RKS-47-08 Depth: 41.3-42.0'  
Sample: 103

The image shows two cylindrical rock samples, one on the left and one on the right, positioned in a direct shear test apparatus. The samples are dark grey and appear to be made of a dense, crystalline material. They are resting on a light-colored, textured surface. The apparatus consists of two black rectangular frames, one on the left and one on the right, which hold the samples in place. The samples are oriented vertically, with their flat ends facing each other. The background is a light-colored, textured surface, possibly a laboratory bench or a specialized testing environment. A white paper label is placed in the center of the image, providing details about the test and the samples.

It should be noted that, as with all saw-cut and ground samples that I have tested, the interfaces exhibited a marked stick-slip behavior. The slip-action was accompanied by an audible “chunk” sound and was a decidedly dynamic event. As such, the stick-slip minima are a consequence of the dynamic overshoot of the slip event. The static friction angles are represented by the stick-slip peaks (used in this report to evaluate the failure envelopes) and the mid-points of the slip events likely represent the dynamic friction angles for this interface.

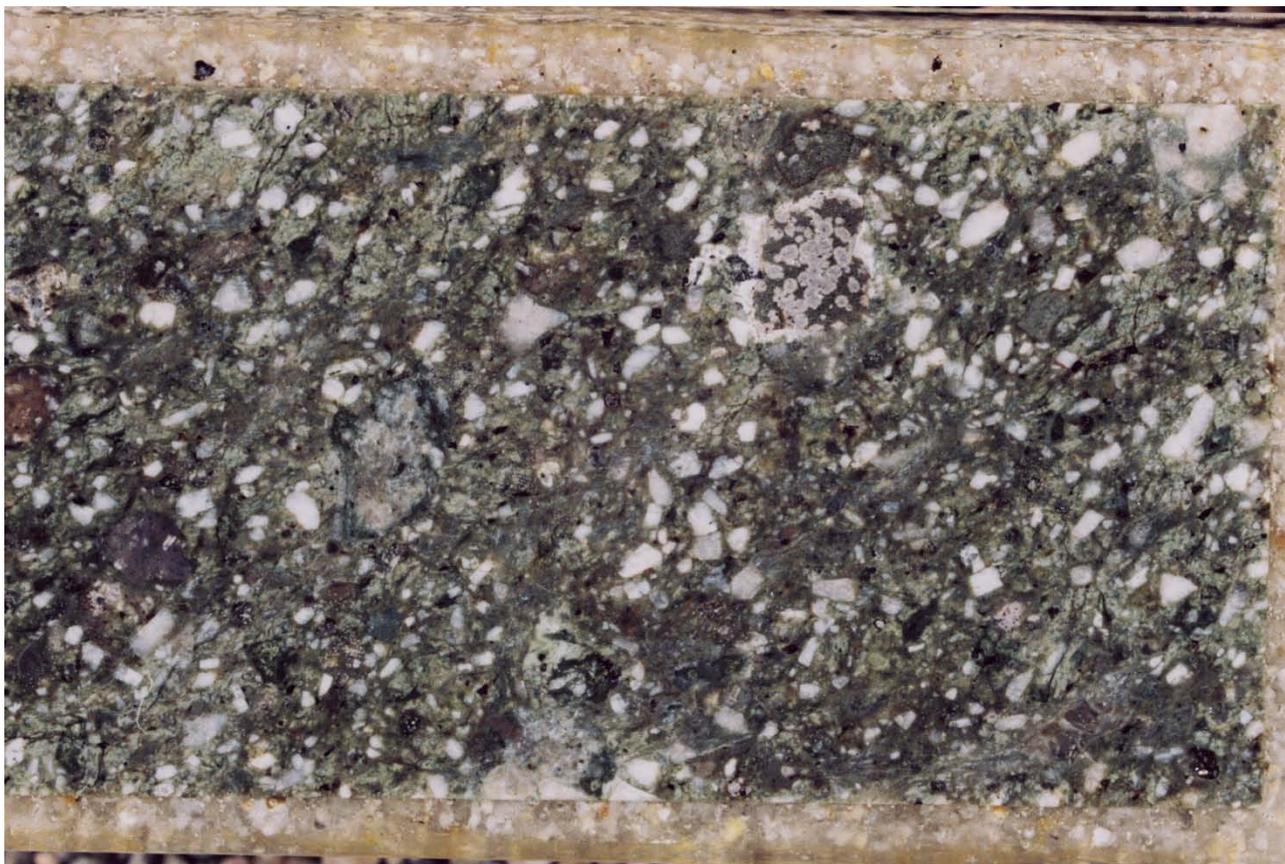
RKS-09-07#202 07041/21/DAY/3X/ULC ALTERED DACITE ASH-FLOW TUFF showing typical appearance of hand specimen.

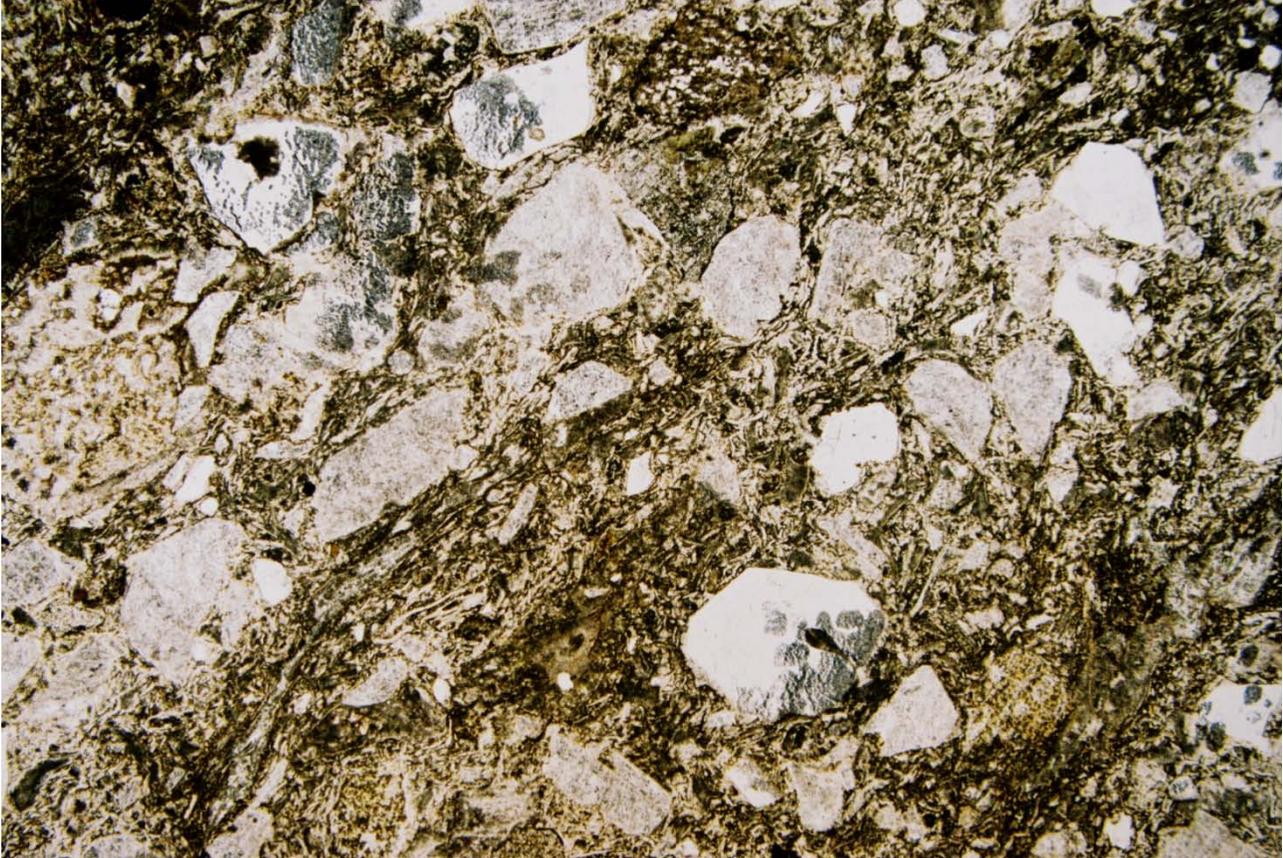
RKS-09-07#202 07052/19/PPL/28X/ULC ALTERED DACITE ASH-FLOW TUFF showing typical appearance of phenocrysts and lithic fragments in a groundmass of weakly welded devitrified glass shards.

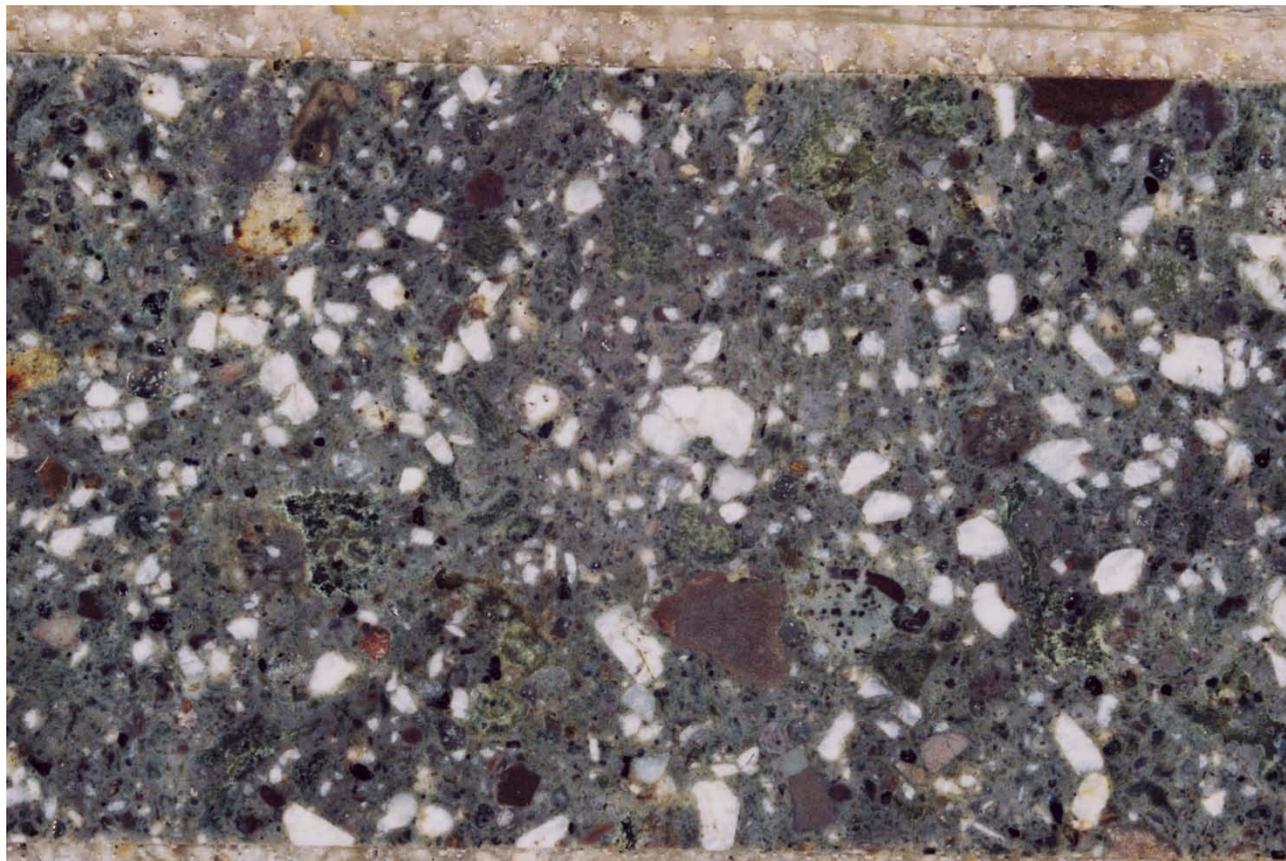
RKS-12-07#201 07052/20/PPL/28X/ULC ALTERED DACITE ASH-FLOW TUFF showing typical appearance of phenocrysts and lithic fragments in a groundmass of weakly welded devitrified glass shards.

<b>SAMPLE #</b>	<b>RKS-12-07 #201</b>
<b>ROCK NAME</b>	ALTERED DACITE ASH-FLOW TUFF -- probably formed by devitrification and alteration (secondary quartz + clay + opaques + chlorite + epidote) of a welded dacite ash-flow tuff protolith.
<b>MINERALS</b>	Plagioclase (41%) + cryptocrystalline devitrified K-glass (35%) + quartz (25%) + clay (5%) + opaques (2%) + chlorite (1%) + epidote (1%).
<b>TEXTURES</b>	<p>Pyroclastic, devitrified hypocrySTALLINE. Weak welding has produced a weakly directed fabric.</p> <p><u>Framework Components (50%)</u> are 1.0-4.2 mm, angular to subangular. Contacts between framework components are floating to tangential.</p> <p><b>Phenocryst Fragments (30%)</b> are composed of subhedral to euhedral, whole to broken, isolated [plagioclase (20%) + quartz (10%)].</p> <p><b>Lithic Fragments (17%)</b> are composed of basalt and dacite vitrophyre.</p> <p><b>Pumice Fragments (3%)</b> are porphyritic dacite.</p> <p><u>Matrix/Cement (50%)</u> is composed of weakly welded devitrified K-glass moderately devitrified to quartz.</p>

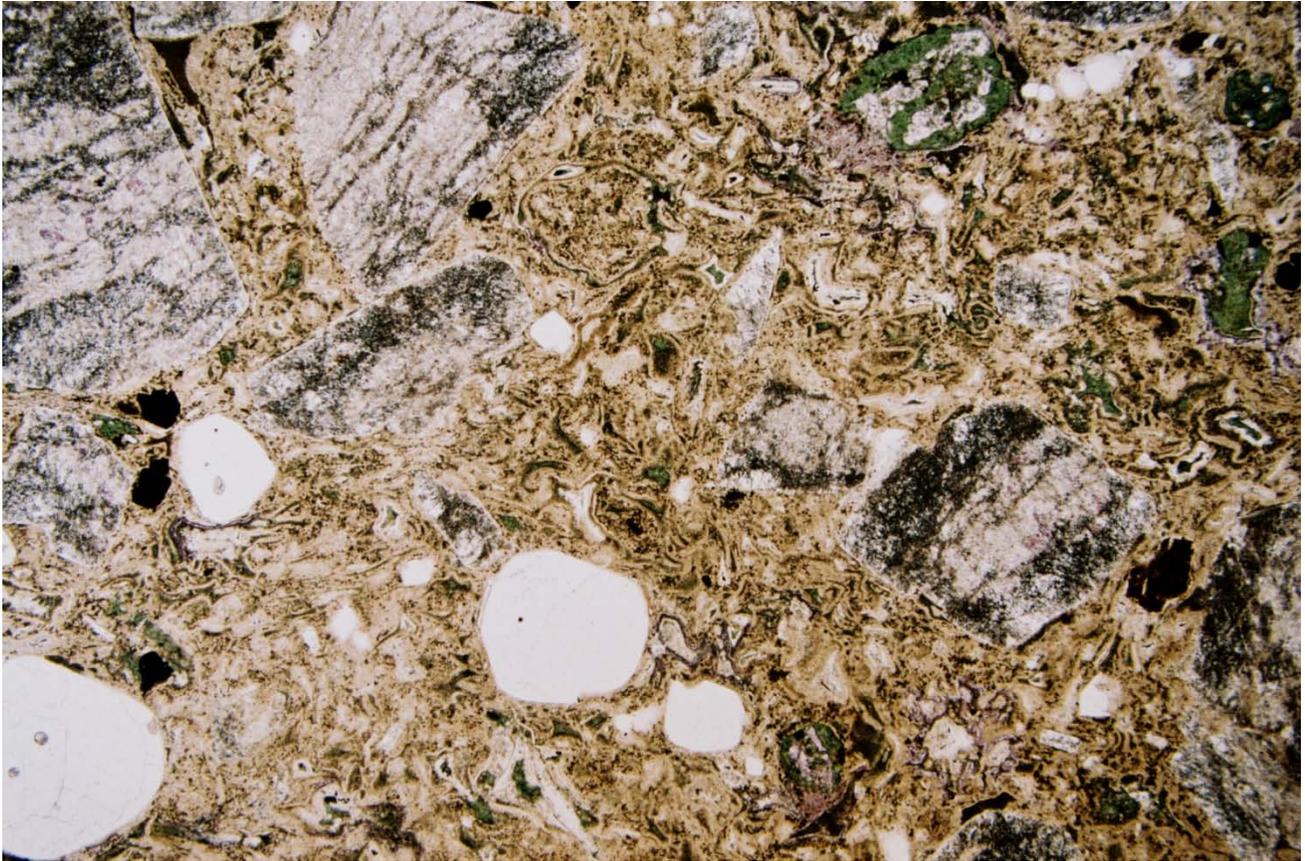
RKS-12-07#202 07052/21/PPL/28X/ULC ALTERED DACITE ASH-FLOW TUFF showing typical appearance of phenocrysts and lithic fragments in a groundmass of weakly welded devitrified glass shards.

**ROCK NAME** ALTERED DACITE ASH-FLOW TUFF -- probably formed by devitrification and alteration (secondary quartz + clay + ferroan calcite + opaques + chlorite) of a welded dacite ash-flow tuff protolith.

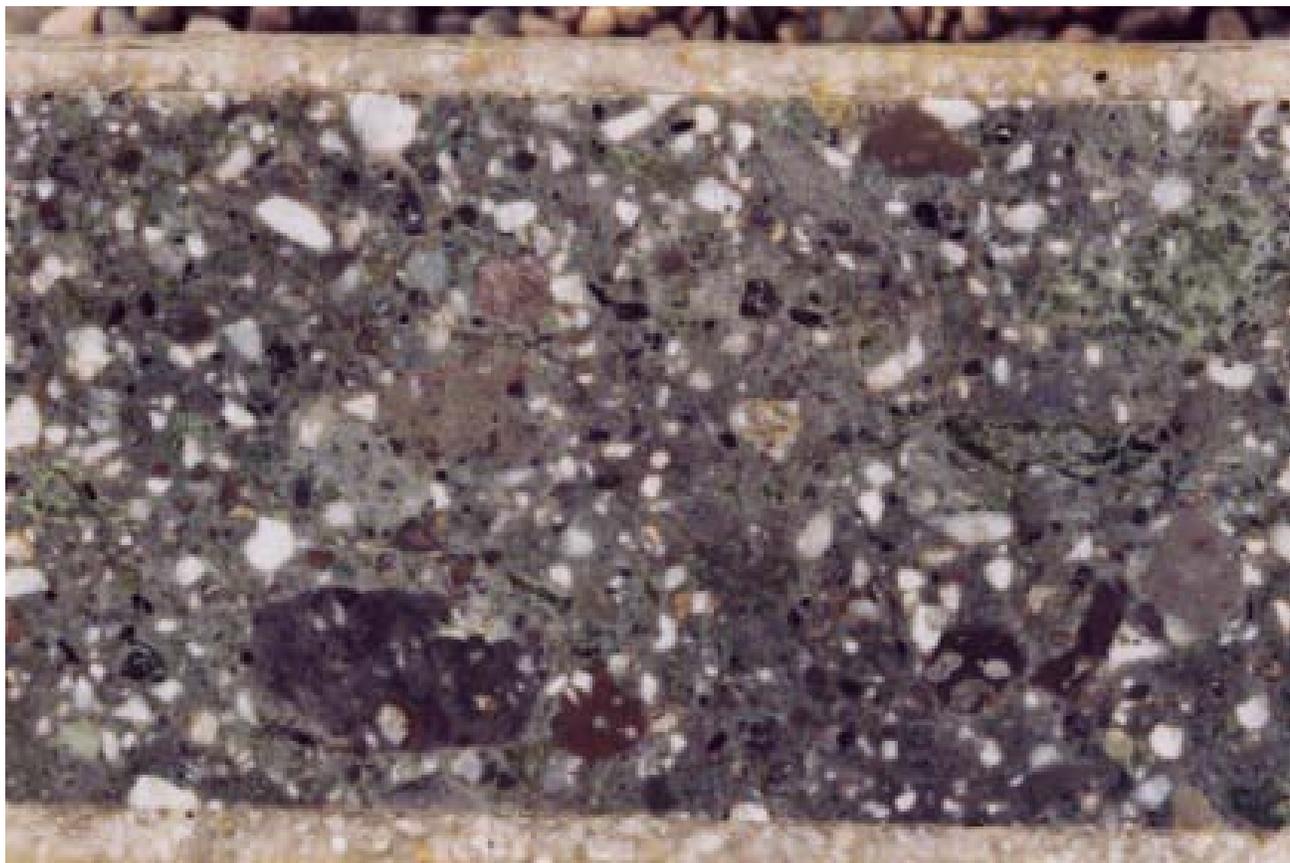
RKS-18-07#201 07052/23/PPL/28X/ULC ALTERED DACITE ASH-FLOW TUFF showing typical appearance of phenocrysts and lithic fragments in a groundmass of weakly welded devitrified glass shards.

<b>SAMPLE #</b>	<b>RKS-18-07 #201</b>
<b>ROCK NAME</b>	ALTERED DACITE ASH-FLOW TUFF -- probably formed by devitrification and alteration (secondary quartz + clay + chlorite + opaques + epidote + prehnite) of a welded dacite ash-flow tuff protolith.
<b>MINERALS</b>	Plagioclase (33%) + cryptocrystalline devitrified K-glass (30%) + quartz (25%) + clay (5%) + chlorite (4%) + opaques (2%) + epidote (1%) + prehnite (<1%).
<b>TEXTURES</b>	<p>Pyroclastic, devitrified hypocrySTALLINE. Weak welding has produced a weakly directed fabric.</p> <p><u>Framework Components (55%)</u> are 1.2-9.6 mm, angular to subangular. Contacts between framework components are floating to tangential.</p> <p><b>Phenocryst Fragments (27%)</b> are composed of subhedral to euhedral, whole to broken, isolated [plagioclase (17%) + quartz (10%)].</p> <p><b>Lithic Fragments (25%)</b> are composed of basalt and dacite vitrophyre.</p> <p><b>Pumice Fragments (3%)</b> are composed of porphyritic dacite.</p> <p><u>Matrix/Cement (45%)</u> is composed of weakly welded devitrified K-glass moderately devitrified to quartz.</p>

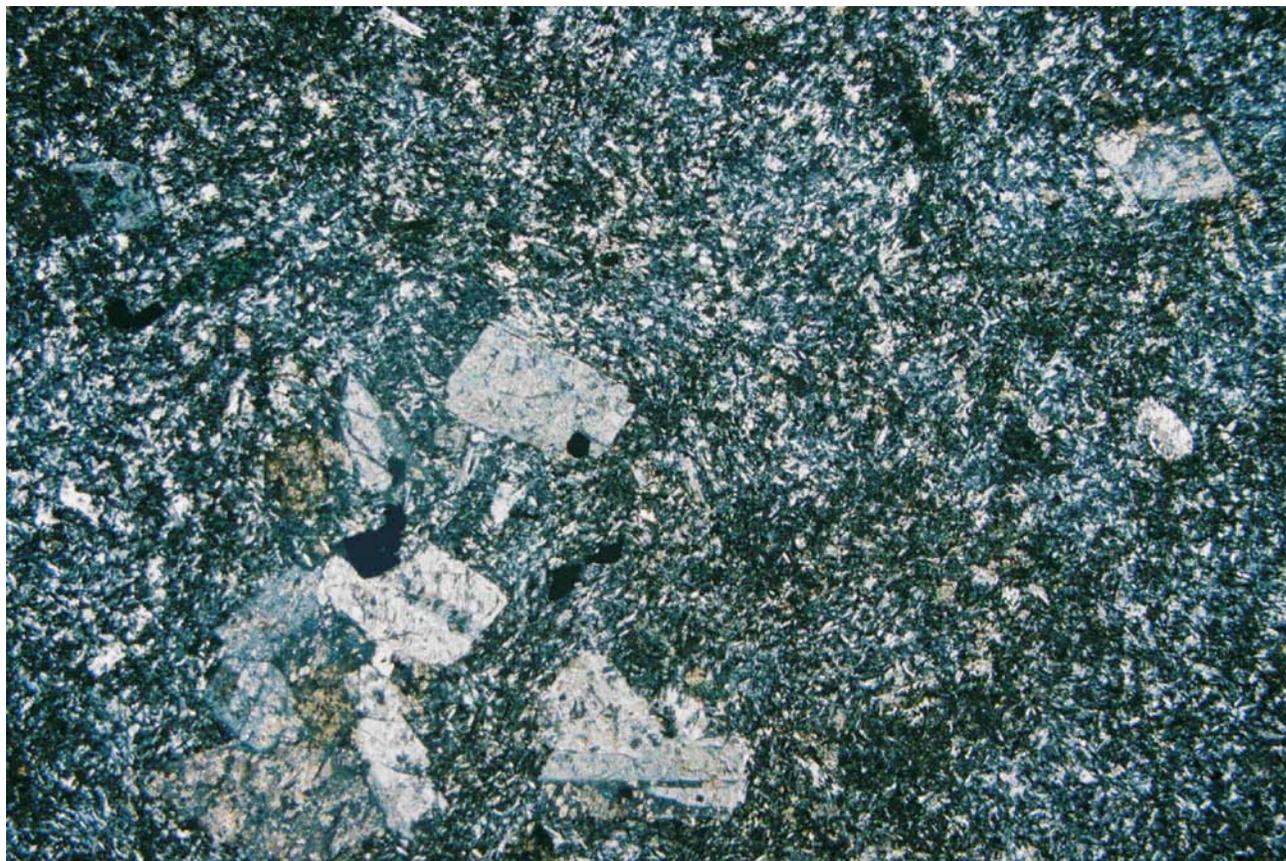
RKS-46-08 201 08045\_18m.jpg/X/FOV = 4.00 x 5.83 mm/WCF ALTERED PORPHYRYTIC BASALT or ANDESITE showing typical appearance.

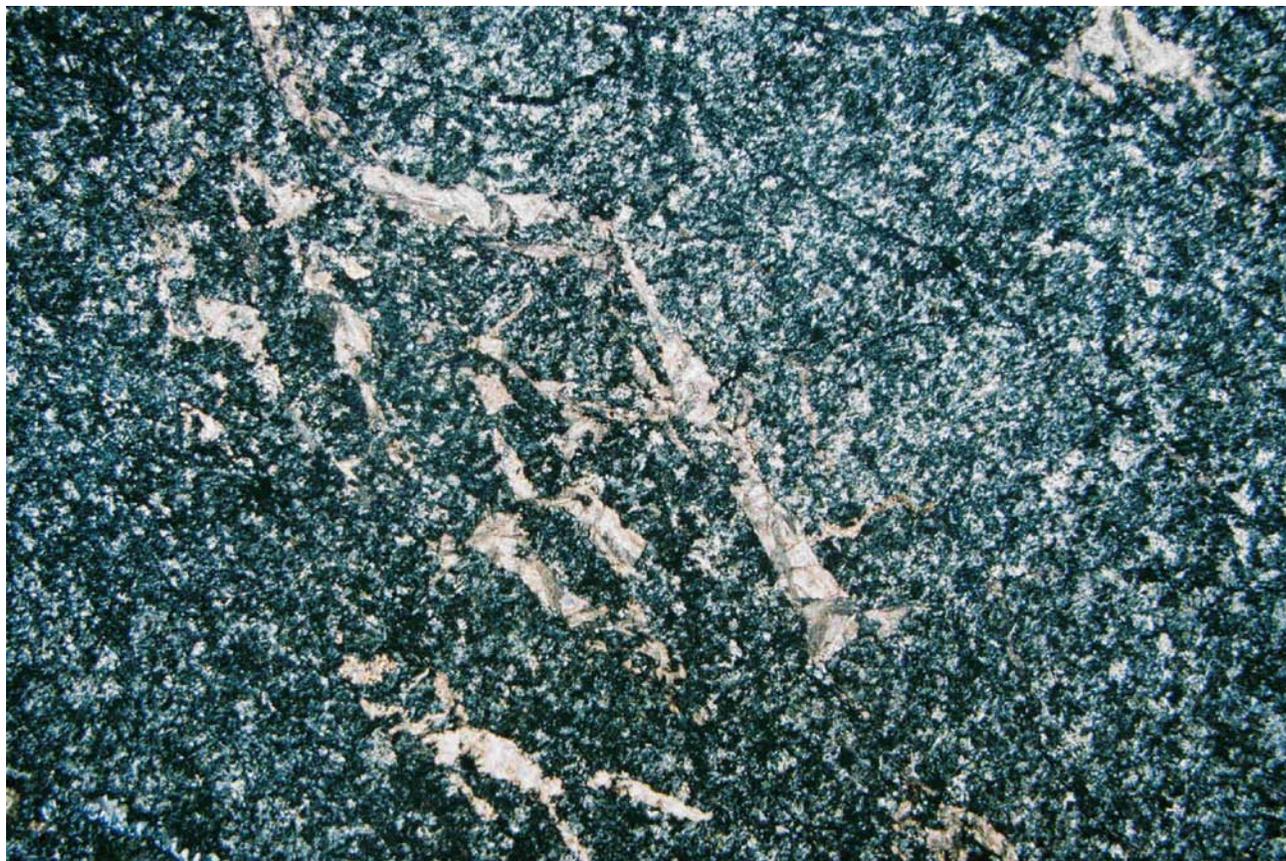
RKS-47-08 201 08045\_22m.jpg/XPL/FOV = 4.00 x 5.83 mm/WCF ALTERED SILICIC VOLCANIC ROCK showing typical appearance of fine aphyric texture structures mineralized by weakly ferroan calcite.

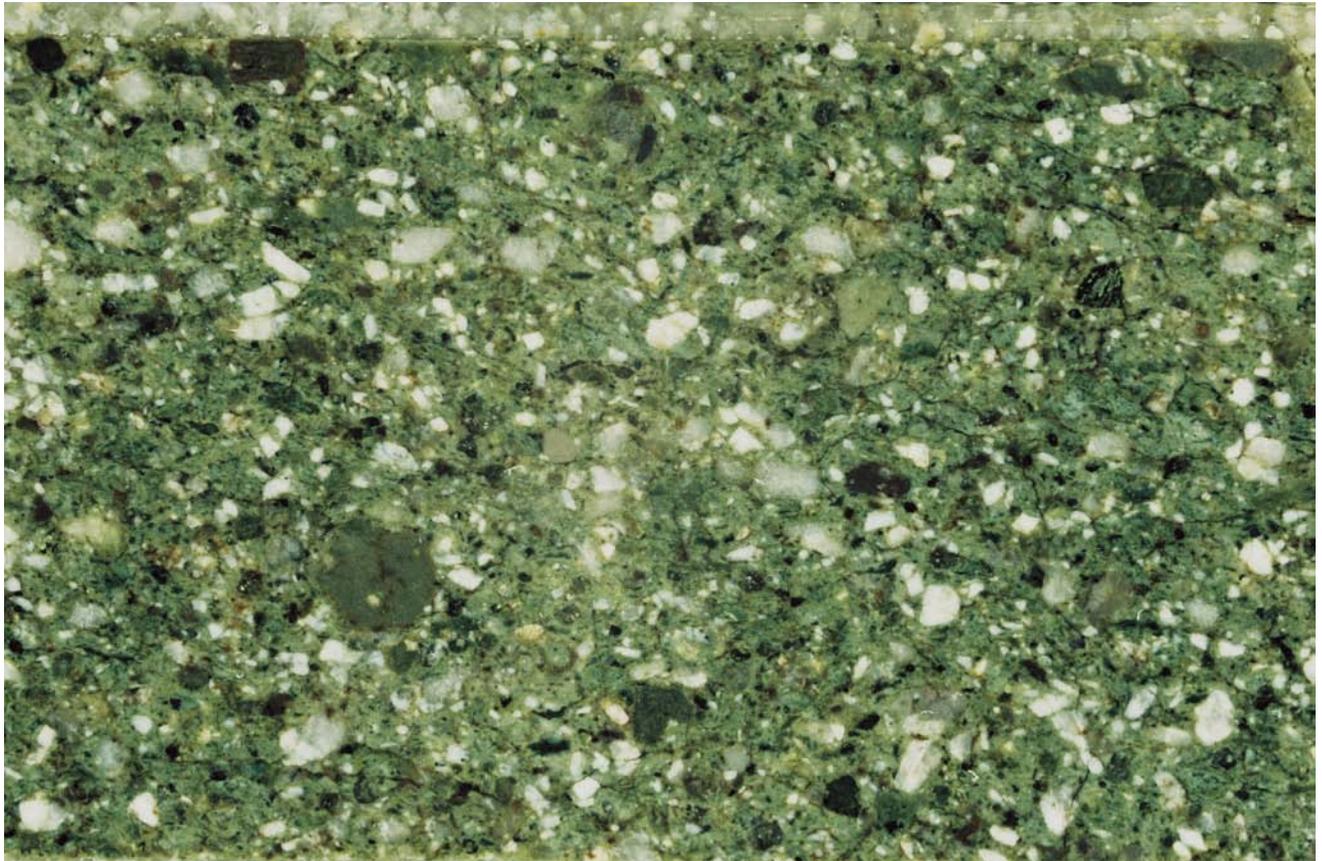
MRE-S14A 07051/14/PPL/28X/UNN ALTERED DACITE ASH-FLOW TUFF showing typical appearance of phenocrysts and lithic fragments in a groundmass of moderately welded devitrified glass shards.

<b>SAMPLE #</b>	<b>MRE-SI4A</b>
<b>ROCK NAME</b>	ALTERED DACITE ASH-FLOW TUFF -- probably formed by devitrification and alteration (secondary quartz + opaques + prehnite + chlorite + clay) of a welded dacite ash-flow tuff protolith.
<b>MINERALS</b>	Cryptocrystalline devitrified K-glass (45%) + quartz (25%) + plagioclase (25%) + opaques (2%) + prehnite (1%) + chlorite (1%) + clay (1%).
<b>TEXTURES</b>	<p>Pyroclastic, devitrified hypocrySTALLINE. Weak welding has produced a weakly directed fabric.</p> <p><u>Framework Components (50%)</u> are 1-4 mm, angular to subangular. Contacts between framework components are floating to tangential.</p> <p><b>Phenocryst Fragments (35%)</b> are composed of subhedral to euhedral, whole to broken, isolated [plagioclase (25%) + quartz (10%)].</p> <p><b>Lithic Fragments (15%)</b> are composed of basalt and dacite</p> <p><b>Pumice Fragments (0%)</b> were not observed.</p> <p><u>Matrix/Cement (50%)</u> is composed of moderately welded K-glass moderately devitrified to quartz.</p>

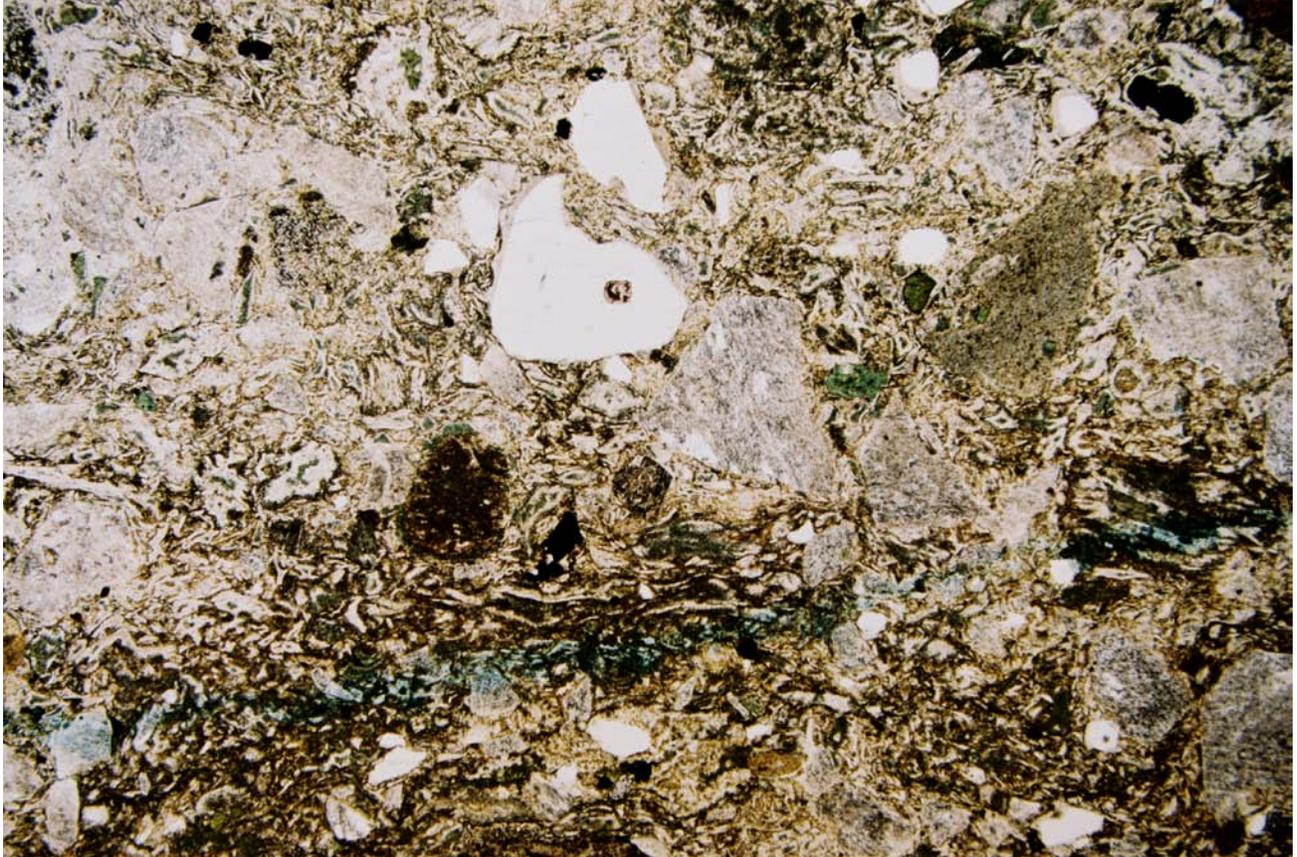
MRE-SI4B 07051/15/PPL/28X/UNN ALTERED DACITE ASH-FLOW TUFF showing typical appearance of phenocrysts and lithic fragments in a groundmass of moderately welded devitrified glass shards.

**ROCK NAME** ALTERED DACITE ASH-FLOW TUFF -- probably formed by devitrification and alteration (secondary quartz + chlorite + ferroan calcite + opaques) of a welded dacite ash-flow tuff protolith.

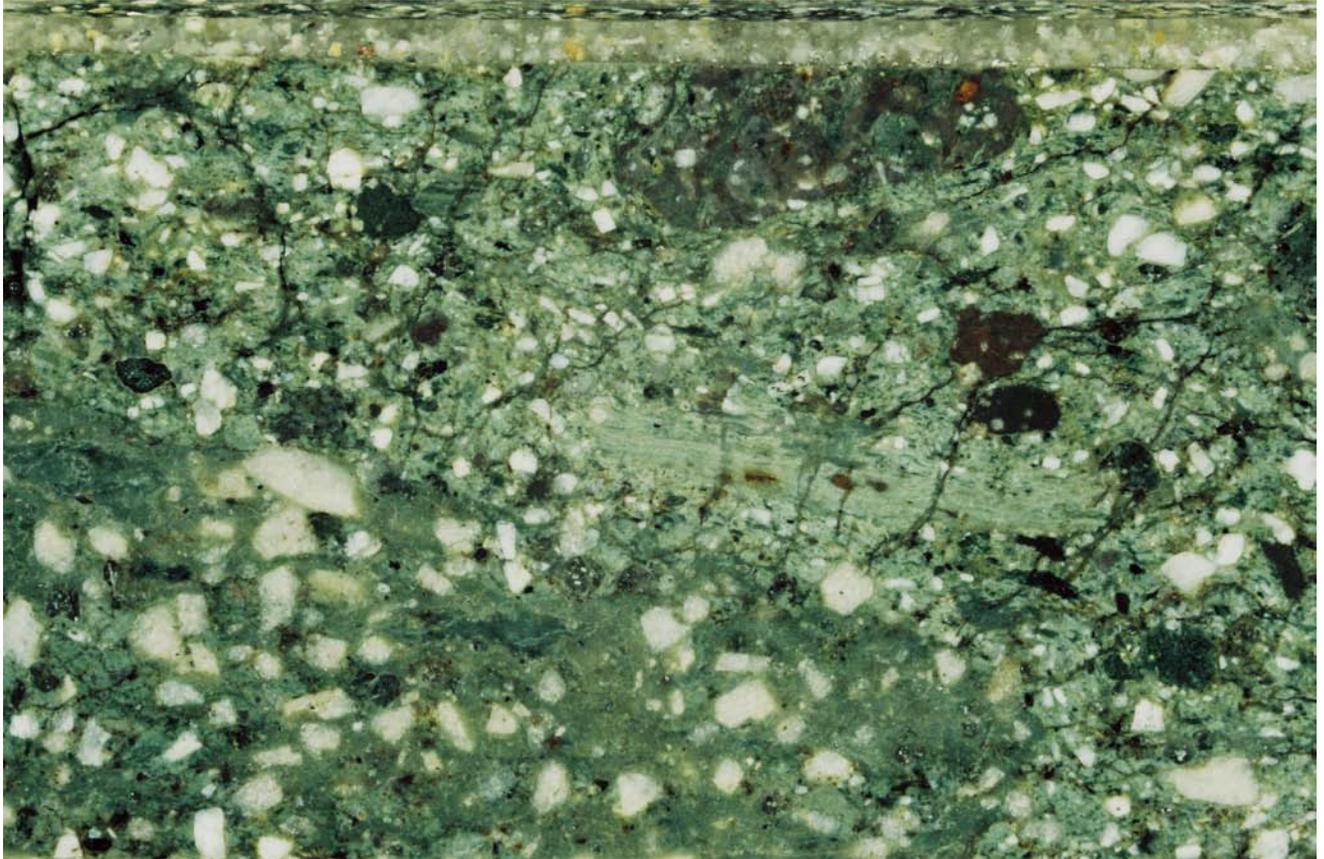
MRE-SI4C 07051/16/PPL/28X/UNN ALTERED DACITE ASH-FLOW TUFF showing typical appearance of phenocrysts and lithic fragments in a groundmass of moderately welded devitrified glass shards.

<b>SAMPLE #</b>	<b>MRE-SI4C</b>
<b>ROCK NAME</b>	ALTERED DACITE ASH-FLOW TUFF -- probably formed by devitrification and alteration (secondary quartz + chlorite + opaques + ferroan calcite) of a welded dacite ash-flow tuff protolith.
<b>MINERALS</b>	Cryptocrystalline devitrified K-glass (37%) + plagioclase (30%) + quartz (25%) + chlorite (3%) + opaques (2%) + ferroan calcite (<1%).
<b>TEXTURES</b>	<p>Pyroclastic, devitrified hypocrySTALLINE. Moderate welding has produced a moderately directed fabric.</p> <p><u>Framework Components (50%)</u> are 1-14 mm, angular to subangular. Contacts between framework components are floating to tangential.</p> <p><b>Phenocryst Fragments (30%)</b> are composed of subhedral to euhedral, whole to broken, isolated [plagioclase (20%) + quartz (10%)].</p> <p><b>Lithic Fragments (20%)</b> are composed of basalt and dacite</p> <p><b>Pumice Fragments (0%)</b> were not observed.</p> <p><u>Matrix/Cement (50%)</u> is composed of moderately welded devitrified K-glass.</p>

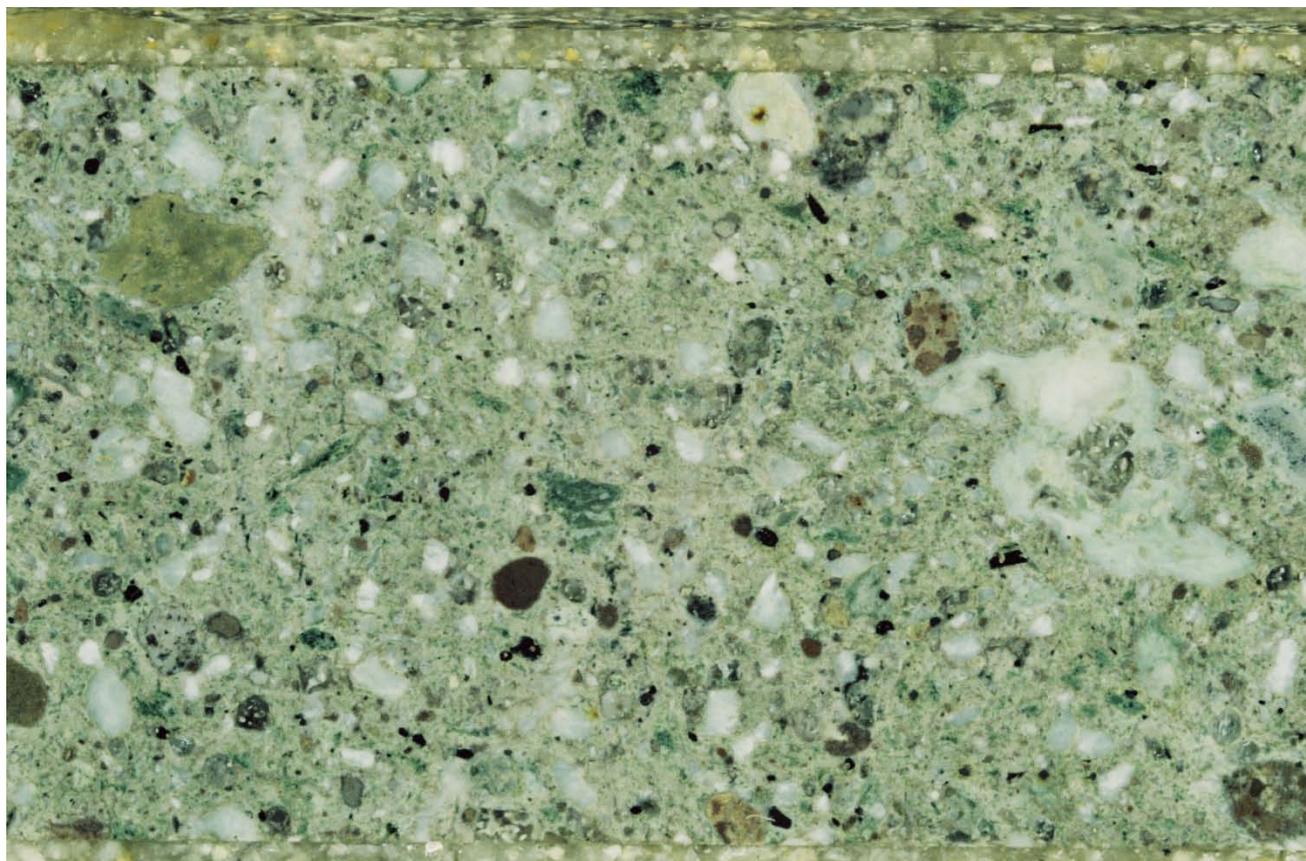
MRE-SI5A 07051/17/PPL/28X/UNN ALTERED DACITE ASH-FLOW TUFF showing typical appearance of phenocrysts and lithic fragments in a groundmass of moderately welded devitrified glass shards.

<b>SAMPLE #</b>	<b>MRE-SI5A</b>
<b>ROCK NAME</b>	ALTERED DACITE ASH-FLOW TUFF -- probably formed by devitrification and alteration (secondary quartz + clay (sericite ?) + ferroan calcite + chlorite + opaques) of a welded dacite ash-flow tuff protolith.
<b>MINERALS</b>	Cryptocrystalline devitrified K-glass (53%) + plagioclase (15%) + quartz (15%) + clay (sericite ?) (10%) + ferroan calcite (3%) + chlorite (2%) + opaques (2%).
<b>TEXTURES</b>	<p>Pyroclastic, devitrified hypocrySTALLINE. Weak welding has produced a weakly directed fabric.</p> <p><u>Framework Components (50%)</u> are 1-26 mm, angular to subangular. Contacts between framework components are floating to tangential.</p> <p><b>Phenocryst Fragments (30%)</b> are composed of subhedral to euhedral, whole to broken, isolated [plagioclase (20%) + quartz (10%)].</p> <p><b>Lithic Fragments (18%)</b> are composed of basalt and dacite</p> <p><b>Pumice Fragments (2%)</b> are composed of dacite porphyry.</p> <p><u>Matrix/Cement (50%)</u> is composed of moderately welded K-glass moderately devitrified to quartz ± ferroan calcite.</p>

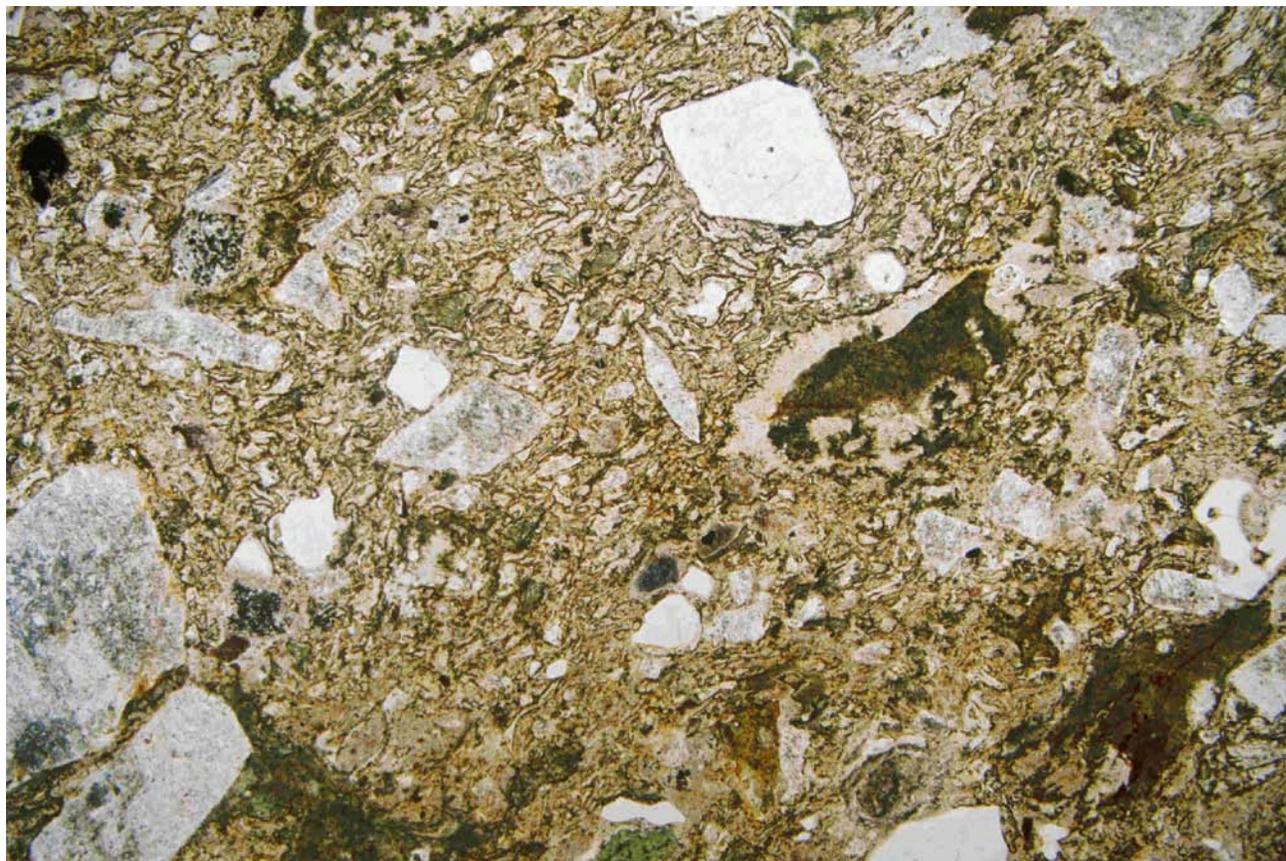
MRE-06-08 201 08045\_08m.jpg/PPL/FOV = 4.00 x 5.83 mm/WCF ALTERED DACITE ASH-FLOW TUFF showing typical appearance.

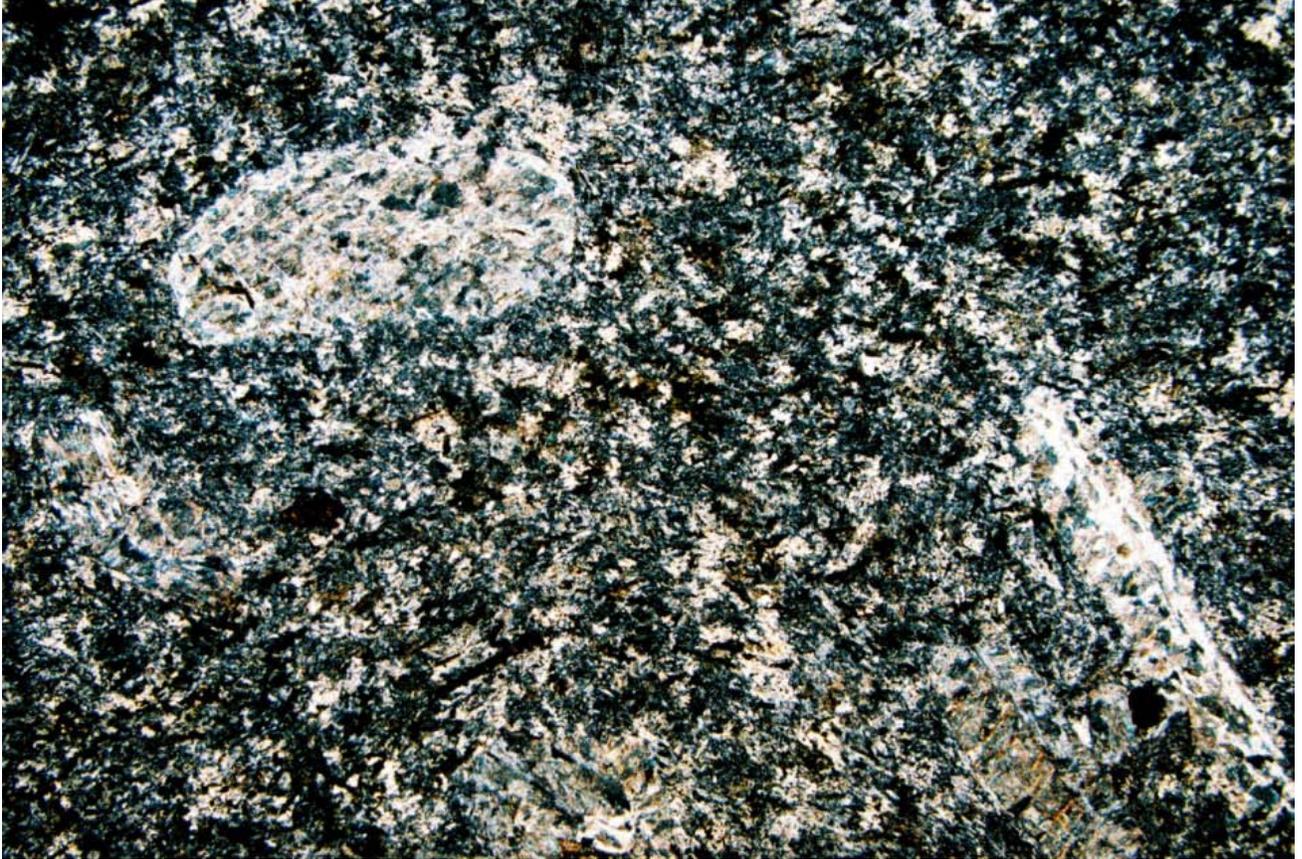
MRE-SI7A 08042\_06m.jpg/XPL/FOV = 4.00 x 5.83 mm/VZM HIGHLY ALTERED ANDESITE? showing typical appearance.

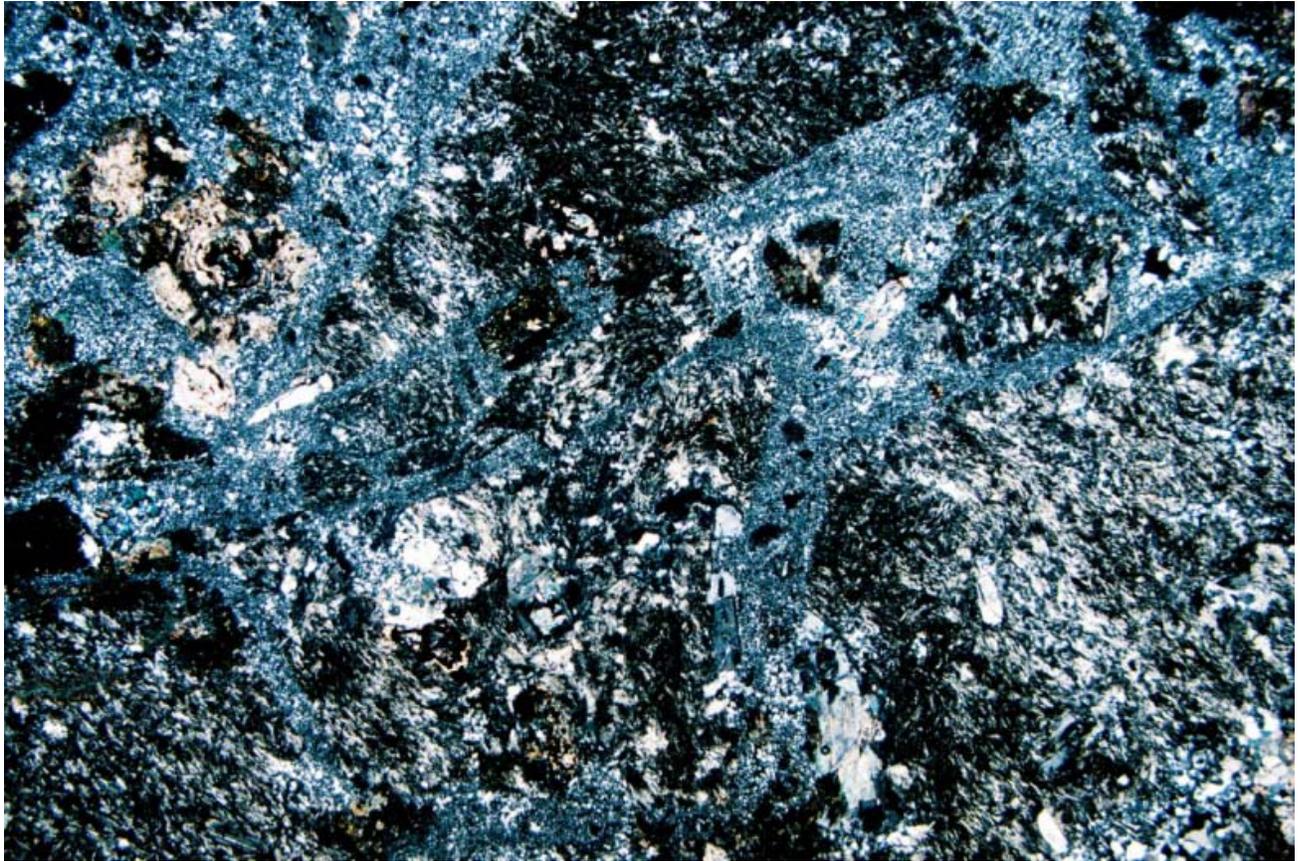
MRE-SI7B 08042\_07m.jpg/XPL/FOV = 4.00 x 5.83 mm/VZM ALTERED ANDESITE showing typical appearance (same view as 08042/08).

**ROCK NAME** ALTERED ANDESITE -- secondary veins indicate hydrothermal brecciation, and hydrothermal alteration (secondary quartz + weakly ferroan calcite + opaques + leucoxene + K-feldspar) of a porphyritic basalt protolith very much like #7 201.
