APPENDIX H  
LABORATORY REPORTS

Strength Testing Reports  
Corrosion Testing Reports  
Atterberg Limits Testing Reports  
Petrographic Analysis Reports

# Strength and Direct Shear Testing Results

**Rock Testing  
WDOT - I90 Hyak Extension**

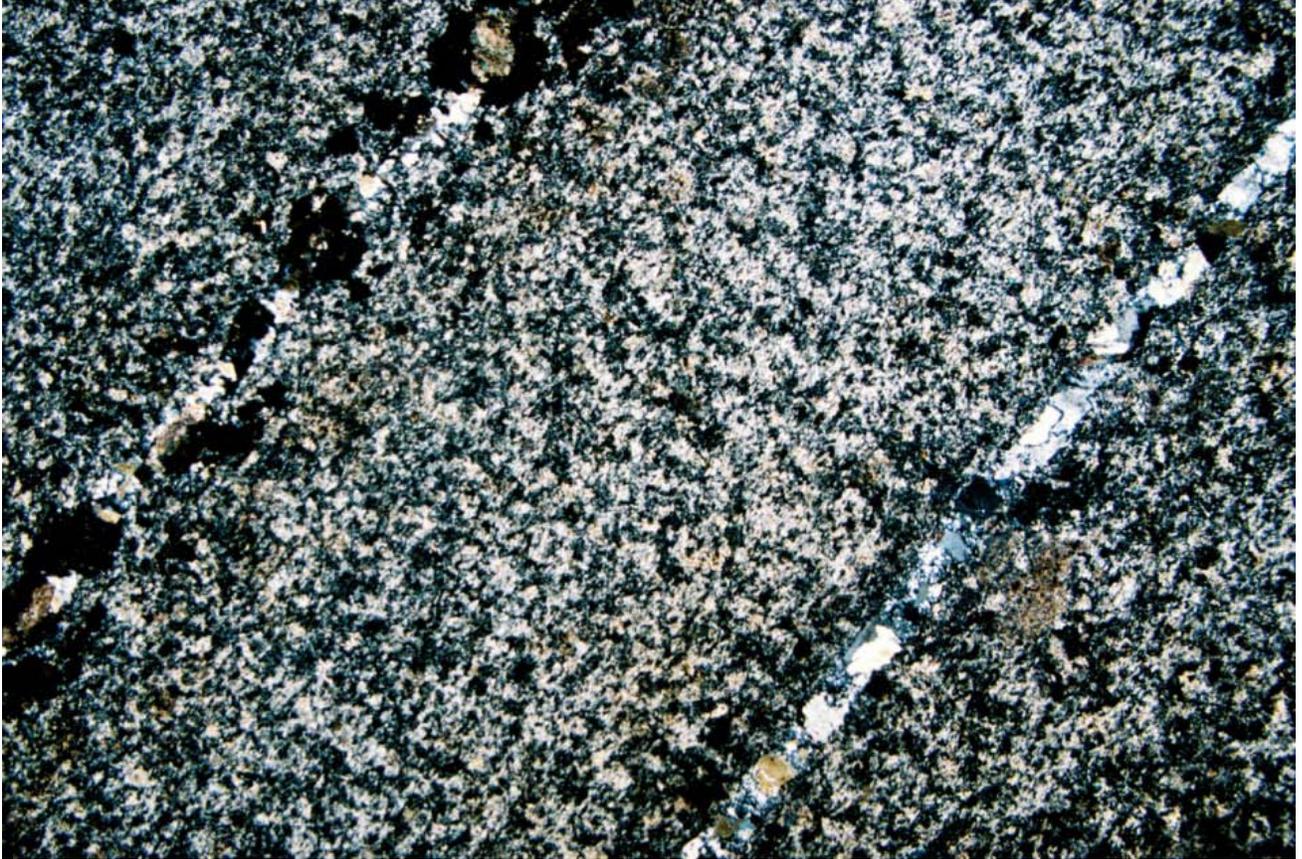
MRE-SI8A 204 08042\_10m.jpg/XPL/FOV = 4.00 x 5.83 mm/VZM ALTERED FELSIC VOLCANIC ROCK showing typical fine grained appearance.
