**I-405 SR 515 Interchange Project
(Thunder Hills Creek Tributary) Stream Mitigation Site**

USACE NWP (14) NWS-2007-1788

2014 MONITORING REPORT

**Washington State
Department of Transportation**

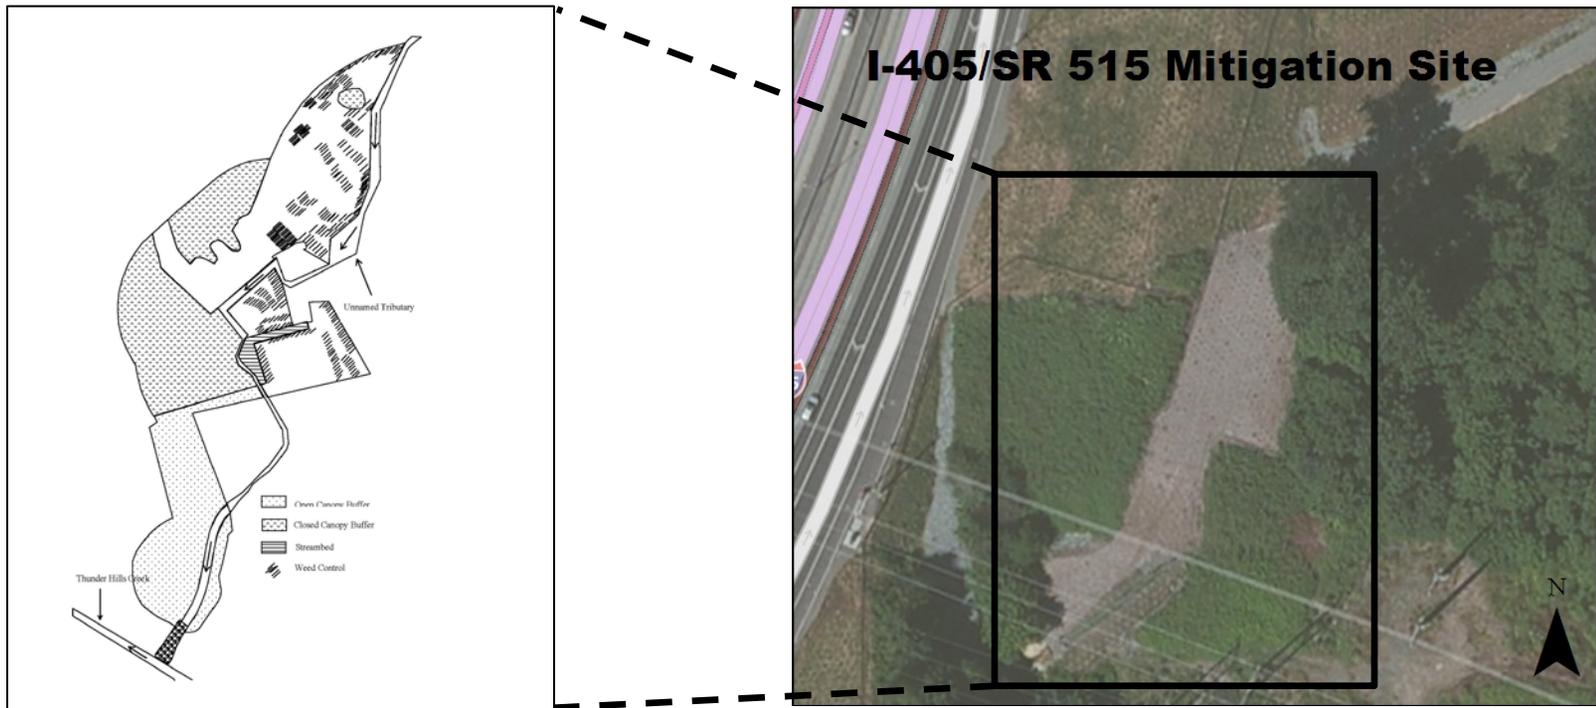
Figure 1 Site Sketch

The I-405 Thunder Hills Tributary Stream Mitigation site contains three vegetative communities along the new stream channel: a streambed mix, an open canopy mix, and a closed canopy mix. Appendix 1 includes site directions.

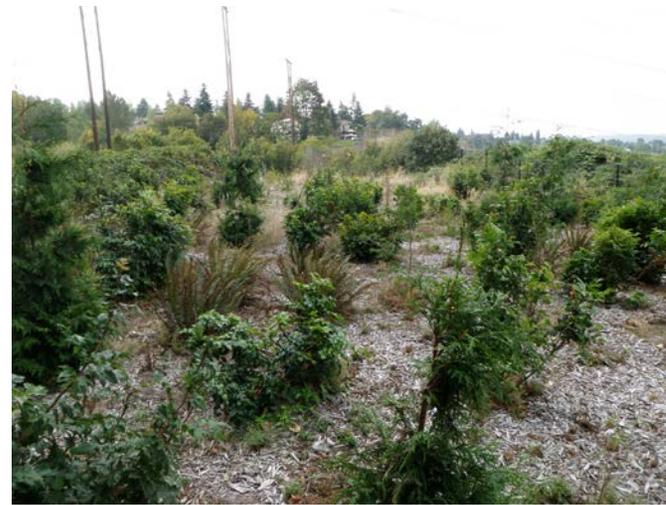
Native woody density is estimated at 2.8 plants per 100 square feet. Survival has been exceedingly low on the steep slope and the lower southern bench (Photo 2); however the upper bench is beginning to develop (Photo 1). A total of 10 bigleaf maple (*Acer macrophyllum*), 30 western red cedar (*Thuja plicata*), 10 beaked hazelnut (*Corylus cornuta*), 20 snowberry (*Symphoricarpos albus*), 20 tall oregongrape (*Mahonia aquifolium*), and 30 western swordfern (*Polystichum munitum*) were planted in the fall of 2014.

Photo 1
Woody density on the upper bench (September 2014)

Fall 2014 replanting efforts will be evaluated for successful establishment. Supplemental planting will occur in fall 2015 as-needed. Herbivory will be assessed, and plant protection added if needed. Weed control efforts will be ongoing.

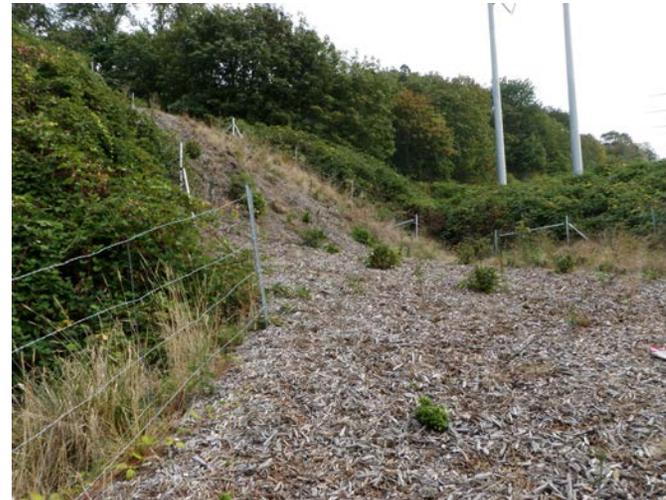
Photo 2
Woody density on the slope and lower bench (September 2014)
