PANEL ASSESSMENT OF INTERSTATE BRIDGES SEISMIC VULNERABILITIES

Draft Technical Report

December 18, 2006

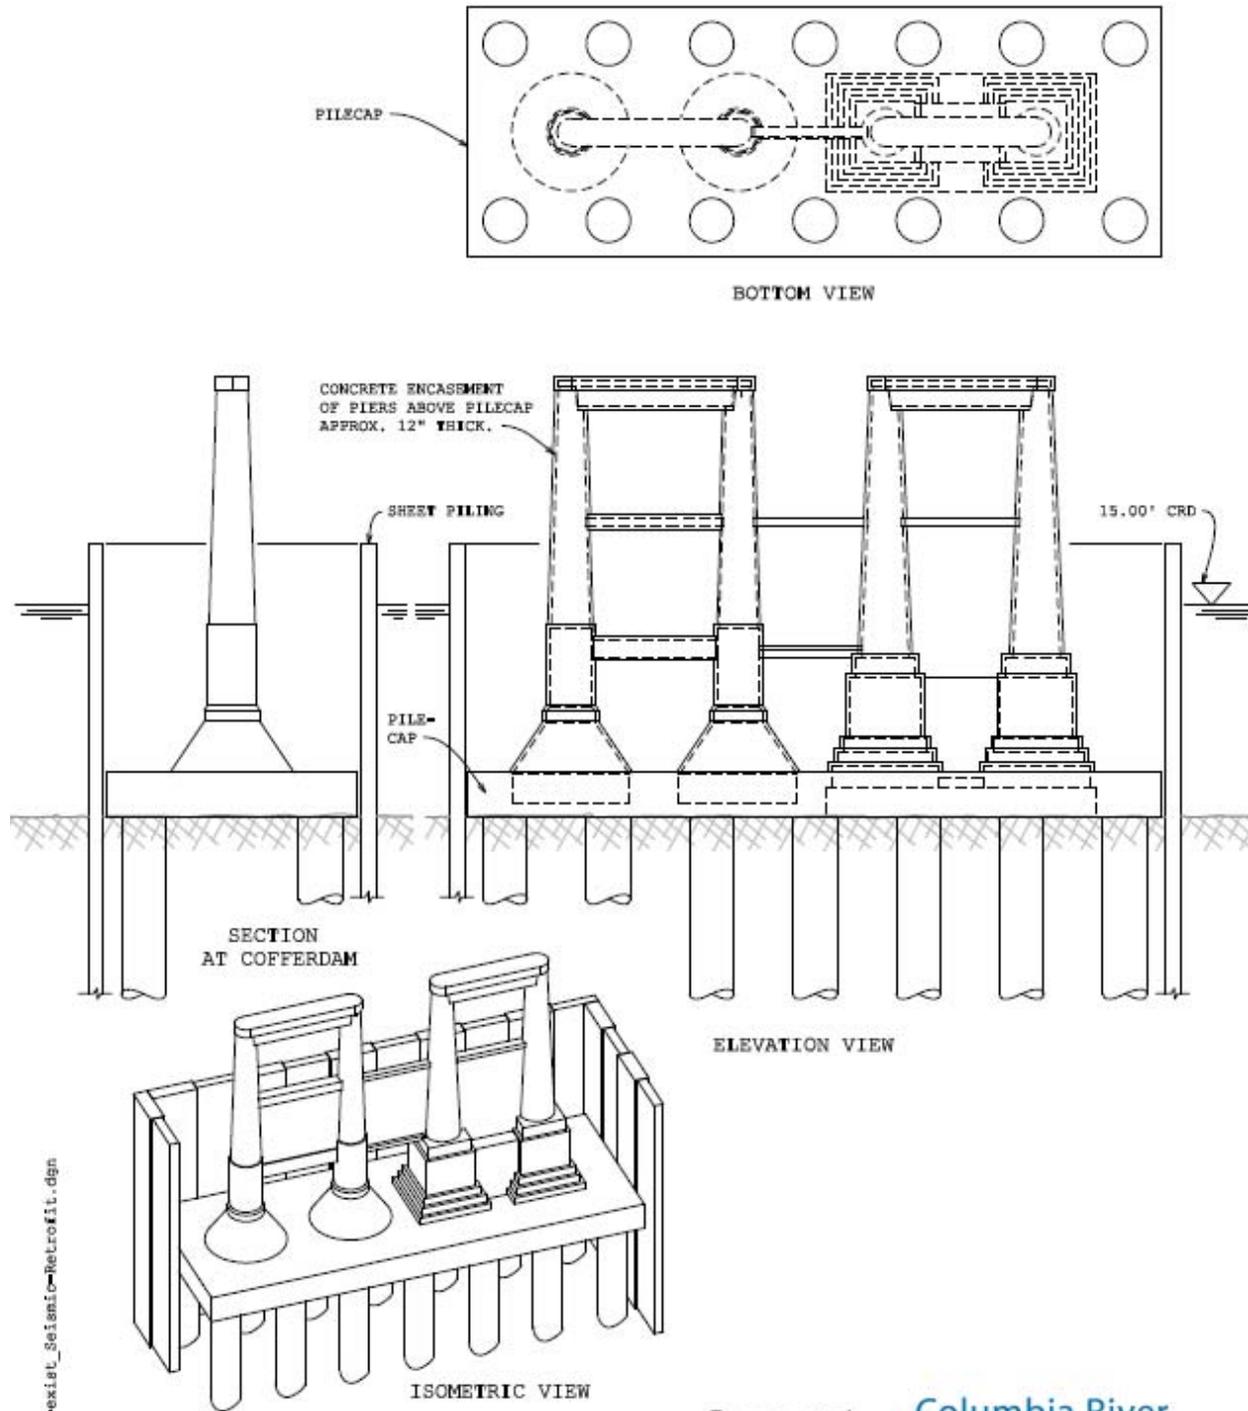
Figure 4-1. Foundation and Pier Retrofit Alternative 1

For the retrofit of the piers, primarily to provide additional ductility, the concept assumes that #8 welded hoops are placed at 6-inch spacing along the entire face of the pier. This includes drilling through the in-fill walls between the columns and running the hoops through the drilled holes. The entire pier would then be encased in a shotcrete jacket either 6 inches or 12 inches thick. These concepts are shown in Figures 4-1 and 4-2.

Concept 1
Existing Structure Seismic Retrofit

Foundation and Pier Retrofit: The foundations will comprise the largest element and cost of the retrofit. Two alternatives were considered: one that retrofits the foundations at the pile cap level and below and one that constructs a new pile cap at or above the water level. For costing purposes, both options assumed pile groups that consist of large (8 feet to 12 feet) diameter shafts around each pier, and that the piles would be up to 200 feet long, reaching far below the liquefaction layers and to or nearly to the Troutdale formation (rock).

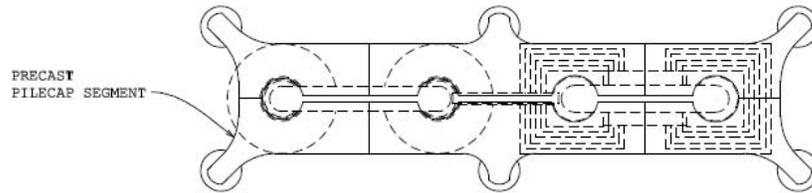
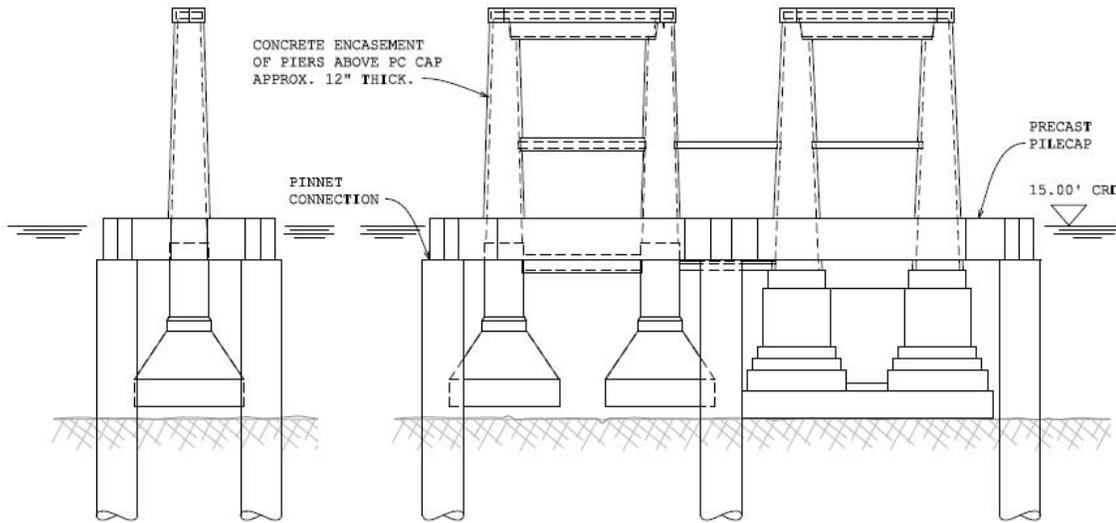
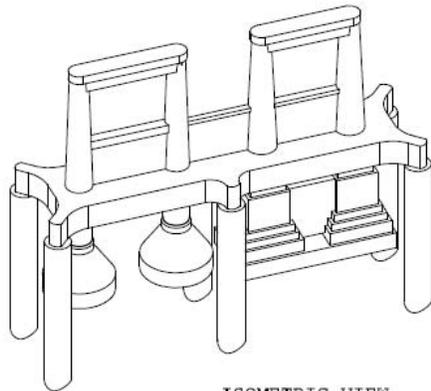
LARGE DIAMETER STEEL OR (CIDH)
CONCRETE PILING (6'-12'Ø)
ASSUME PILES EXTEND TO
TROUTDALE FORMATION.

PLAN VIEW

ELEVATION VIEW

ISOMETRIC VIEW

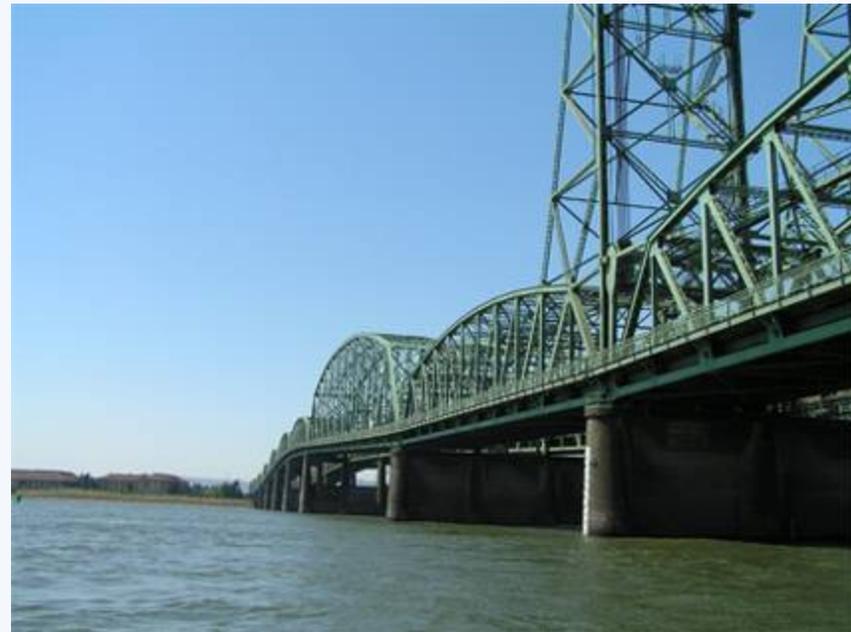
Seismic Panel Cost Summary

Serviceable		No Collapse	
		Low	High	Low	High
100y - 500y	Foundation	50	100	50	100
	Pier	10	30	10	30
	Bearing	6	6	6	6
	Superstructure	22	31	22	31
		88	167	88	167

500y - 1000y	Foundation	55	105	55	105
	Pier	10	30	10	30
	Bearing	9	9	9	9
	Superstructure	26	36	26	36
		100	180	100	180

500y - 2500y	Foundation	60	110	60	110
	Pier	10	30	10	30
	Bearing	13	13	13	13
	Superstructure	29	40	29	40
		112	193	112	193

Serviceable		No Collapse	
		Low	High	Low	High
100y - 500y	Foundation	50	100	50	100
	Pier	10	30	10	30
	Bearing	6	6	6	6
	Superstructure	22	31	22	31
		88	167	88	167

500y - 1000y	Foundation	55	105	55	105
	Pier	10	30	10	30
	Bearing	9	9	9	9
	Superstructure	26	36	26	36
		100	180	100	180

500y - 2500y	Foundation	60	110	60	110
	Pier	10	30	10	30
	Bearing	13	13	13	13
	Superstructure	29	40	29	40
		112	193	112	193

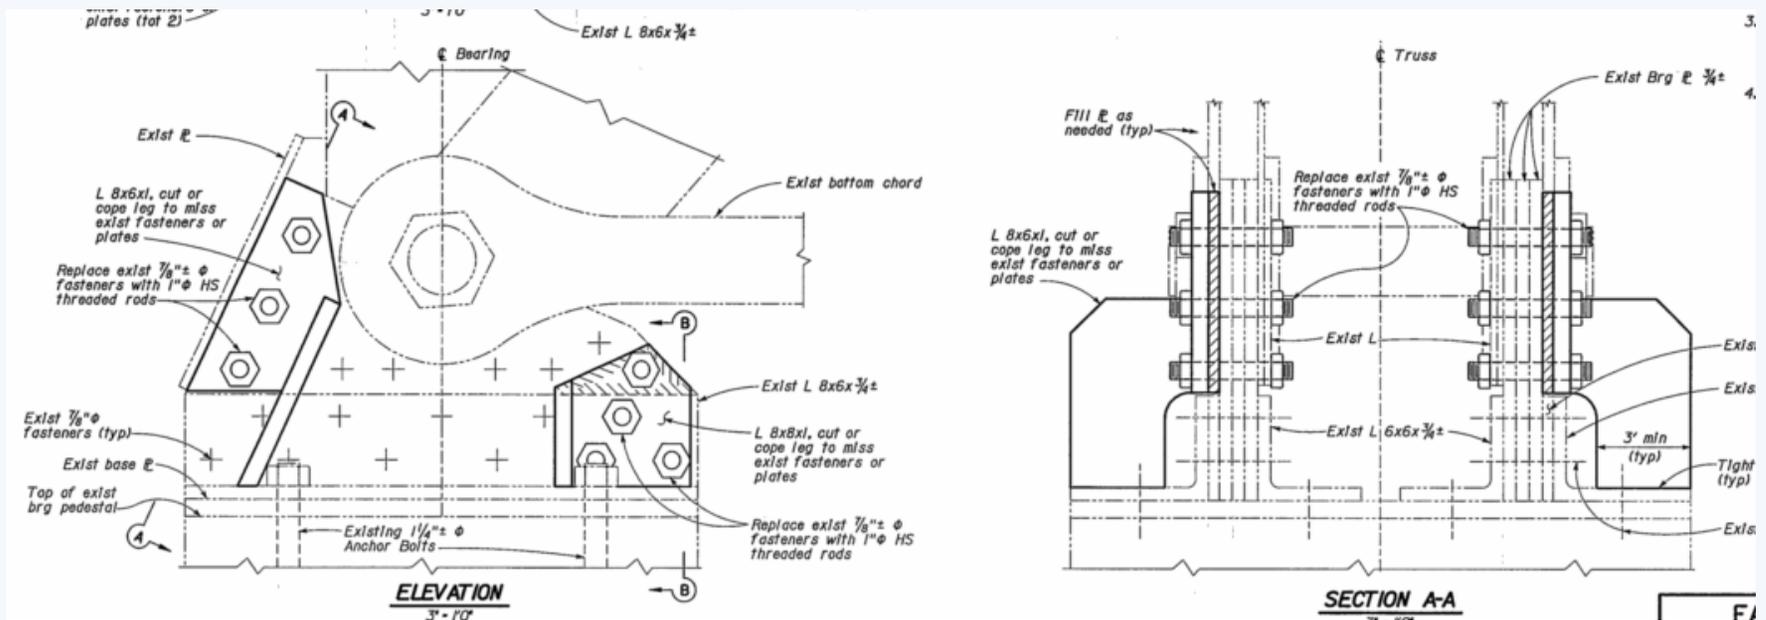
Lateral Stiffening of High-Profile Rocker Bearings

\$20000 Each Typical locations

Excluding 8 Custom replacement for Lift Span Bearings

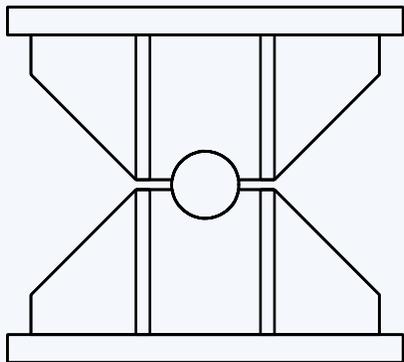
Isolation Bearings

\$75000 + \$15000

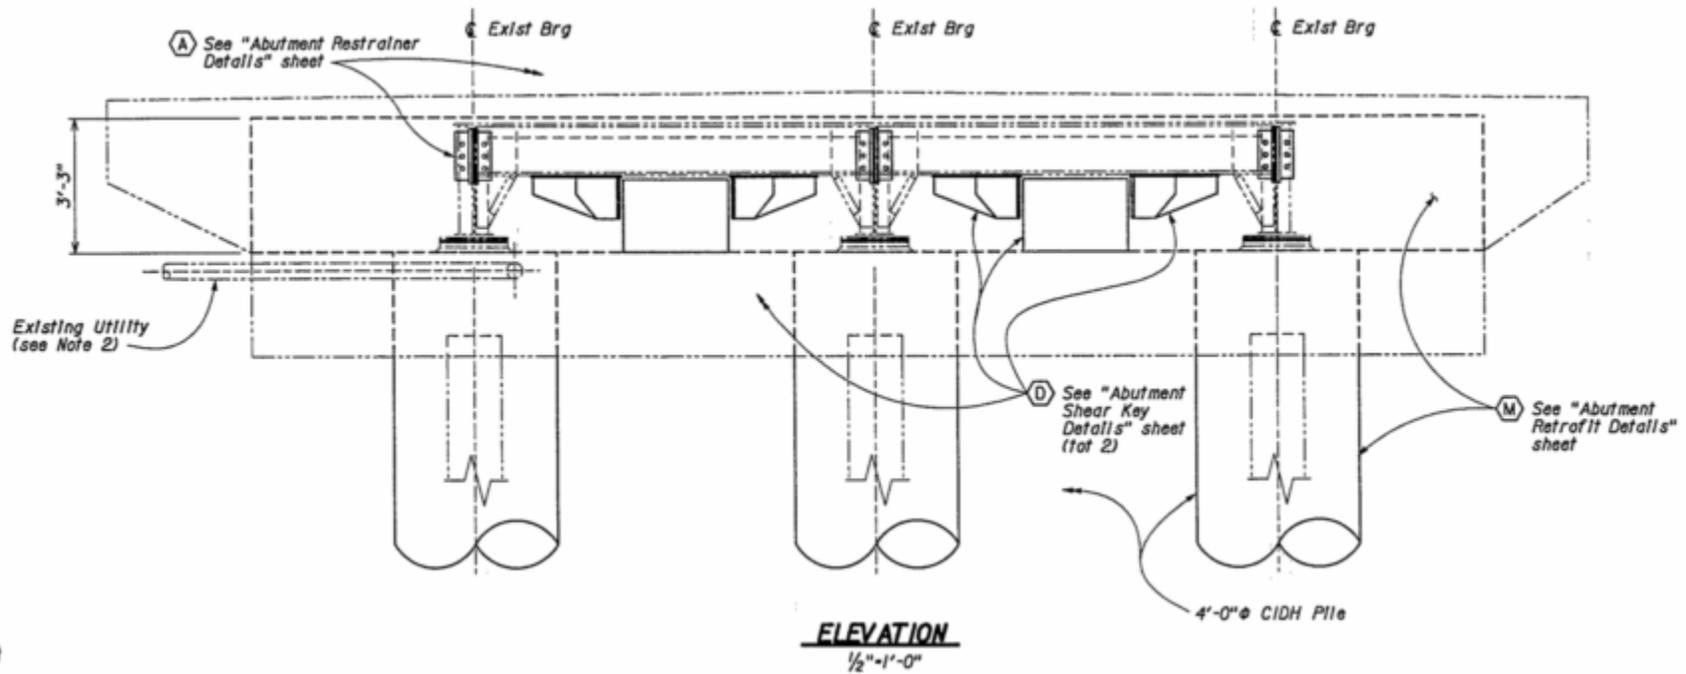
Vertical Catcher Blocker/Future Jacking Assembly

\$5000

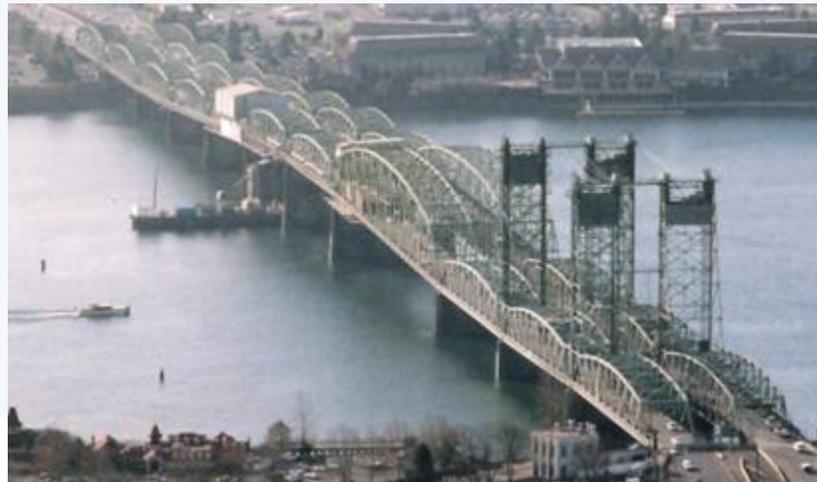
Steel Member Retrofit

- Add angles and plates to chords
- Strengthen portal cross frames
- Strengthen diagonal members
- Strengthen lateral bracing
- Replace towers
- Deck connections to beams
- Gusset plate replacement
- Stiffening gusset plates
- Connection strengthening
- Rivet and bolt replacements
- Replace of laced members
- Mechanical System
- Electrical System

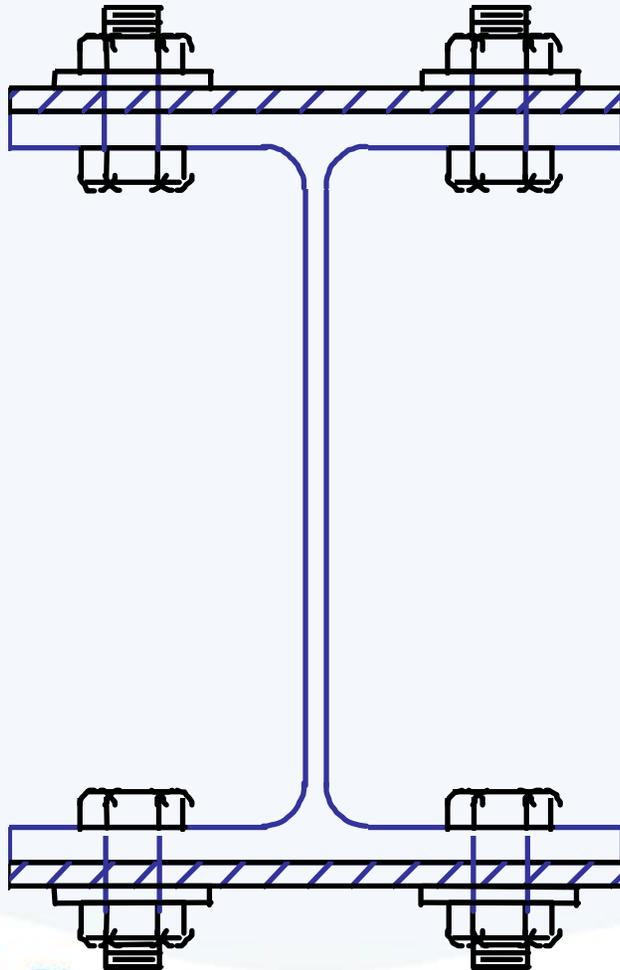
Retrofit Measures

A minimum level of member replacement and retrofit was assumed to be required to provide for a superstructure that would not experience damage. A weight of additional superstructure steel was estimated at 10 pounds per square foot of deck based primarily on the retrofits of major steel truss bridges in California; namely, the I-80 Carquinez, I-580 Richmond-San Rafael, and I-680 Benicia Martinez toll bridges.

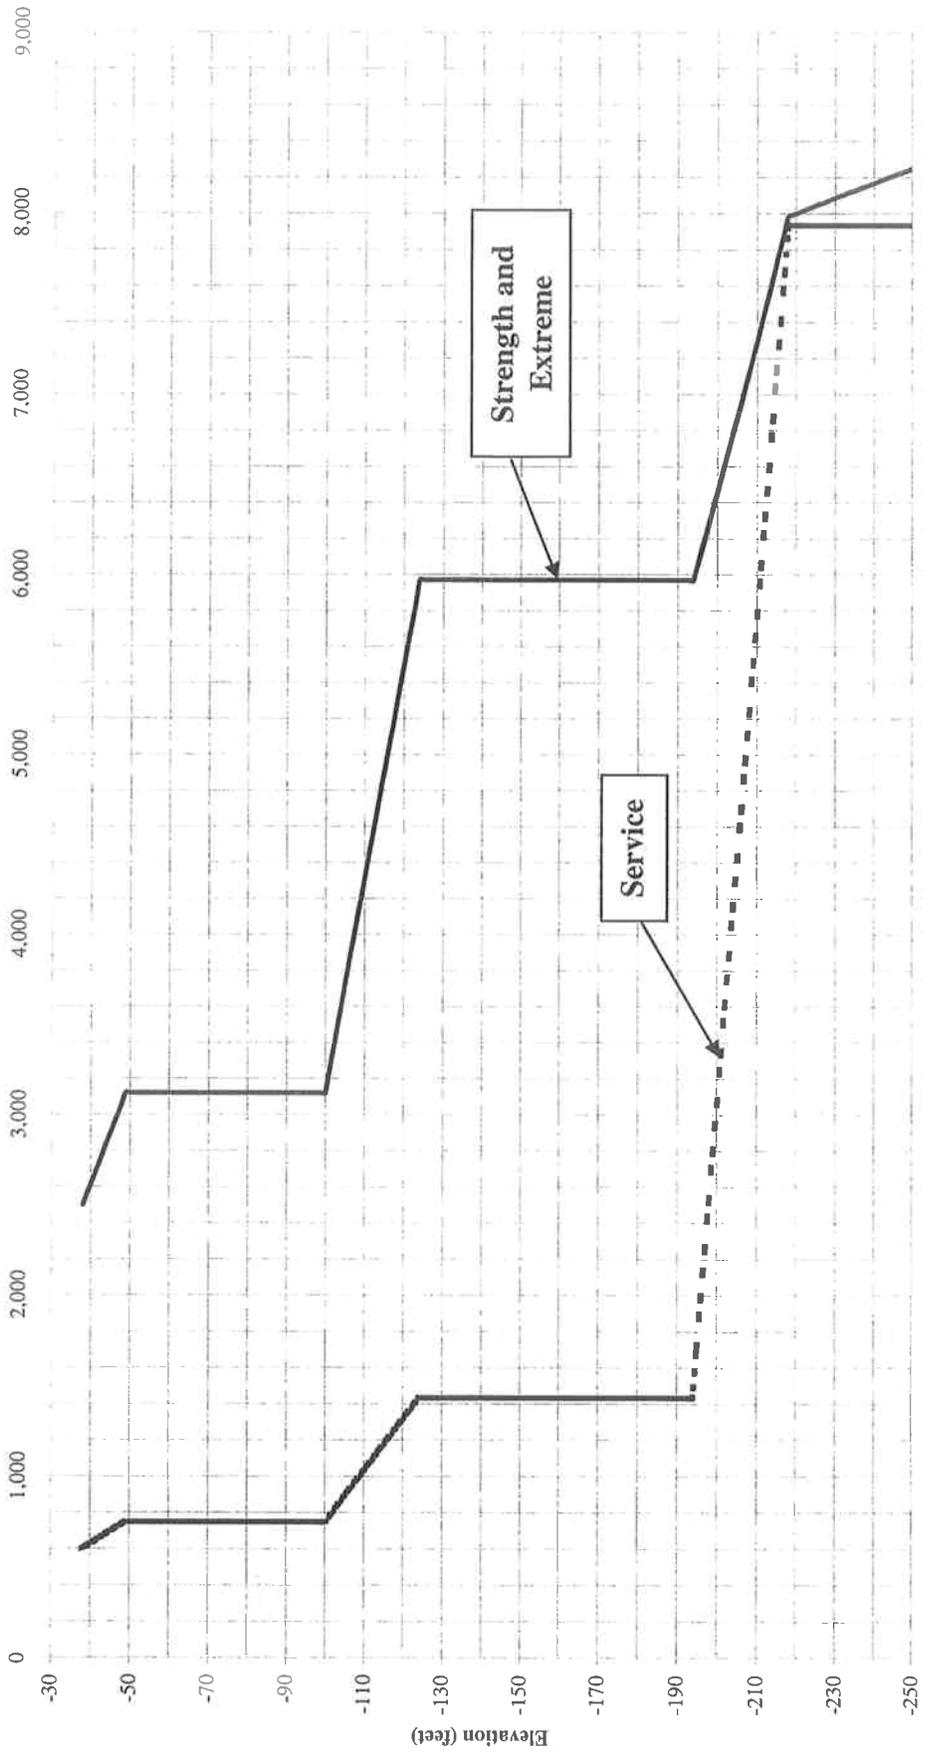
Unfactored End Bearing CRC-RC-003, 12-Foot Diameter Shaft

Ultimate Bearing Capacity (kips)

— Strength and Extreme - - - Service
