WASHINGTON STATE HIGHWAY DEPARTMENT RESEARCH PROGRAM  
REPORT

# **STUDDED TIRE PAVEMENT WEAR REDUCTION & REPAIR**

## **PHASE 1**

Y-1439

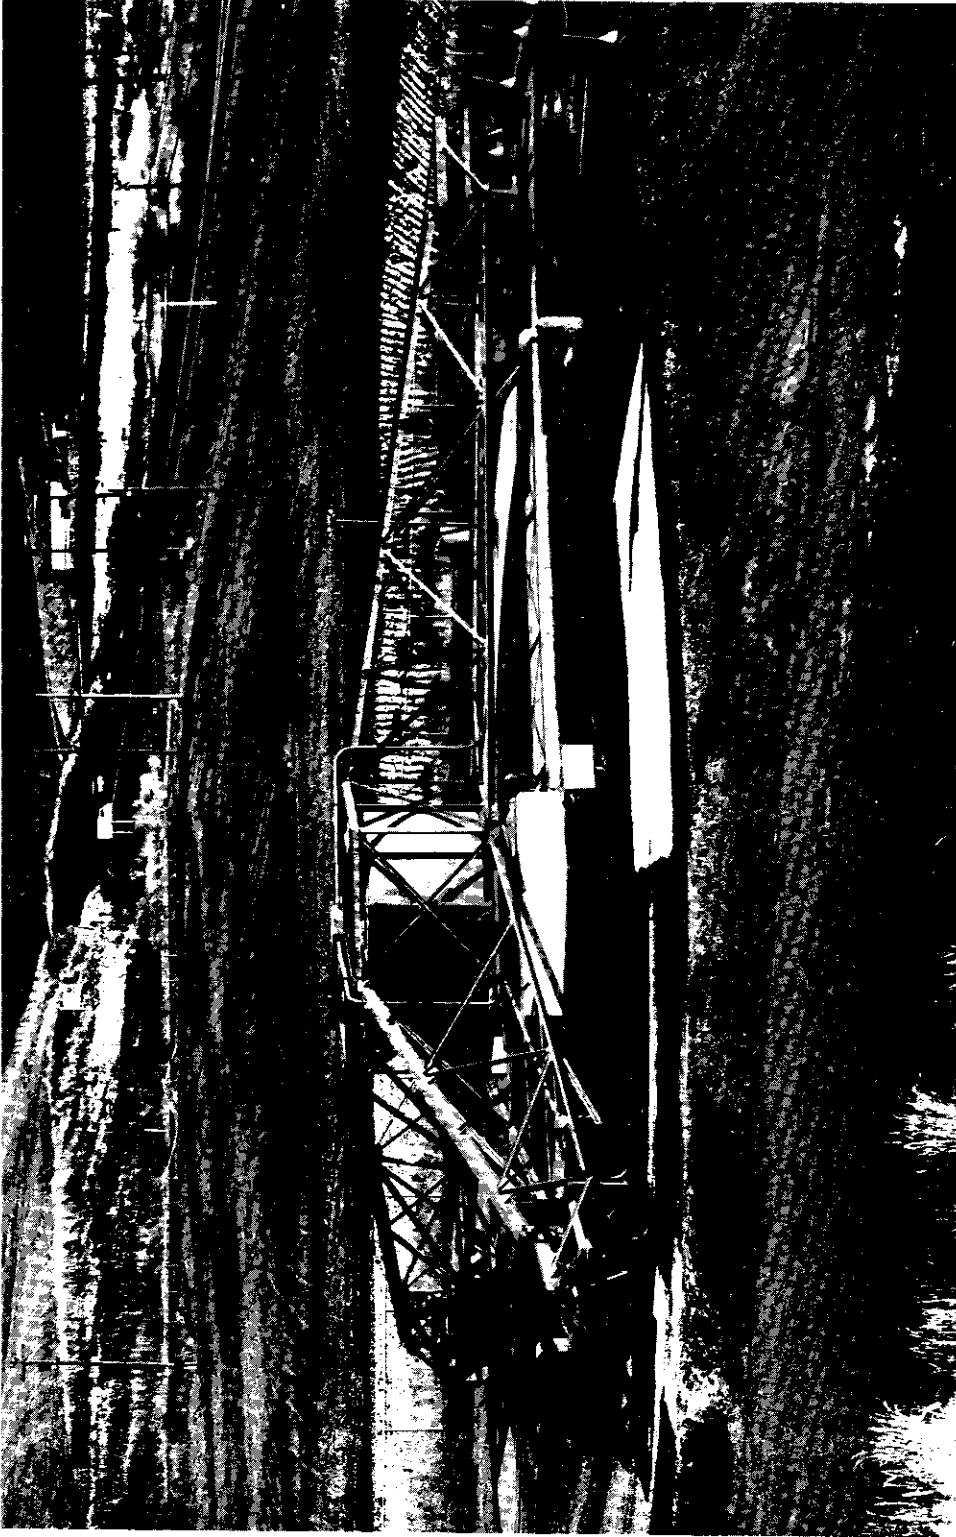
Figure 1: An overall view of the G. A. Riedesel Pavement Testing Facility with modifications and the track. The track shown here is Ring No. 6.

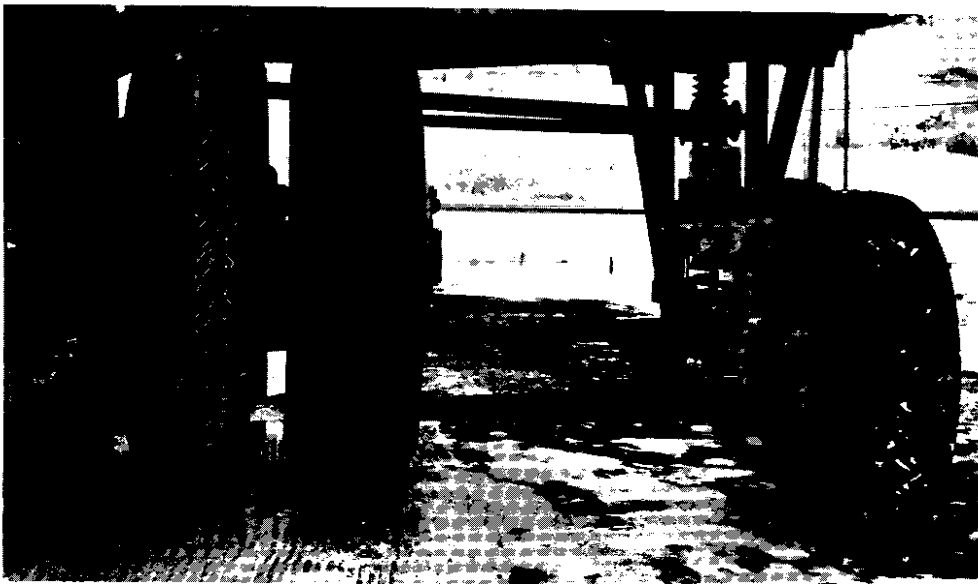
Figure 3: A close-up of the frame extension and the truck and passenger tires on the center and outside tracks.

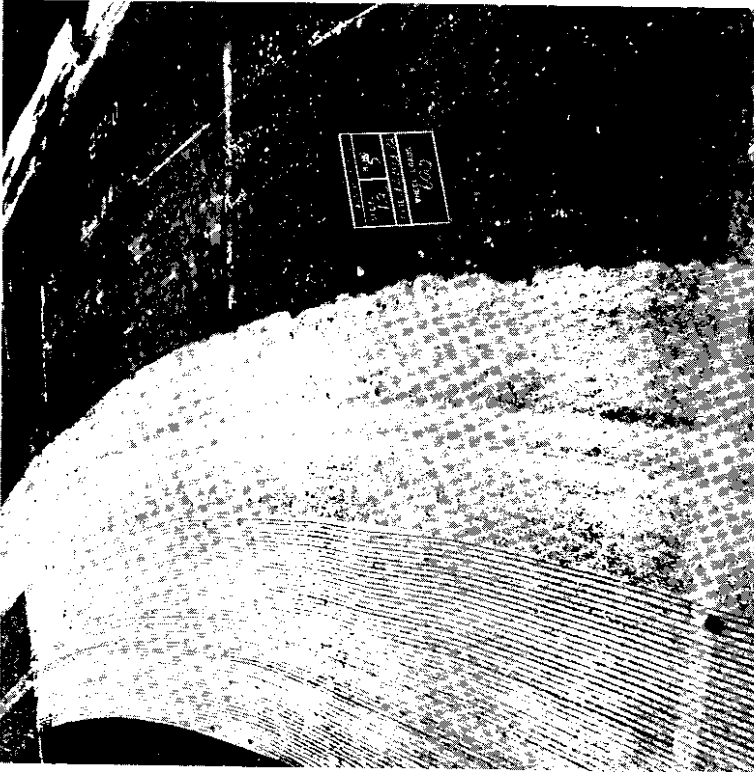
Figure 33: The appearance of Section 1a after the test. Note that at 600 wheel applications, the stud tires had scratched the surface of the pavement. Also note that the polymer concrete sections on the outside track had deteriorated due to poor construction.

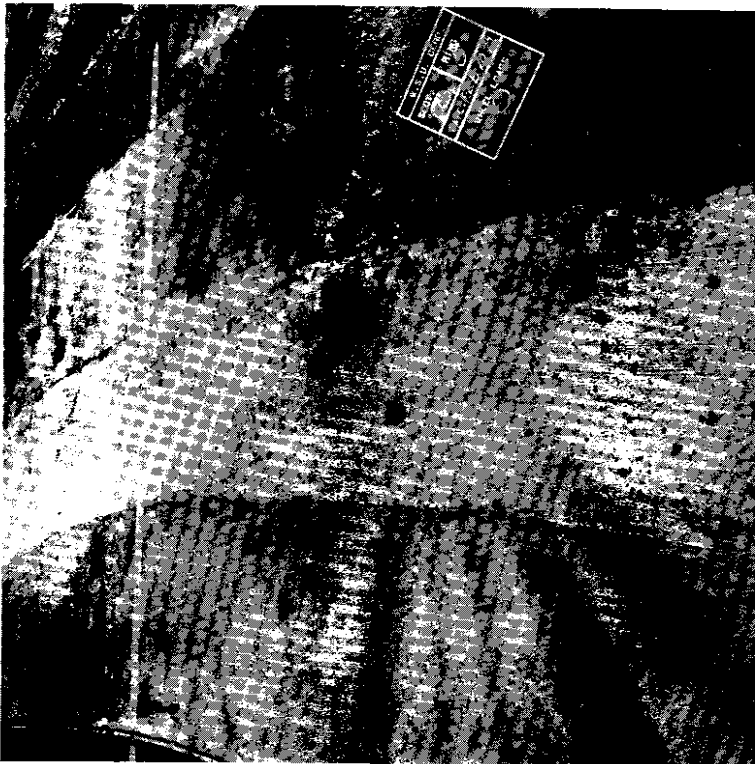
Figure 36: The appearance of Section 2b before and after the testing.  
Note that parts of the overlay has been worn right through.

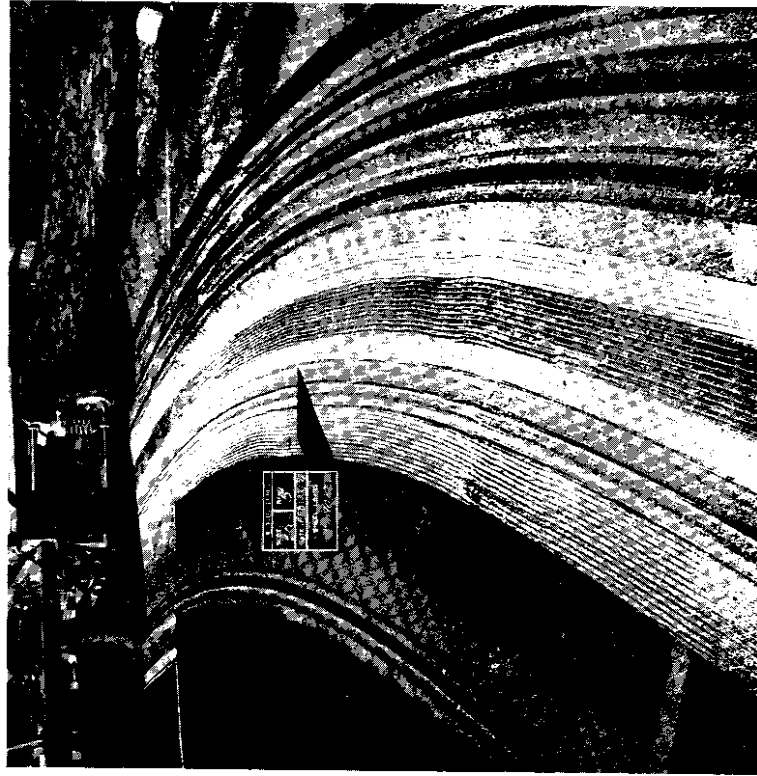
Figure 37: These photographs show Section 3a and the progressive wear shown on the pavement. At 600 w.a. the eccentricity was zero while at 49,190 w.a. the eccentricity was 0.50 inches. Note the center ridge in the center of the wheel paths in (b).

The use of photographs can show up many unusual features which data cannot bring to light. Hence a series of photographs are included for comparison purposes. Before and after photographs of the different sections are shown in Figures 33-44. Figures 33 and 43 are interesting in that they depict the miniature failures of the polymer concrete and Idaho chip seal sections, respectively. Figures 33 (a) and 37 (a) at 600 w.a. show the initial wear due to studs which looks worse than it is. The wear at 600 w.a. was unmeasurable. Figure 37 (b) shows that the eccentricity had to be increased

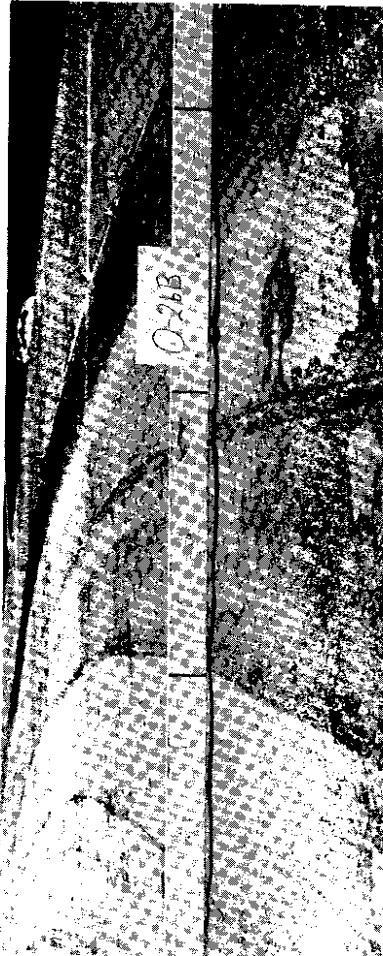
(c) Section 0-2bB  
Note the wear through the Polymer Concrete overlay.

Figure 47: Cross-section views of Wirand R and Polymer Concrete Sections Final Appearance.
