Bridge No. 12/915

Snake River Bridge Thin Overlay

WA-RD 101.1

Post-Construction Report
April 1987

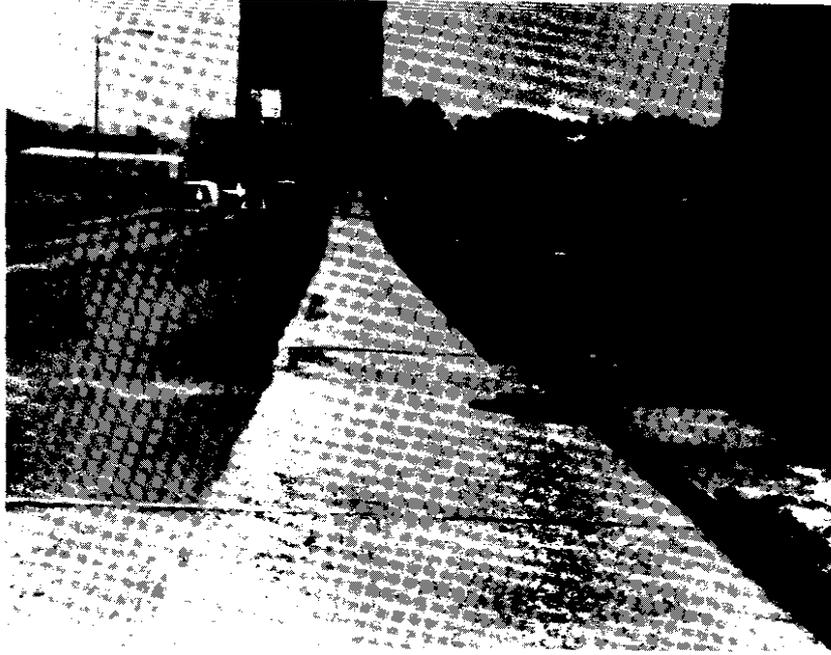
1/2 Stage 1 After Shot Blasting

- A. Deck Preparation
 - Cleaning was performed using a portable shot blast cleaning system.
 - Contractor covered the expansion joints and drains.
- B. Epoxy Mixing Operation

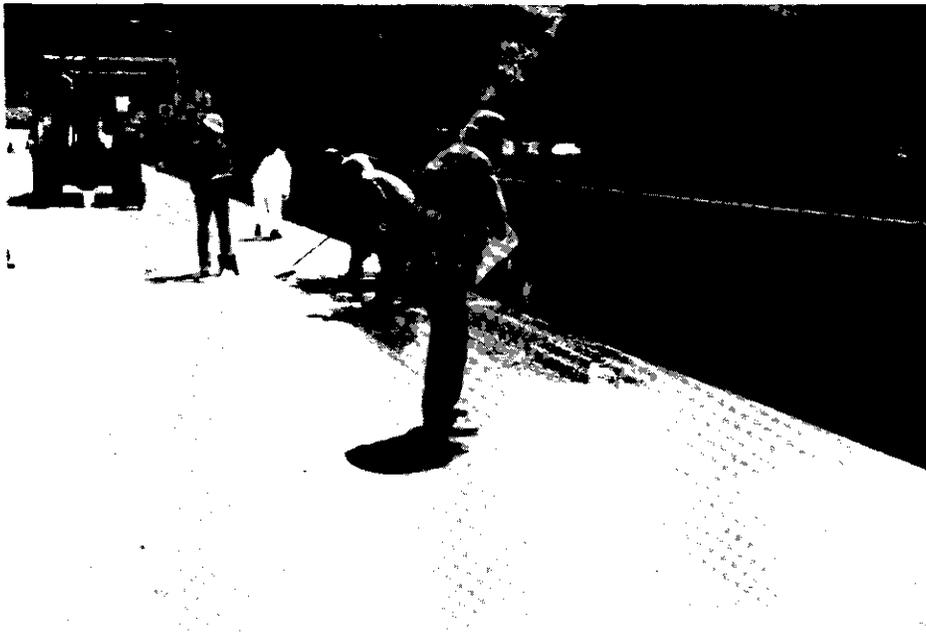
Stage 1 Epoxy Spreading and Aggregate Spreading by Hand

- Laborers filled five gallon buckets with the aggregate and then broadcast the aggregate by hand - similar to "feeding chickens."
- E. Removed excess aggregate from first lift of epoxy surface by sweeping.
