1. REPORT NO. WA-RD 361.1		2. GOVERNMENT ACCESSION NO.		3. RECIPIENT'S CATALOG NO.	
4. TITLE AND SUBTITLE "Seismic Vulnerability of Strutted-Column Bridge Bents"				5. REPORT DATE December 1995

**Technical Report**  
for  
Research Project T9234-16  
"Seismic Vulnerability of Strutted-Column Bridge Bents"

**SEISMIC VULNERABILITY OF  
STRUTTED-COLUMN BRIDGE BENTS**

Glen J. Pappas and M. Lee Marsh  
**Washington State Transportation Center (TRAC)**  
Washington State University  
101 Sloan Hall  
Pullman, Washington 99164-2910

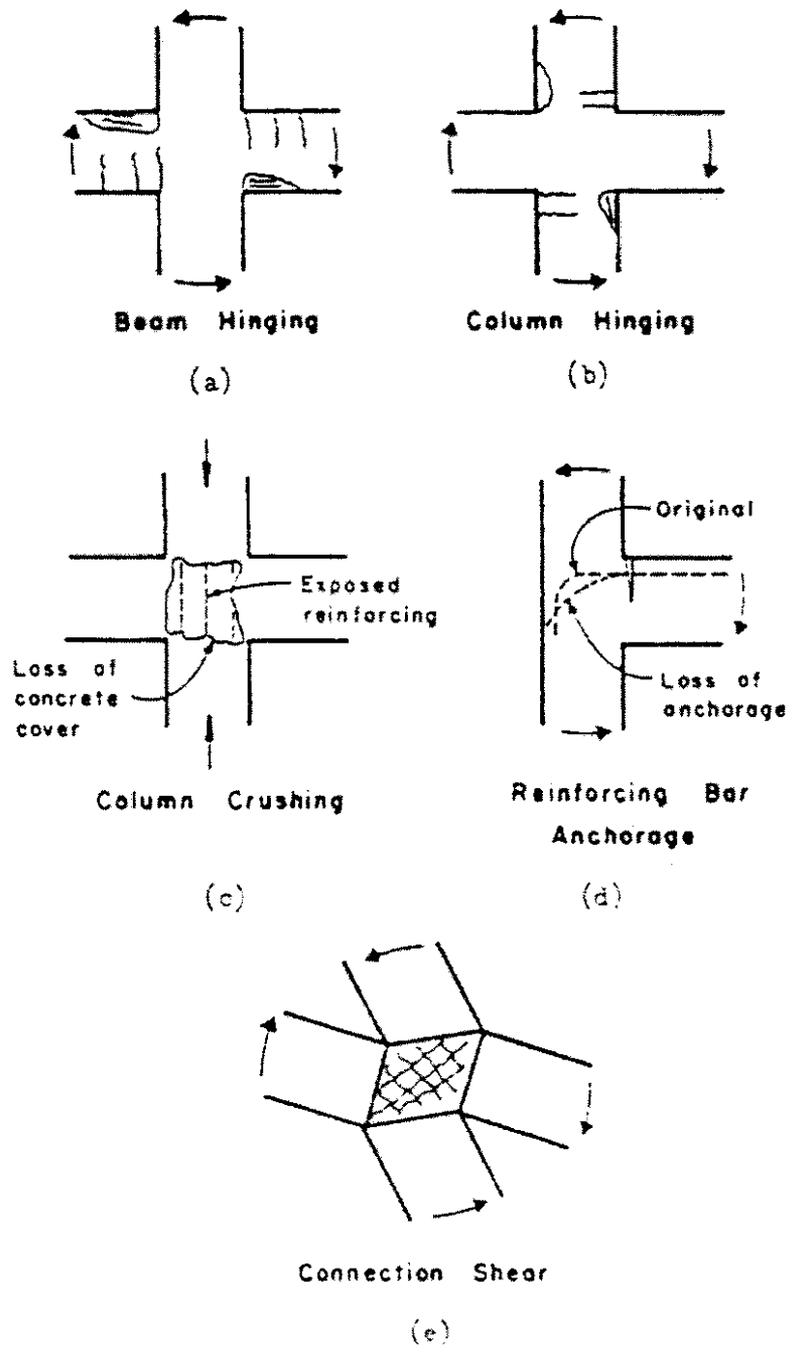
Figure 10 Potential failure modes of B-C joint regions (from Meinheit et al. 1981).

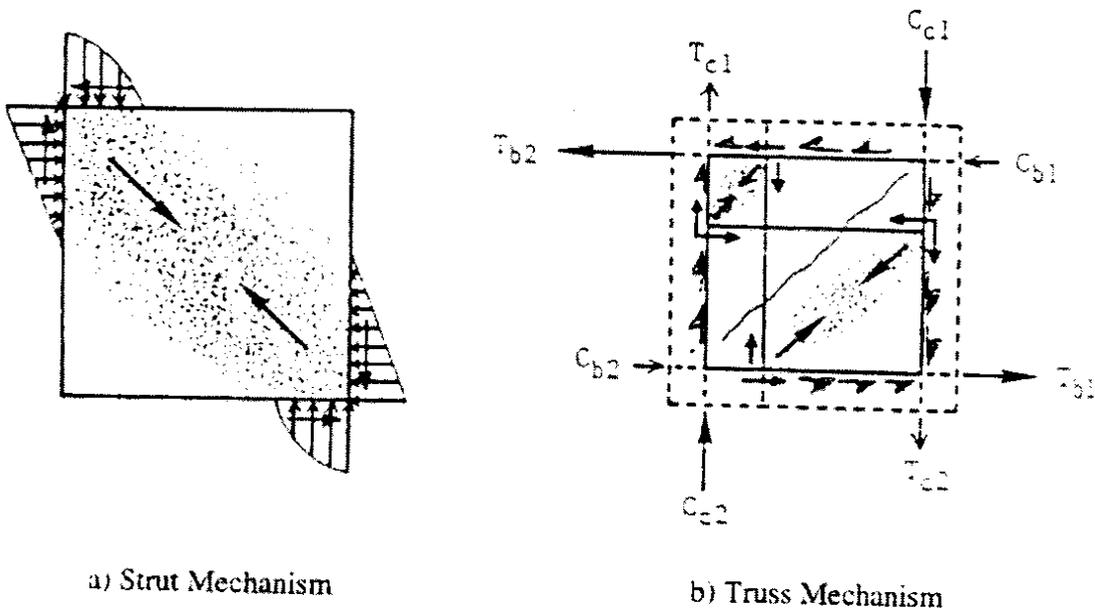
Figure 11 Mechanisms of seismic shear transfer in B-C joints (from Kitayama et al. 1991).

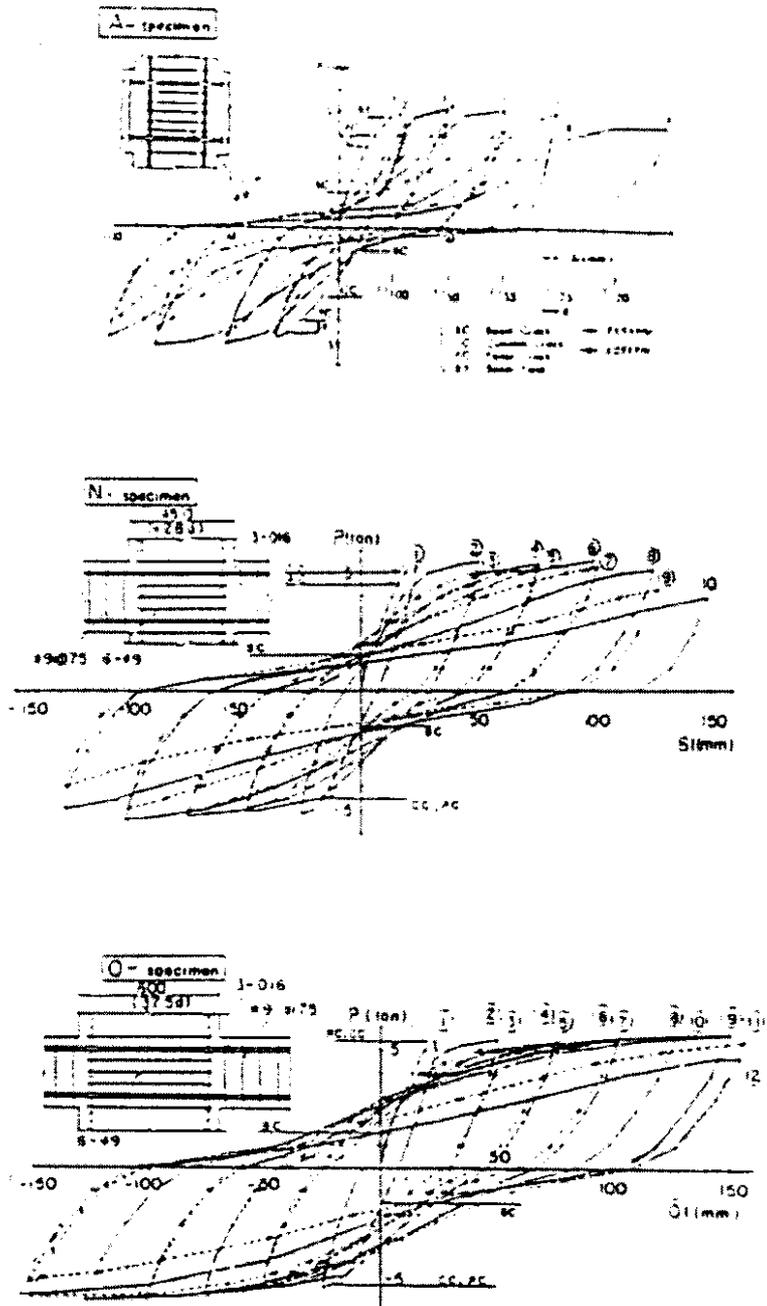
Figure 14 "Beam shear force -- story drift curves for selected specimens" (from Kaku et al. 1991).

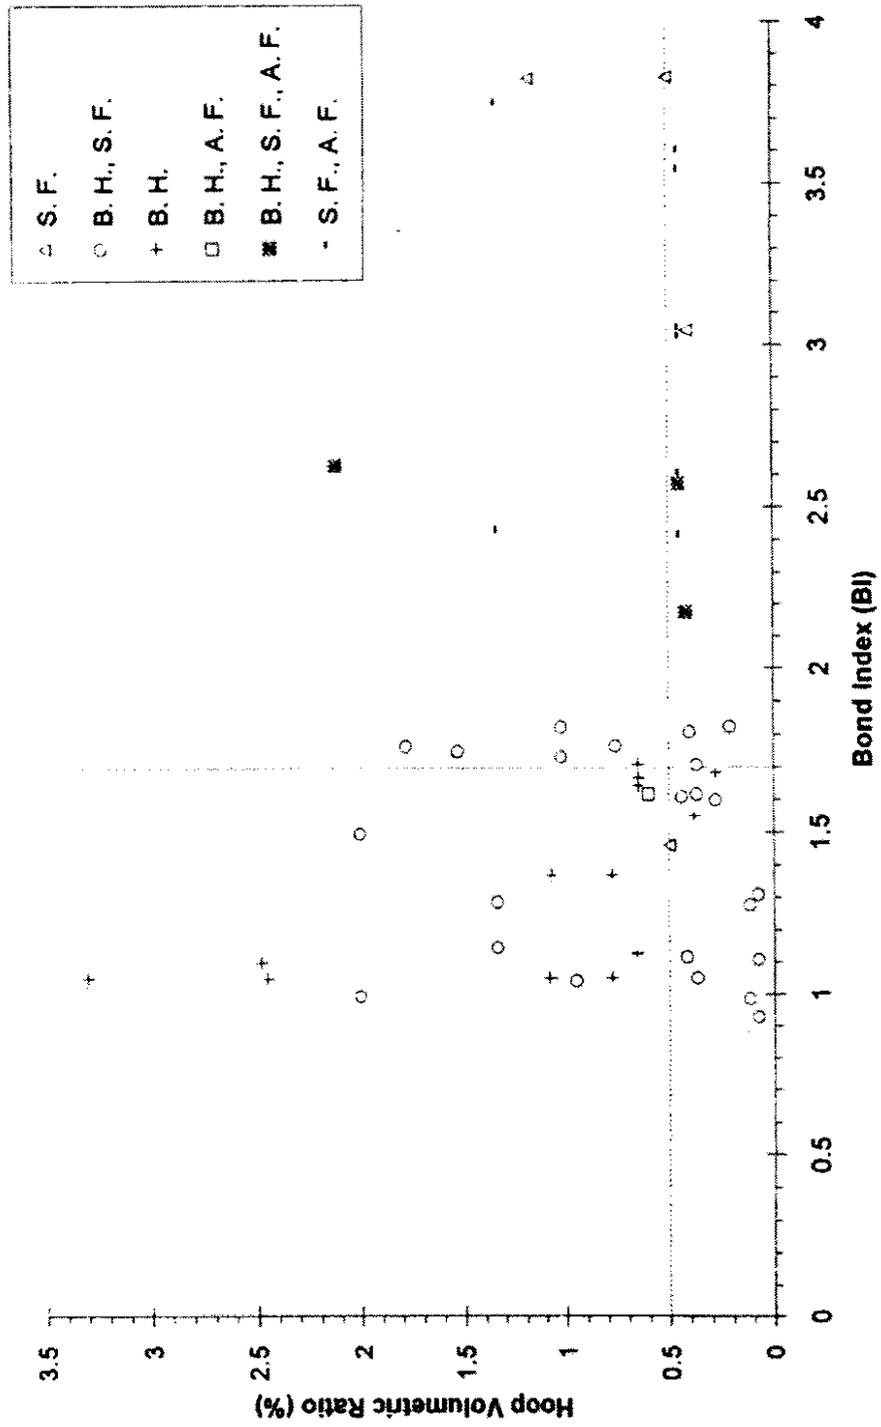
Figure 22 Bond index (BI) versus volumetric hoop ratio ( $\rho_s$ , %).

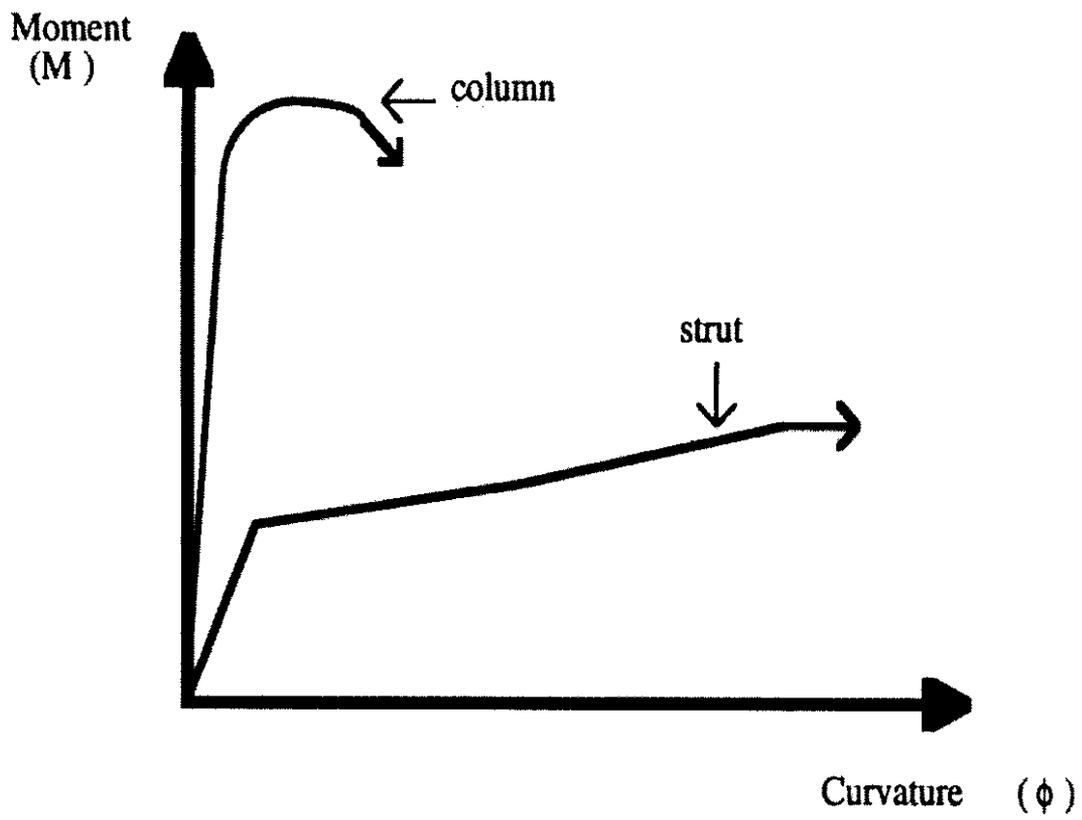
Figure 25 Typical M- $\phi$  relations for the columns and for the struts in the inventory.

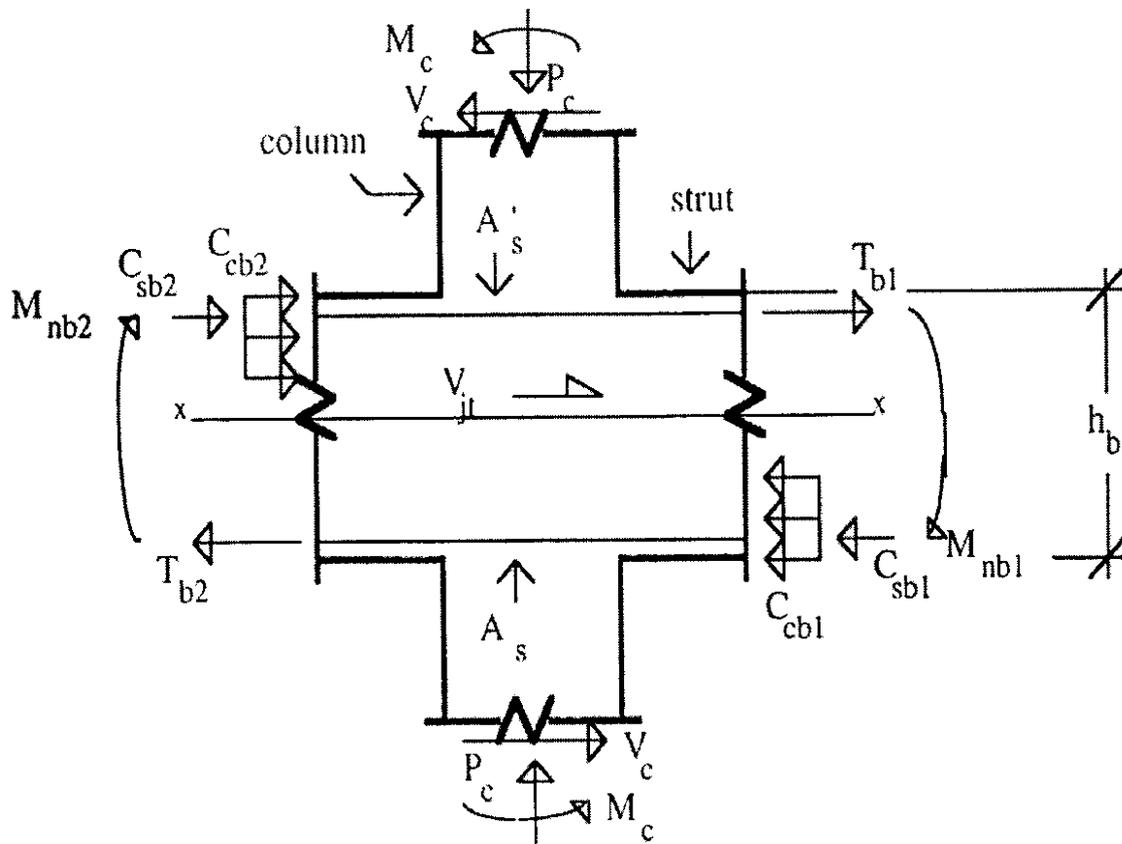
Figure 27 Actions on an interior joint that determine  $v_{jt}^*$ .

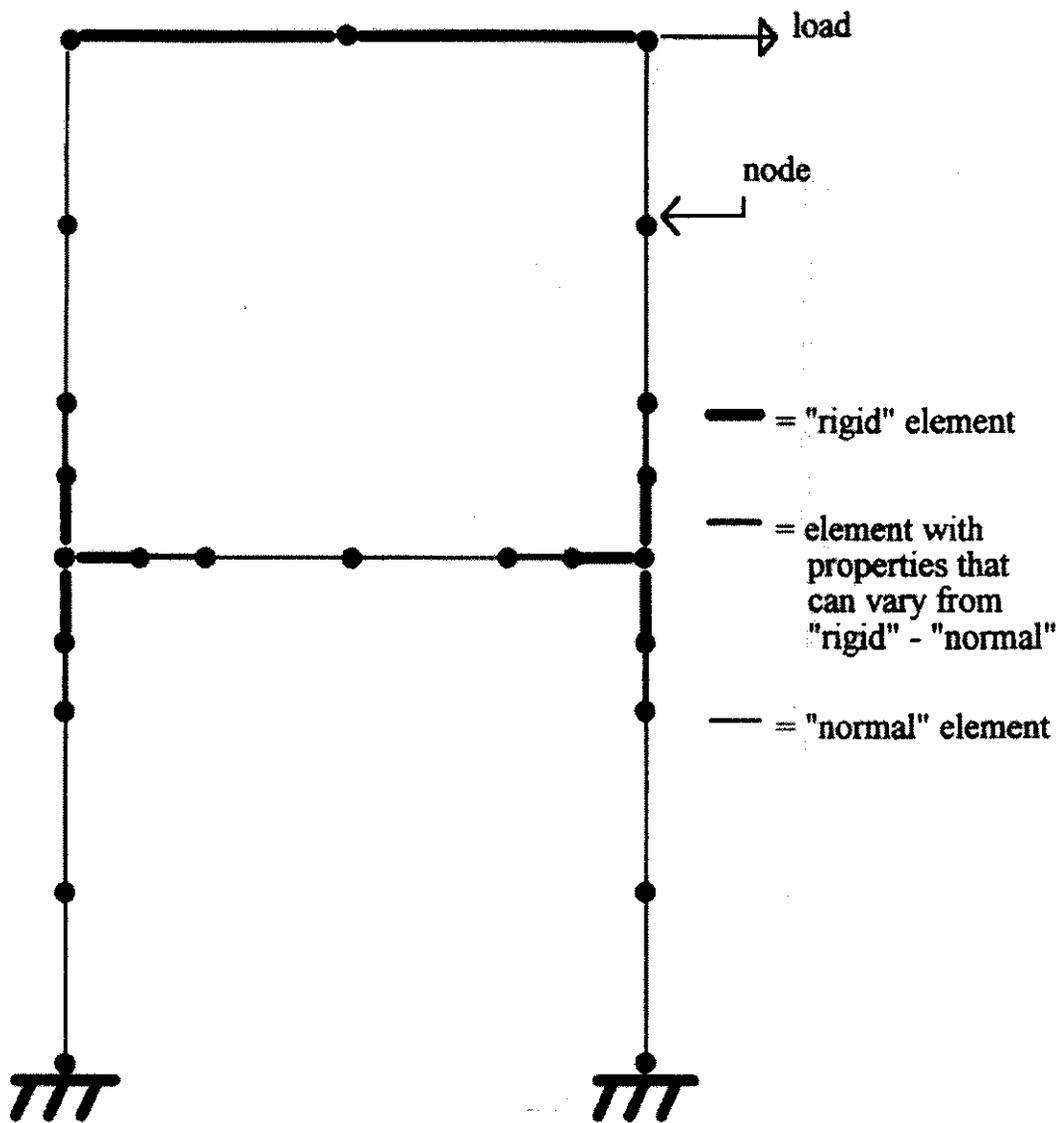
Figure 30 Typical model of a bent used for limit analyses in the *EPFO* and the *IDARC* software.

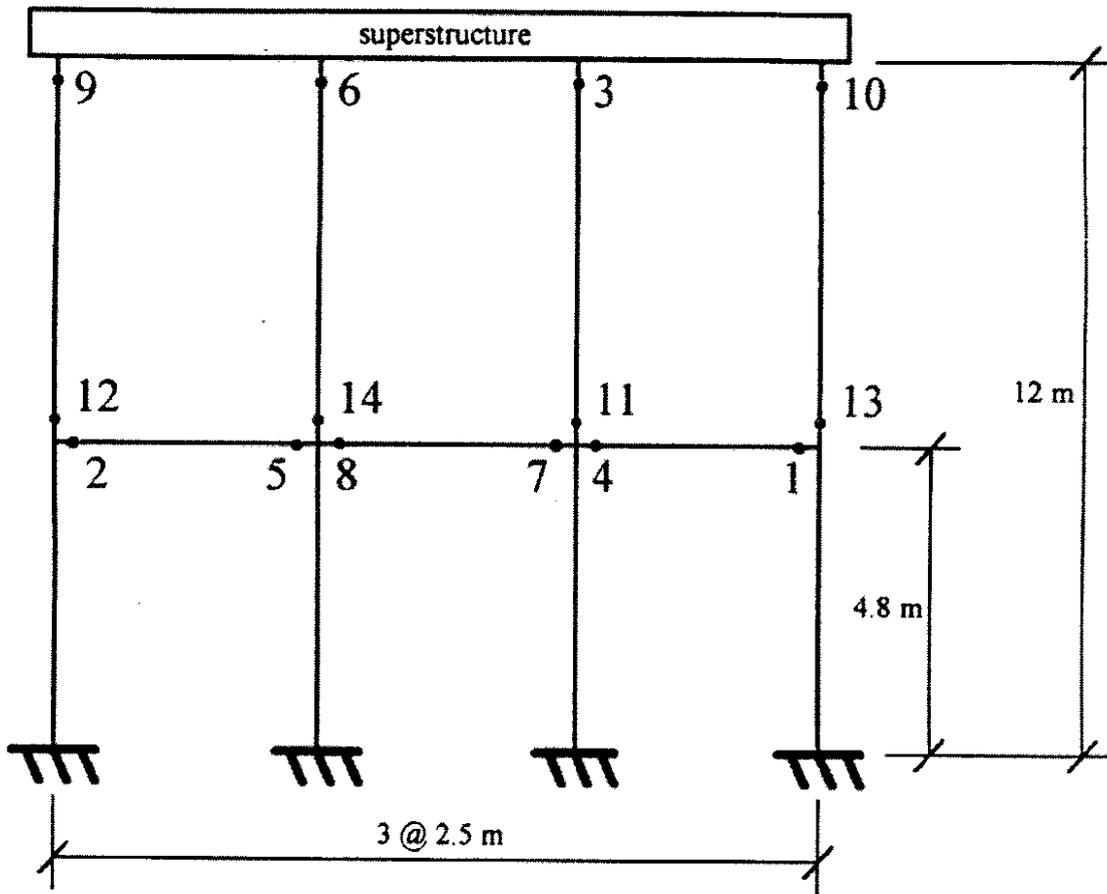
Figure 33 Model bent used to represent the flexural hinge formation sequence in multiple-column bents with rectangular columns.

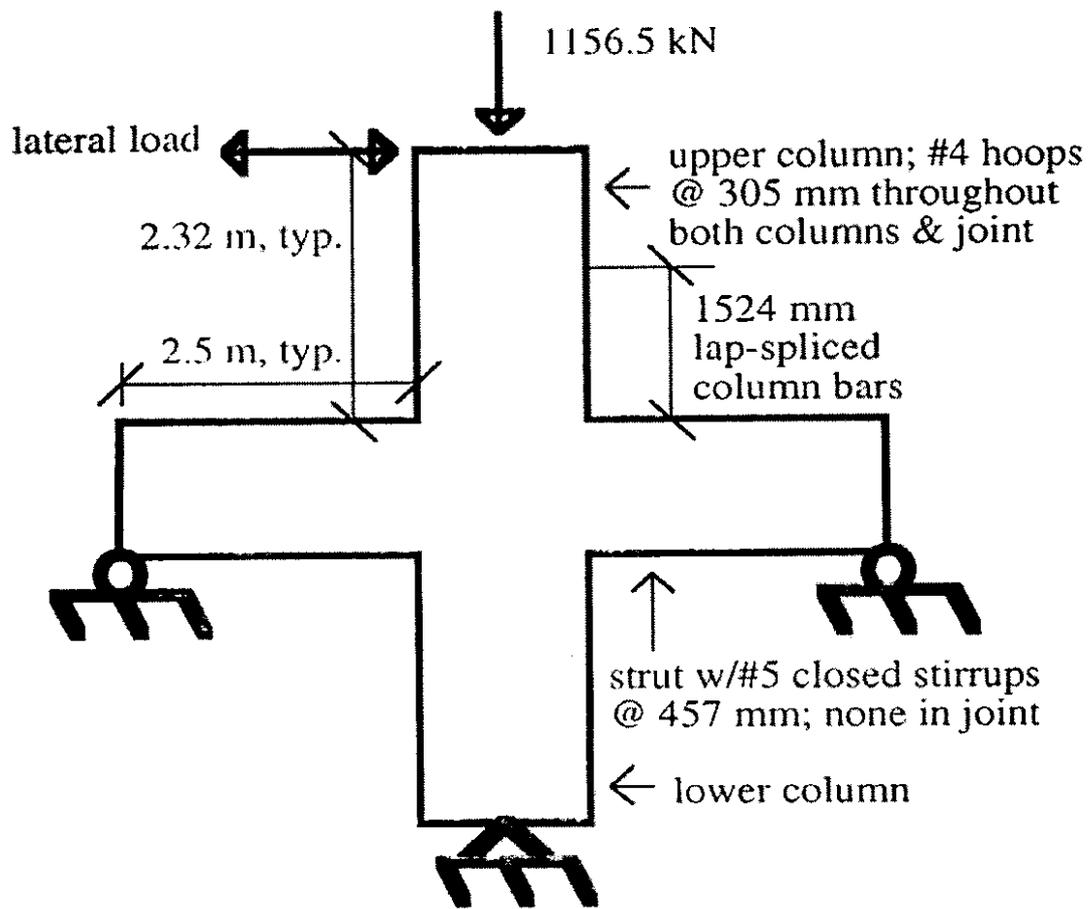
Figure 35 Prototype subassembly designs.

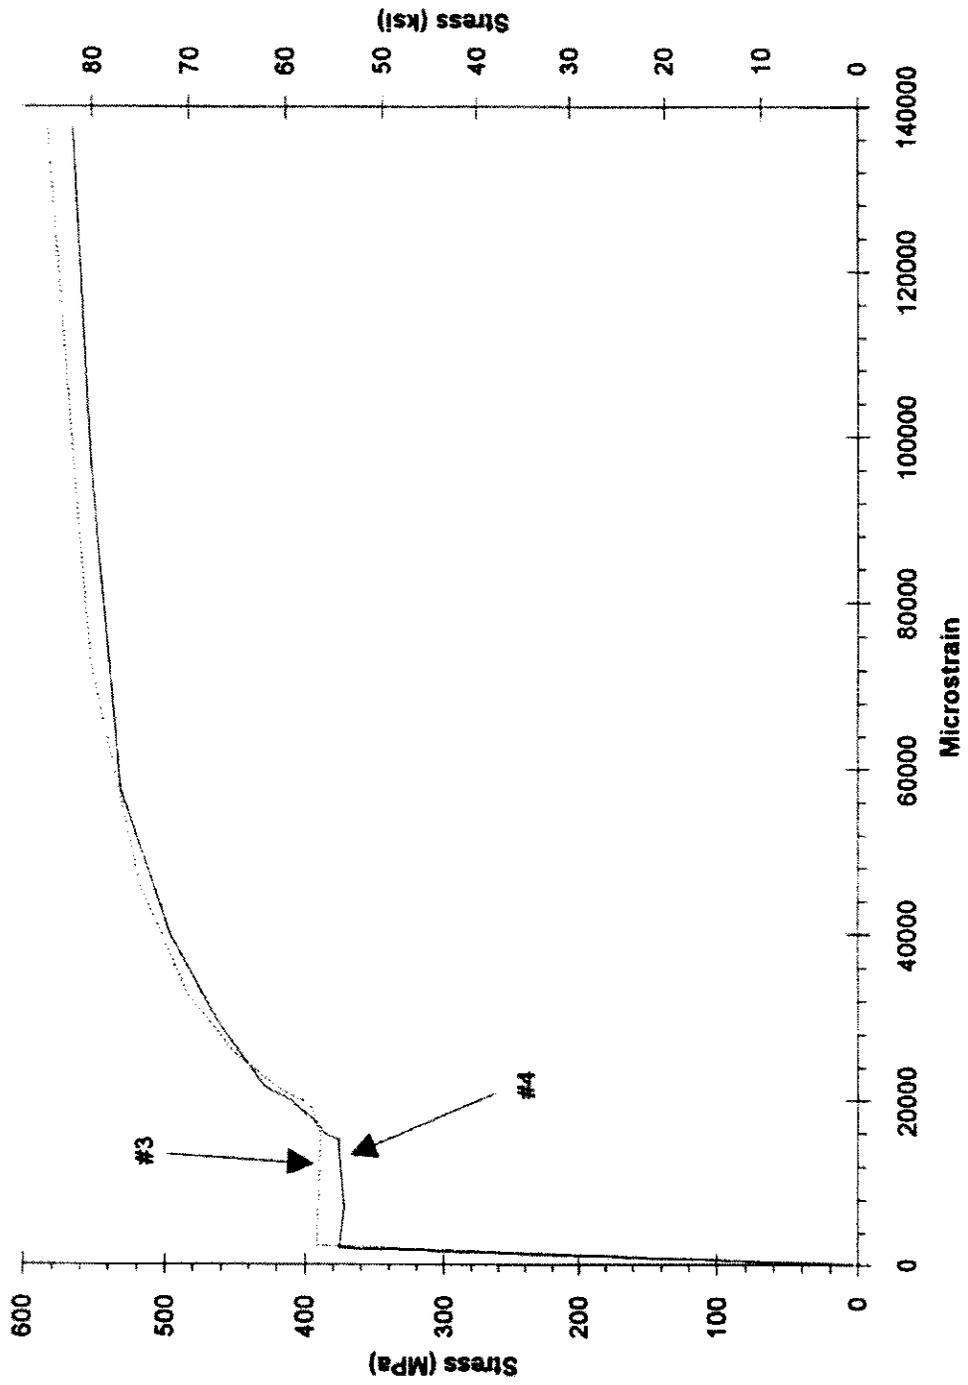
Figure 39 Typical stress versus strain plots for the #4 and #3 bars used in Units I and II.

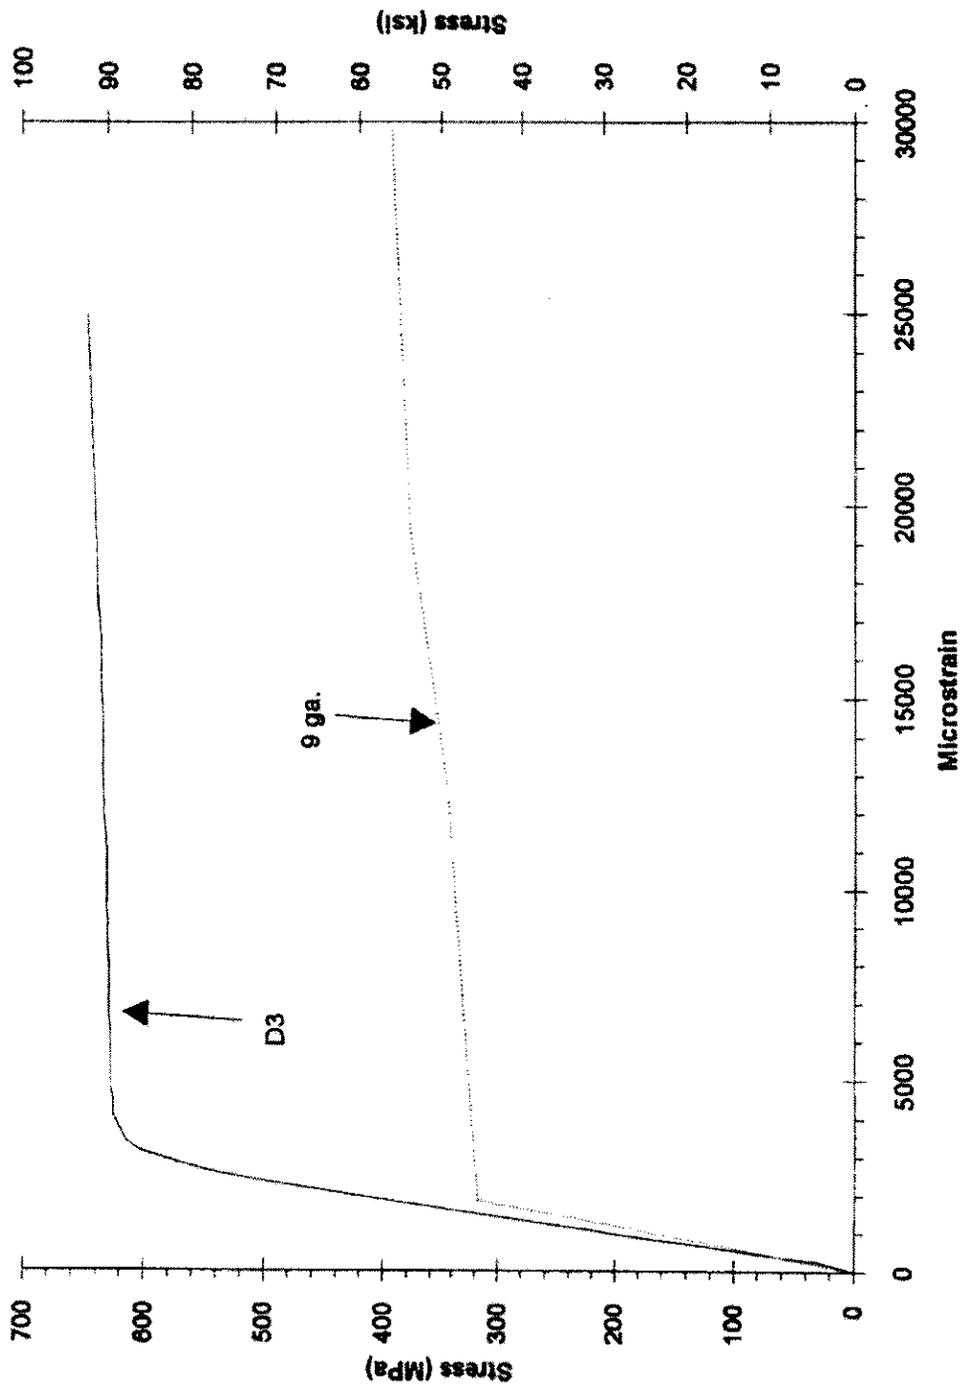
Figure 40 Typical stress versus strain plots for the D3 and 9 Ga wire used in Units I and II.

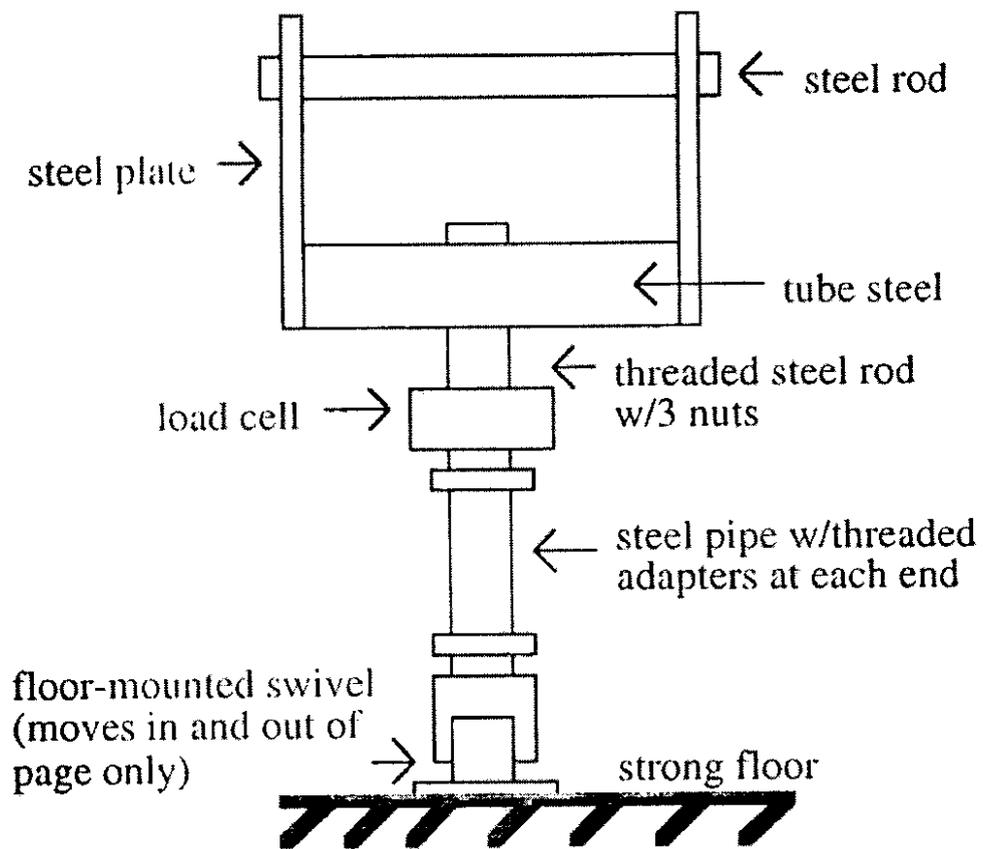
Figure 41 Sketch of the structure used as a "roller" support fixture at the free ends of the struts in the specimens.

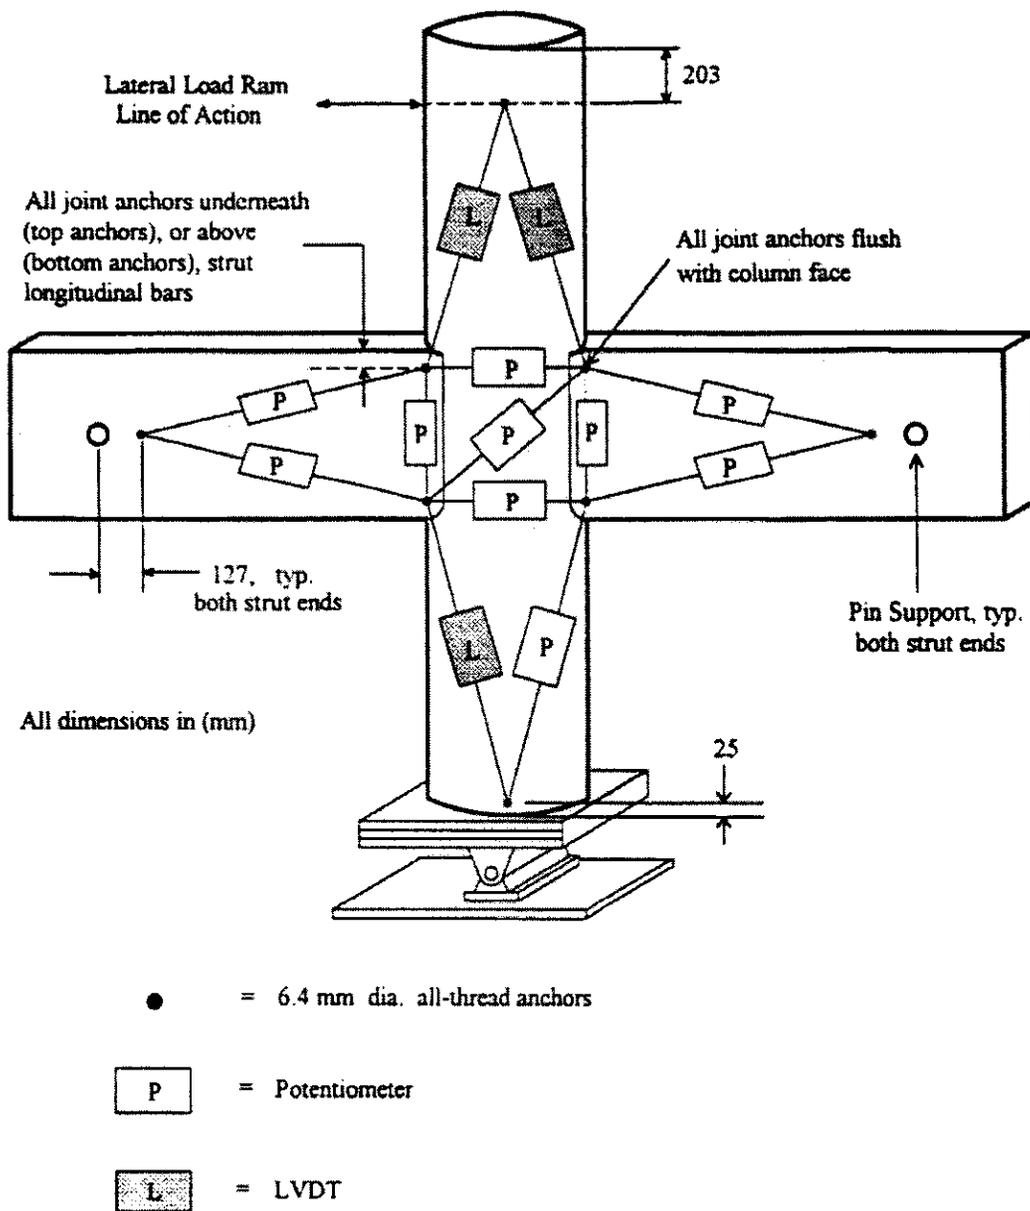
Figure 55 Layout of the instrument array used to measure joint distortion and member rotation (pot.'s and LVDT's).

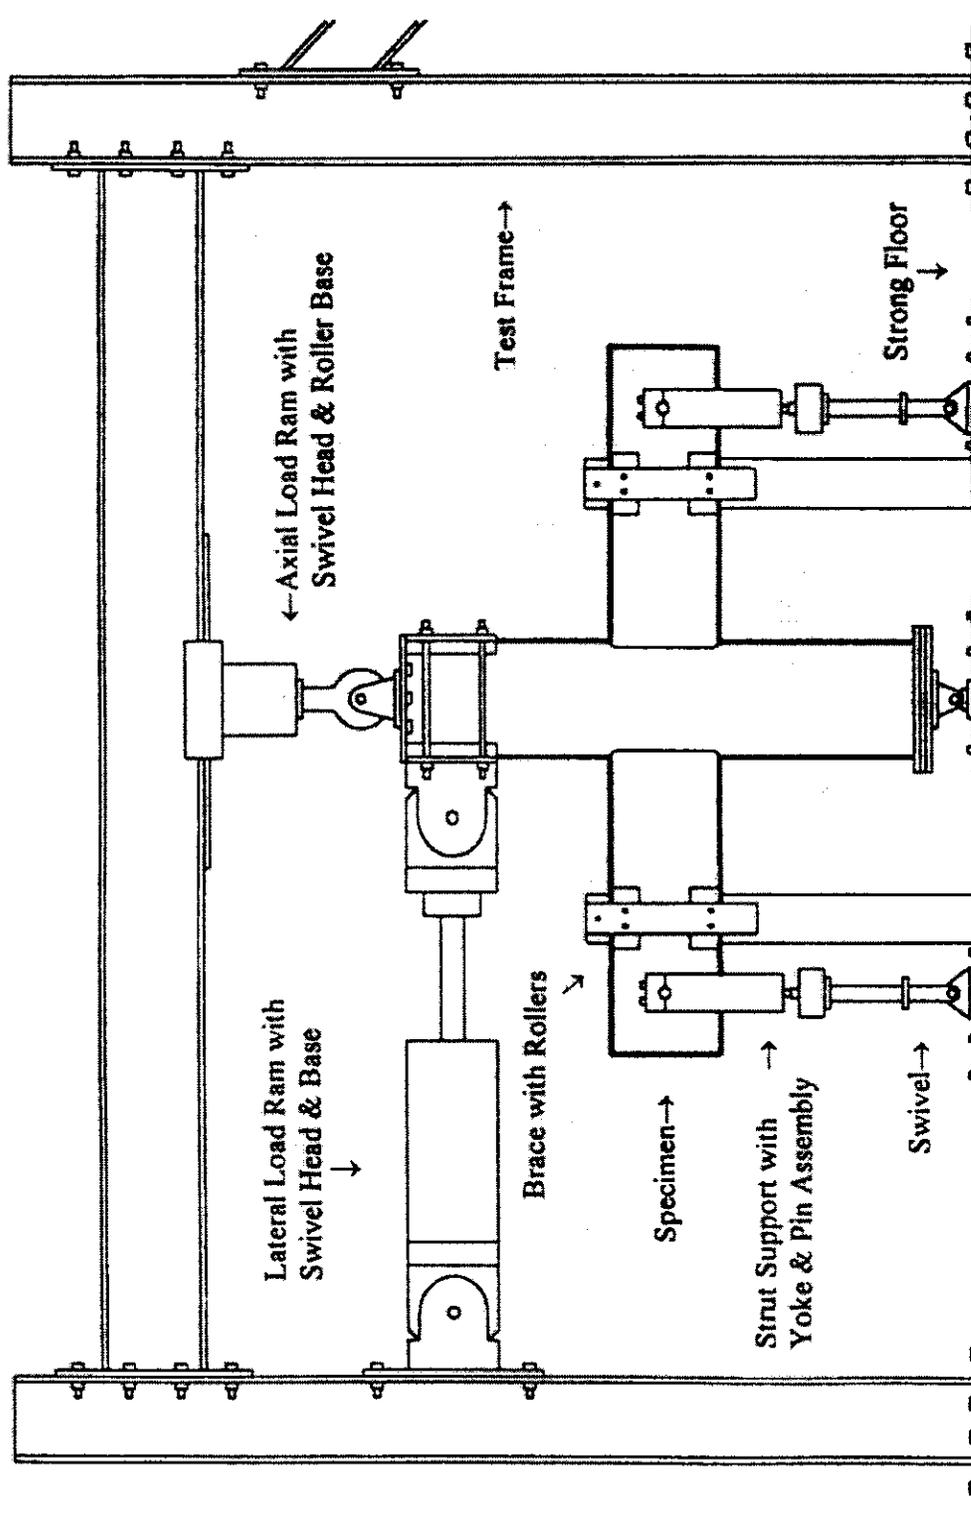
Figure 58 Unit I in the test frame with the load actuators and the fixtures.

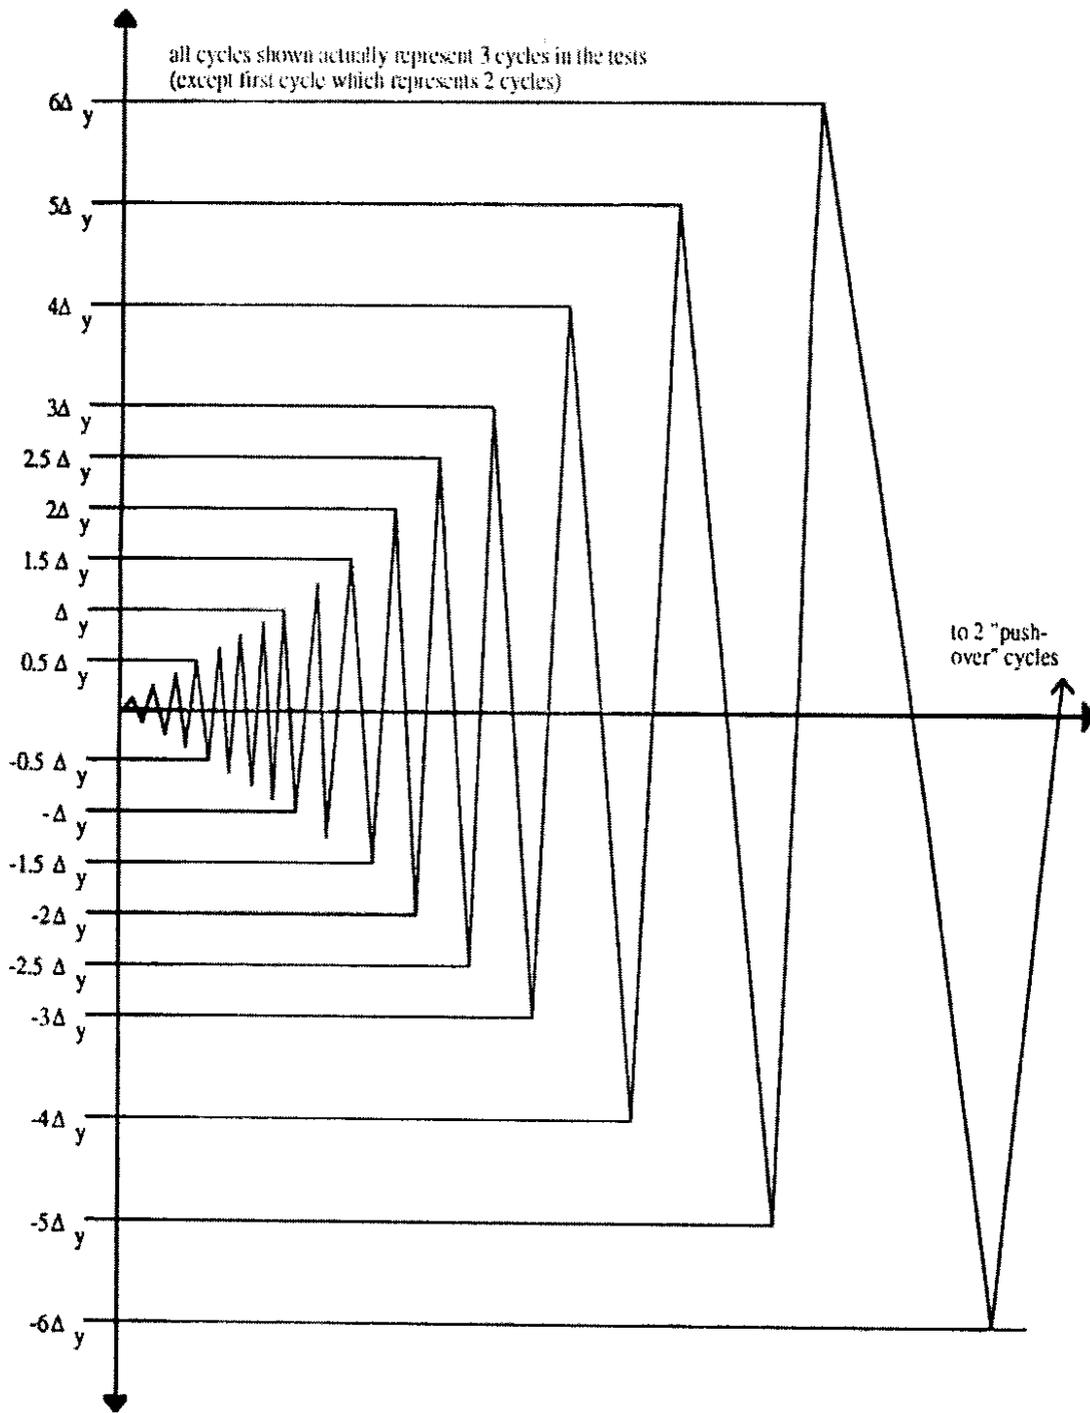
Figure 59 Displacement history used for the test specimens.

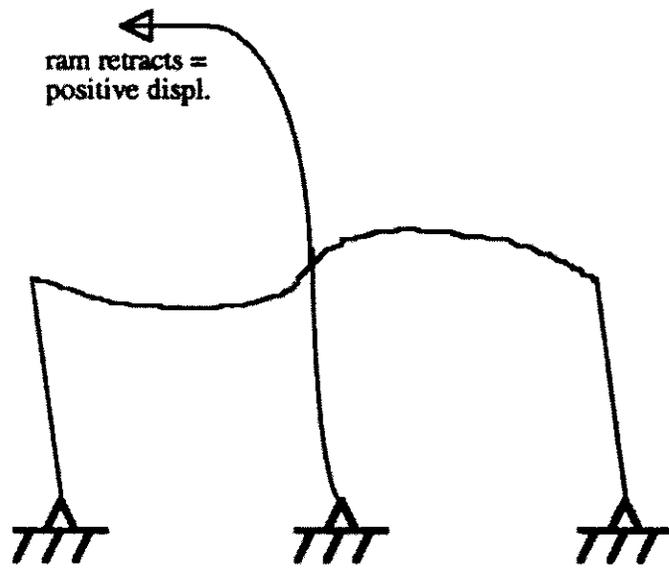
Figure 61 The displacement convention used in the tests.

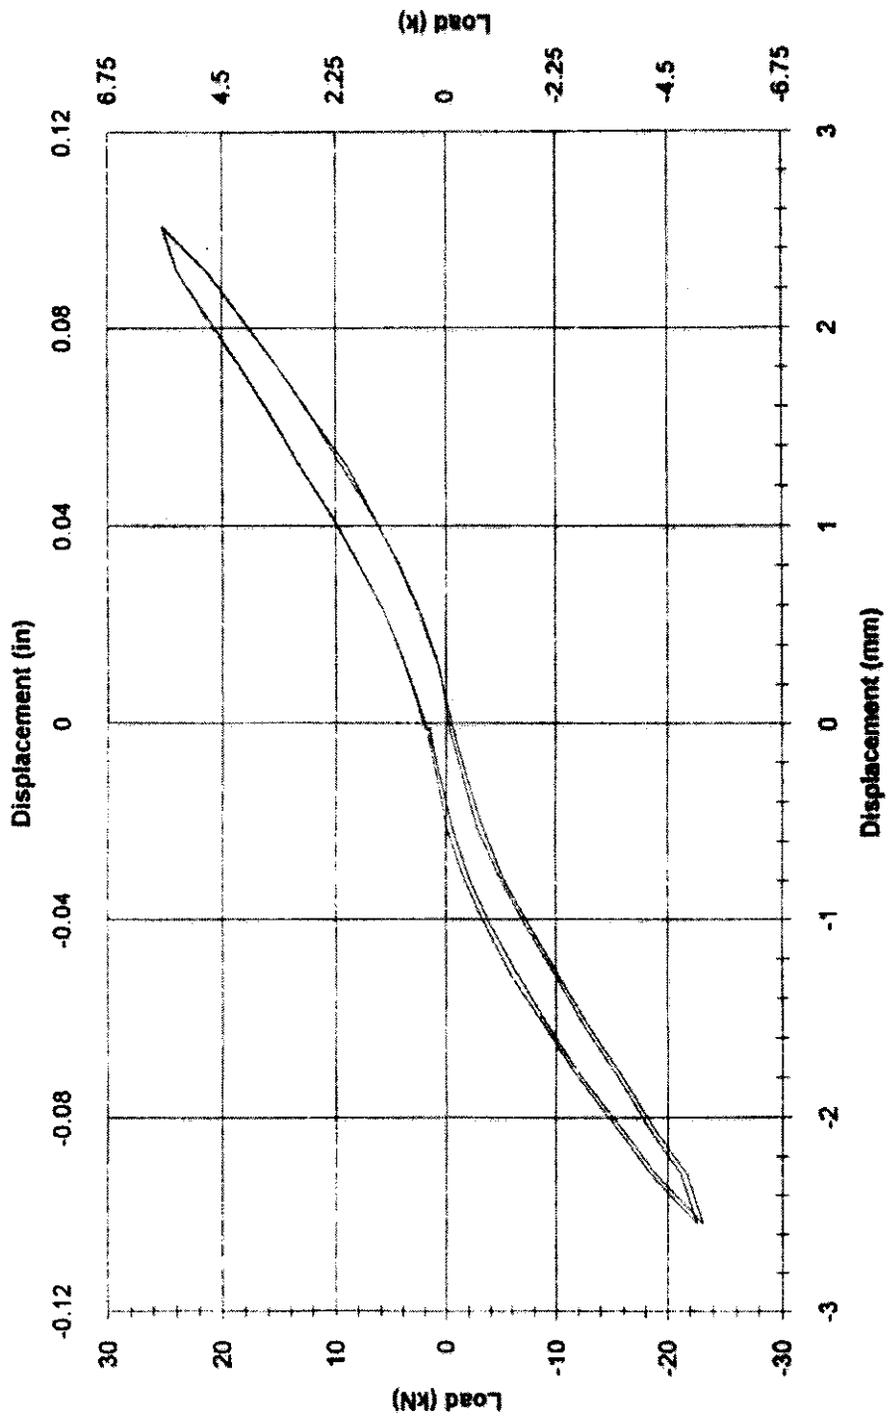
Figure 62 Hysteresis loops for Unit I (two cycles to 2.54 mm).

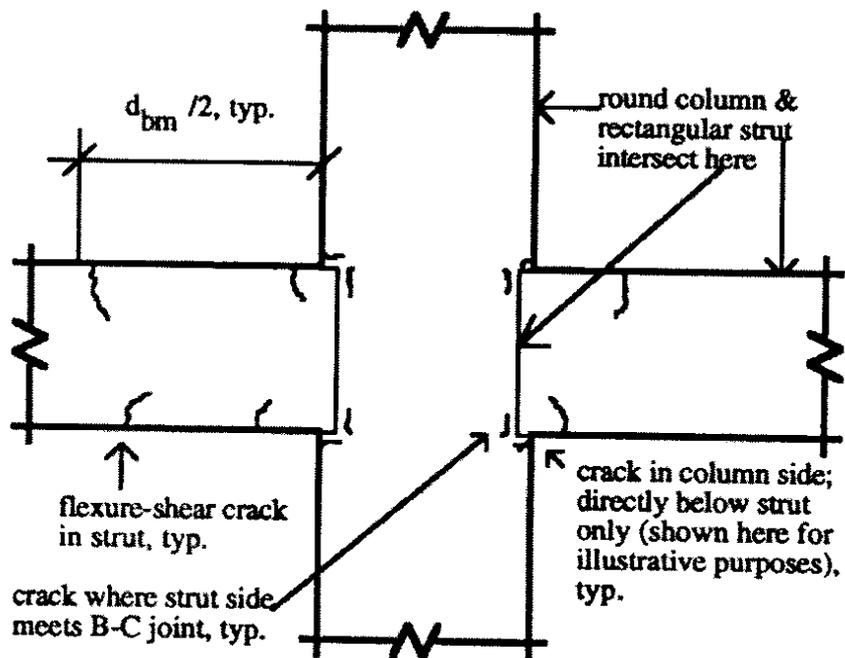
Figure 63 Cracking typically observed in Unit I through the cycles to 12.7 mm.

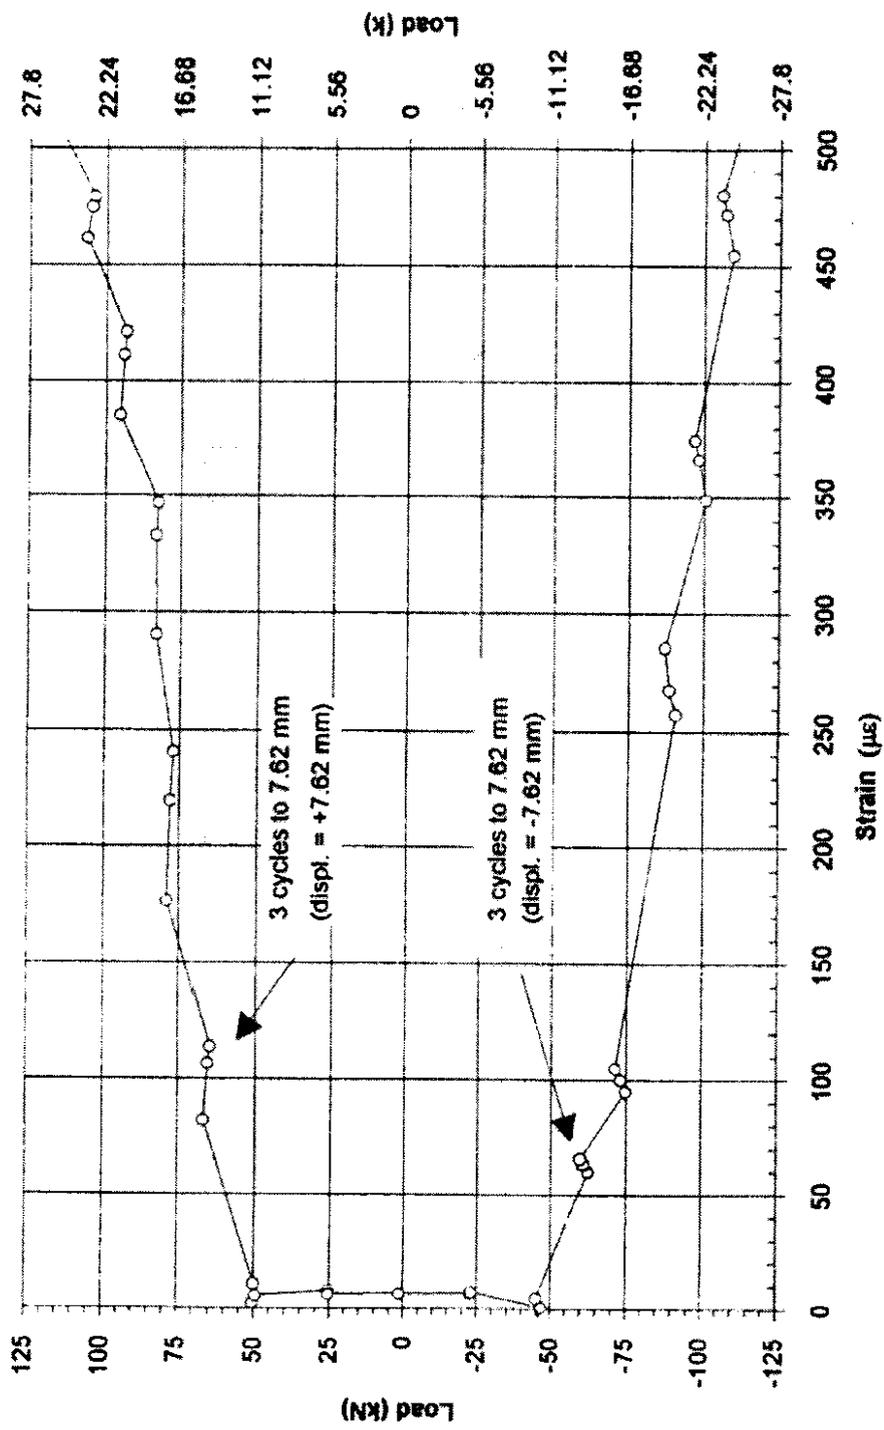
Figure 64 Load versus strain for hoop AJ in Unit I (at the displacement peaks early in the test).

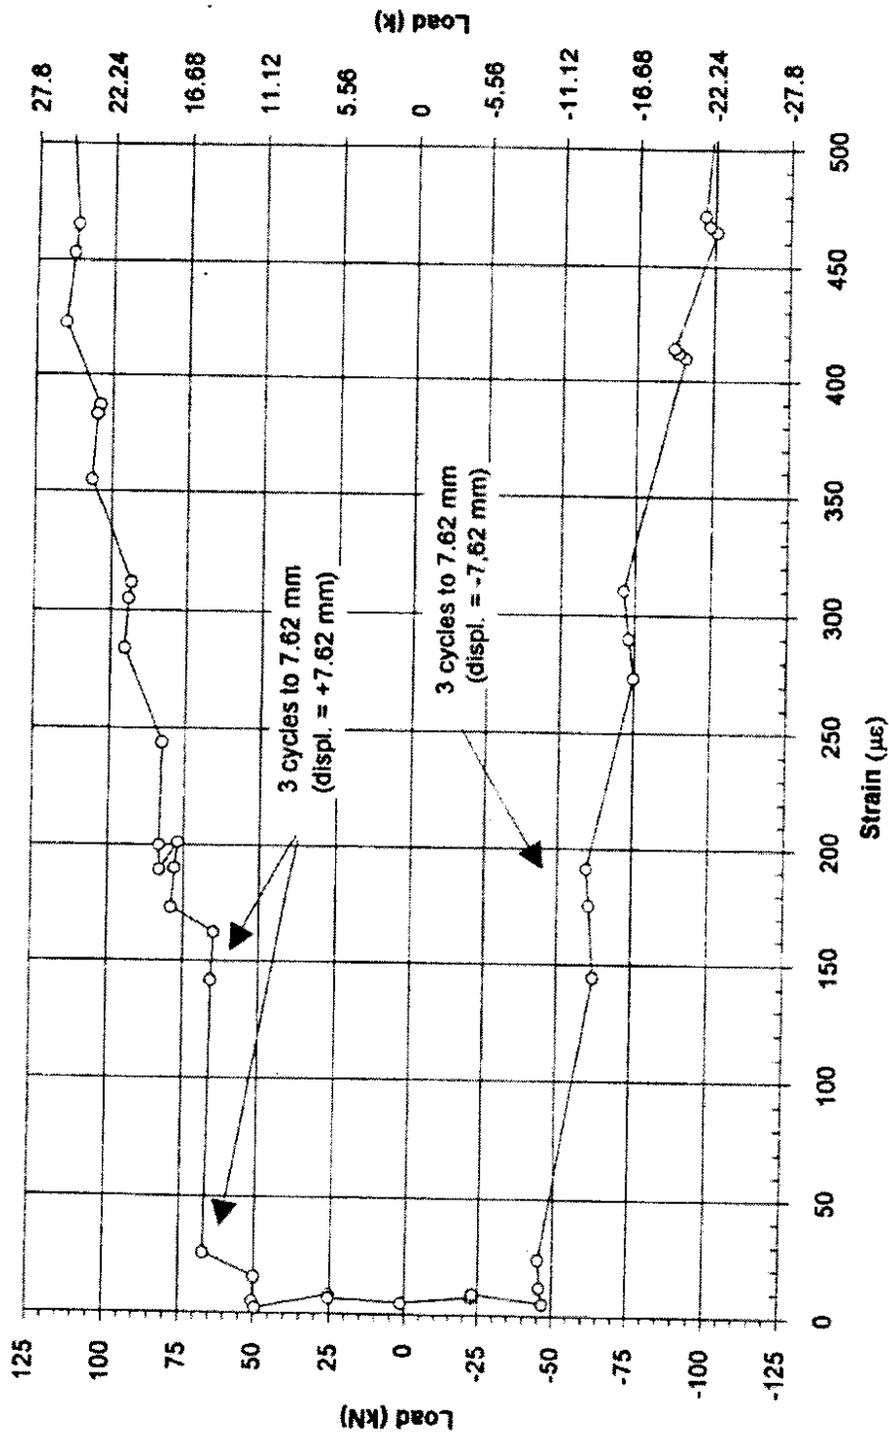
Figure 65 Load versus strain for hoop JB -- front face of B-C joint in Unit I (at the displacement peaks early in the test).
