1. REPORT NO. WA-RD 361.1		2. GOVERNMENT ACCESSION NO.		3. RECIPIENT'S CATALOG NO.	
4. TITLE AND SUBTITLE "Seismic Vulnerability of Strutted-Column Bridge Bents"				5. REPORT DATE December 1995

**Technical Report**  
for  
Research Project T9234-16  
"Seismic Vulnerability of Strutted-Column Bridge Bents"

**SEISMIC VULNERABILITY OF  
STRUTTED-COLUMN BRIDGE BENTS**

Glen J. Pappas and M. Lee Marsh  
**Washington State Transportation Center (TRAC)**  
Washington State University  
101 Sloan Hall  
Pullman, Washington 99164-2910

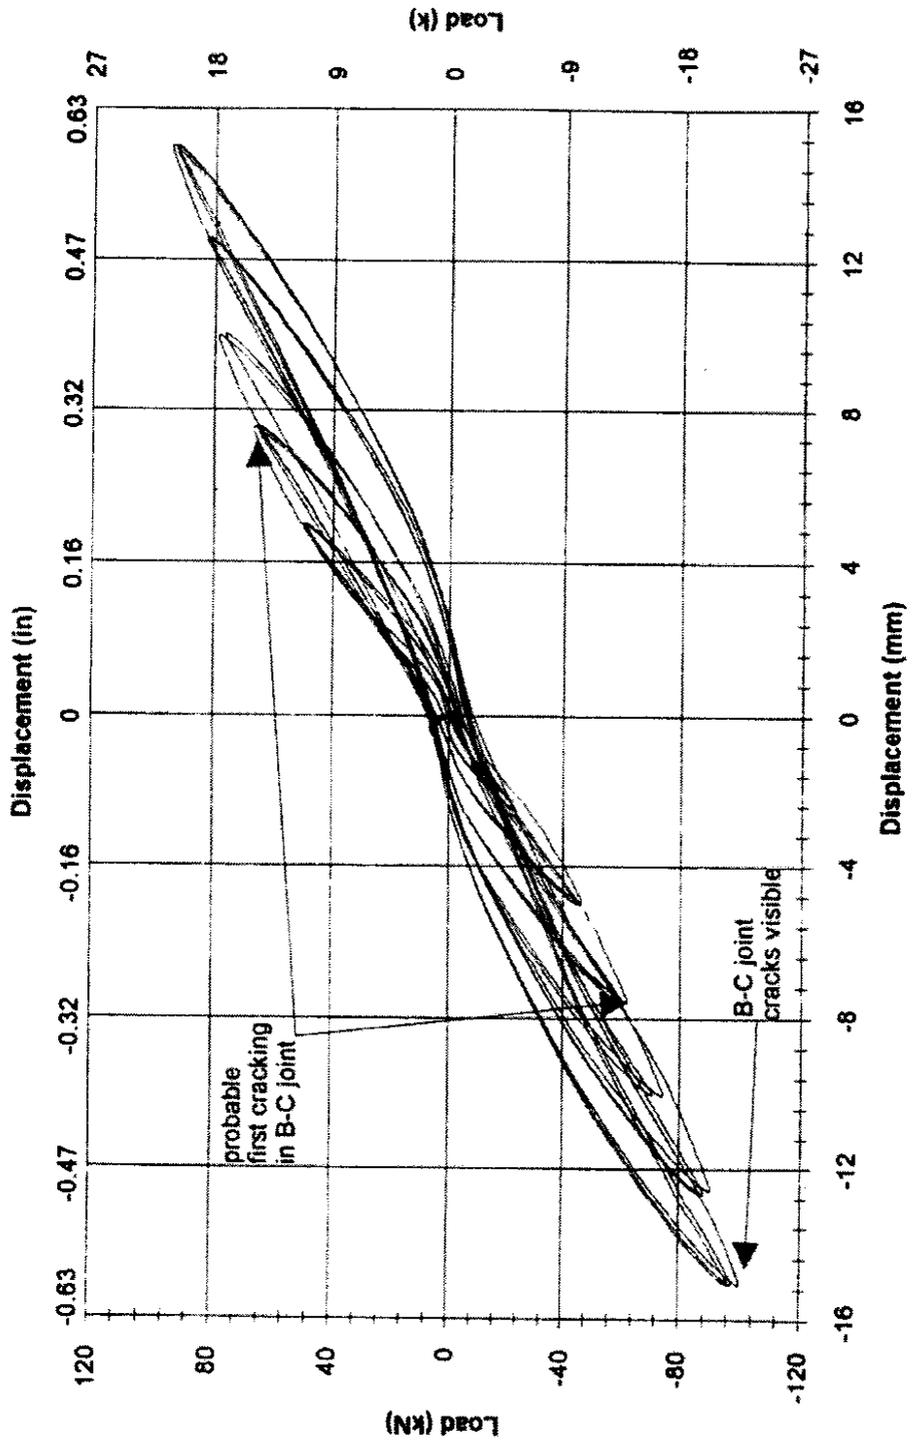
Figure 67 Hysteresis loops for Unit I (cycles through 15.24 mm).

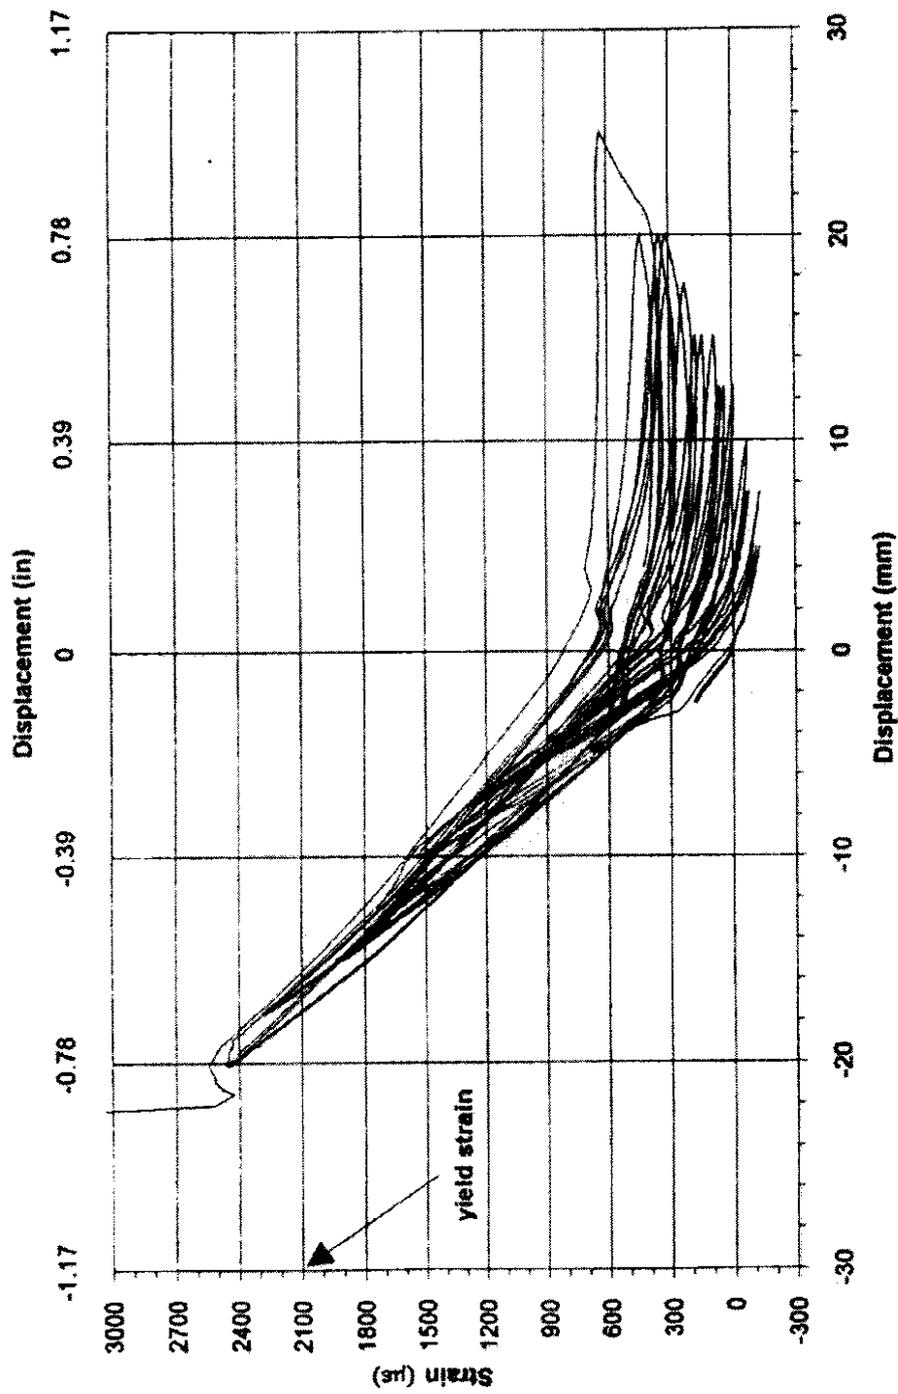
Figure 68 Typical strain history at the locations adjacent to the B-C joint for the main bars in the struts in Unit I (at the fixed-end of the right strut in one of the lower main bars).

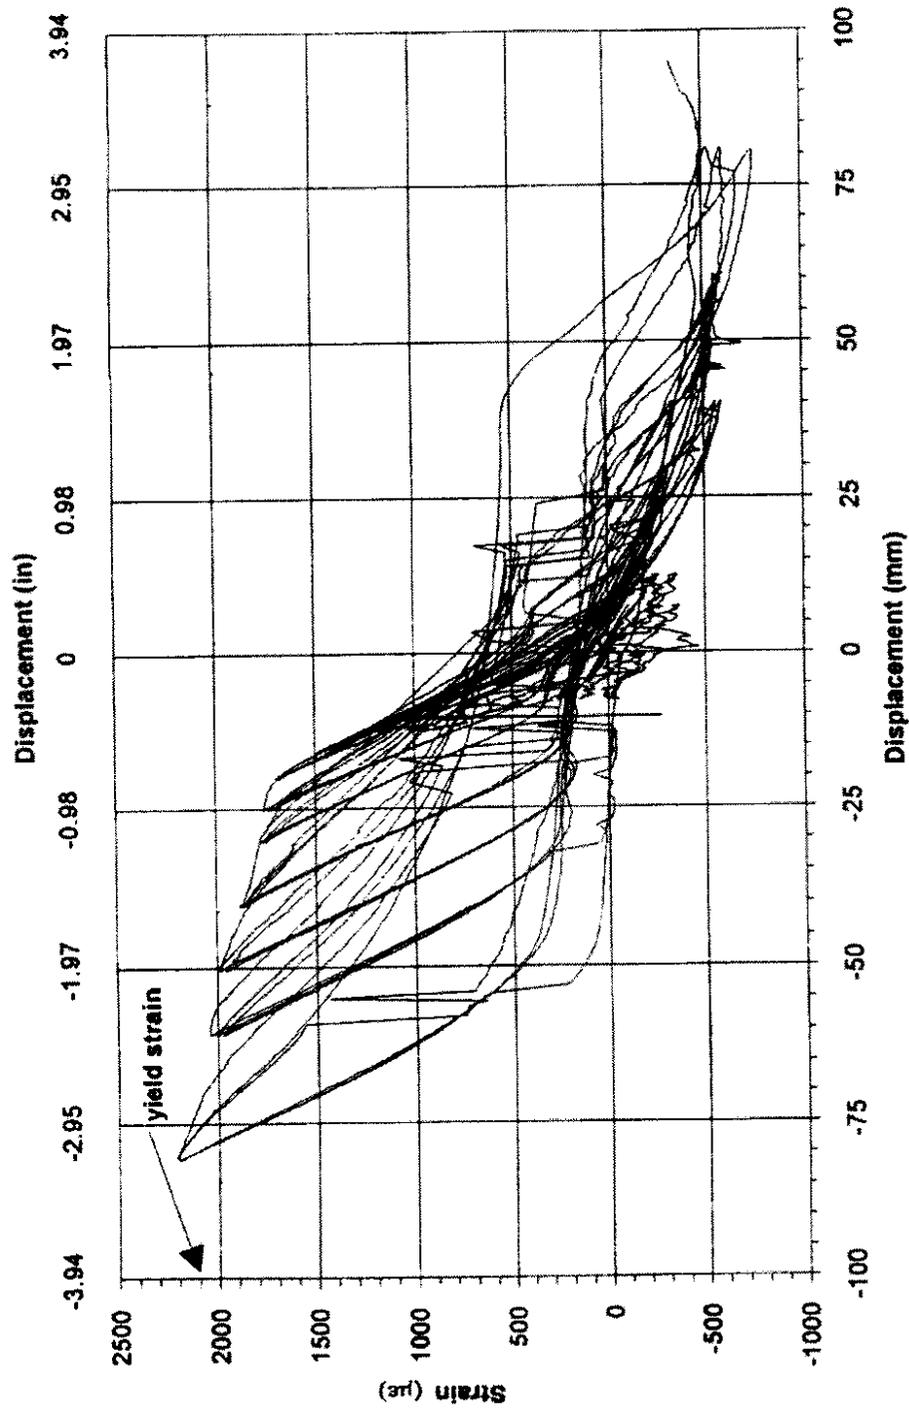
Figure 69 Typical strain history at the locations near the expected plastic hinge regions for the main bars in the struts in Unit I (near the fixed-end of the right strut in the lower main bar).

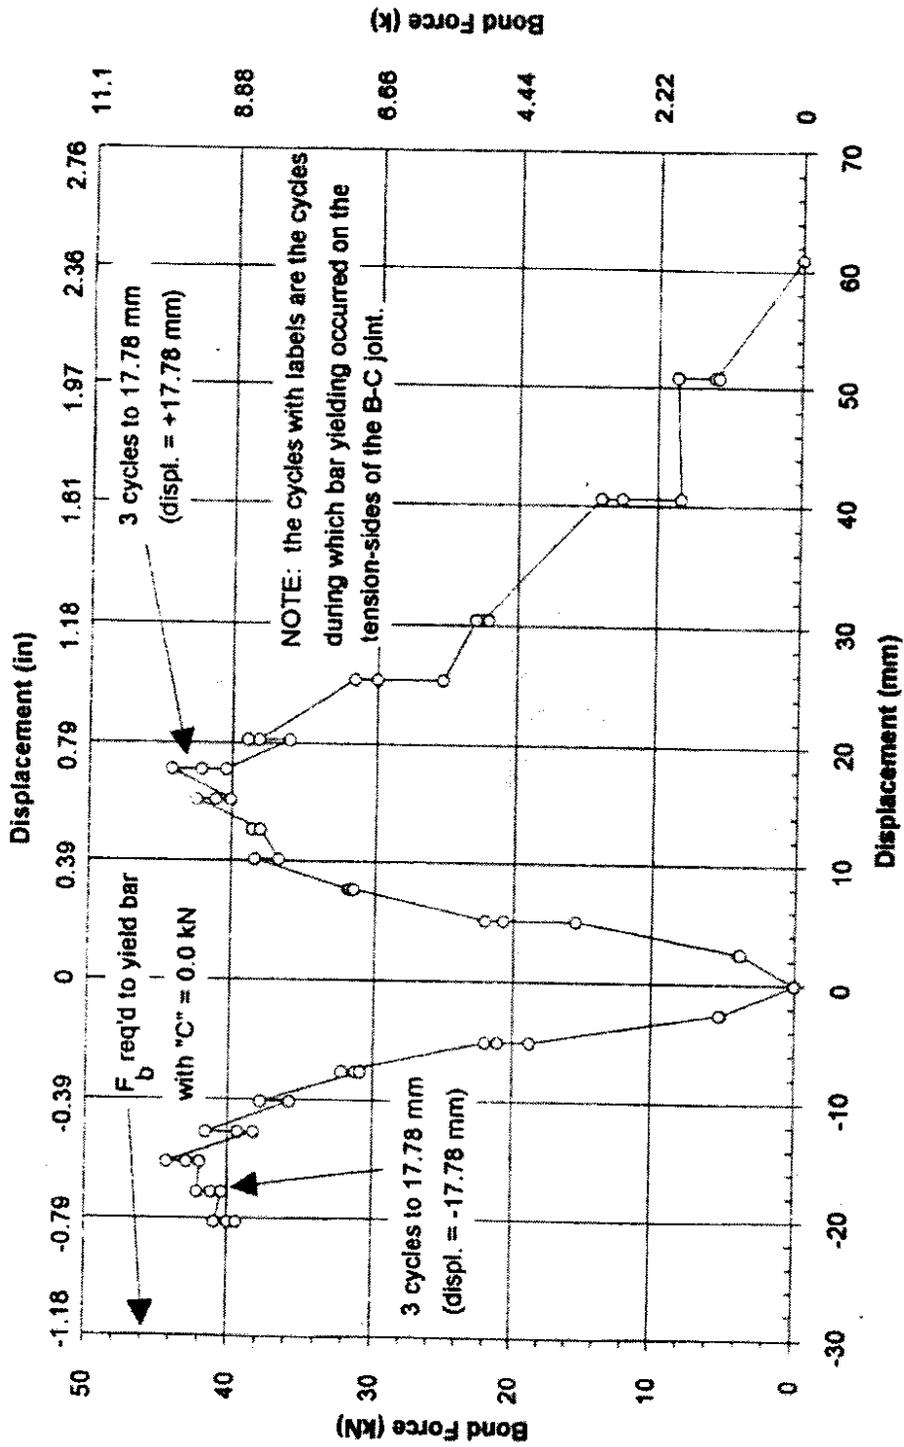
Figure 70 Bond force in a strut lower main bar versus displacement for Unit I (at the displacement peaks).

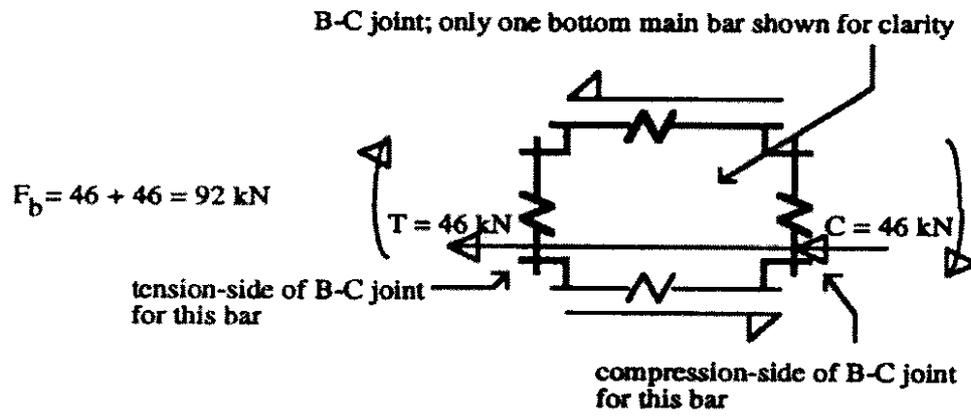
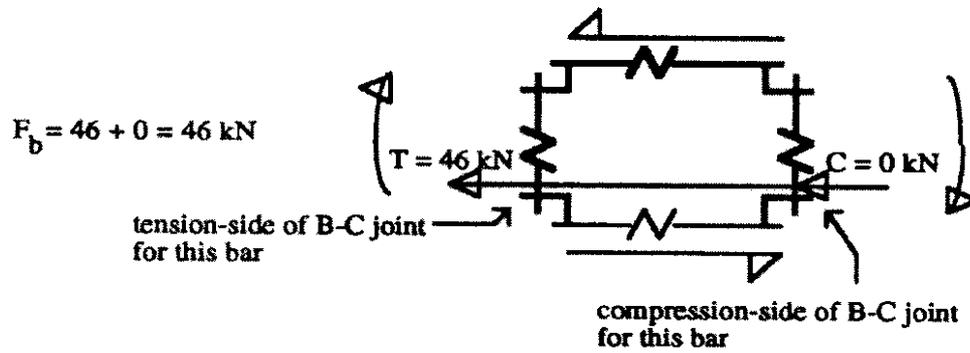
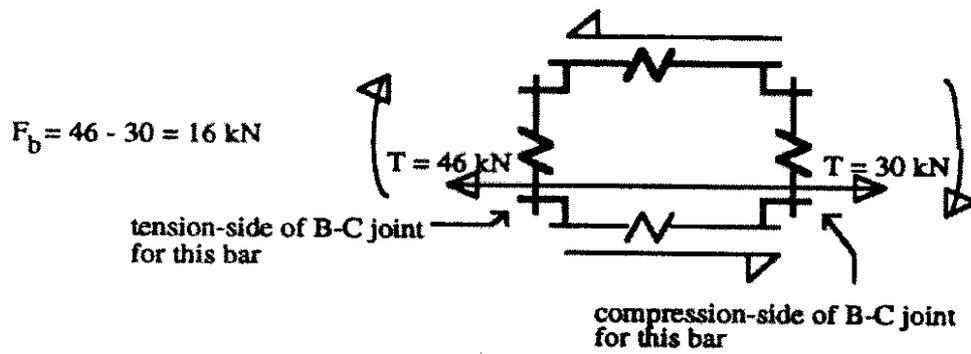
Figure 71 Three B-C joint bond-condition scenarios; retract-direction displacement, yield force for bar = 46 kN.

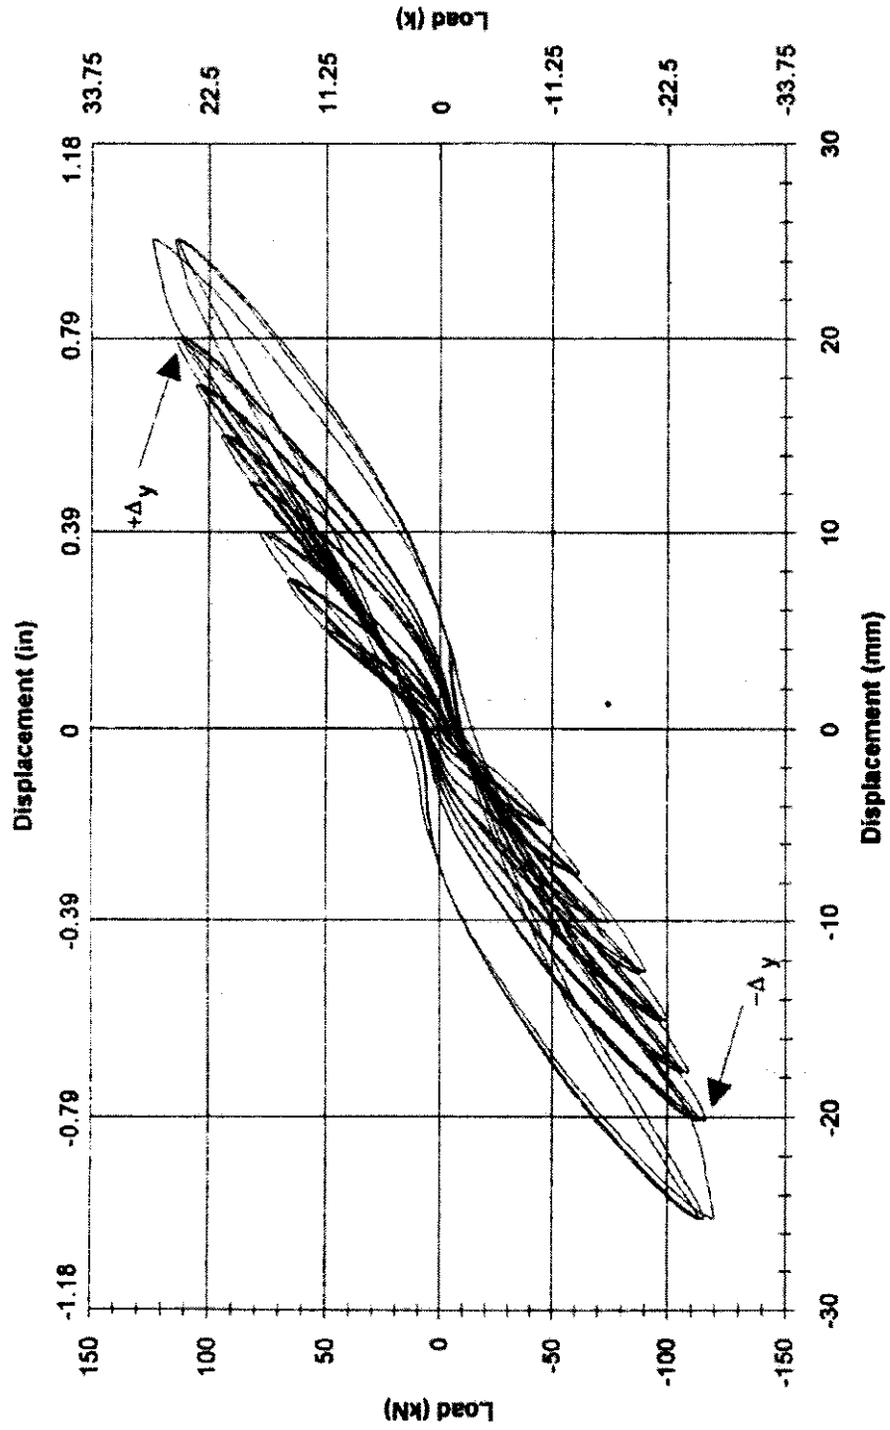
Figure 72 Hysteresis loops for Unit I (cycles through 25.4 mm).

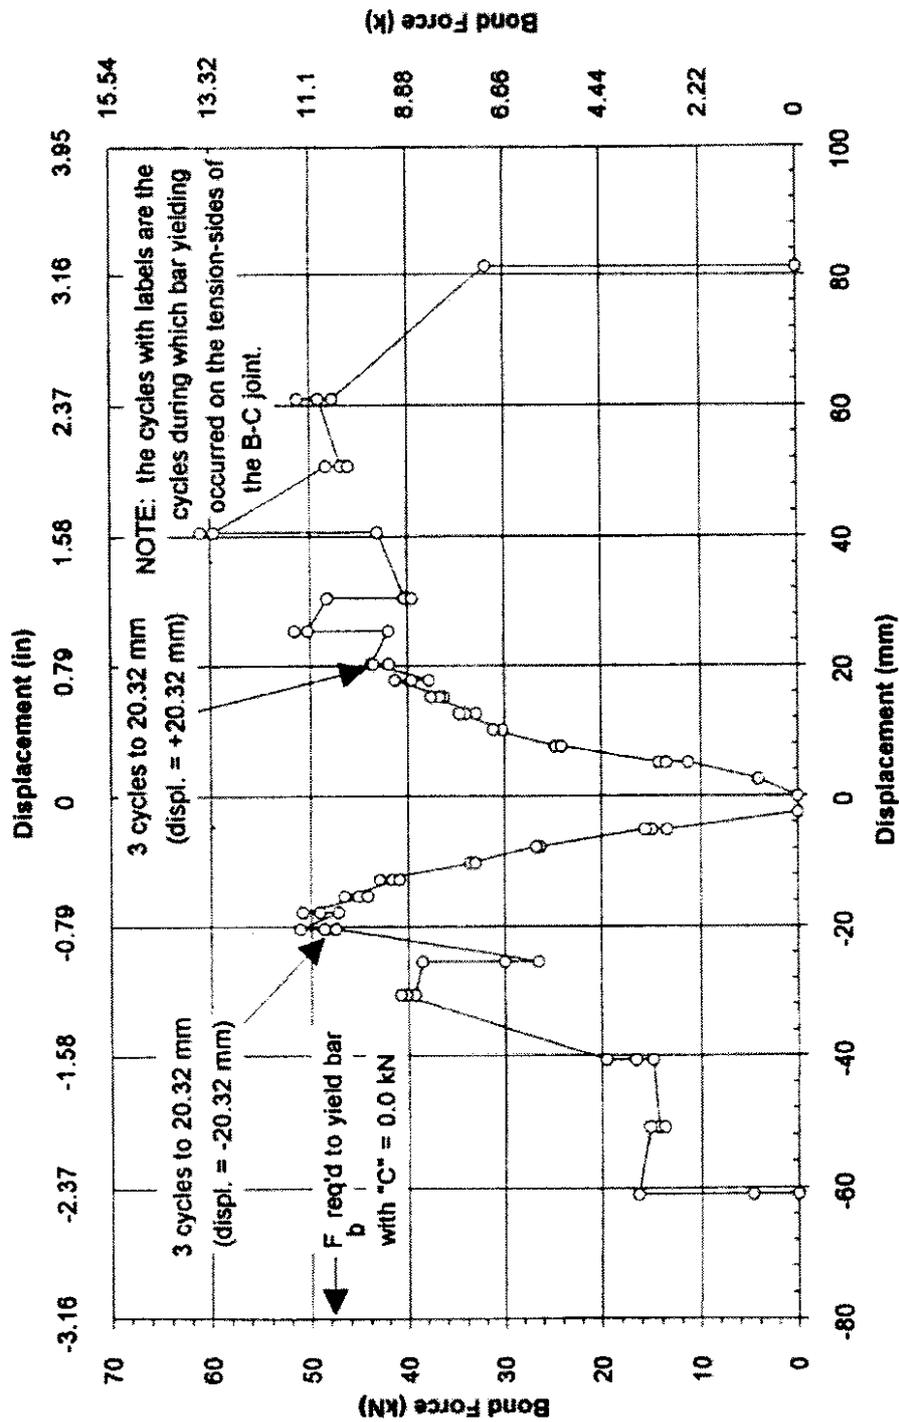
Figure 73 Bond force in a strut upper main bar versus displacement for Unit I (at the displacement peaks).

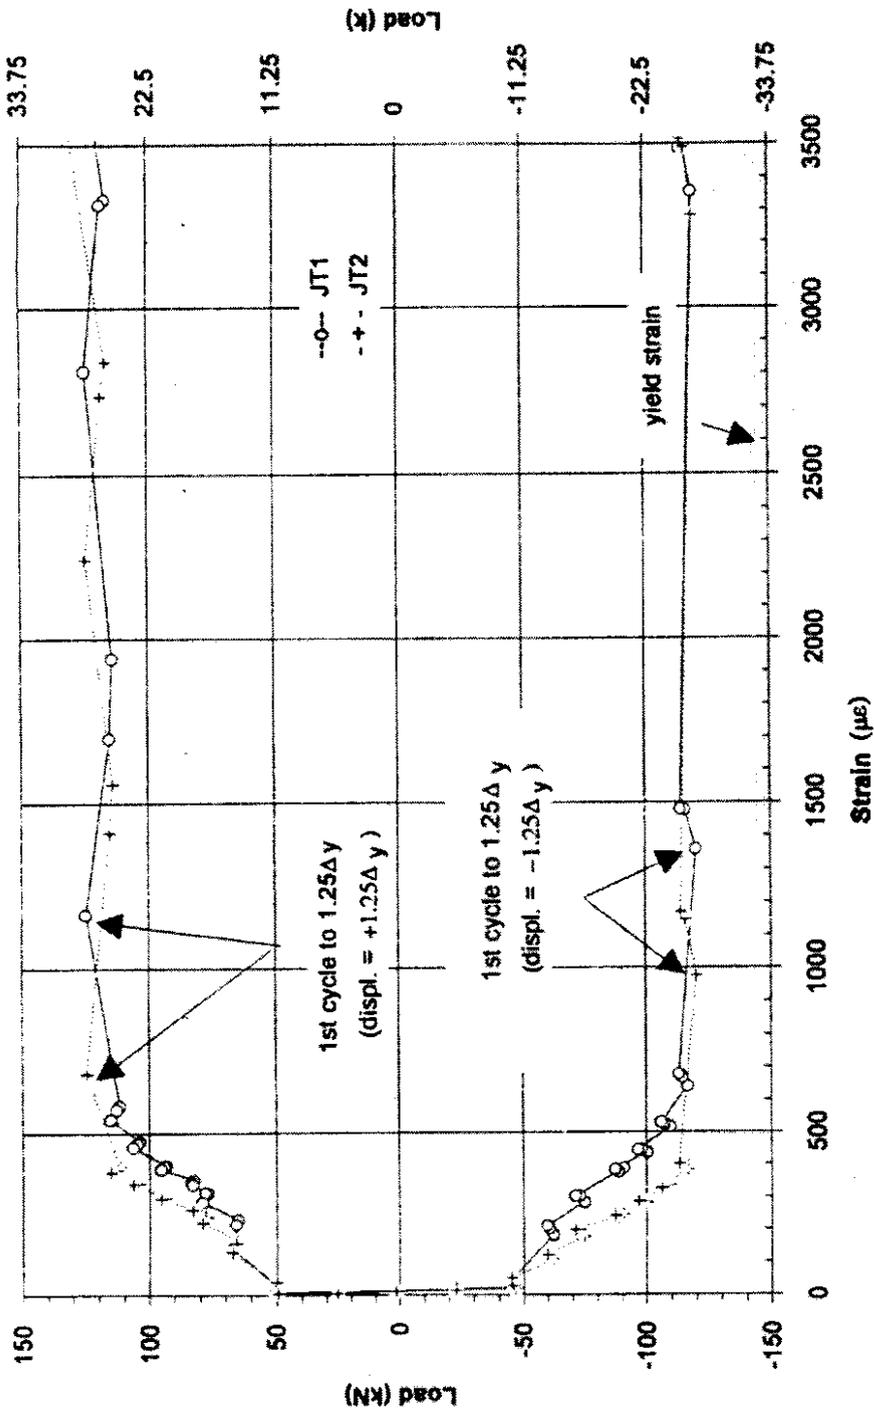
Figure 74 Load versus strain for hoop JT in Unit I (at the displacement peaks).

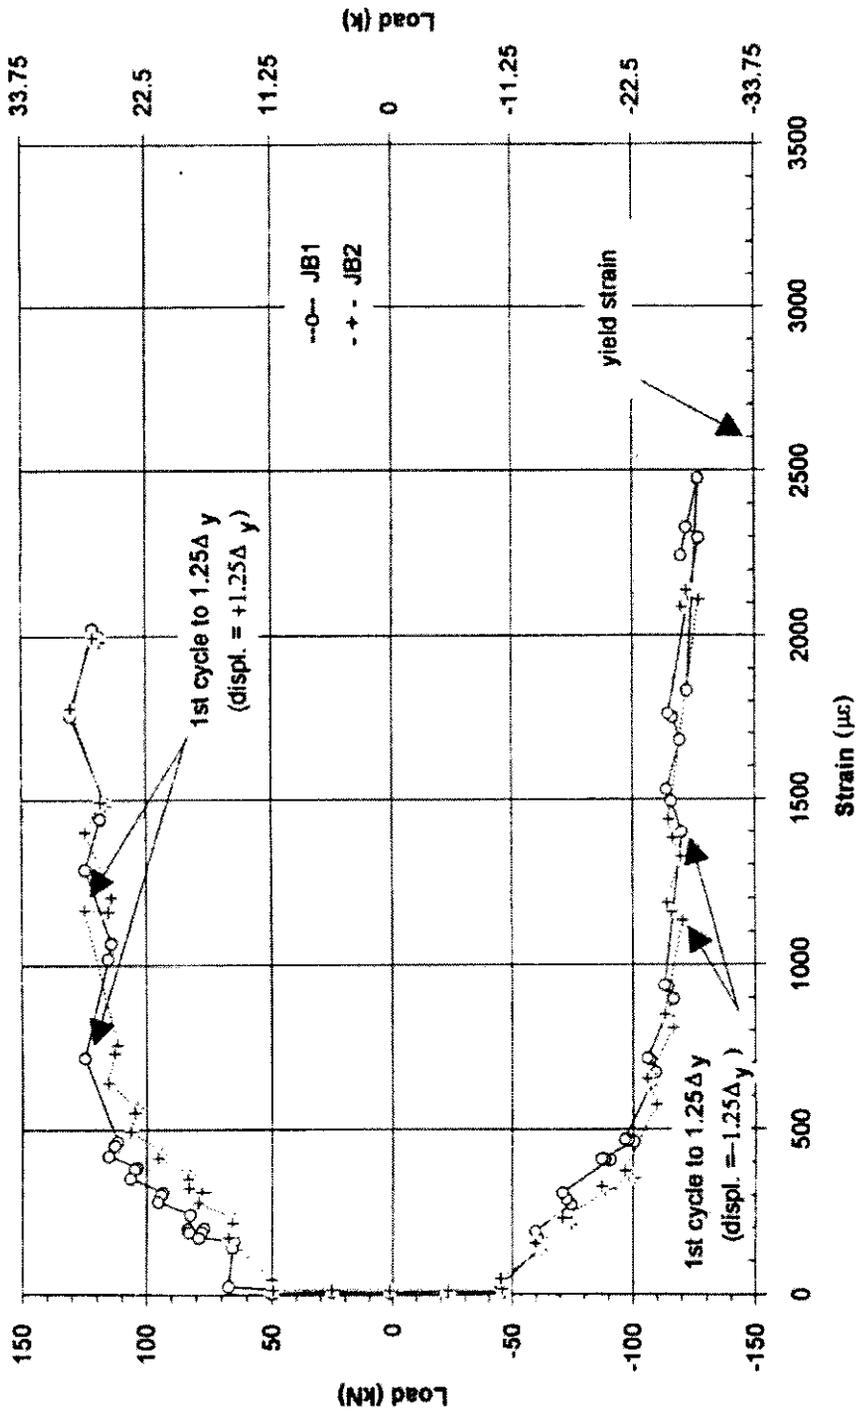
Figure 75 Load versus strain for hoop JB in Unit I (at the displacement peaks).

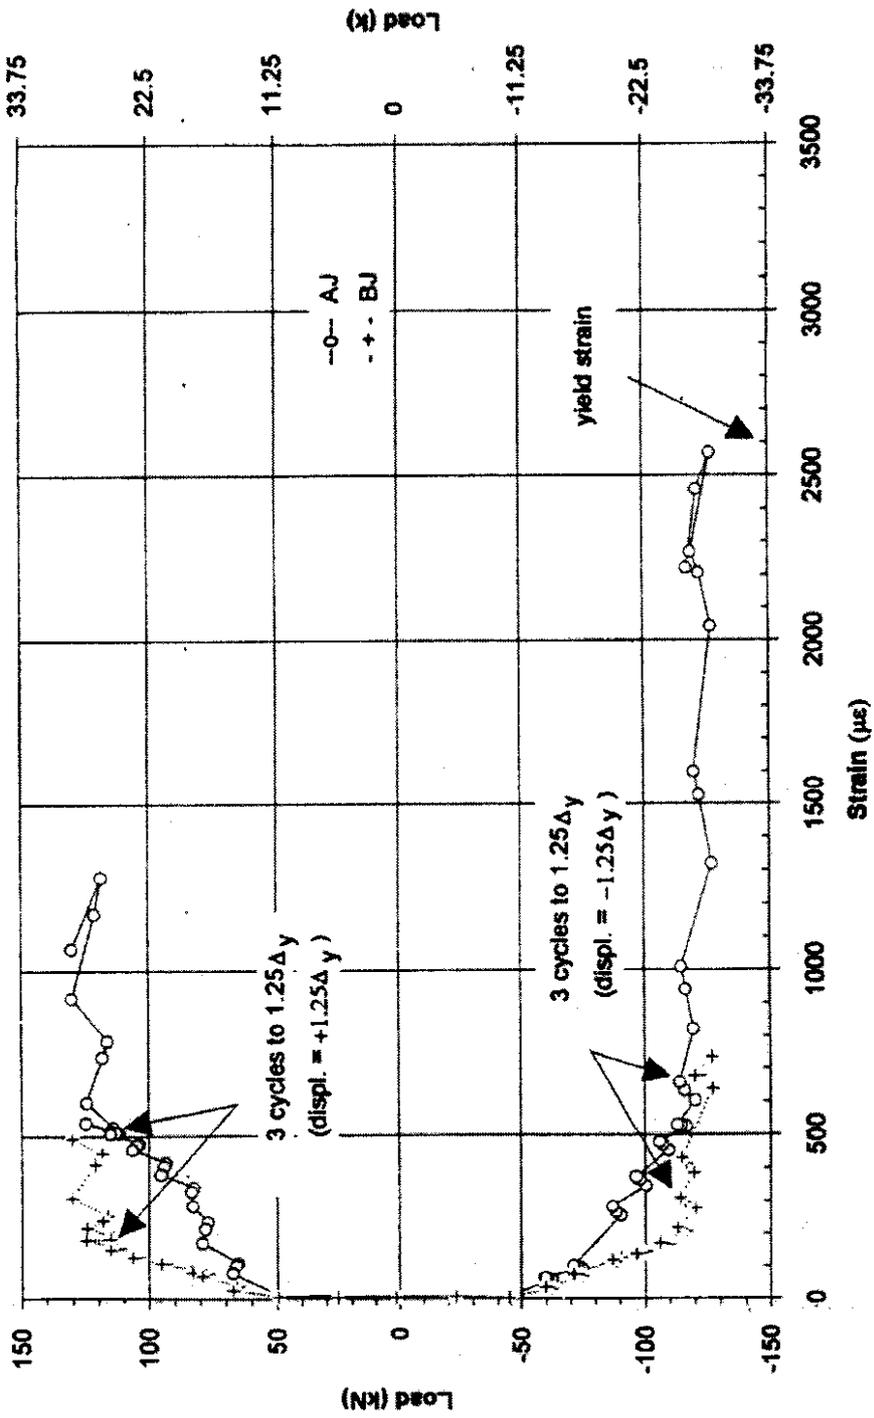
Figure 76 Load versus strain for hoops AJ and BJ in Unit I (at the displacement peaks).

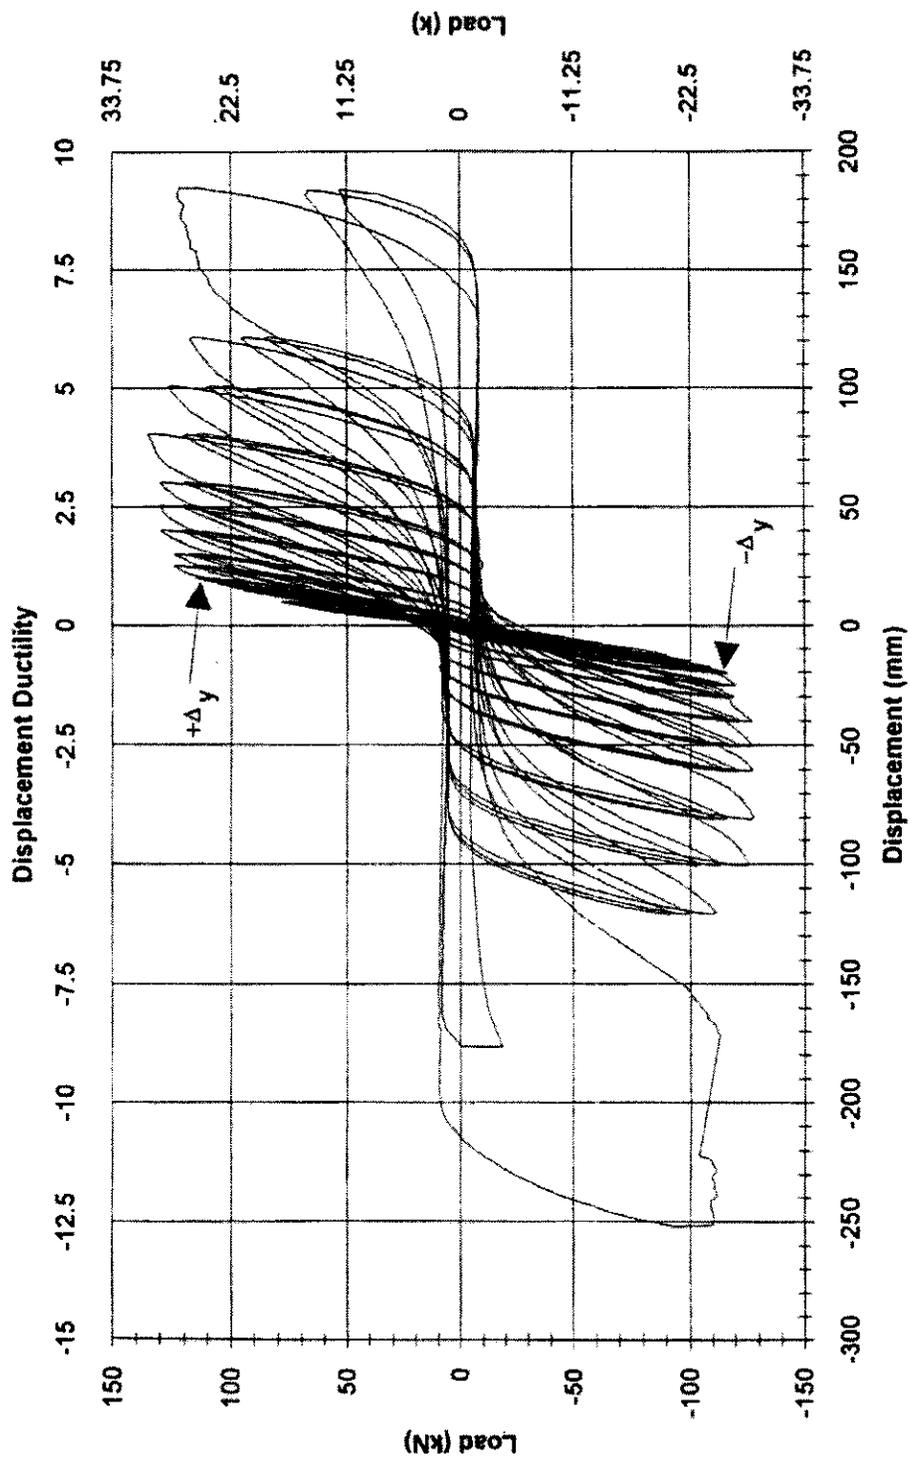
Figure 77 Hysteresis loops for Unit I (all cycles).

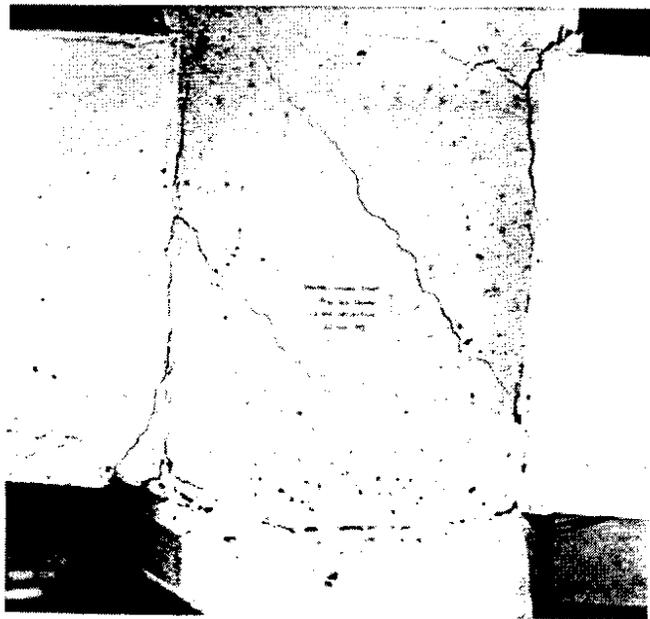
Figure 79 Cracking along the major joint diagonal of the back face of the B-C joint at the displacements equal to  $-1.5\Delta_y$  for Unit I.

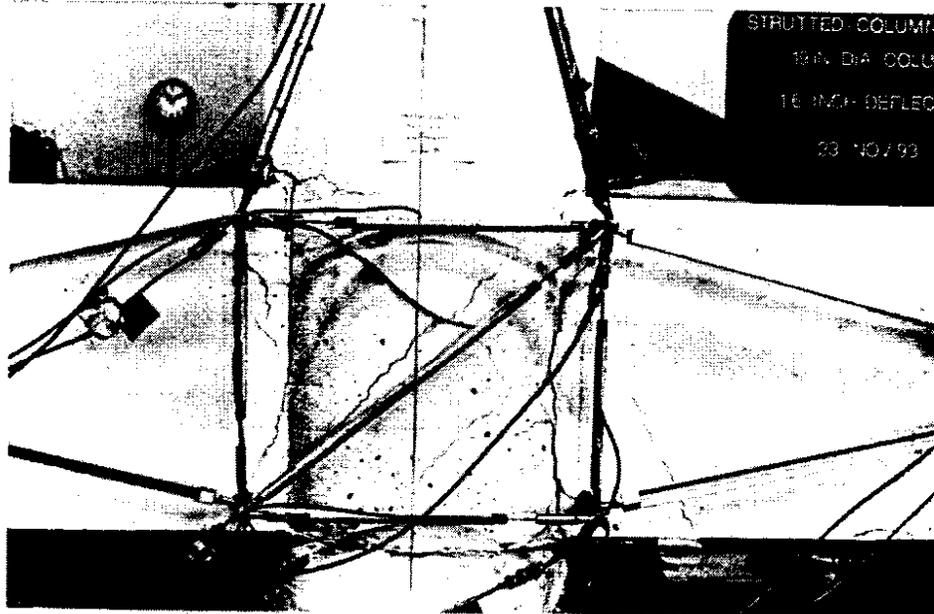
Figure 80 Cracking along the major joint diagonal in the B-C joint during the cycles to  $2\Delta_y$  for Unit I (front face of the B-C joint).

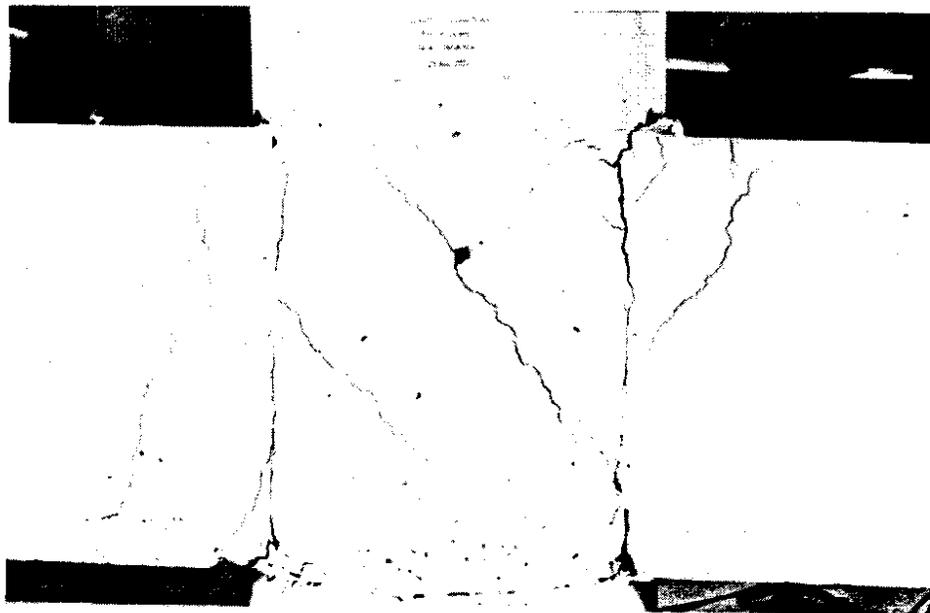
Figure 81 Cracking along the major joint diagonal in the B-C joint during the cycles to  $2\Delta_y$  for Unit I (back face of the B-C joint).

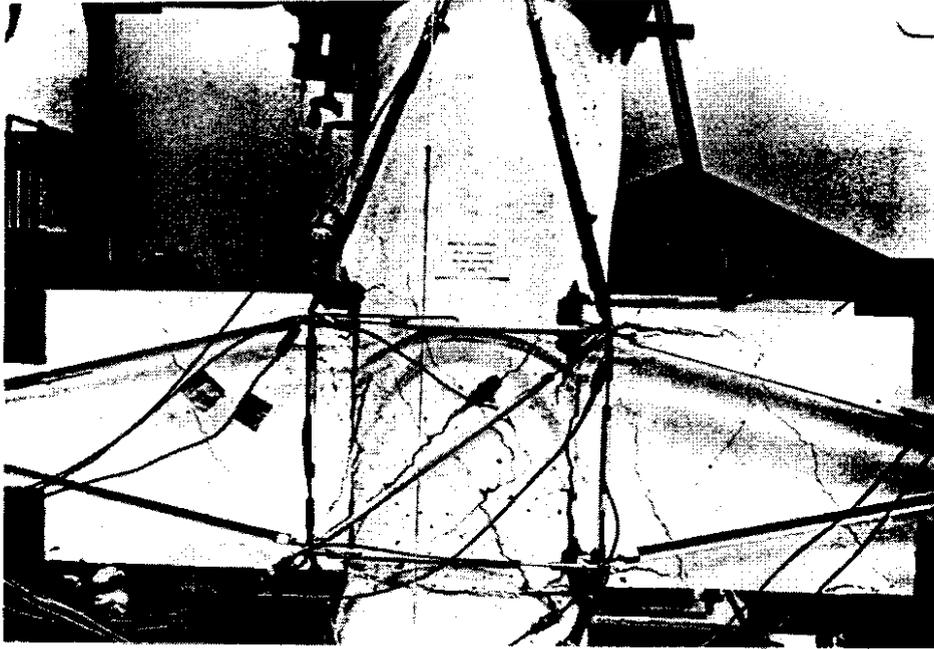
Figure 82 Spalling in the B-C joint region at a displacement equal to  $-4\Delta_y$  for Unit I (front face).

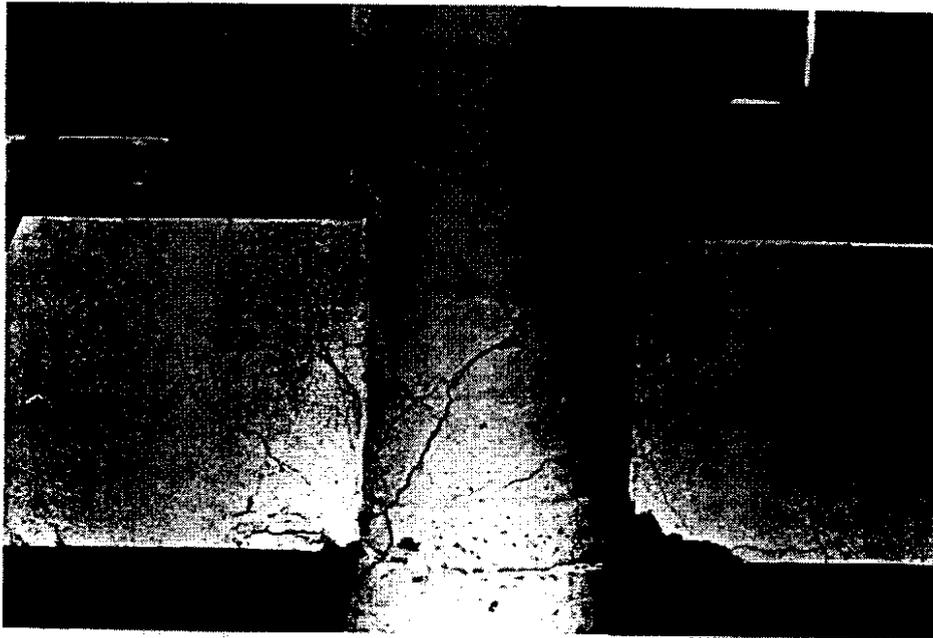
Figure 83 Spalling in the B-C joint region at a displacement equal to  $+4\Delta_y$  for Unit I (back face).

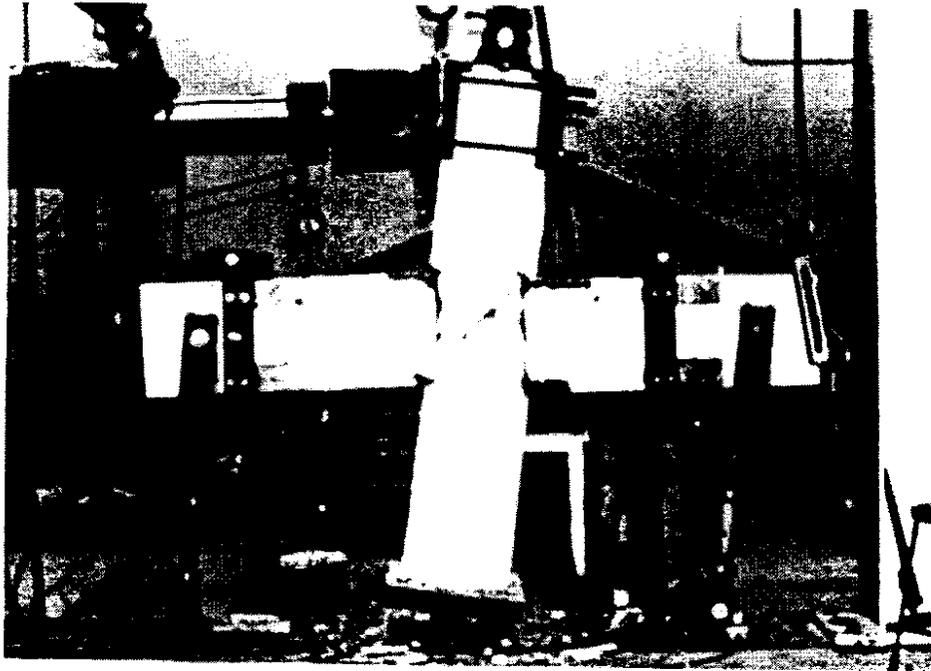
Figure 84 Unit I at the peak displacement reached in the extend portion of the first "push-over" cycle.

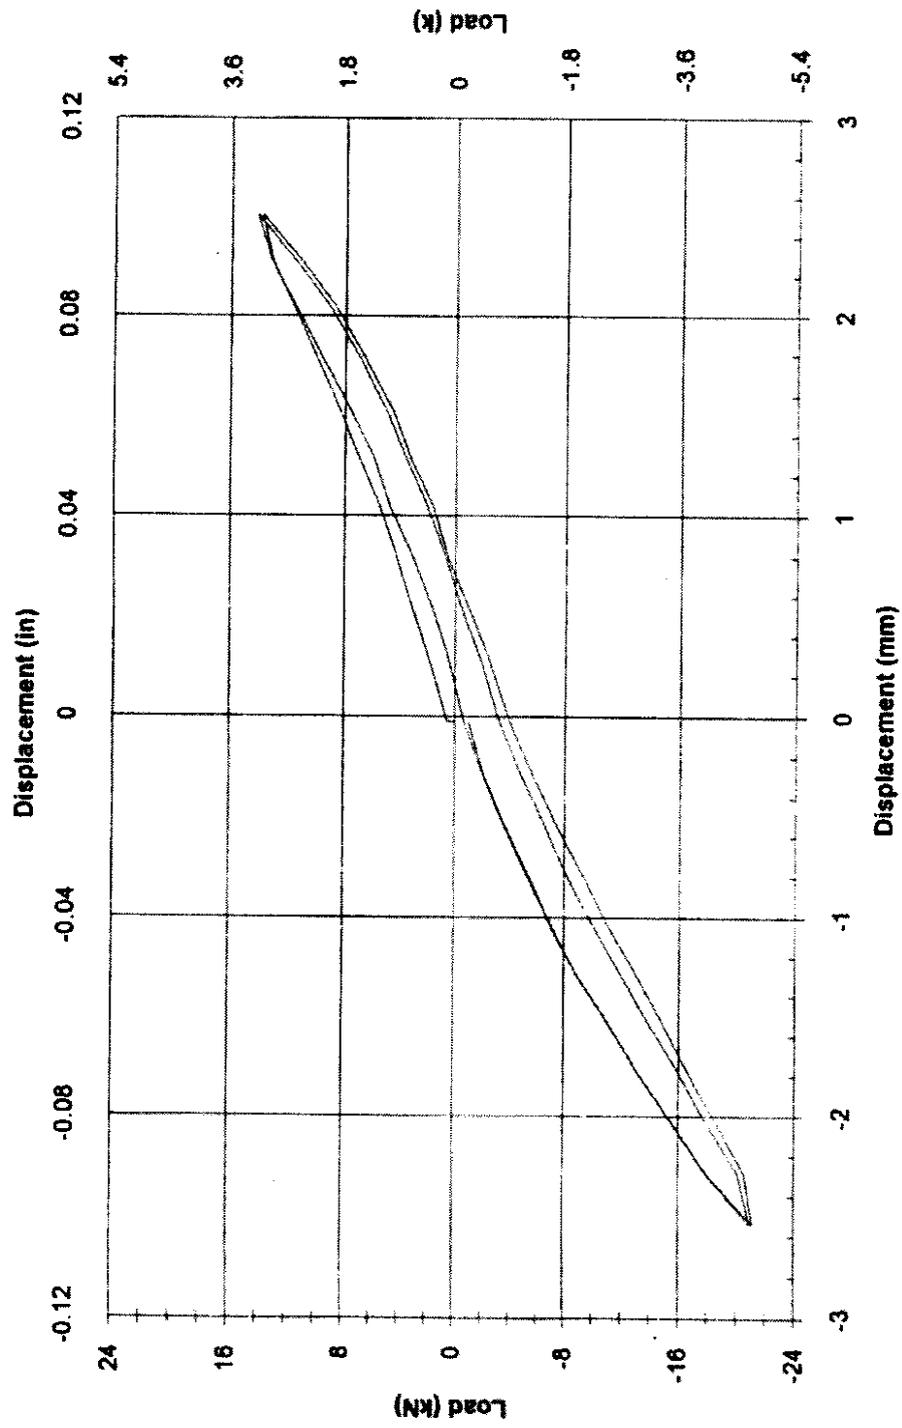
Figure 90 Hysteresis loops for Unit II (two cycles to 2.54 mm).

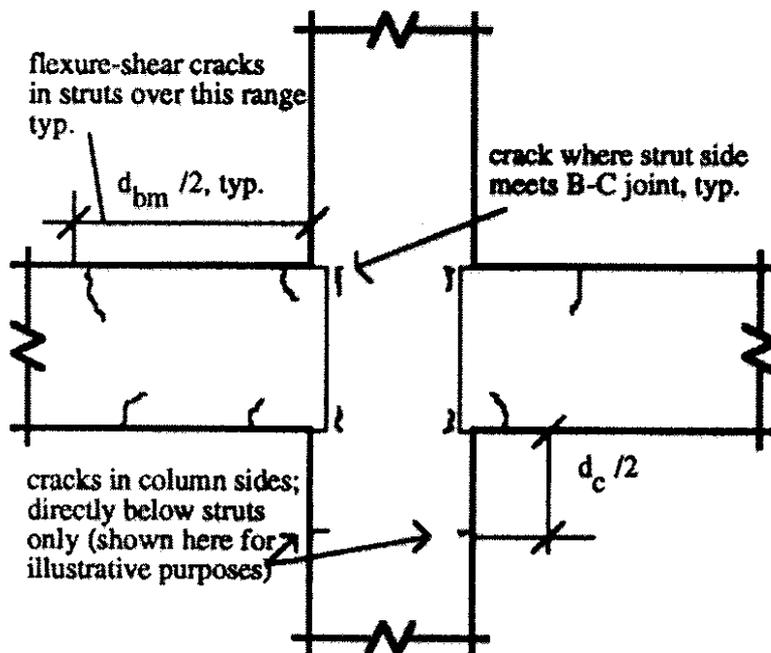
Figure 91 Cracking typically observed in Unit II through the cycles to 12.7 mm.

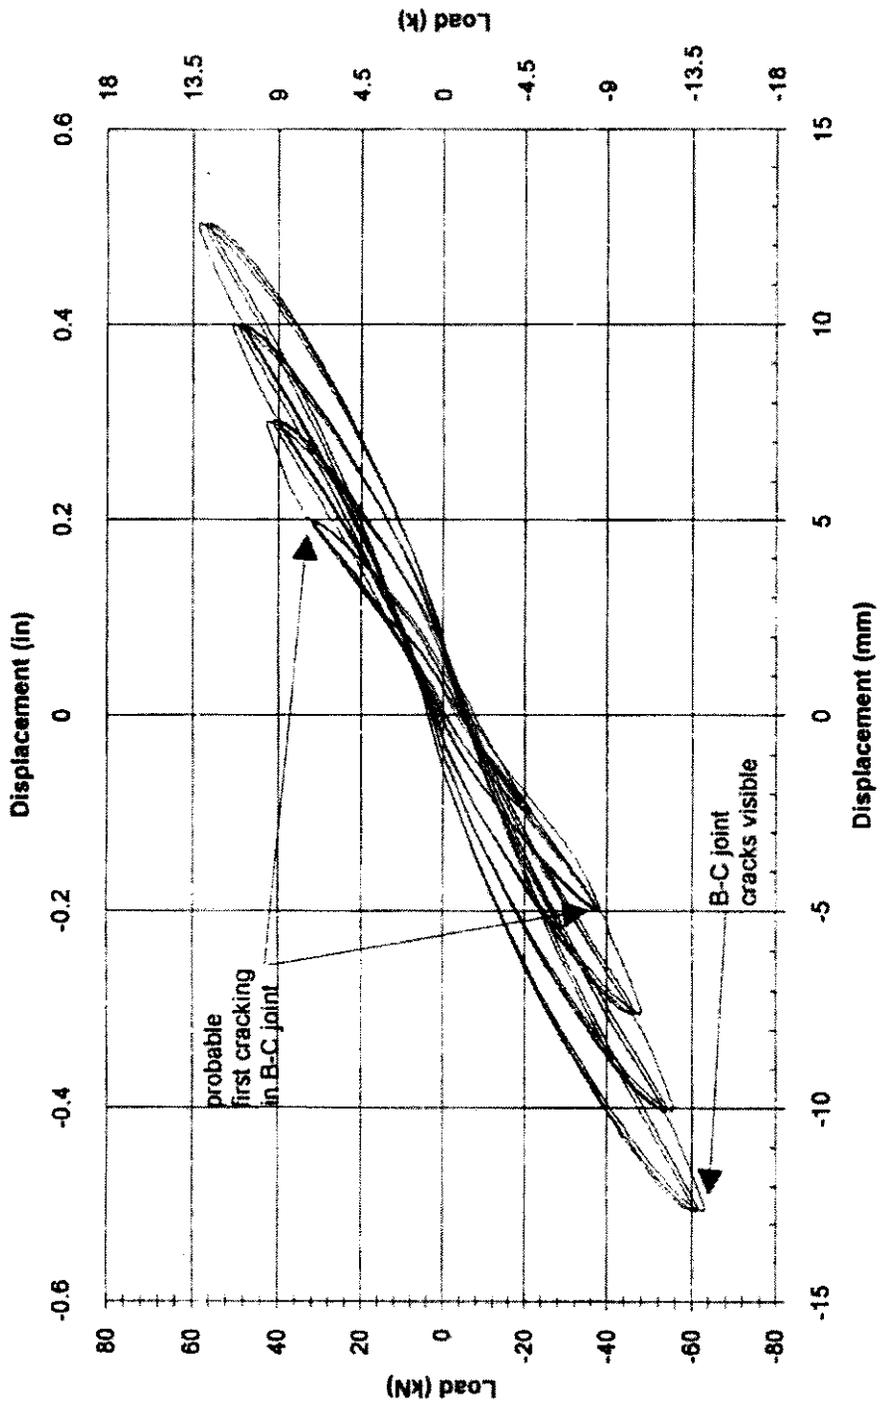
Figure 92 Hysteresis loops for Unit II (cycles through 12.7 mm).

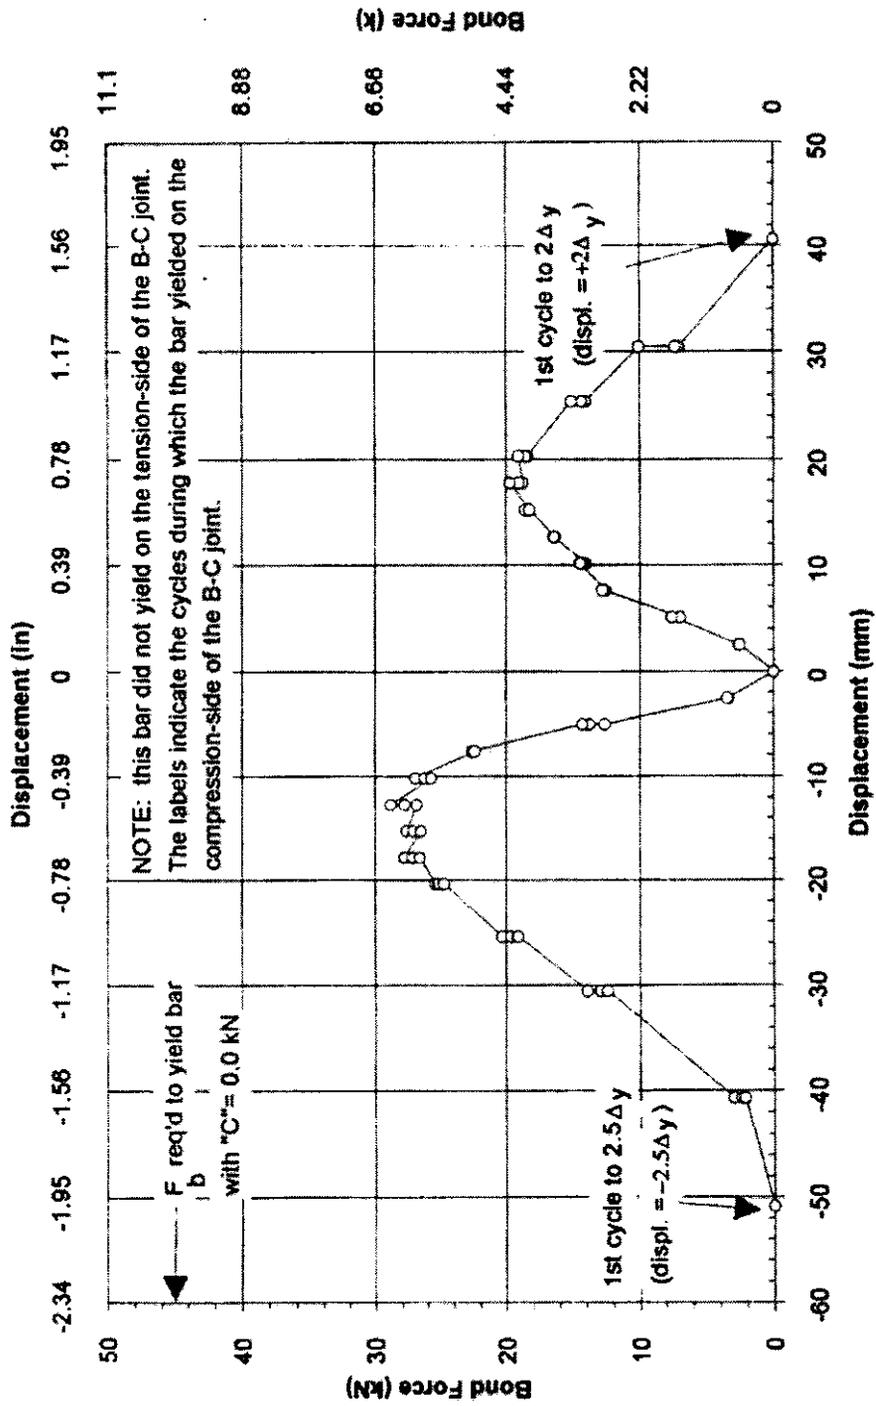
Figure 93 Bond force in a strut lower main bars versus displacement for Unit II (peak values).
