1. REPORT NO. WA-RD 361.1		2. GOVERNMENT ACCESSION NO.		3. RECIPIENT'S CATALOG NO.	
4. TITLE AND SUBTITLE "Seismic Vulnerability of Strutted-Column Bridge Bents"				5. REPORT DATE December 1995

**Technical Report**  
for  
Research Project T9234-16  
"Seismic Vulnerability of Strutted-Column Bridge Bents"

**SEISMIC VULNERABILITY OF  
STRUTTED-COLUMN BRIDGE BENTS**

Glen J. Pappas and M. Lee Marsh  
**Washington State Transportation Center (TRAC)**  
Washington State University  
101 Sloan Hall  
Pullman, Washington 99164-2910

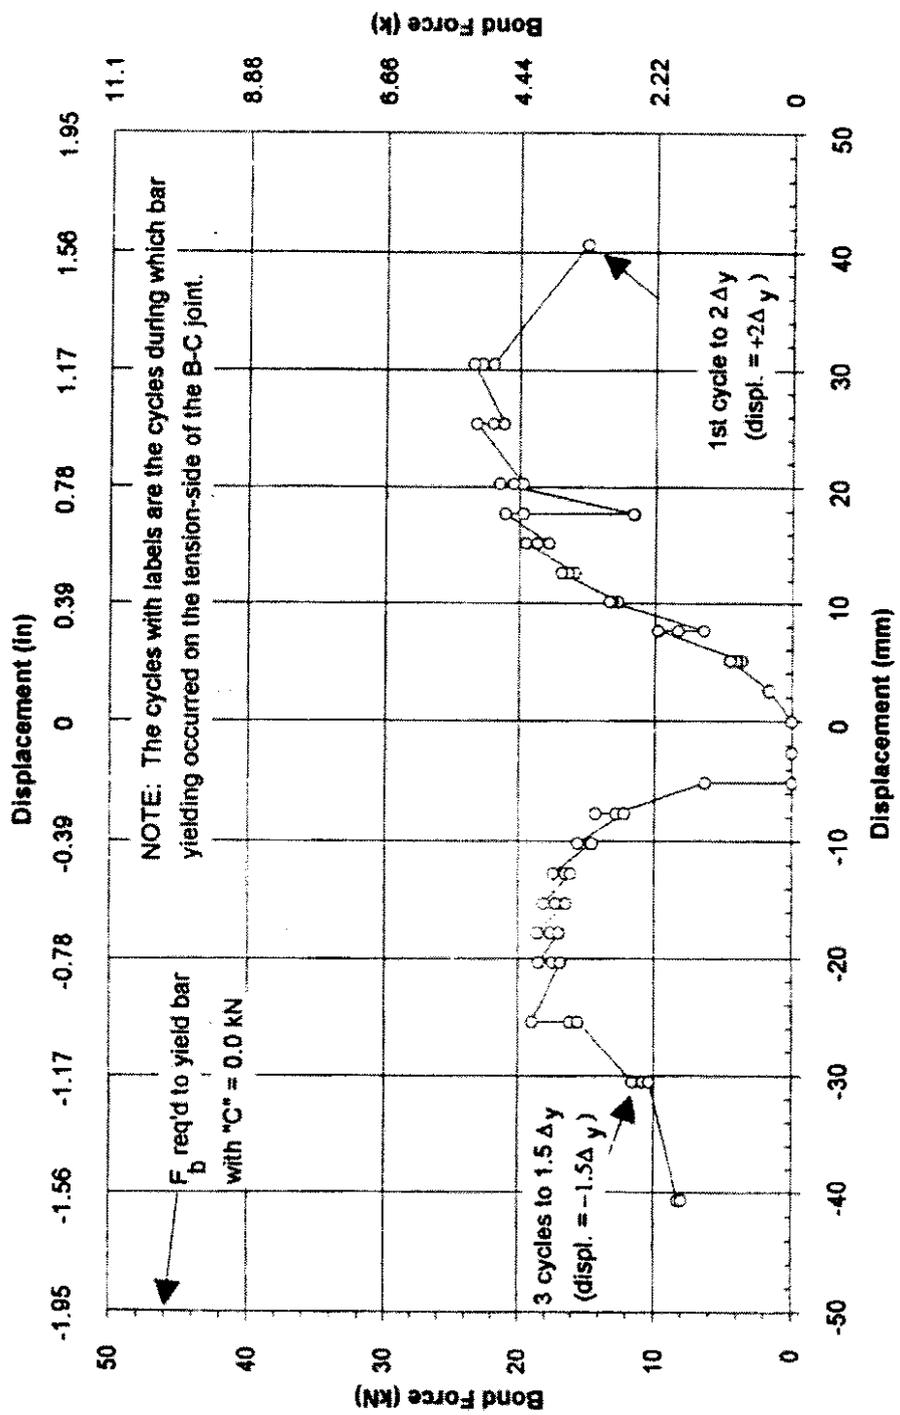
Figure 94 Bond force in a strut upper main bar versus displacement for Unit II (peak values).

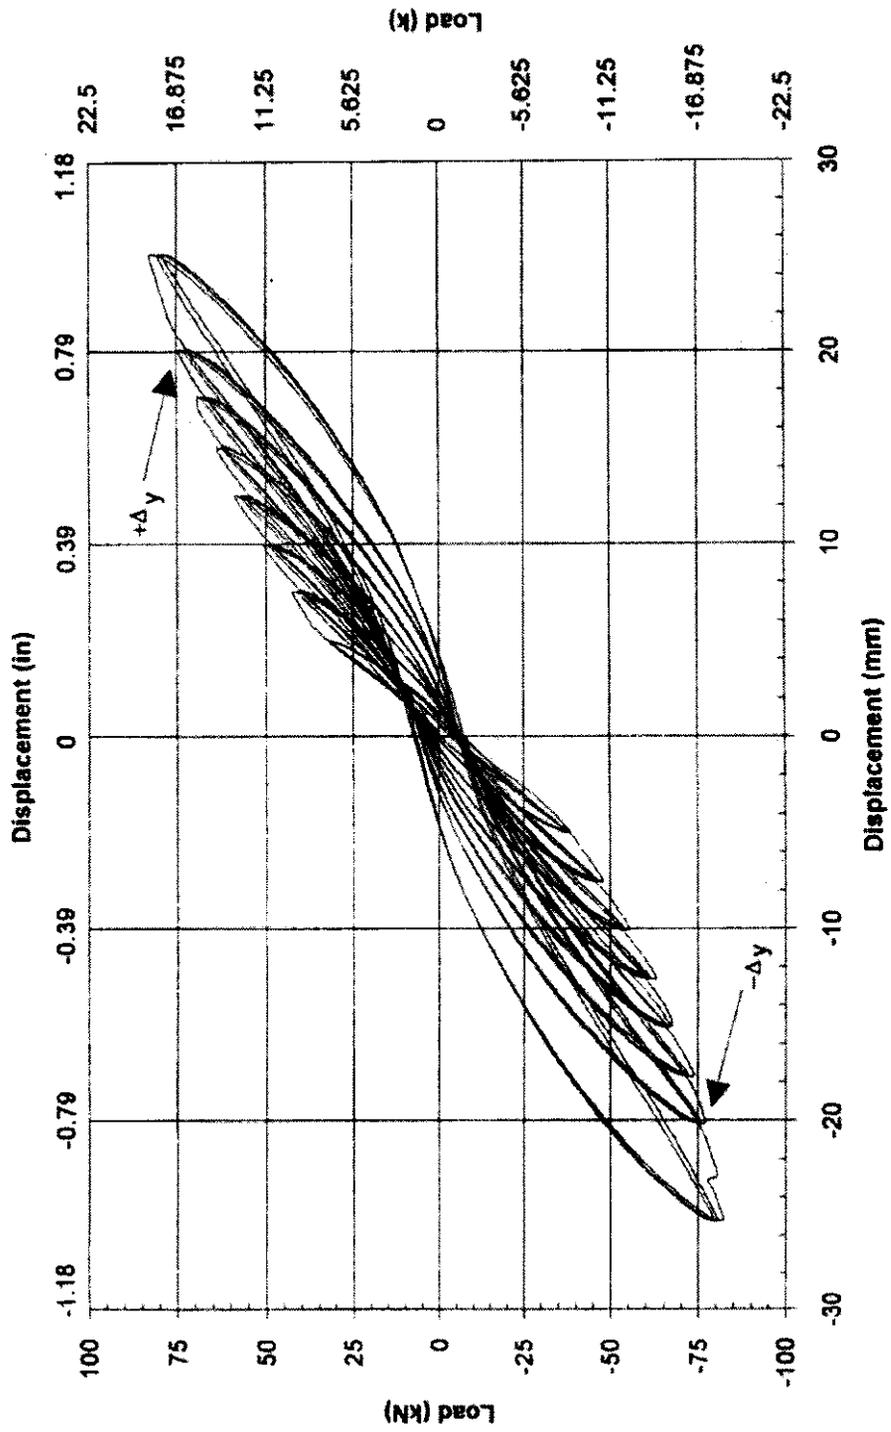
Figure 95 Hysteresis loops for Unit II (cycles through  $1.25\Delta y$ ).

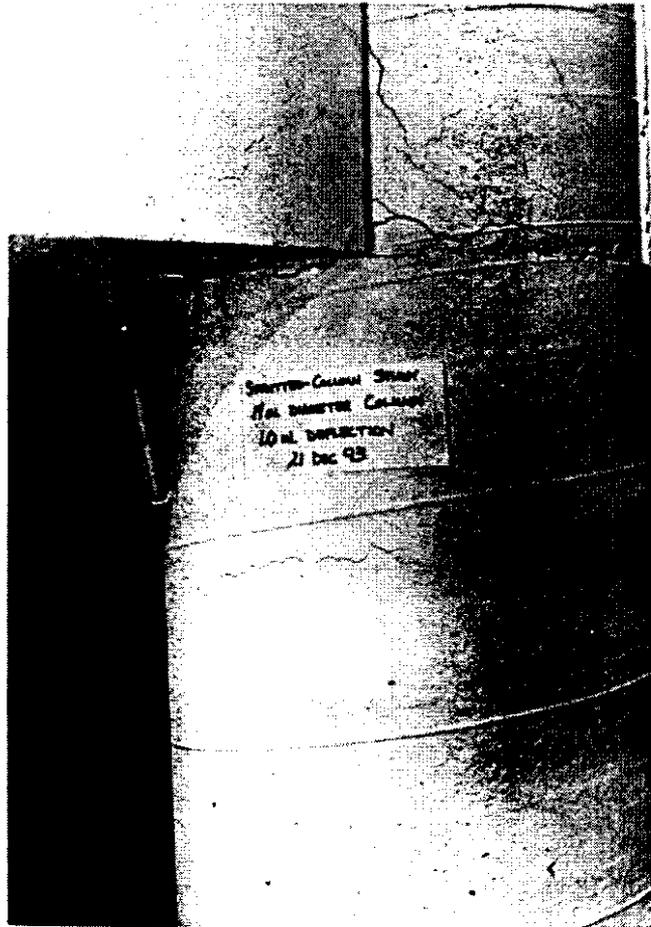
Figure 96 The extent of flexural cracking in the anticipated plastic hinge region of the lower column at a displacement of  $-1.25\Delta_y$  in Unit II.

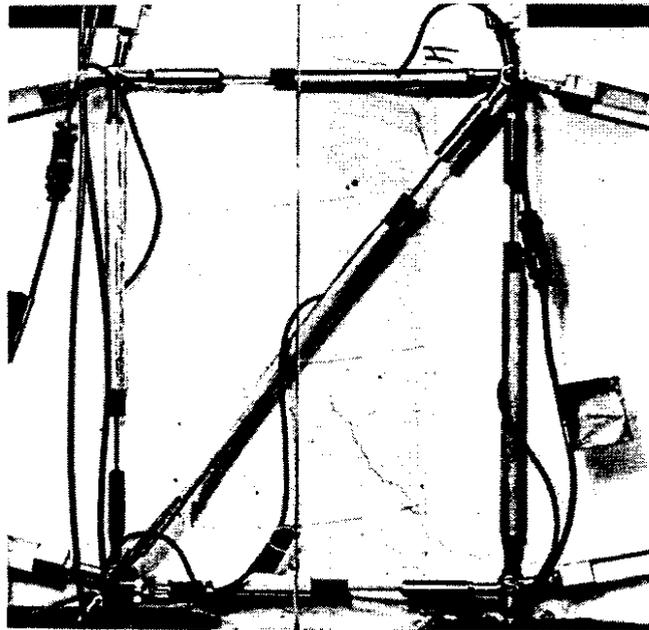
Figure 98 Shear cracks on the front face of the B-C joint that occurred at the displacements equal to  $+1.25\Delta_y$  in Unit II.

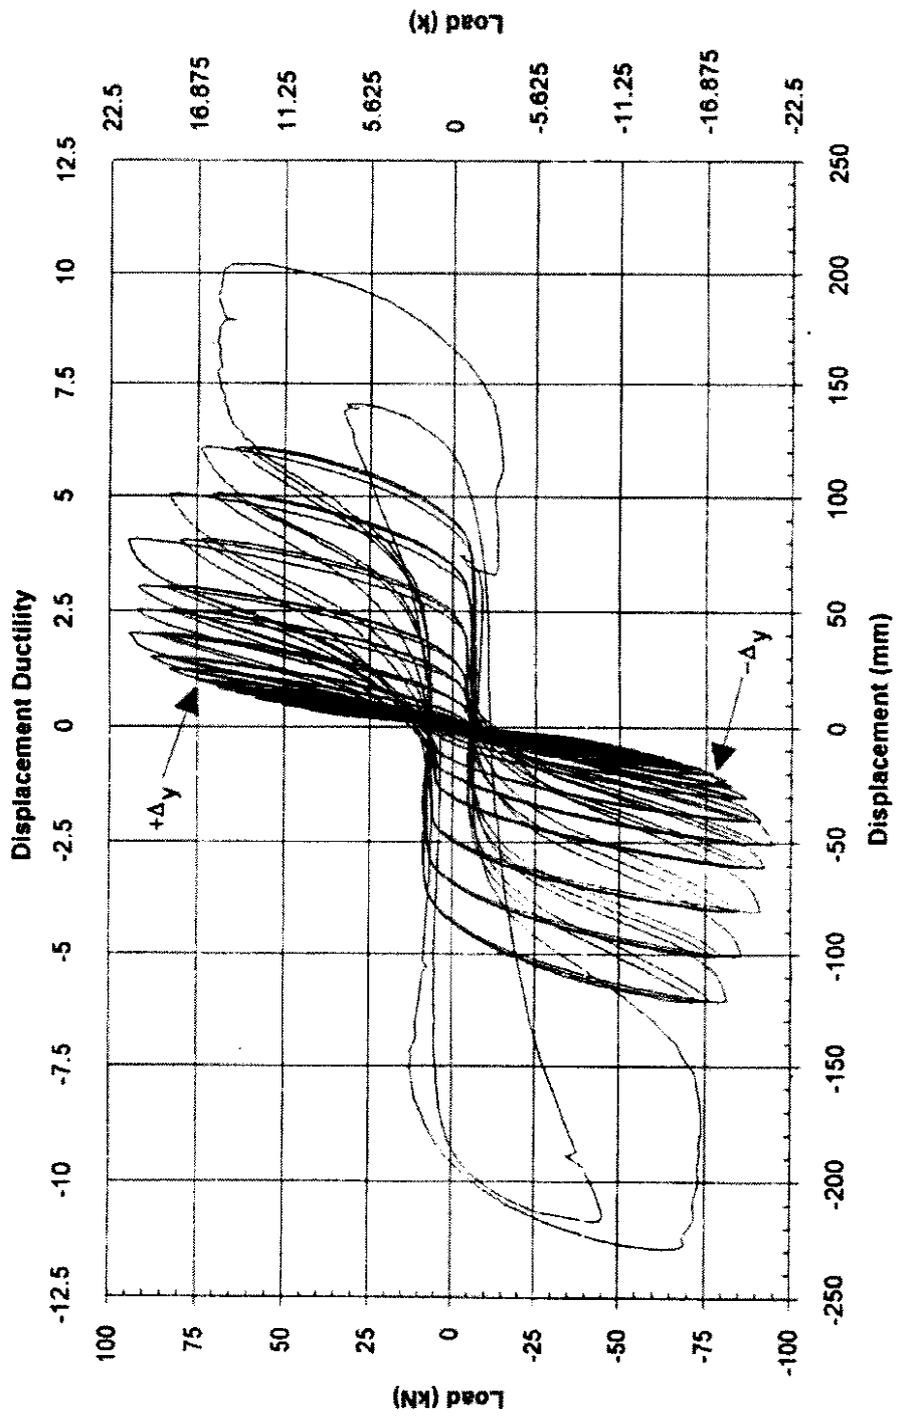
Figure 99 Hysteresis loops for Unit II (all cycles).

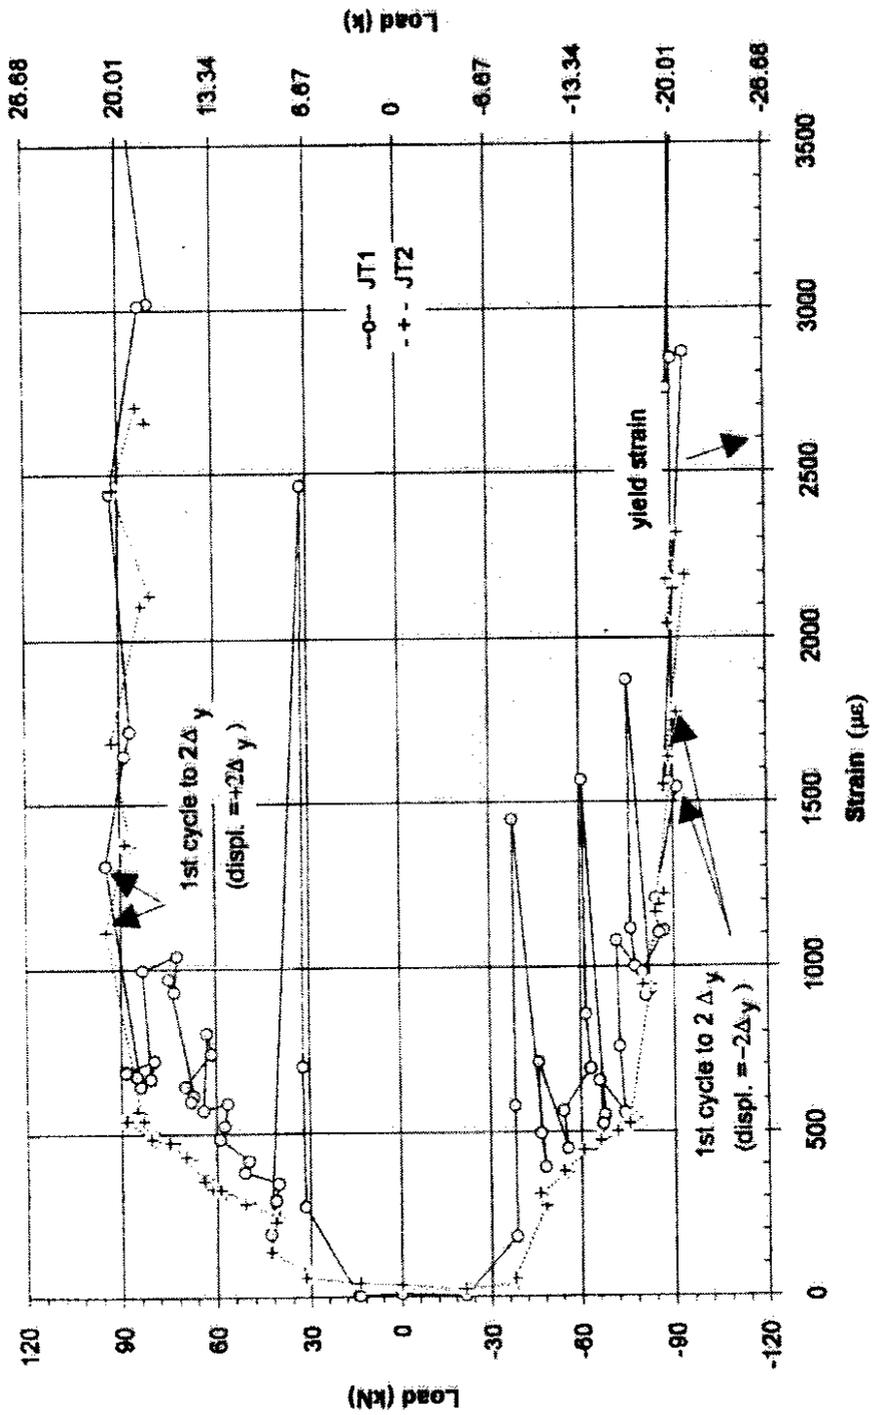
Figure 100. Load versus strain for hoop JT in Unit II (at the displacement peaks).

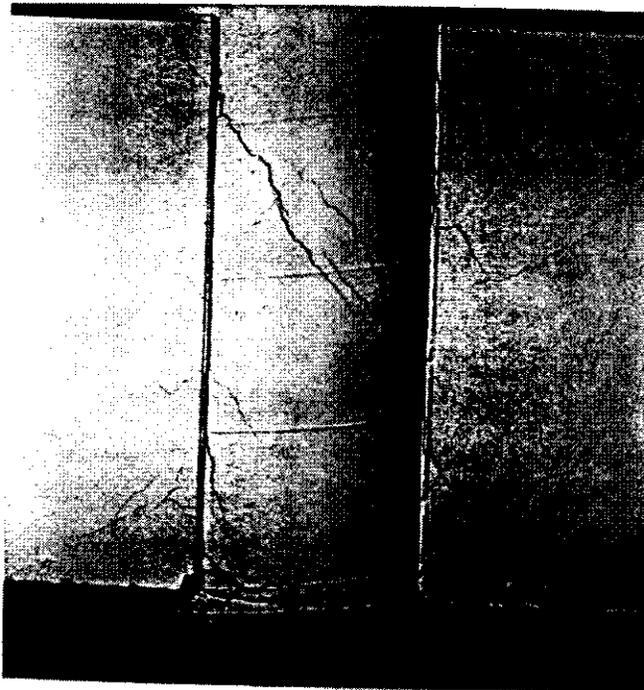
Figure 102 The back face of Unit II at the last displacement equal to  $-2.5\Delta_y$ .

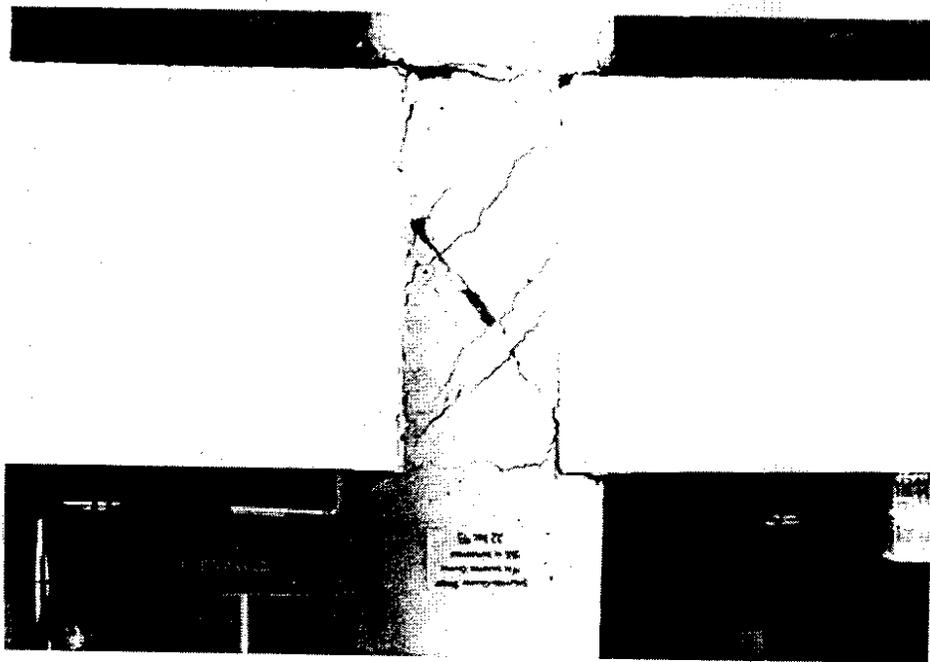
Figure 103 Typical spalling in the front of the lower column of Unit II (displacements equal to  $\pm 3\Delta_y$ )

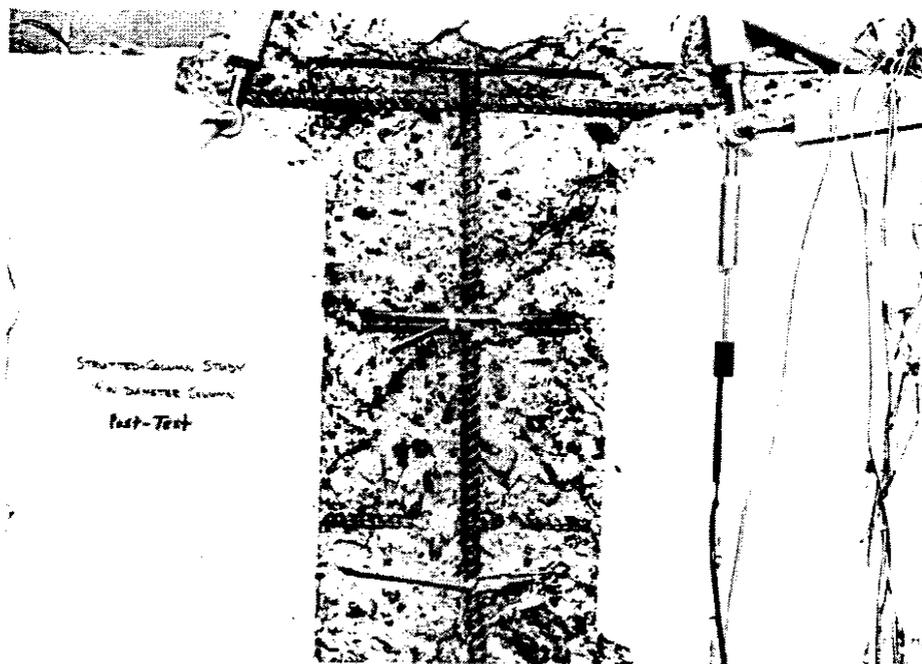
Figure 108 The front face of the B-C joint of Unit II following the removal of loose concrete.

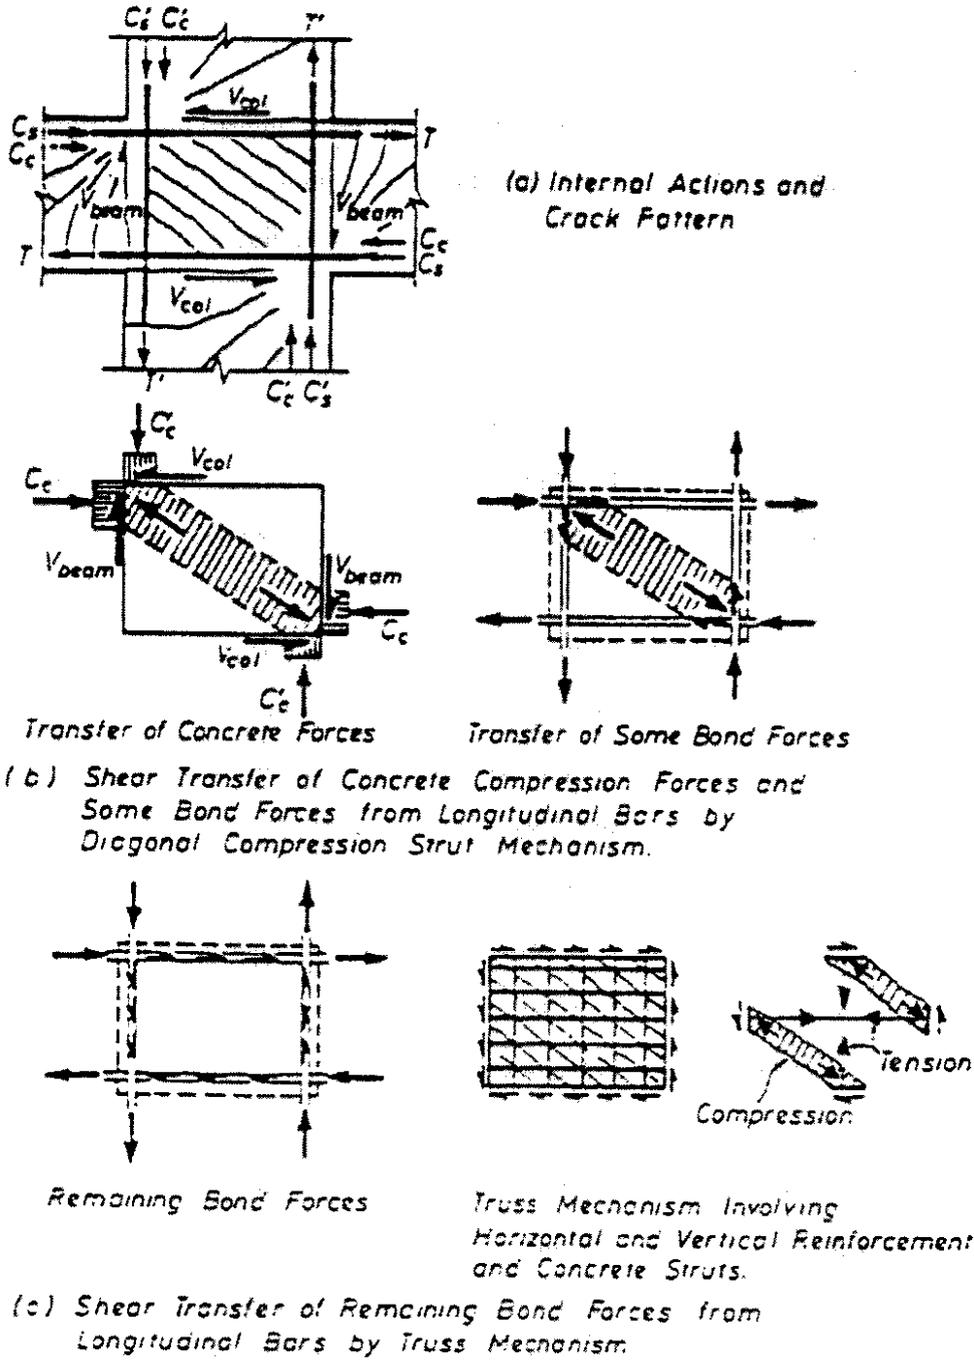
Figure A.1 Mechanisms of seismic shear transfer in B-C joints (from Wong et al. 1990).

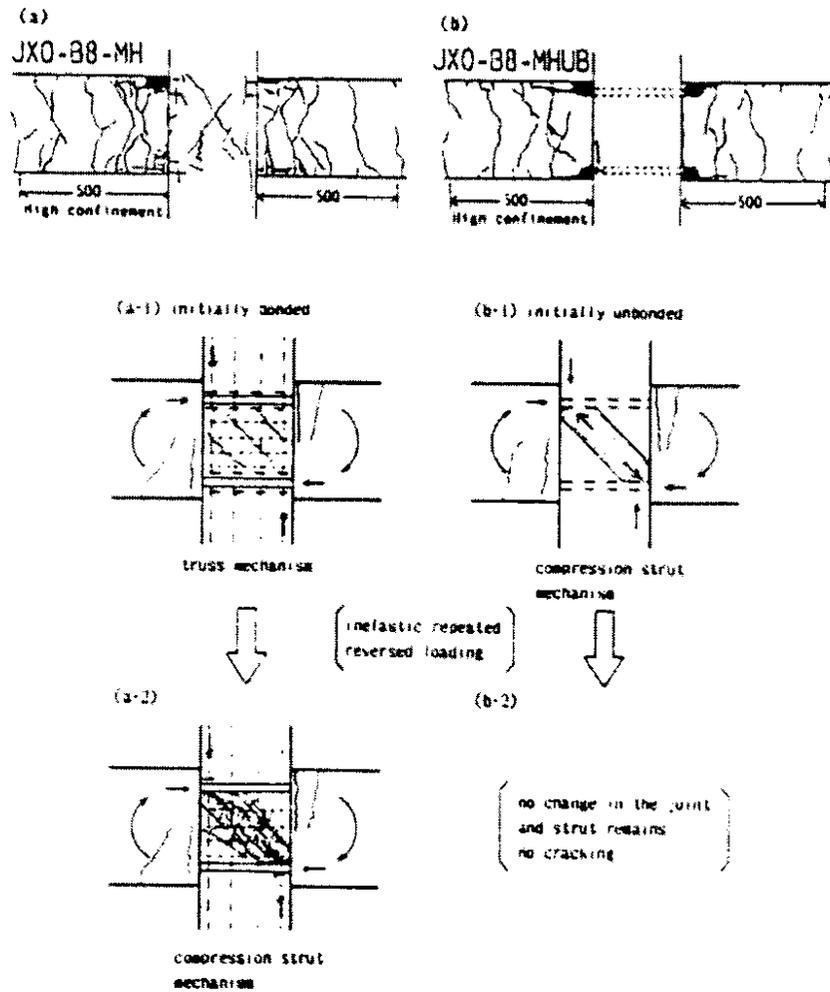
Figure A.2 Post-test crack patterns of a specimen with bonded bars and of a specimen with unbonded bars (from Kaku et al. 1991).

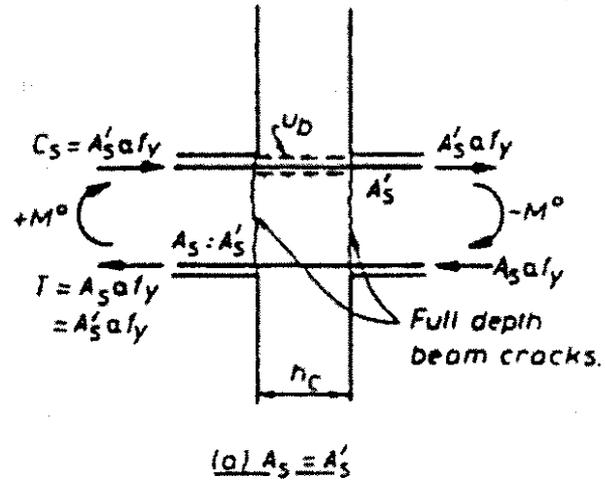
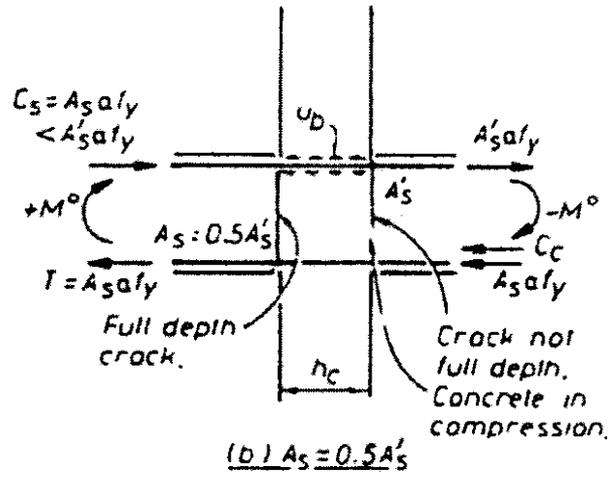
Figure A.3 "Forces acting on beam bars across a joint core" (from Kaku et al. 1991).

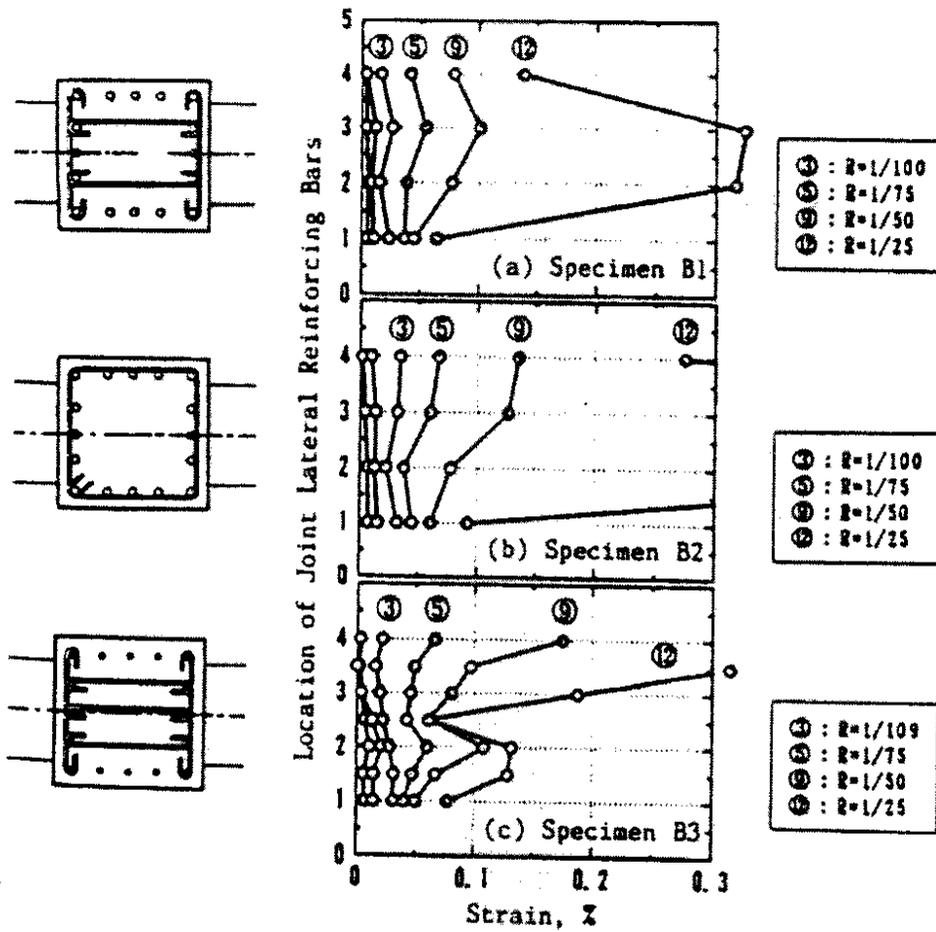
Figure A.9 "Strains in joint ties orthogonal to loading direction" (from Kitayama et al. 1991).

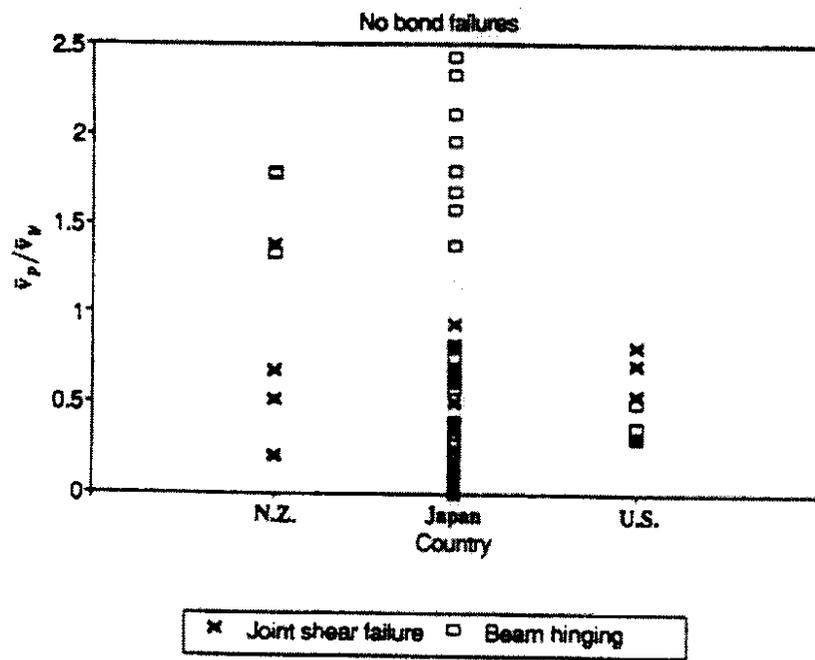
Figure A.11 The relationship between specimen failure modes and a shear stress ratio (from Bonacci et al. 1993).

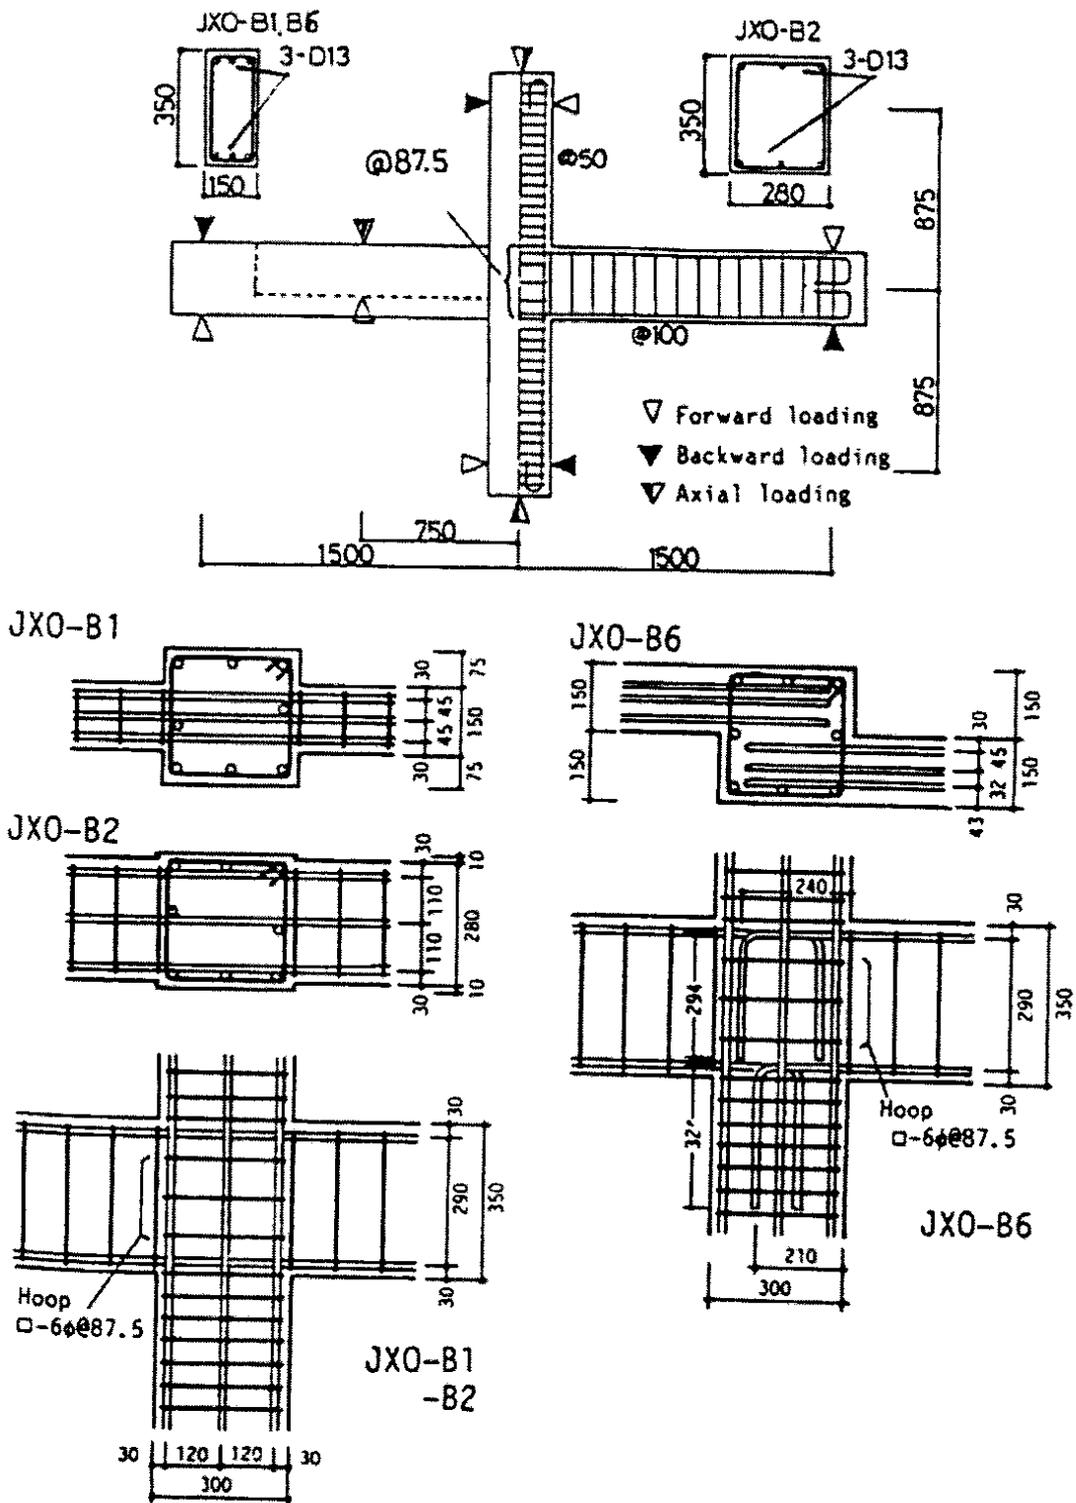
Figure A.14 Details of the specimens tested by Joh et al. (from Joh et al. 1991b).
