Final Technical Report
Research Project T9233, Task 41
Seismic Vulnerability—Alaskan Way Viaduct II

**SEISMIC VULNERABILITY OF THE ALASKAN
WAY VIADUCT: SED TYPICAL UNIT**

1. REPORT NO. WA-RD 363.3	2. GOVERNMENT ACCESSION NO.	3. RECIPIENT'S CATALOG NO.	
4. TITLE AND SUBTITLE SEISMIC VULNERABILITY OF THE ALASKAN WAY VIADUCT: SED TYPICAL UNIT		5. REPORT DATE July 1995

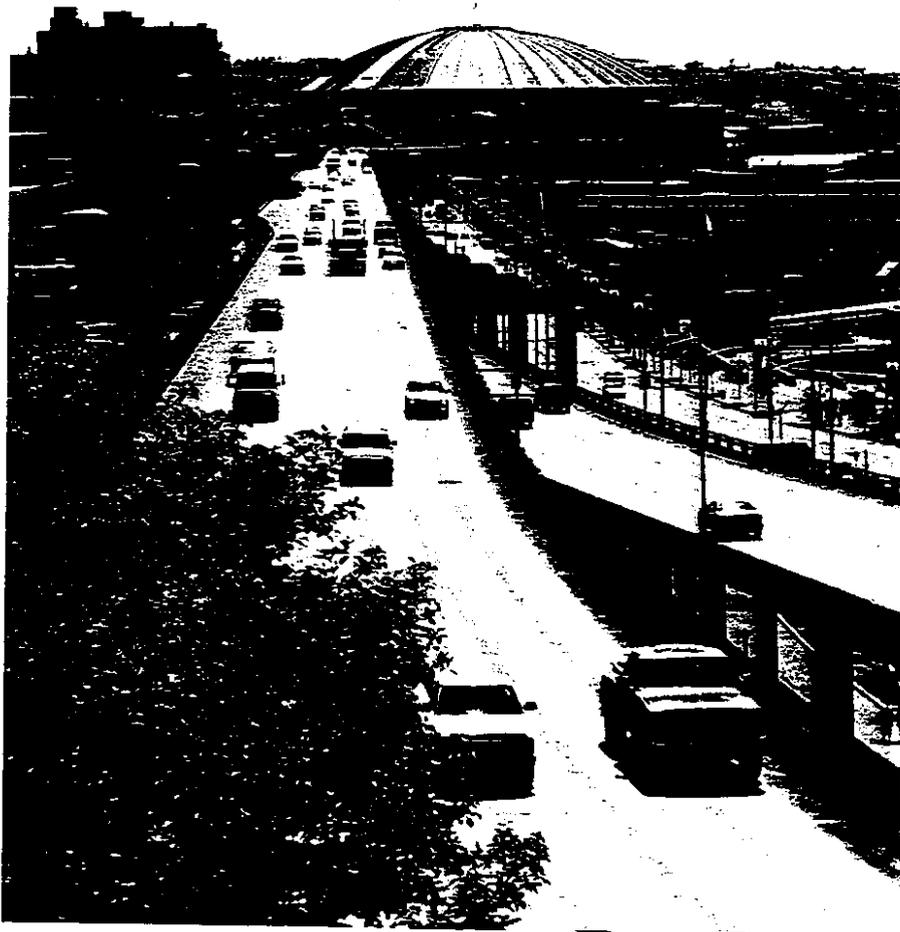
Figure 2.1. Single- to Double-Deck Transition (Bents 53 thru 63)

The Seattle section has some atypical features along its length. The viaduct changes from a single-deck to a double-deck structure between bents 53 and 63 (Figure 2.1). The geometry of this transition zone is extremely complex. Another atypical feature is short cantilever sections that provide clearance for pedestrian under-crossings (Figure 2.2). The Seattle section has two pedestrian under-crossings: one between bents 69 and 70, and one between bents 87 and 88. The Seattle section's double-deck structure has one curved section. The curved section is 406 feet long with an 800-foot radius. It consists of one curved 184-foot unit and one curved 222-foot unit. There are also numerous deck widenings for on- and off-ramps.

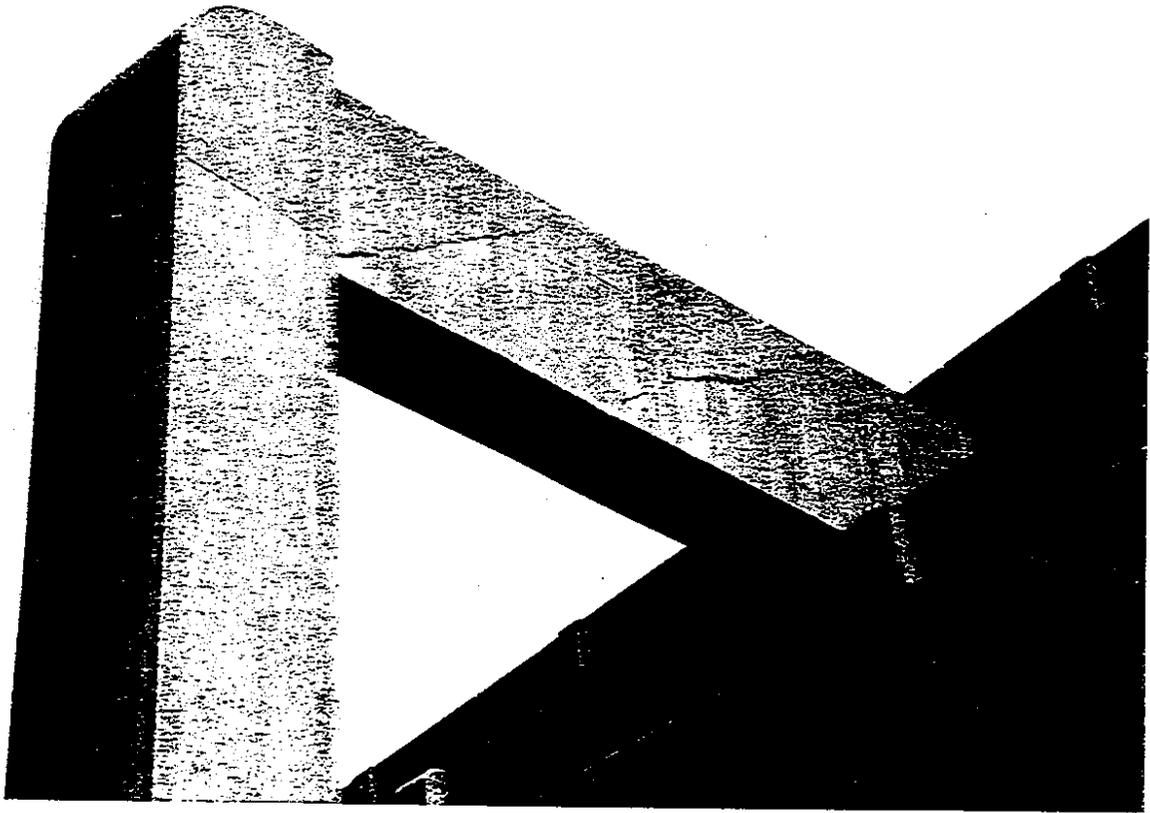
Figure 2.3. Shear Cracks in Outrigger Beam at Bent 56

Many cracks were visible in the Seattle section. Most of the cracks were minor and expected. Some severe cracking was observed in outrigger beams that were used in the single-deck to double-deck transition zones and where columns were moved outward to avoid obstructions. Most outrigger beams had significant shear cracks. Figure 2.3 shows the extensive shear cracking at bent 56, which is located in the single- to double-deck transition zone.

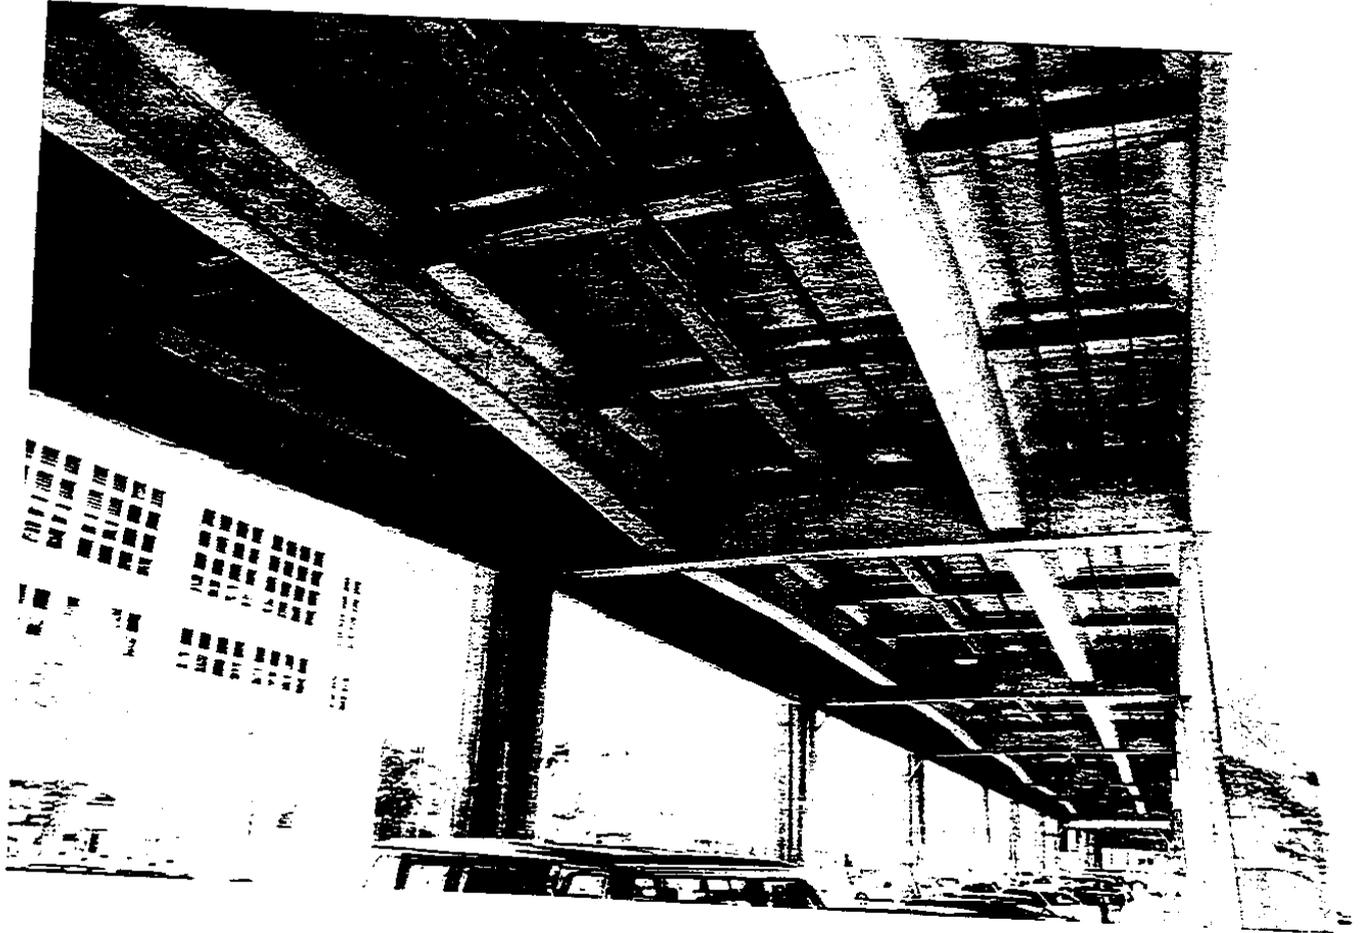
Figure 2.5. Deck Framing of the Typical SED Unit

Figure 2.5 shows the typical SED unit's deck framing. Large transverse beams span between columns at the column bents. The beams at the exterior bents are approximately half the width of those at the interior bents. Ten small transverse stringers, three in each end bay and four in the interior bay, are evenly spaced between the cross-beams. Large exterior girders span between columns in the longitudinal direction. The girders' inside, vertical faces are flush with the inside faces of the columns, and the girders' centerlines are offset 16 inches from the columns' centerlines. Two large, haunched girders and one small stringer along the bridge's centerline are evenly spaced

between the exterior girders. The interior girders have a thickened haunch section at both interior bents. Both SED and WSDOT units have 6.5-inch thick slabs.

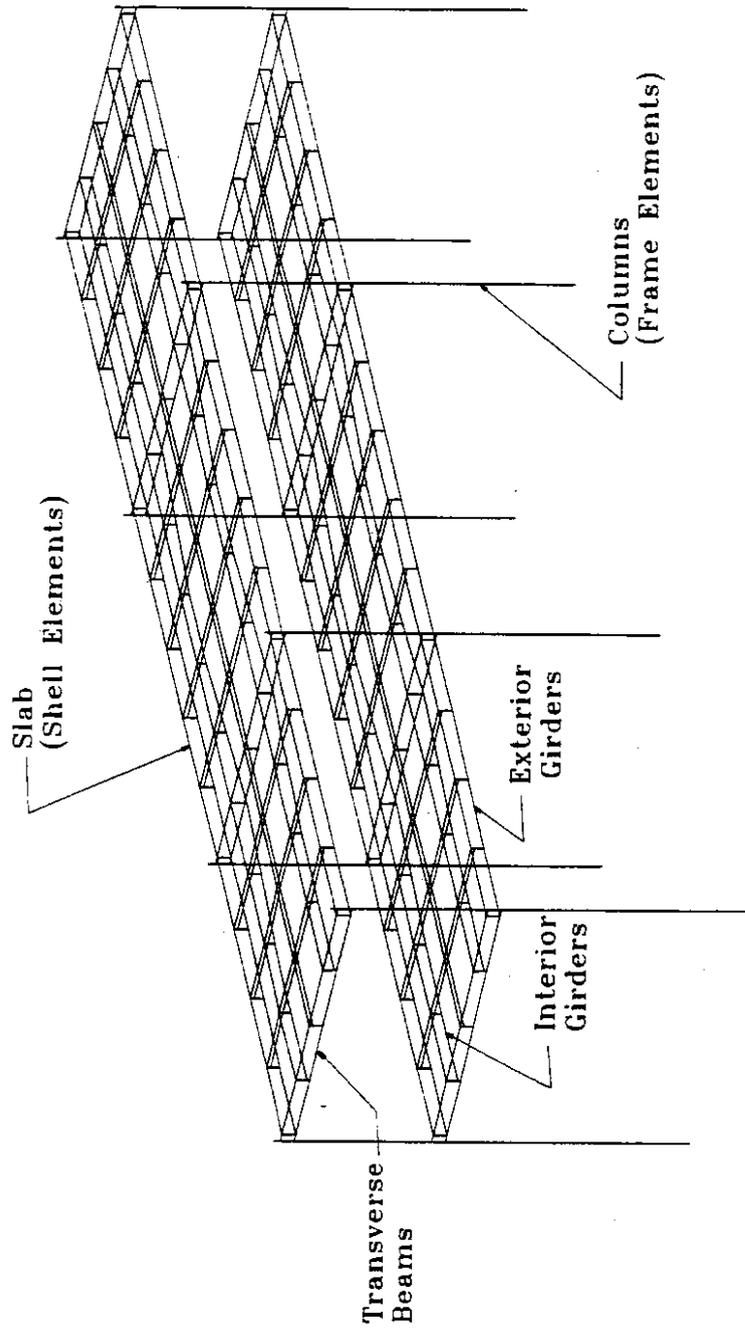
Figure 3.1. Three-dimensional Finite Element Model of the Typical SED Unit

The beam and column reinforcement changes frequently along the members' lengths. Consequently, it would have been tedious to compute the transformed-section

properties for each cross-section. As an approximation, the transformed-section moments of inertia were assumed to be half that of the gross-section. This approximation was also made for the WSDOT unit (Eberhard et al., 1995). Column stiffnesses at the joints were increased by a factor of 8.

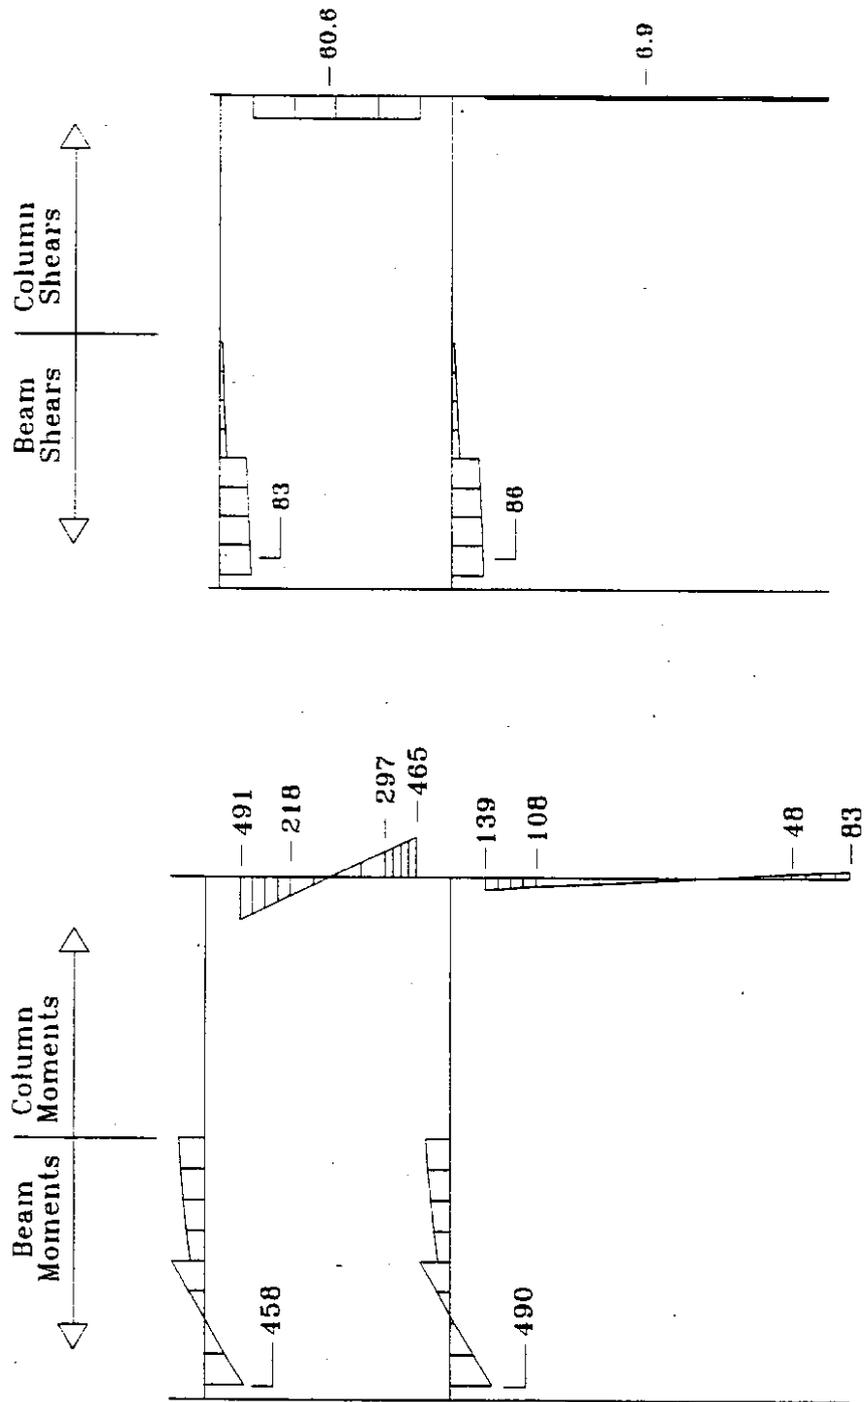
Figure 3.2. Gravity Moment and Shear Diagrams - Exterior Frame

A gravity analysis was performed using the three-dimensional, linear model. The moment and shear diagrams for the exterior and interior transverse frames are shown in Figures 3.2 and 3.3. The plotted beam moments include three contributions: (1) the moment in the beam element at the column face, (2) moments from the slab elements, and (3) moments due to coupled axial forces between the beam and slab elements. The shapes of the diagrams were similar to those of the WSDOT unit in that the moments were much larger in the upper-story than in the lower-story columns. Because the upper-story columns were shorter and stiffer than the lower-story columns, they attracted more of the beam moments. The column moments were much larger in the SED unit than in the

WSDOT unit; the exterior transverse frame moments were twice as large, and the interior frame moments were 2.5 times as large. This difference was a consequence of the differences in framing systems. The SED unit uses interior, longitudinal girders to transfer deck loads to cross beams at the column bents. The WSDOT unit uses intermediate, transverse cross beams between column bents to transfer deck loads to exterior, longitudinal girders. It follows that the transverse gravity moments were higher in the SED unit than in the WSDOT unit.

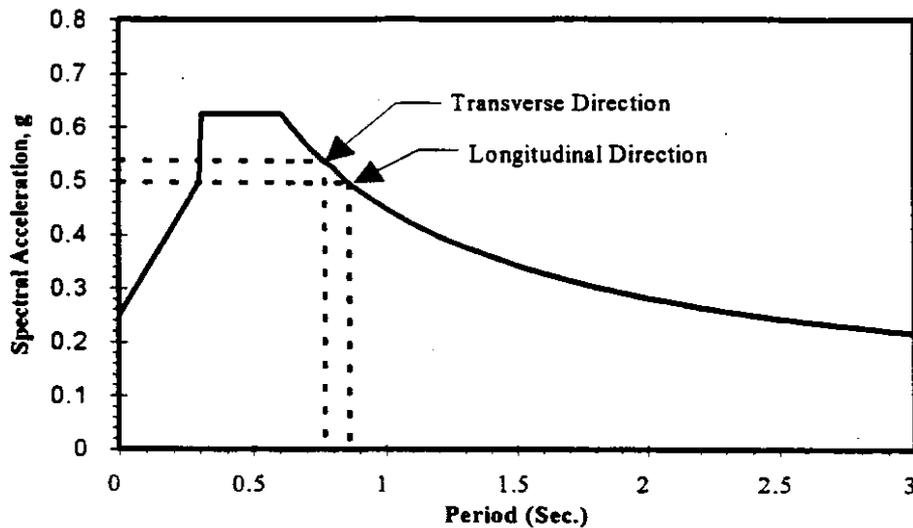
Figure 3.5. ATC-6 Response Spectrum (0.25g)

Spectral analyses were performed in both the transverse and longitudinal directions. The response spectrum, shown in Figure 3.5, was derived from Section 5.2.2 of "Seismic Design Guidelines For Highway Bridges, ATC-6" (ATC, 1981). The response spectrum was constructed by assuming a soil type III and a peak ground acceleration of 0.25g. SAP90 used the Complete Quadratic Combination (CQC) method to combine modal responses. To be consistent with the analysis of the WSDOT unit, 5 percent damping was used in the analysis.

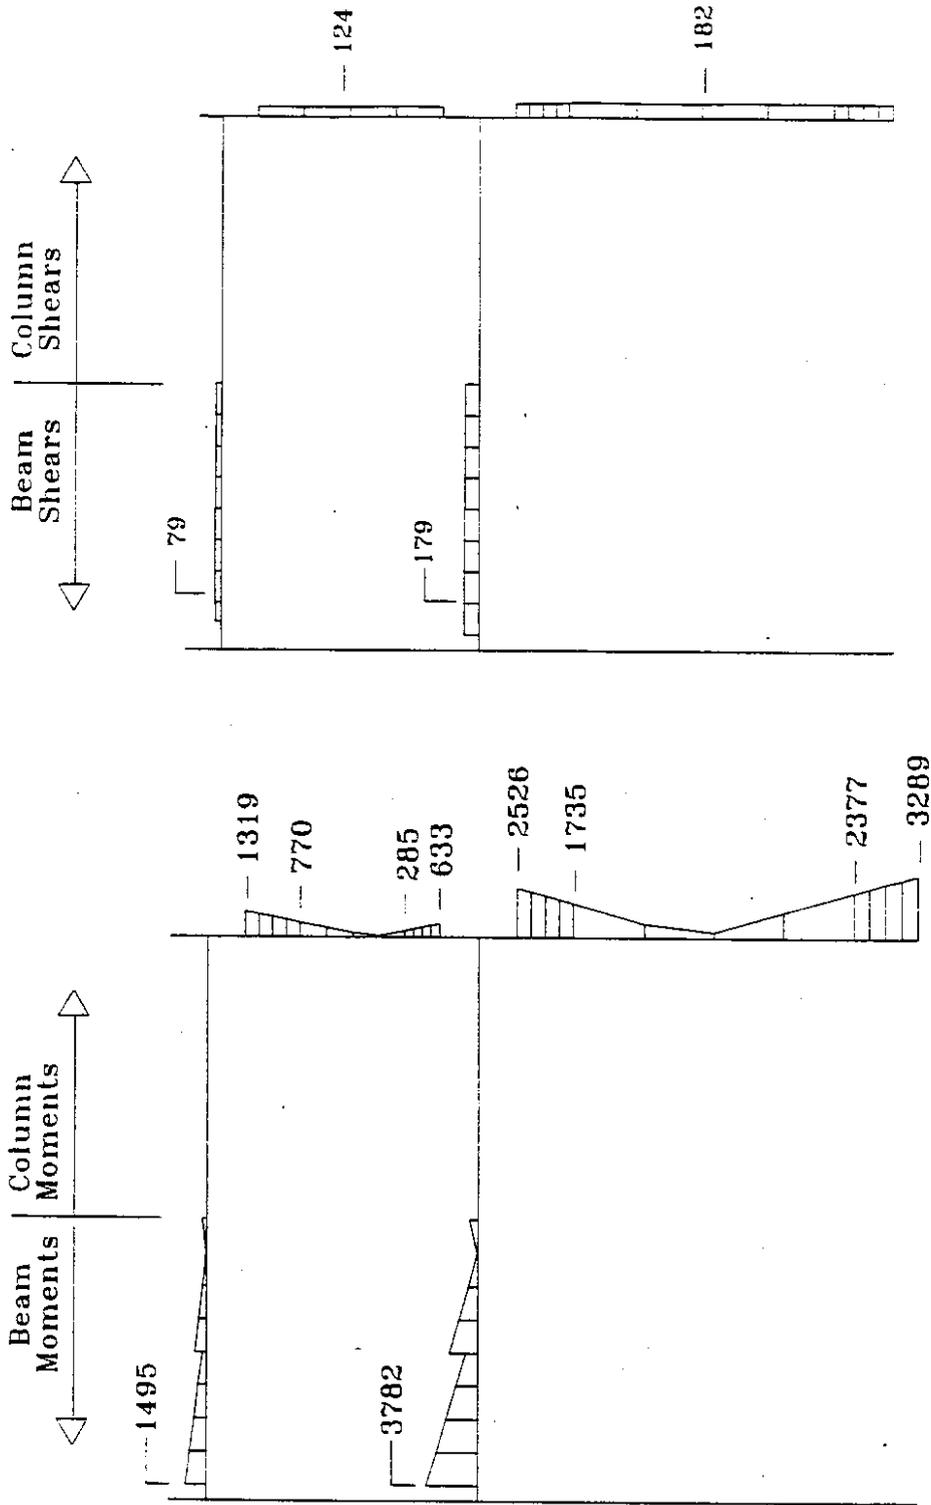
Figure 3.6 shows the moments and shears for an exterior transverse frame. Because the CQC method does not give the directions of forces, all forces were plotted with the same sign. The moments were largest at the ends of the lower-story columns and at the ends of the lower-story beam. The column moments were smallest at the bottom of the upper-story columns.

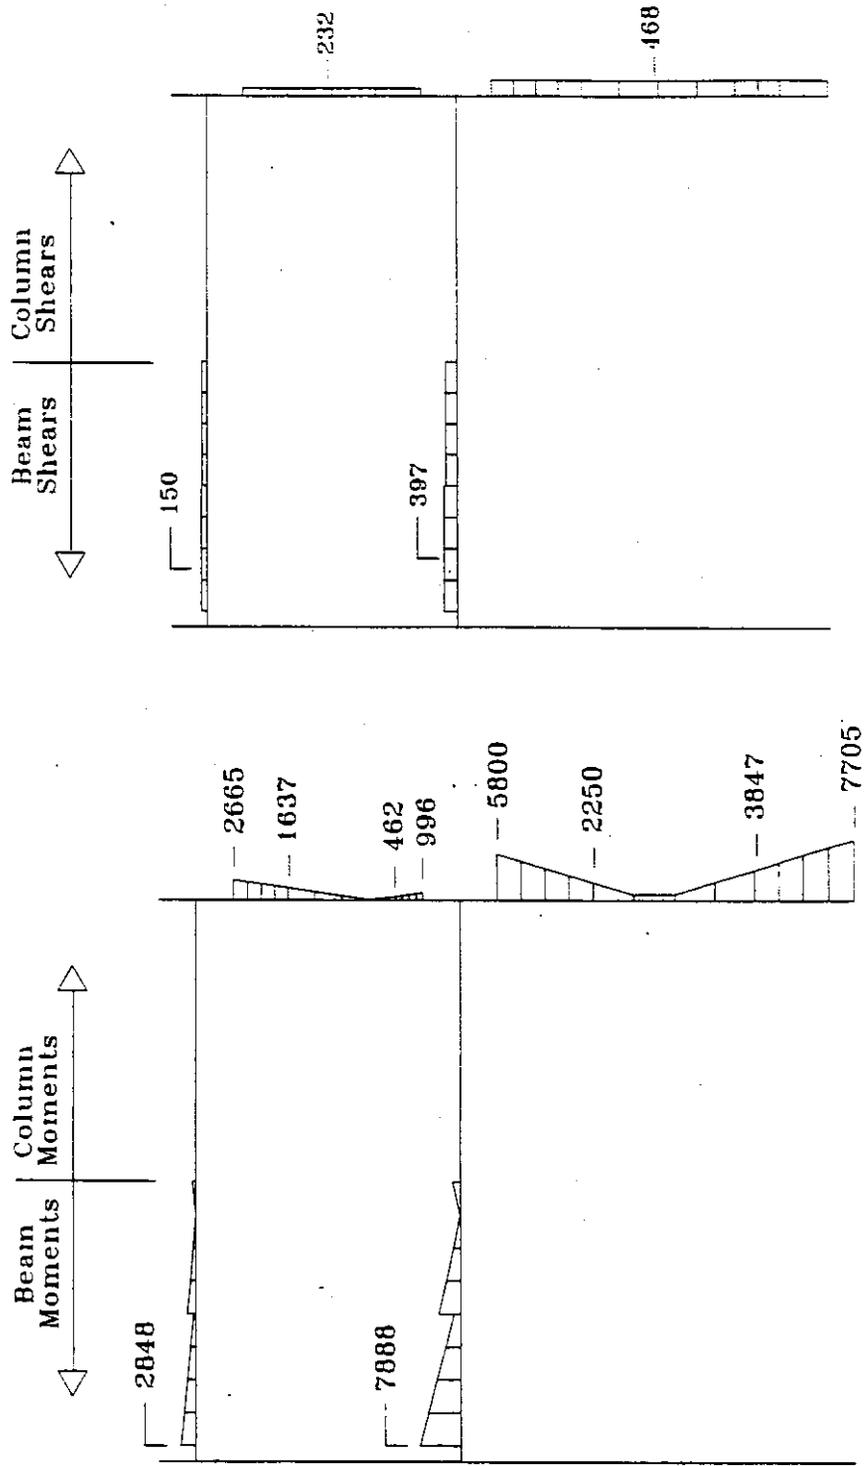
Figure 3.7 shows the moment and shear forces for an interior transverse frame. The force distributions were similar to those of the exterior frame, but the magnitudes were much larger because of the interior frame's higher stiffness. The forces were also much higher than those of the WSDOT unit's interior frame, up to three times higher for the beams and 25 to 30 percent higher for the columns. The beams and columns of the

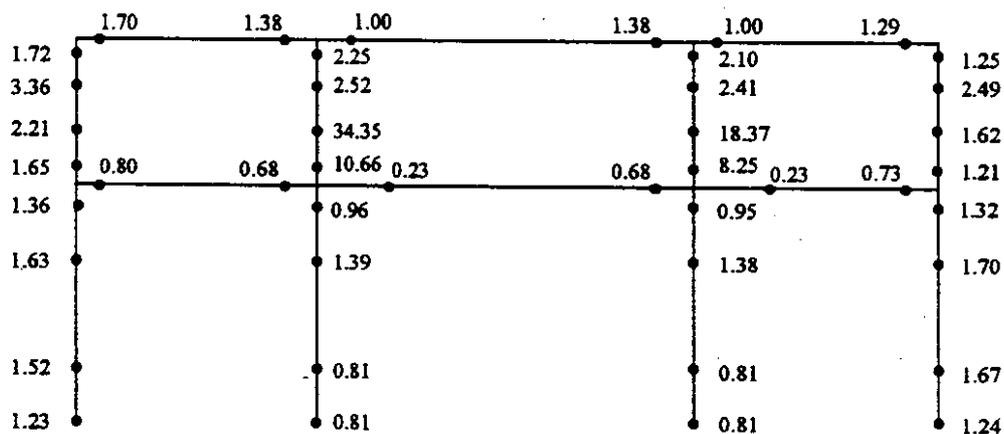
Figure 3.11. Flexural C/D Ratios for a Longitudinal Frame

In contrast to the columns, the ductility demands were high for the lower-story girders. The value of r_{eb} at a lower-story girder in positive bending at an interior column was 0.23. These girders had little positive moment reinforcement at these locations, and the demands in the exterior girders were high because the interior girders contributed little to seismic resistance. The values of r_{eb} for the upper-story girders were all greater than or equal to 1.0.

The flexural C/D ratios were typically higher in the columns of the SED unit's longitudinal frame than those in the WSDOT unit. This was due to the heavier reinforcement of the SED unit's columns. The upper-story, exterior columns of the SED unit were the exception. Their capacity was slightly less than that in the WSDOT unit, and therefore their r_{ec} values were also slightly less. However, the difference was insignificant because the upper-story columns of both units did not yield.

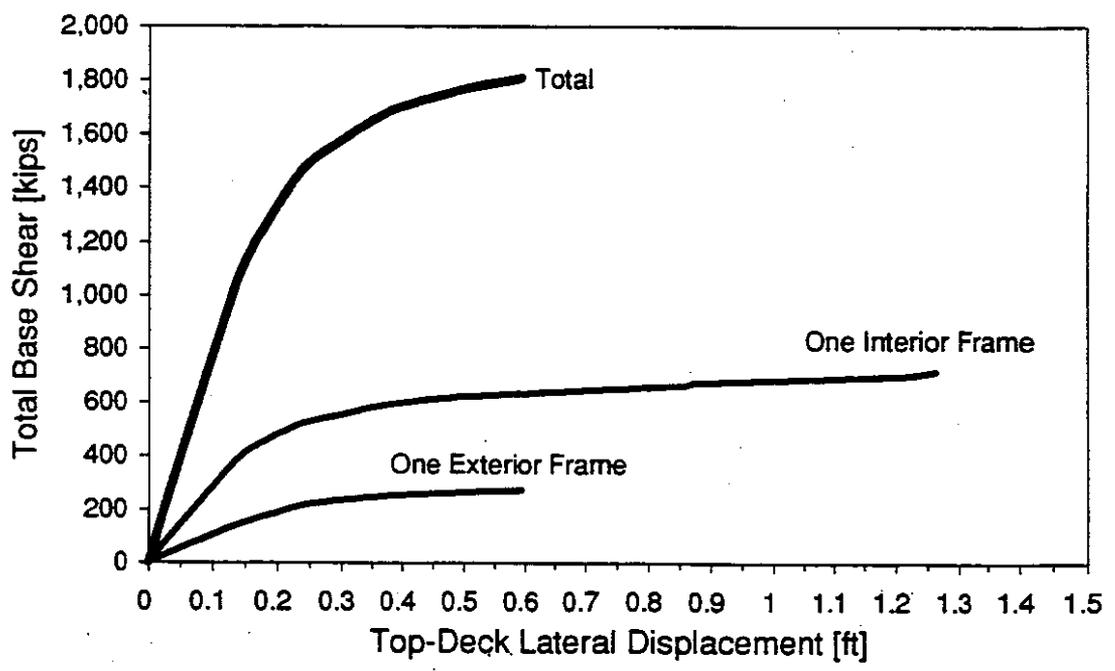
Figure 4.2. Lateral Force-Displacement Relations - Transverse Direction

Figure 4.2 shows the lateral force-displacement relationships for the interior and exterior frames. The total force capacity was found to be 1850 kips (36 percent of the unit's weight) at an upper-deck displacement of 0.6 feet (a 1.1 percent drift ratio). The total ultimate displacement was limited by the displacements of the exterior frames, and therefore, the interior frames did not develop their full lateral force capacities of 740 kips each. At a top-deck displacement of 0.6 feet, the lateral force carried by the interior frame was 640 kips. As expected, the interior frame was stronger than the exterior frame because the interior columns were shorter, wider, and more heavily reinforced at the base. The interior frame was much more ductile because at the location of yielding (6 feet above the footing) the interior column had a lower reinforcement ratio.

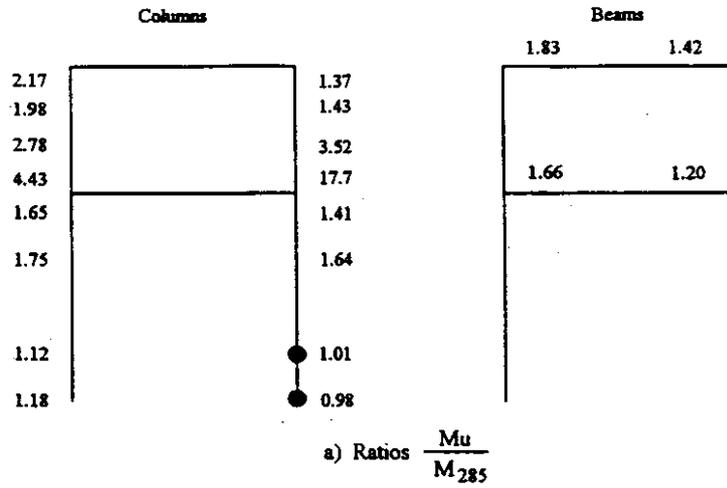
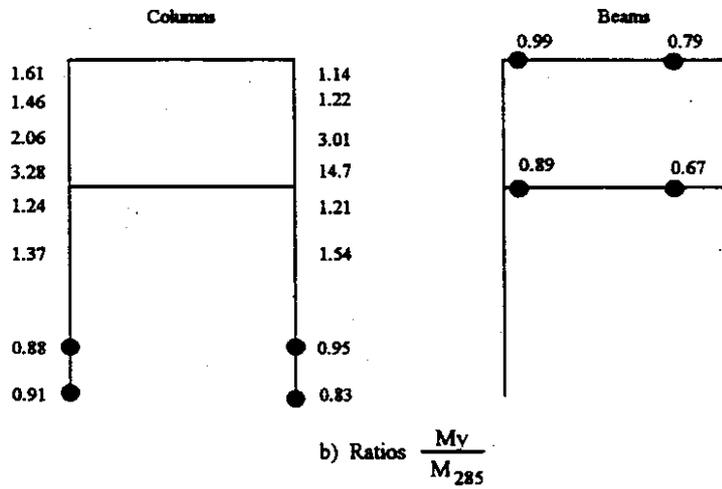
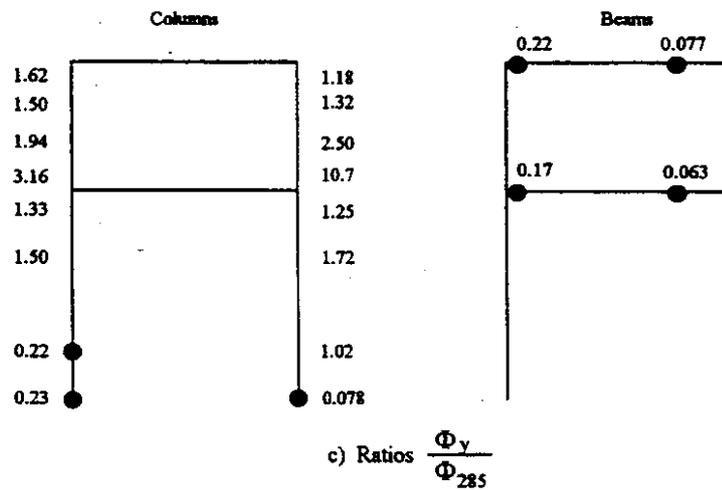
Figure 4.8. Flexural Capacity/Demand Ratios for Exterior Frames

Figure 4.8 summarizes the flexural demands for the columns and beams of an exterior frame. Part (a) shows that the ultimate flexural capacity was reached at locations 1 and 2 of the right-side column. Part (b) shows that yielding occurred at column locations 1 and 2, in each beam at 6 feet from the face of the right-side columns and in each beam at the face of the left-side columns. Part (c) shows that the curvature ductility demands were highest in the beams and at the base of the columns. The failure mechanism for an exterior frame was similar to that of an interior frame, except that yielding in the interior frames' columns was concentrated at location 2.

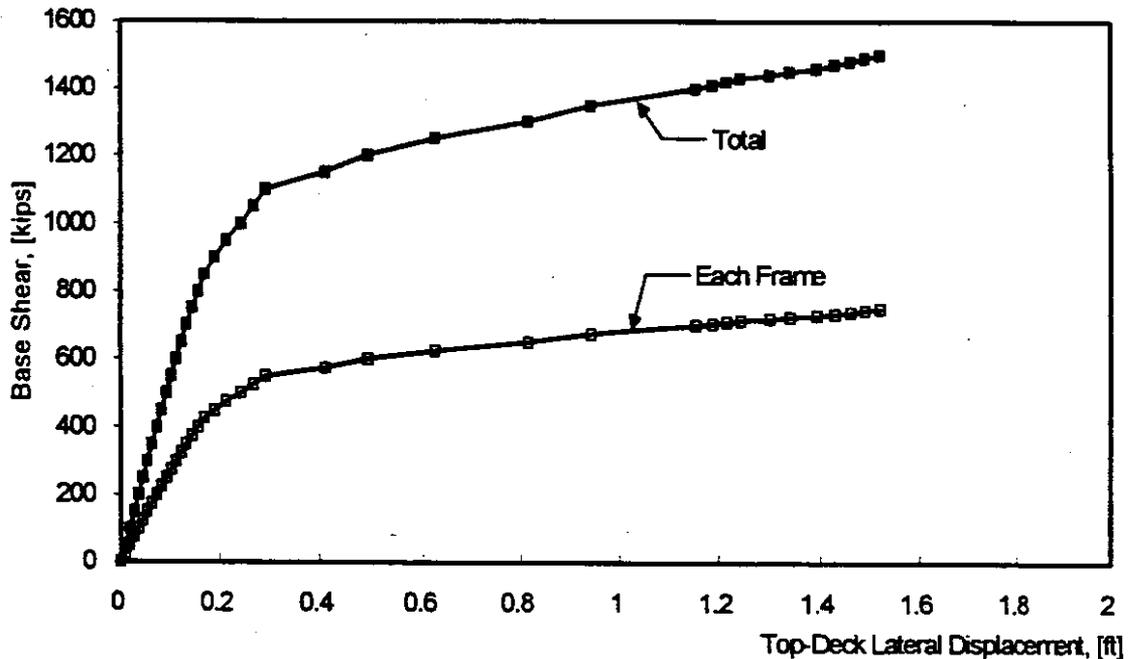
Figure 4.9. Lateral Force-Displacement Relationships for Longitudinal Frames

The lateral force-displacement relationships for the longitudinal frames are shown in Figure 4.9. The total force capacity was found to be 1500 kips (28 percent of the unit's weight) at an upper-deck displacement of 1.5 feet (a 2.8 percent drift ratio). The total lateral force capacity was 20 percent less in the longitudinal direction than in the transverse direction for two main reasons. First, the girders were relatively weak in comparison to the transverse beams, and second, in the longitudinal direction the exterior columns were bent about their weak axis. The exterior columns were relatively flexible and ductile about their weak axis, and therefore, they did not limit the ultimate lateral displacements as they did in the transverse direction. As a result, the ultimate drift ratio in the longitudinal direction was 2.5 times higher than in the transverse direction.

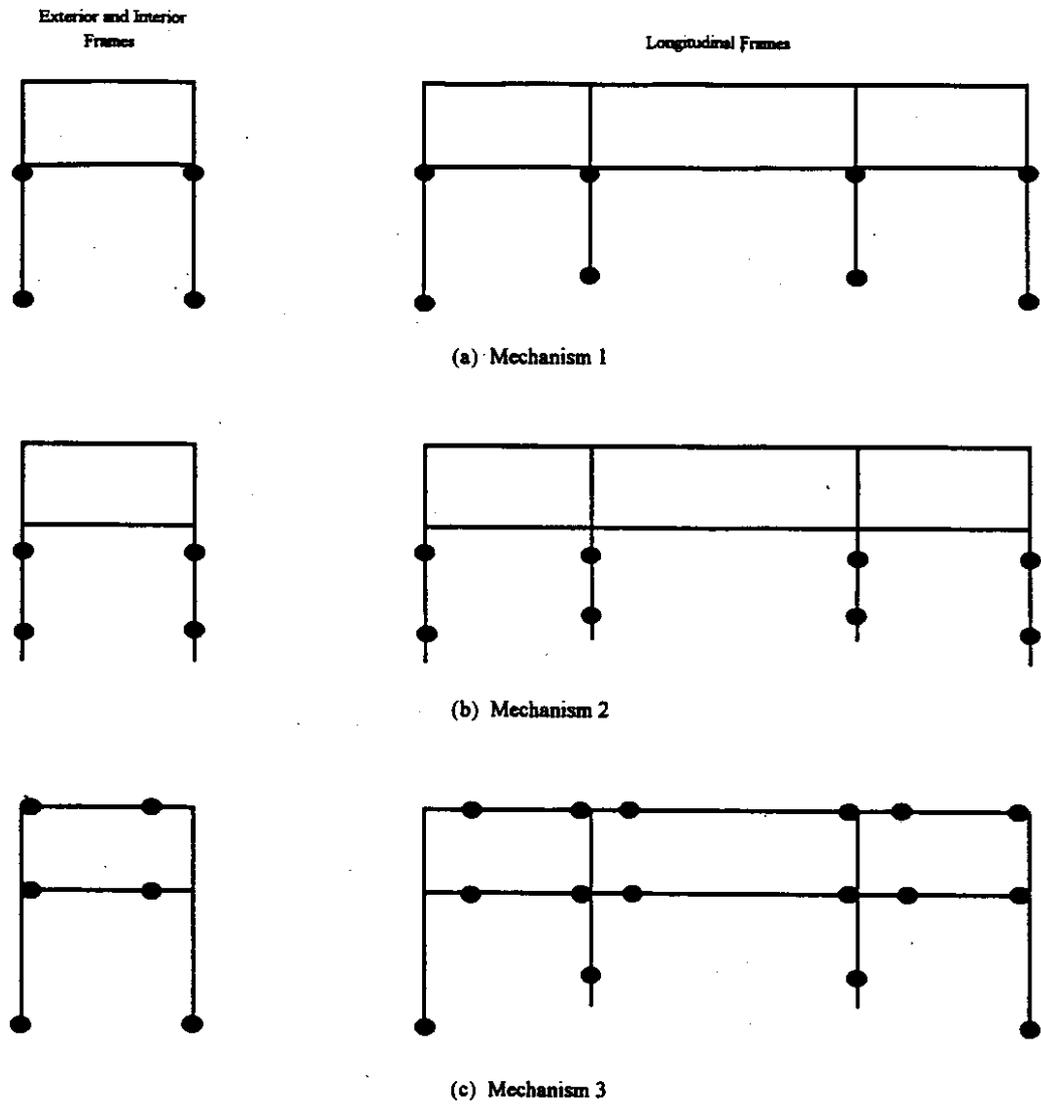
Figure 4.13. Plastic-Hinging Mechanisms 1 thru 3

Plastic-hinge analyses were conducted to compute the yield and ultimate capacities of each lateral frame. The capacities of each frame were computed using the three failure mechanisms shown in Figure 4.13. Mechanism 1 consisted of plastic hinges at the ends of the lower-story columns. Mechanism 2 consisted of plastic hinges at column locations 2 and 3. Mechanism 3 consisted of plastic hinges in the beams or girders and at either column location 1 or 2, depending on which resulted in the lowest capacity. The hinge locations in the beams and girders were selected on the bases of the results of the nonlinear analyses.

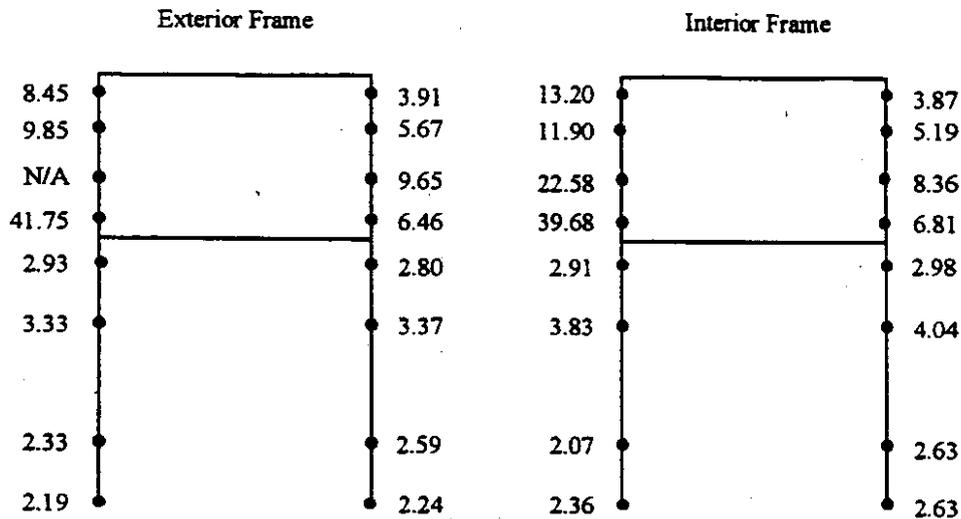
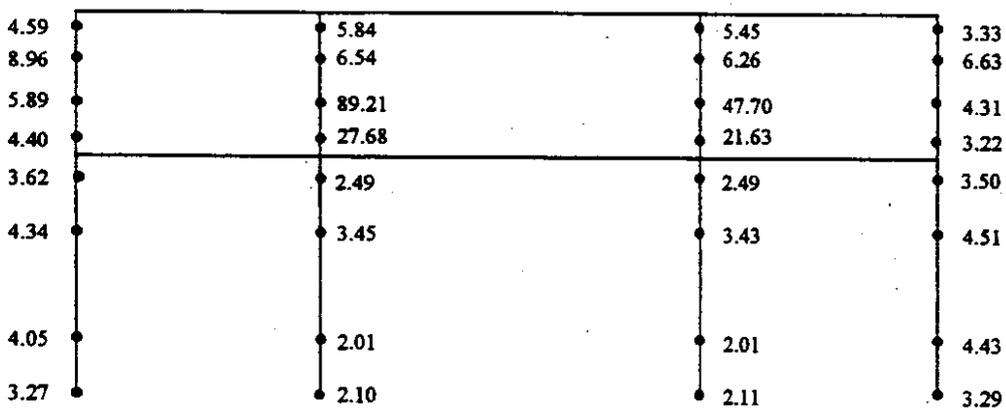
Figure 5.1 ATC-6-2 C/D Ratios for Transverse Confinement, r_{cc}

Figure 5.1 summarizes the values of r_{cc} for each column of the SED unit. All values greatly exceeded 1.0 because the flexural C/D ratios greatly exceeded 0.5 (Section 3.5). The ductility capacities, μ , were found to be relatively low (between 2.4 and 2.7) because the transverse reinforcement was inadequately anchored.

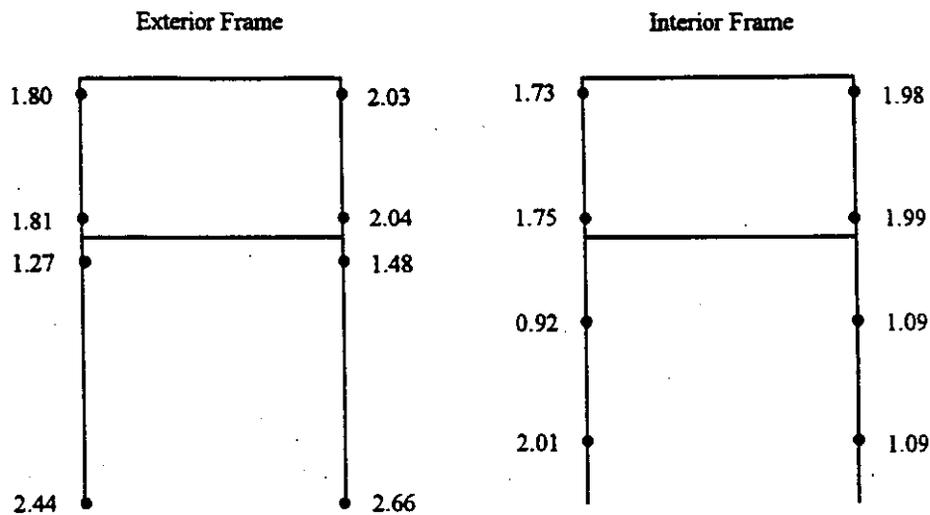
Figure 6.2. Shear C/D Ratios for Transverse Frames

Yielding was not predicted in the exterior frame's upper-story columns, and the elastic shear demands were less than the initial shear capacities. Consequently, the values of r_{CV} were all greater than 1.0. Nonetheless, the shear demands associated with plastic hinging, $V_u(d)$, were much greater than the initial shear capacities, and shear case A would apply if the demands increased enough.

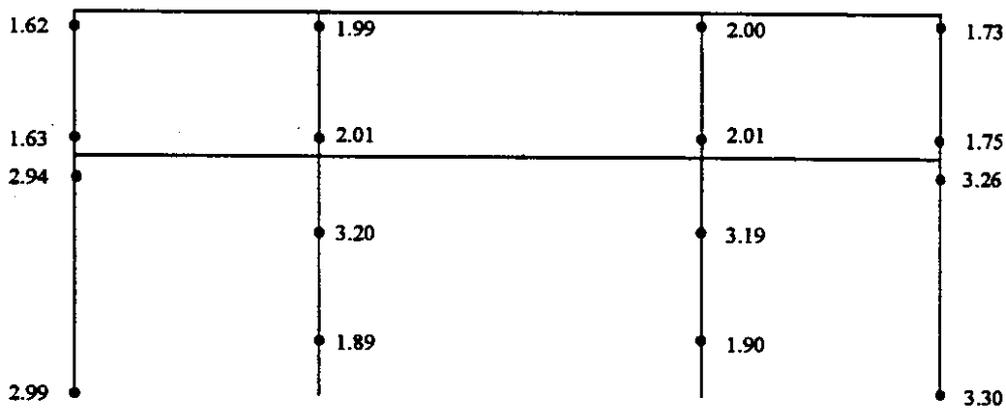
Figure 6.3. Shear C/D Ratios for Longitudinal Frame

For the exterior columns, no yielding was predicted, and all elastic shear demands were less than the initial shear capacities. Therefore, all values of r_{CV} exceeded 1.0. The values of r_{CV} for the exterior, upper-story columns were less than those for the exterior, lower-story columns. This is because the elastic analysis predicted higher shear demands in the stiff, upper-story columns than those predicted for the more flexible lower-story columns. For all the exterior column locations, the ultimate shear capacities, $V_u(d)$, as determined from limit analyses, were less than the initial shear capacities, $V_i(c)$; therefore, shear case B would apply if the shear demands increased enough.

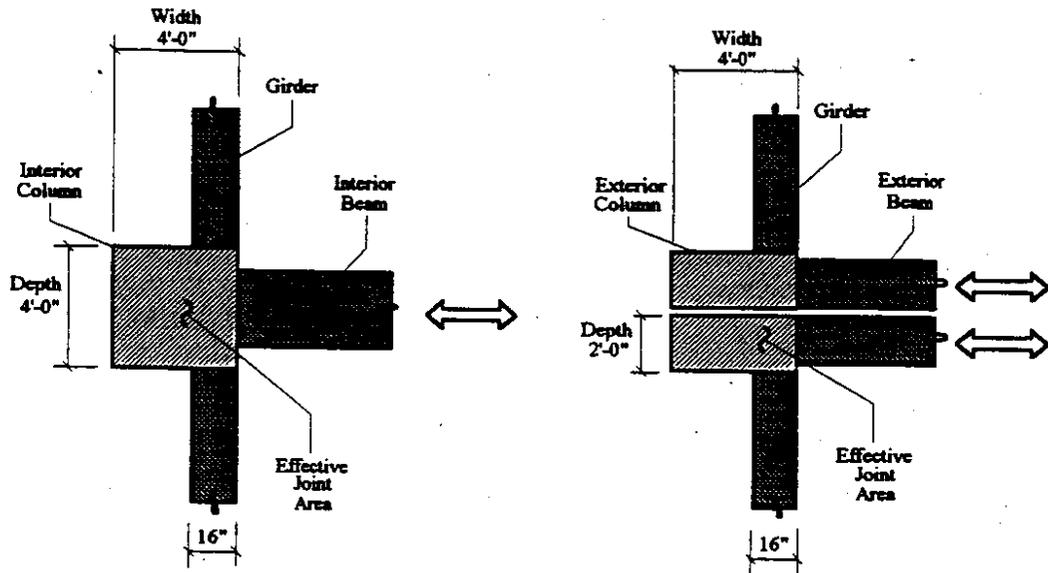
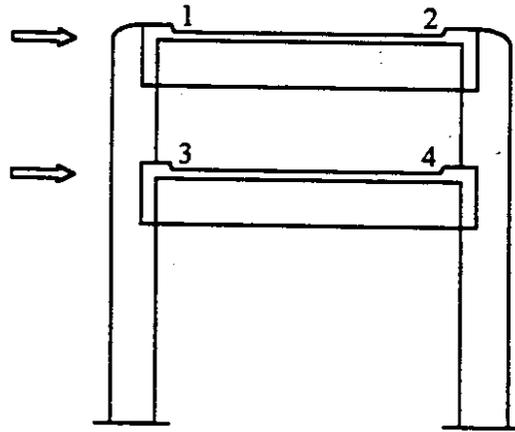
Figure 9.1. Effective Joint Areas and Designations - Transverse Direction

approximated by a line extending from the girder's exterior face at 45 degrees through the column. The effective width was calculated to be the girder width plus either 1/2 the protruding column dimension, or 1/2 the column depth, whichever was less (Figure 9.2).

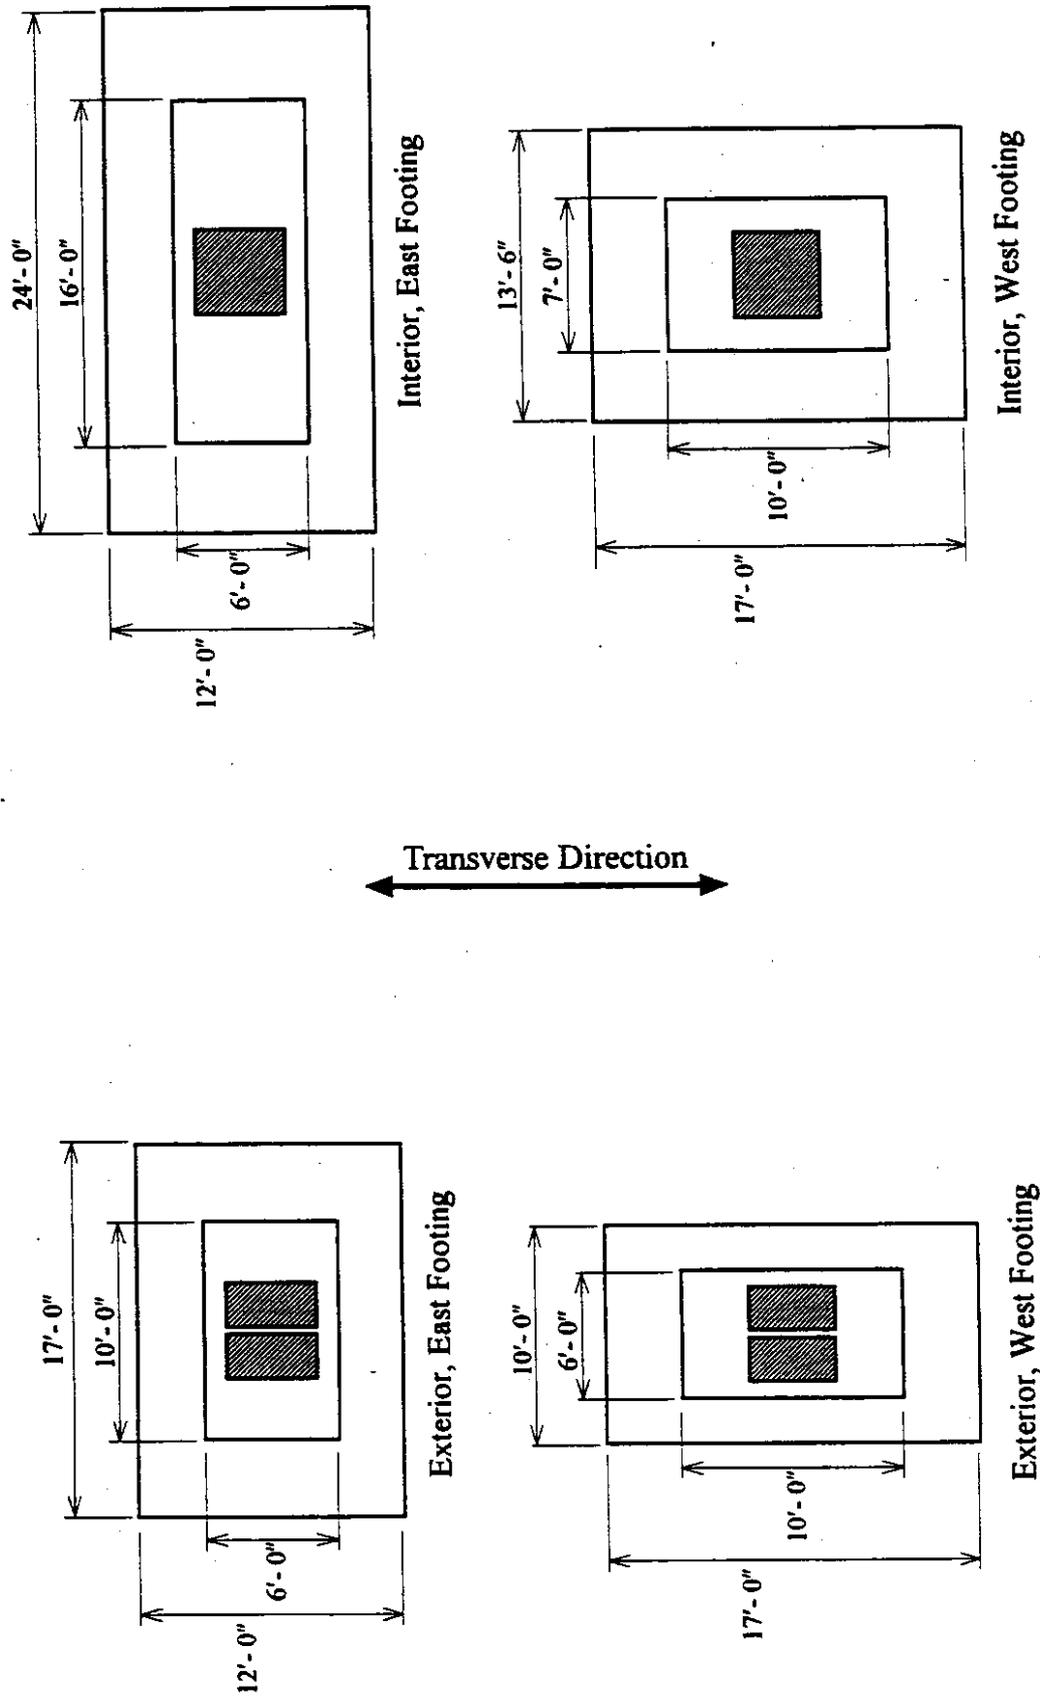
Figure 10.1. Footing Configurations and Plan Dimensions

The seismic vulnerability of each footing was evaluated in the transverse direction only. Each footing was evaluated for flexural and shear failures near the face of the columns and near the face of the pedestal. Each column-to-footing joint was also evaluated for joint shear failure.
