STONE MATRIX ASPHALT SR-524, 64TH AVENUE WEST TO I-5 MP 3.30 TO MP 4.88

WA-RD 504.1

Post Construction Report
November 2000

**Washington State
Department of Transportation**

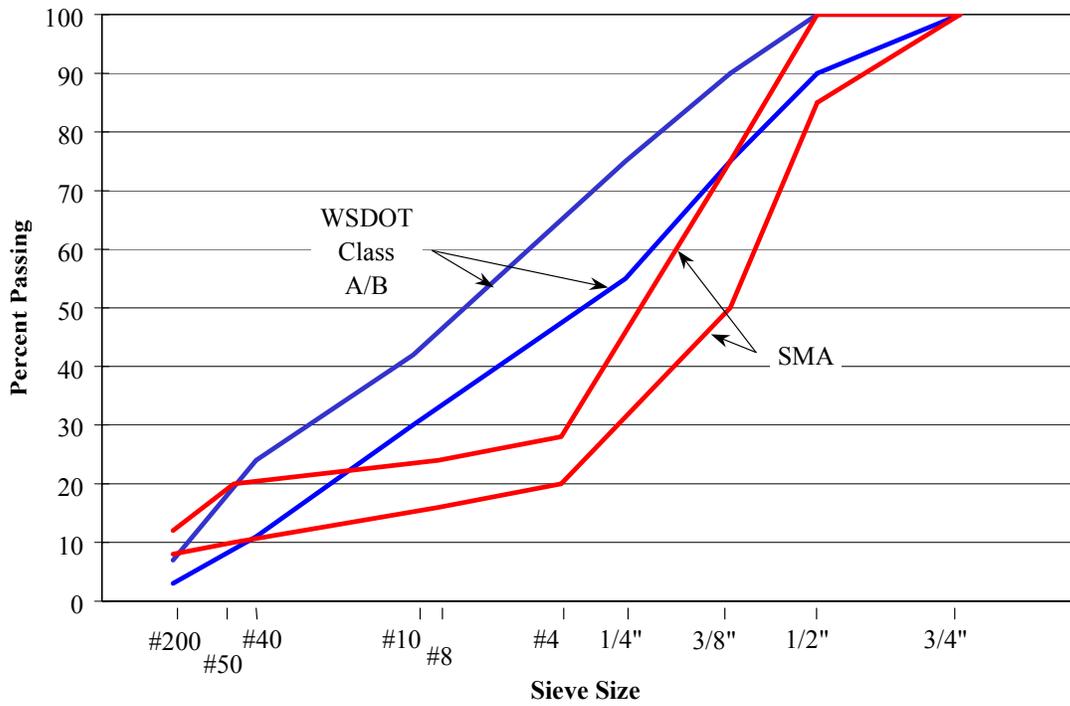
Figure 1. Aggregate gradation band for SMA and WSDOT Class A/B mixes.

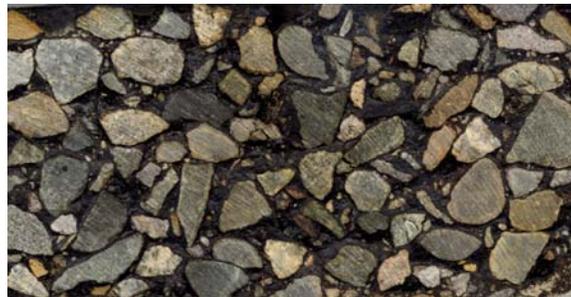
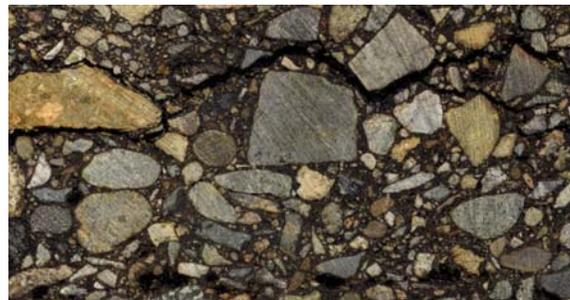
SMA

WSDOT Class A/B

Figure 2. SMA and WSDOT dense graded mixture.

Figure 2 illustrates the comparison of the aggregate structure for SMA mixtures versus WSDOT standard Class A/B mixture.

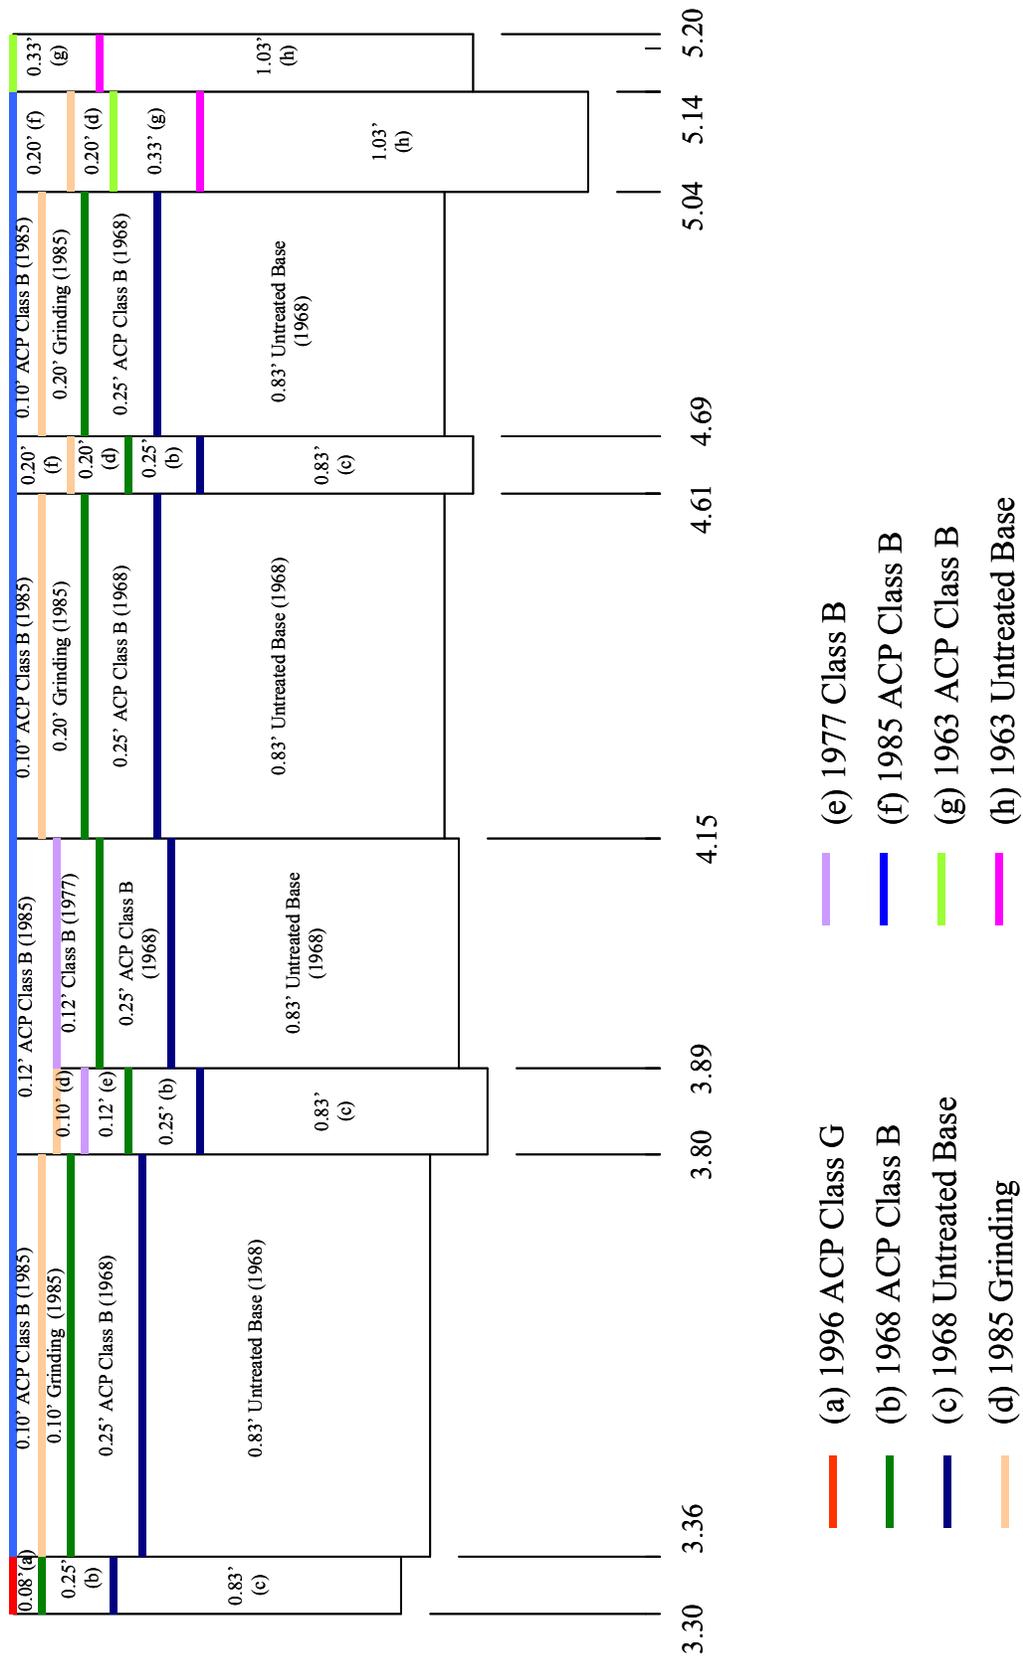
Figure 3. Pavement structural cross section

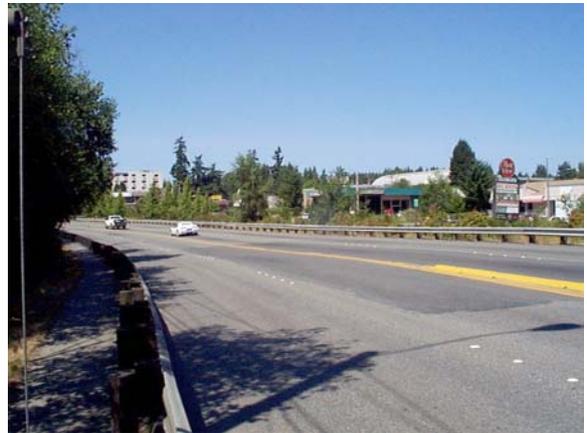
Photo 2. Settlement area between 52nd Avenue West and 56th Avenue West.

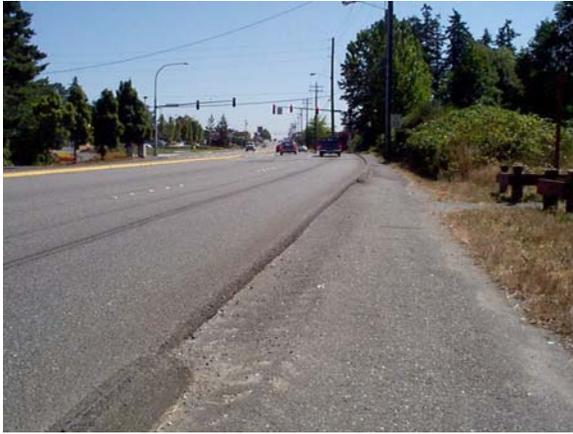
Photo 3. East end of settlement area looking towards 56th Avenue West.

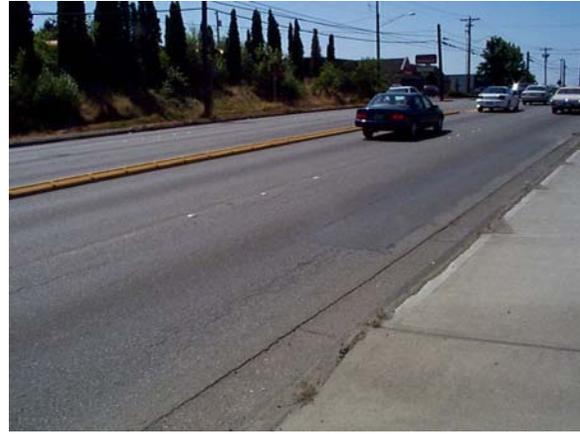
Photo 4. Typical roadway distress.

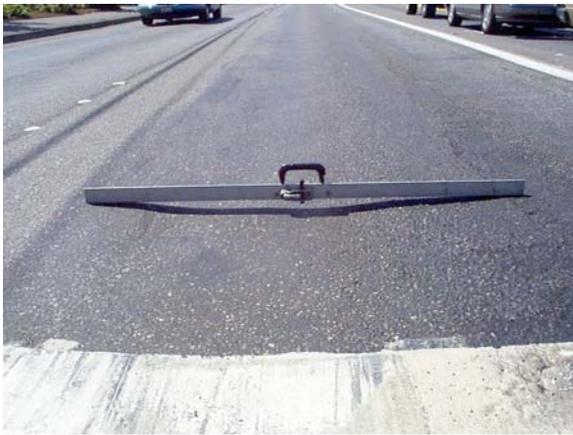
Photo 5. Rutting (EB) 44th Avenue West.

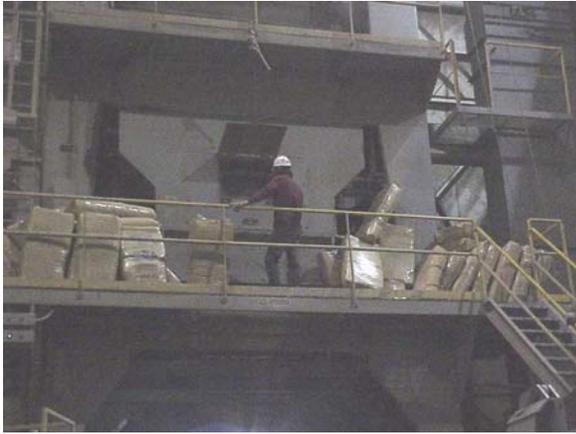
Photo 7. Fibers were added by hand into the pug mill.

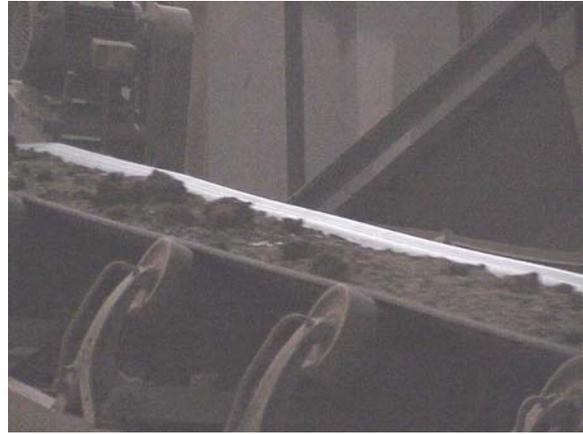
Photo 8. Aggregate on the cold feed conveyor. Clumping due to wet mineral filler.

Some balls of wet fly ash were found on the cold feed belt going into the drum. The loader operator was asked to avoid the edges and bottom of the stockpile of No.4-dust/fly ash, which was found to be wet enough for the material to ball up. After this no further such balls of fly ash were observed.

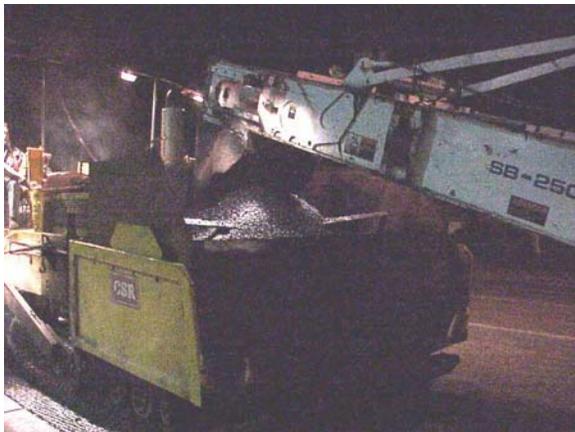
Photo 11. Mix paver hopper from Roadtec Shuttlebuggy.

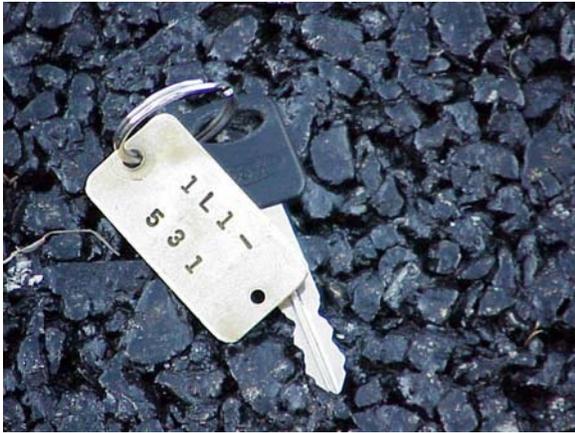
Photo 13. SMA surface.

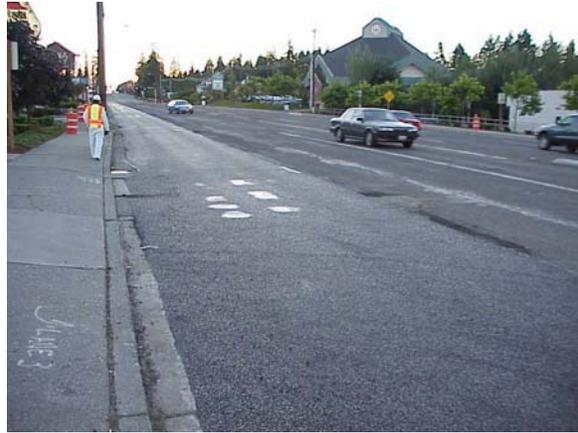
Photo 14. Fat spots due to drain-down.

Several isolated spots of drain-down also occurred, it was determined that these spots were caused by the use of diesel fuel for cleaning truck beds and by not allowing them to drain the excess diesel prior to loading. According to the specification, diesel fuel was not to be used for cleaning truck beds.

The surface texture and appearance of the mix was satisfactory with the exception of several spots rich in AC due to drain-down. These spots were located between the wheel paths and were caused by running the conveyor of the MTV when the hopper is empty, and by insufficient fiber content to prevent drain-down in the truck. It was decided that the proportion of fiber stabilizer needed to be increased. After this was done on Wednesday, drain-down was essentially eliminated. There were some similar spots noticed Wednesday night, but these spots were primarily caused by truckers using fuel oil to clean out their truck beds (rather than an approved releasing agent) and from excessive tack build-up on the tires of the MTV which would drop off onto the surface just prior to the paver covering it up.

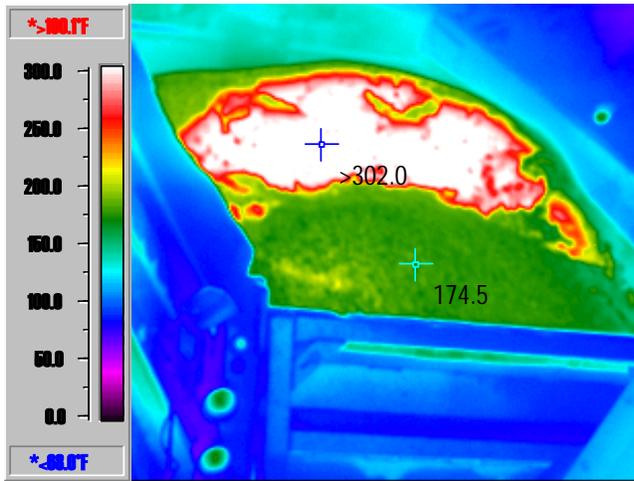
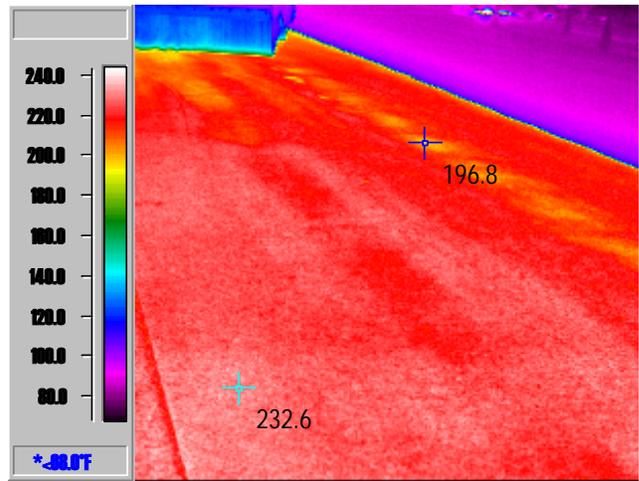
a. SMA mixture in truck bed with temperature differentials of 130°F.

b. SMA mixture immediately after breakdown roller. Cool spots are fat spots.

Figure 4. Infrared images from second test section (9-1-99).

Another problem was attributed to the lack of an aggressive compaction train. The breakdown roller was several 100 feet behind the paver causing low compaction results and allowing the mixture to cool prior to compaction. Typical infrared images are shown in Figures 4 to 6.

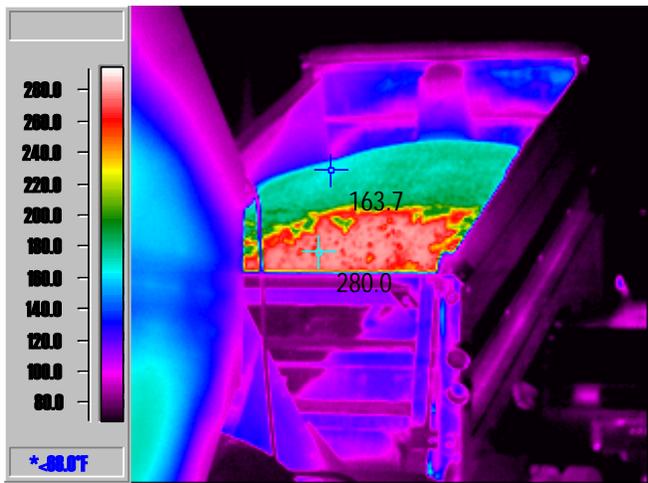
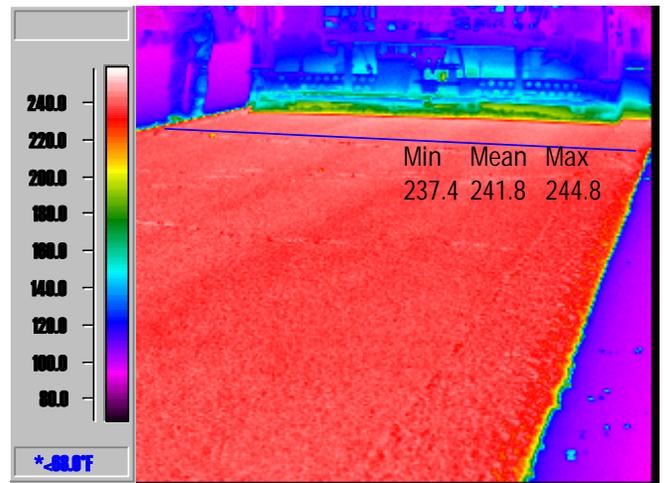
a. SMA mixture in truck bed with temperature differentials of 160°F.

b. Mat is very uniform with only a 7°F temperature differential.

Figure 5. Infrared images during production paving (9-9-1999).

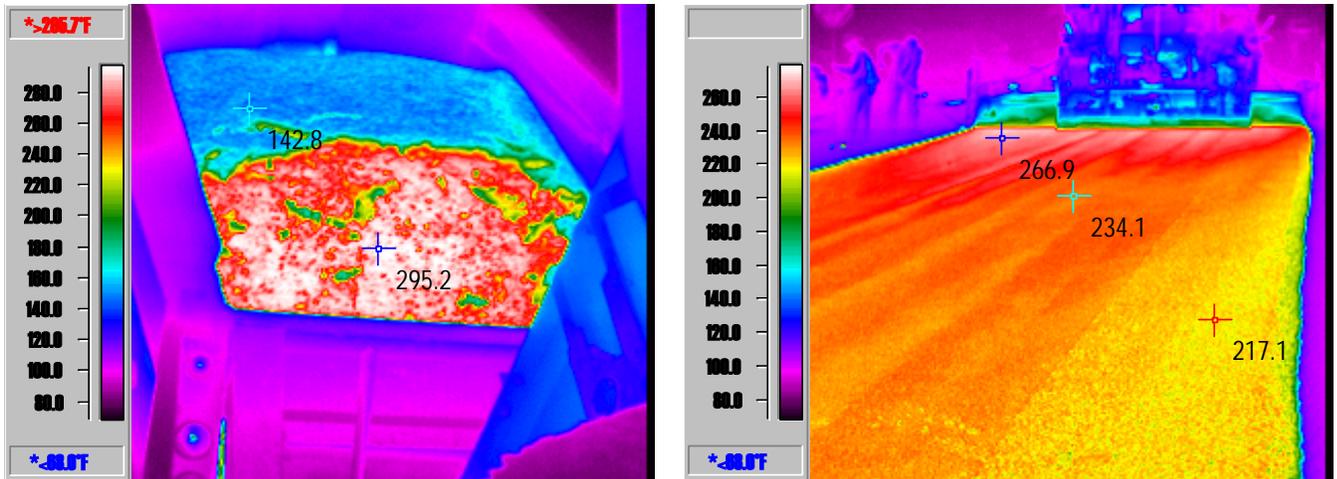
- a. Stone matrix asphalt mixture in truck bed with temperature differentials of 160°F.
- b. Mat is very uniform directly behind the paver, however within about 30 feet the mat has cooled 50°F without being compacted.

Figure 6. Infrared images during production paving (9-15-1999).

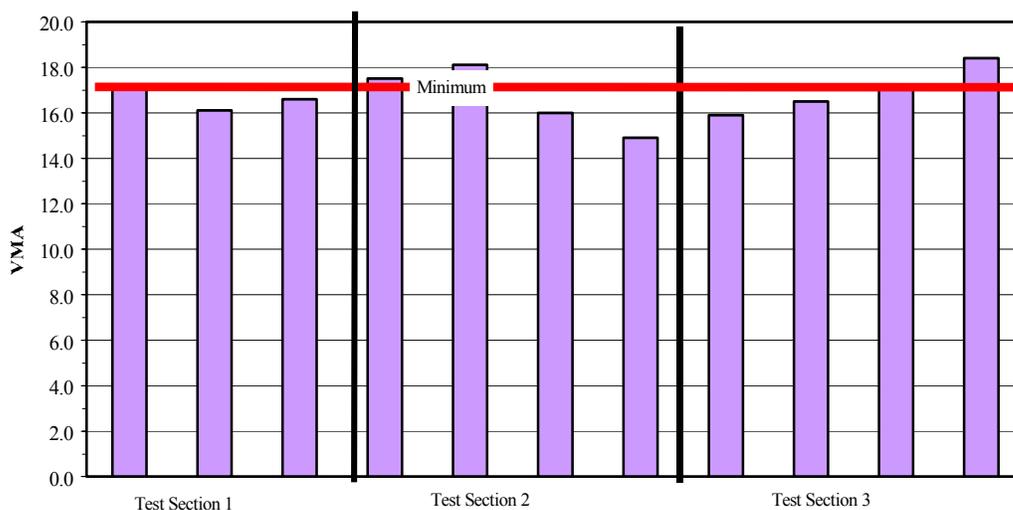
Figure 7. Test Section VMA - gyrotory compacted samples

Based on the final production values, both the asphalt content and VFA were lower than specified, and the VMA values were within the target values (see Figures 7 through 14). The final pay factors for this project resulted in a 1.0 pay factor with a \$600 bonus, but a \$65,000 penalty due to low asphalt content and low compaction values.

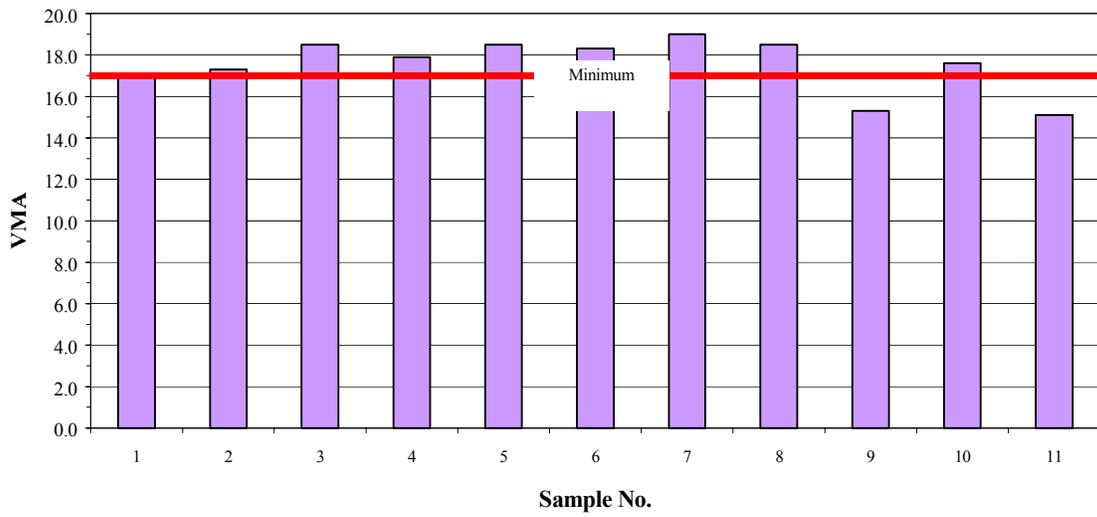
Figure 8. Production VMA - gyrotory compacted samples

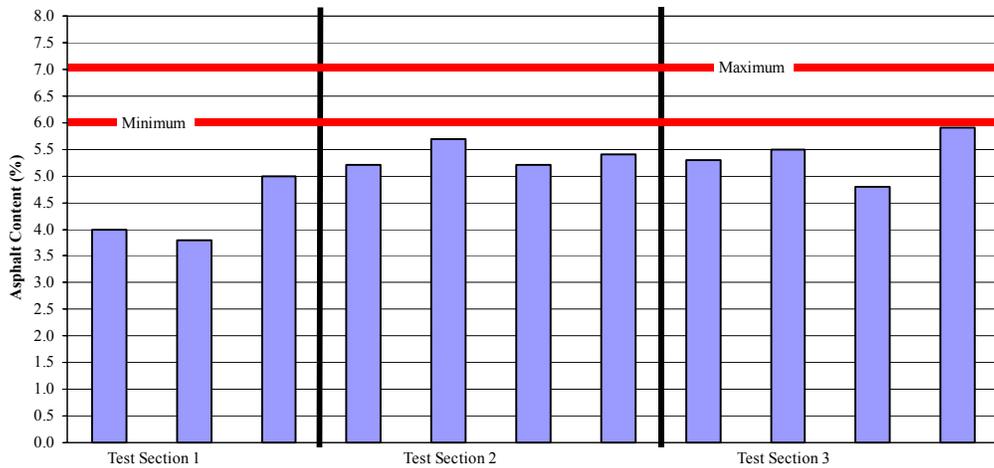
Figure 9. Test section asphalt content – gyrotory compacted samples

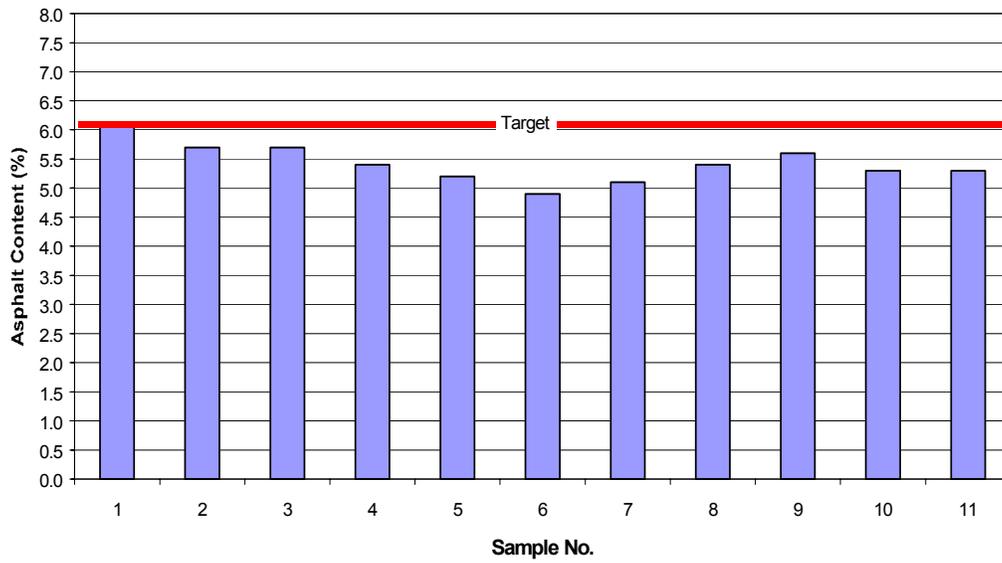
Figure 10. Production asphalt content – gyratory compacted samples

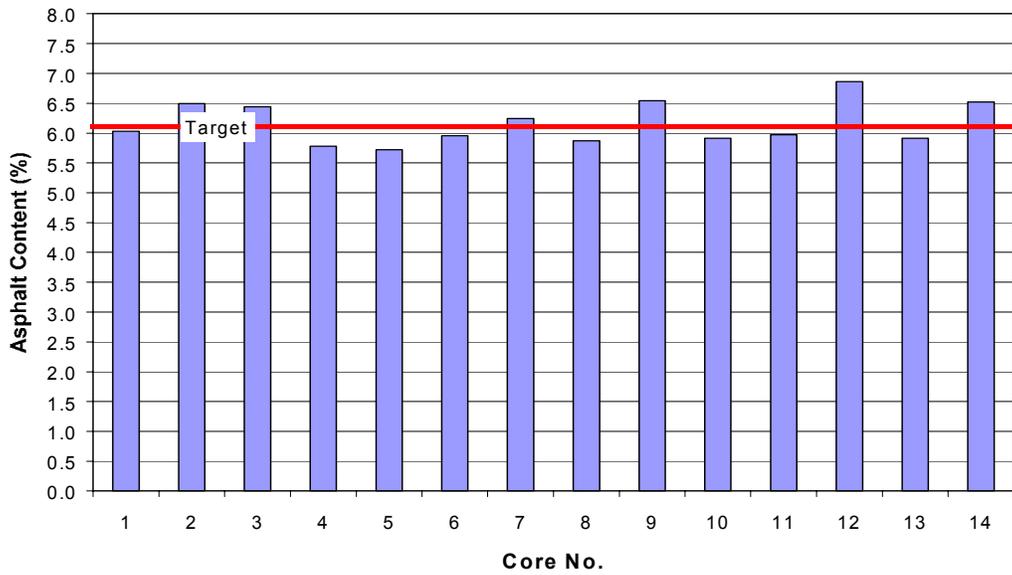
Figure 11. Production asphalt content – core samples

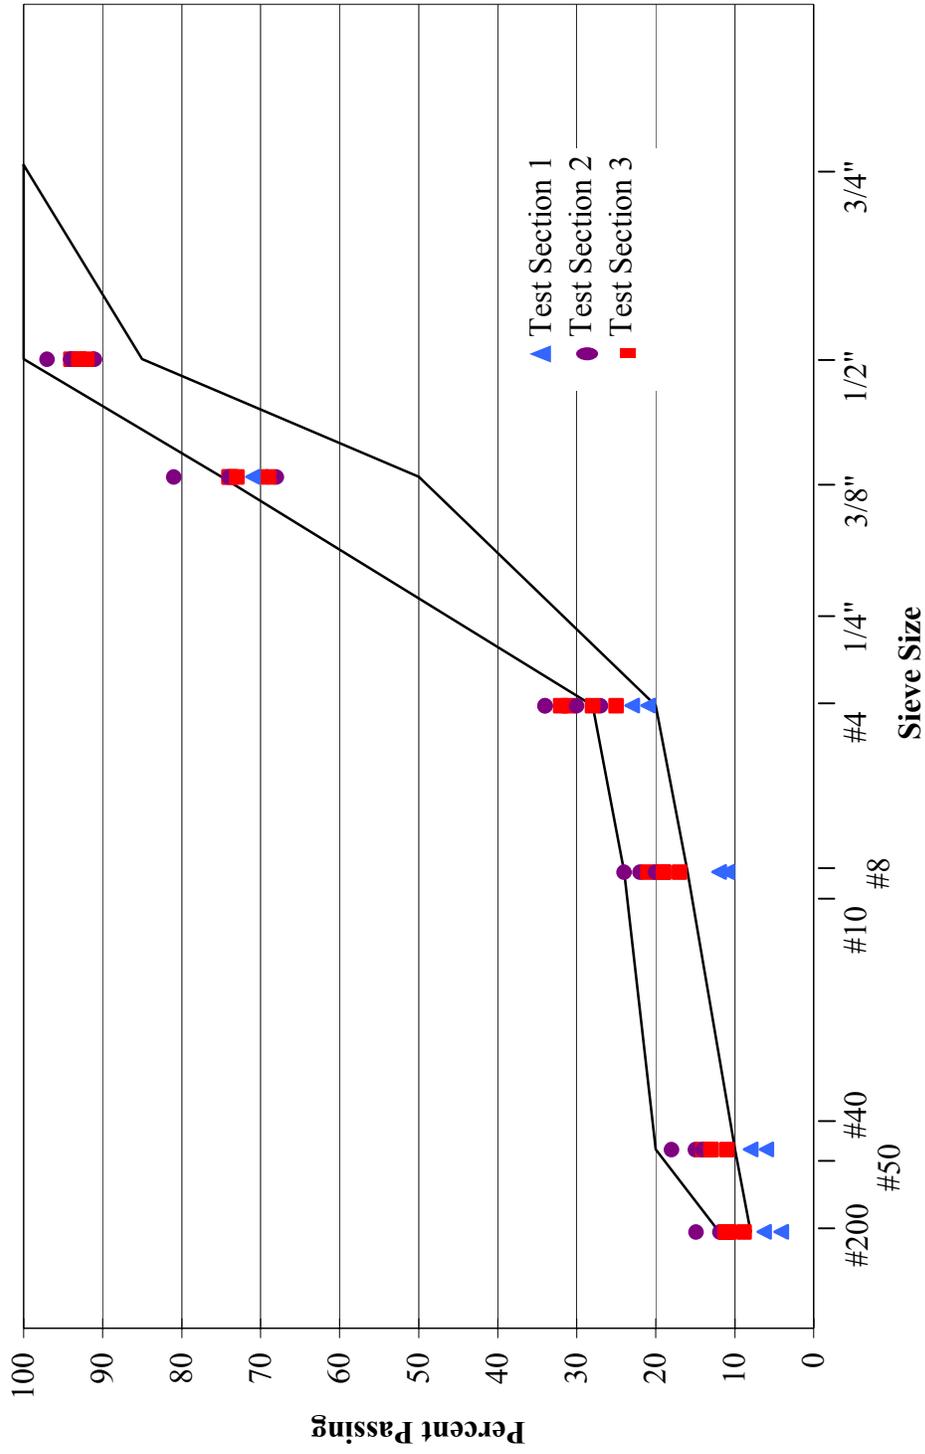
Figure 12. Test section gradation

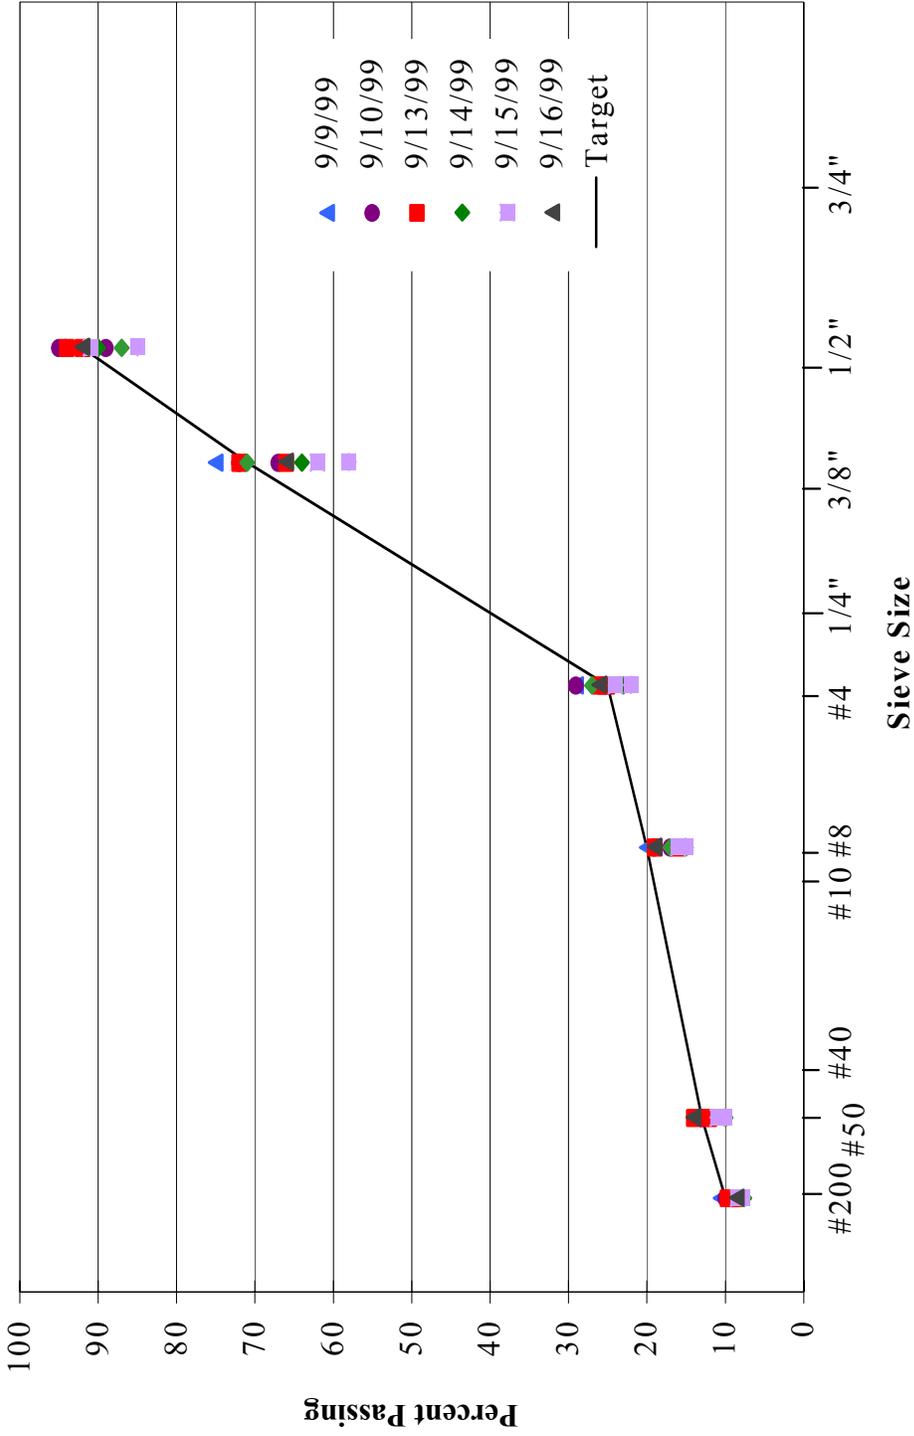
Figure 13. Production gradation

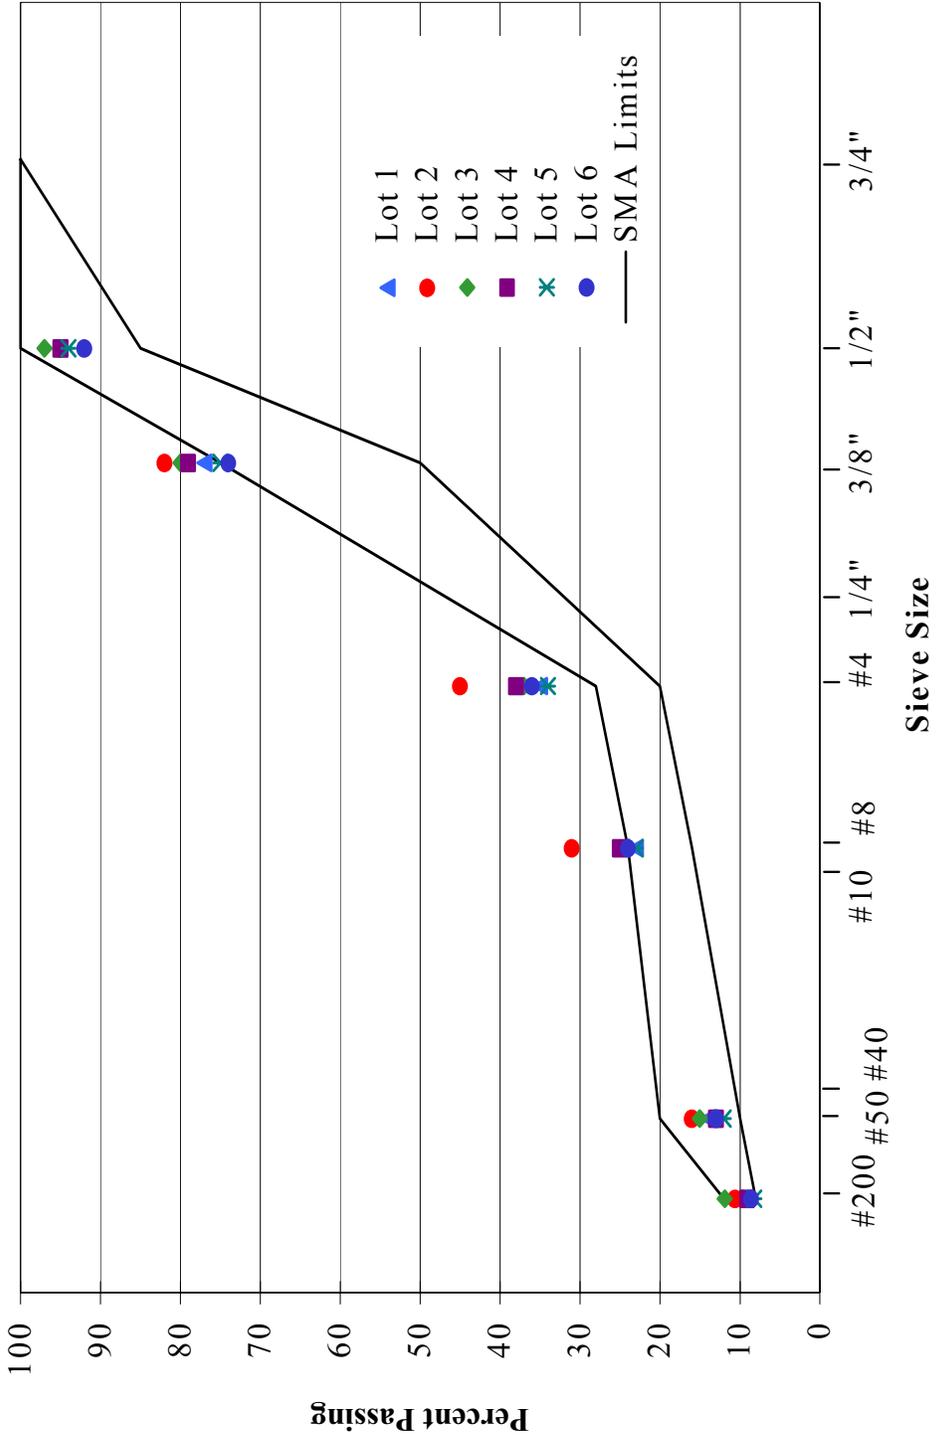
Figure 14. Production gradation – core samples
