Agreement T2695, Task 94  
Pedestrian Safety Treatments

**AN EVALUATION OF ENGINEERING TREATMENTS  
AND PEDESTRIAN AND MOTORIST BEHAVIOR ON  
MAJOR ARTERIALS IN WASHINGTON STATE**

September 2008

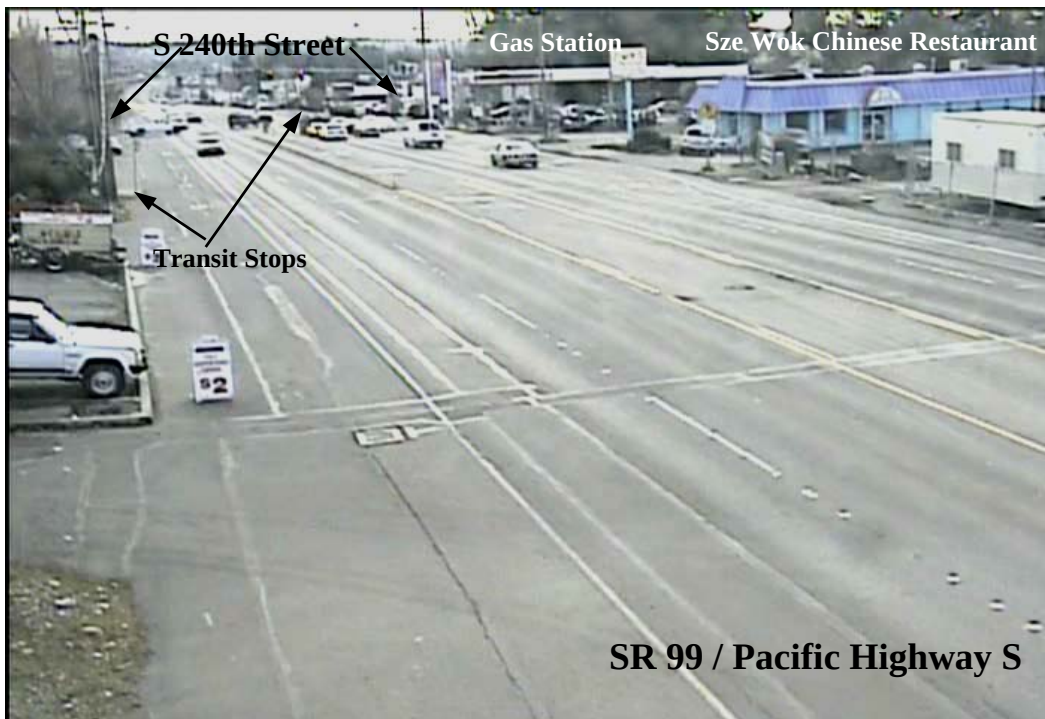
The *before-after* analysis focused on the midblock crossings made between South 240<sup>th</sup> Street and the camera location. Figure 2.9 shows the camera view looking south along SR 99. The camera is approximately 450 feet north of South 240<sup>th</sup> Street. A bus stop is located 275 feet north of the intersection with South 240<sup>th</sup> Street in the northbound direction and 325 feet south of the intersection in the southbound direction. Signalized intersections are located less than one tenth of a mile to the south at South 240<sup>th</sup> Street and four tenths of a mile to the north at South Kent-Des Moines Road (SR 516). Commercial properties in the area consist of restaurants (JJ's Bar and Grill, Sze Wok Chinese Restaurant), gas stations/mini-markets, a three-story office building, and detached retail facilities (Bucky's Brake and Muffler, Midway Tropical Fish and Pets). A mobile home park is located on the east side of SR 99, next to Bucky's Brake and Muffler; single family residential neighborhoods lie one to two blocks to the west of SR 99; and several multifamily apartment buildings lie one block to the east of SR 99.

Figure 2.9. Observation boundaries, SR 99 north of S 240<sup>th</sup> Street—*before* conditions—Kent

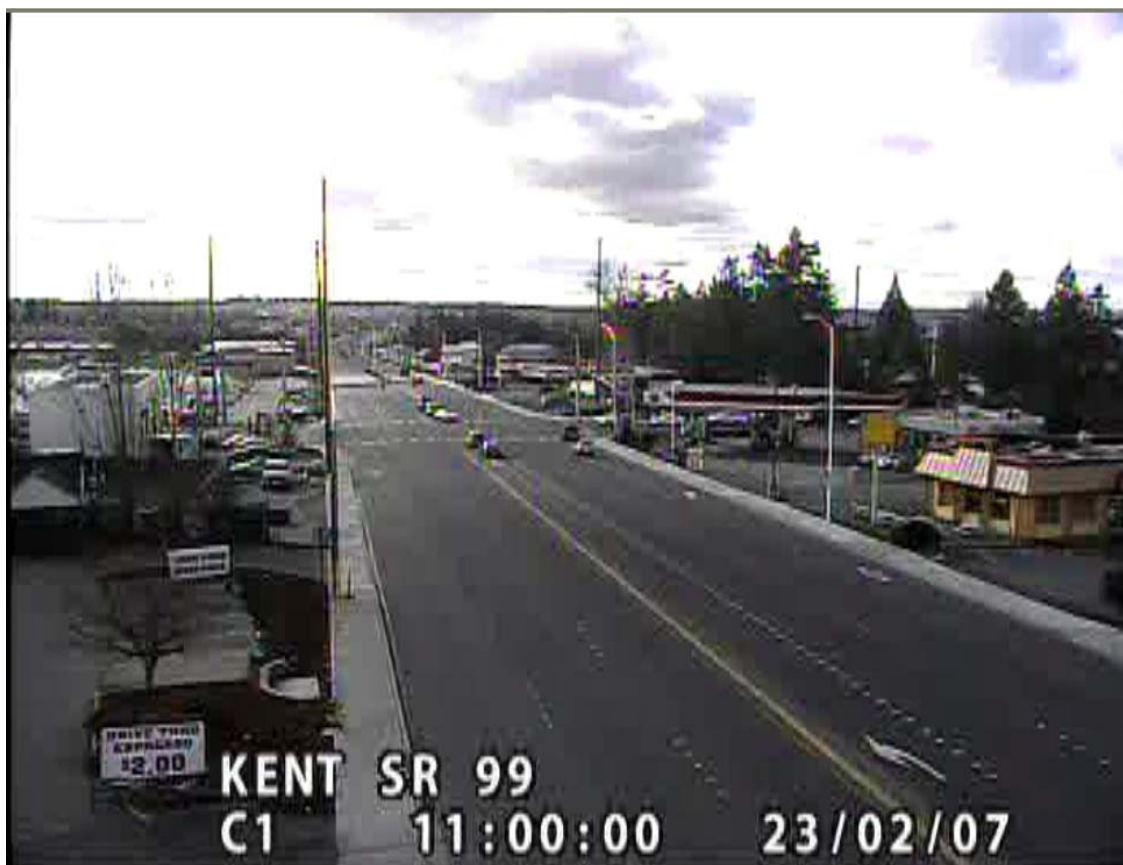
The camera view used in the *after* study is shown in Figure 2.10.

**Figure 2.10. Observation boundaries for the *after* data collection—Kent**

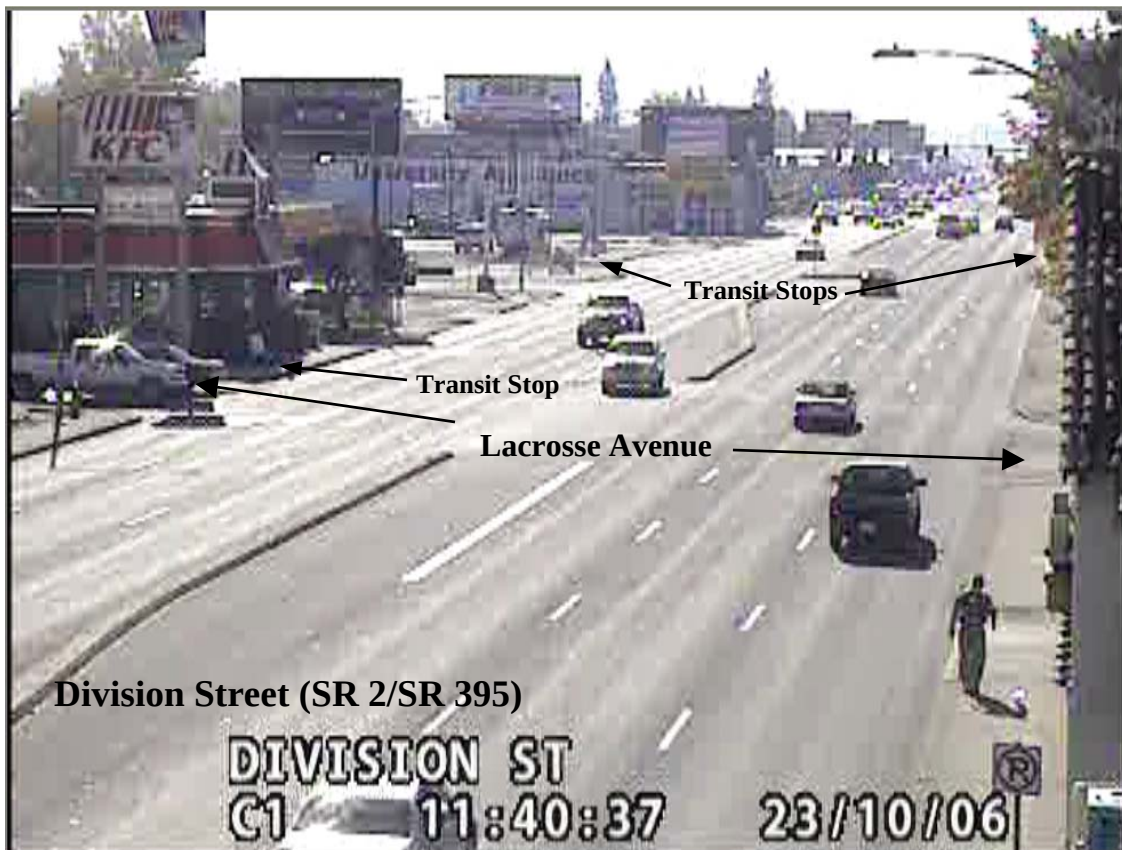
The site analysis focused on the crossings made between East Garland Avenue (two blocks south of Lacrosse) and the camera location. Figure 2.17 shows the camera view looking south along SR 2. The camera is approximately 300 feet north of Lacrosse Avenue. There is a near side (before the bus passes through the intersection) bus stop located at Lacrosse in the northbound direction and bus pullout stops 450 feet south of the intersection in both the northbound and southbound directions. The total usable distance observed by the camera was roughly one tenth of a mile.

Figure 2.17. Observation boundaries, SR 2 north of Lacrosse Avenue—Spokane

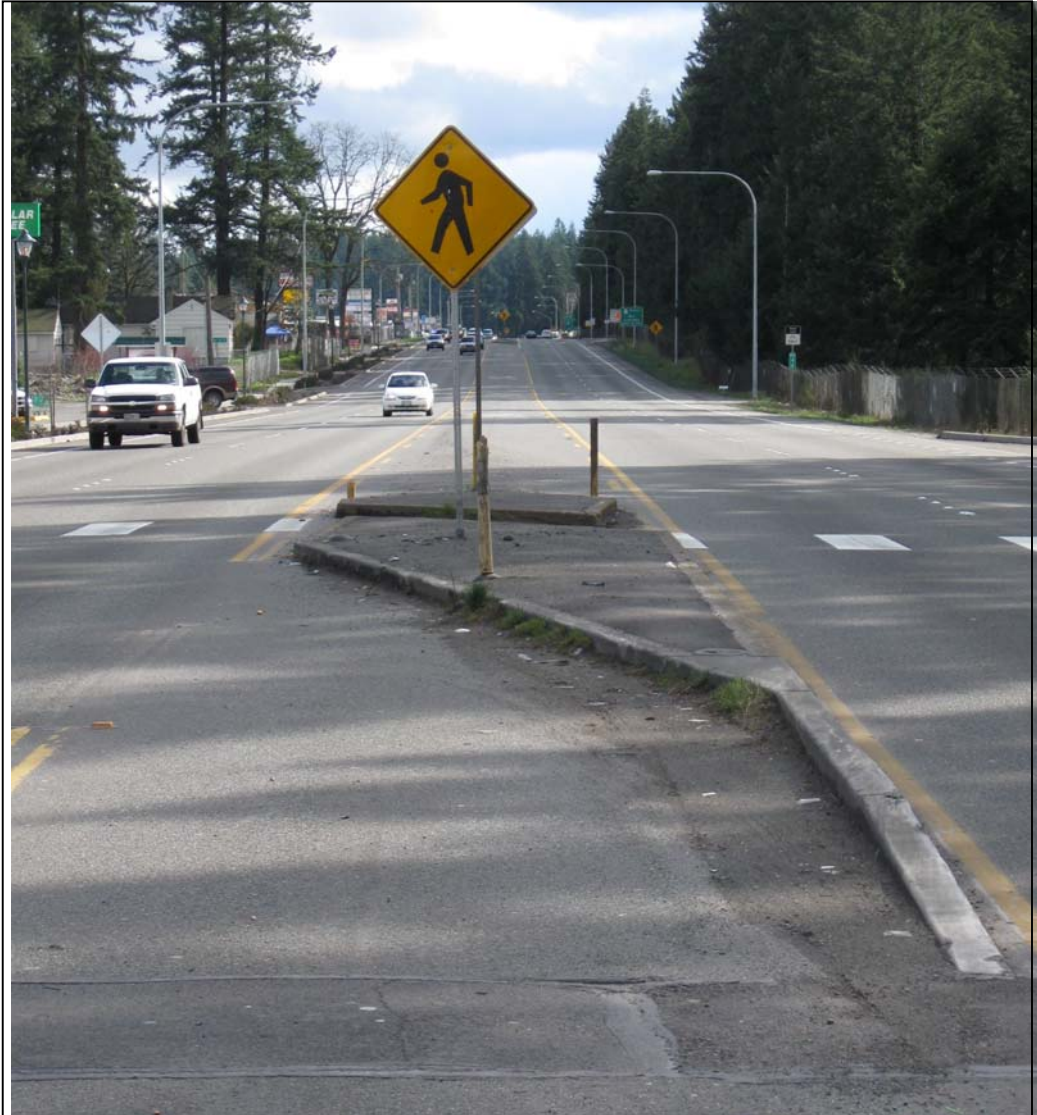
During the second phase of improvements, sidewalks, curbs, gutters, and overhead lights were installed. New crosswalk markings were placed in line with the crossing path provided by the refuge island (shown in Figure 3.3). Transit stops were enhanced with shelters to improve the comfort of the riders while waiting for the bus to arrive.

**Figure 3.3. Front view of median with crosswalk markings—Spanaway**

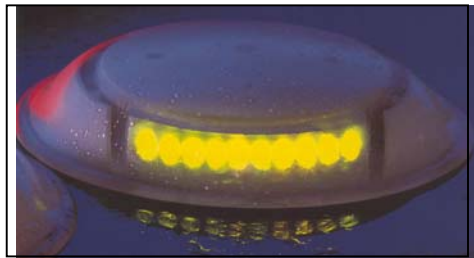
Figure 3.4 is an example of an in-pavement warning light.

**Figure 3.4. In-pavement warning light (Trepanier)**

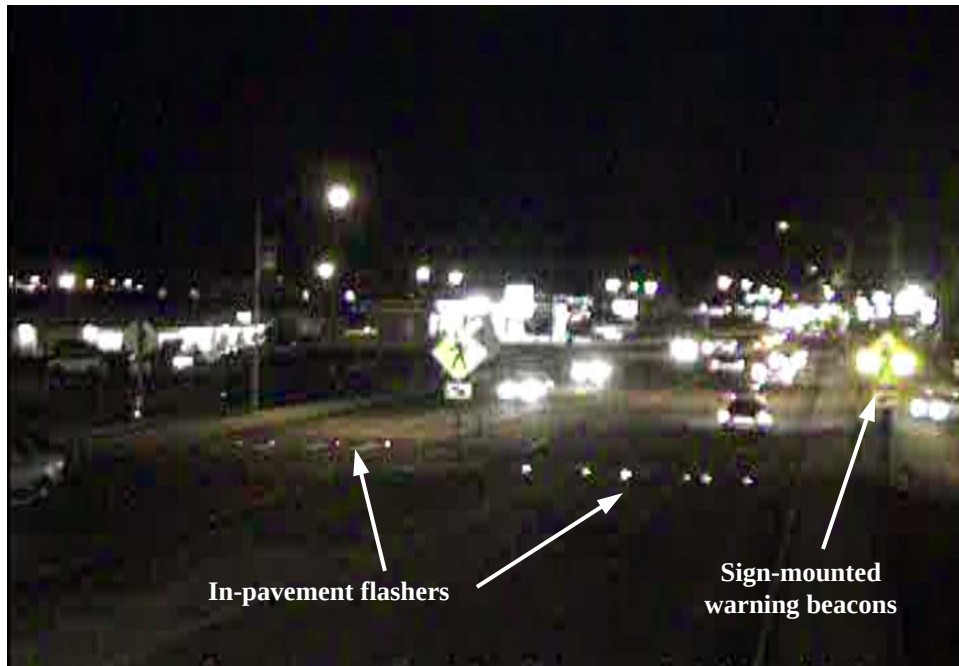
Figure 3.5 and Figure 3.6 show the camera view of a pedestrian crossing SR 2 at night with the flashers. The video quality is somewhat better in Figure 3.6, which depicts the *after* condition, but one can see the approximate degree to which the in-pavement flashers are functioning in each scenario.

Figure 3.5. Warning lights lit for pedestrian crossing—*before* condition—Airway Heights

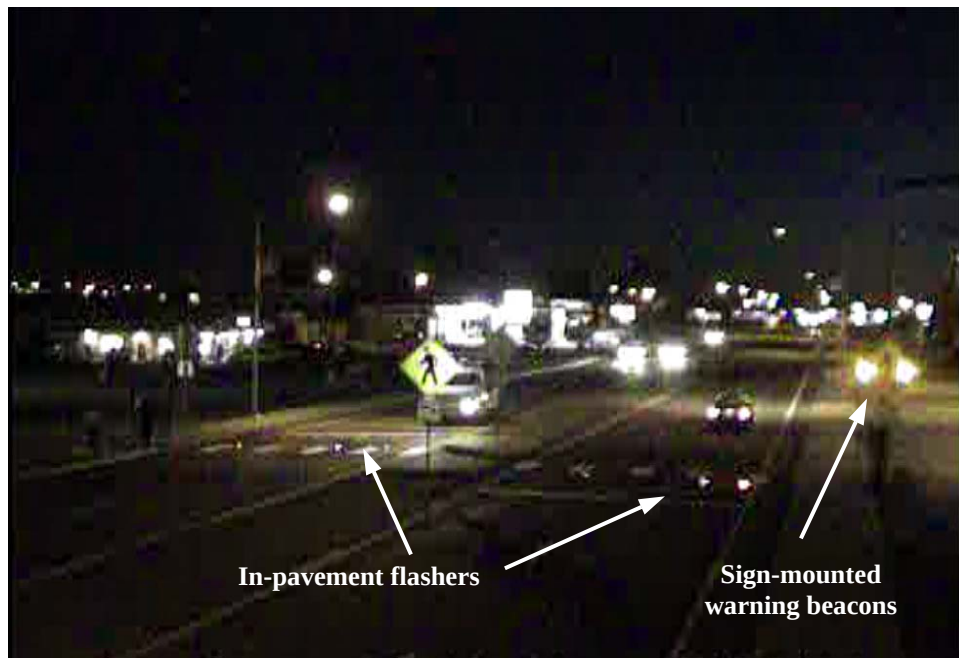
Figure 3.6. Warning lights lit for pedestrian crossing—*after* condition—Airway Heights

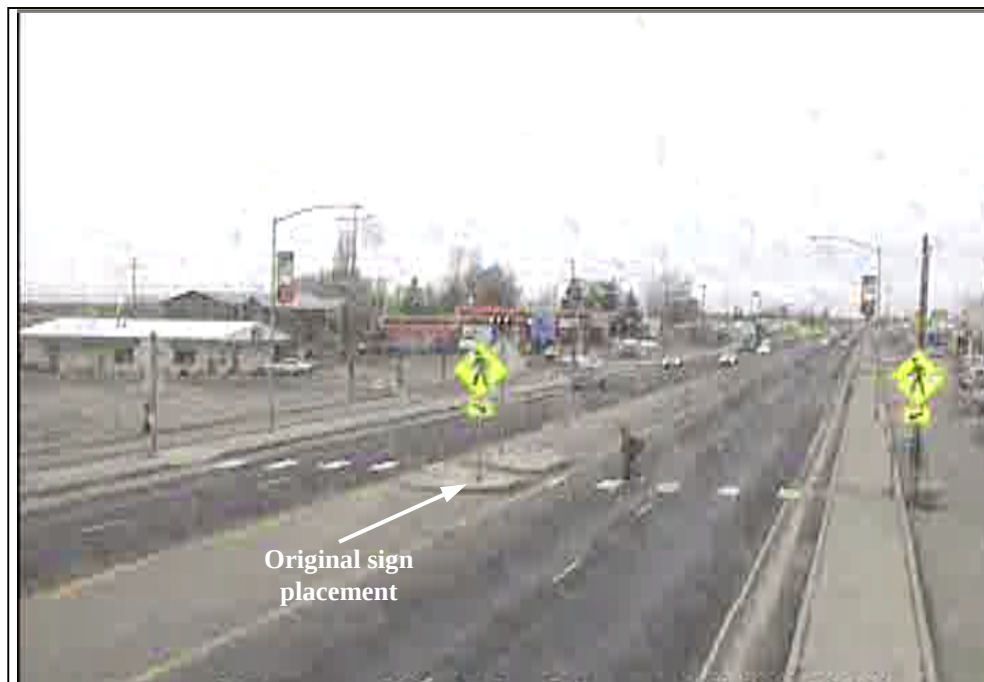
Stop bars were added for the *after* condition. They were located 20 feet upstream from the leading edge of the crosswalk in each direction. When this change was made, the signs on the side of the street and in the median were changed slightly. The diagonal down sloping arrow signs that pointed to the crosswalk were changed to “Stop Here for Pedestrians” signs, with arrows pointing to the stop bar. The addition of the stop bars also required the pedestrian crossing signs to be moved from the raised median to the center left turn lane. The goal of the addition of the stop bar was to increase driver awareness and pedestrian safety, as well as to move stopped vehicles farther from the crosswalk, thus increasing sight distance. The changes described can be seen in Figure 3.9 and Figure 3.10.

**Figure 3.9. Median sign placement—*before* condition—Airway Heights**

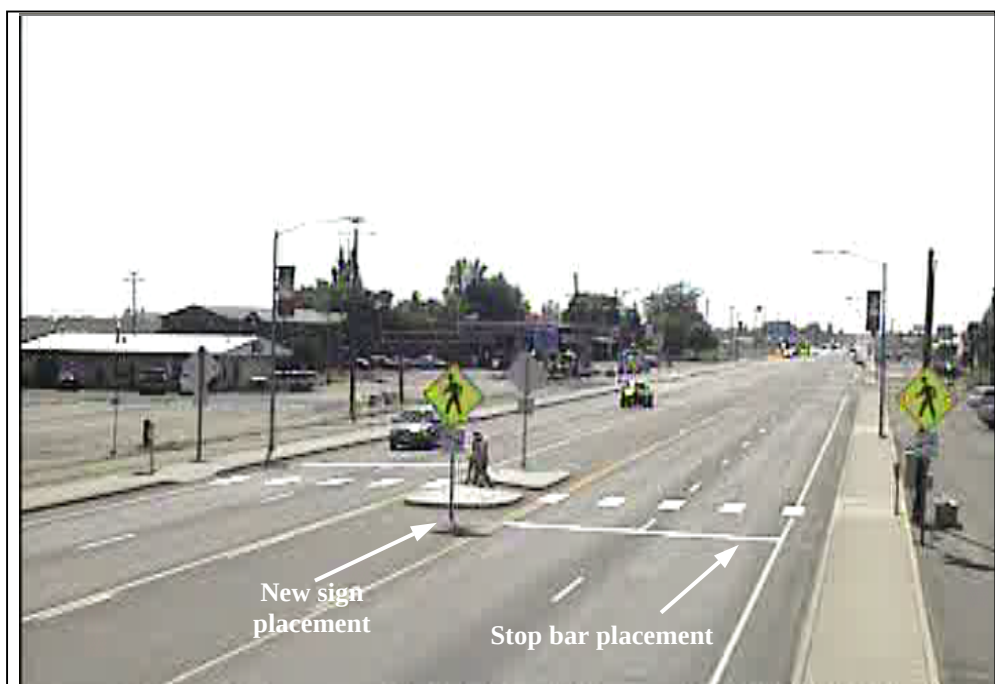
**Figure 3.10. Median sign and stop bar placement—*after* condition—Airway Heights**

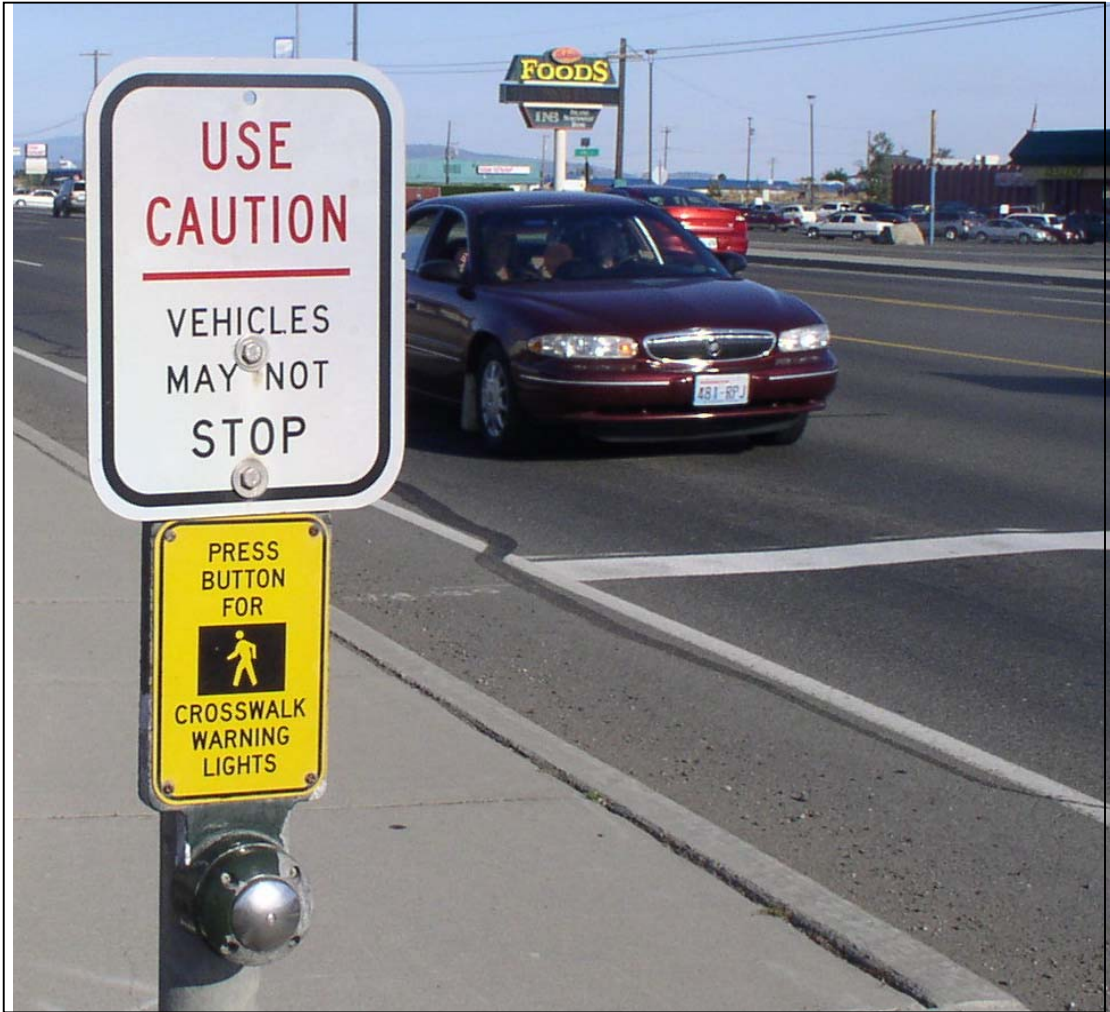
Signs located at the pedestrian actuation buttons were present during both the *before* and *after* studies. An example of these signs is shown in Figure 3.11.

**Figure 3.11. Signs present at the pedestrian actuation button—Airway Heights**

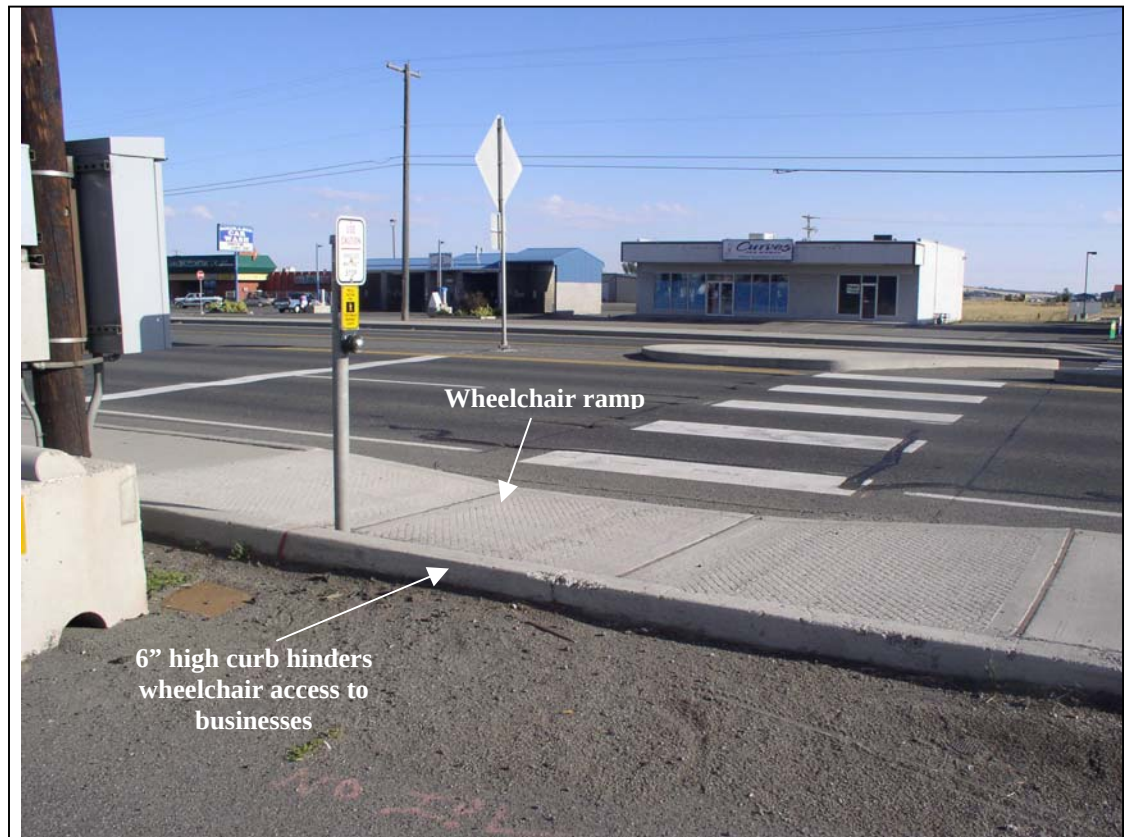
Sidewalk/curb design—The current design allows at-grade pedestrian access to the sidewalk at wheelchair ramps and driveways. However, no wheelchair ramps have been built on the far side of the sidewalk (away from the highway). They are located only at the street corners—see Figure 4.1. This may present a tripping hazard to some pedestrians and prevent others from accessing the sidewalk, causing them to have to travel through the parking areas of retail establishments until the next access point, which could be dangerous.

**Figure 4.1. Wheelchair ramp on SR 2 between King and Lundstrom Streets**

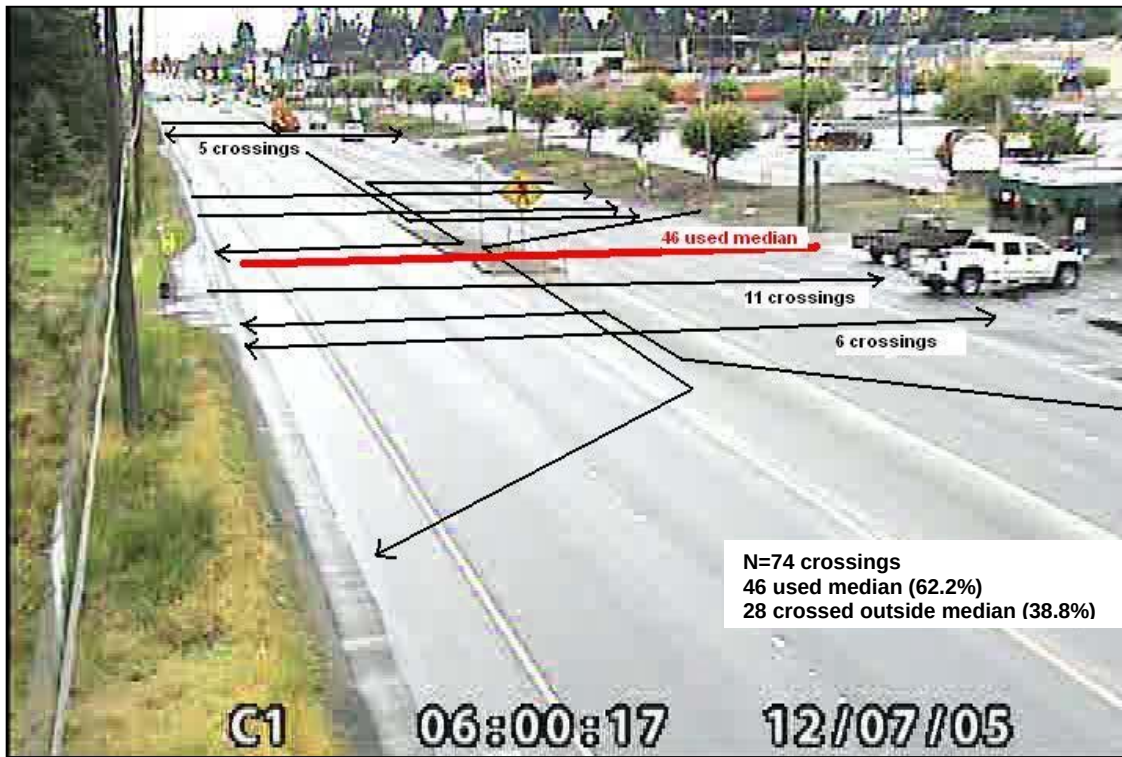
Figure B-10 displays the crossing paths after installation of the median. Note that an additional 15 percent of the crossings occurred just to the south of the median (path labeled “11 crossings” in Figure B-10).

Figure B-10. Pedestrian crossing paths after median treatment —*after*—phase I condition (Spanaway) (Kopf and Hallenbeck 2005)

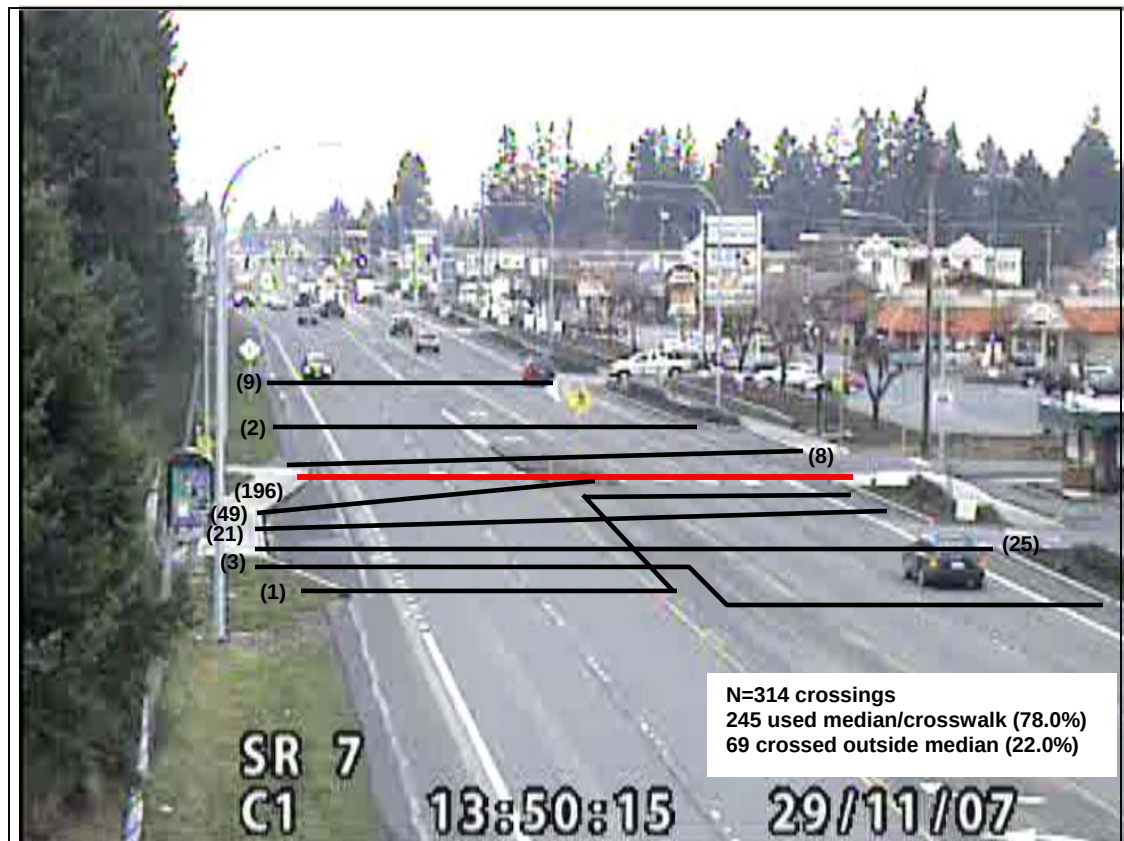
Figure B-11 displays the crossing paths after reinstatement of the crosswalk markings.

Figure B-11. Pedestrian crossing paths—after—phase II condition (Spanaway)

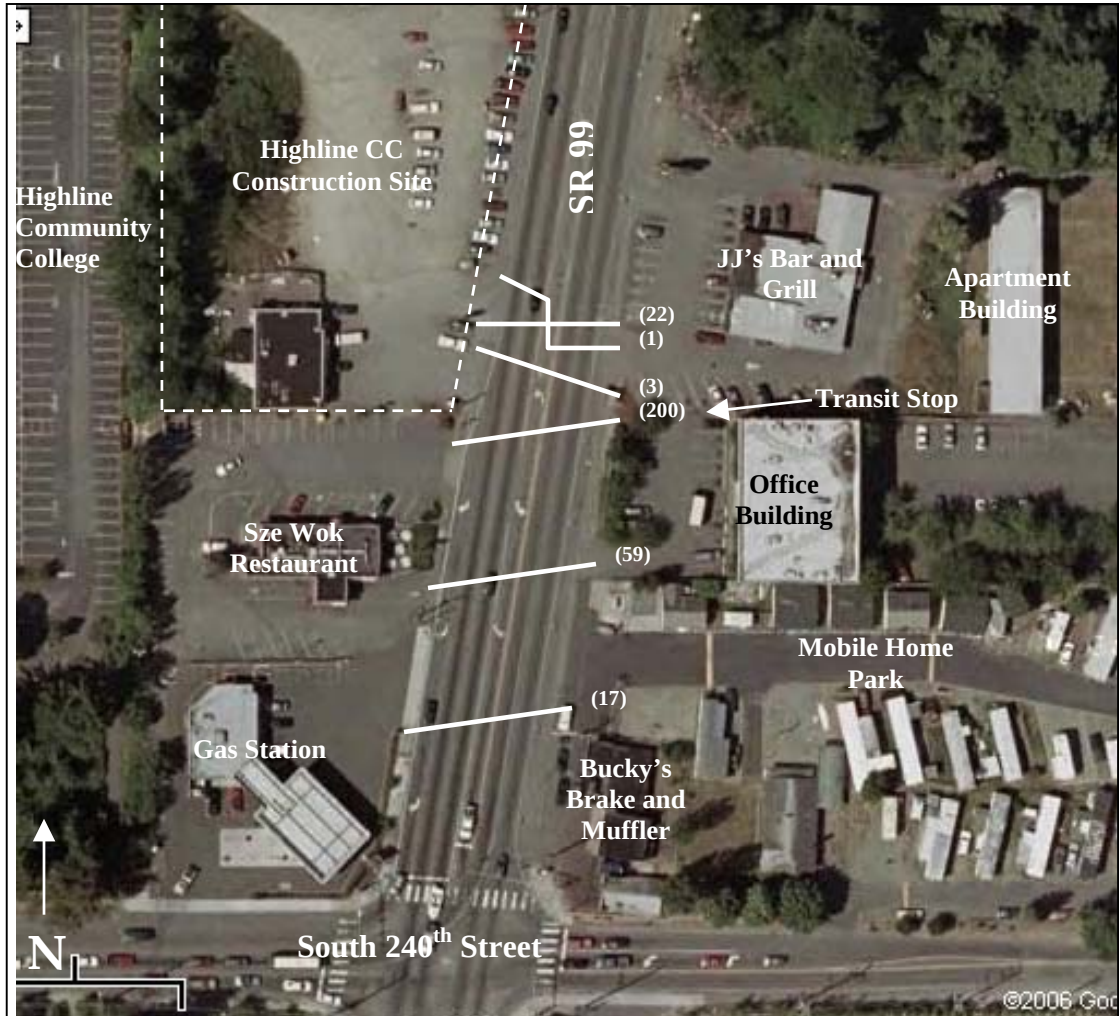
Figure B-13 displays the crossing paths at the Kent site, before improvements were made (includes only those pedestrians not using the signalized marked crosswalks).

Figure B-13. Pedestrian crossing paths—*before* condition—Kent (Google Maps)

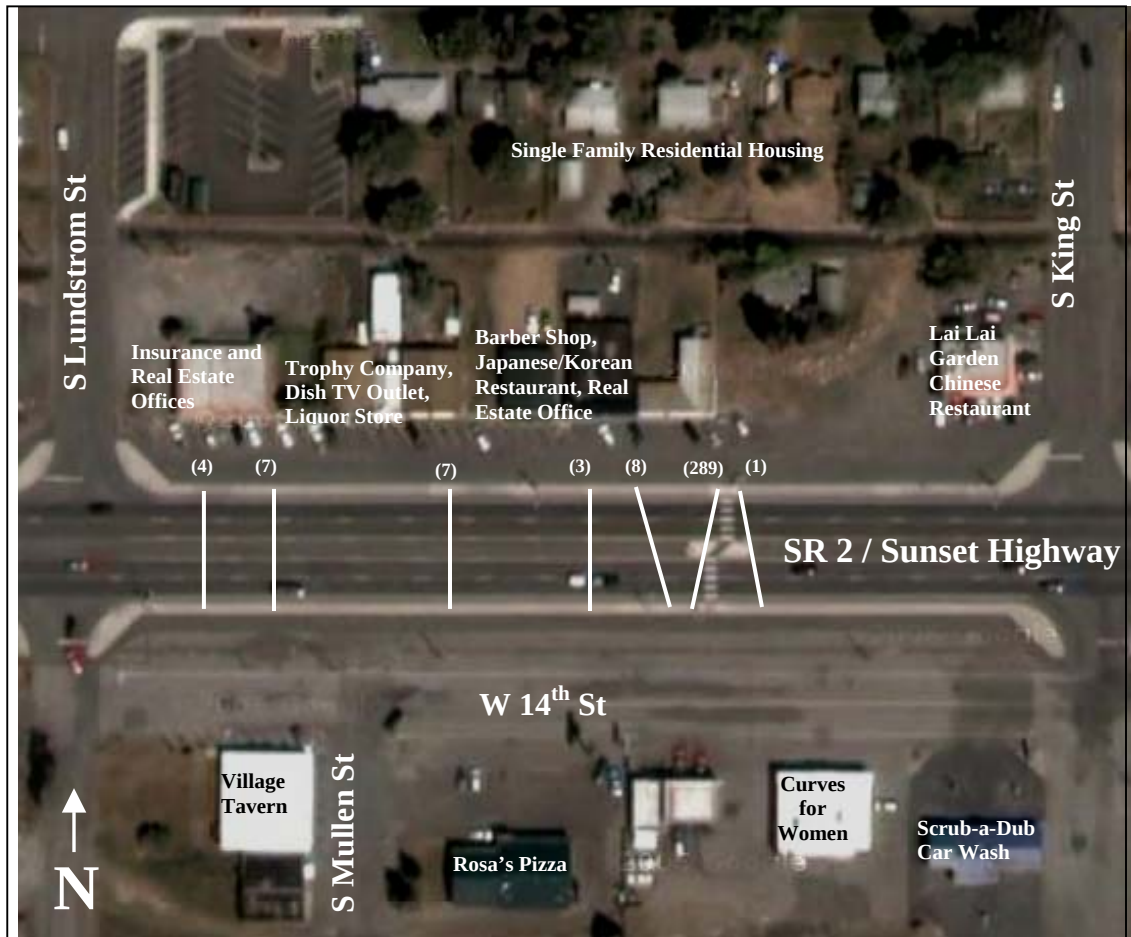
Figure B-16 displays the crossing paths at the Airway Heights site, after improvements were made.

Figure B-16. Pedestrian crossing paths in the *after* analysis—Airway Heights (Google Maps)

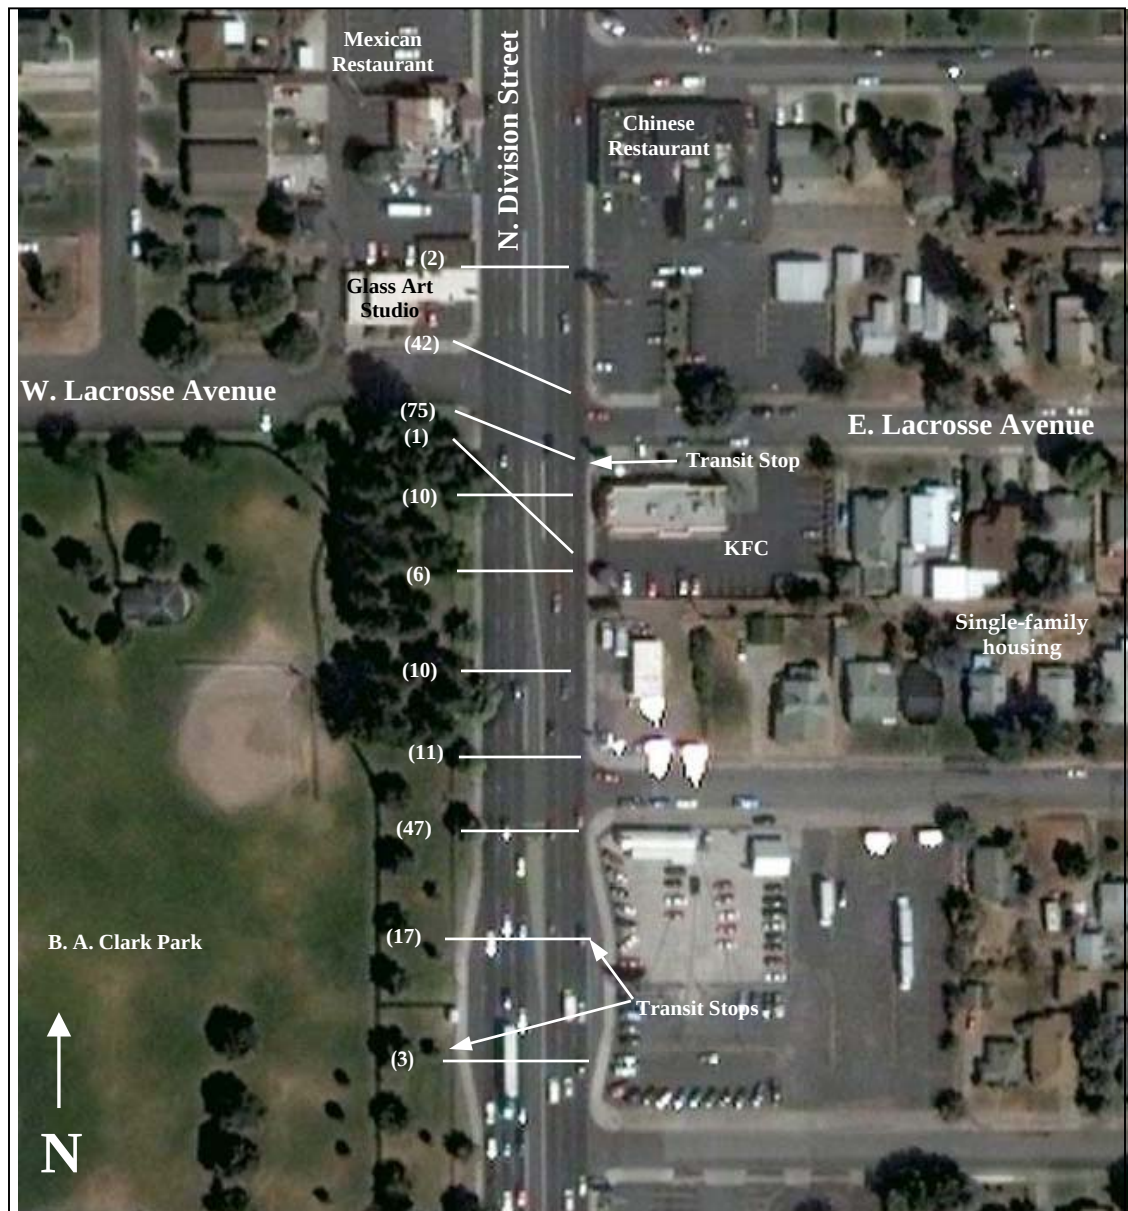
Figure B-17 through Figure B-19 display the crossing paths at the Spokane sites.

Figure B-17. Pedestrian crossing paths at Lacrosse Avenue—Spokane (Google Maps)
