# Portland Cement Concrete Pavement Best Practices Summary Report

WA-RD 744.1

WSDOT Research Report

Research Report  
Agreement T2695, Task 88  
PCCP Best Practices

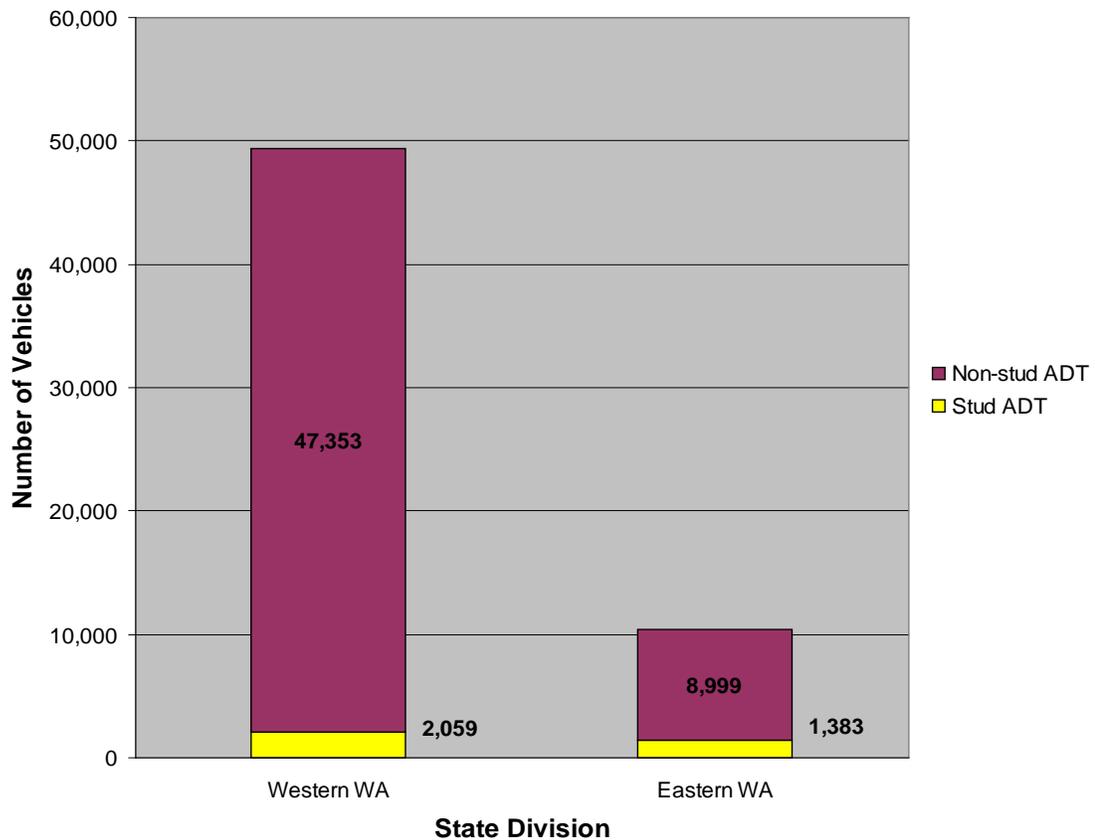
**Figure 1: Average traffic levels in western Washington and eastern Washington showing non-stud ADT (top) and stud ADT (bottom).**

- **Stud volumes across Washington State are comparable.** In general, western Washington has higher AADTs and lower stud use, while eastern Washington has lower AADTs and higher stud use (Figure 1). Given the existing data, there does not seem to be much merit to the argument that stud traffic is significantly higher in eastern Washington with the possible exception of I-90 through Spokane.

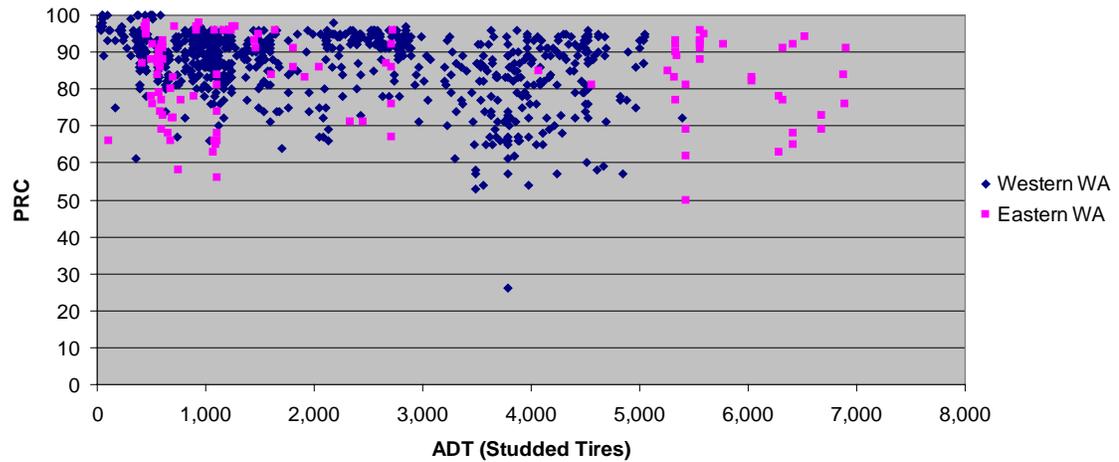
**Figure 2: PRC vs. stud ADT.**

- **Higher stud volumes generally correlate with lower wear depth ratings** (Figures 2 and 3). This is a weak conclusion because most PCC pavement in

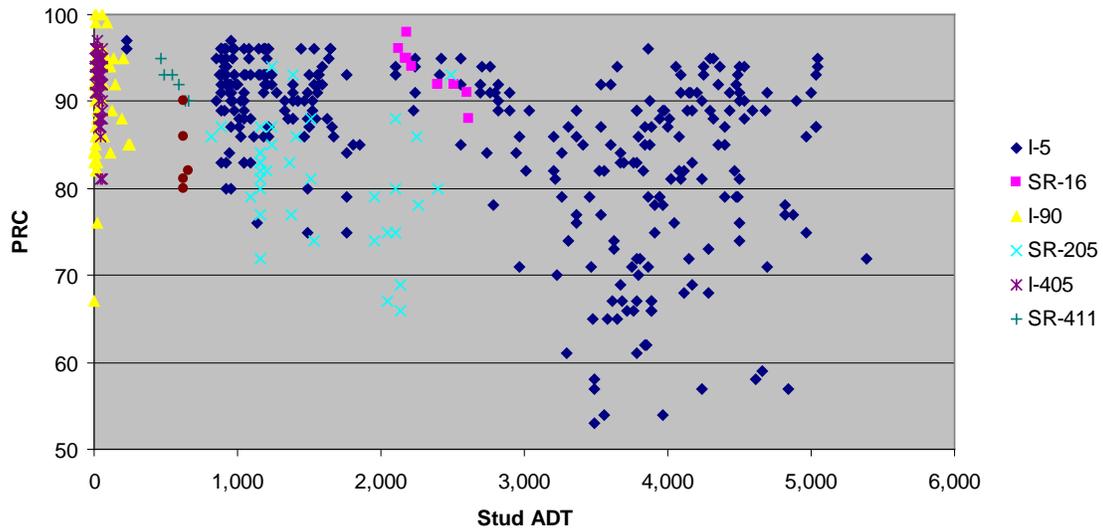
**Figure 3: Distribution of PRC vs. stud ADT by western highway.**

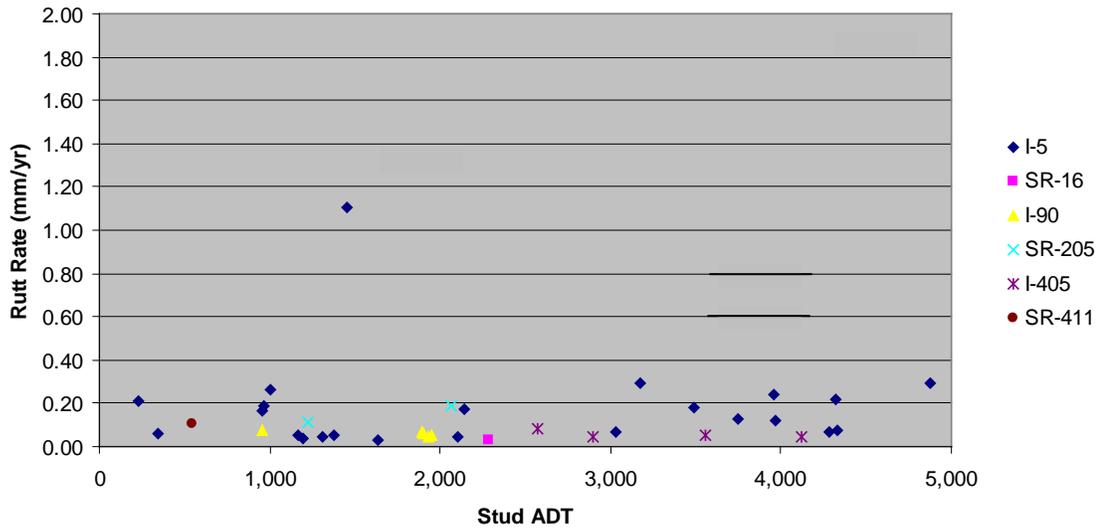
**Figure 4: Western stud ADT vs. wear rate.**

- **The average PCC pavement wear rate across Washington State is about 0.01 inches per 1 million studded vehicle passes (Figures 4 and 5). This holds true for both western and eastern Washington with few exceptions.**

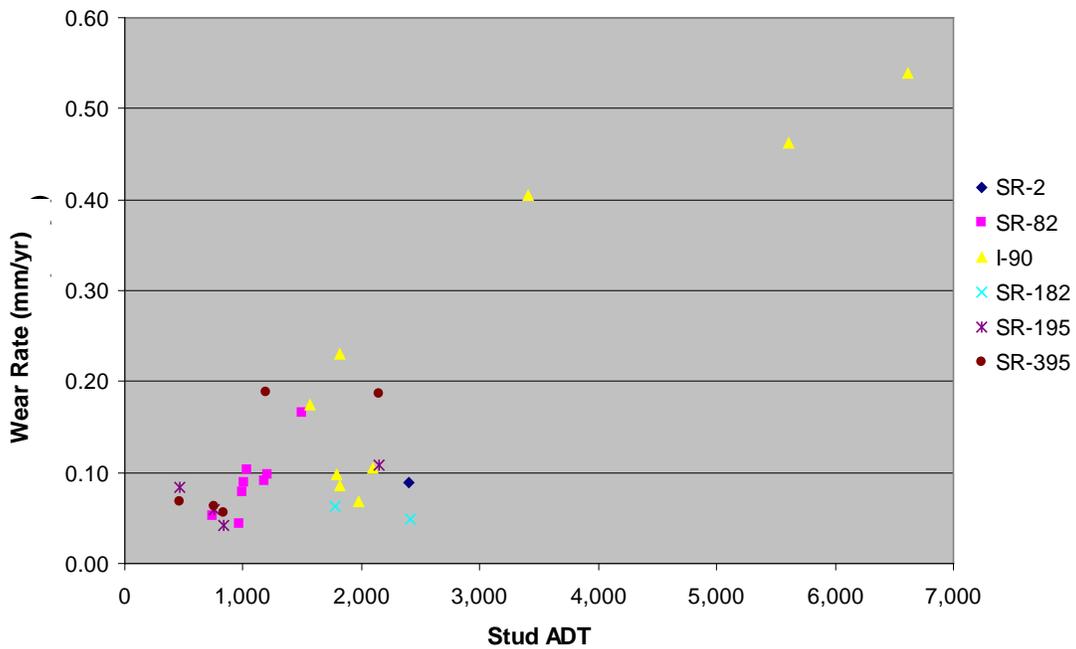
**Figure 5: Eastern stud ADT vs. rut rate.**

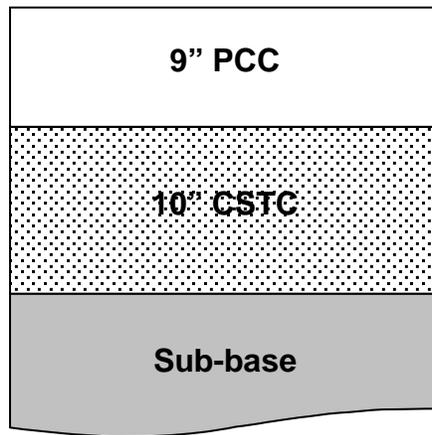
**Figure 6. Cross-section of Existing PCC Highway.**

WA-RD 744.4 compares the environmental impact of three different options for replacing an existing PCC pavement (Figure 6) over an analysis period of 50 years. This existing pavement section was chosen to represent typical conditions on I-5 in the greater Seattle area. Replacement options are:

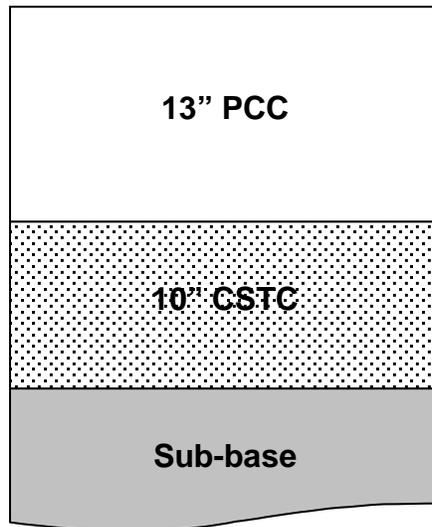
**Figure 7. Cross-section of PCC replacement option.**

- **Remove and replace with new PCC pavement.** Remove the existing 9 inches of PCC and replace with 13 inches of doweled PCC (Figure 7).
- **Remove and replace with new HMA pavement.** Remove the existing 9 inches of PCC and replace with 13 inches of HMA placed in five lifts (Figure 8).
- **Crack, seat and overlay (CSOL).** Crack seat and overlay the existing pavement with 5 inches of HMA placed in two lifts (Figure 9).

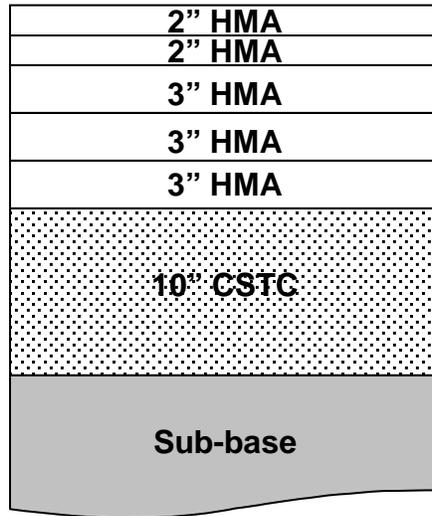
**Figure 8. Cross-section of HMA replacement option.**

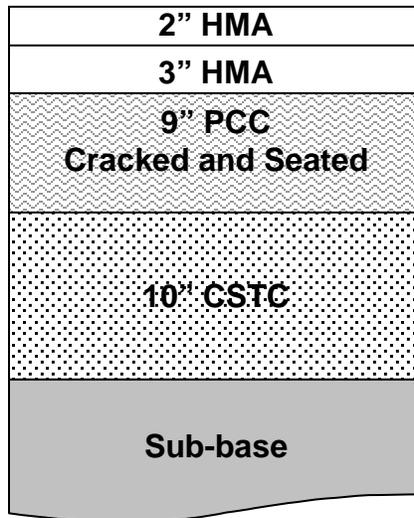
**Figure 9. Cross-section of CSOL option.**

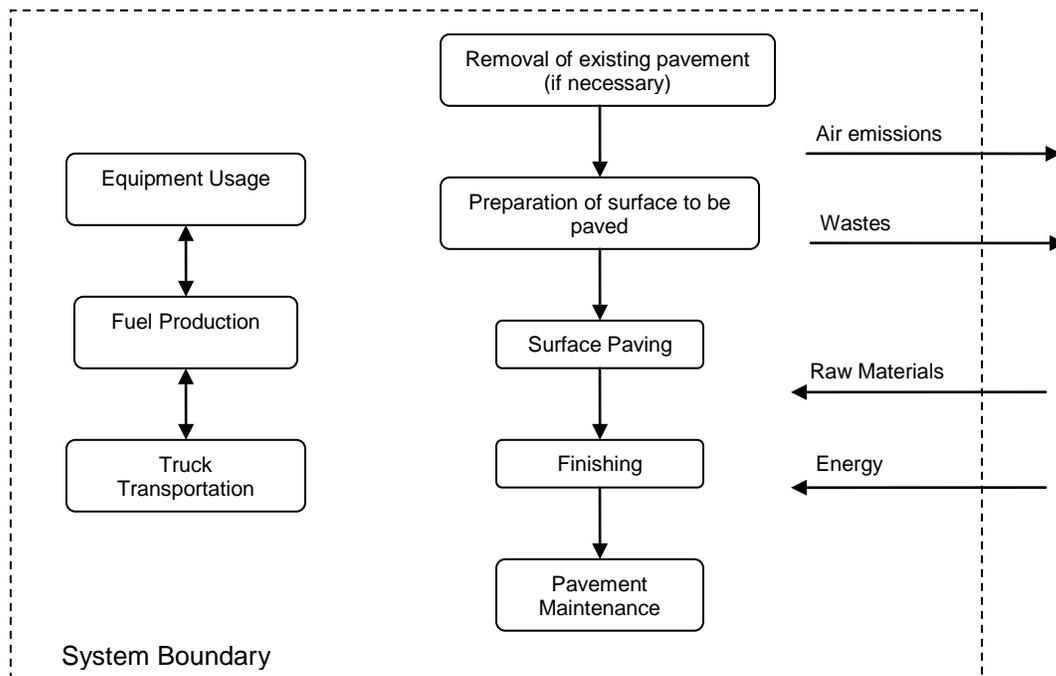
**Figure 10. Sequence of main activities and scope included in LCA.**

These options are not meant to comprehensively evaluate current WSDOT design standards with LCA. Rather, they were chosen as representative of potential pavement designs for a new pavement on I-5. Even if the ultimate pavement replacement options do not exactly match those analyzed in WA-RD 744.4, the relative relationship between the options is unlikely to change. In general, the LCA considered the processes associated with paving as shown in Figure 10.

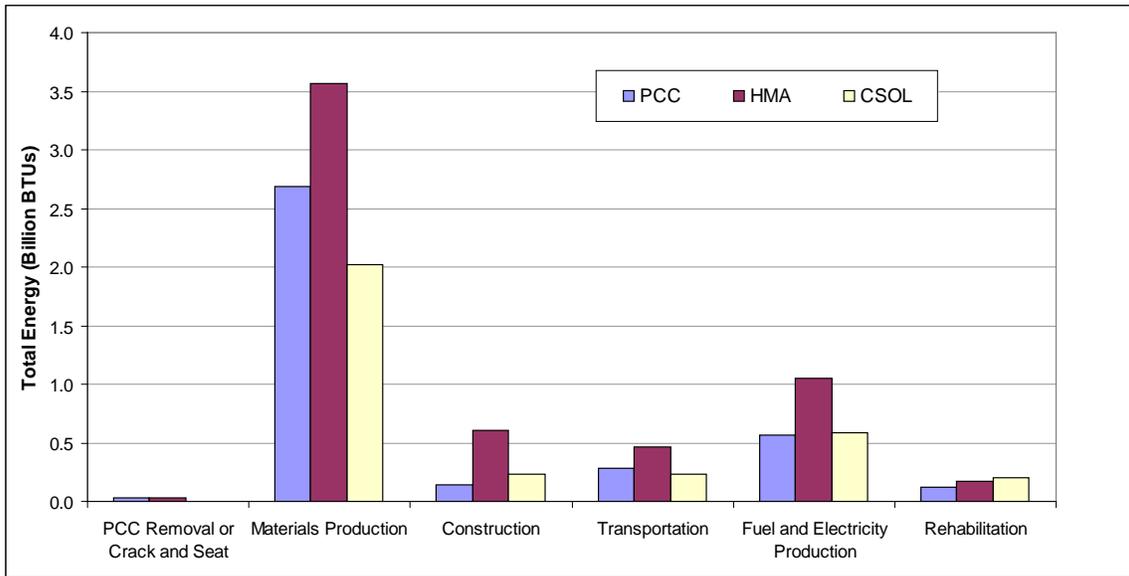
**Figure 11. Total energy contribution analysis.**

**Interpretation.** An effort was made to determine the relative contribution of each process within an option to the overall inventory and impact of that option. Figures 11 and 12 show that the overwhelming contributor to all three rehabilitation options is materials production (i.e., production of asphalt, cement, HMA and PCC). This suggests that efforts to reduce environmental impact could be focused on the materials production or higher use of recycled products in order to have the biggest impact.

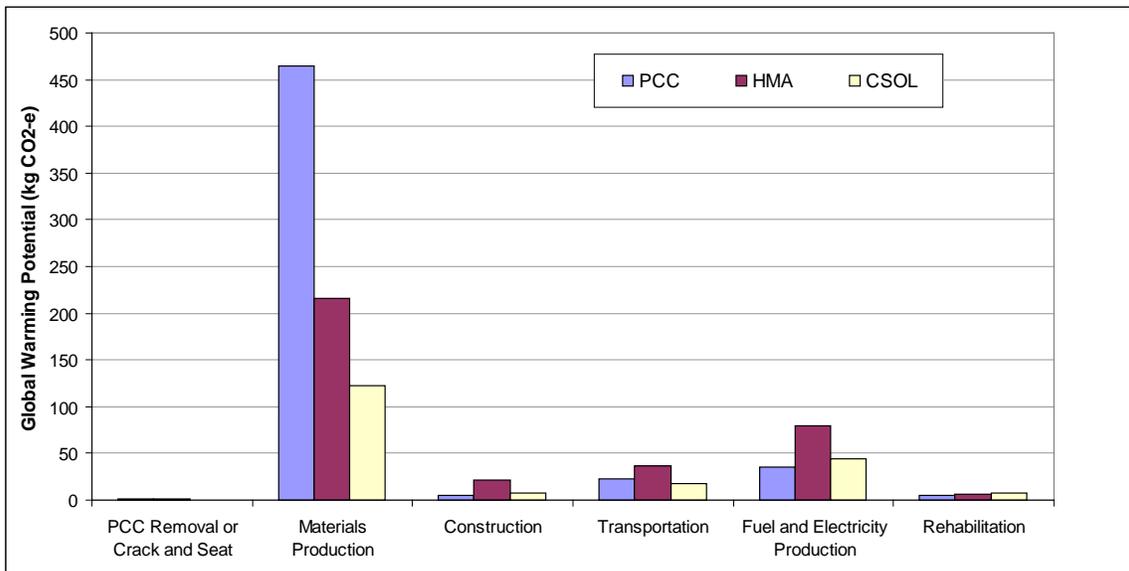
**Figure 12. Global warming potential contribution analysis.**
