Studded Tire Wear on Portland Cement Concrete Pavement in the Washington State Department of Transportation Route Network

WA-RD 744.3

June 2010

Research Report
Agreement T2695, Task 88
PCCP Best Practices

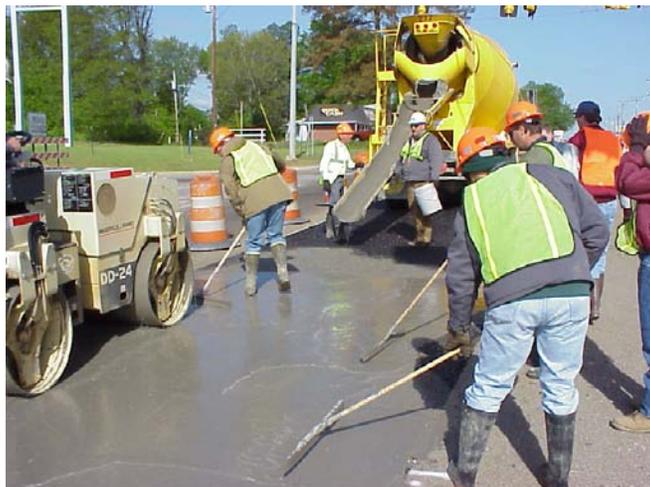
A Mississippi study placed RMP test sections on two HMA pavement intersections on US 72 with histories of traditional rutting (from pavement deformation) (FHWA 2006b). Ultimately, after 5 years of observation between 2001 and 2006, the Mississippi Department of Transportation (MDOT) published a final report in 2007 which featured both positive and negative reviews of their experience with RMP. From the construction end, the project was reported to be very challenging overall. Despite attention to detail, as shown in Figure 18 below, there was one area of failure where the removal of a 75-ft section of the pavement due was required due to a lack of grout penetration of the mat.

Figure 18: Excess grout worked into areas needing more (Battey and Whittington 2007).
