# Permeability of Existing Structures for Terrestrial Wildlife: A Passage Assessment System

WA-RD 777.1

WSDOT Research Report

Report to the Washington State Department  
of Transportation  
Research Report No. WA-RD 777.1

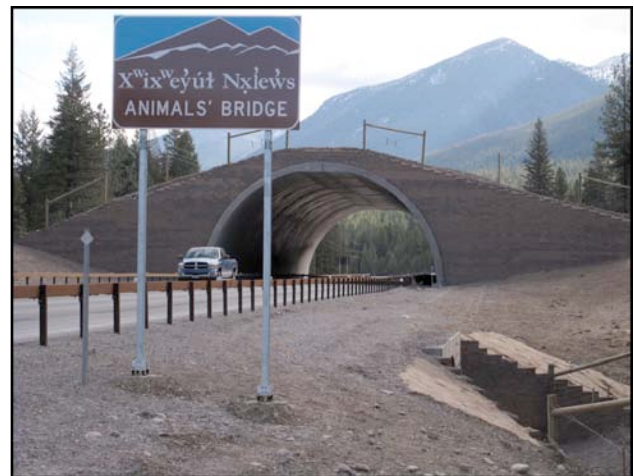
Figure 1. Wildlife overpass over Highway 93, MT  
© P. Cramer

A wildlife crossing is a structure that allows wildlife to pass over or under the road. A wildlife crossing structure is designed and built specifically or in part to assist in wildlife movement (Bissonette and Cramer 2008) and include both overpasses and underpasses. Overpasses are built to allow wildlife to move over the flow of traffic to get to the other side of the roadway (Fig.1). Underpasses are much more common and entail two different types of structures, culverts and bridges, both of which allow wildlife to move under the roadway. Bridged wildlife passages can be single span bridges where the structure rests on abutments with no intermediate support columns (Fig. 2). Multi-span bridges are on abutments as well but also have one or more intermediate support columns between abutments (Fig. 3). Culvert underpasses are conduits for wildlife under the road that have an embankment around the entire perimeter. Typically either

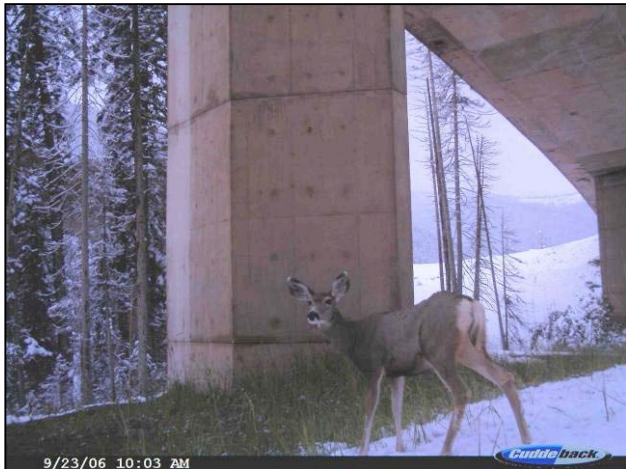
*Figure 3. Multi-span bridge functioning as a crossing under I-70, Colorado © Center for Native Ecosystems, ECO-resolutions, LLC & CDOT*

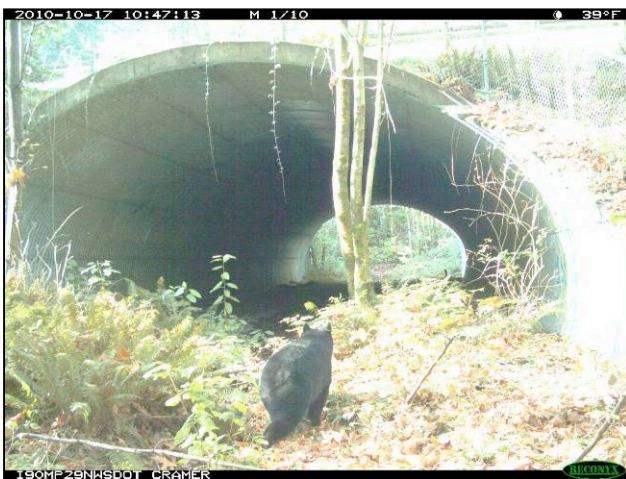
*Figure 5. Black bear entering a multi-plate steel arch culvert "game crossing" under I-90 in Washington (built in 1976) © P. Cramer, J. Kintsch, & WSDOT*

concrete box culverts (Fig. 4) or corrugated steel plate arch culverts are used (Fig. 5). More recently, a new arch design for wildlife passages that is intermediate between bridges and culverts has been constructed. An arch crossing consists of pre-fabricated six foot-wide arch spans that rest on abutments and are fastened together to form an arched passageway beneath the road. There is some soil at the sides of the arches, but the abutments are large enough that there are two to one slopes coming off of them to the passage area, making the entrance appear more like a bridged structure than a culvert (Fig. 6)

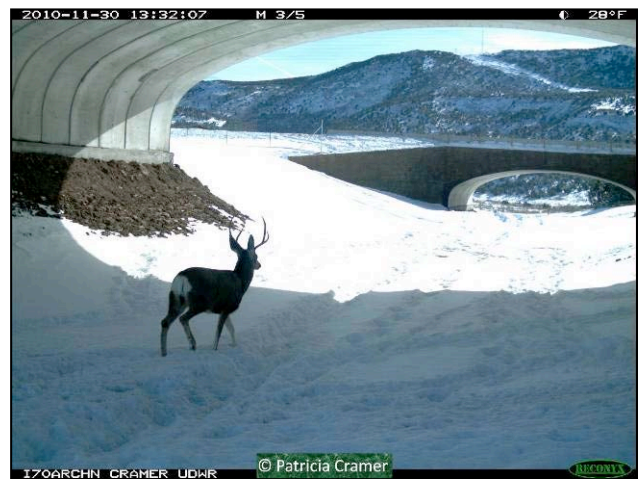
*Figure 6. Arch span wildlife crossing in Utah under I-70 © P. Cramer*

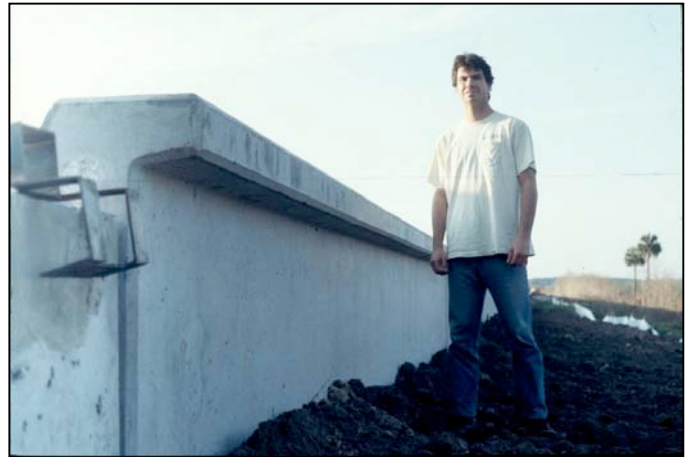
*Figure 7. Amphibian and reptile barrier wall at Paynes Prairie State Preserve, along US 441 in Gainesville, Florida © P. Cramer*

- The height of the vertical guide walls can vary from 18 inches (45.7 cm) to over 3.3 feet (1 m; Fig. 7; Aresco 2005, Jackson 2003). The length should extend from the wing walls for 100-300 feet (30-90 m) on both sides of the road. The tops of these walls should be angled away from the road to prevent climbing organisms from getting over the fence. Jackson and Tyning (1989) also suggest that the drift fences should be sunk into the ground 2.5-4 inches (6-10 cm; Figure 8). Some animals do not follow fences. Jackson and Tyning (1989) found that wood

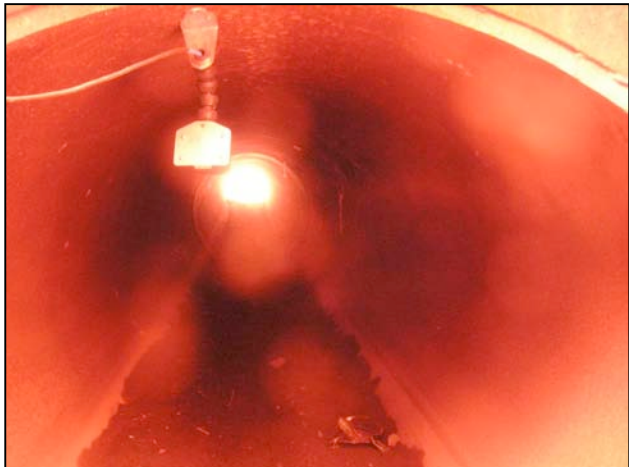
Figure 10. Painted turtle using new turtle crossing culvert in Portland ©Port of Portland

Overall, research indicates that reptilian species preferences for crossing types and placement are varied among species (Jochimsen et al. 2004, Little et al. 2002), underscoring the importance of local research on the target species of interest to inform the design of mitigation solutions (Woltz et al. 2008). In Portland Oregon, the Port of Portland Authority built turtle culverts for painted turtles, which, although not scientifically studied, appear to work (Figs. 10 & 11).

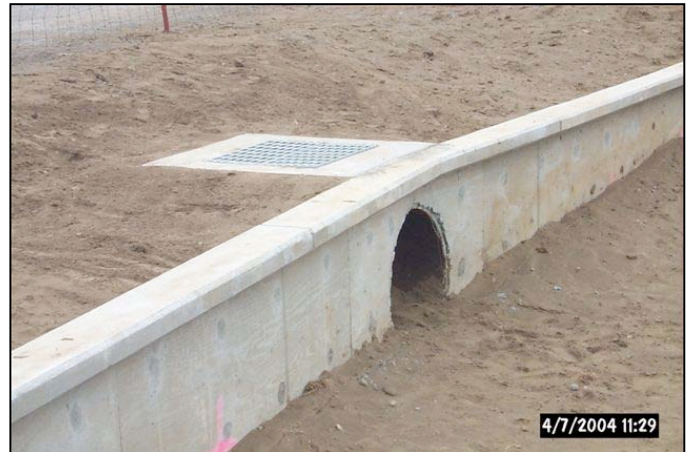
Figure 11. Turtle culvert, wall, and grate ©Port of Portland

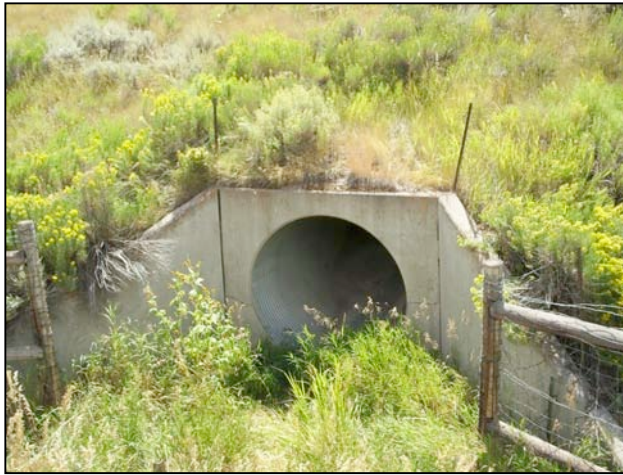
Figure 29. Example of a Class 1 Small Culvert, I-70 CO © J. Kintsch

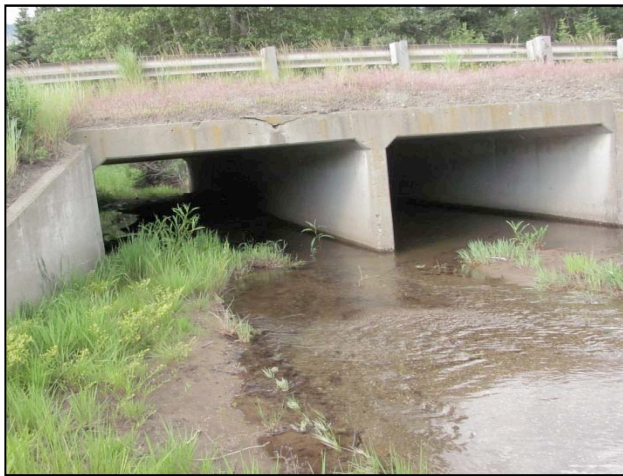
Figure 30. Example of a Class 2 Medium Culvert, I-90 WA © J. Kintsch & P. Cramer

Also included in this class are small bridges up to 8 feet (2.4 m) high. While still classified as medium underpasses, these bridges are much wider than a culvert of the same height and span, and provide a greater appearance of openness. Medium underpasses are typically used by medium sized animals such as coyotes, bobcat, lynx, black bear, and puma, and smaller low mobility and moderately mobile fauna such as snakes, turtles, marmots, otter, beaver, and some ground birds.
