Evaluation of Tyregrip® High-Friction Surfacing

WA-RD 788.1

Post-Construction Report
Experimental Feature 10-02

SR-14
SE 164th Ave Interchange
MP 7.93
014 S2 00794 Ramp
SE 164th Ave Southbound to SR 14 Westbound

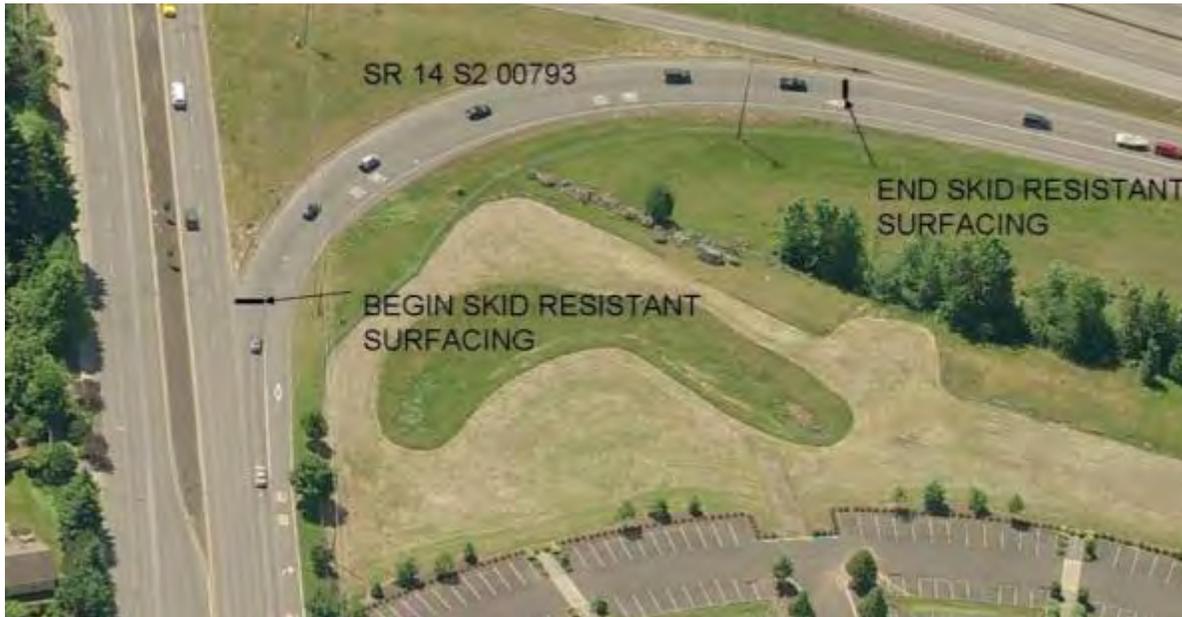
Figure 1. Approximate limits of Tyregrip® installation on SR 14 S2 00793 ramp.

Tyregrip® was installed on the 014 S2 00793 Ramp (SE 164th Ave Southbound to SR 14 Westbound) at the approximate limits shown in Figure 1. SE 164th Avenue carries high volumes of traffic from the southeast Vancouver area heading westbound to connect with I-205 to Portland or SR-14 into downtown Vancouver. The length of the installation was 500 feet and the width 22 feet for a total of 1,200 square yards. Only the outside lane (Lane 2) and outside shoulder of the two lane ramp received the Tyregrip® treatment.

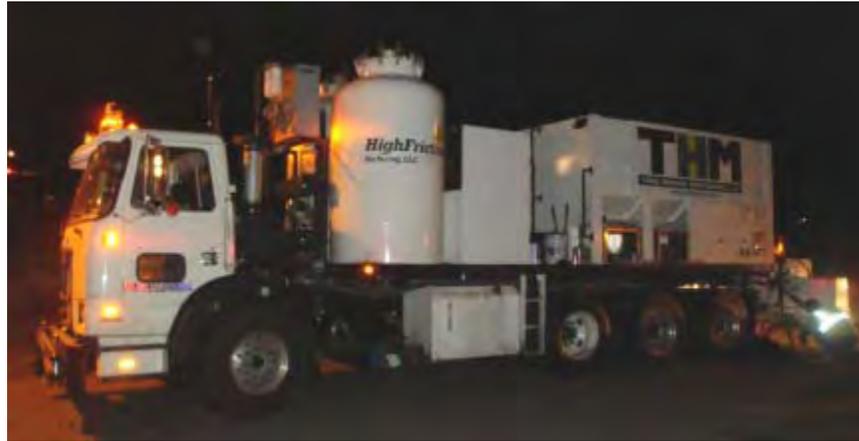
Figure 2. Vehicle used to mix and place epoxy binder and aggregates.

Tyregrip®, as described previously, is composed of a two part epoxy based binder that is covered with aggregate. The aggregate is fractured 100 percent and is approximately No. 10 (2 mm) size material. For this project a machine application process was used which consists of a vehicle equipped with two feeder tanks (one for each epoxy component), a mixing unit, a spreader bar, and an aggregate containment system (Figure 2).

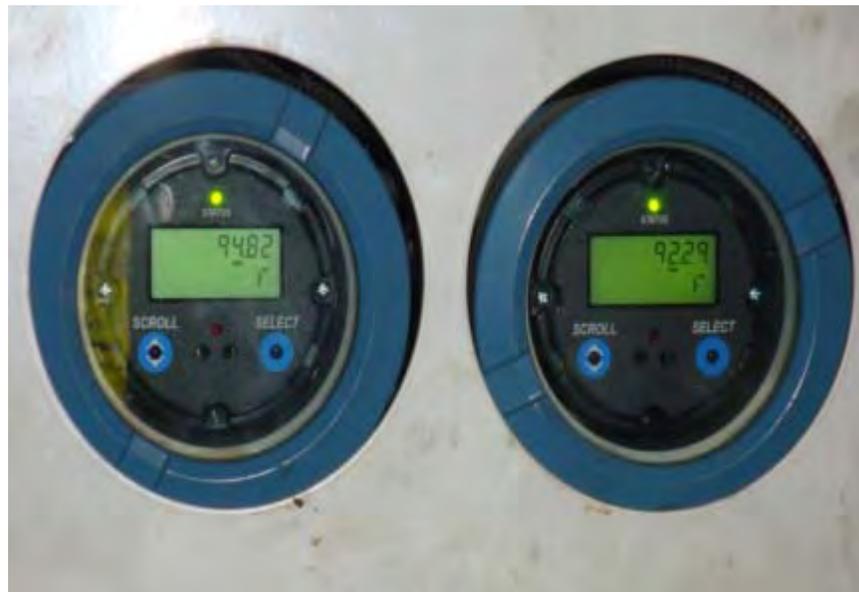
Figure 3. Temperature of Component A (left) and Component B (right) prior to production.

The containment tanks hold a thermoset two part epoxy which, when mixed together, create the epoxy based binder. These components are mixed at a ratio of 1:1. Component A is slightly thicker than Component B and is mixed at a temperature of 105 °F while Component B is mixed at 95 °F during production (Figure 3).

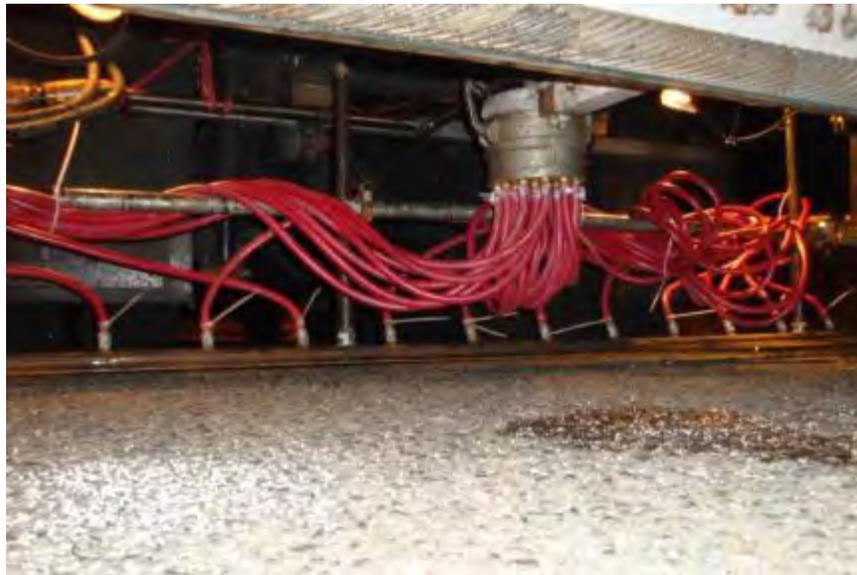
Figure 4. Supply hoses and spreader bar prior to production.

When the two components have been mixed, they are pumped through a series of hoses to the spreader bar (Figure 4). The 12-foot long spreader bar is vertically adjustable and is positioned approximately two inches from the pavement surface and allows the epoxy binder to flow uniformly onto the pavement at a rate of approximately 12 gallons per foot of travel.

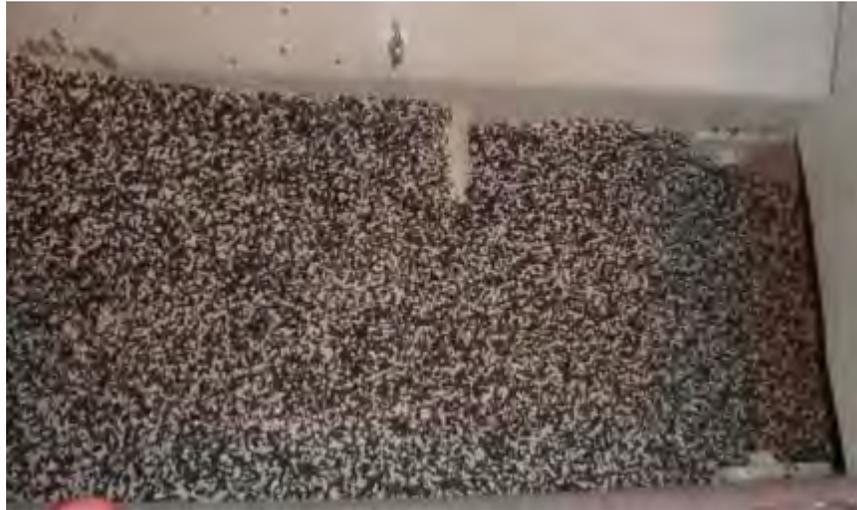
Figure 5. Aggregate in spreader box prior to production.

Crushed bauxite or granite aggregate is then placed over the extruded epoxy in a manner similar to that of a bituminous surface treatment. The aggregate is loaded into a holding bin which feeds a spreader box located on the back of the application vehicle (Figure 5). According to the equipment operator, the rate of aggregate application varies but they try to place it in a manner where the epoxy will not quite bleed through. Figure 6 shows the aggregate being dropped on top of the extruded epoxy binder.

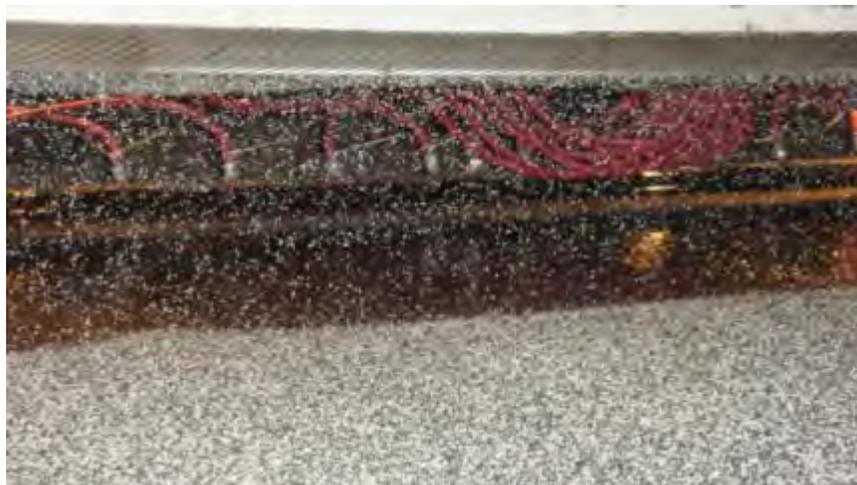
Figure 6. Aggregate dropping onto the extruded epoxy binder.

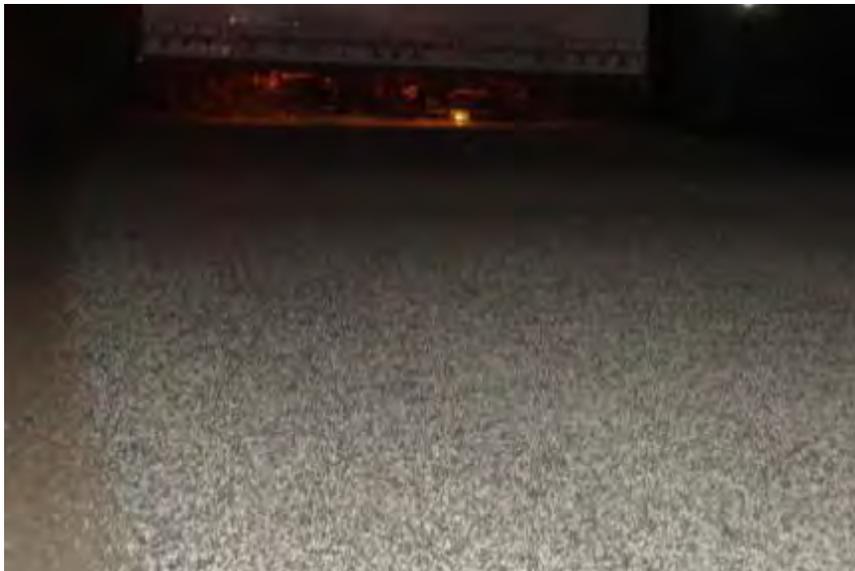
Figure 11. Illustration of uniform aggregate placement.

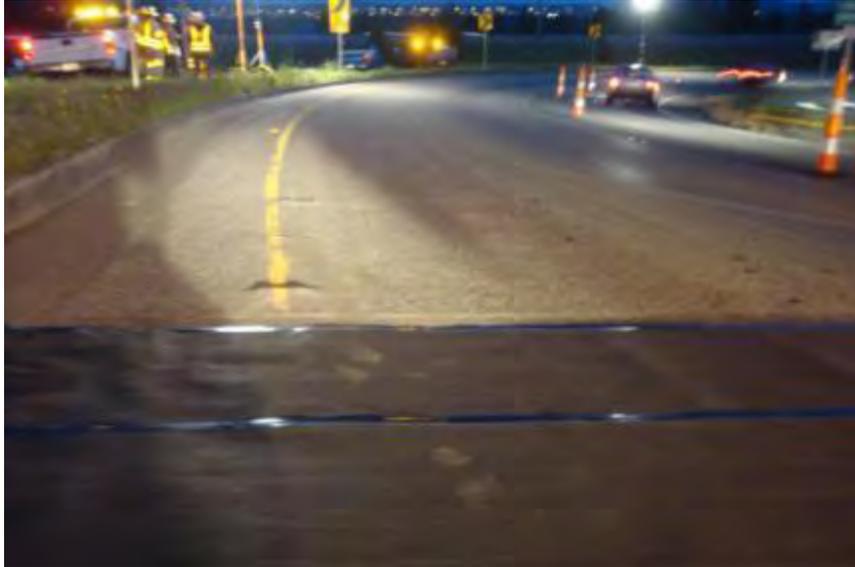
Figure 14. Tar paper placed at the start of the 500 foot test section.

At startup, distribution of the aggregate began a short distance after the start of the epoxy binder. This was addressed by hand placing aggregate onto the epoxy binder. Distribution of the aggregate was consistent throughout the remainder of the application which was completed within approximately 15 minutes. The Supervisor for IRM mentioned that they target an application rate of approximately 47 ft/min. For this section the target rate was slightly less because the material was being installed on a downhill corner with a significant super elevation. Although the installation was slower than that typically targeted, it was substantially faster than the two prior placements. Figures 14 to 20 capture the essence of the construction sequence.

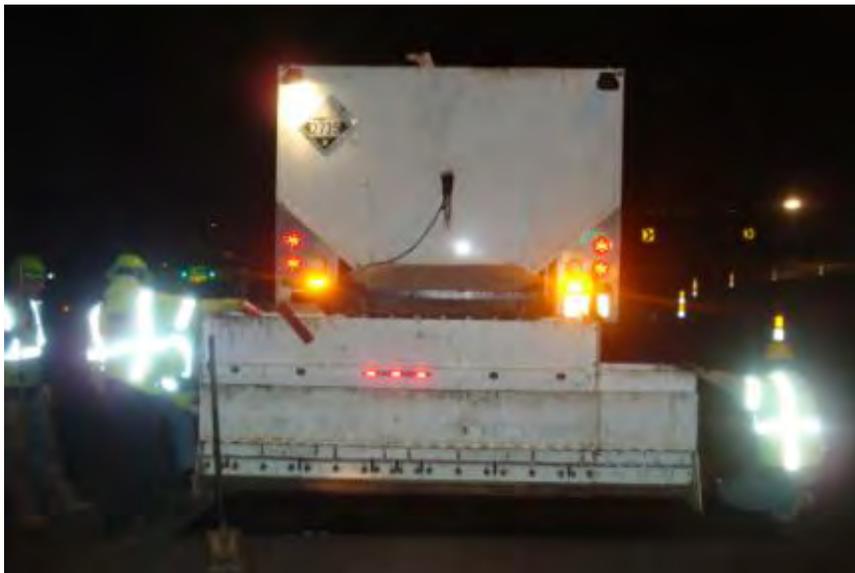
Figure 15. Application vehicle at start of the test section.

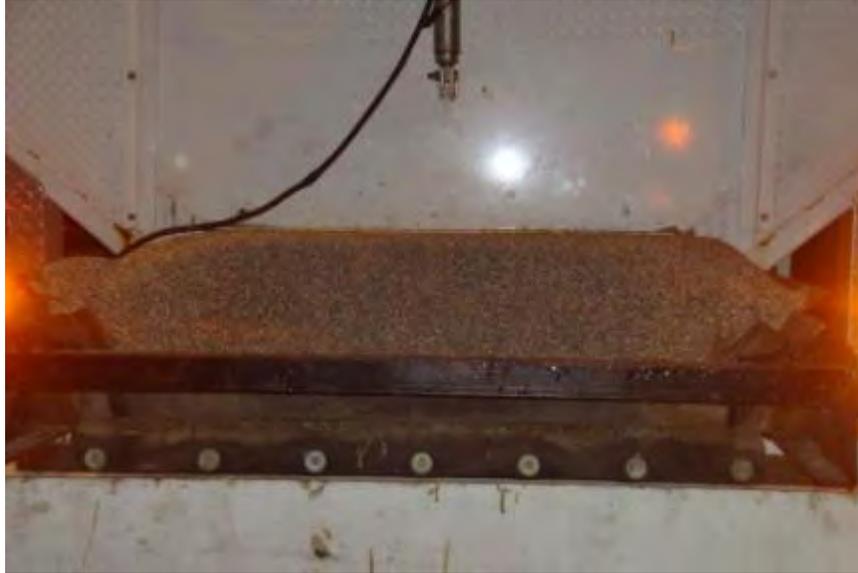
Figure 16. Calcined bauxite aggregate ready for distribution.

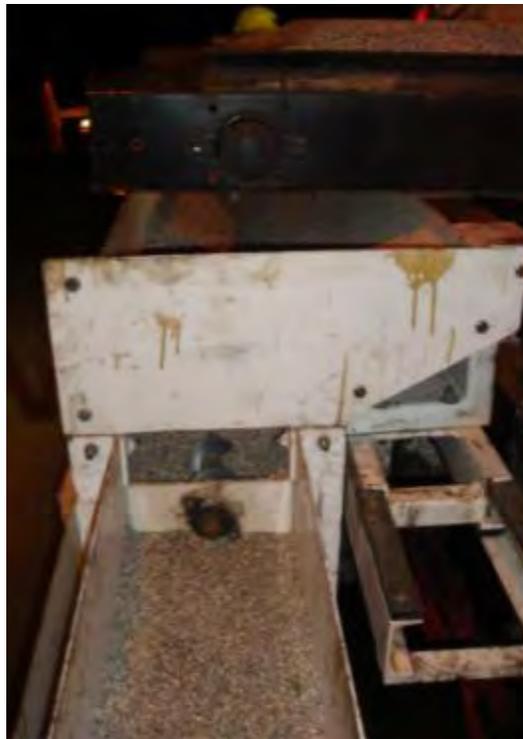
Figure 17. Aggregate in spreader box prior to production.

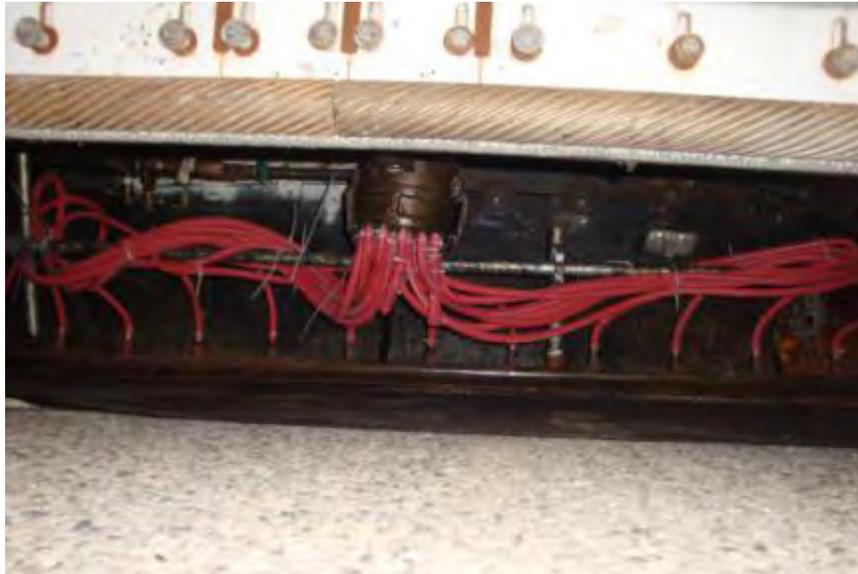
Figure 18. Multiple hoses used to distribute epoxy binder from the mixer to the spreader.

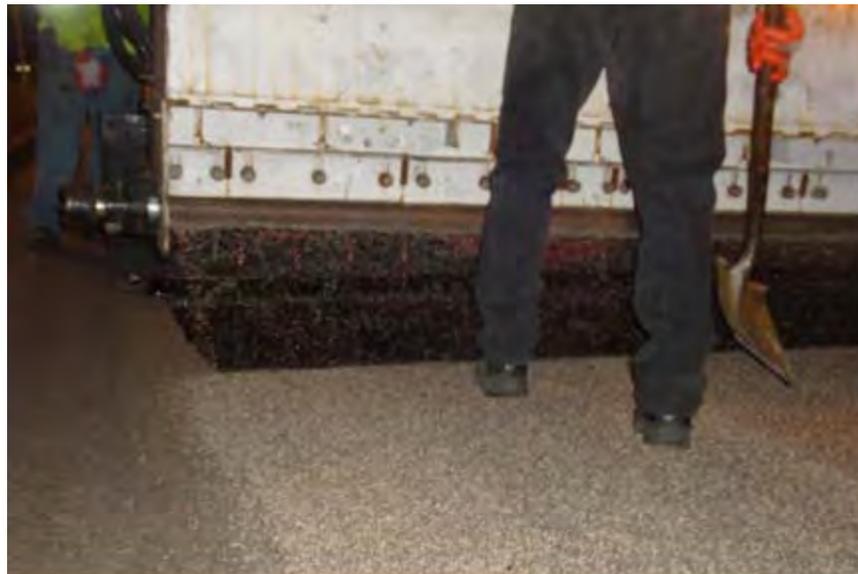
Figure 19. Aggregate being applied to epoxy after being placed on the pavement surface.

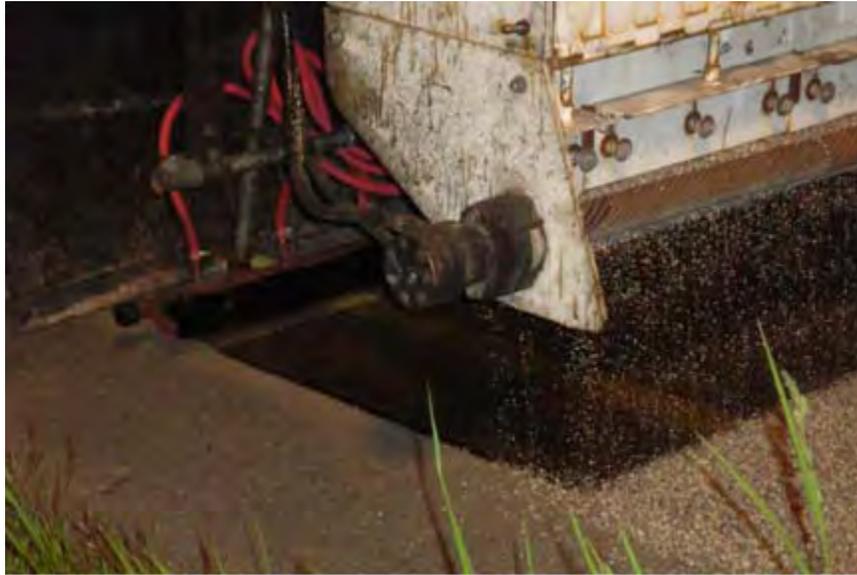
Figure 20. Close-up of spreader bar distributing epoxy binder and aggregate spreader dropping material on top of the epoxy.

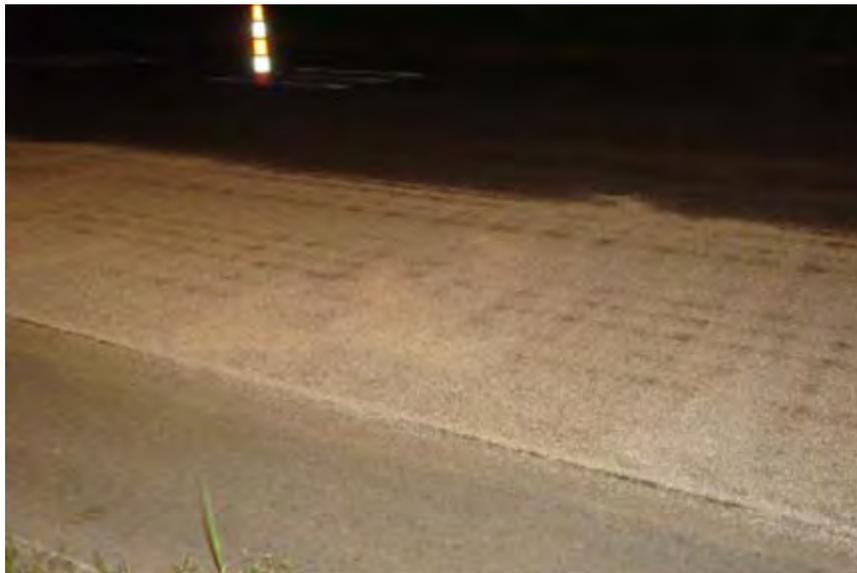
Figure 21. Completed installation prior to the removal of the excess aggregate.

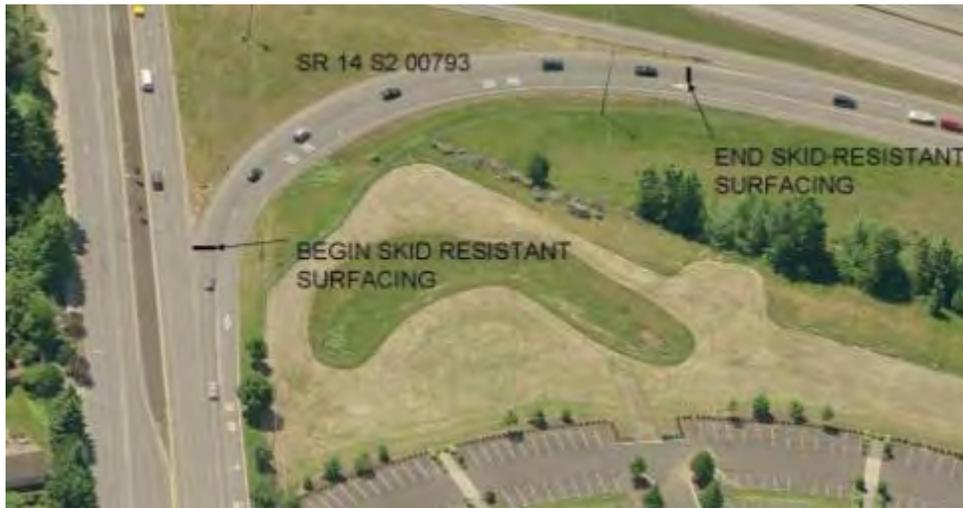
Figure 1. Approximate limits of Tyregrip® installation on SR 14 S2 00793 ramp.

Tyregrip® will be installed on the 014 S2 00793 Ramp (SE 164th Ave Southbound to SR 14 Westbound) at the approximate limits shown in Figure 1. The length of the installation will be approximately 500 feet.
