Spalling repairs for cycle 1 pontoons

September 2012

Spalling repairs in Aberdeen

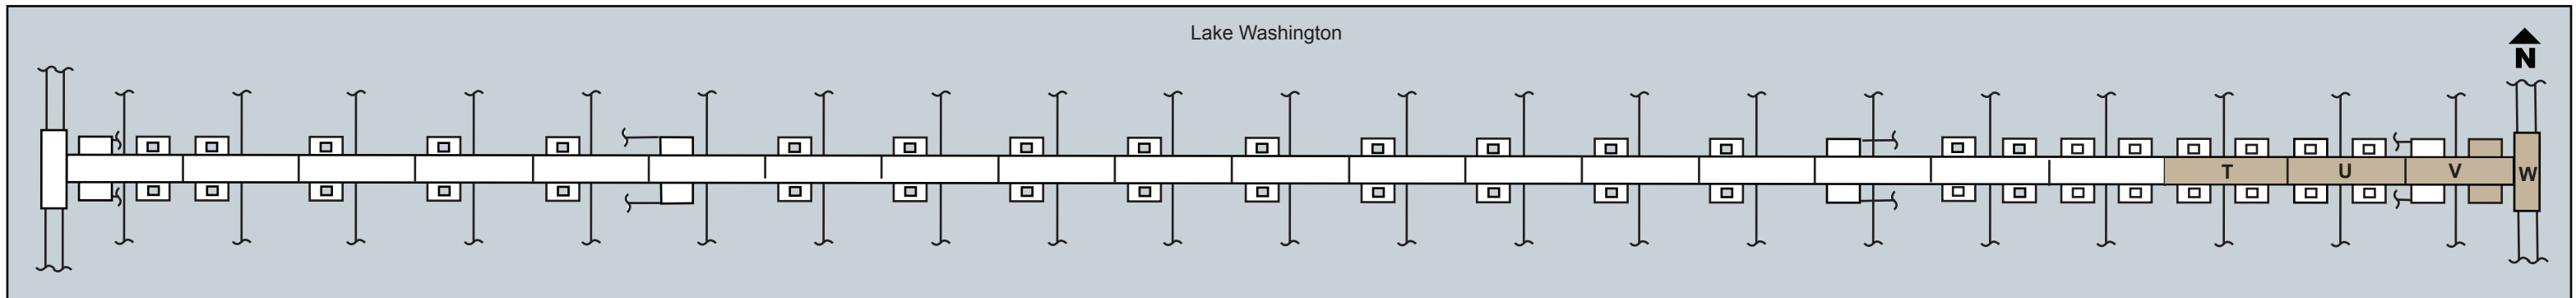
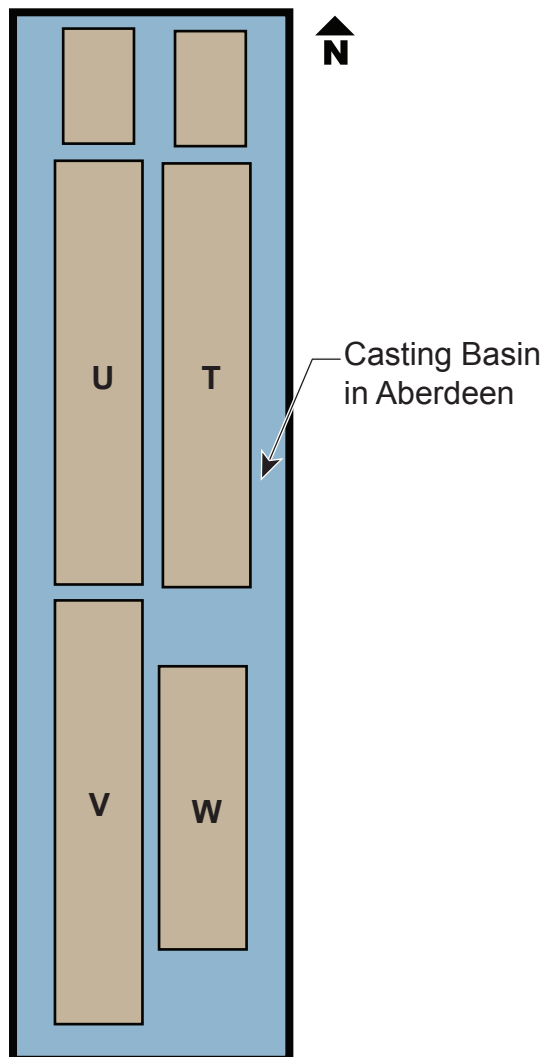
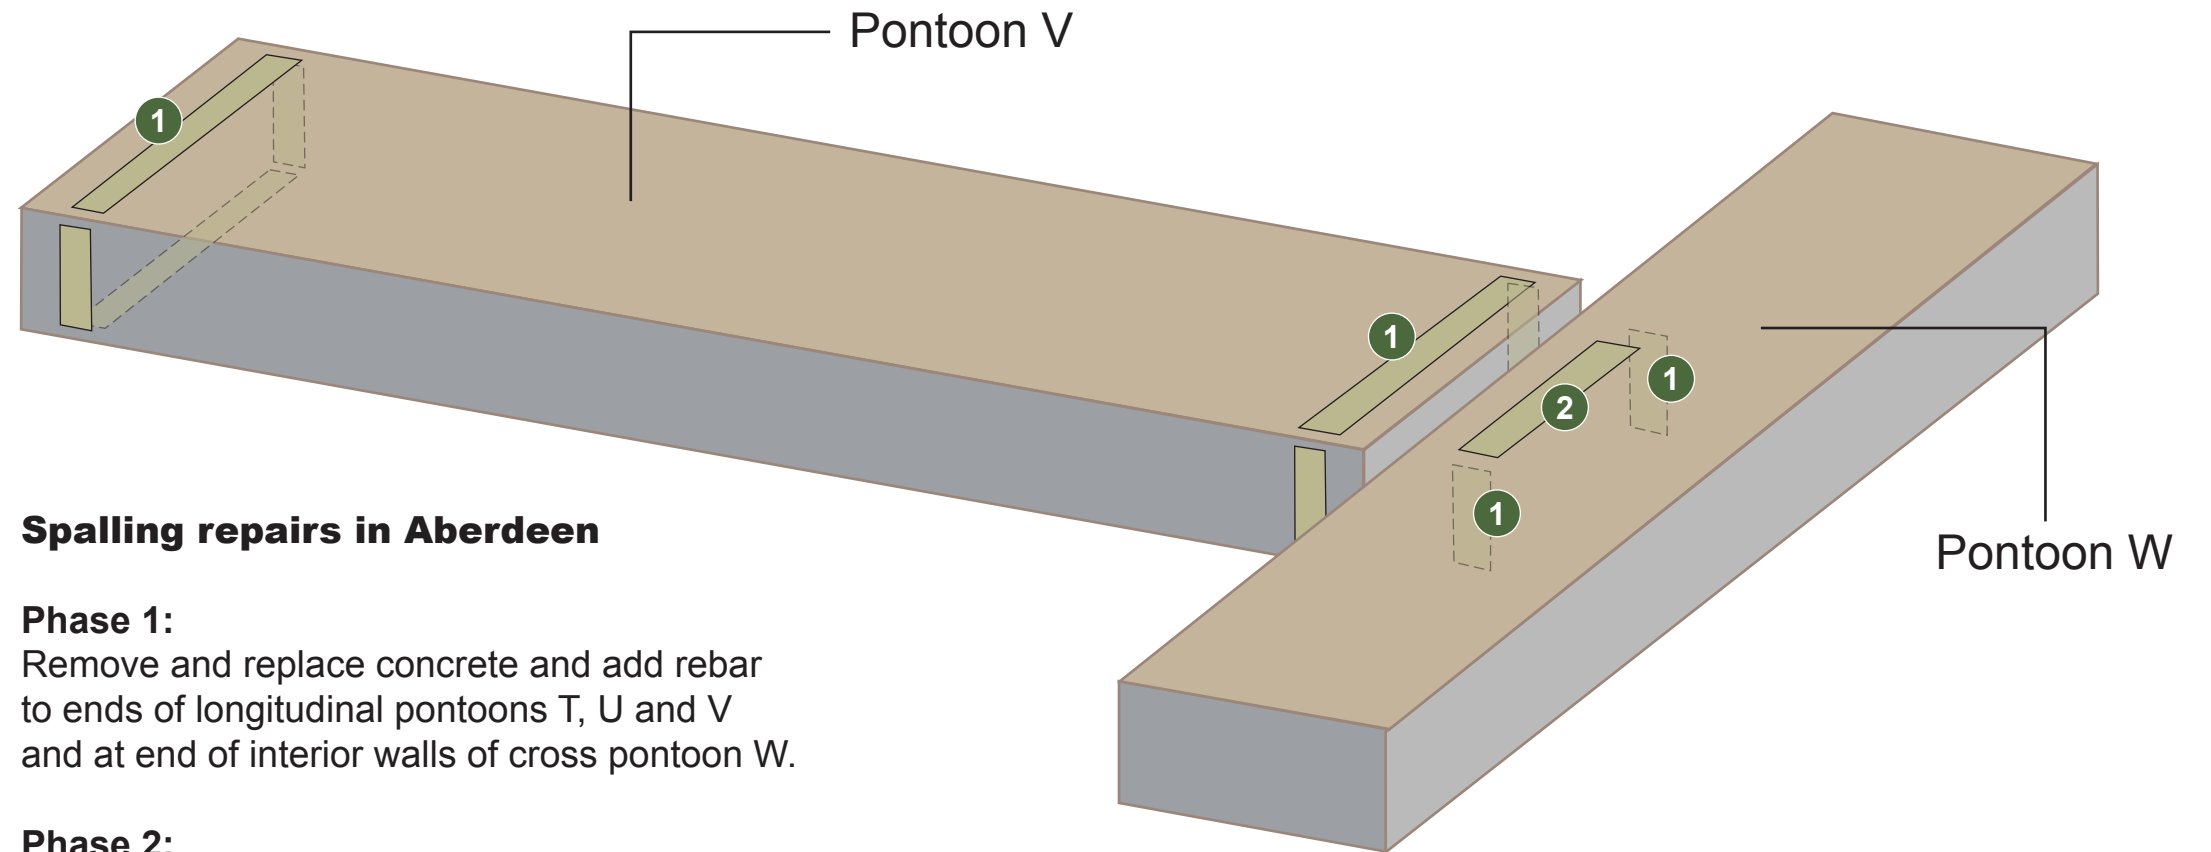
Phase 1:

Remove and replace concrete and add rebar to ends of longitudinal pontoons T, U and V and at end of interior walls of cross pontoon W.

Phase 2:

Remove and replace concrete and add rebar to center section of cross pontoon W.
