SPANAWAY AIRPORT
2005 PAVEMENT MANAGEMENT REPORT

February 2006

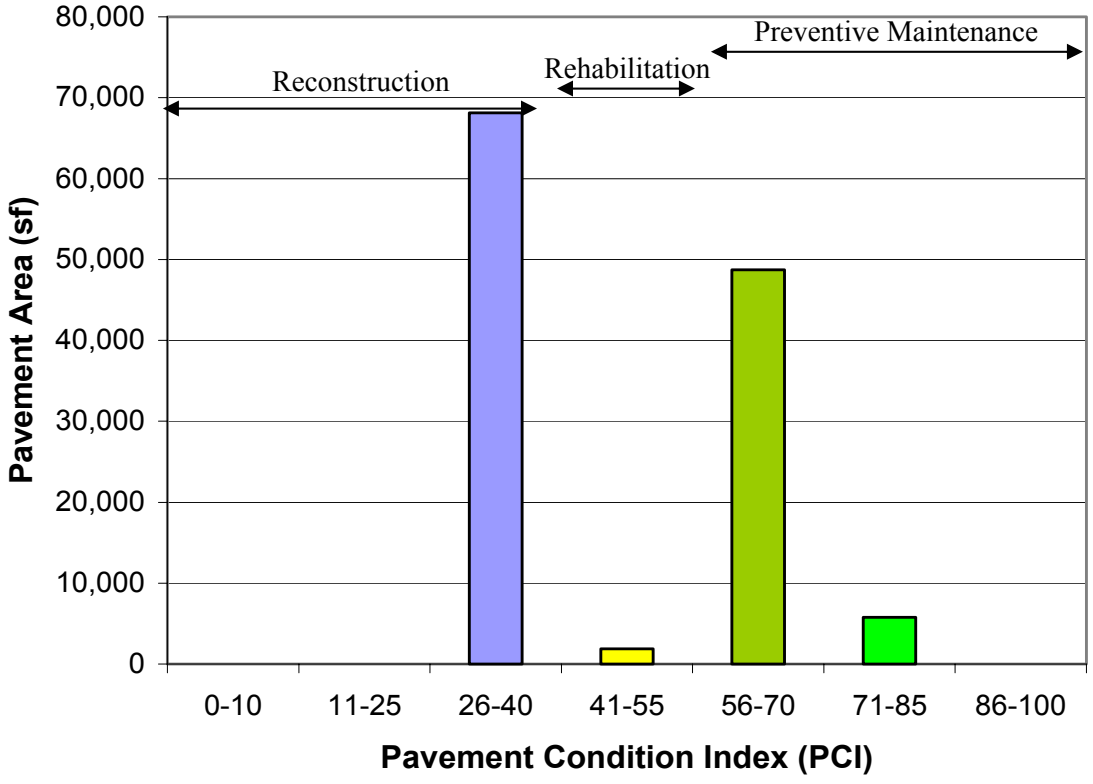
Figure 6. Spanaway Airport overall condition.

The pavements at Spanaway Airport were inspected on June 19, 2005. The 2005 area-weighted condition of Spanaway Airport is 51, with conditions ranging from 36 to 76 (on a scale of 0 [failed] to 100 [excellent]). During the previous inspection in 1999, the area-weighted condition was 49.

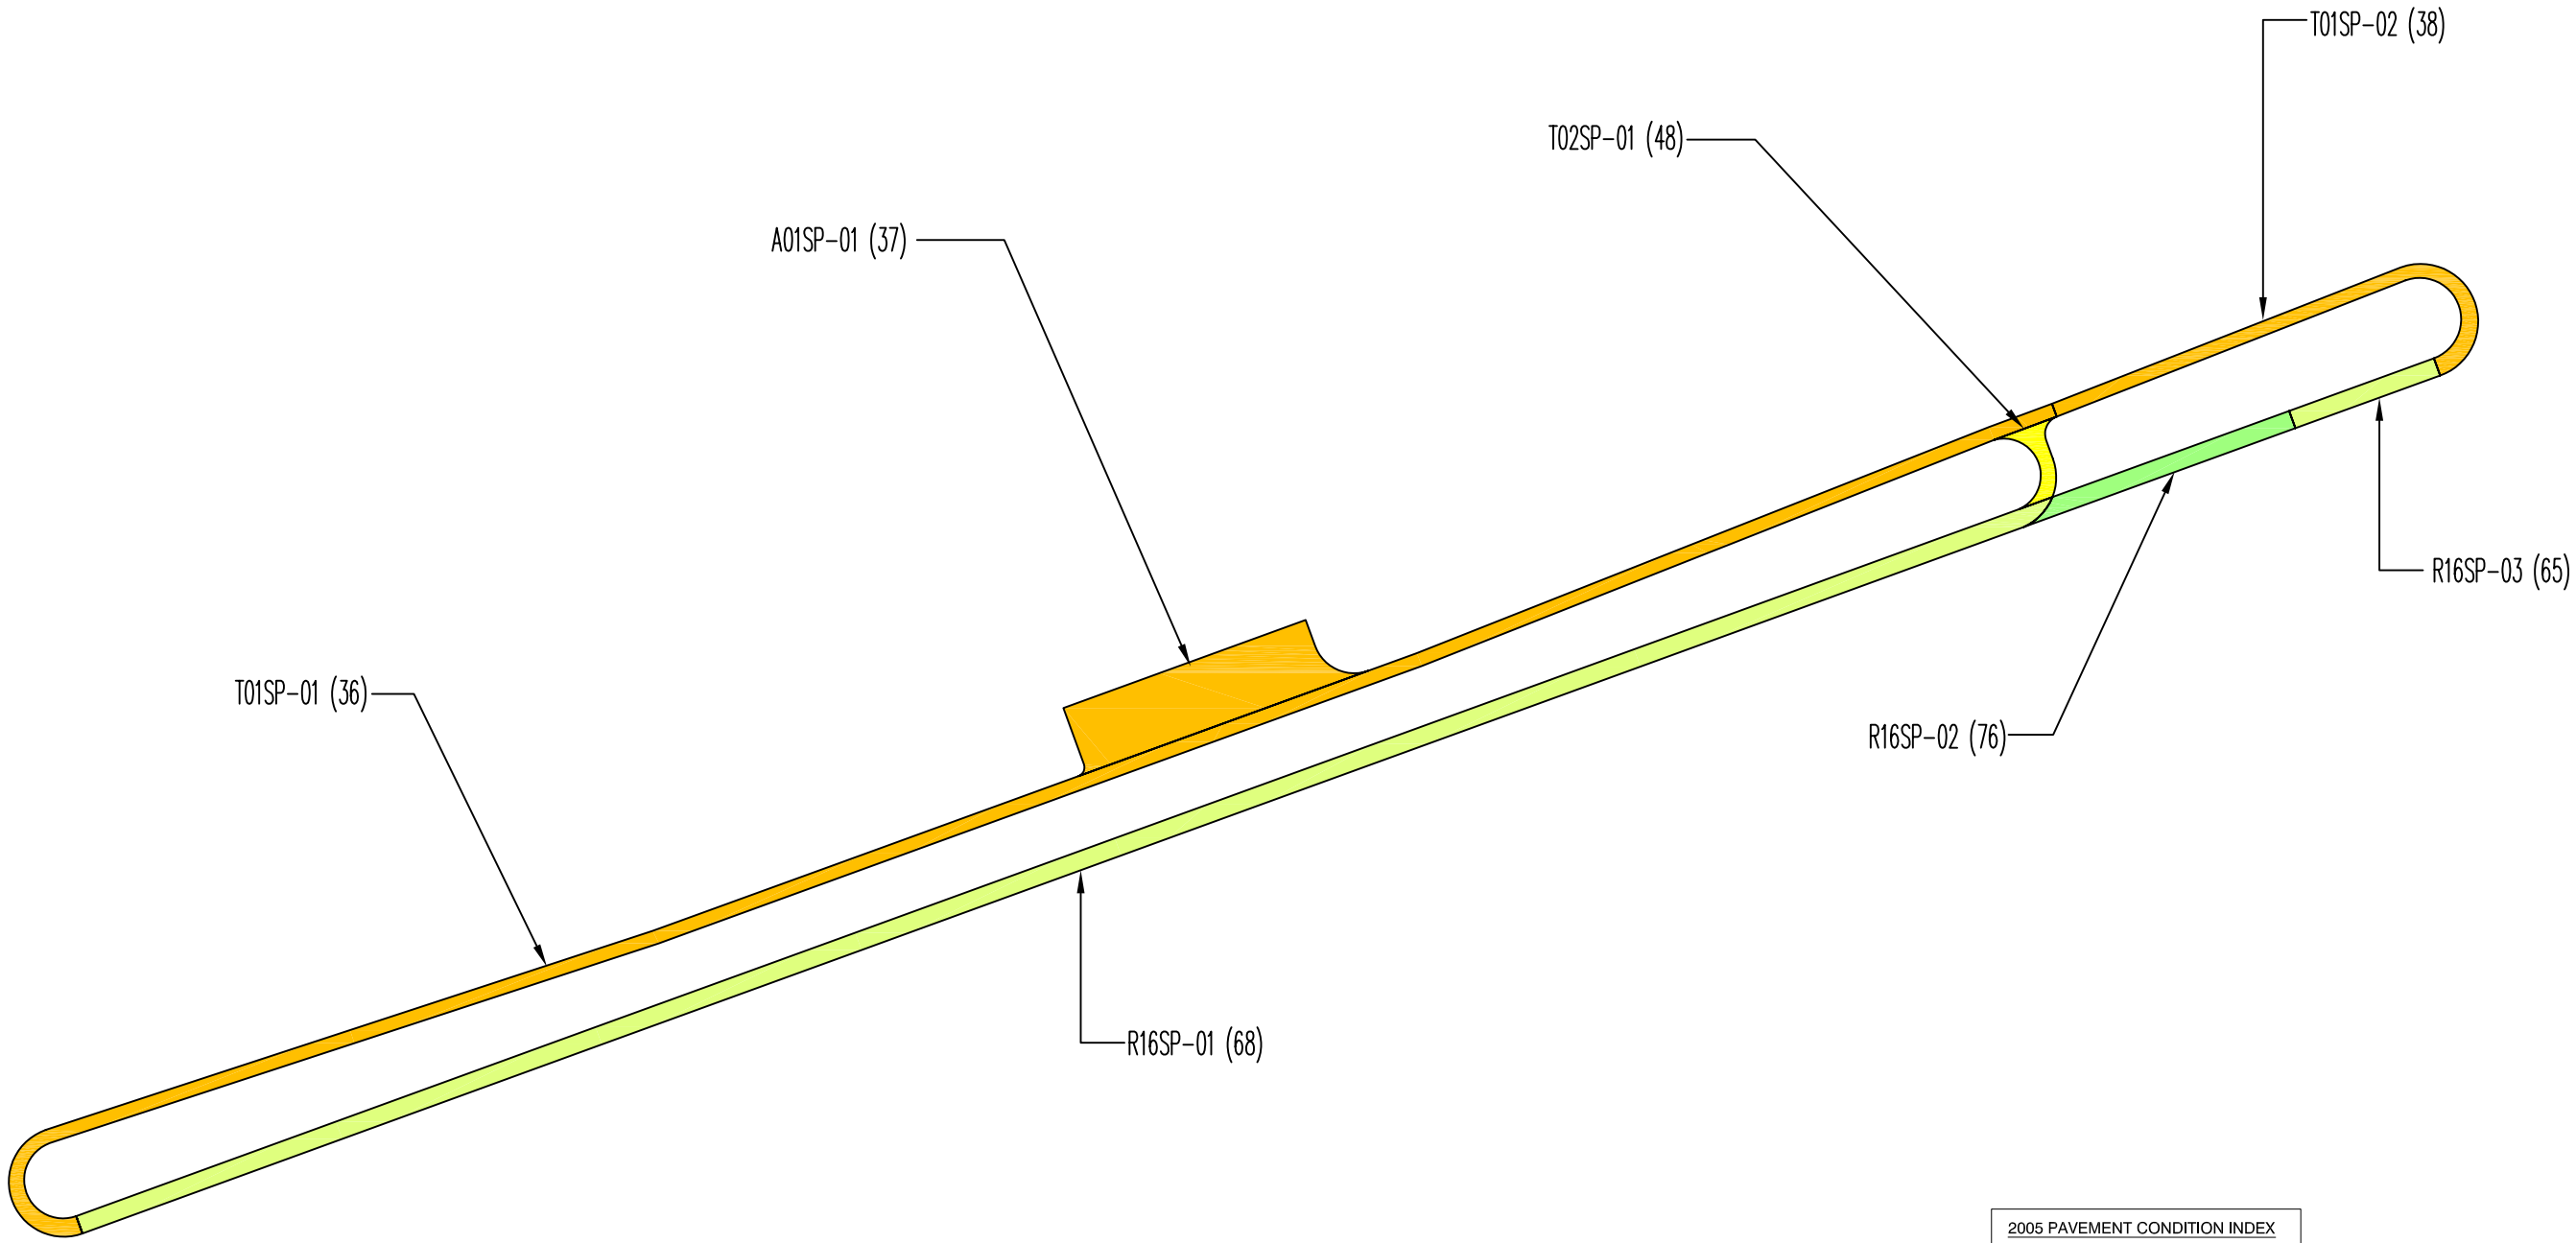
LOCATION: Spanaway Airport, Spanaway, Washington			
PAGE TITLE: 2005 Pavement Condition Index Map			
DRAWING SCALE: 1" = 200'	DATE: February 2006	REVISED BY: TJS	DRAWN BY: JR
FILENAME: Spanaway.dwg	AIRPORT ID: S44	LAYOUT NAME/NUMBER: Spanaway (PCI	PAGE NUMBER: 9

Figures 6 and 7 summarize the overall condition of the pavements at the Spanaway Airport. Figure 8 displays the condition of the pavements evaluated. Table 1 summarizes the results of the pavement evaluation. Appendix C presents photographs taken during the PCI inspection and Appendix D details the distresses observed during the visual survey.

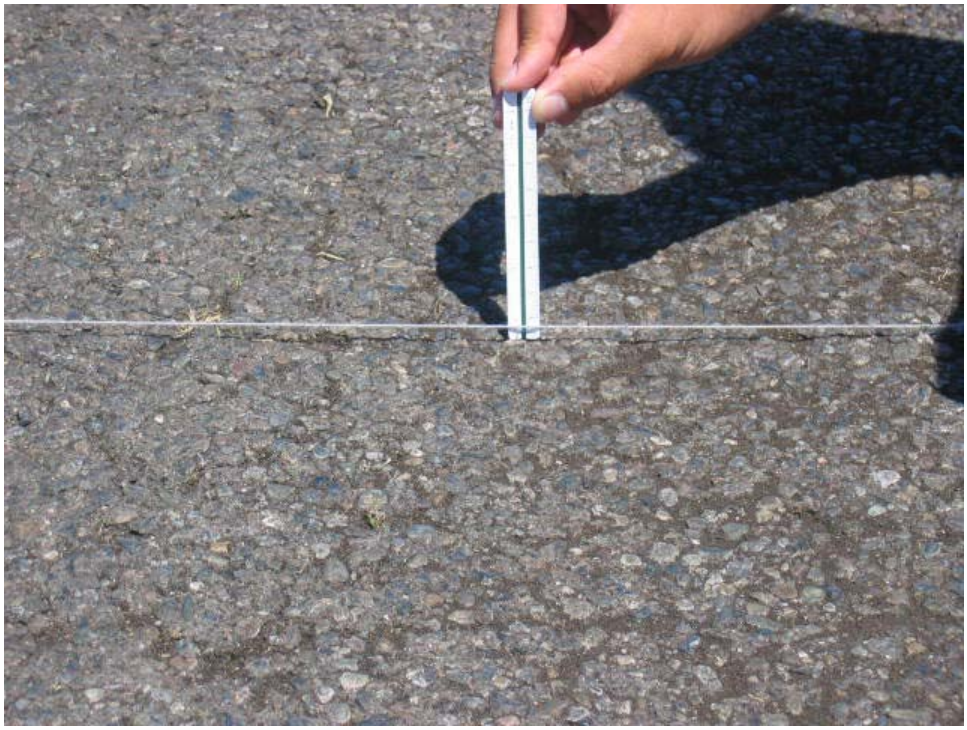
T01SP-02. Rutting.
