GRANT COUNTY AIRPORT
2005 PAVEMENT MANAGEMENT REPORT

February 2006

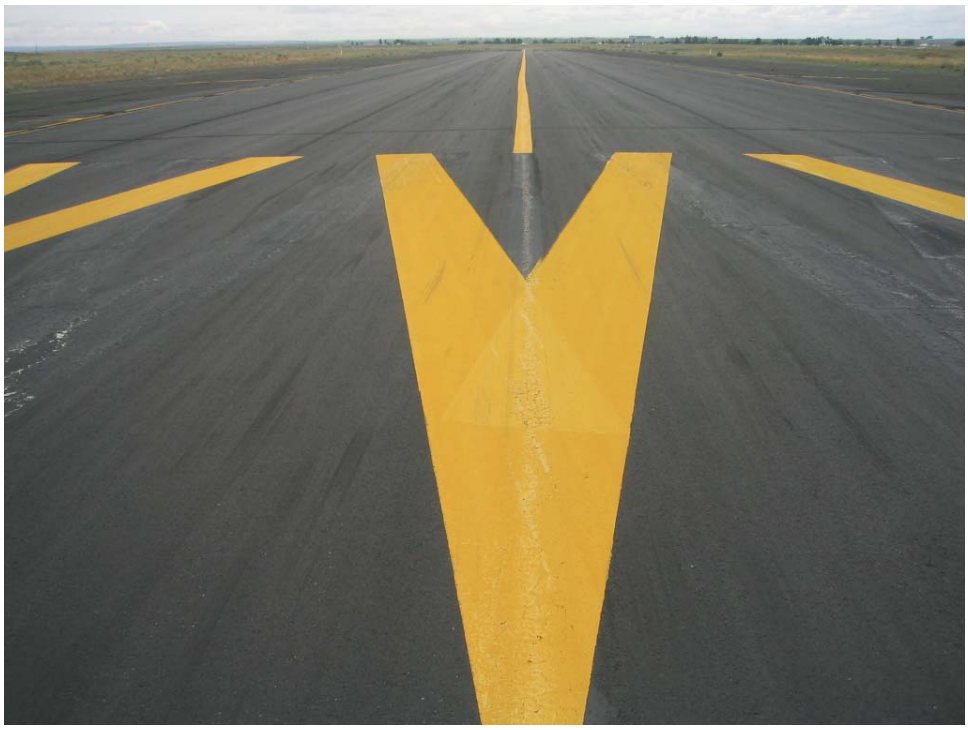
TCGC-01. Overview.

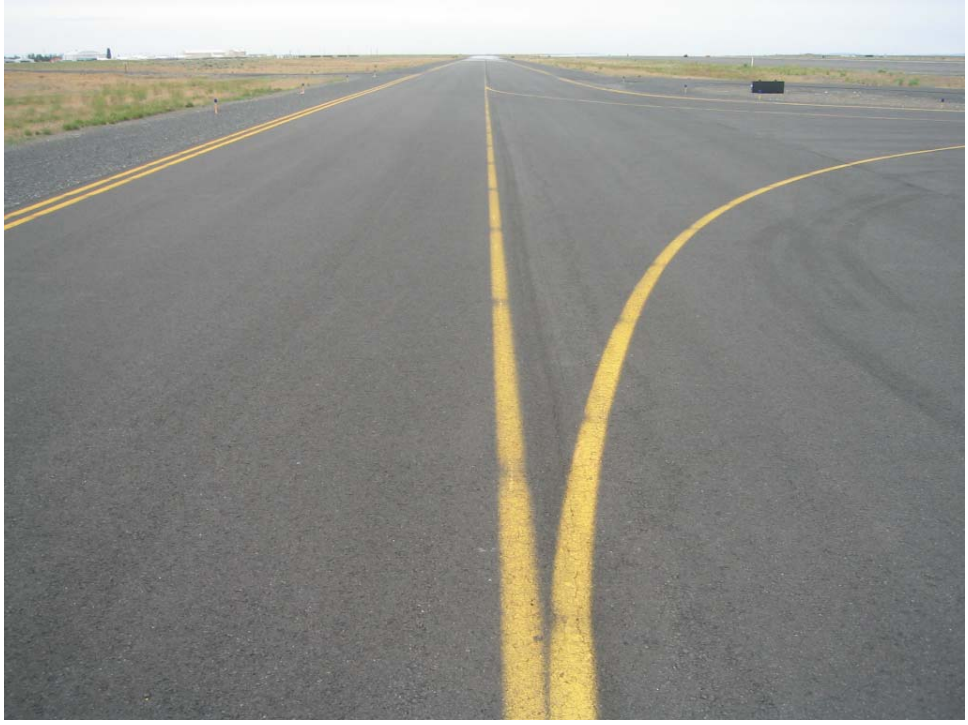
TJGC-02. Overview.

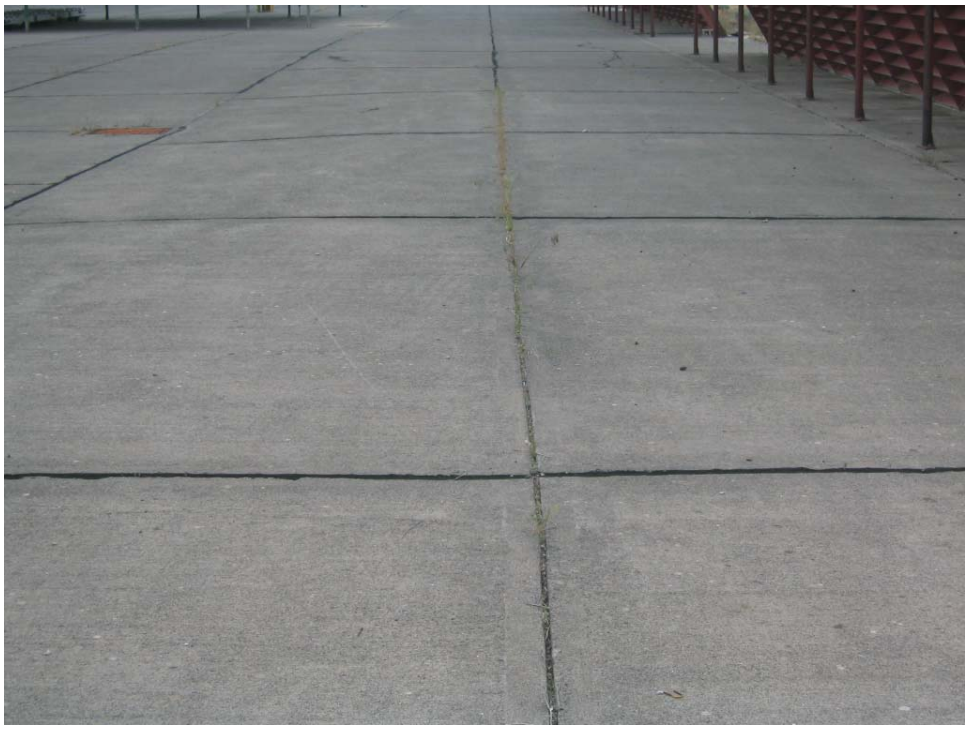
AEASTGC-03. Shattered slab.
