FORKS MUNICIPAL AIRPORT
2005 PAVEMENT MANAGEMENT REPORT

February 2006

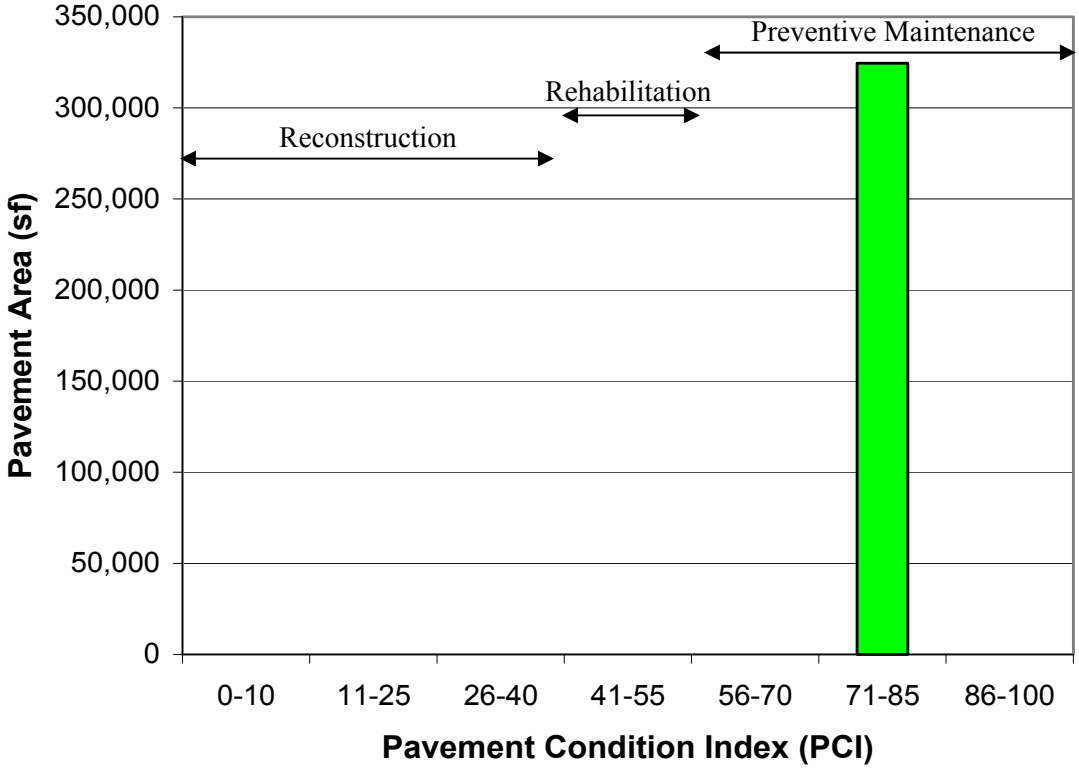
Figure 6. Forks Municipal Airport overall condition.

The pavements at Forks Municipal Airport were inspected on March 18, 2005. The 2005 area-weighted condition of Forks Municipal Airport is 75, with conditions ranging from 71 to 82 (on a scale of 0 [failed] to 100 [excellent]). During the previous inspection in 1999, the area-weighted condition was 89.

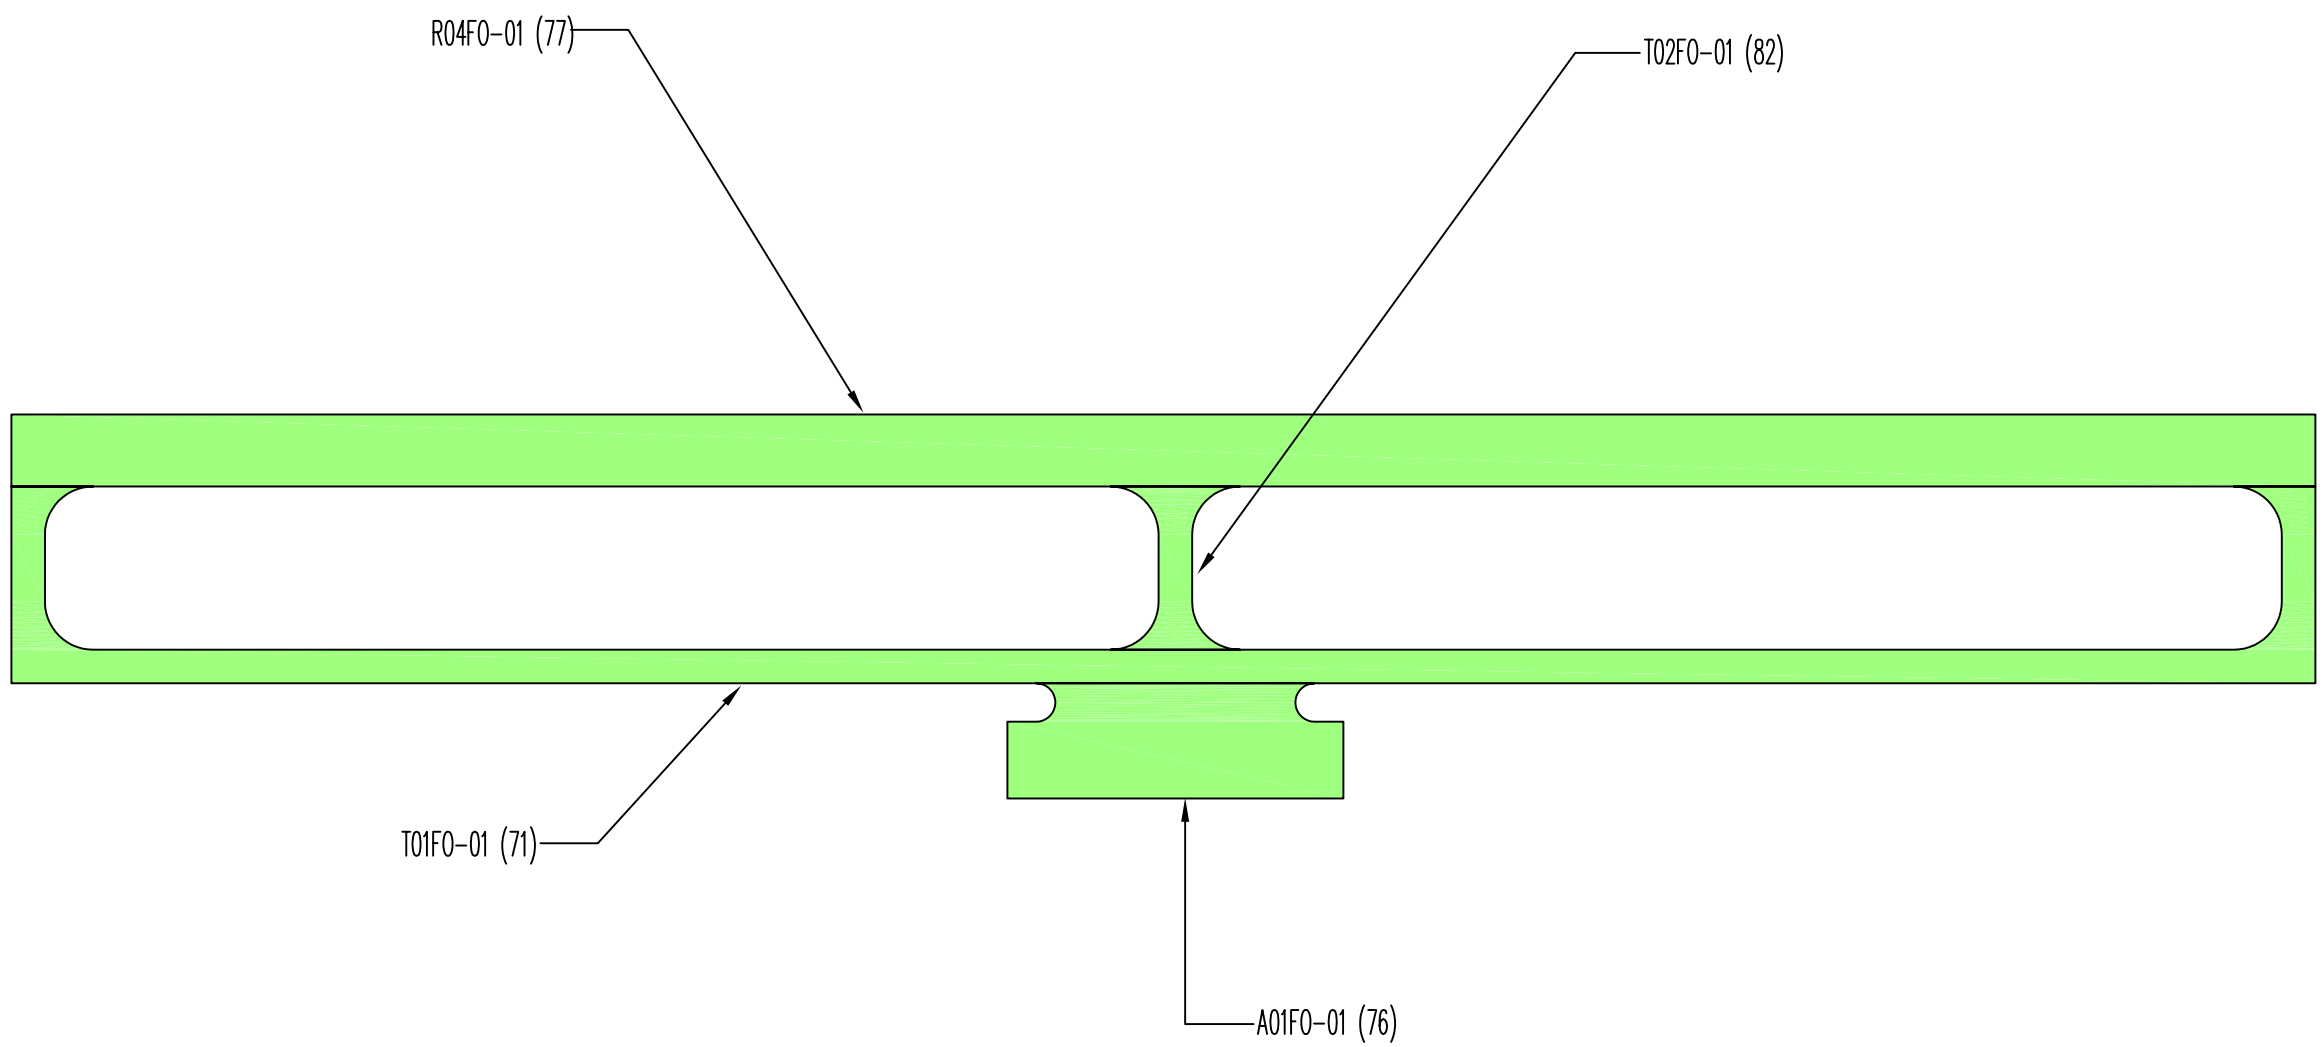
PAGE TITLE: 2005 Pavement Condition Index Map

Figures 6 and 7 summarize the overall condition of the pavements at the Forks Municipal Airport. Figure 8 displays the condition of the pavements evaluated. Table 1 summarizes the results of the pavement evaluation. Appendix C presents photographs taken during the PCI inspection and Appendix D details the distresses observed during the visual survey.

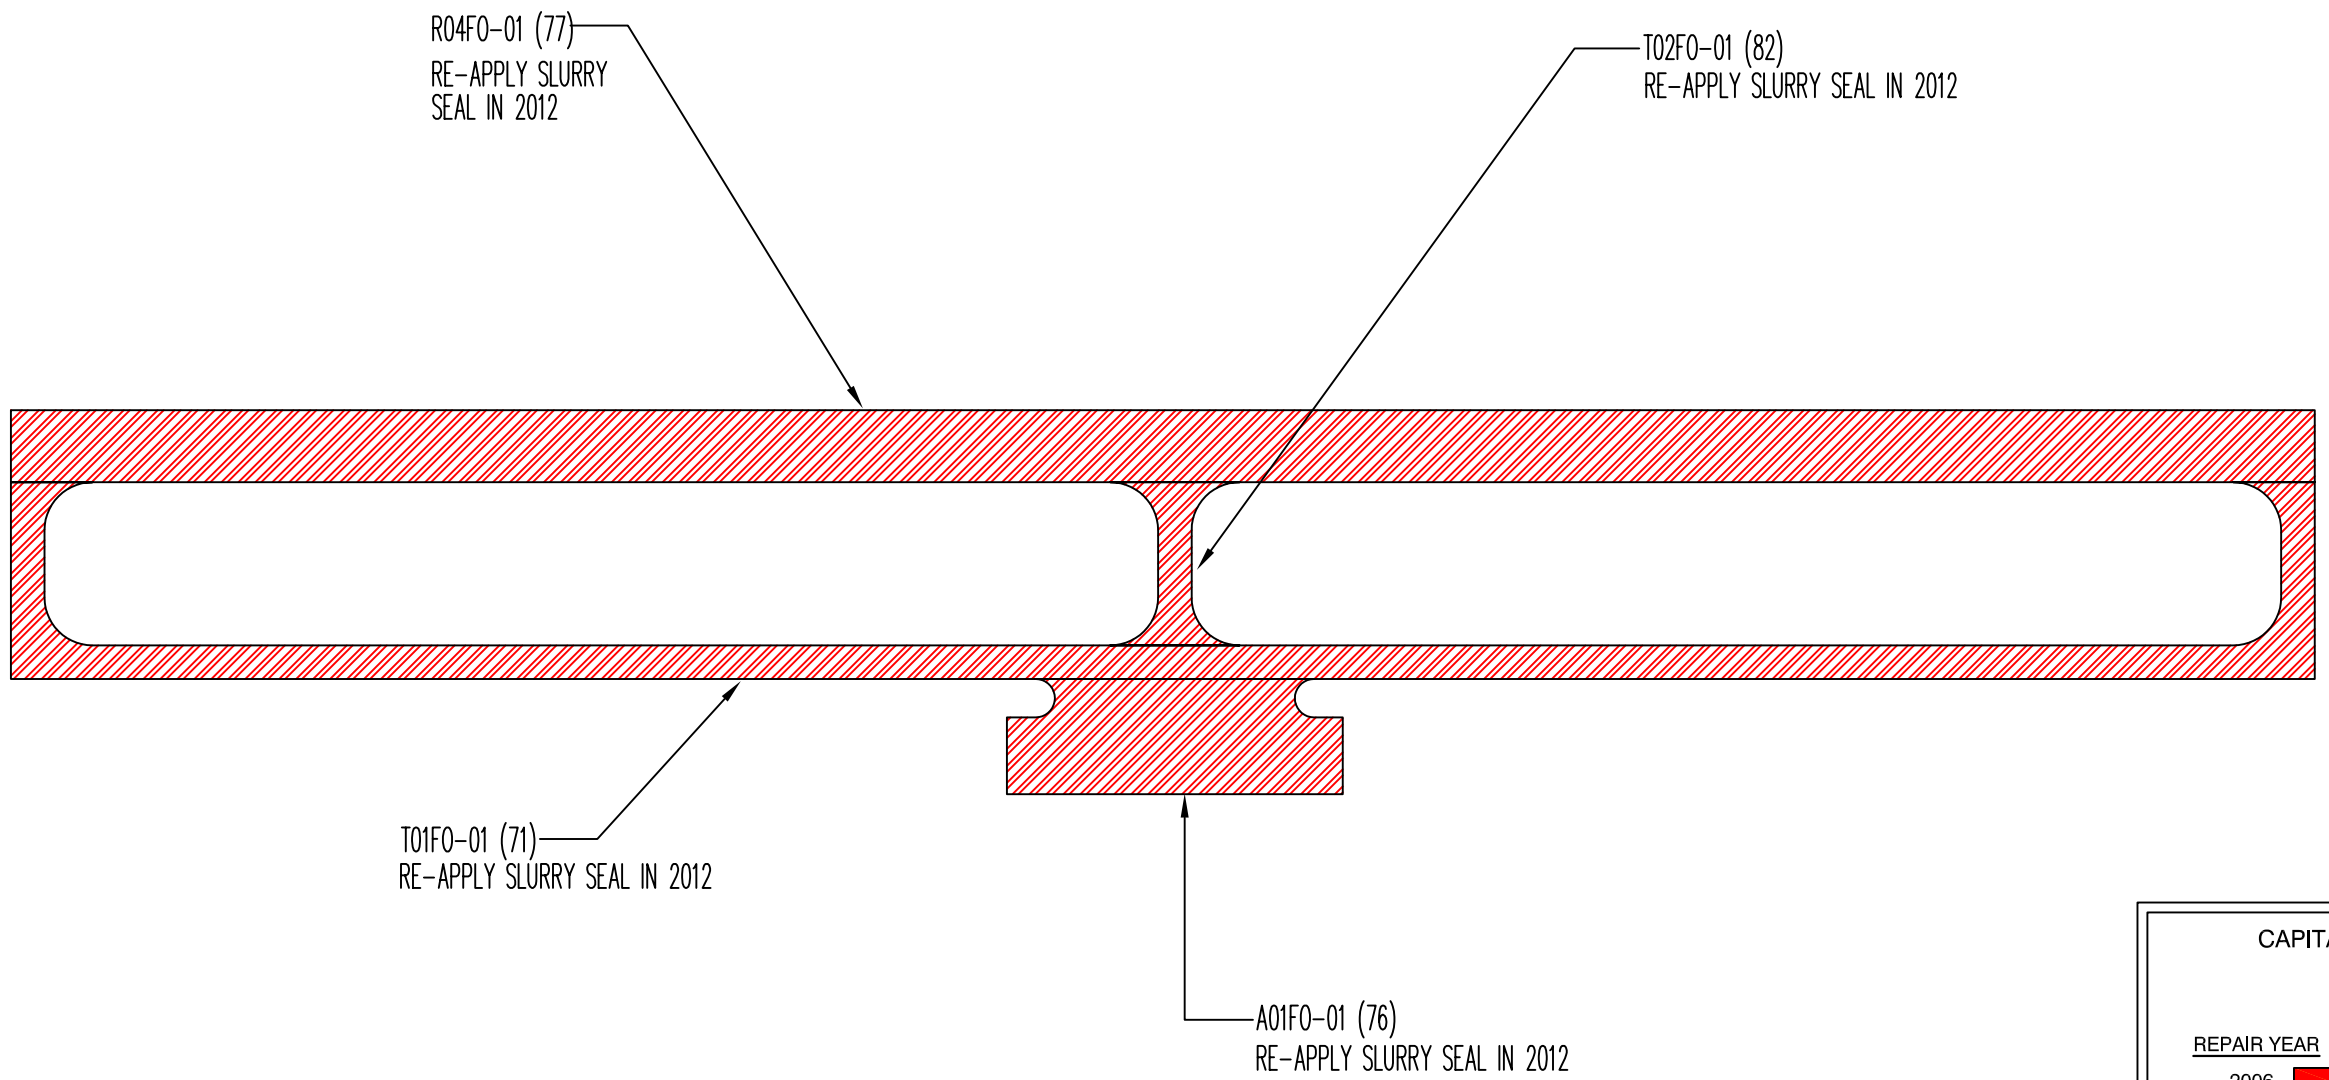
A summary of the pavement repair program for Forks Municipal Airport is presented in Table 4 and in Figure 9. Detailed information on the localized maintenance plan for 2006 is contained in Appendix F.
