RANGER CREEK STATE AIRPORT
2005 PAVEMENT MANAGEMENT REPORT

February 2006

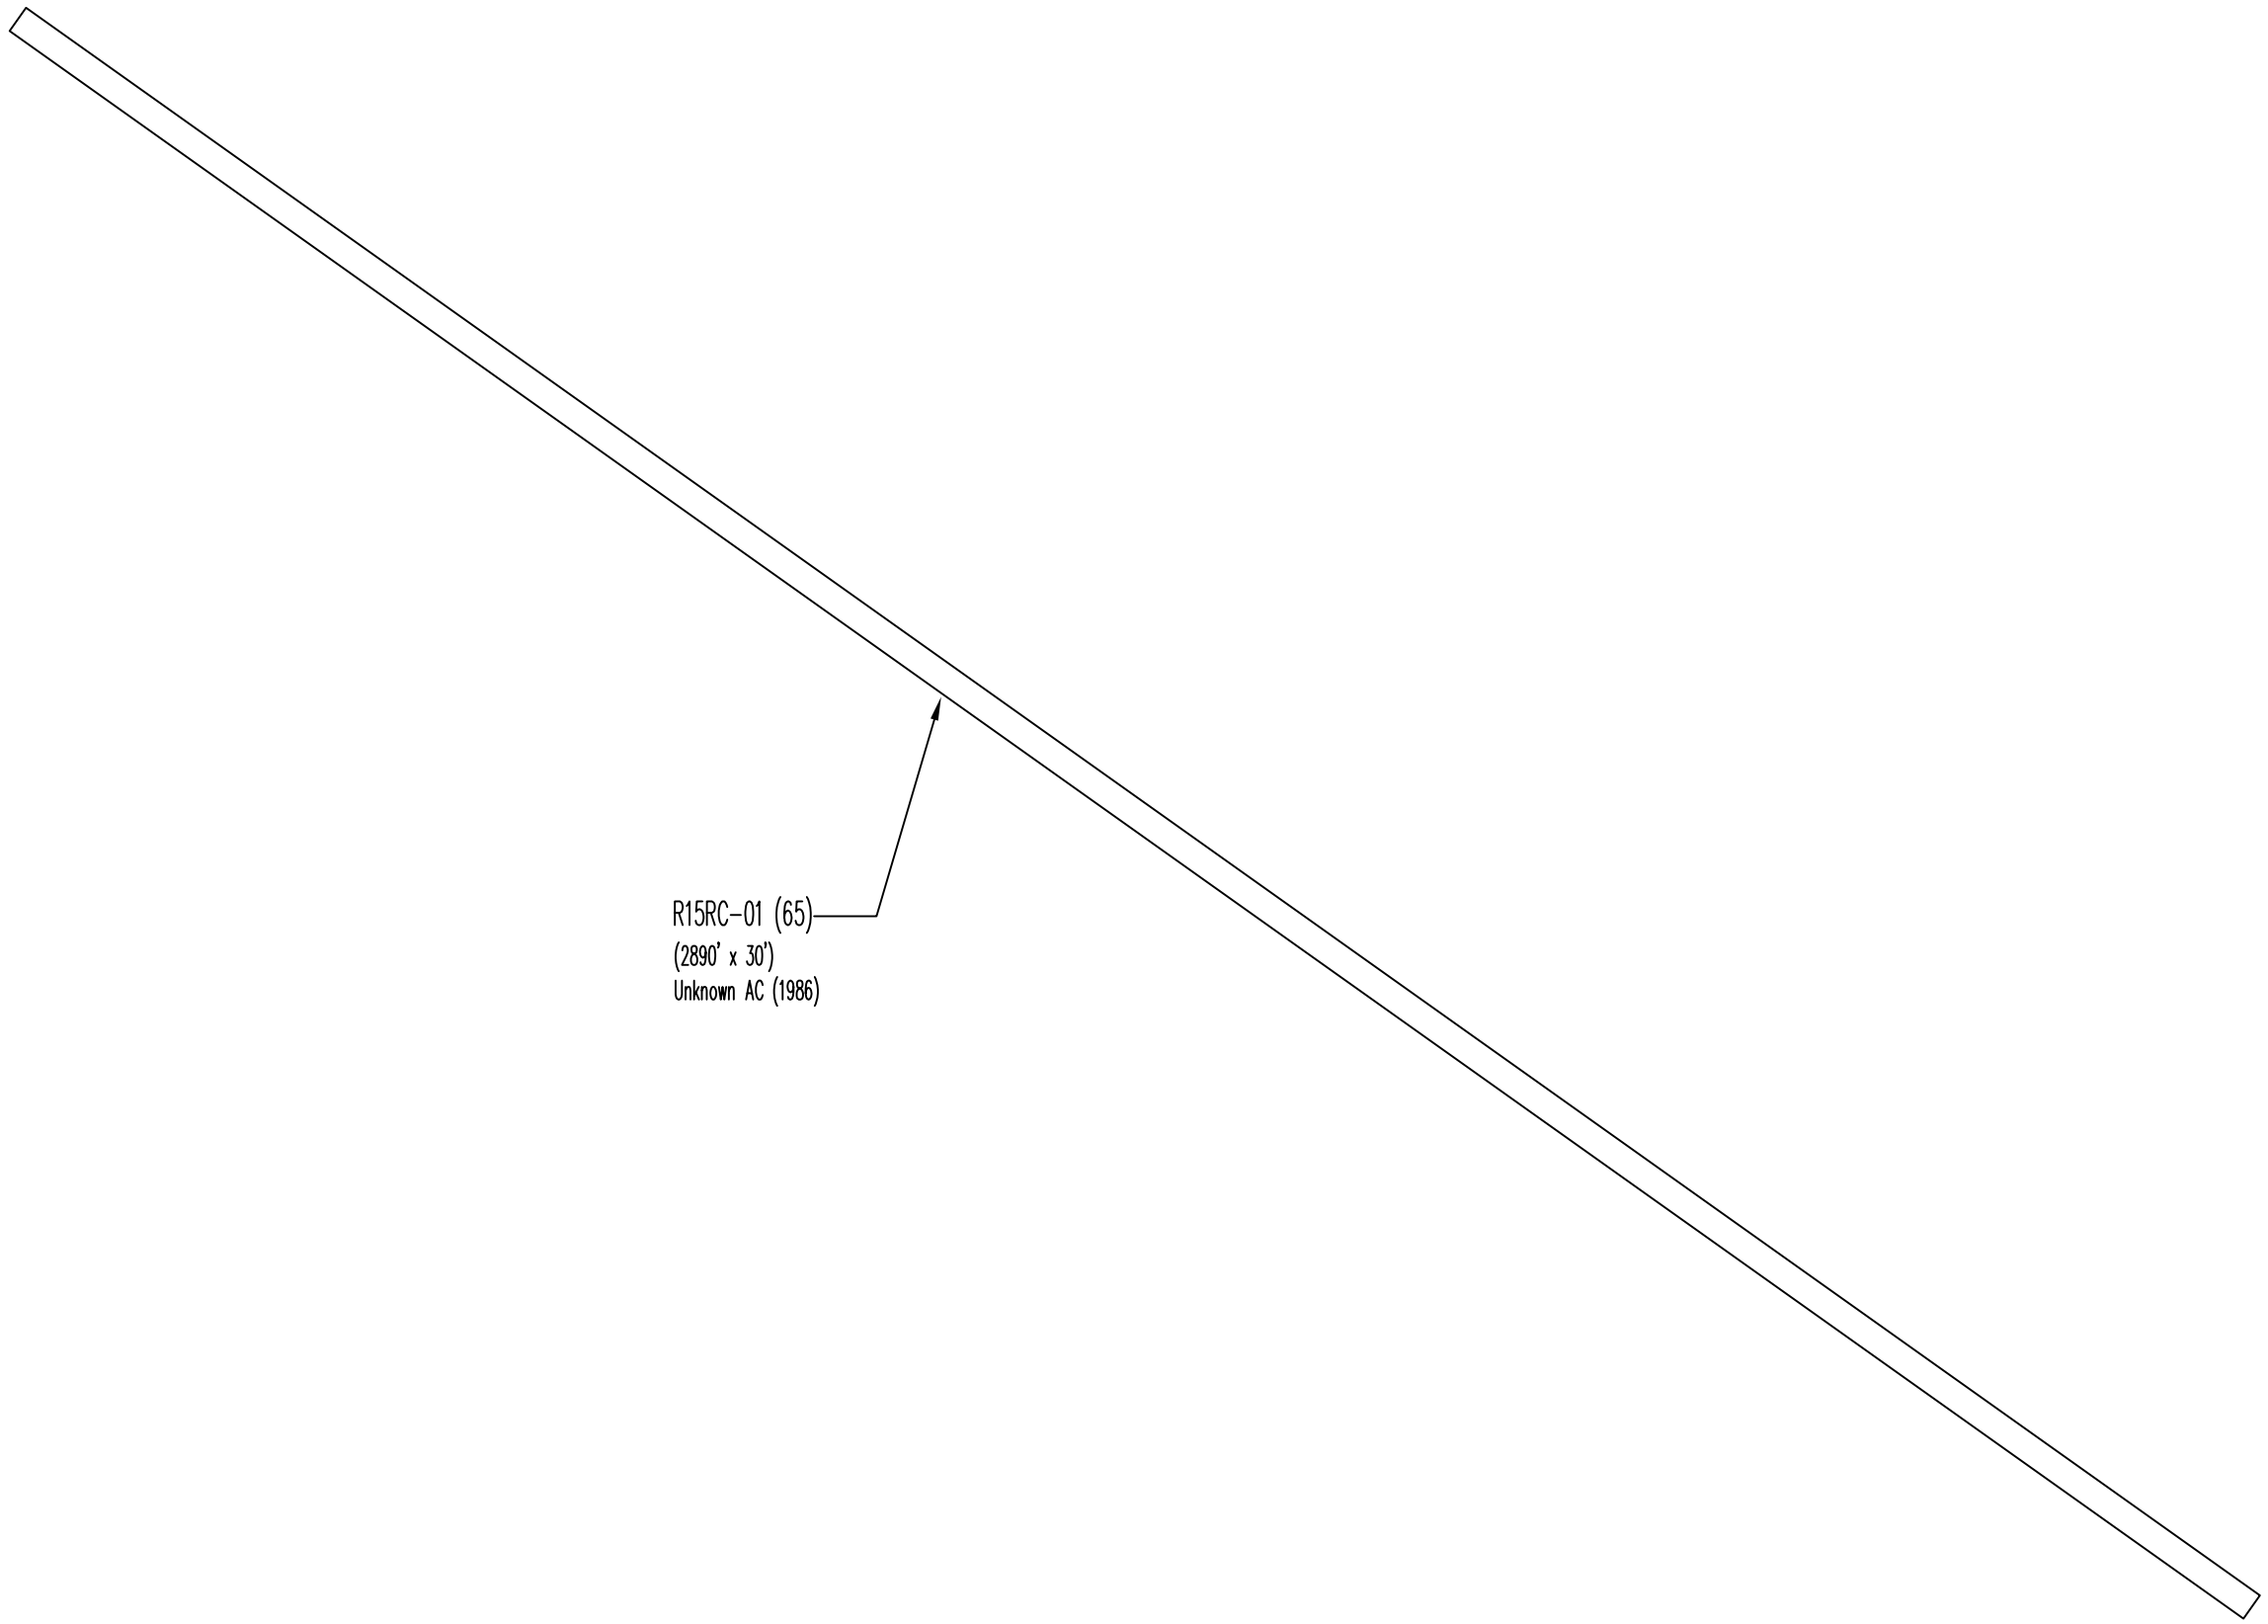
Figure 3 presents the records review results in the form of a work history map. The Micro PAVER database (see the inside back cover of this report) contains detailed inventory information about the pavement system at the airport.

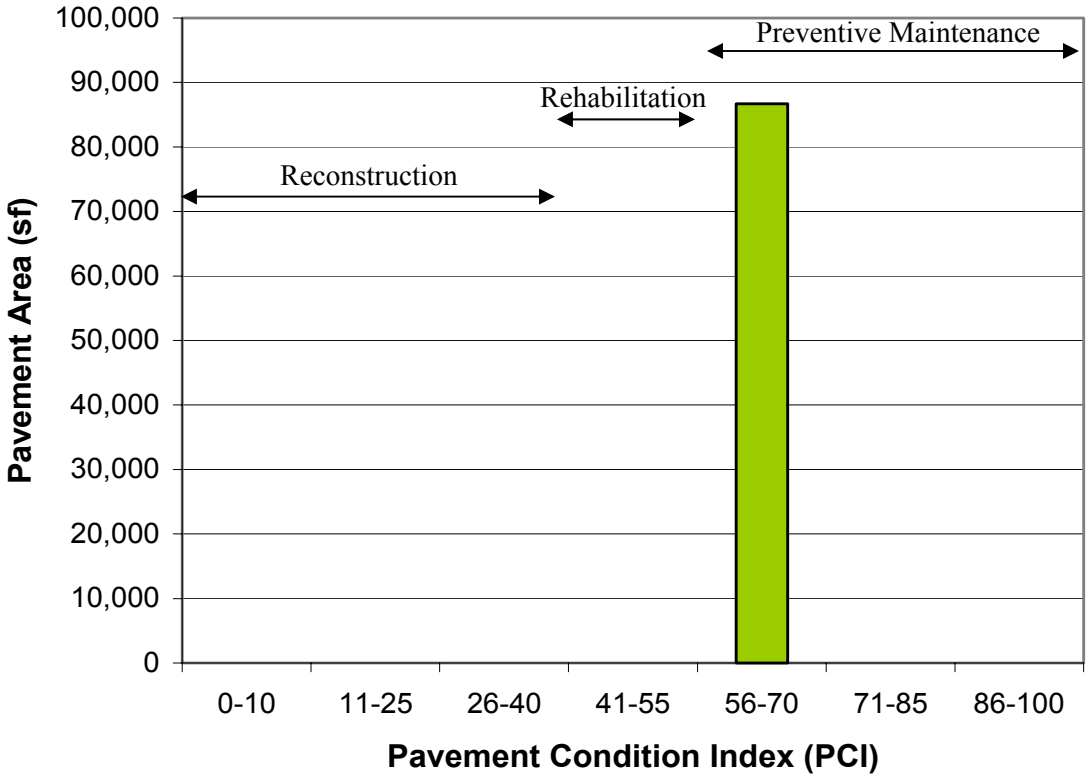
Figure 6. Ranger Creek State Airport overall condition.

The pavements at Ranger Creek State Airport were inspected on June 18, 2005. The 2005 area-weighted condition of Ranger Creek State Airport is 65.

Figures 6 and 7 summarize the overall condition of the pavements at the Ranger Creek State Airport. Figure 8 displays the condition of the pavements evaluated. Table 1 summarizes the results of the pavement evaluation. Appendix C presents photographs taken during the PCI inspection and Appendix D details the distresses observed during the visual survey.

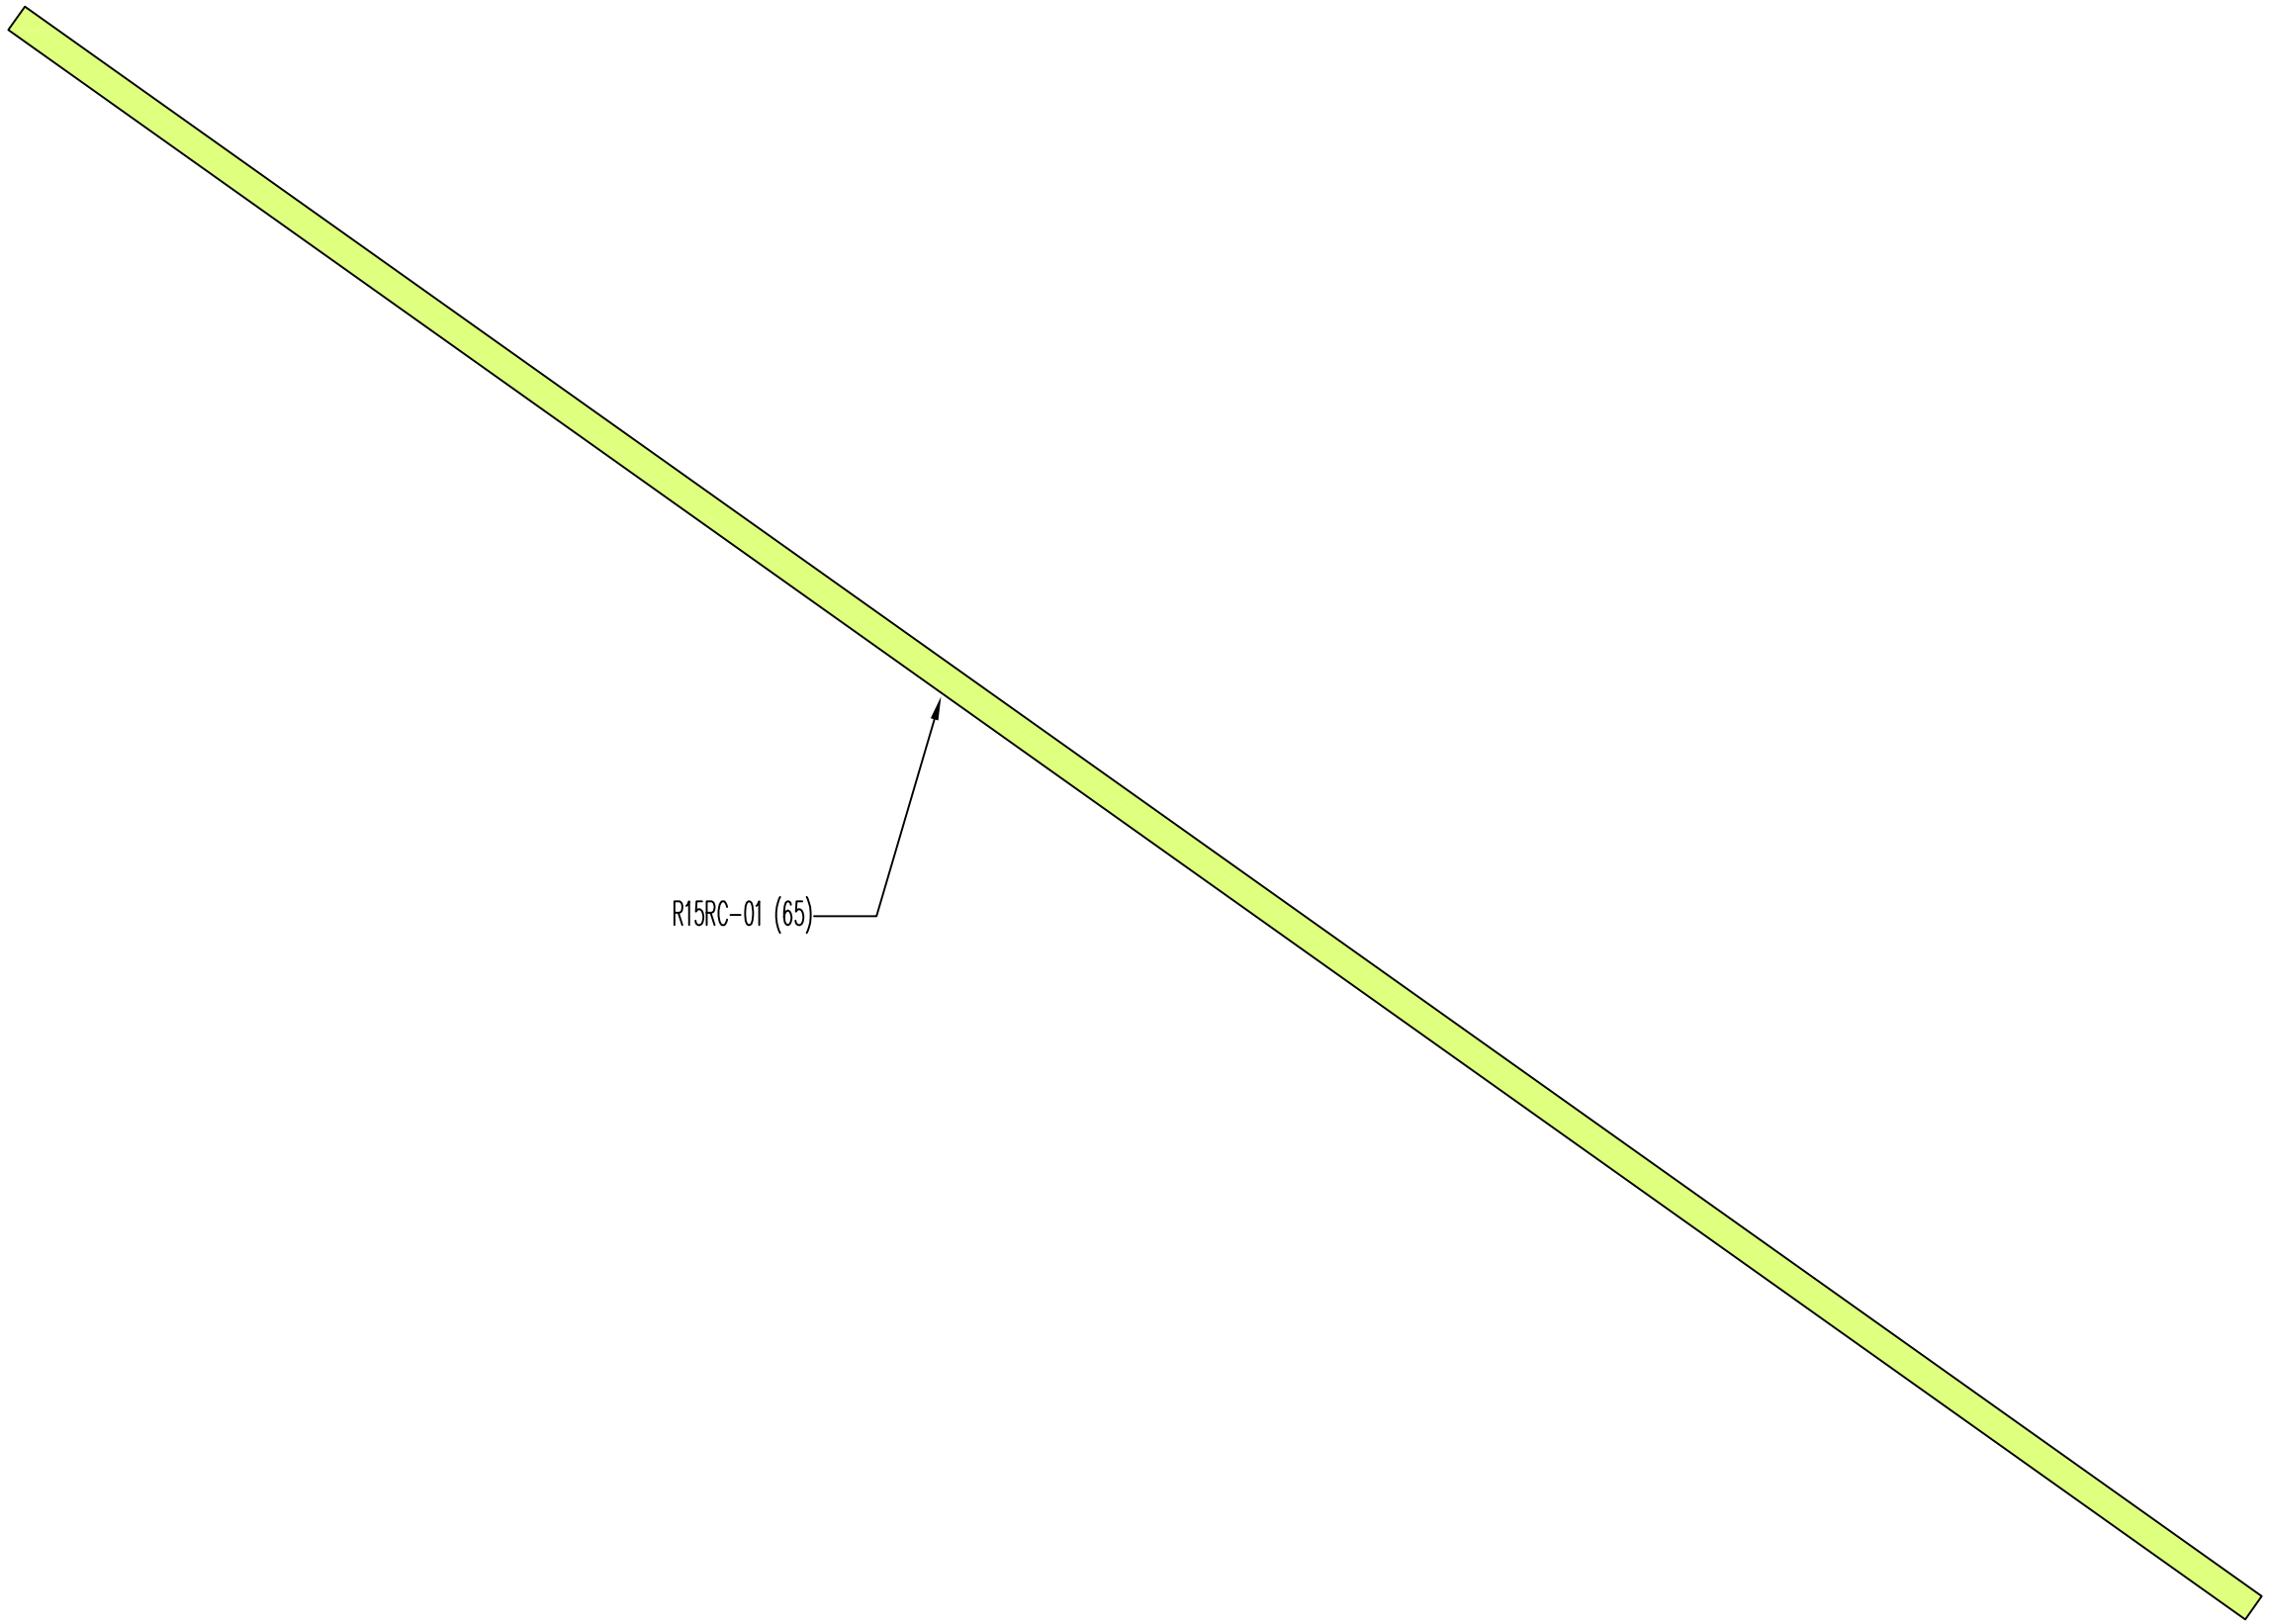
LOCATION: Ranger Creek State Airport, Greenwater, Washington			
PAGE TITLE: 2005 Pavement Condition Index Map			
DRAWING SCALE: 1" = 200'	DATE: February 2006	REVISED BY: MK	DRAWN BY: MK
FILENAME: Greenwater.dwg	AIRPORT ID: 6WA8	LAYOUT NAME/NUMBER: Greenwater (PCI)	PAGE NUMBER: 9

Ranger Creek State Airport								
Branch[1]	Section	Surface Type[2]	Section Area, sf	LCD[3]	2005 PCI	% Distress Due to:		Distress Types
						Load[4]	Climate or Durability[5]	
R15RC	01	AC	86,700	9/1/1986	65	78	20	Alligator cracking, longitudinal and transverse cracking, patching, swelling, raveling and weathering

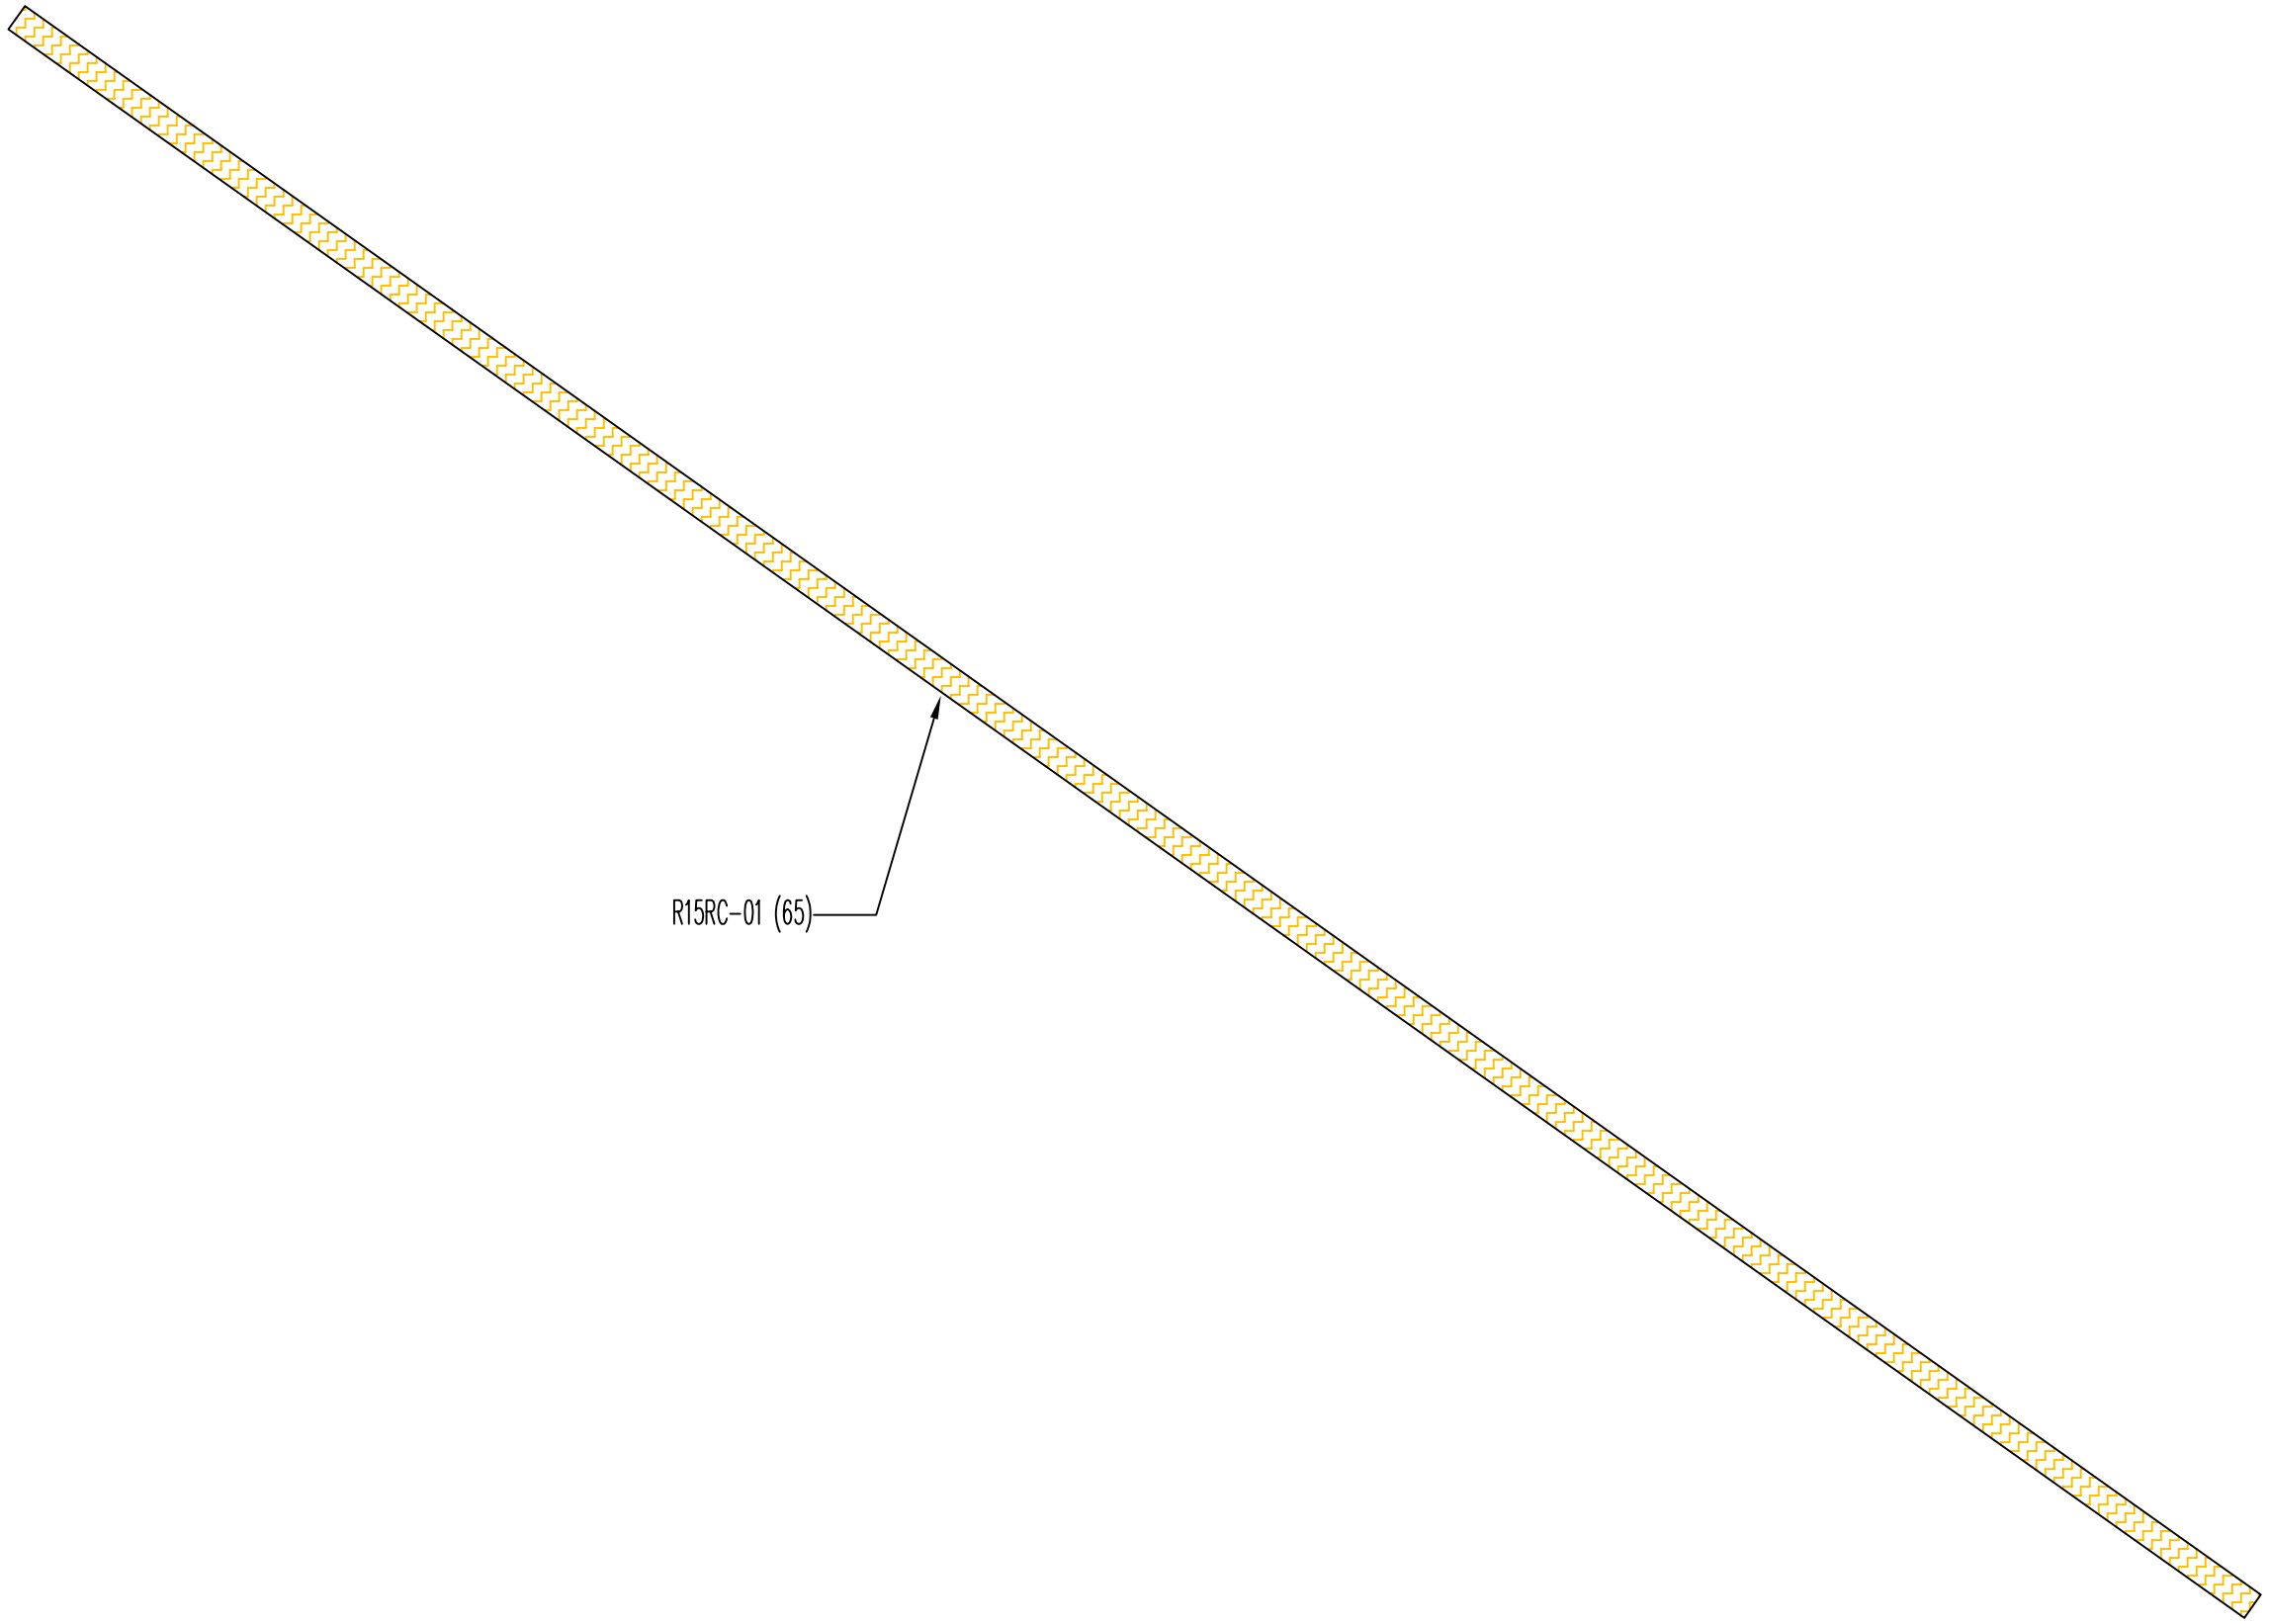
A summary of the pavement repair program for Ranger Creek State Airport is presented in Table 4 and in Figure 9. Detailed information on the localized maintenance plan for 2006 is contained in Appendix F.

REPAIR YEAR	REPAIR TYPE
2006	FOG SEAL
2007	SLURRY SEAL
2008	REHABILITATION
2009	RECONSTRUCTION
2010	
2011	
2012
