WILLIAM R. FAIRCHILD INTERNATIONAL AIRPORT 2005 PAVEMENT MANAGEMENT REPORT

February 2006

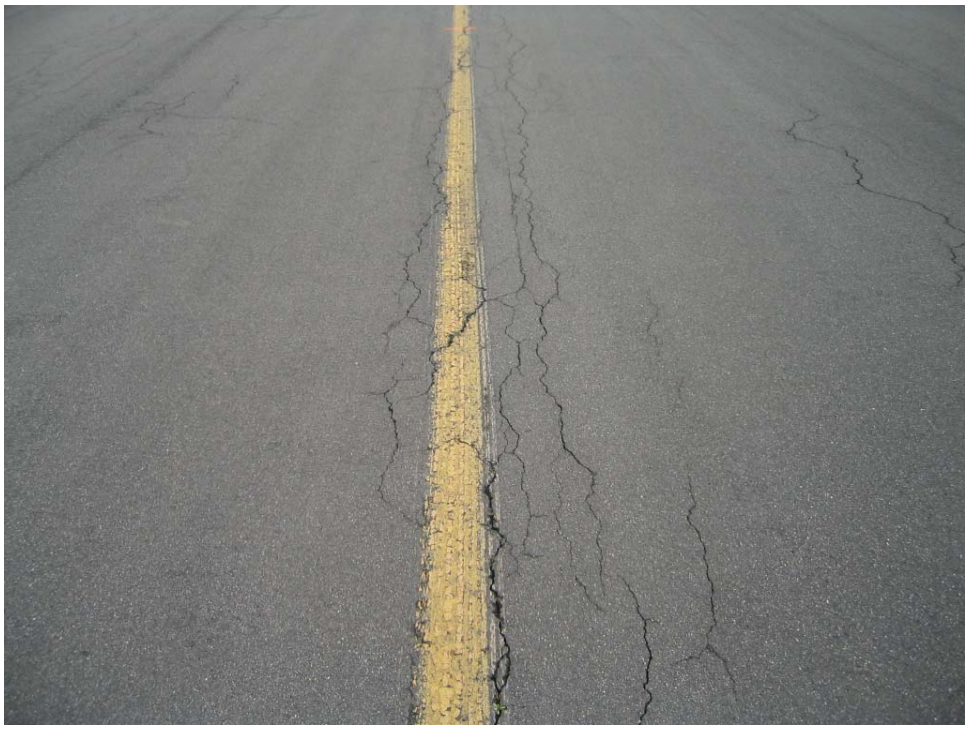
TAPO-03. Alligator cracking.
