CHELAN MUNICIPAL AIRPORT
2005 PAVEMENT MANAGEMENT REPORT

February 2006

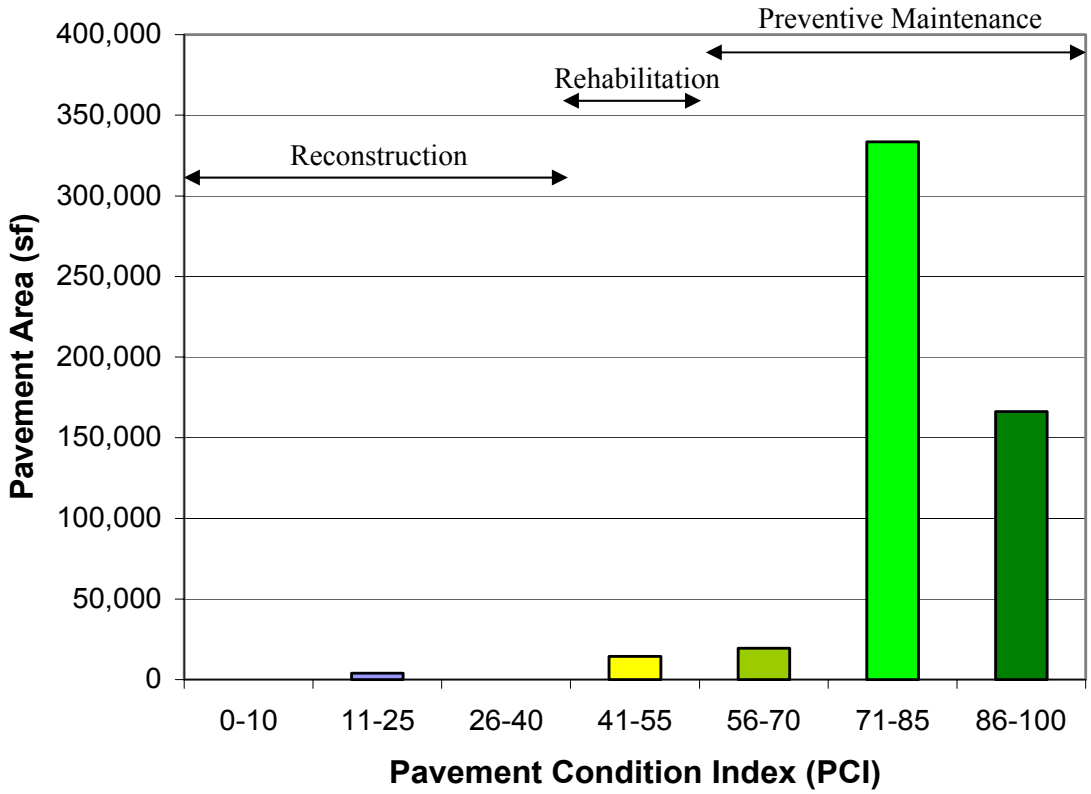
Figure 6. Chelan Municipal Airport overall condition.

The pavements at Chelan Municipal Airport were inspected on June 7, 2005. The 2005 area-weighted condition of Chelan Municipal Airport is 80, with conditions ranging from 15 to 100 (on a scale of 0 [failed] to 100 [excellent]). During the previous inspection in 1999, the area-weighted condition was 83.

Figures 6 and 7 summarize the overall condition of the pavements at the Chelan Municipal Airport. Figure 8 displays the condition of the pavements evaluated. Table 1 summarizes the results of the pavement evaluation. Appendix C presents photographs taken during the PCI inspection and Appendix D details the distresses observed during the visual survey.

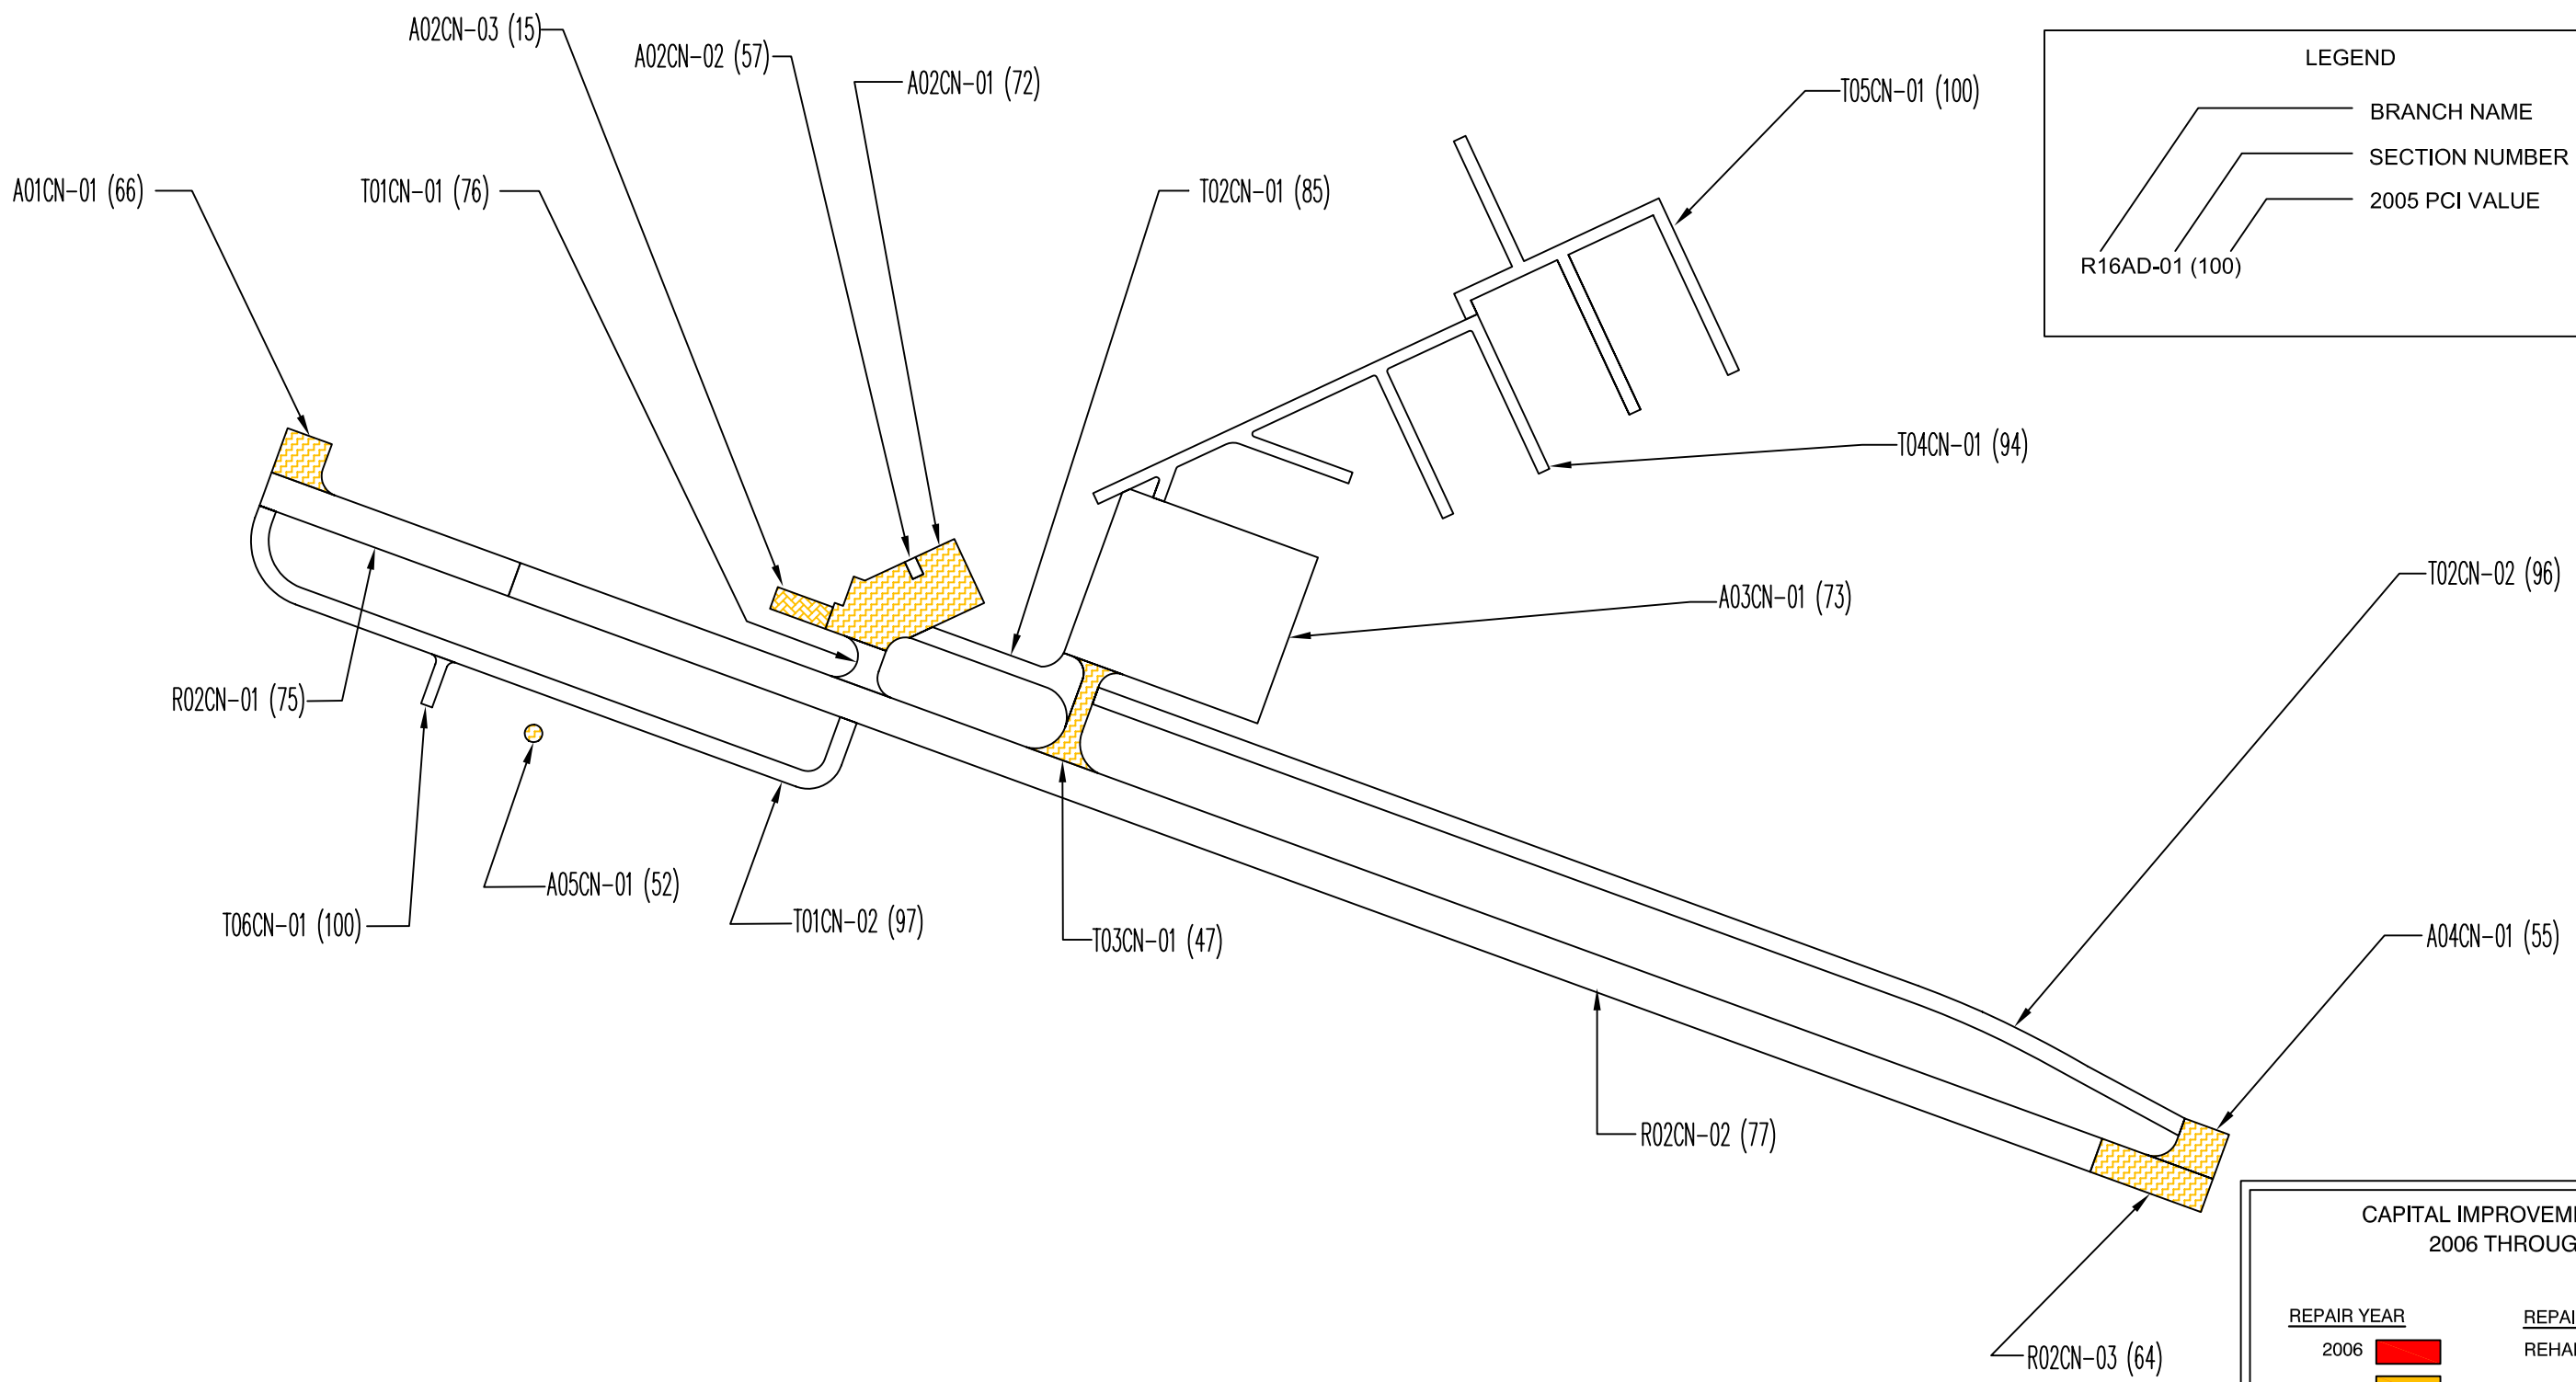
A summary of the pavement repair program for Chelan Municipal Airport is presented in Table 4 and in Figure 9. Detailed information on the localized maintenance plan for 2006 is contained in Appendix F.

The goal of the rehabilitation program is to maintain the pavements above established critical PCI values. Major rehabilitation was recommended for pavements in the year they dropped below their critical PCI value for 2007 through 2012. However, no major rehabilitation was recommended for 2006 unless the project is already programmed in the FAA's CIP. In situations where major rehabilitation was recommended for 2006 but the project is not in the FAA's CIP, the major rehabilitation was shifted to 2007. With the assistance of WSDOT and the FAA, some work activities were grouped into single project years and work types for economic and operational reasons. For example, if one section of a runway was triggered for work in one year and another for a different year, or if different repair types were triggered, the plan was adjusted to a single treatment year and treatment type for the runway.

For 2006, a localized preventive maintenance plan was developed for those pavement sections that were above their critical PCI value. If major rehabilitation was triggered for a section in 2006 or 2007, then localized maintenance was not recommended for 2006. While localized preventive maintenance should be an annual undertaking at Chelan Municipal Airport, it is not possible to accurately predict the propagation of cracking and so on. The airport should budget for maintenance every year and can use the 2006 maintenance plan as a baseline for that work. As the pavements age, it can be assumed that the amount of localized maintenance required will increase.
