SEQUIM VALLEY AIRPORT
2005 PAVEMENT MANAGEMENT REPORT

February 2006

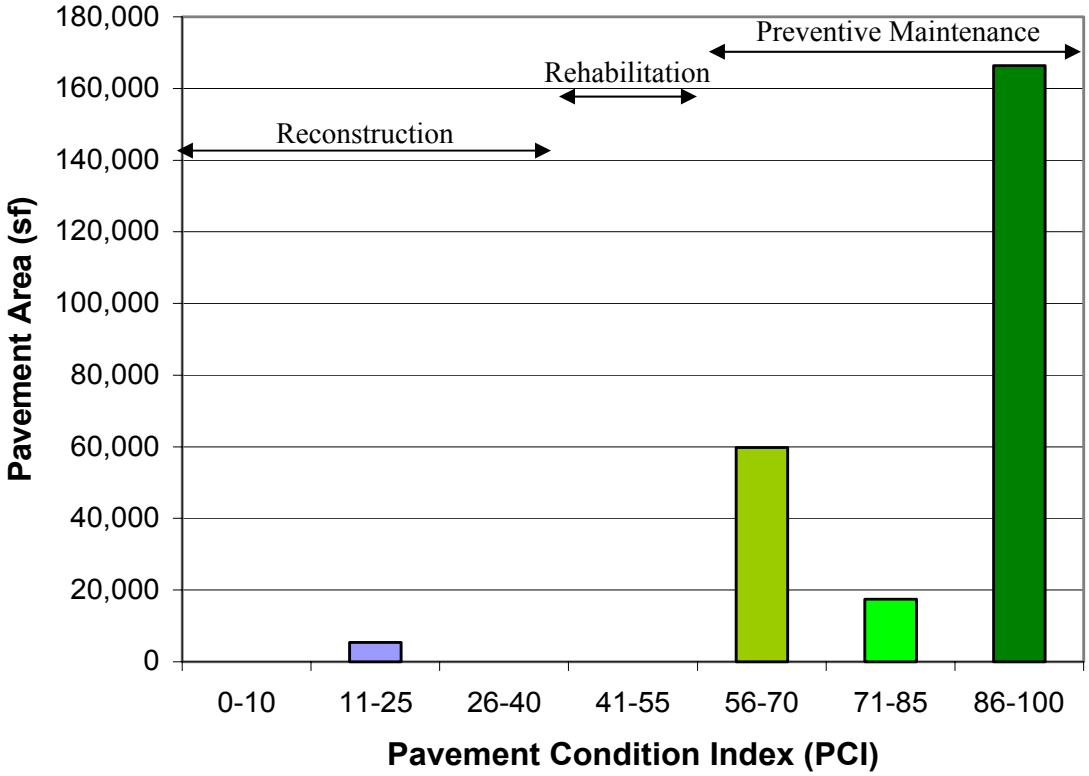
Figure 6. Sequim Valley Airport overall condition.

The pavements at Sequim Valley Airport were inspected on April 8, 2005. The 2005 area-weighted condition of Sequim Valley Airport is 87, with conditions ranging from 20 to 100 (on a scale of 0 [failed] to 100 [excellent]). During the previous inspection in 1999, the area-weighted condition was 89.

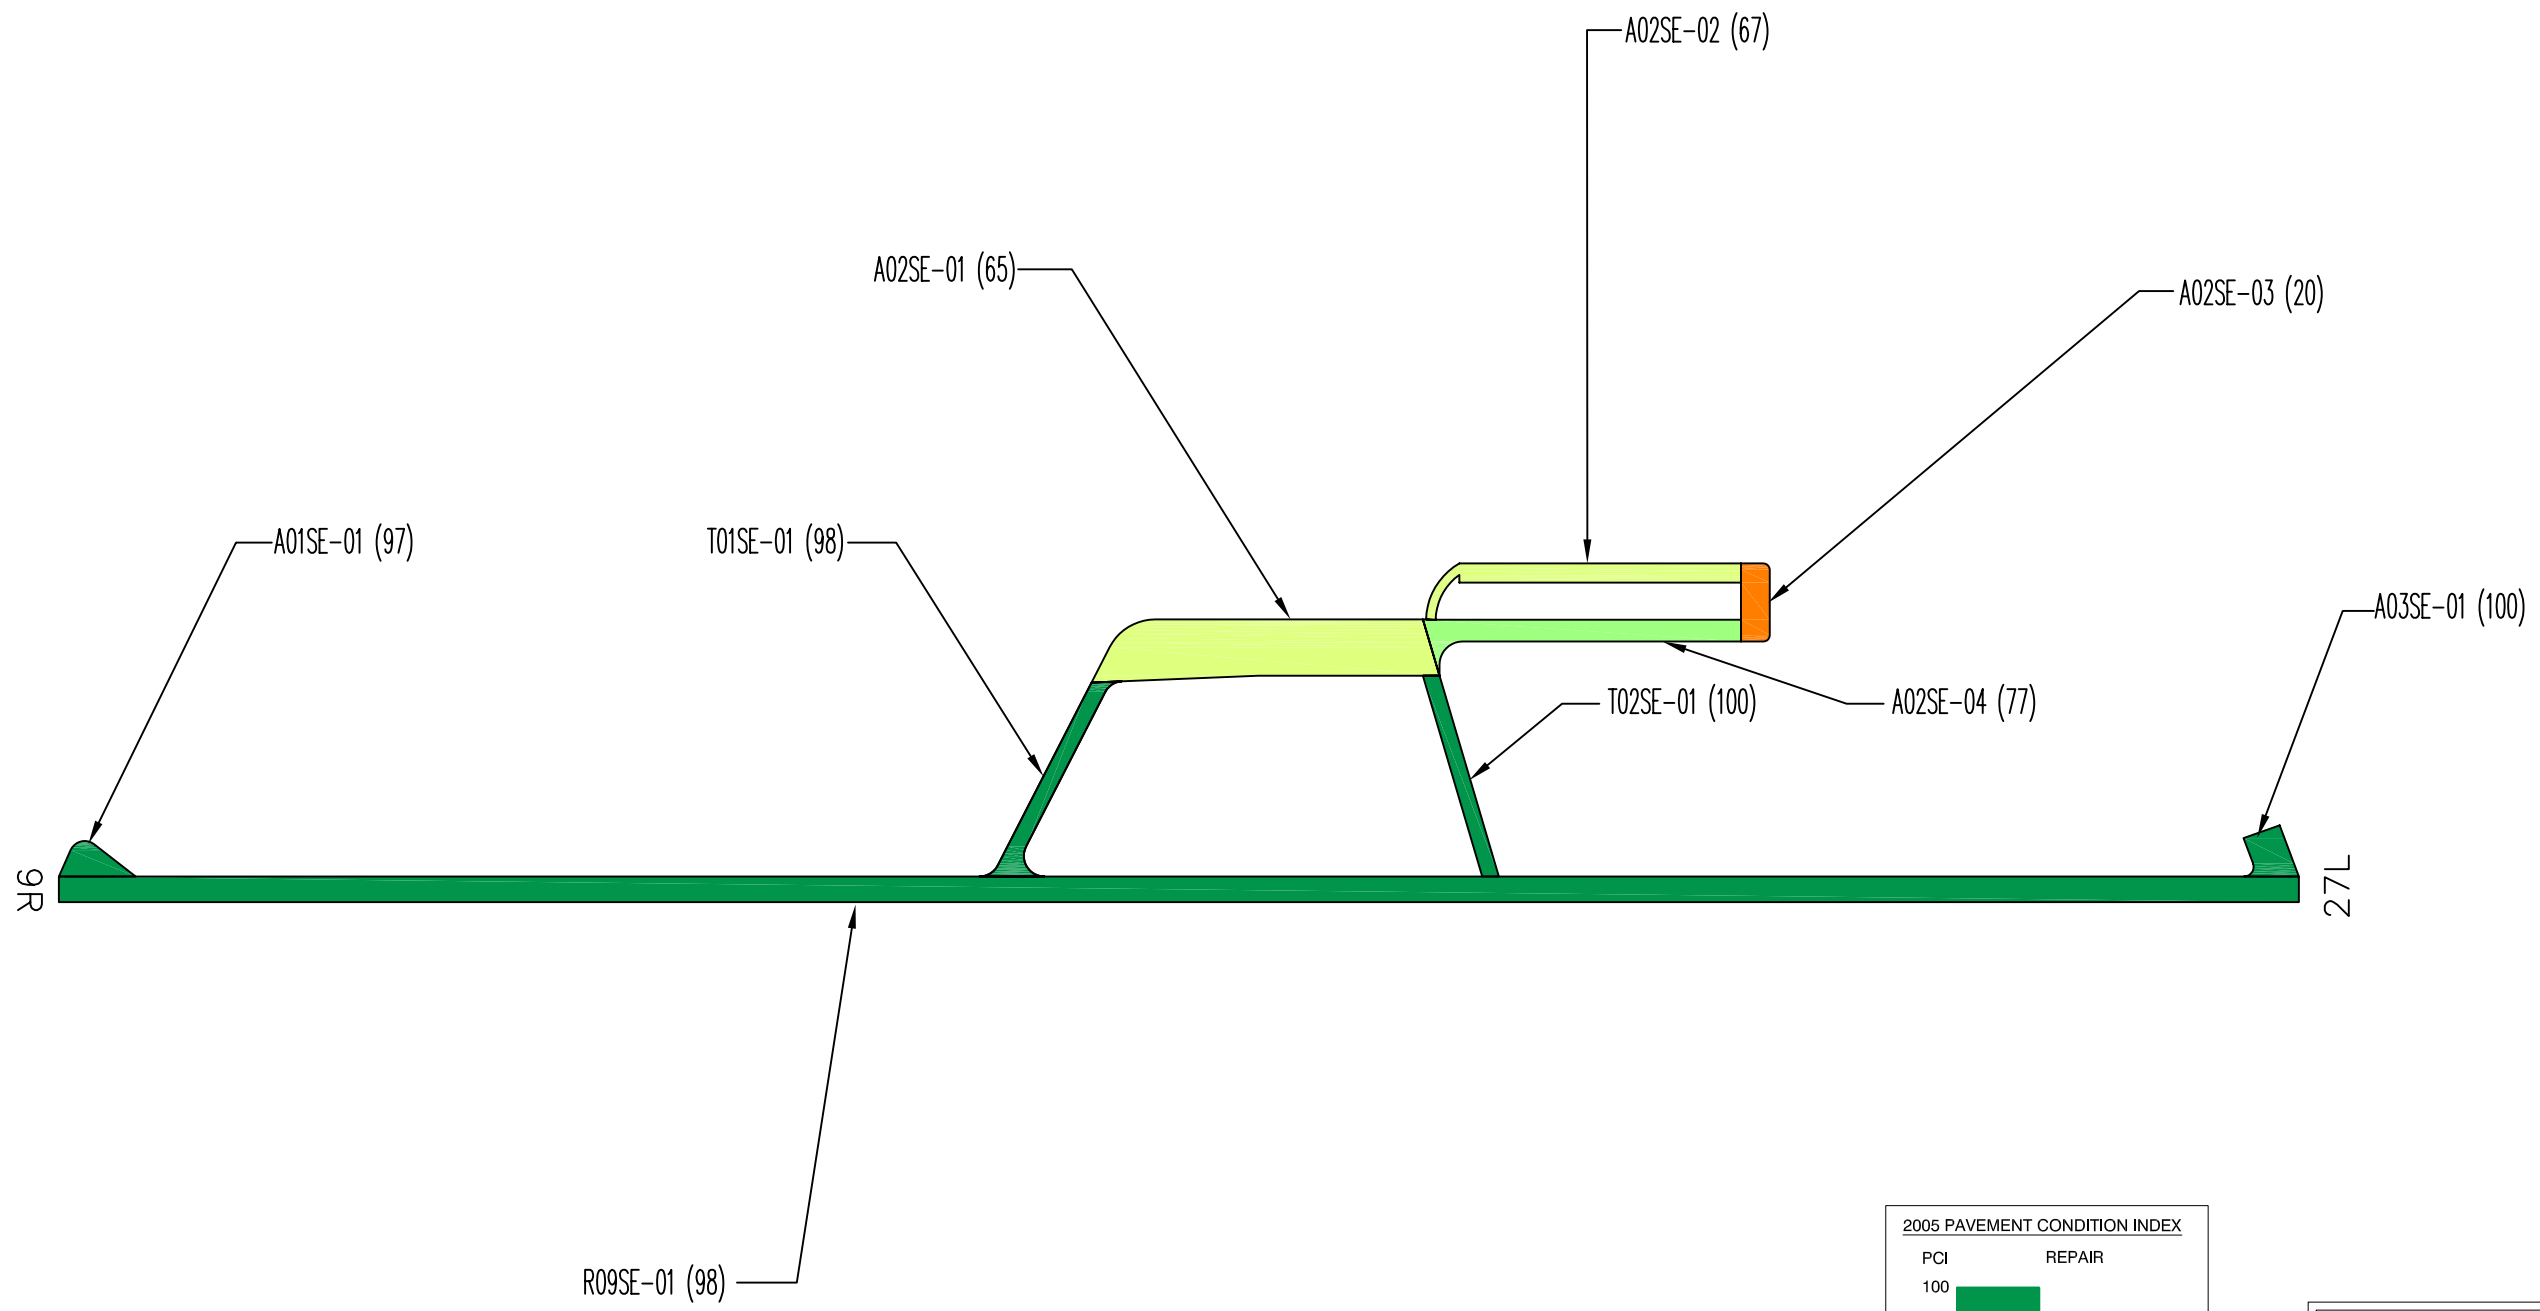
2005 PAVEMENT CONDITION INDEX

Figures 6 and 7 summarize the overall condition of the pavements at the Sequim Valley Airport. Figure 8 displays the condition of the pavements evaluated. Table 1 summarizes the results of the pavement evaluation. Appendix C presents photographs taken during the PCI inspection and Appendix D details the distresses observed during the visual survey.
