COLVILLE MUNICIPAL AIRPORT
2005 PAVEMENT MANAGEMENT REPORT

February 2006

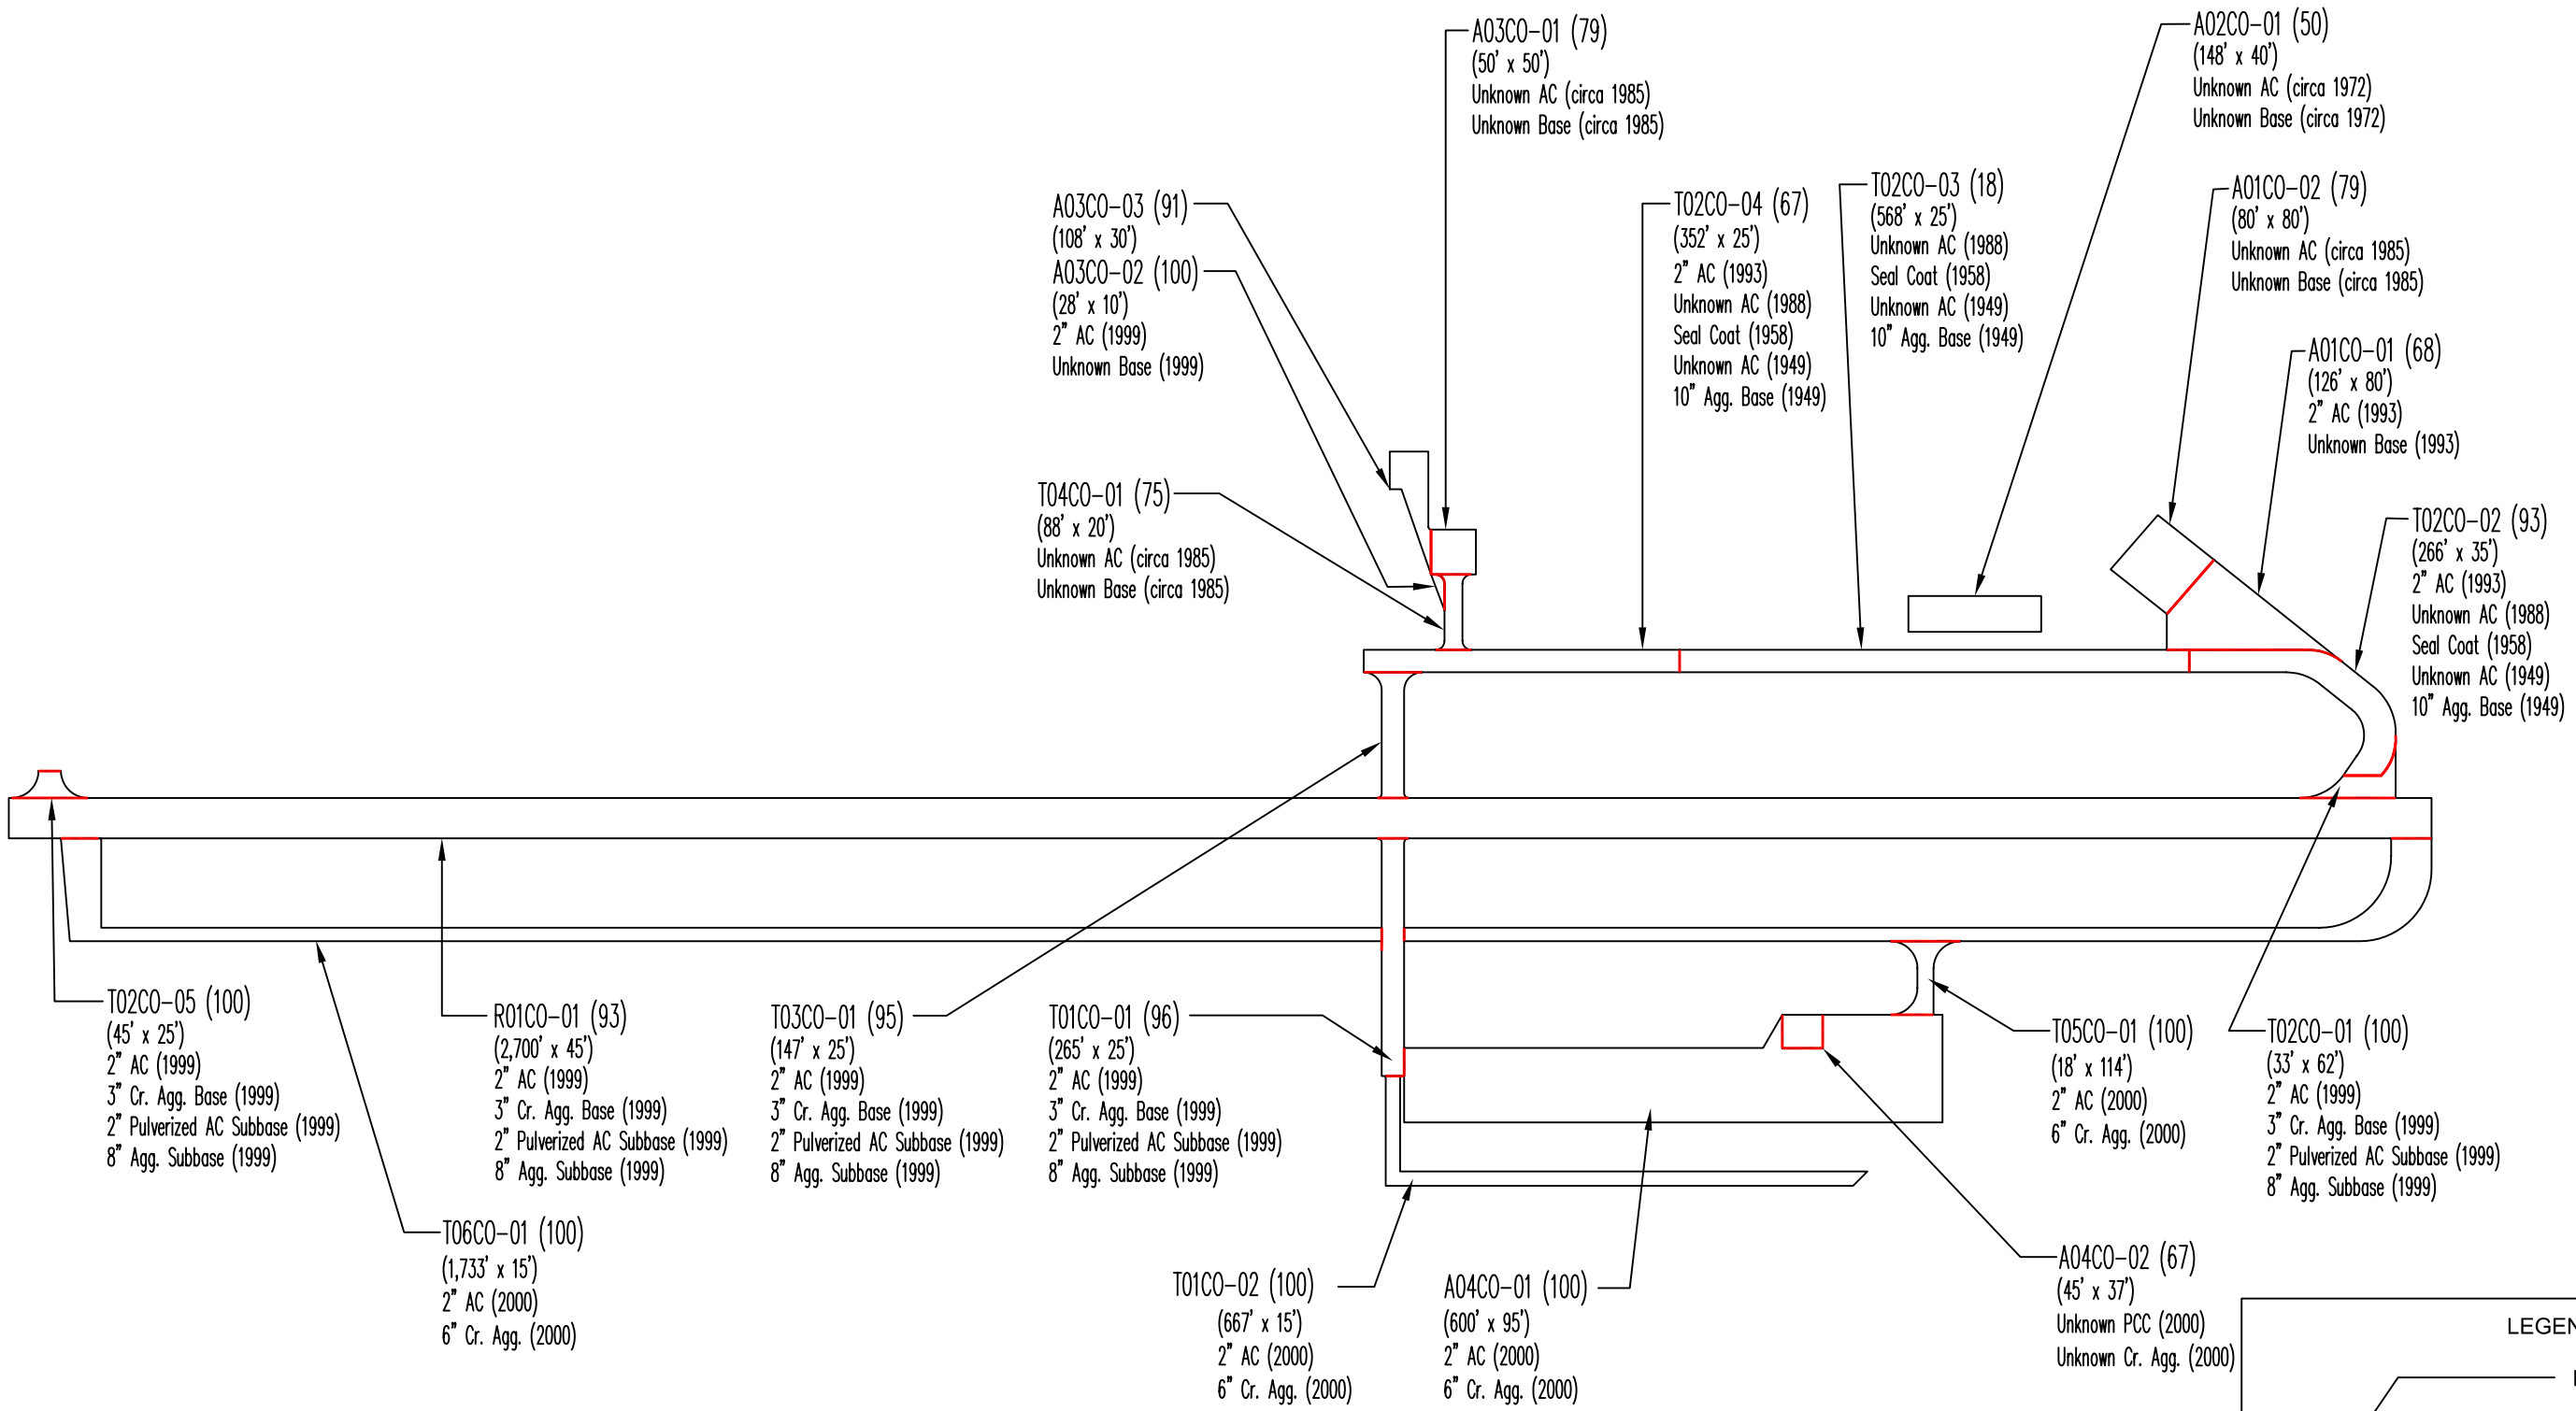
LOCATION: Colville Municipal Airport, Colville, Washington			
PAGE TITLE: 2005 Work History Map			
DRAWING SCALE: 1" = 200'	DATE: February 2006	REVISED BY: AM	DRAWN BY: AM
FILENAME: Colville.dwg	AIRPORT ID: 63S	LAYOUT NAME/NUMBER: Colville (WH)	PAGE NUMBER: 4

Figure 3 presents the records review results in the form of a work history map. The Micro PAVER database (see the inside back cover of this report) contains detailed inventory information about the pavement system at the airport.

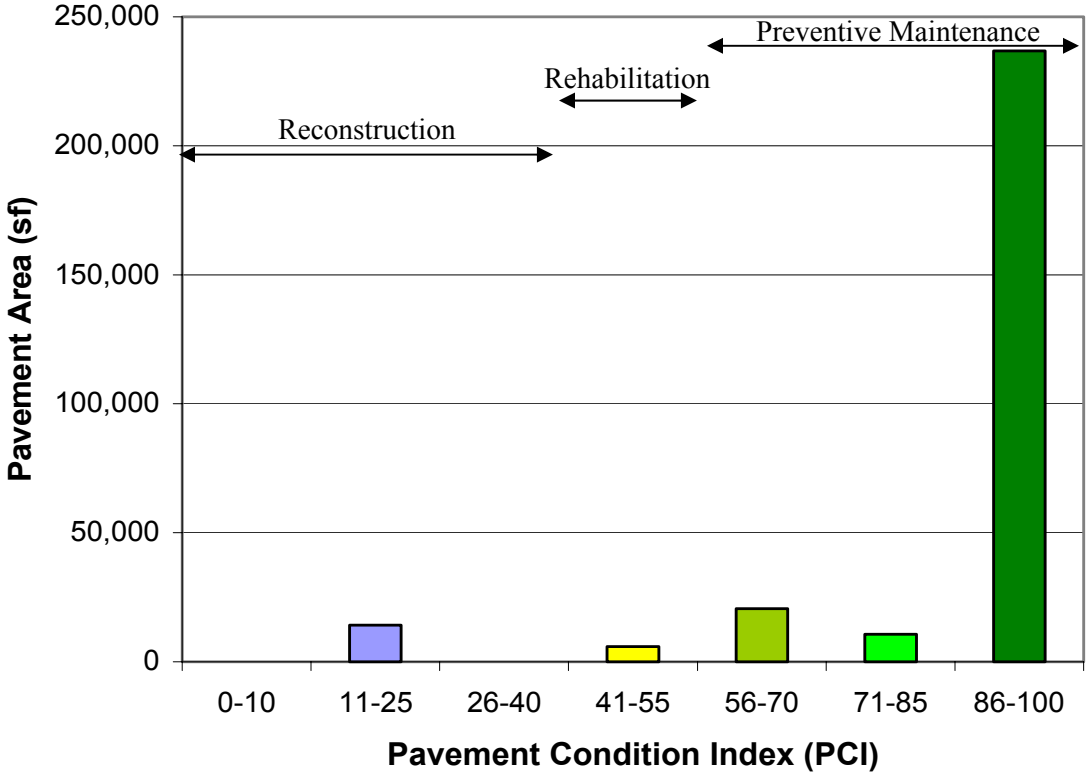
The pavements at Colville Municipal Airport were inspected on June 17, 2005. The 2005 area-weighted condition of Colville Municipal Airport is 88, with conditions ranging from 18 to 100 (on a scale of 0 [failed] to 100 [excellent]). During the previous inspection in 1999, the area-weighted condition was 78.

Figure 6. Colville Municipal Airport overall condition.

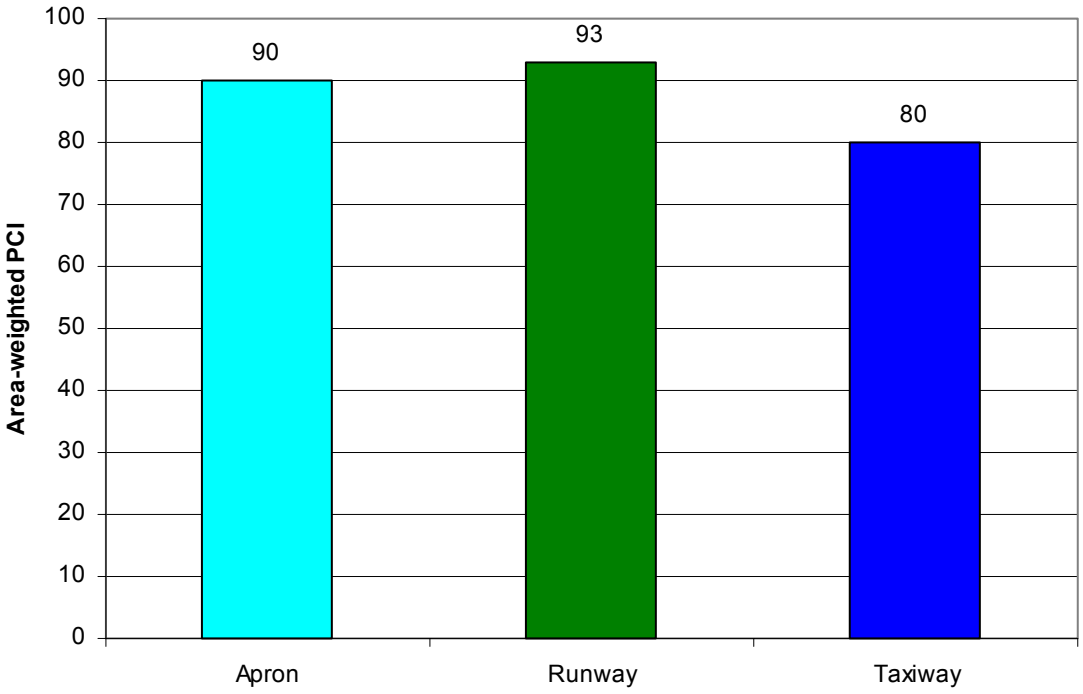
Figure 7. Colville Municipal Airport area-weighted PCI by use.

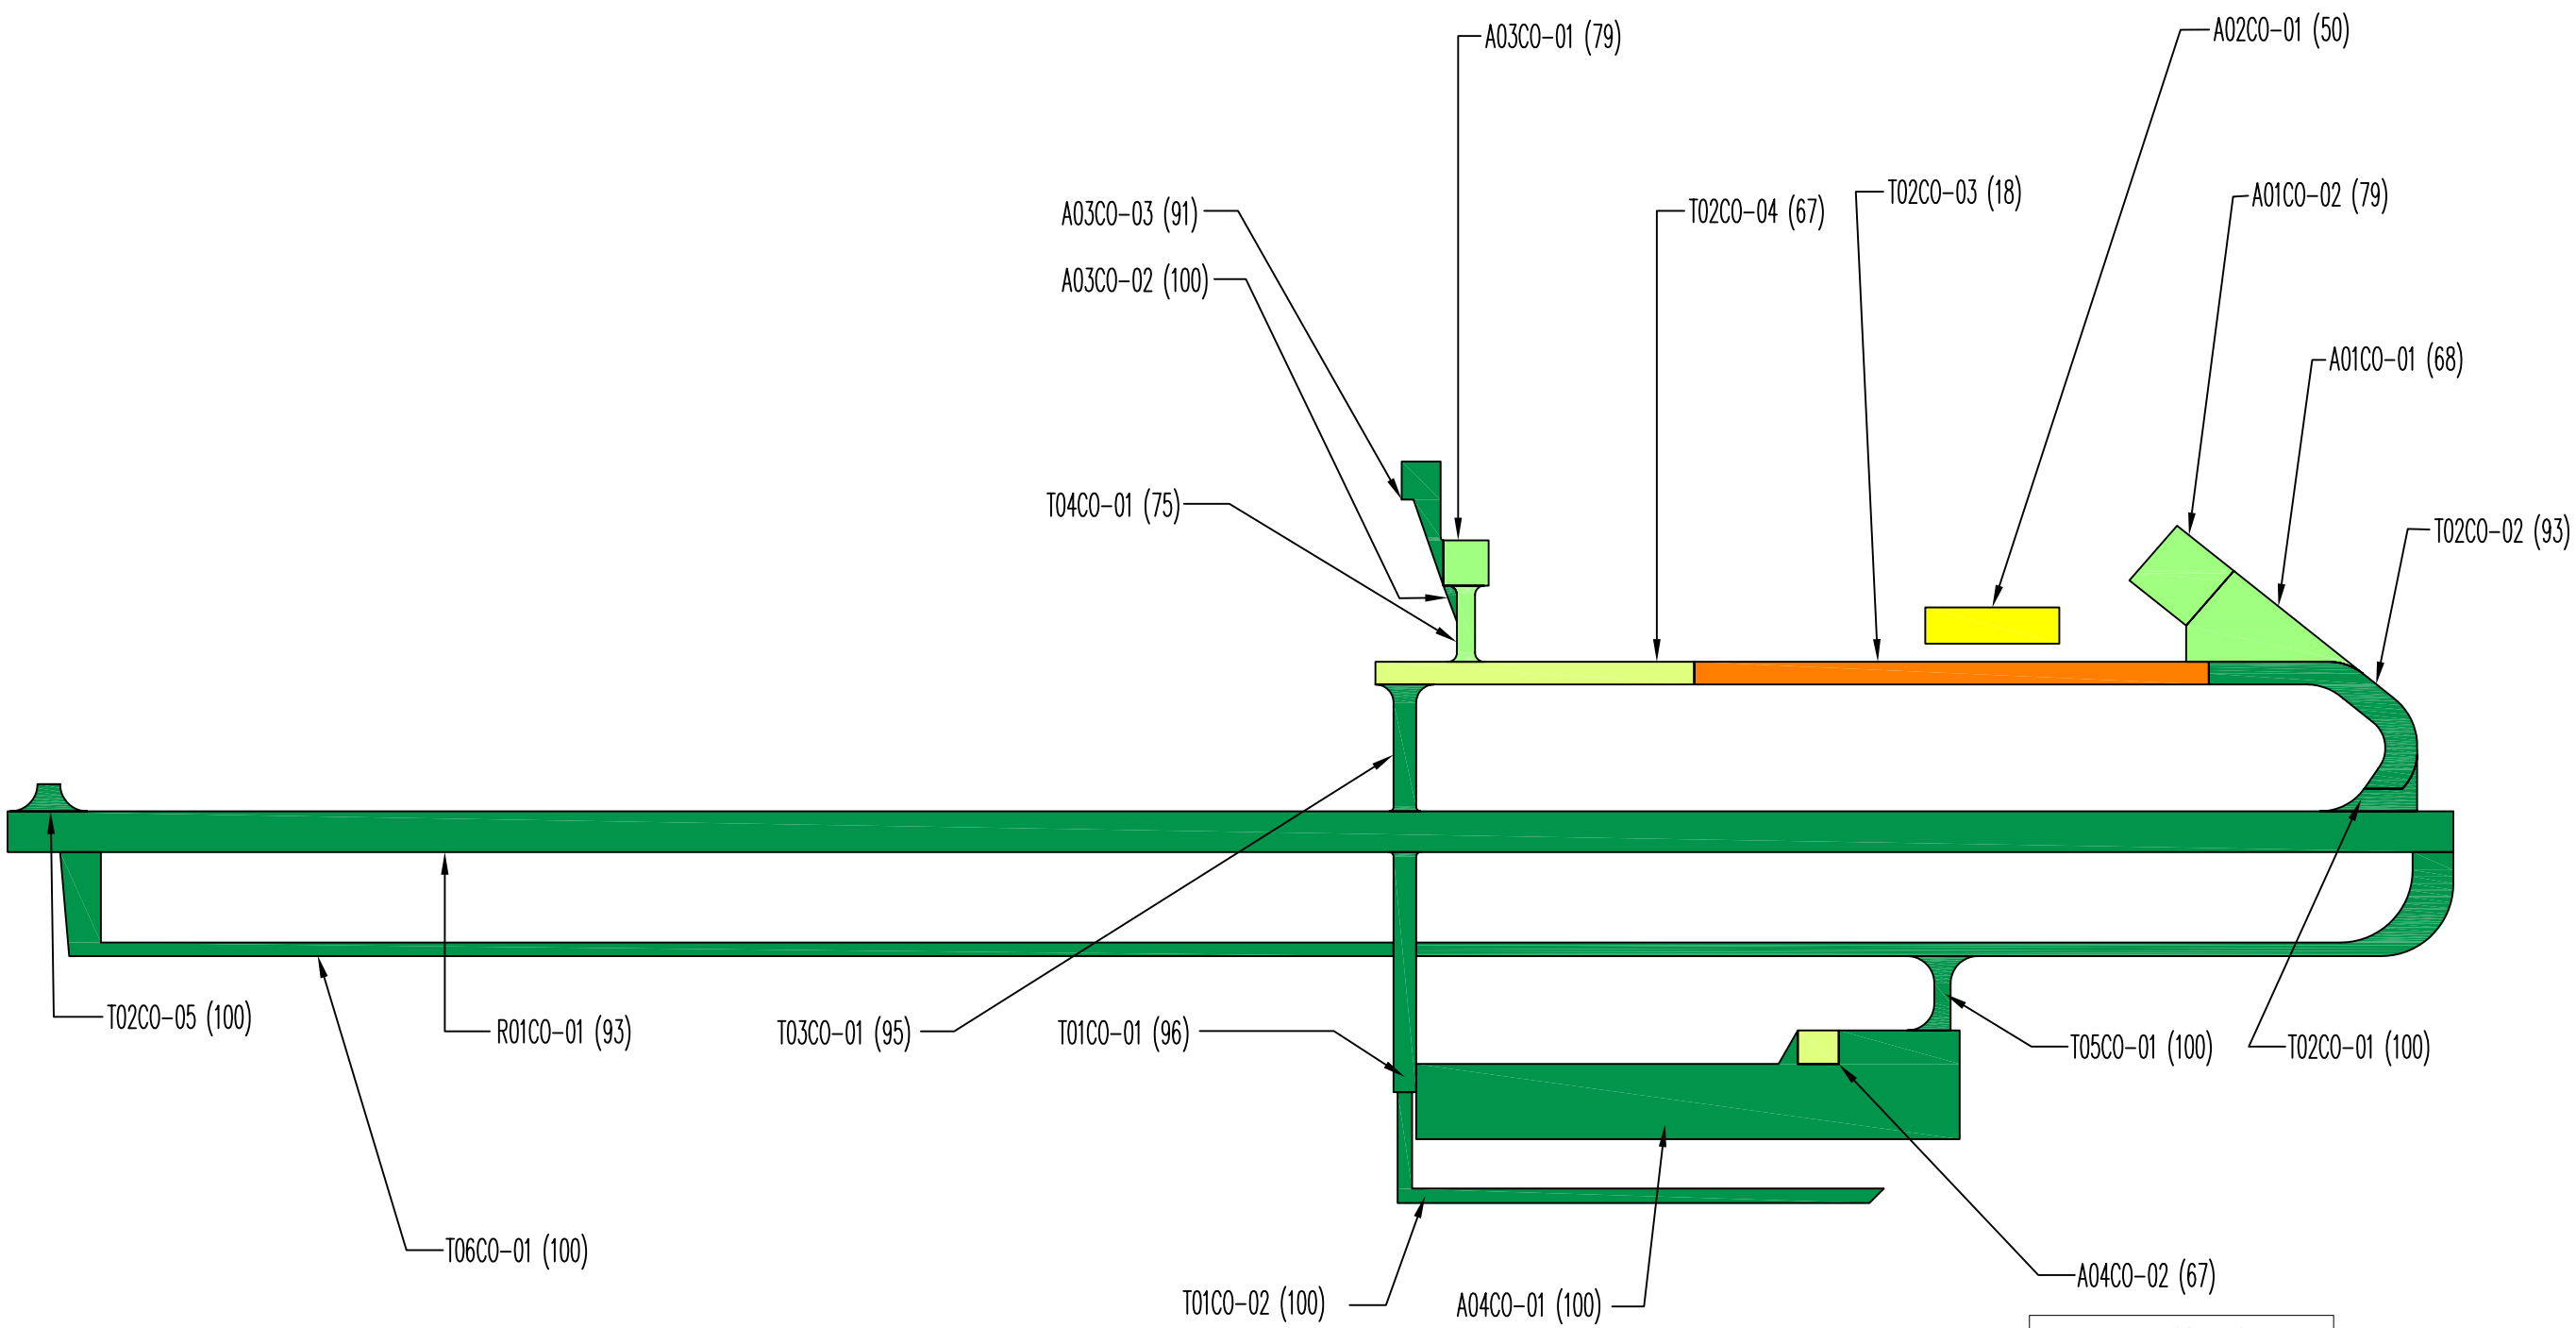
Figures 6 and 7 summarize the overall condition of the pavements at the Colville Municipal Airport. Figure 8 displays the condition of the pavements evaluated. Table 1 summarizes the results of the pavement evaluation. Appendix C presents photographs taken during the PCI inspection and Appendix D details the distresses observed during the visual survey.

LOCATION: Colville Municipal Airport, Colville, Washington			
PAGE TITLE: 2005 Pavement Condition Index Map			
DRAWING SCALE: 1" = 200'	DATE: February 2006	REVISED BY: AM	DRAWN BY: AM
FILENAME: Colville.dwg	AIRPORT ID: 63S	LAYOUT NAME/NUMBER: Colville (PCI)	PAGE NUMBER: 9

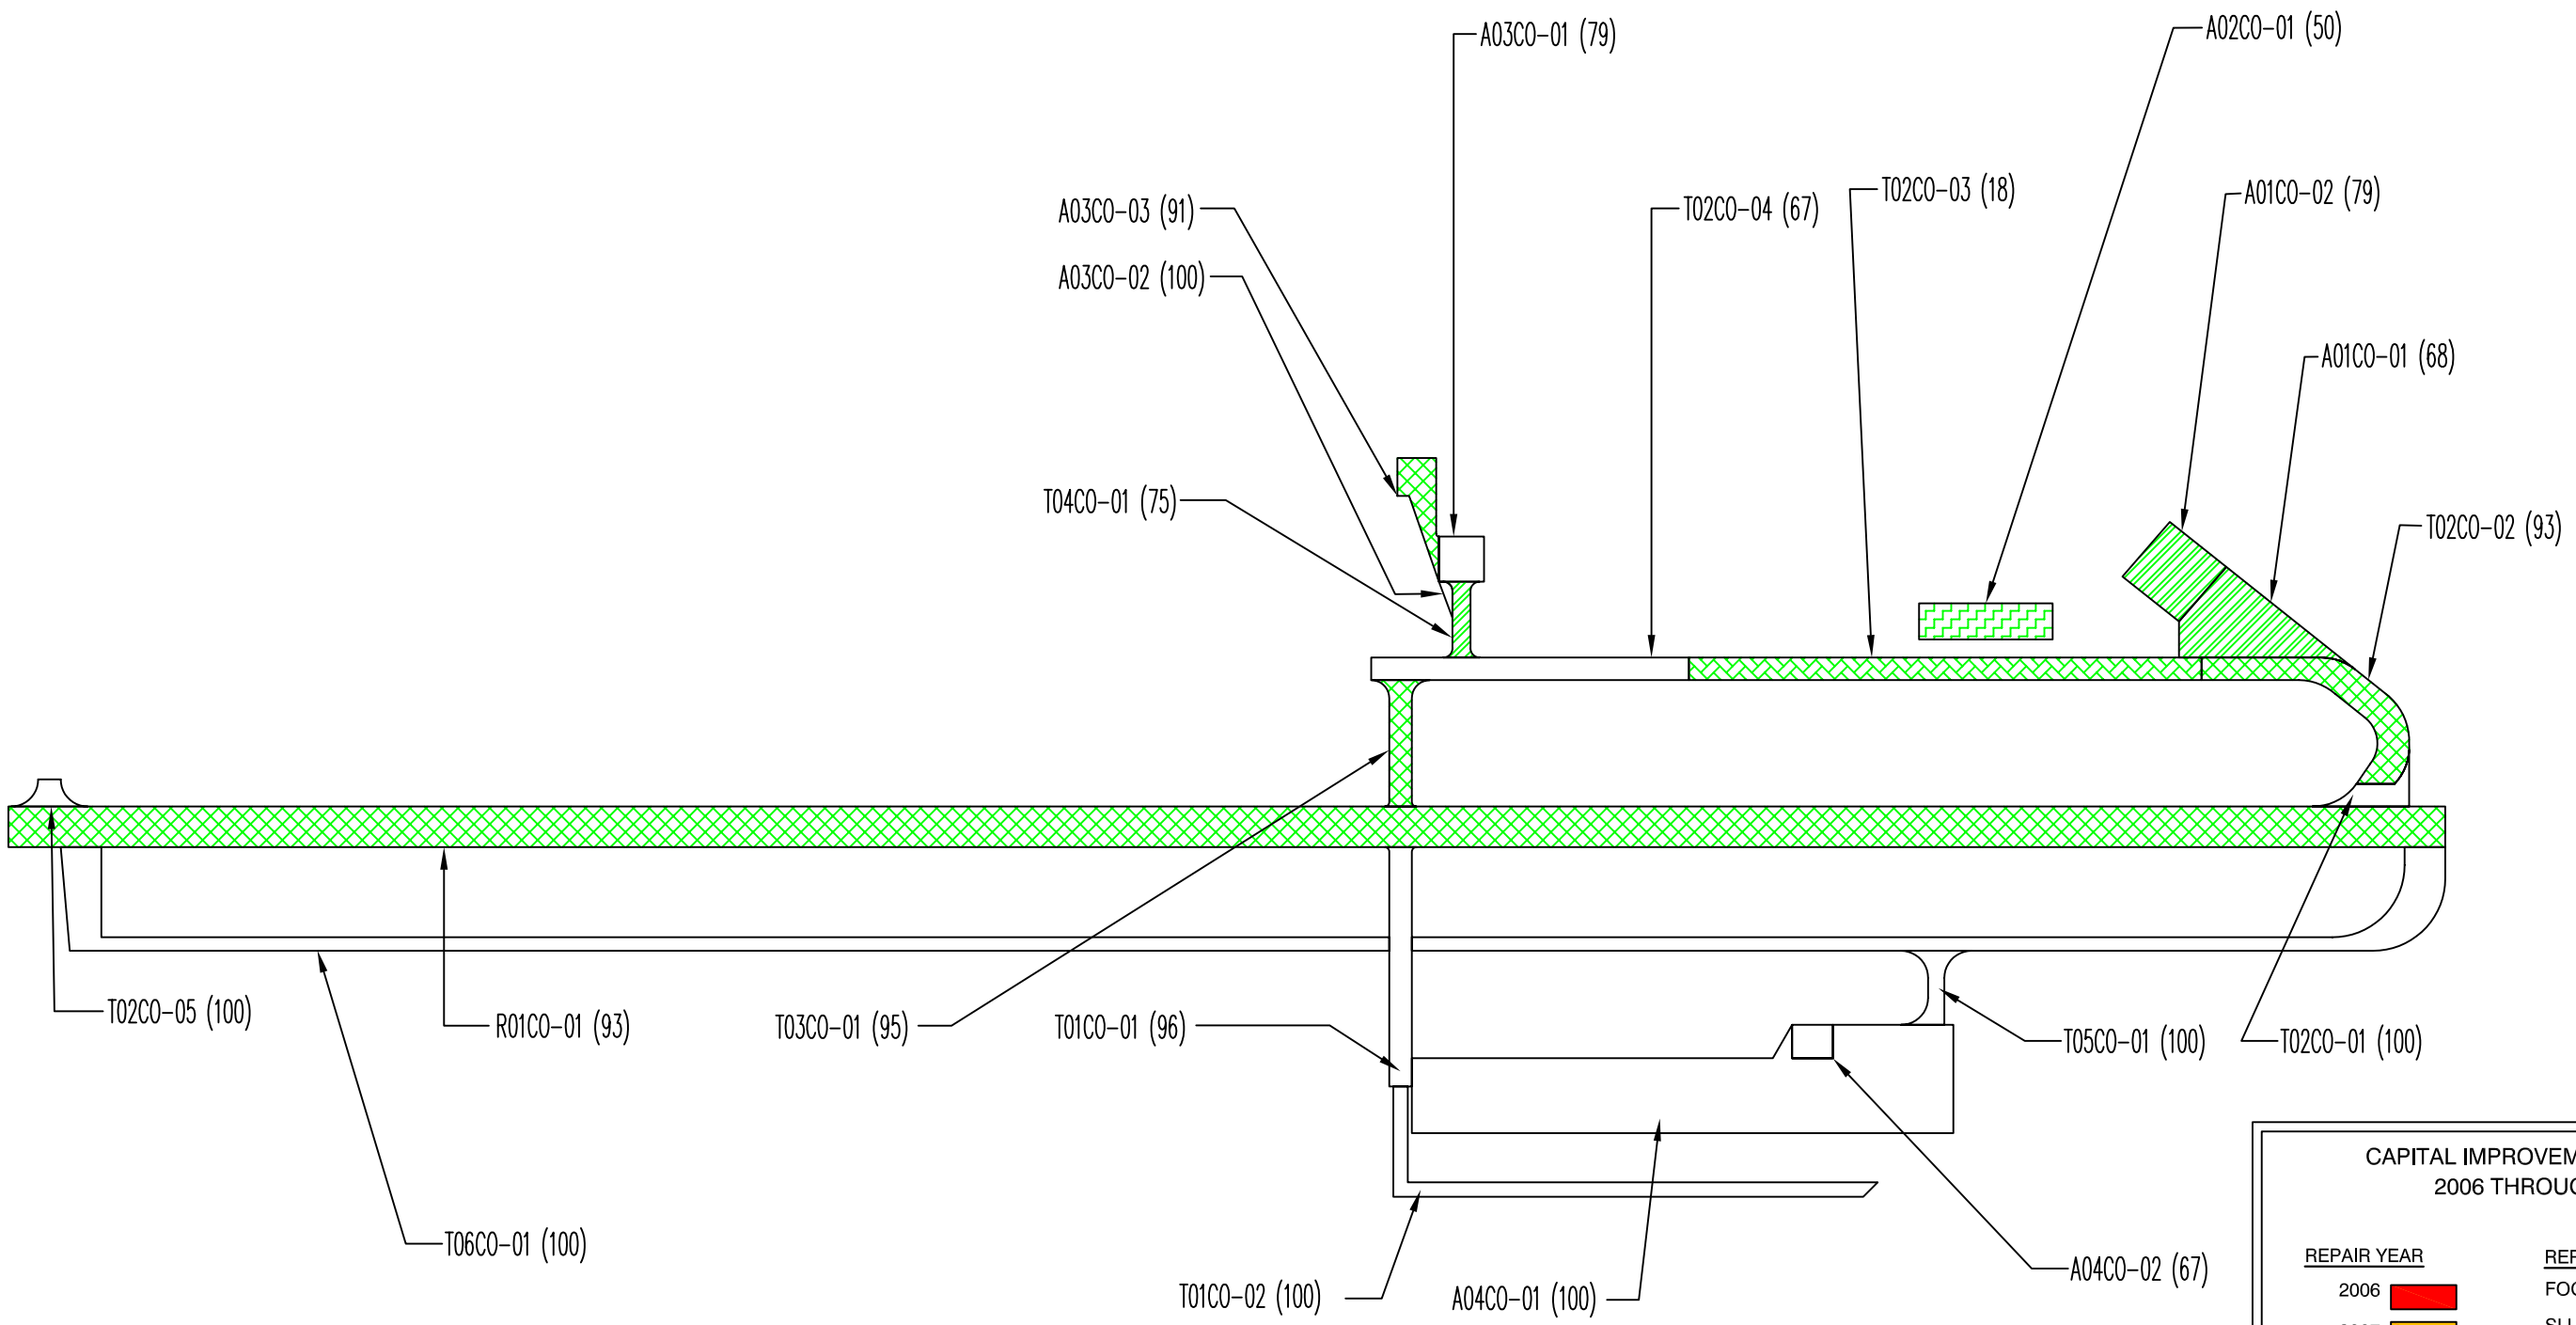
CAPITAL IMPROVEMENT PROGRAM
2006 THROUGH 2012

REPAIR YEAR	REPAIR TYPE
2006	FOG SEAL
2007	SLURRY SEAL
2008	REHABILITATION
2009	RECONSTRUCTION
2010	
2011	
2012

A summary of the pavement repair program for Colville Municipal Airport is presented in Table 4 and in Figure 9. Detailed information on the localized maintenance plan for 2006 is contained in Appendix F.
