IONE MUNICIPAL AIRPORT
2005 PAVEMENT MANAGEMENT REPORT

February 2006

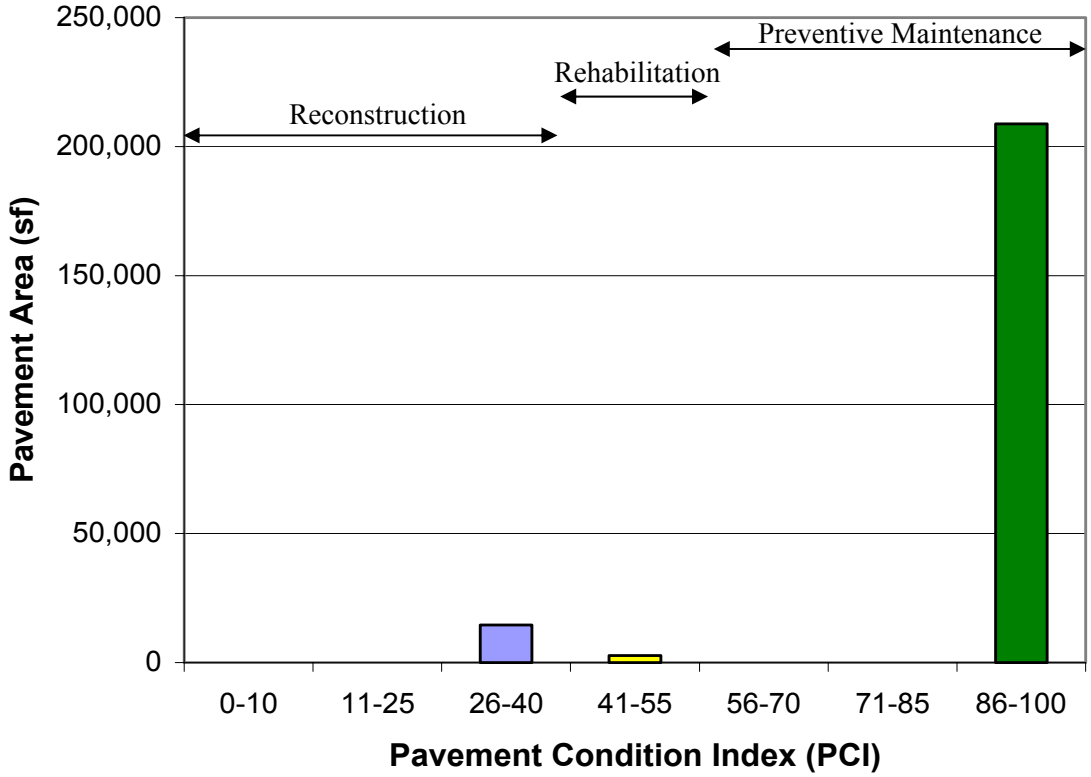
Figure 6. Ione Municipal Airport overall condition.

The pavements at Ione Municipal Airport were inspected on June 10, 2005. The 2005 area-weighted condition of Ione Municipal Airport is 95, with conditions ranging from 27 to 100 (on a scale of 0 [failed] to 100 [excellent]). During the previous inspection in 1999, the area-weighted condition was 80.

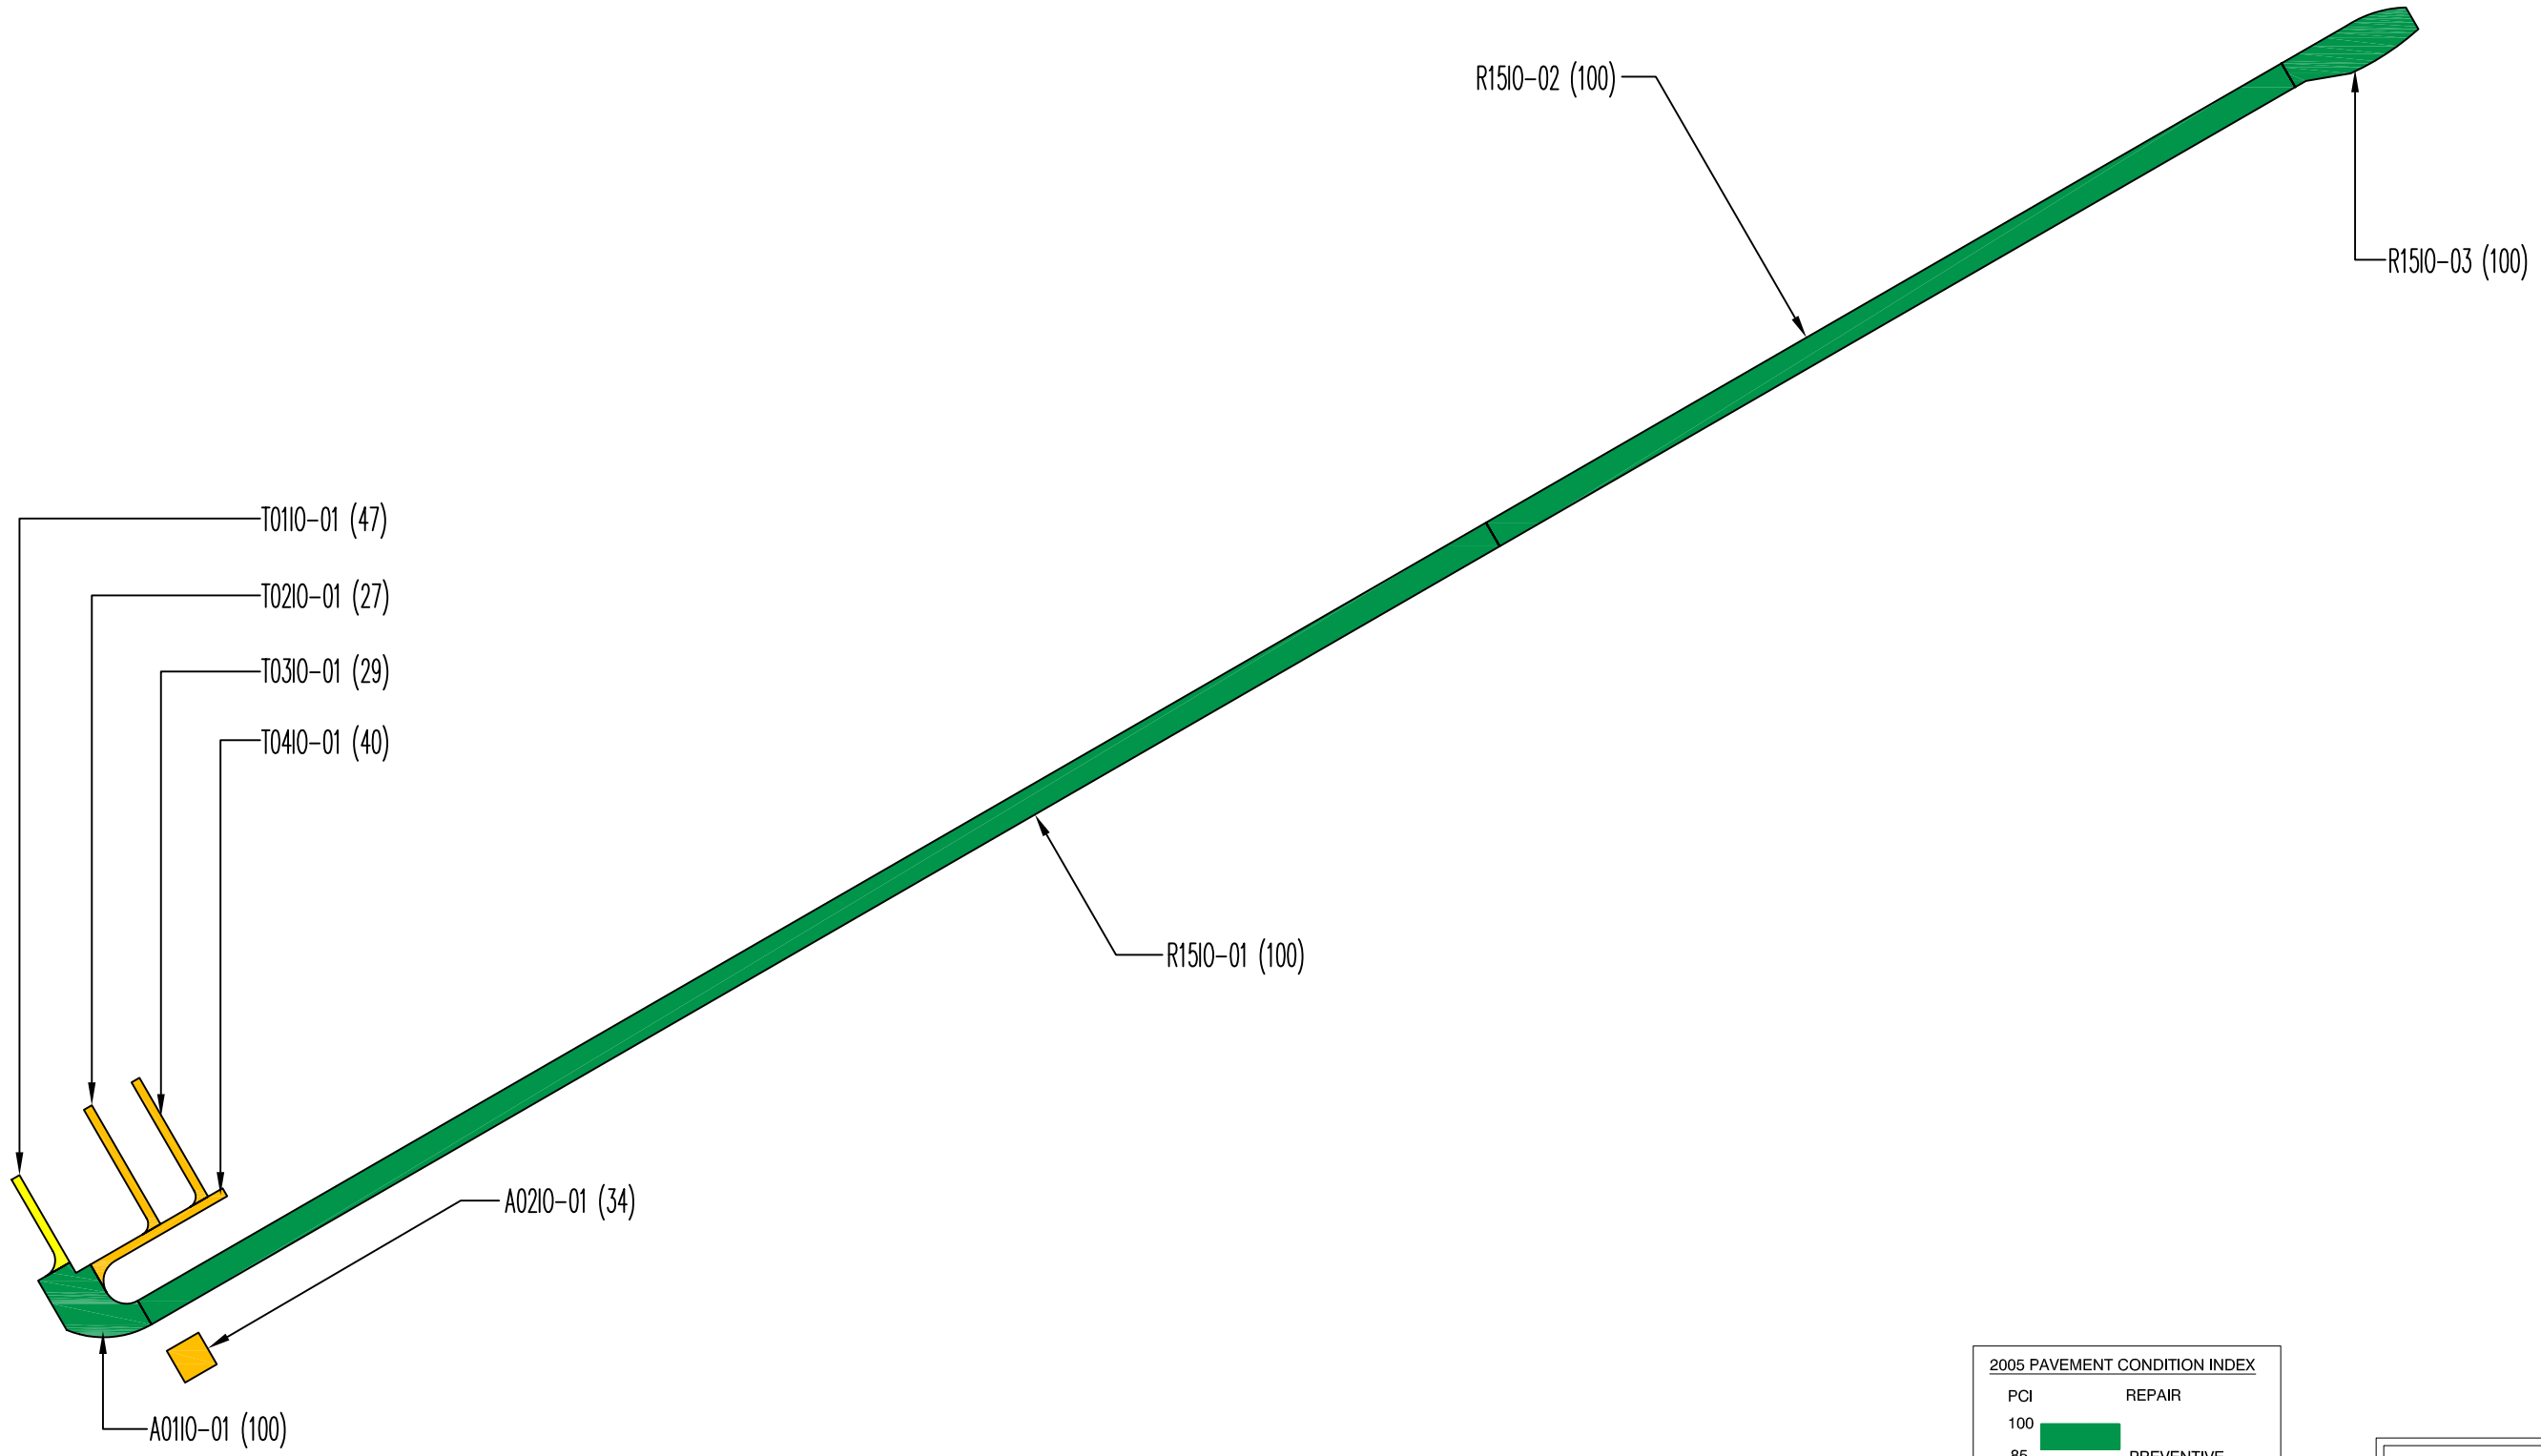
LOCATION: Ione Municipal Airport, Ione, Washington			
PAGE TITLE: 2005 Pavement Condition Index Map			
DRAWING SCALE: 1" = 300'	DATE: February 2006	REVISED BY: AM	DRAWN BY: AM
FILENAME: Ione.dwg	AIRPORT ID: S23	LAYOUT NAME/NUMBER: Ione (PCI)	PAGE NUMBER: 9

Figures 6 and 7 summarize the overall condition of the pavements at the Ione Municipal Airport. Figure 8 displays the condition of the pavements evaluated. Table 1 summarizes the results of the pavement evaluation. Appendix C presents photographs taken during the PCI inspection and Appendix D details the distresses observed during the visual survey.

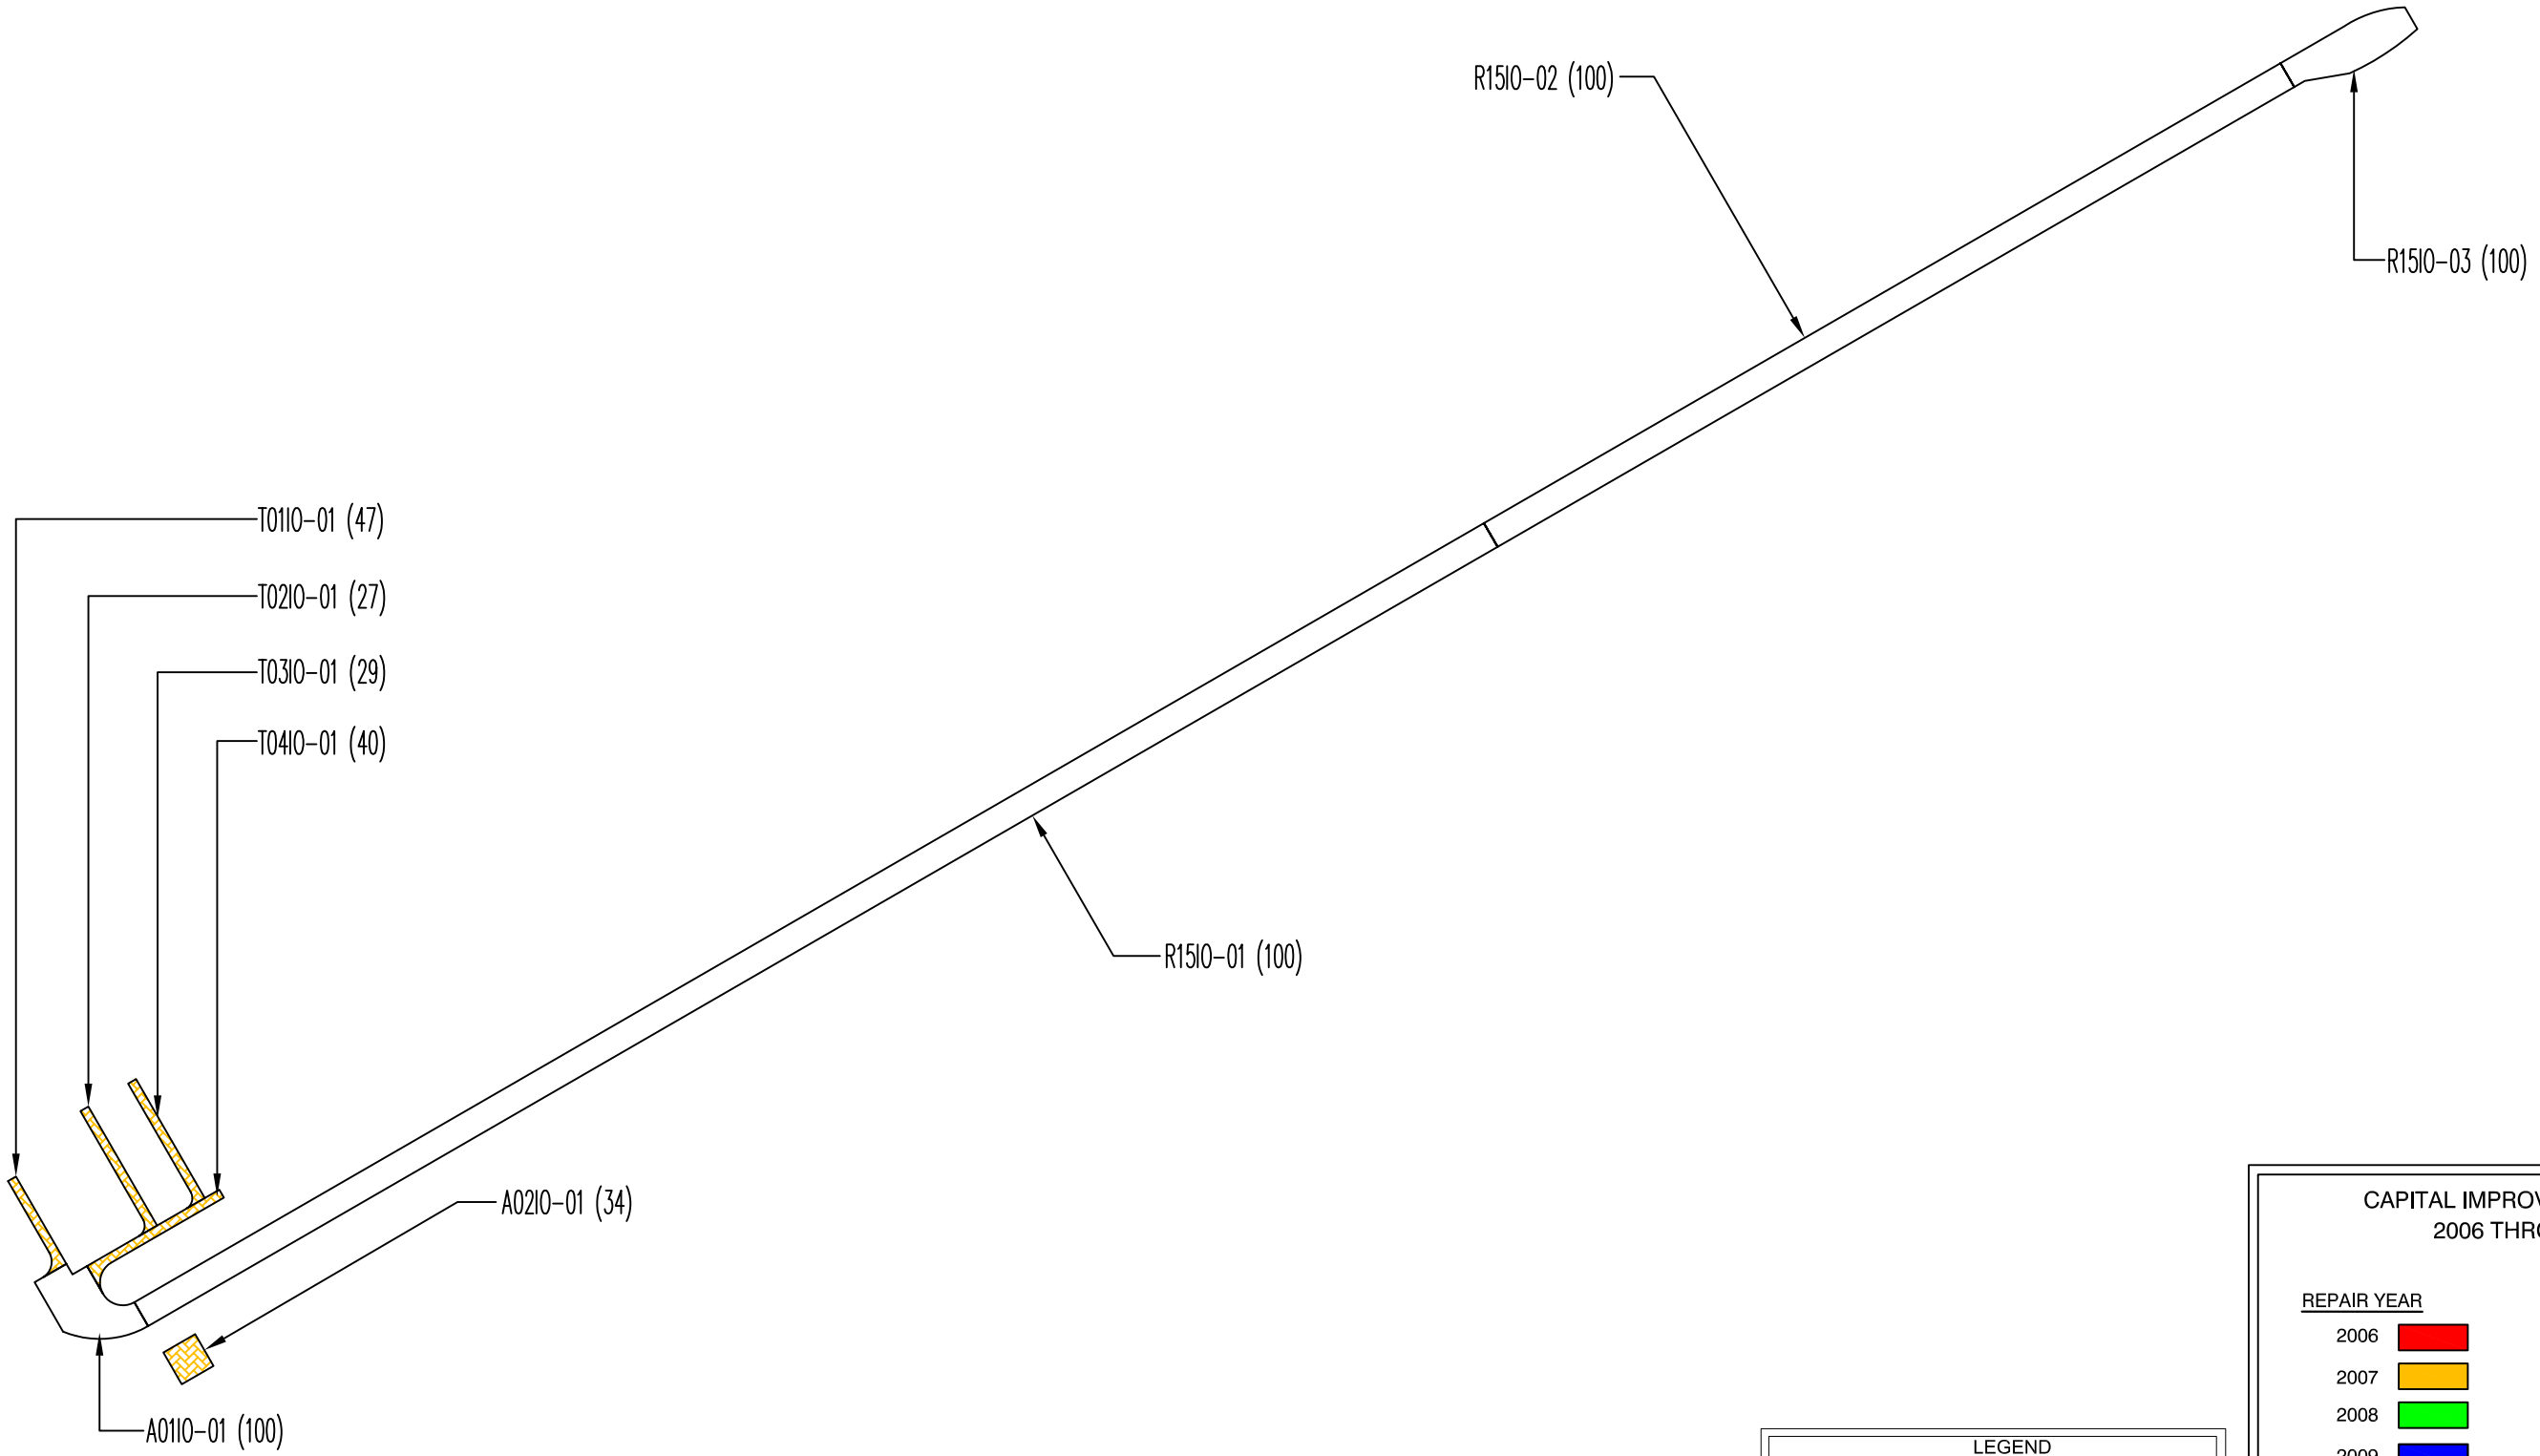
REPAIR YEAR	REPAIR TYPE
2006	REHABILITATION
2007	RECONSTRUCTION
2008	
2009	
2010	
2011	
2012

A summary of the pavement repair program for Ione Municipal Airport is presented in Table 4 and in Figure 9. Detailed information on the localized maintenance plan for 2006 is contained in Appendix F.

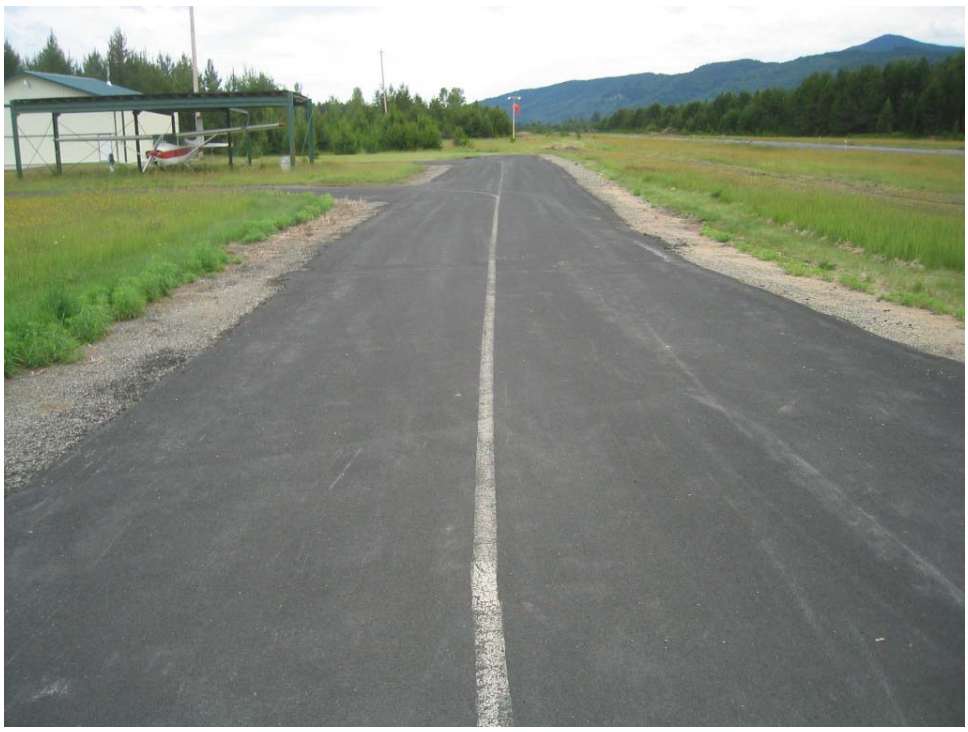
T04IO-01. Overview.

T04IO-01. Alligator cracking.
