DAVENPORT AIRPORT
2005 PAVEMENT MANAGEMENT REPORT

February 2006

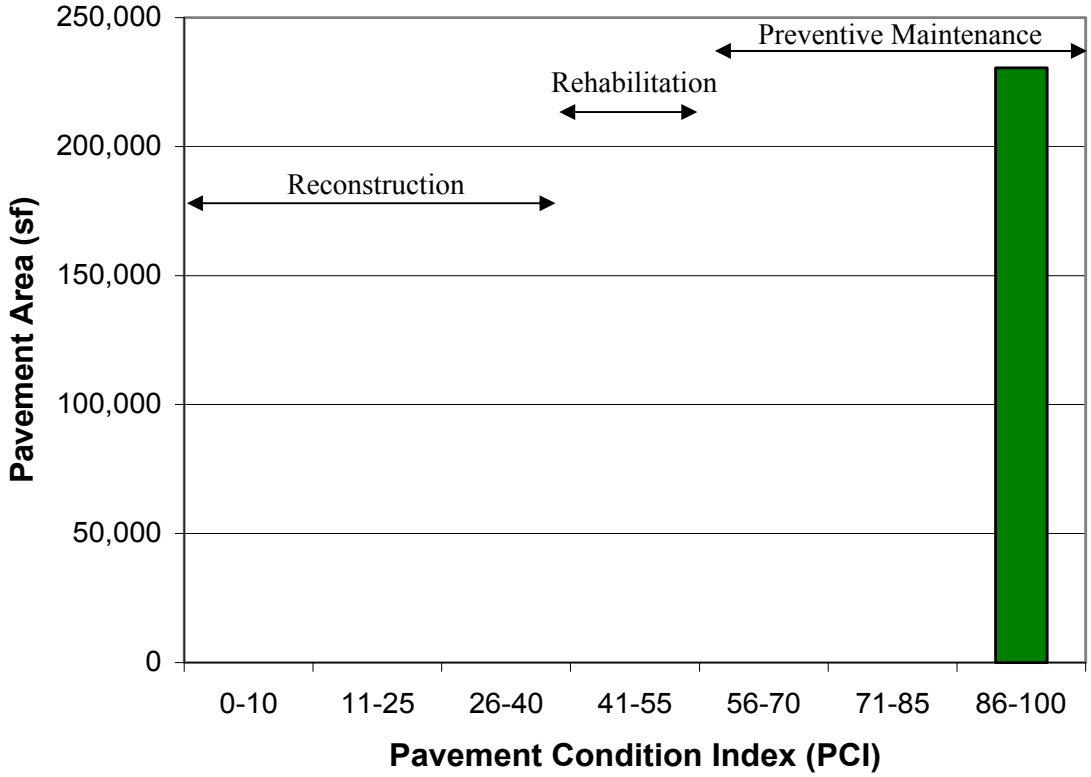
Figure 6. Davenport Airport overall condition.

The pavements at Davenport Airport were inspected on June 18, 2005. The 2005 area-weighted condition of Davenport Airport is 99, with conditions ranging from 95 to 100 (on a scale of 0 [failed] to 100 [excellent]). During the previous inspection in 1999, the area-weighted condition was 45.

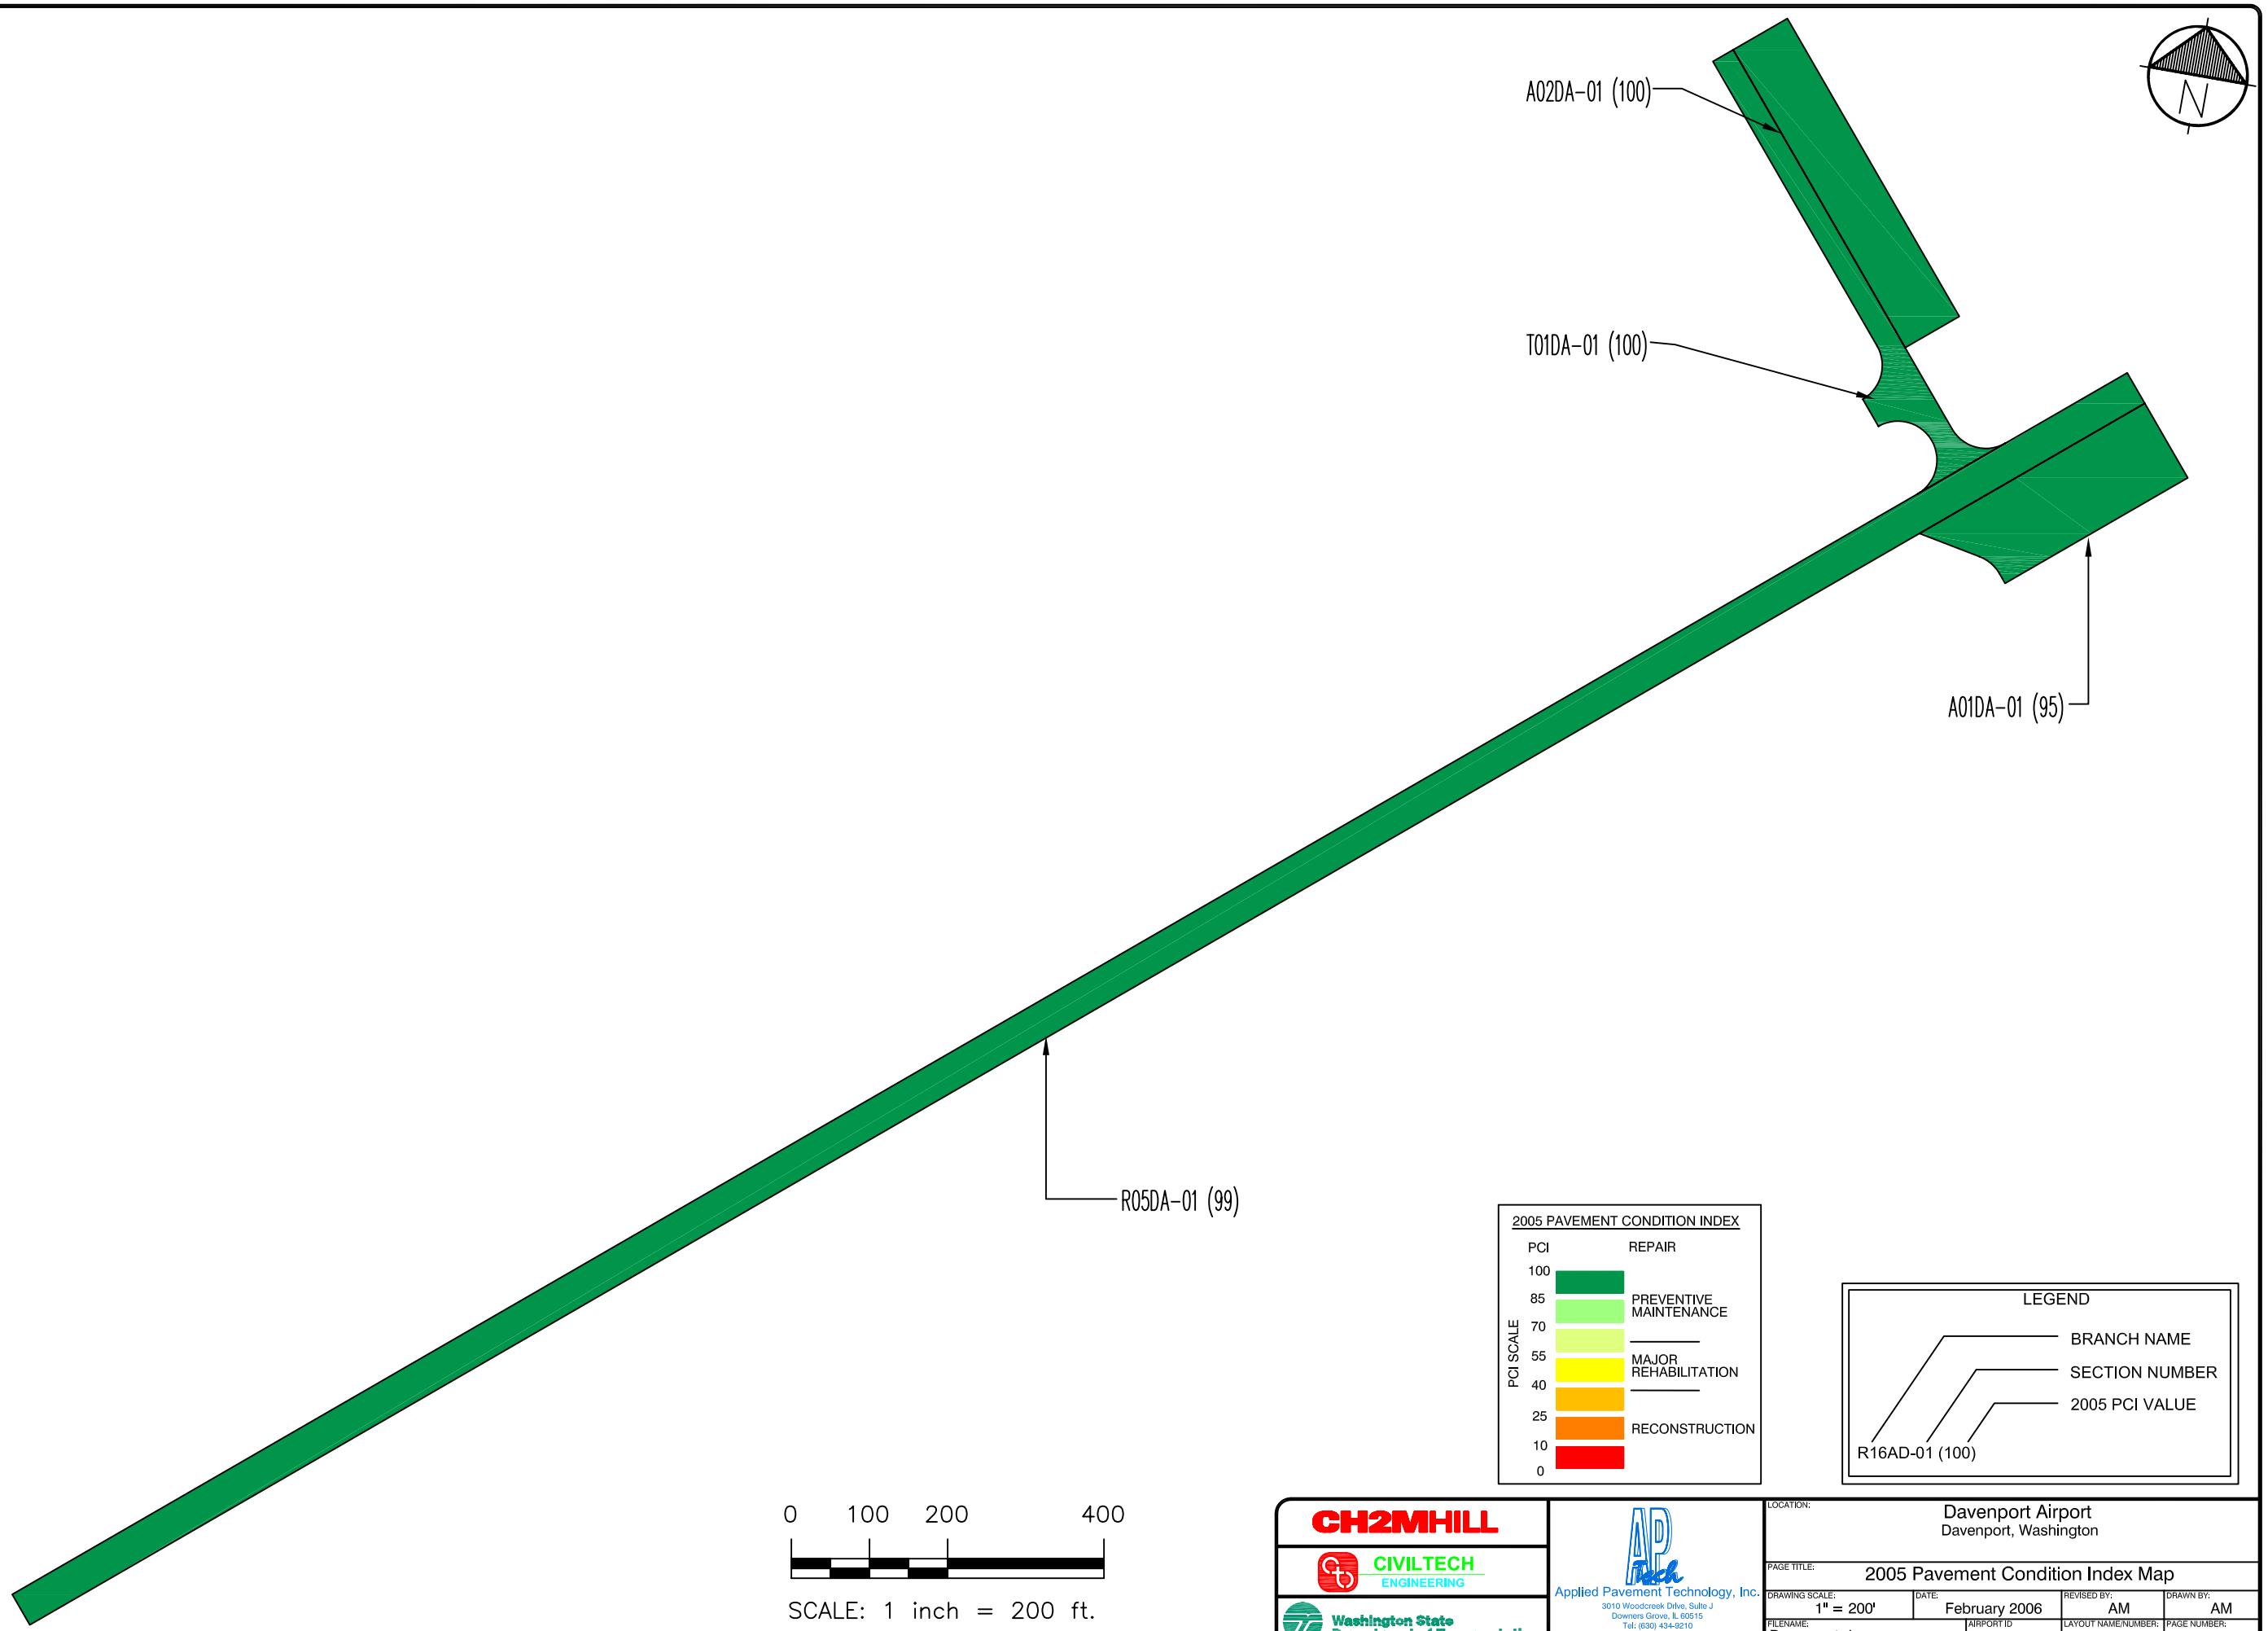
LOCATION: Davenport Airport, Davenport, Washington			
PAGE TITLE: 2005 Pavement Condition Index Map			
DRAWING SCALE: 1" = 200'	DATE: February 2006	REVISED BY: AM	DRAWN BY: AM
FILENAME: Davenport.dwg	AIRPORT ID 68S	LAYOUT NAME/NUMBER: Davenport (PCI)	PAGE NUMBER: 9

Figures 6 and 7 summarize the overall condition of the pavements at the Davenport Airport. Figure 8 displays the condition of the pavements evaluated. Table 1 summarizes the results of the pavement evaluation. Appendix C presents photographs taken during the PCI inspection and Appendix D details the distresses observed during the visual survey.

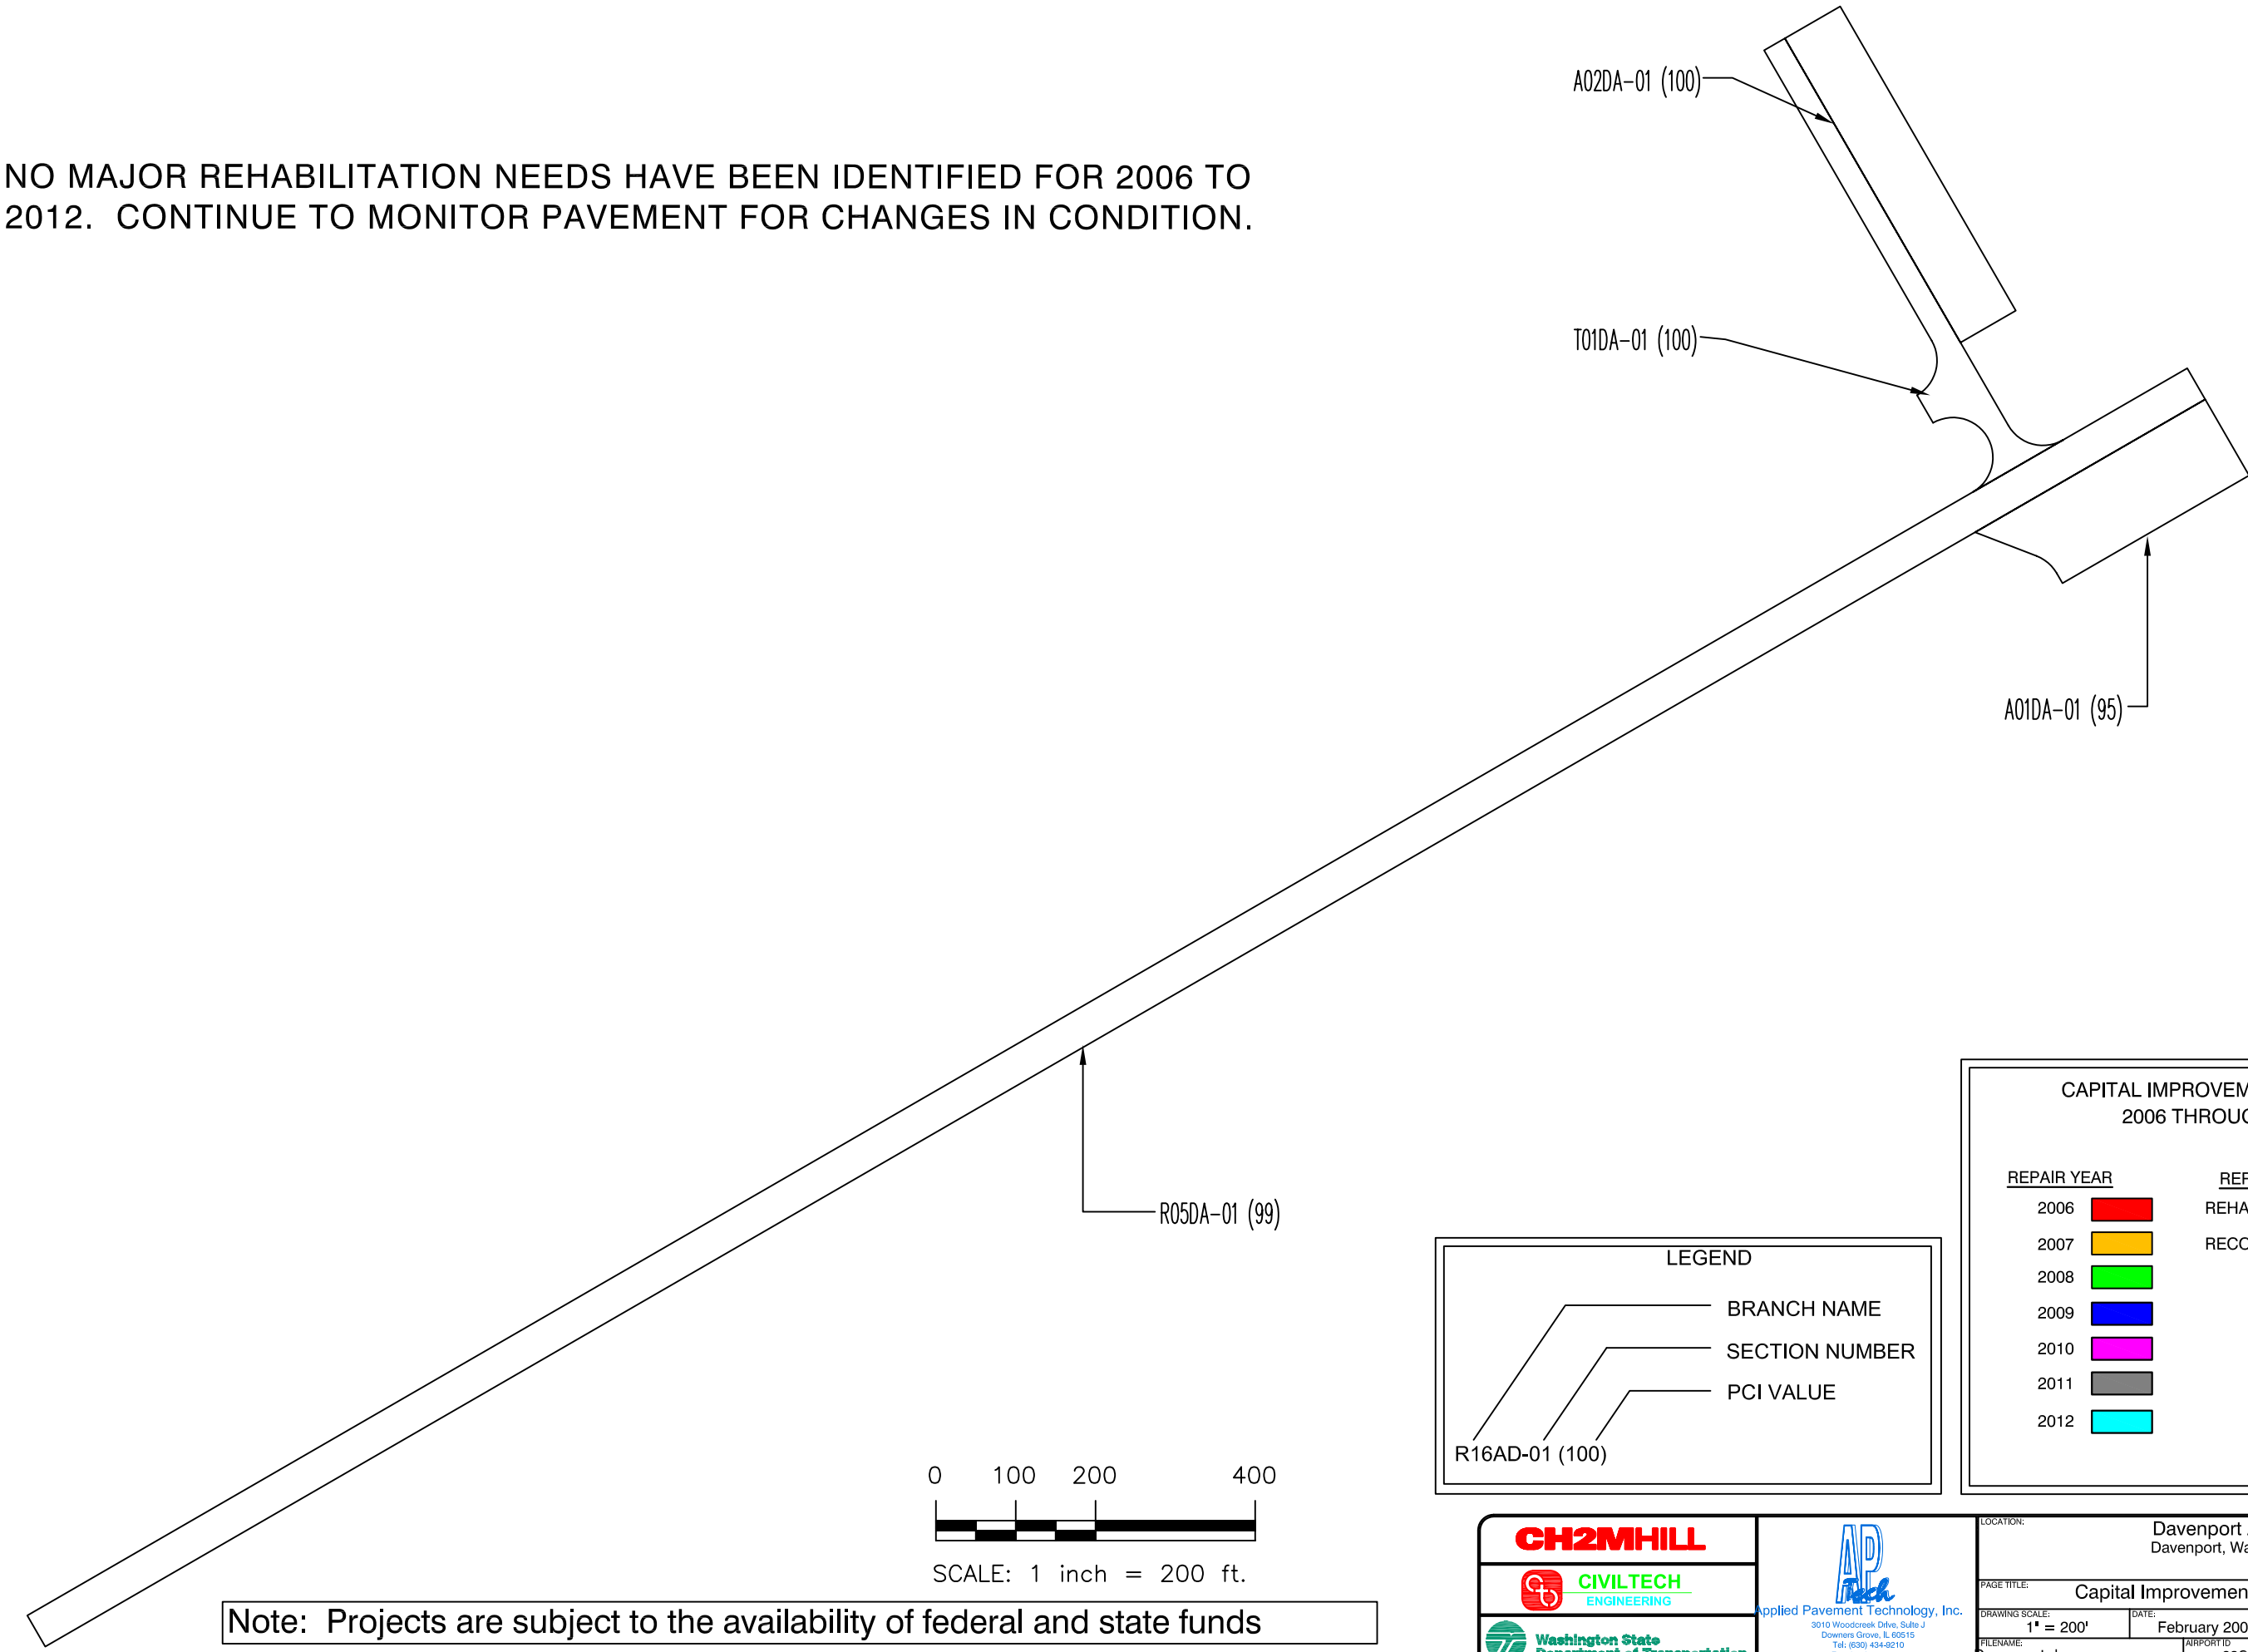
NO MAJOR REHABILITATION NEEDS HAVE BEEN IDENTIFIED FOR 2006 TO 2012. CONTINUE TO MONITOR PAVEMENT FOR CHANGES IN CONDITION.
