SWANSON FIELD AIRPORT
2005 PAVEMENT MANAGEMENT REPORT

February 2006

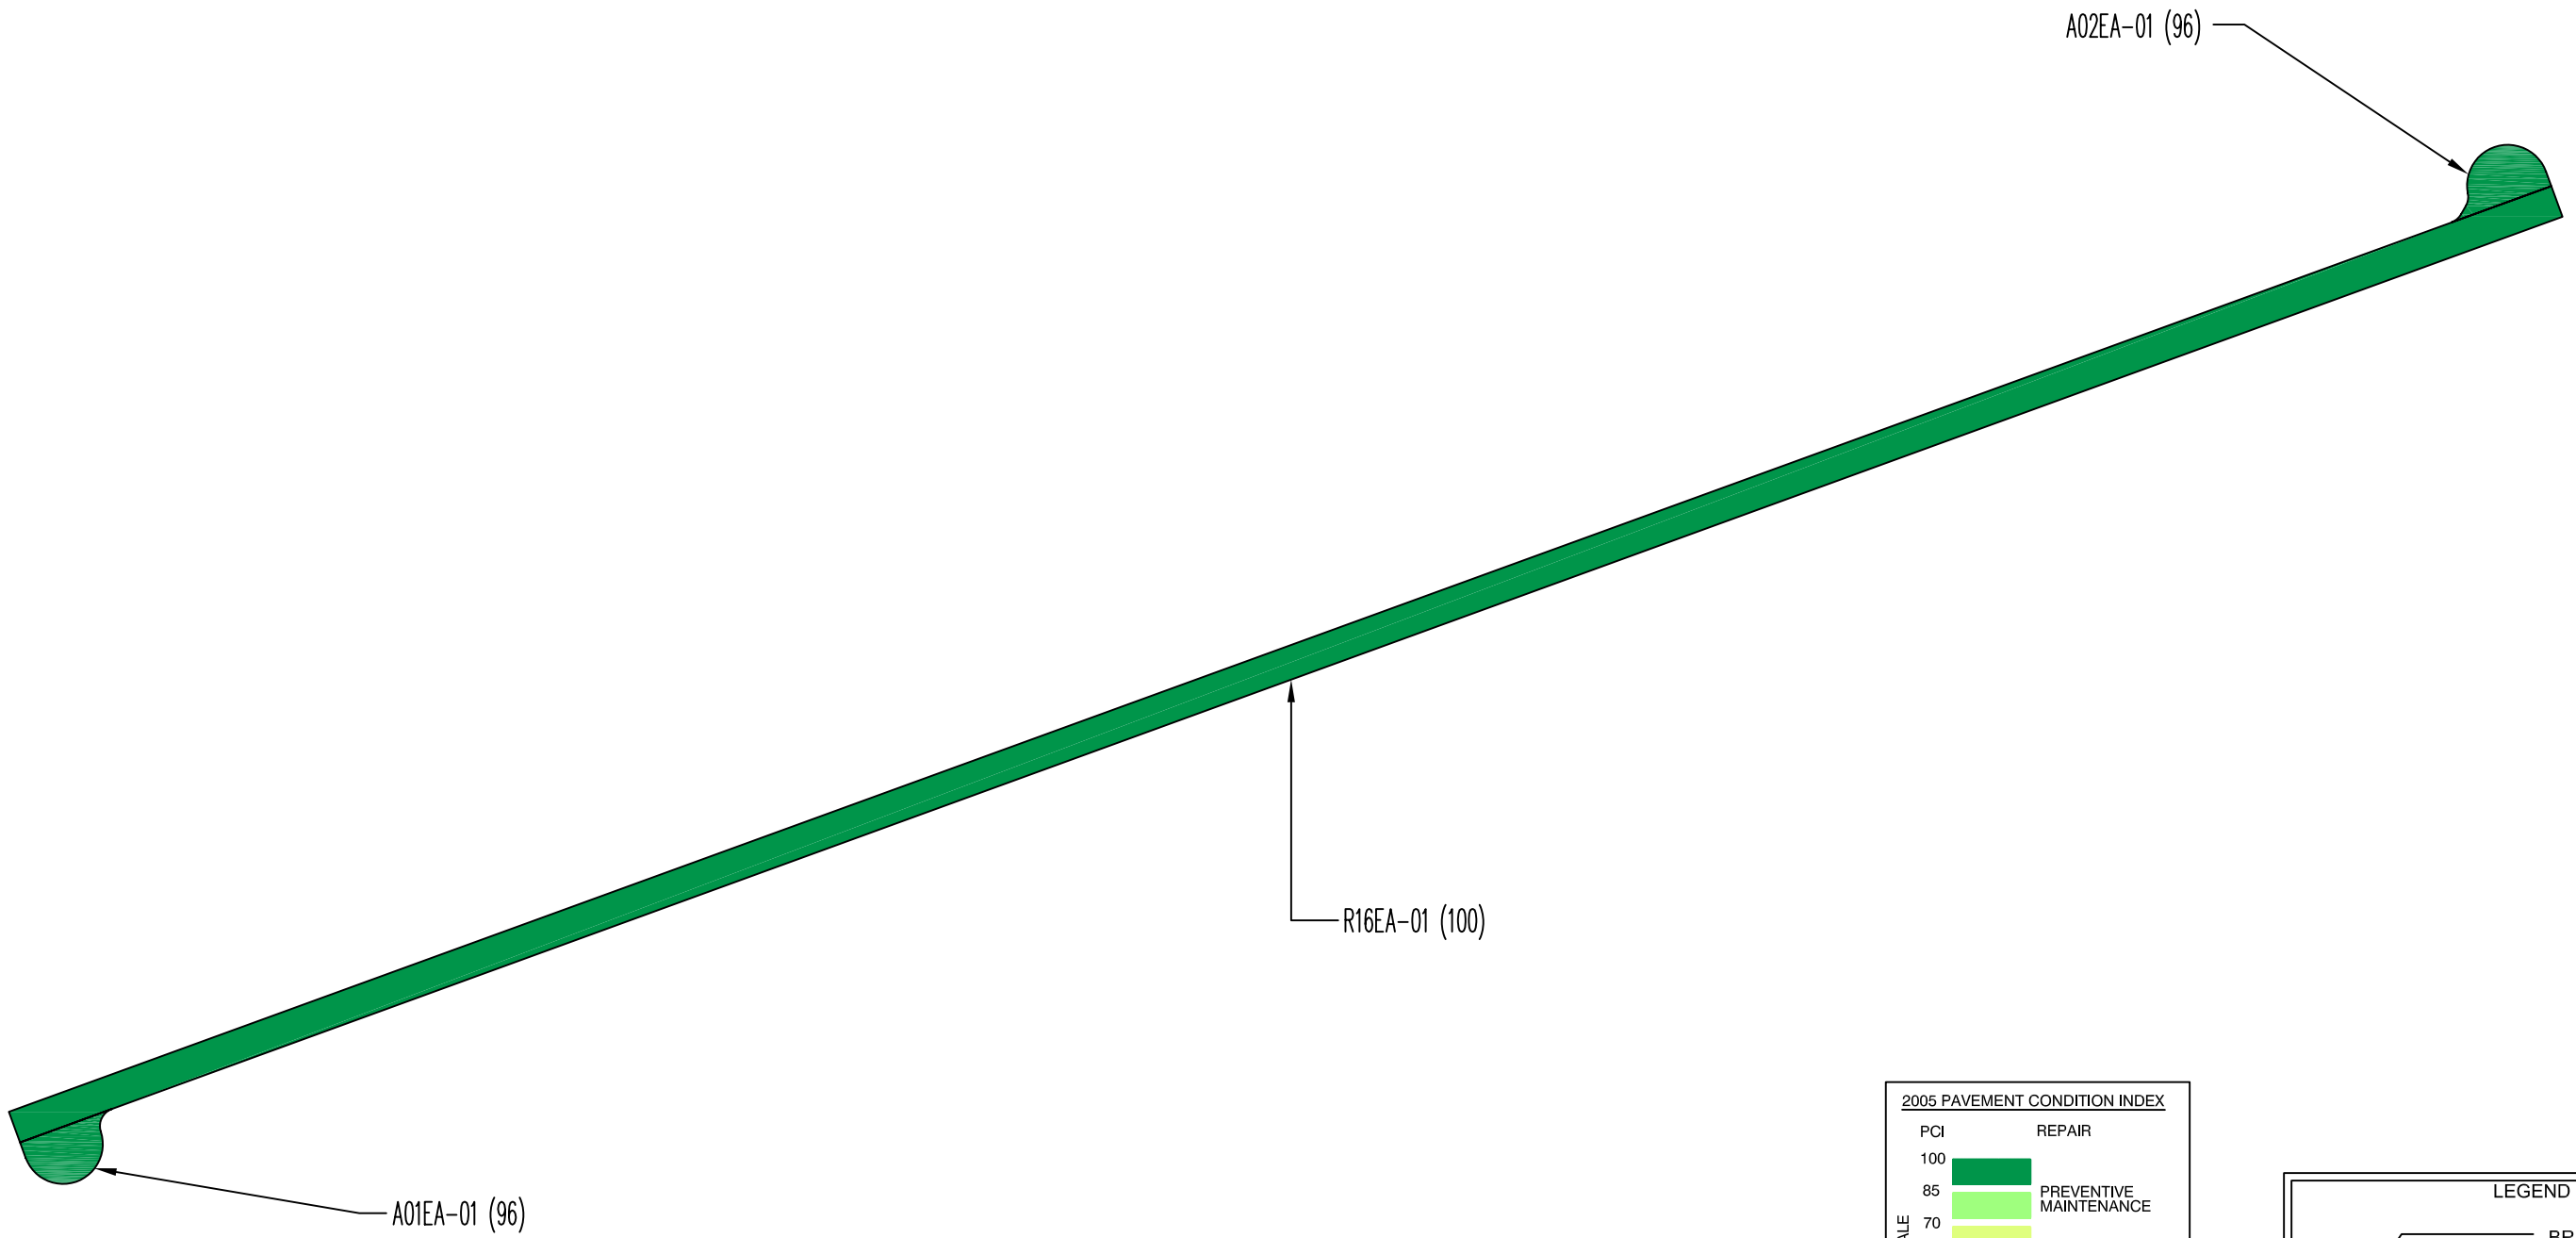
2005 PAVEMENT CONDITION INDEX

The pavements at Swanson Field Airport were inspected on June 18, 2005. The 2005 area-weighted condition of Swanson Field Airport is 100, with conditions ranging from 96 to 100 (on a scale of 0 [failed] to 100 [excellent]). During the previous inspection in 1999, the area-weighted condition was 98.

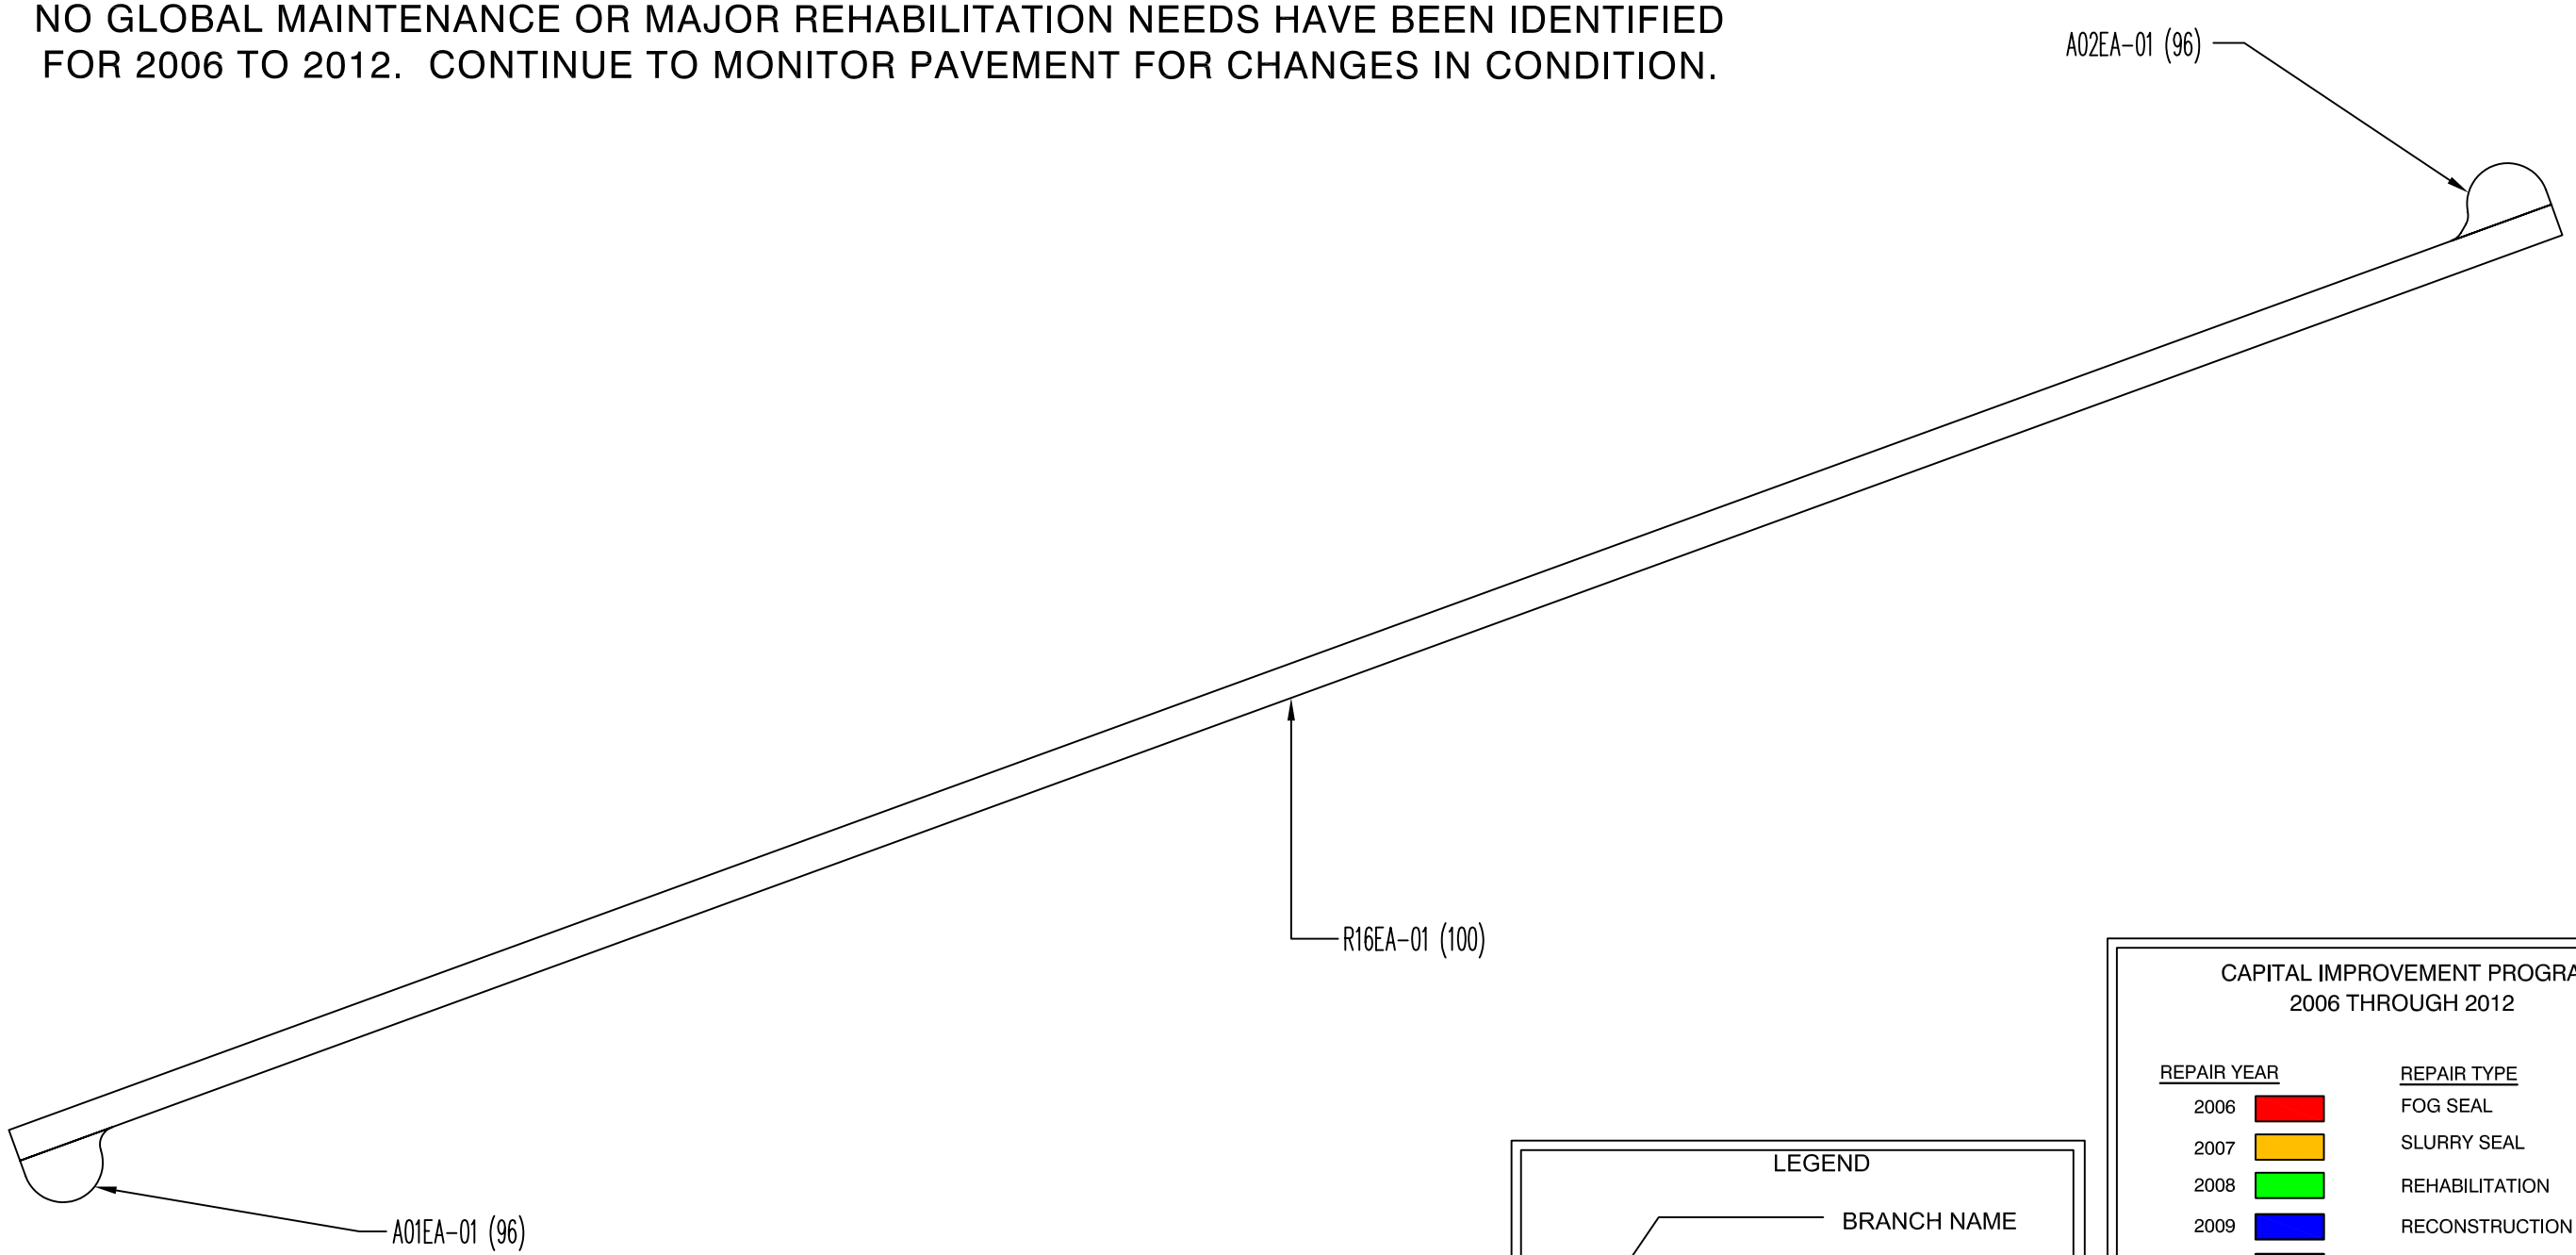
NO GLOBAL MAINTENANCE OR MAJOR REHABILITATION NEEDS HAVE BEEN IDENTIFIED FOR 2006 TO 2012. CONTINUE TO MONITOR PAVEMENT FOR CHANGES IN CONDITION.
