ANDERSON FIELD AIRPORT
2005 PAVEMENT MANAGEMENT REPORT

February 2006

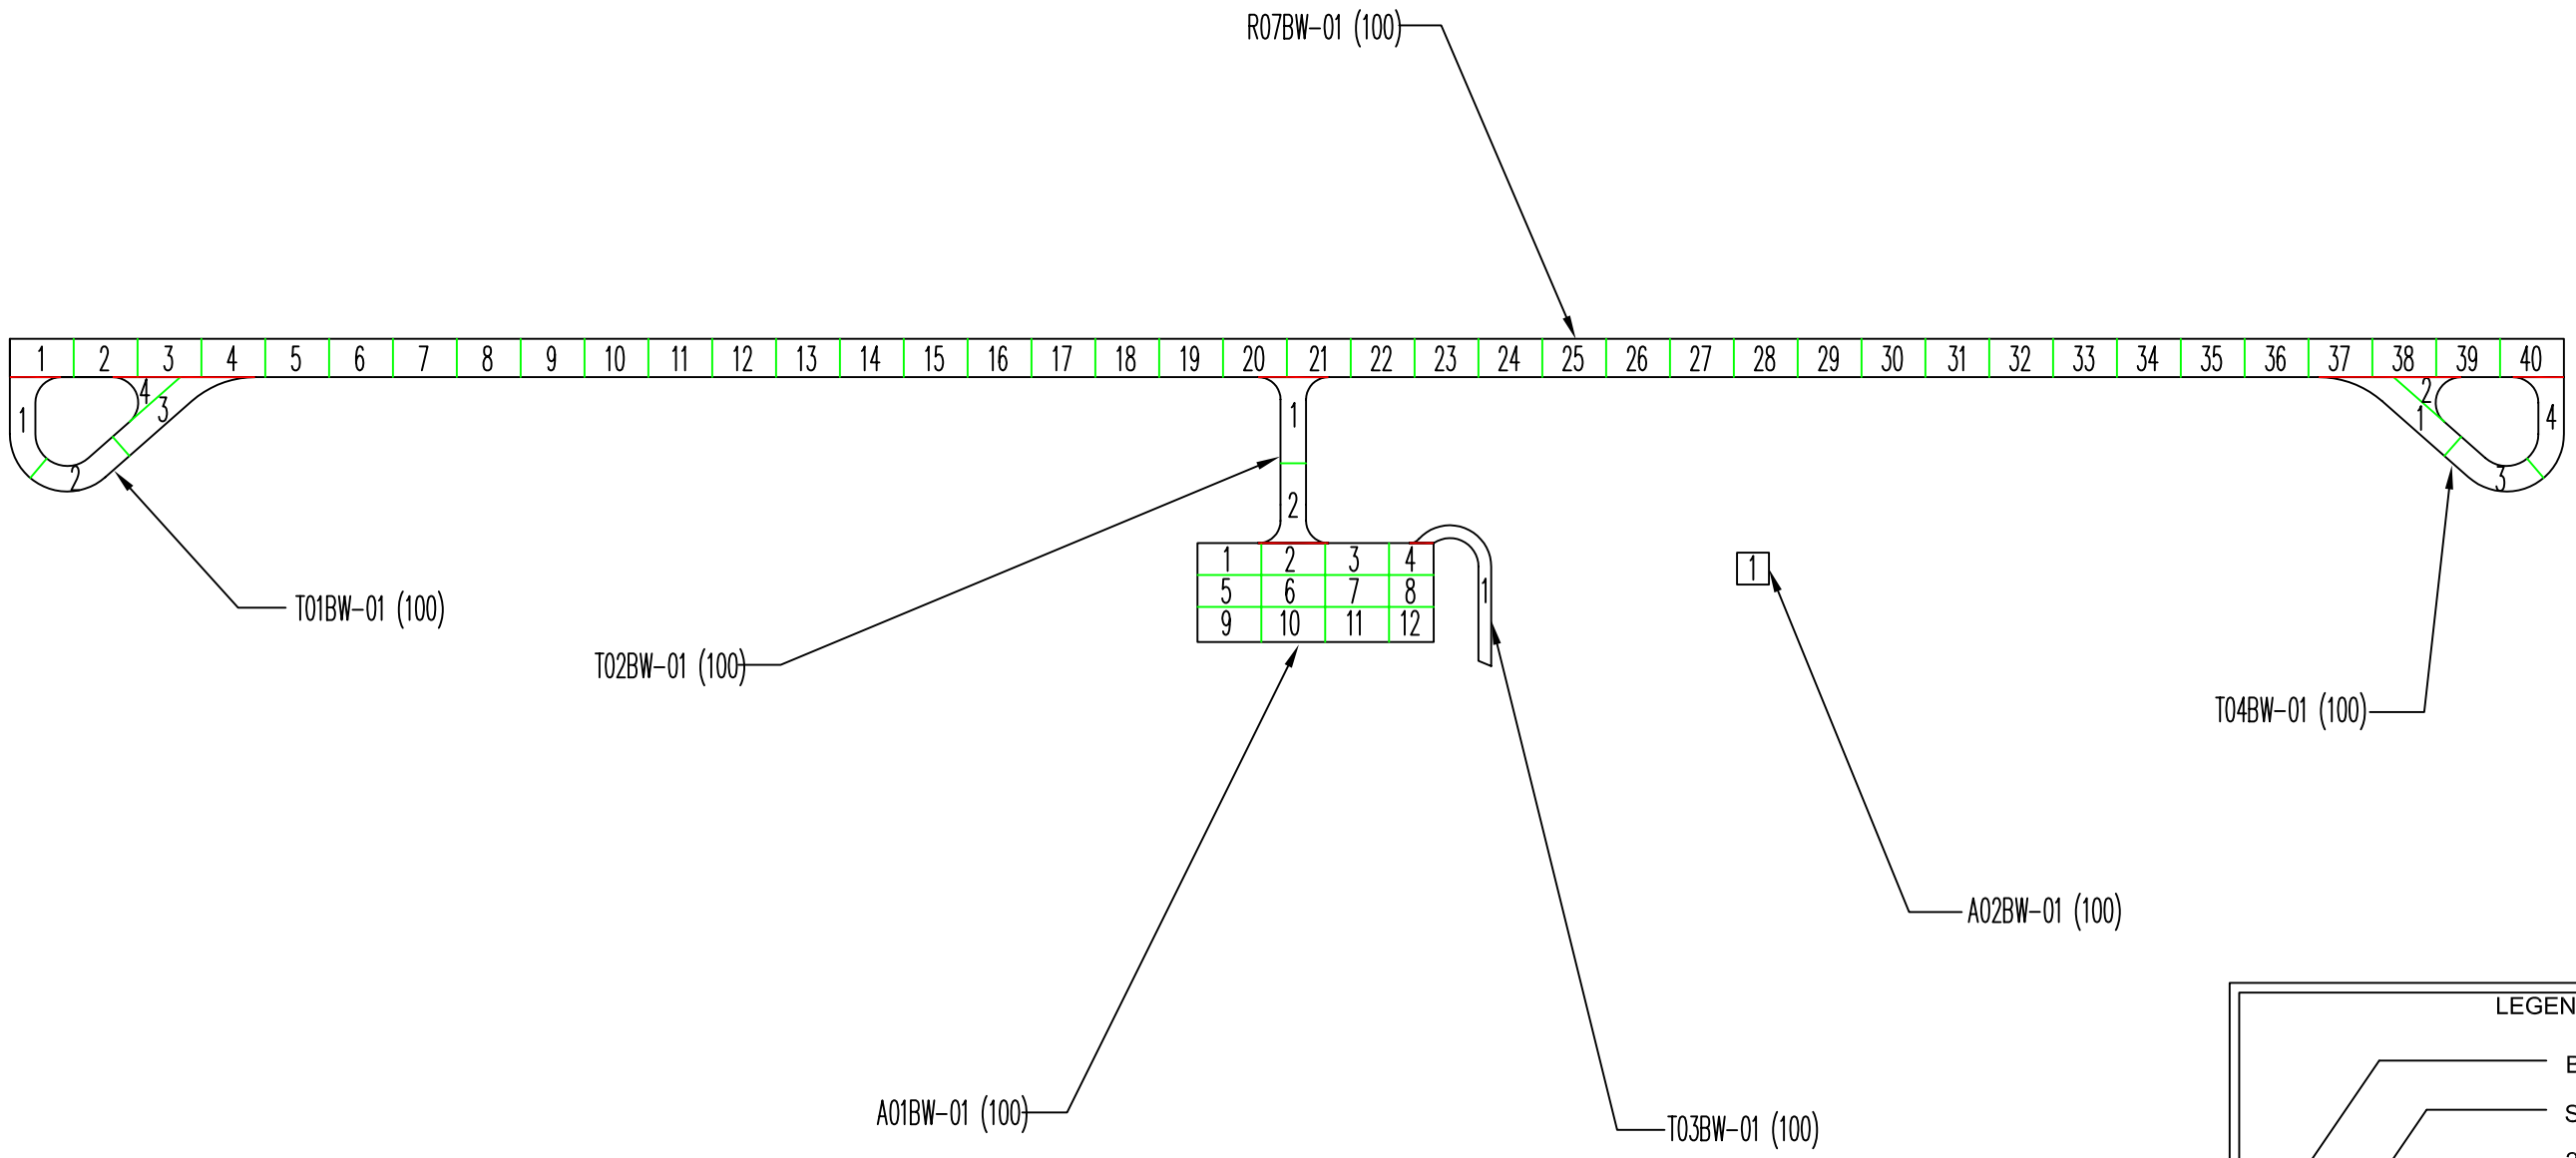
During this project, the pavements at Anderson Field Airport were not inspected. That was because major rehabilitation work was scheduled to occur later in 2005 after the inspections were completed. However, the planned work was entered into the Micro PAVER database and it was assumed that upon completion of that work the area-weighted condition of Anderson Field Airport was 100. During the previous inspection in 1999, the area-weighted condition was 77.

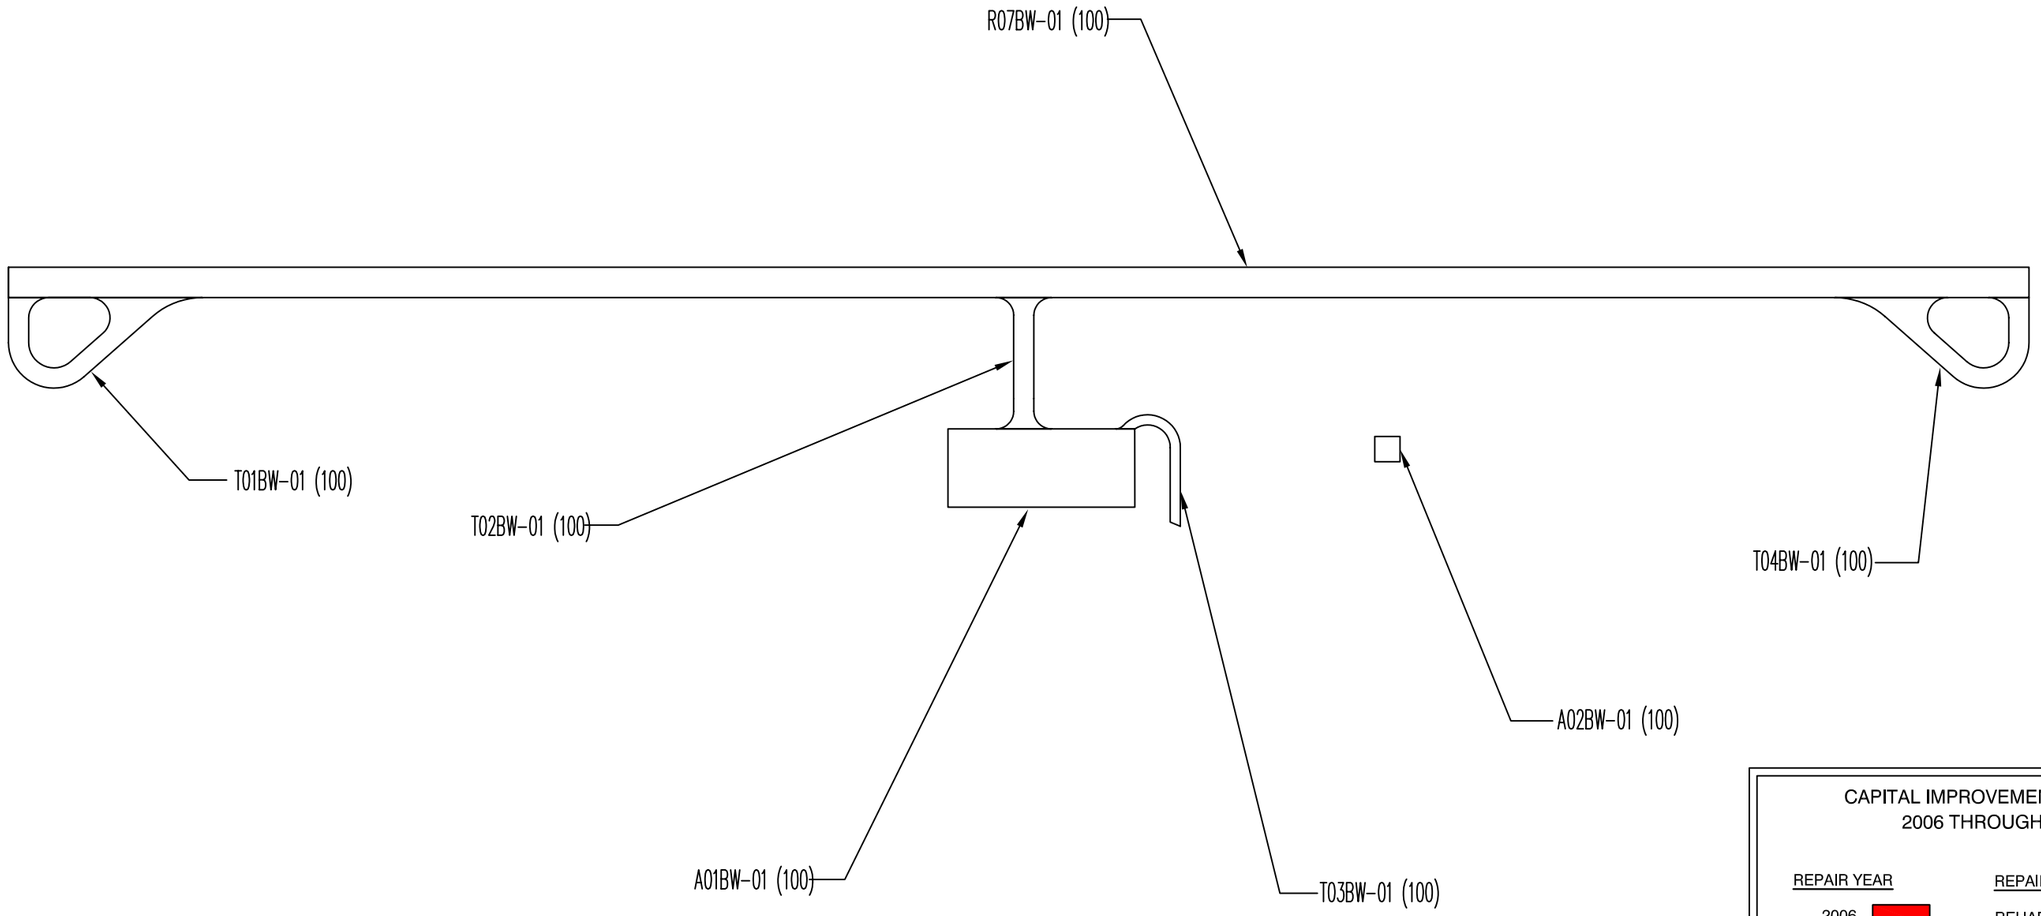
NO MAJOR REHABILITATION NEEDS HAVE BEEN IDENTIFIED FOR 2006 TO 2012.
CONTINUE TO MONITOR PAVEMENT FOR CHANGES IN CONDITION.
