FIRSTAIR FIELD AIRPORT
2005 PAVEMENT MANAGEMENT REPORT

February 2006

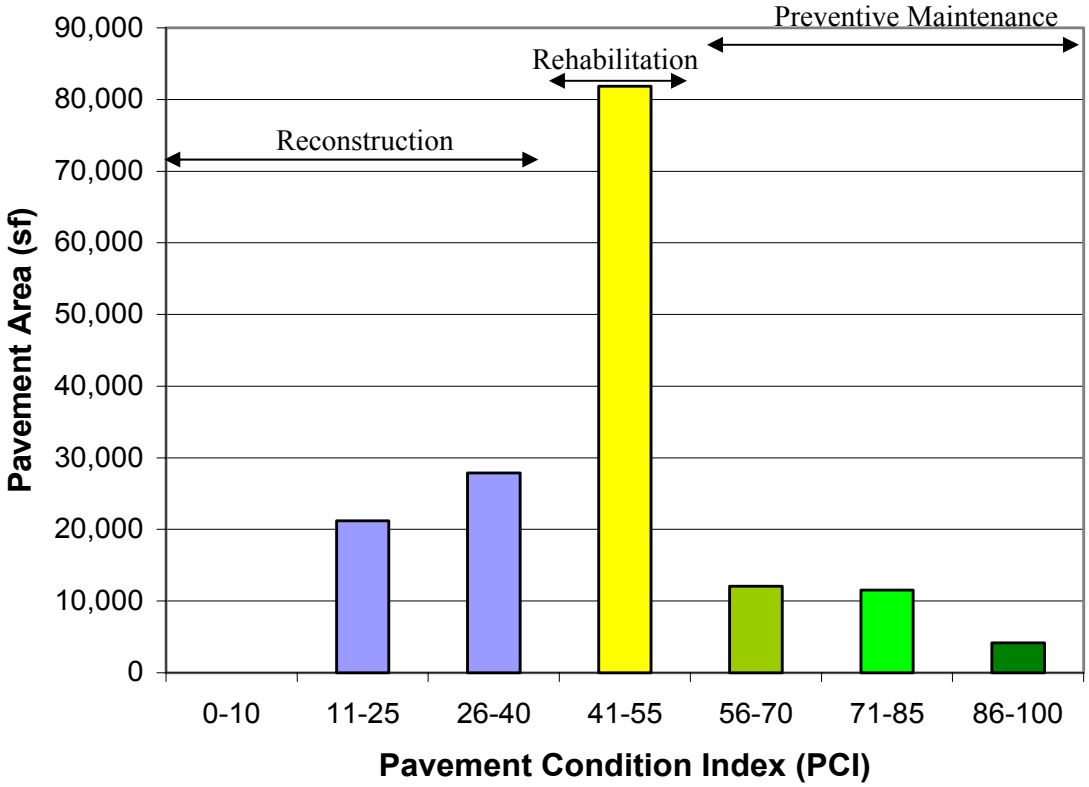
Figure 6. Firstair Field Airport overall condition.

The pavements at Firstair Field Airport were inspected on April 8, 2005. The 2005 area-weighted condition of Firstair Field Airport is 43, with conditions ranging from 16 to 100 (on a scale of 0 [failed] to 100 [excellent]). During the previous inspection in 1999, the area-weighted condition was 50.

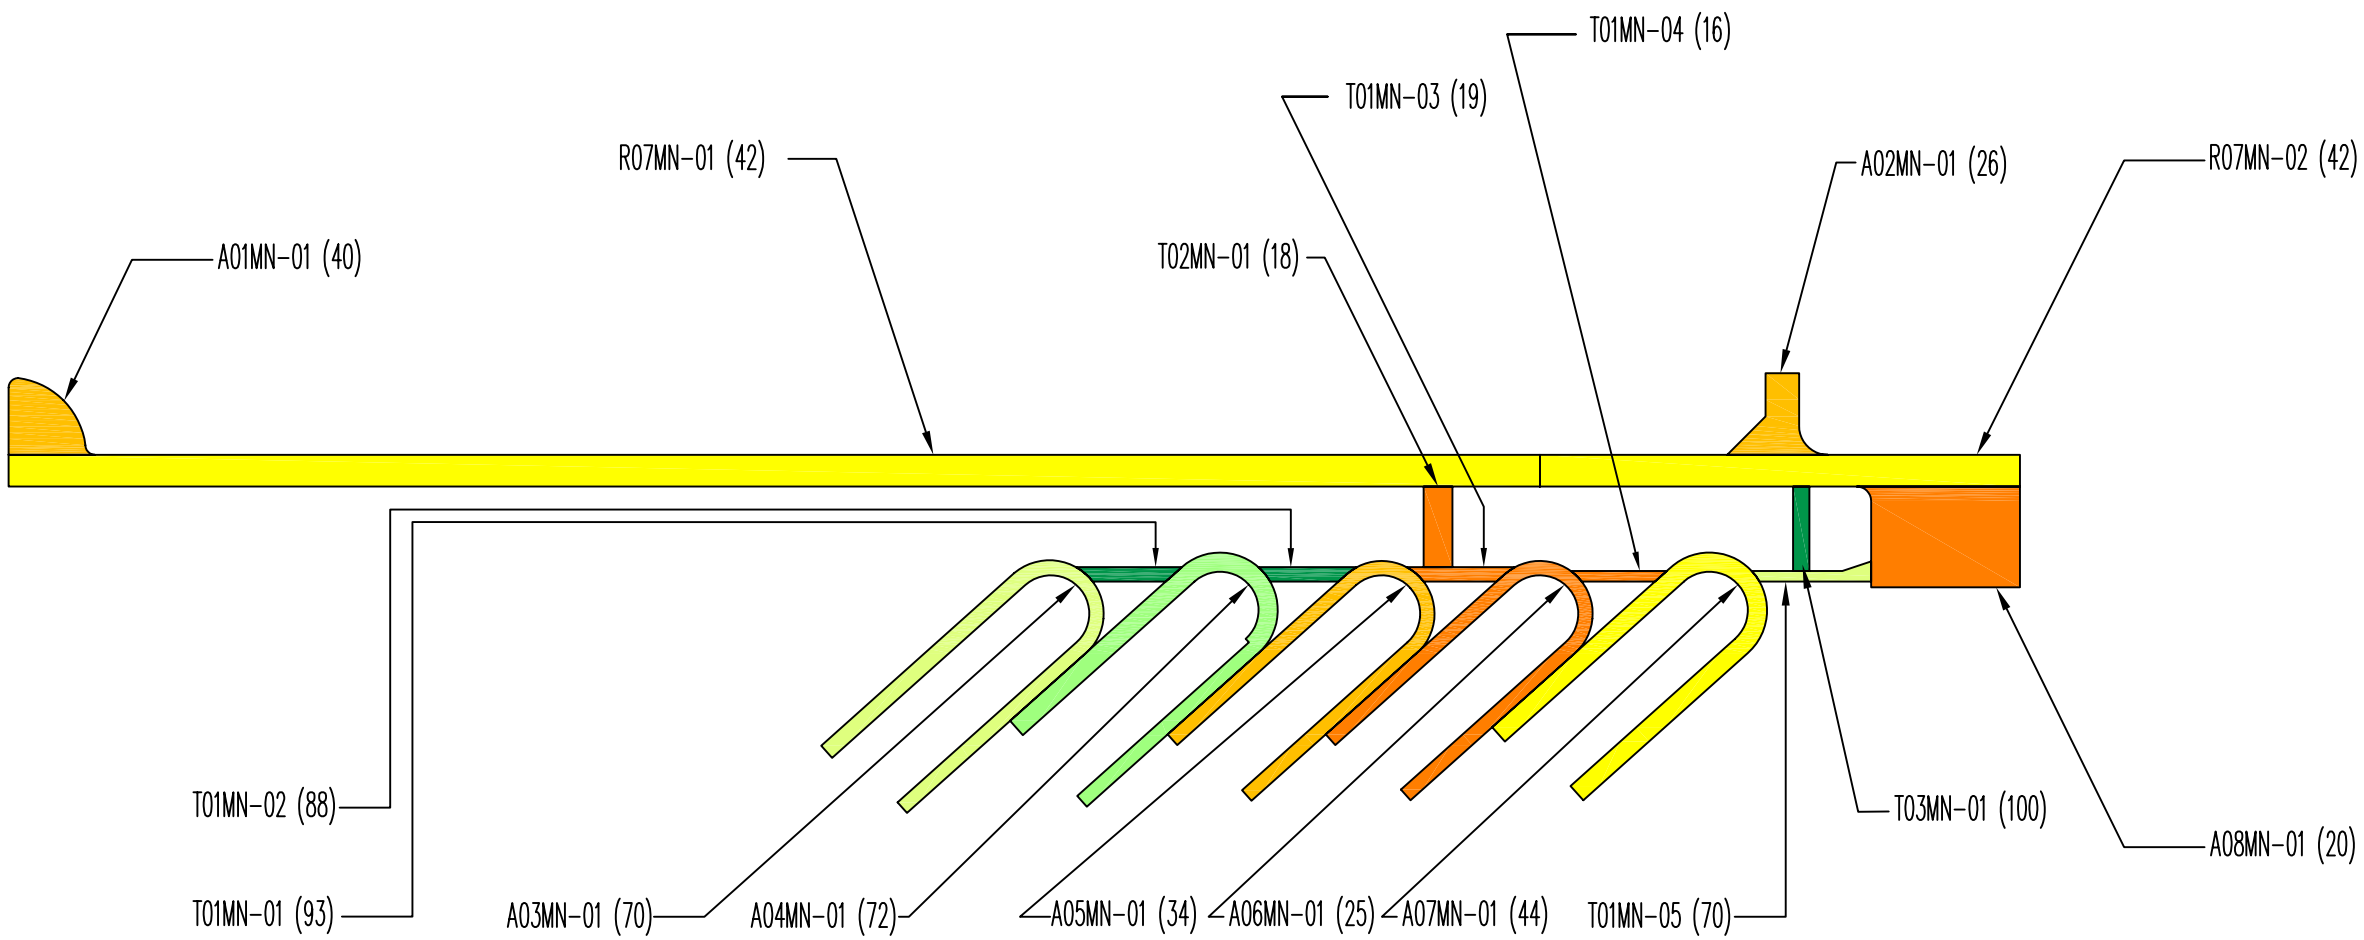
LOCATION: Firstair Field Airport, Monroe, Washington			
PAGE TITLE: 2005 Pavement Condition Index Map			
DRAWING SCALE: 1" = 200'	DATE: February 2006	REVISED BY: MK	DRAWN BY: MK
FILENAME: Monroe.dwg	AIRPORT ID: WA38	LAYOUT NAME/NUMBER: Monroe (PCI)	PAGE NUMBER: 9

Figures 6 and 7 summarize the overall condition of the pavements at the Firstair Field Airport. Figure 8 displays the condition of the pavements evaluated. Table 1 summarizes the results of the pavement evaluation. Appendix C presents photographs taken during the PCI inspection and Appendix D details the distresses observed during the visual survey.
