WHITMAN COUNTY MEMORIAL AIRPORT
2005 PAVEMENT MANAGEMENT REPORT

February 2006

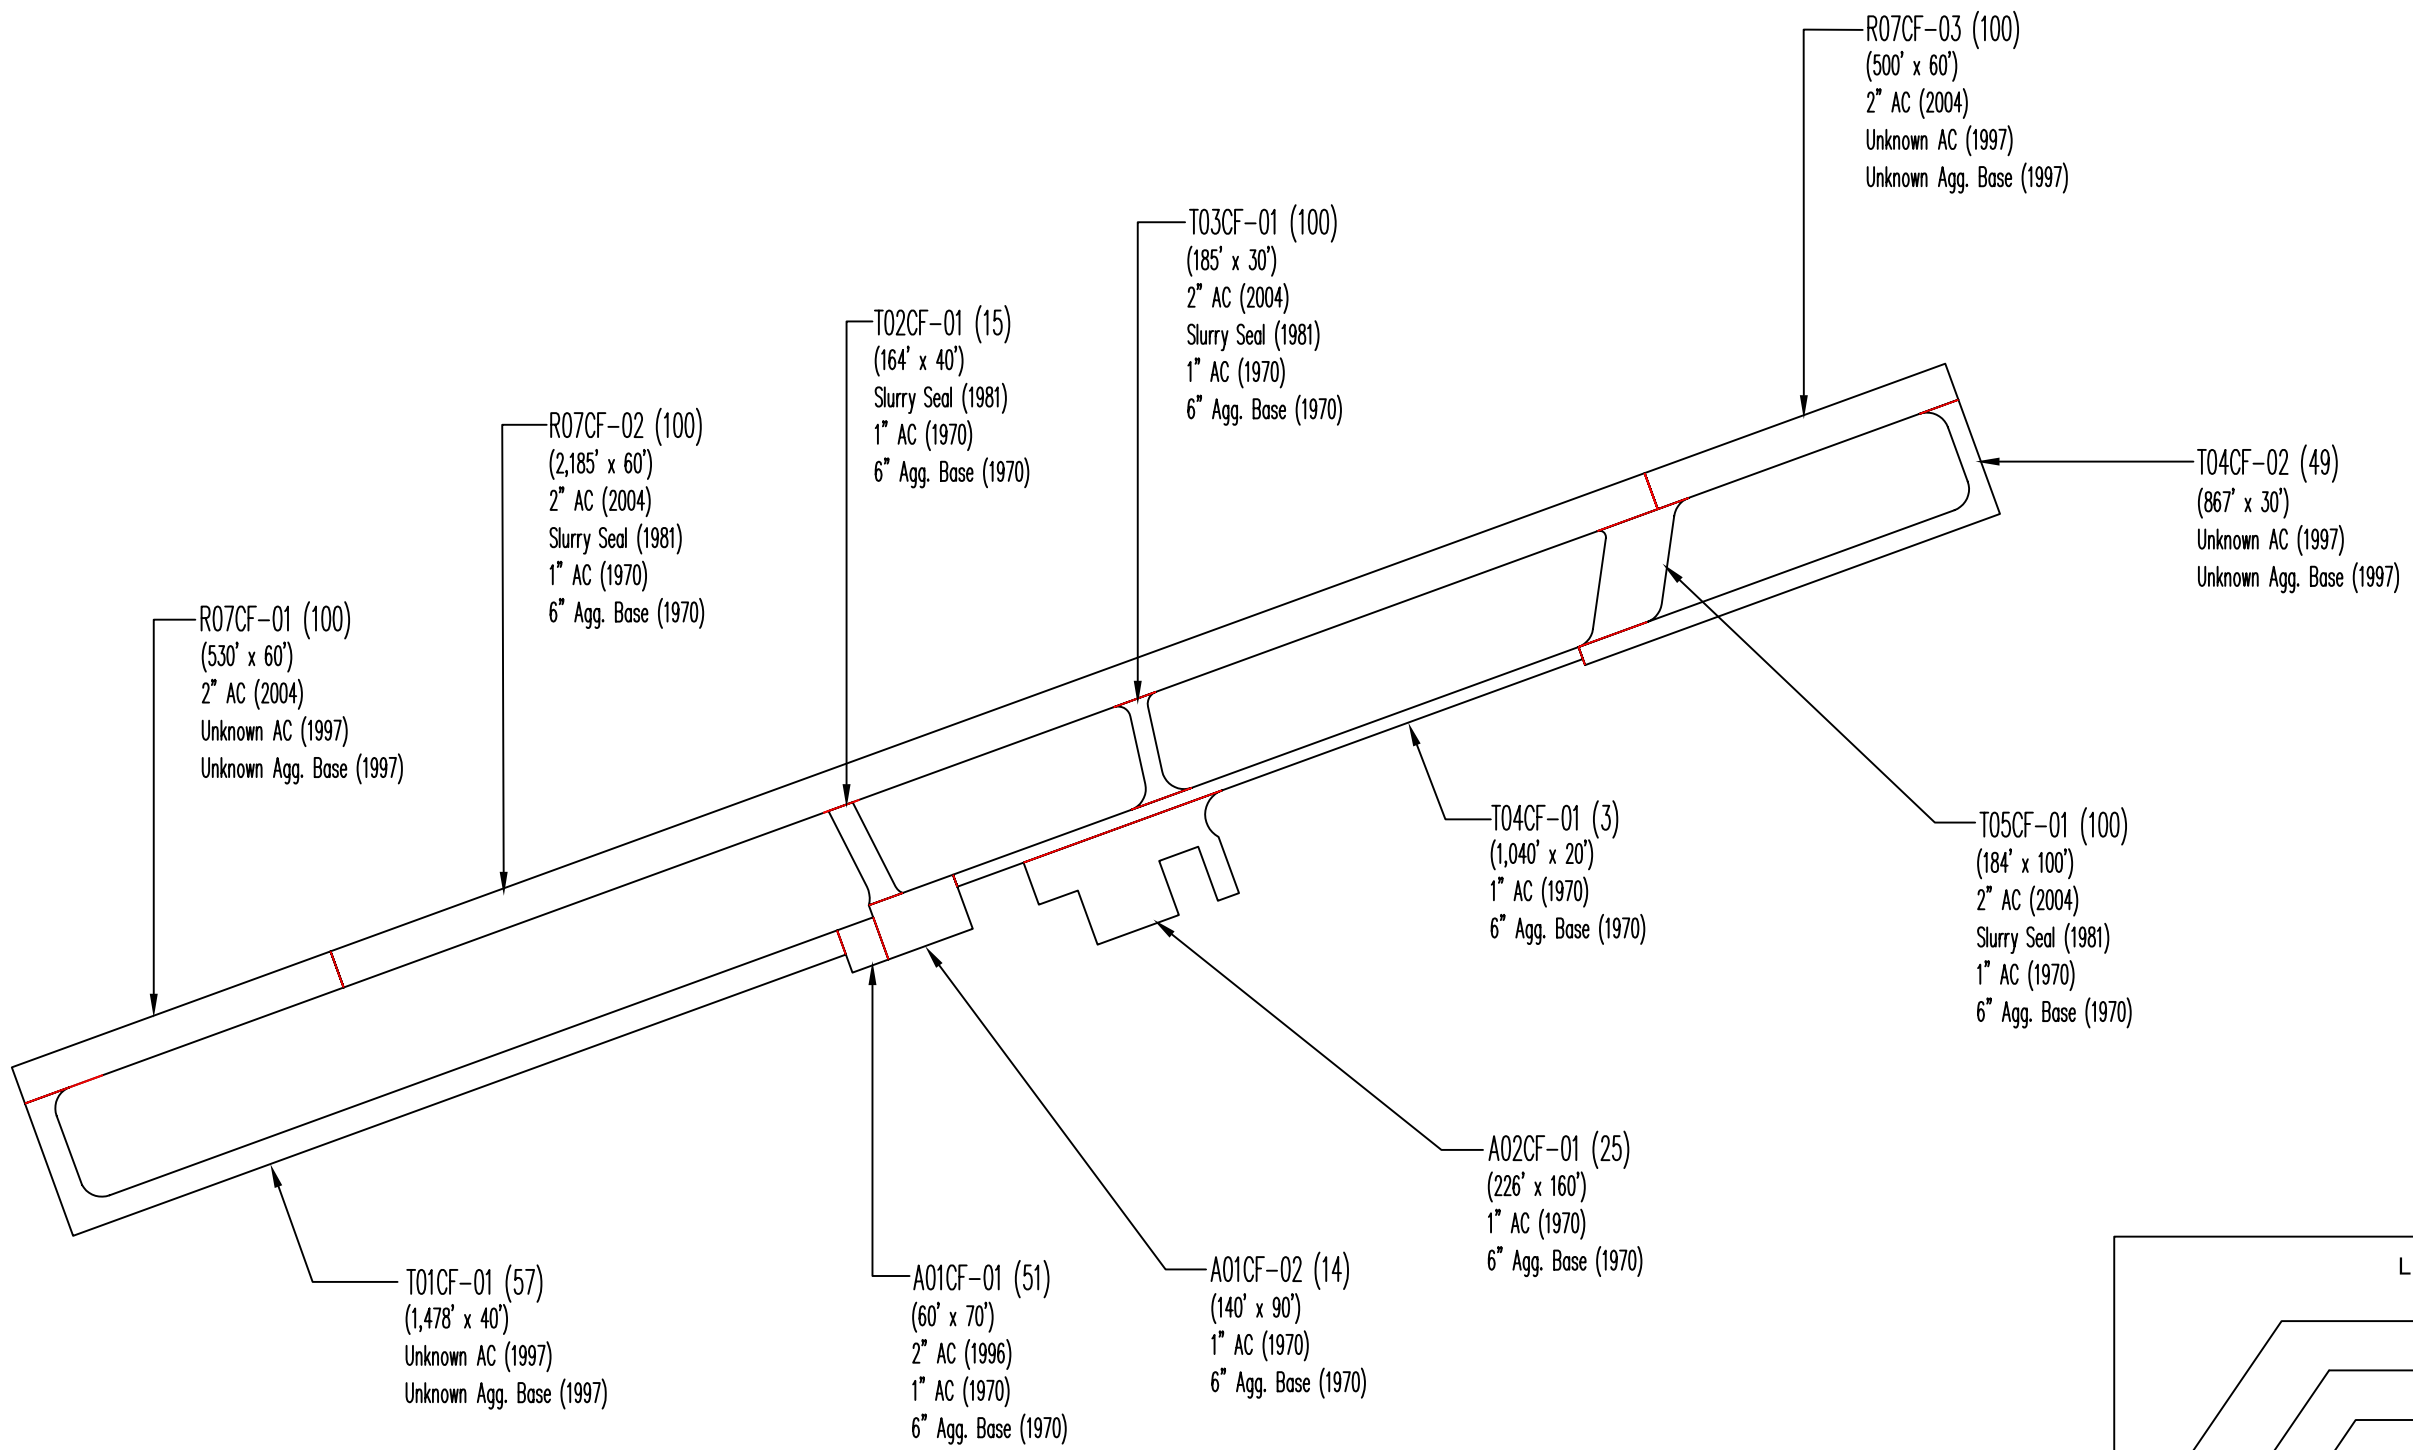
LOCATION: Port of Whitman Business Air Center Airport, Colfax, Washington			
PAGE TITLE: 2005 Work History Map			
DRAWING SCALE: 1" = 300'	DATE: February 2006	REVISED BY: AM	DRAWN BY: AM
FILENAME: Colfax (Whitman County).dwg	AIRPORT ID: S94	LAYOUT NAME/NUMBER: Colfax (WH)	PAGE NUMBER: 4

Figure 3 presents the records review results in the form of a work history map. The work history information and the Micro PAVER database (see the inside back cover of this report) ensure that your airport complies with the "pavement inventory" and "record keeping and information retrieval" requirements of FAA Grant Assurance 11 (discussed later in the section of this report entitled *Public Law 103-305*).

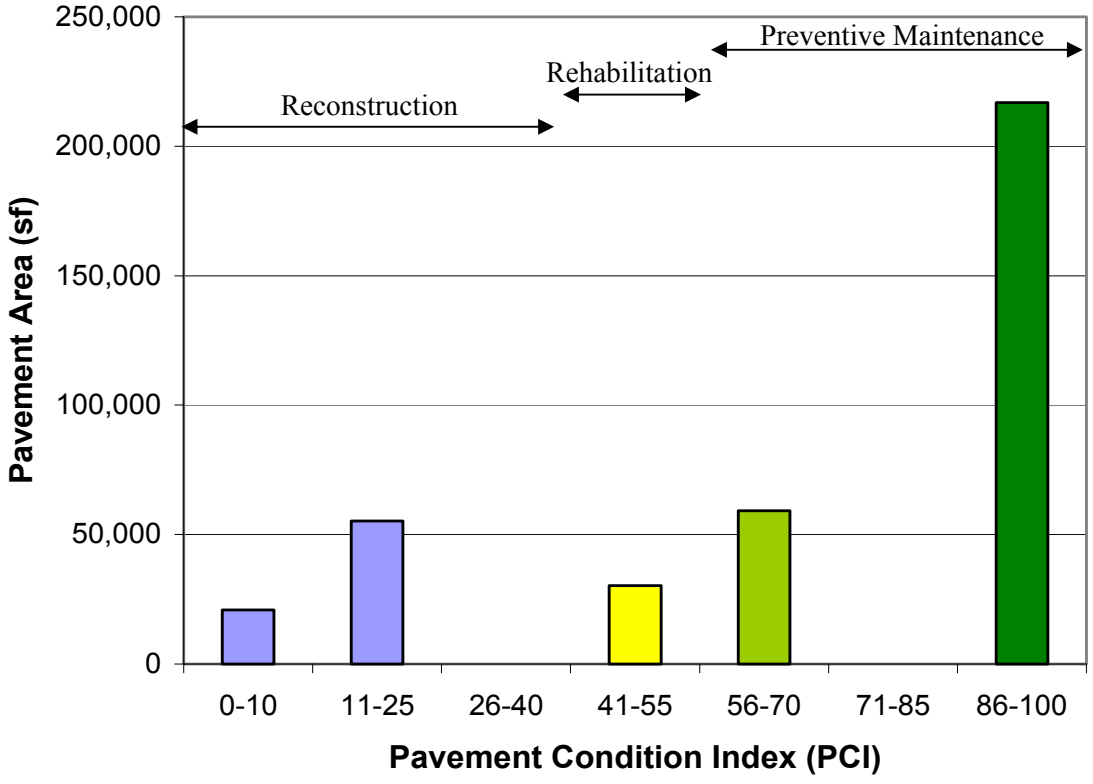
Figure 6. Whitman County Memorial Airport overall condition.

The pavements at Whitman County Memorial Airport were inspected on May 24, 2005. The 2005 area-weighted condition of Whitman County Memorial Airport is 73, with conditions ranging from 3 to 100 (on a scale of 0 [failed] to 100 [excellent]). During the previous inspection in 1999, the area-weighted condition was 47.

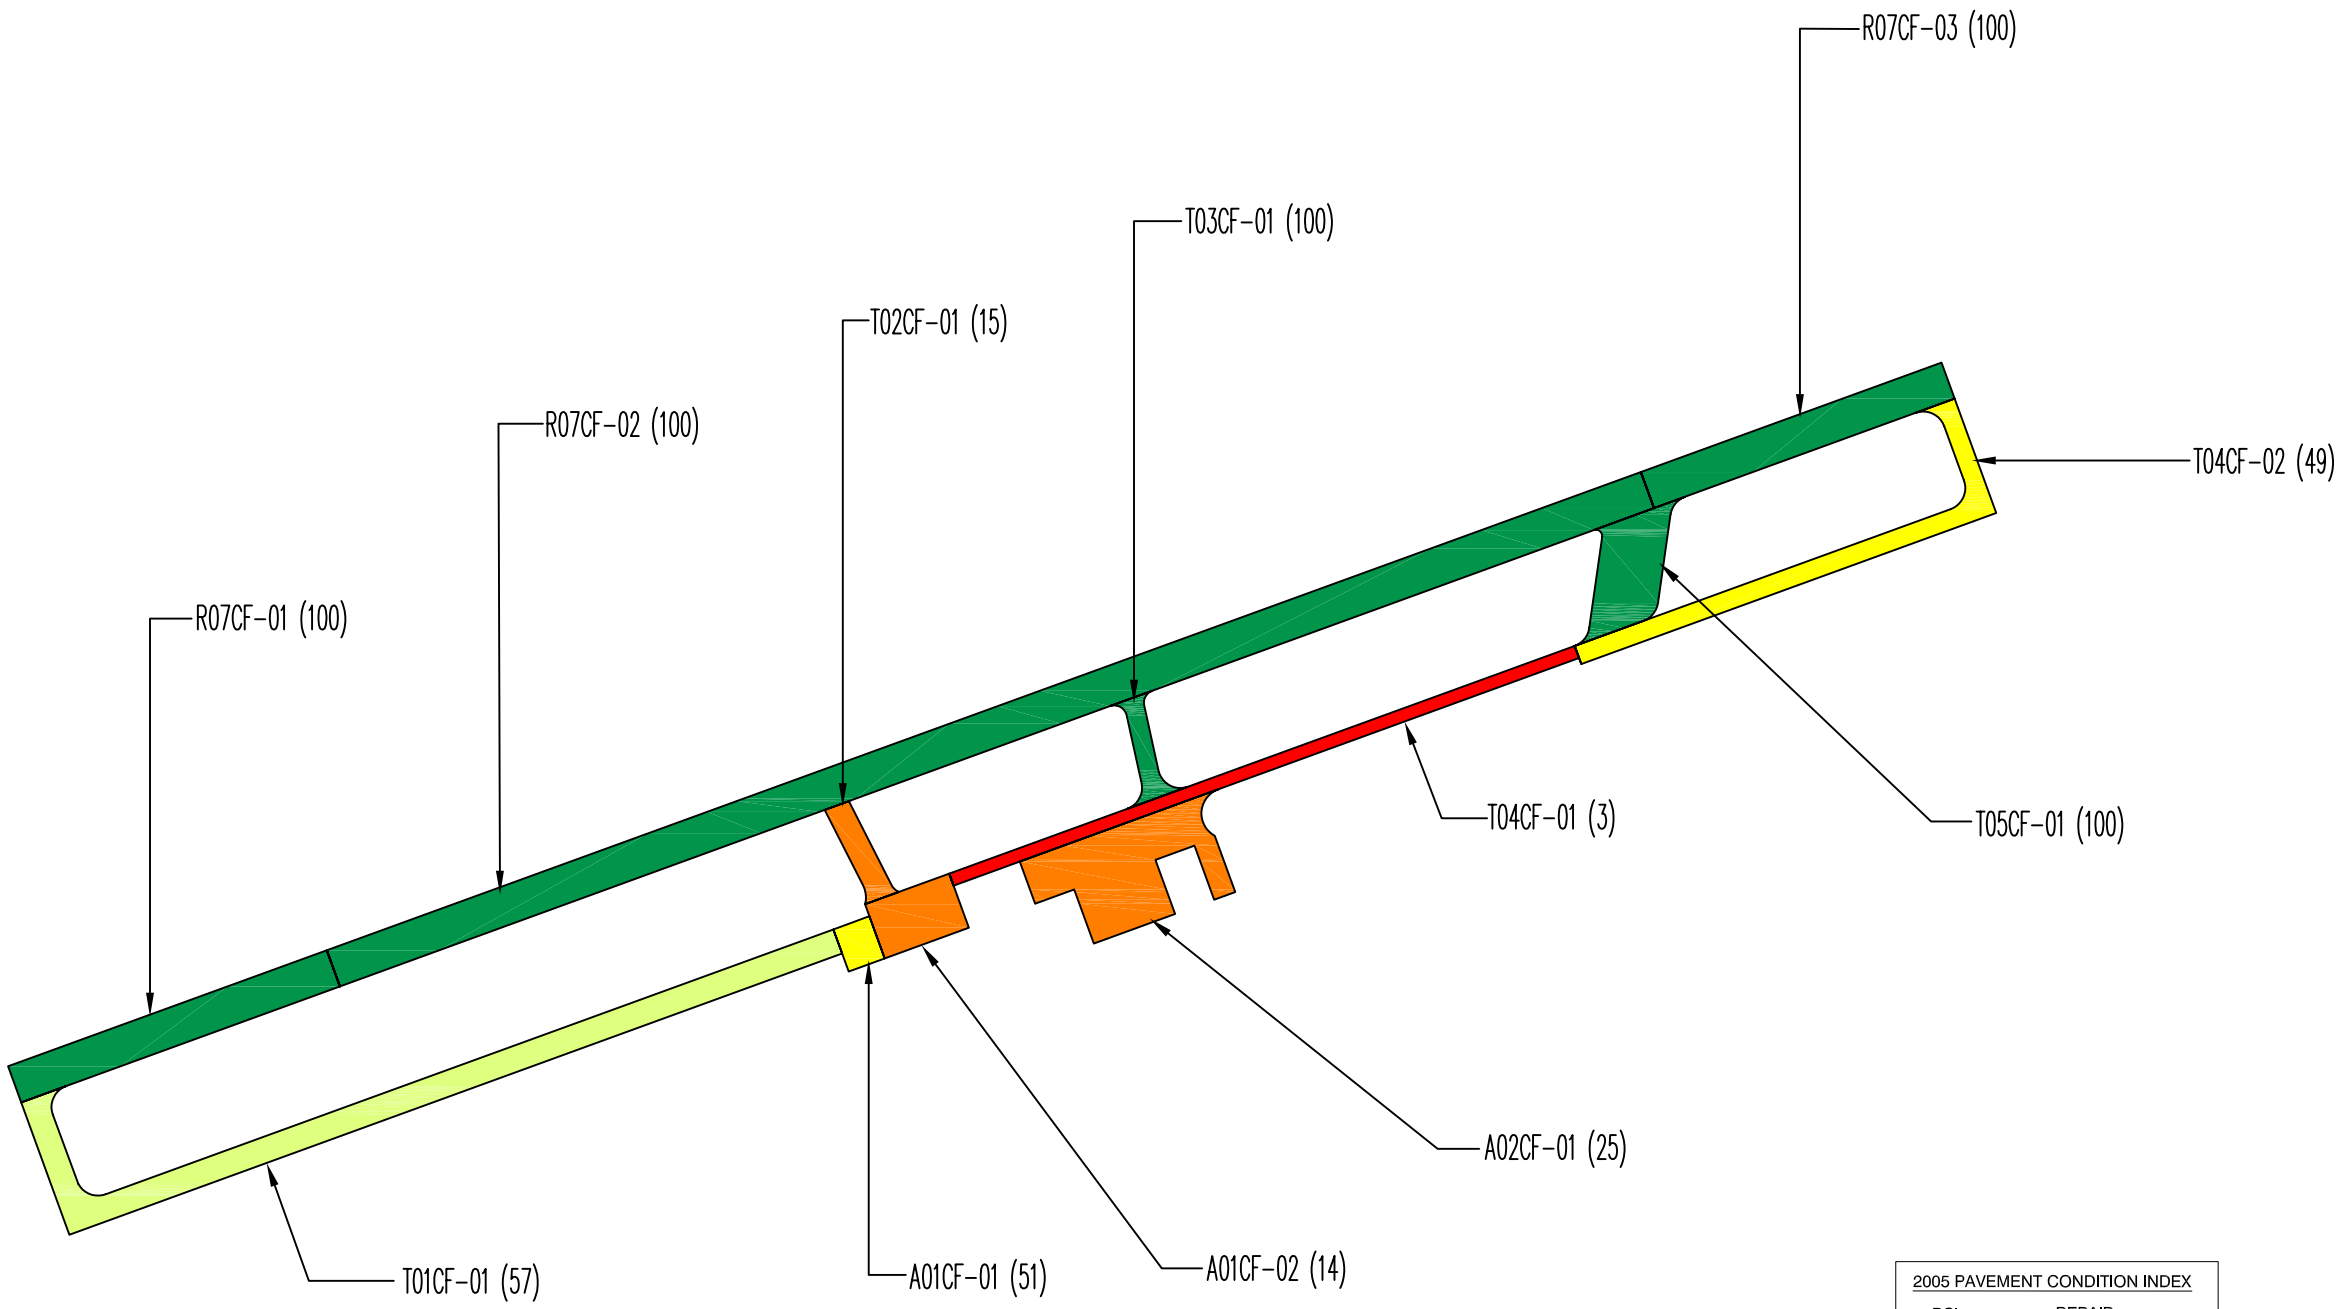
Figures 6 and 7 summarize the overall condition of the pavements at the Whitman County Memorial Airport. Figure 8 displays the condition of the pavements evaluated. Table 1 summarizes the results of the pavement evaluation. Appendix C presents photographs taken during the PCI inspection and Appendix D details the distresses observed during the visual survey.

LOCATION: Port of Whitman Business Air Center Airport, Colfax, Washington			
PAGE TITLE: 2005 Pavement Condition Index Map			
DRAWING SCALE: 1" = 300'	DATE: February 2006	REVISED BY: AM	DRAWN BY: AM
FILENAME: Colfax (Whitman County).dwg	AIRPORT ID: S94	LAYOUT NAME/NUMBER: Colfax (PCI)	PAGE NUMBER: 9
