VISTA FIELD AIRPORT
2005 PAVEMENT MANAGEMENT REPORT

Applied Pavement Technology, Inc.
3001 Research Road, Suite C
Champaign, Illinois 61822
217-398-3977
www.pavementsolutions.com

February 2006

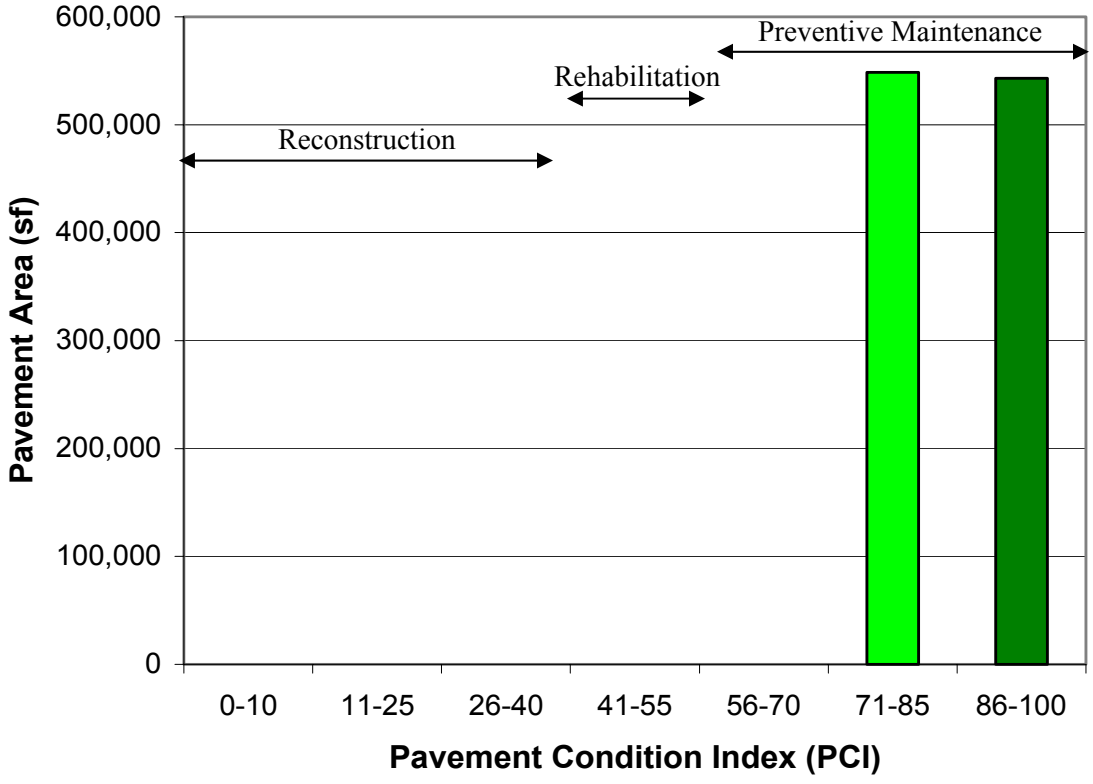
The pavements at Vista Field Airport were inspected on April 14, 2005. The 2005 area-weighted condition of Vista Field Airport is 86, with conditions ranging from 74 to 100 (on a scale of 0 [failed] to 100 [excellent]). During the previous inspection in 1999, the area-weighted condition was 96.

Figure 6. Vista Field Airport overall condition.

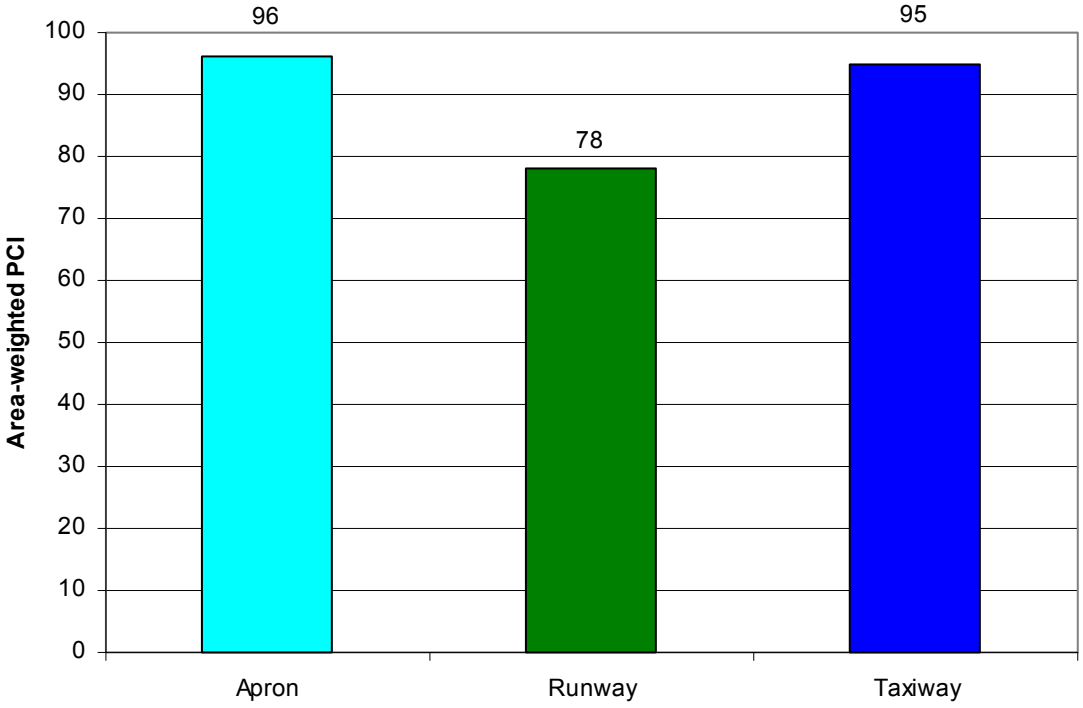
Figure 7. Vista Field Airport area-weighted PCI by use.

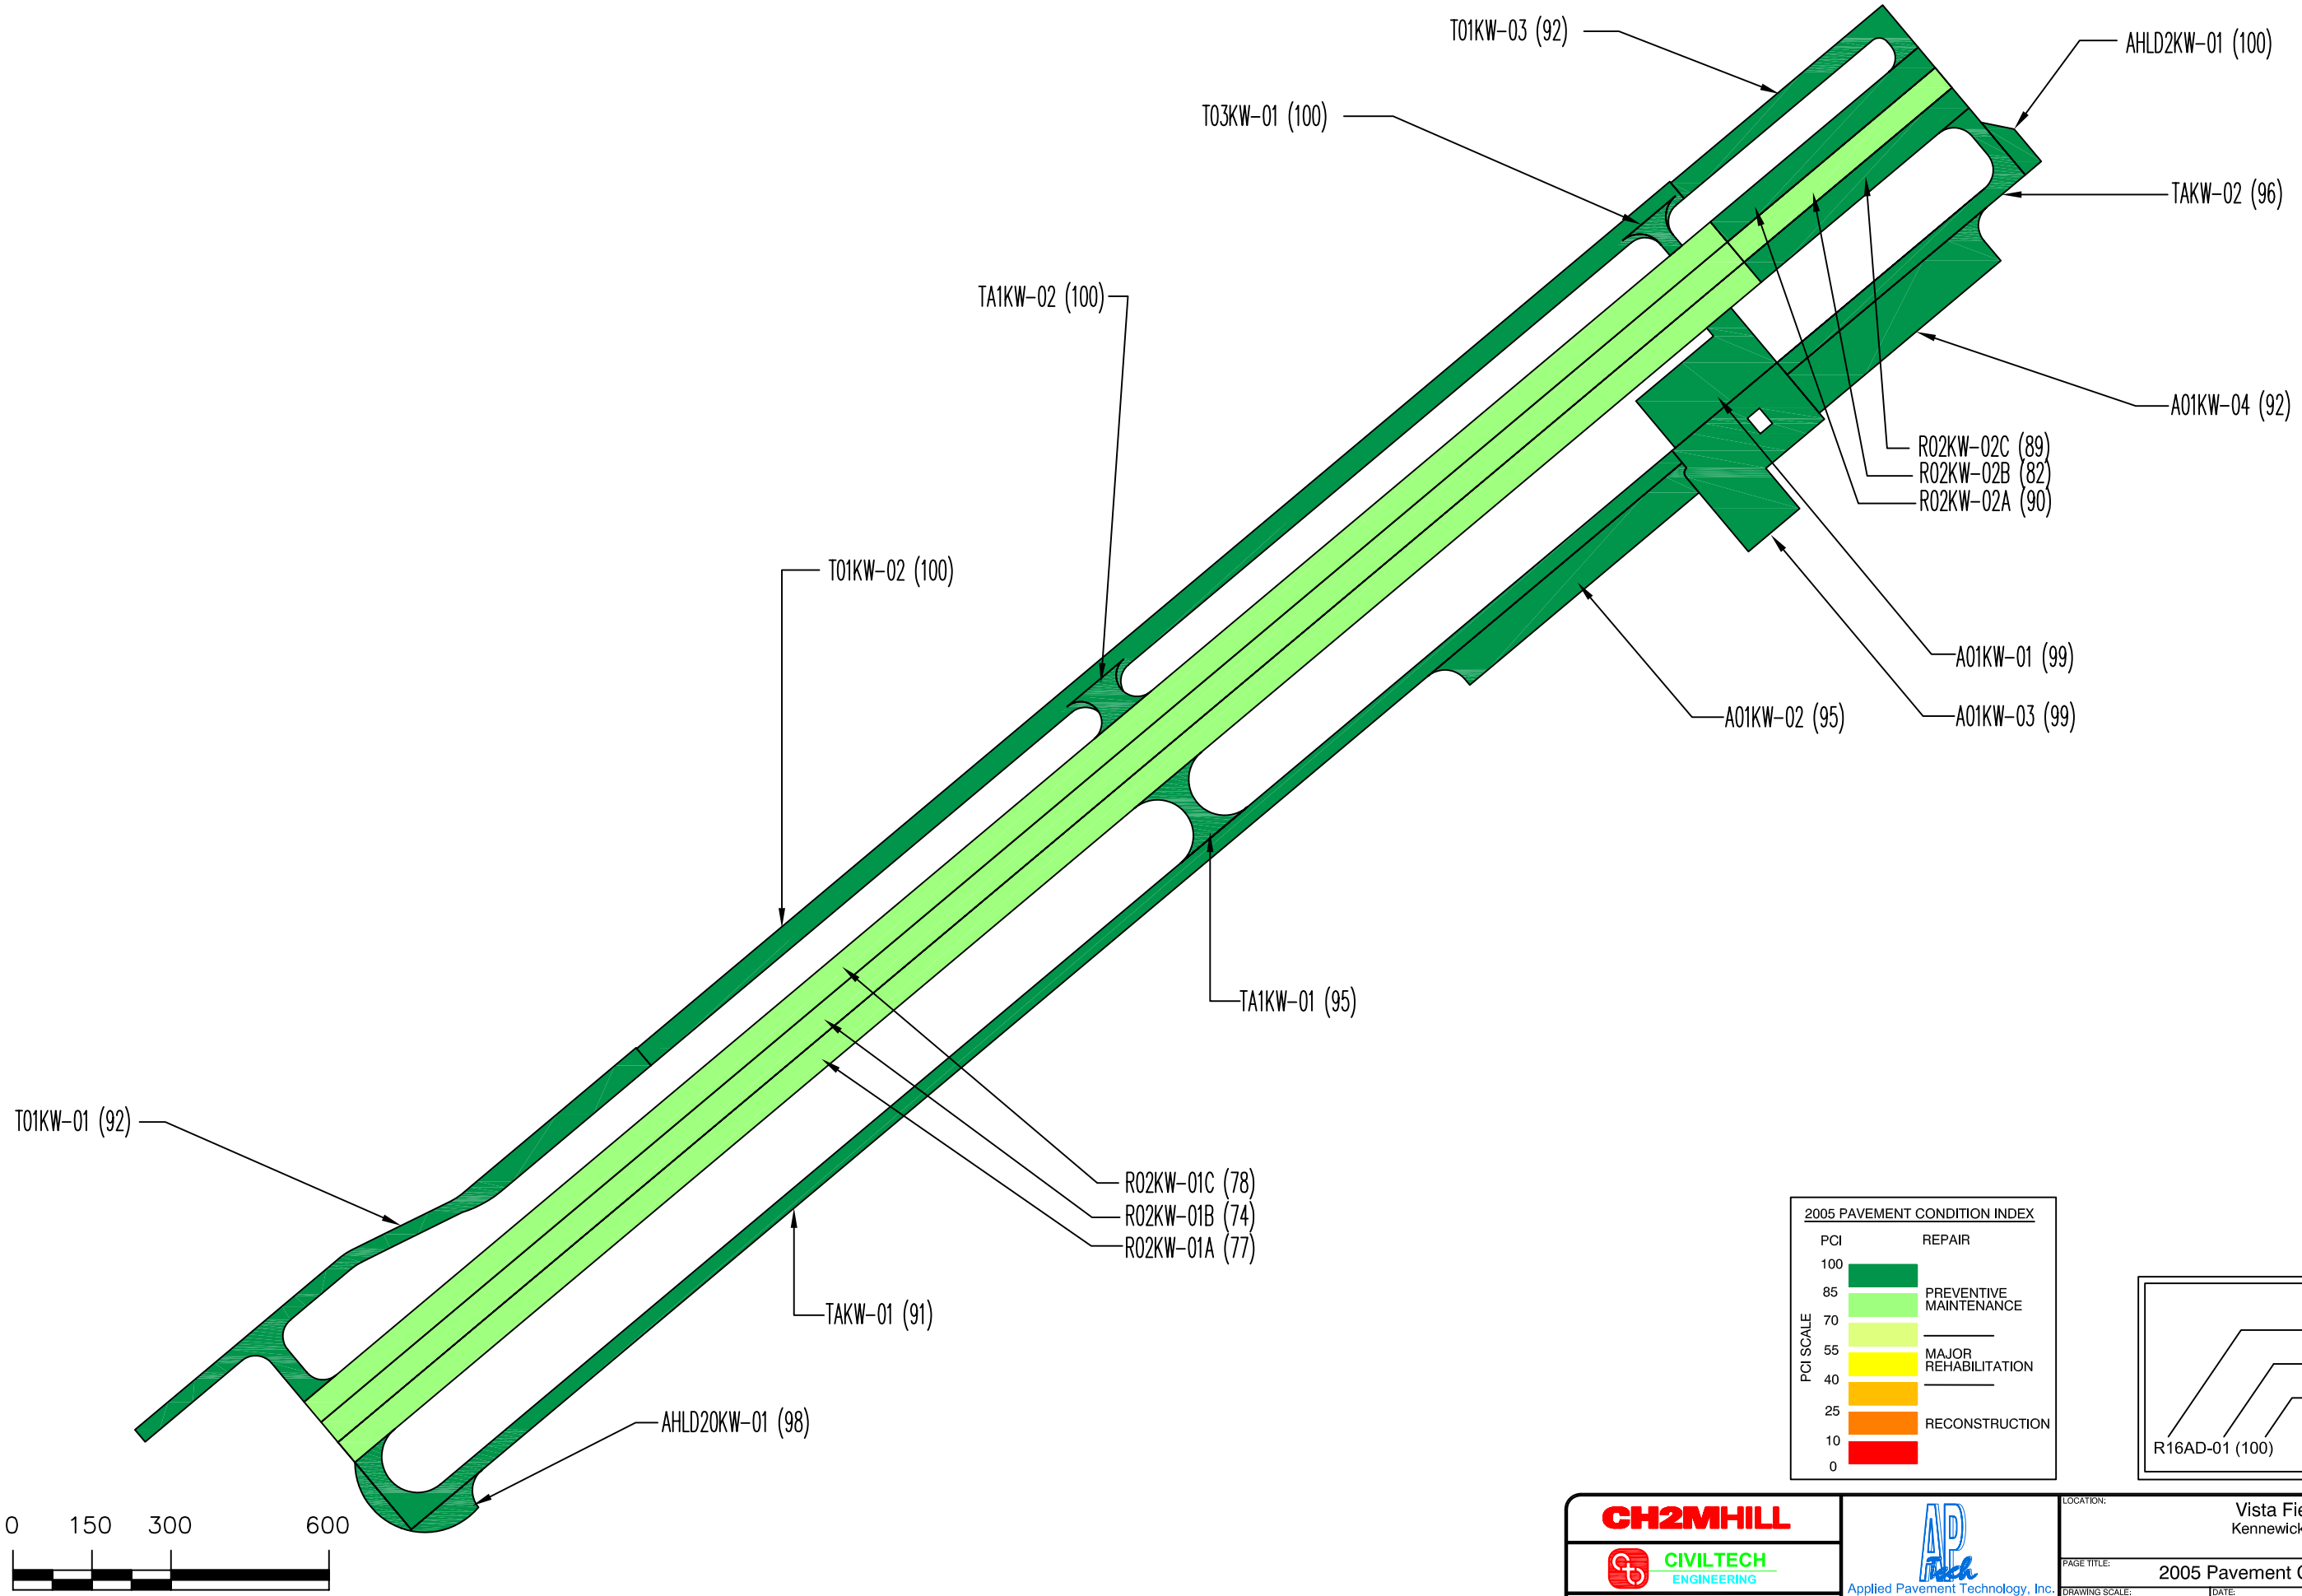
PAGE TITLE: 2005 Pavement Condition Index Map

Figures 6 and 7 summarize the overall condition of the pavements at the Vista Field Airport. Figure 8 displays the condition of the pavements evaluated. Table 1 summarizes the results of the pavement evaluation. Appendix C presents photographs taken during the PCI inspection and Appendix D details the distresses observed during the visual survey.
