Siemens Marine Solutions
Commissioning & Field Services Report

Washington-State-Ferry, WSF "Tacoma" Investigation of "July-29th" Incident

Owner / Operator:	WSF
Vessel Name:	"TACOMA"
IMO No.:	1052576
Contact Person:	Staff C/E Ben Davis
Work Location	Eagle Harbor
City / State / Zip:	Bainbridge, WAQ

Propulsion System Switchboard End 2

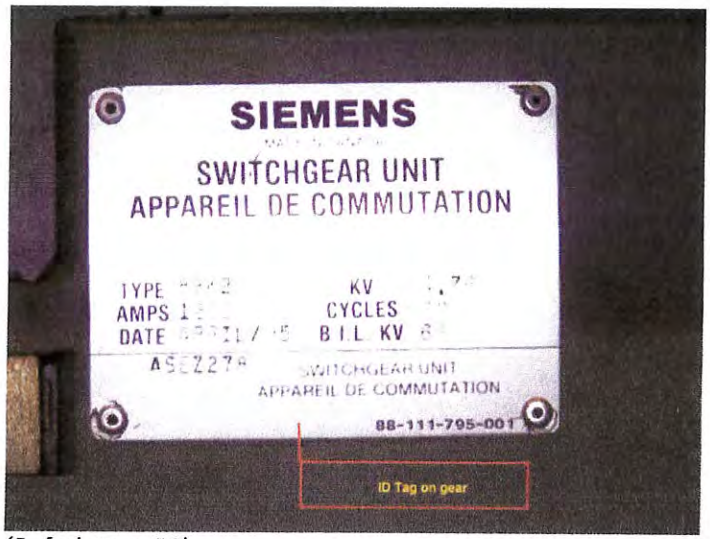
(Ref.picture #1)

- Switchgear was De-energized on arrival and the rear bottom panel covers were removed on sections 4 and 5 for (Gen # 4 and # 3)
- Feeder breakers for the Generators were removed, and so were the Surge arrestors and mounting bracket (Surge Arrestor were bad and the brackets were bent out of shape).
- Extensive damage in the rear of switchgear section 4 (Gen. #4) burnt insulators and melted disconnect contact fingers on all three phases,

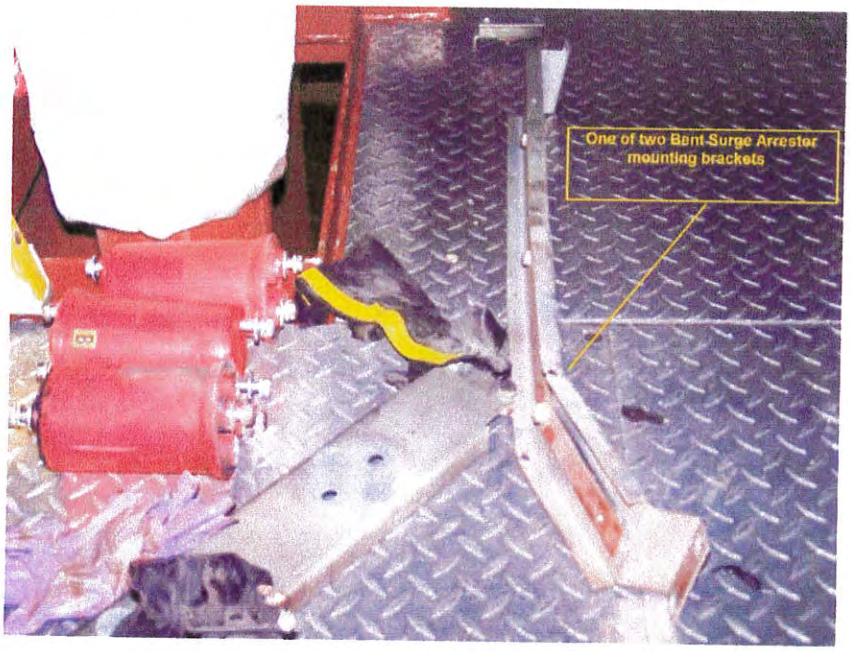
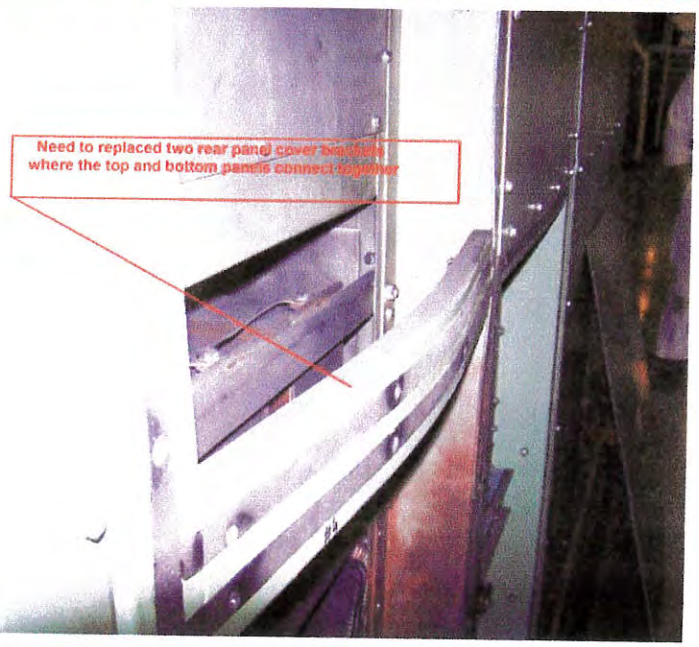
(Ref.picture #5and #6)

Mounting brackets for the surge arrestors and frame damage,

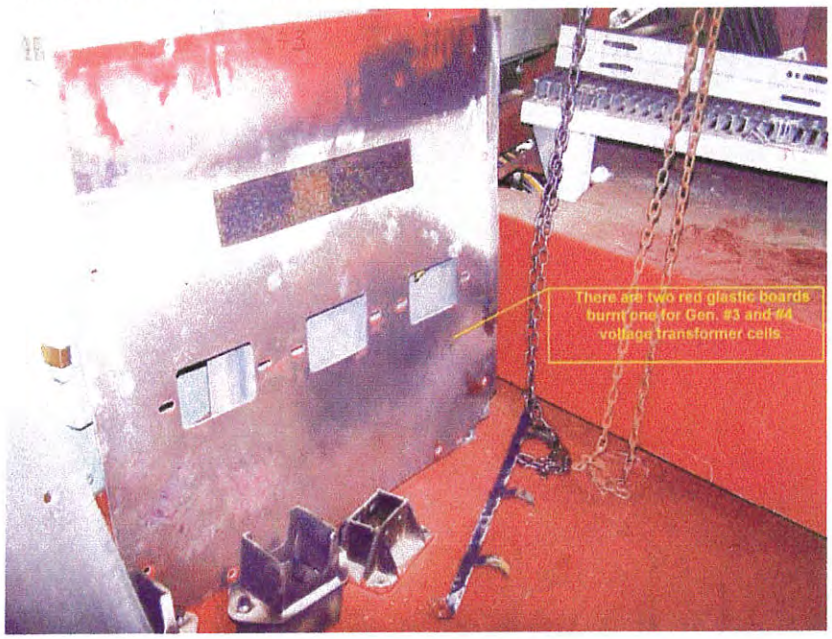
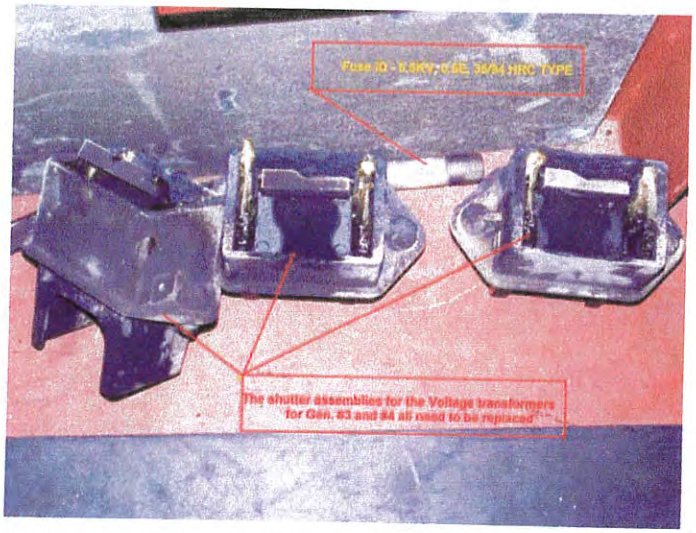
(Ref.picture #7, #8 and #9)

Red glastic boards with individual phase shutters badly burnt,

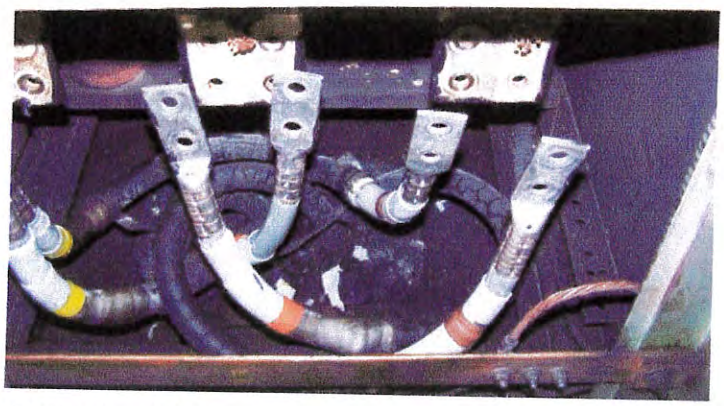
(Ref.picture #10)

5KV 500 Marine type cables with extra damage.

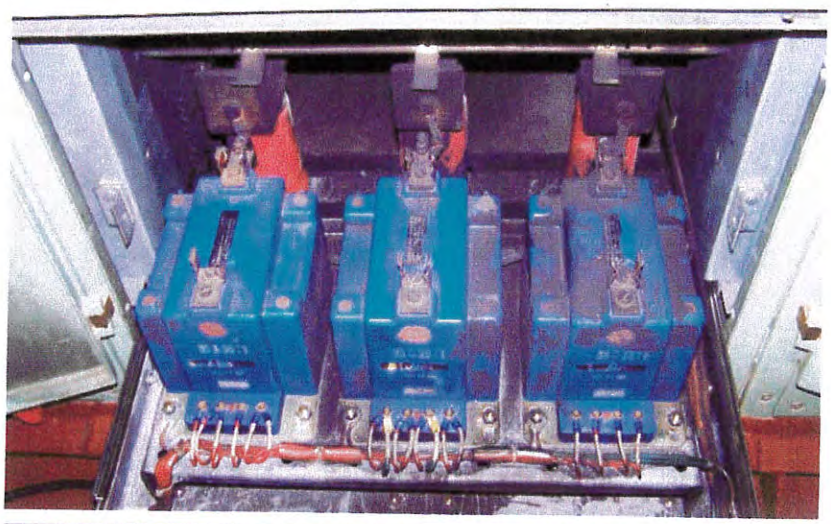
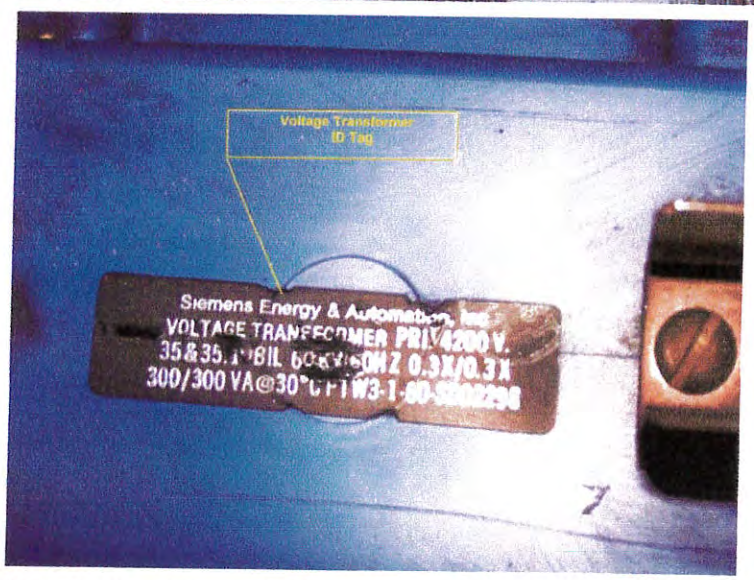
(Ref.picture #11and # 14)

- Damage in the Voltage Transformer drawer of switchgear section 4 (Gen. #4) burnt insulators, All three voltage transformers, and blown fuses,

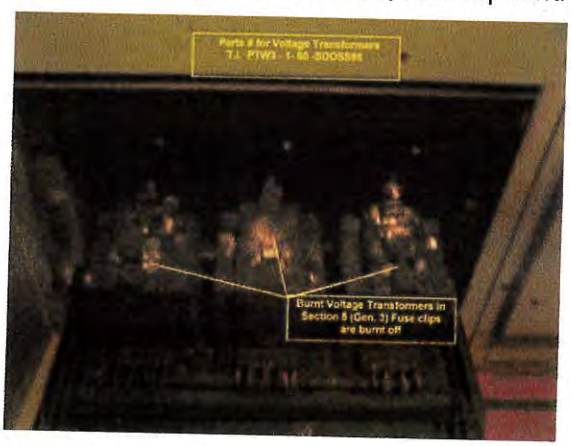
(Ref.picture #12)

- Extensive damage in the Voltage Transformer drawer of switchgear section 5 (Gen. #3);

All three Voltage Transformers, fuse clips and fuses, secondary control power wiring,

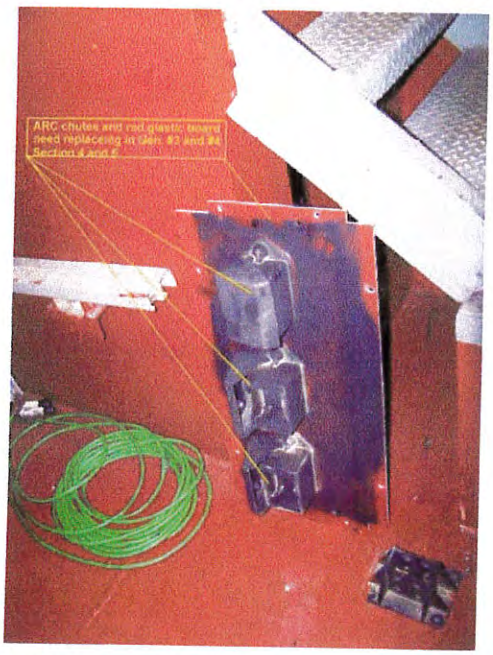
(Ref.picture #8)

Red glastic boards with individual phase shutters.

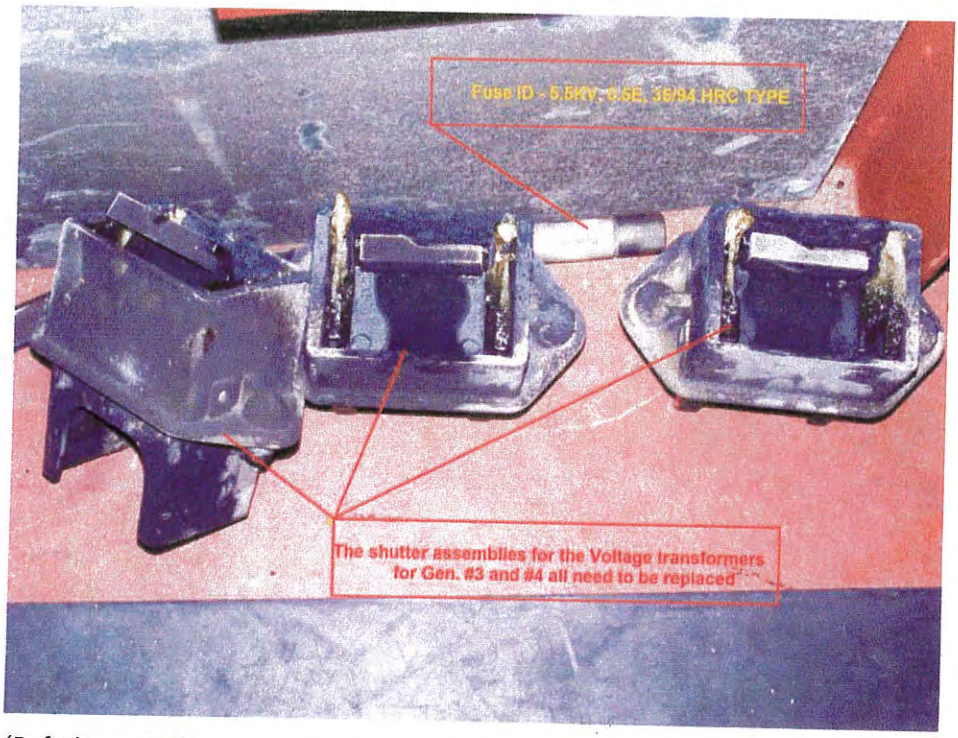
(Ref.picture #9)

5.5KV,0.5E, Type 35/94 HRC fuses
