FERRY COUNTY AIRPORT
2005 PAVEMENT MANAGEMENT REPORT

February 2006

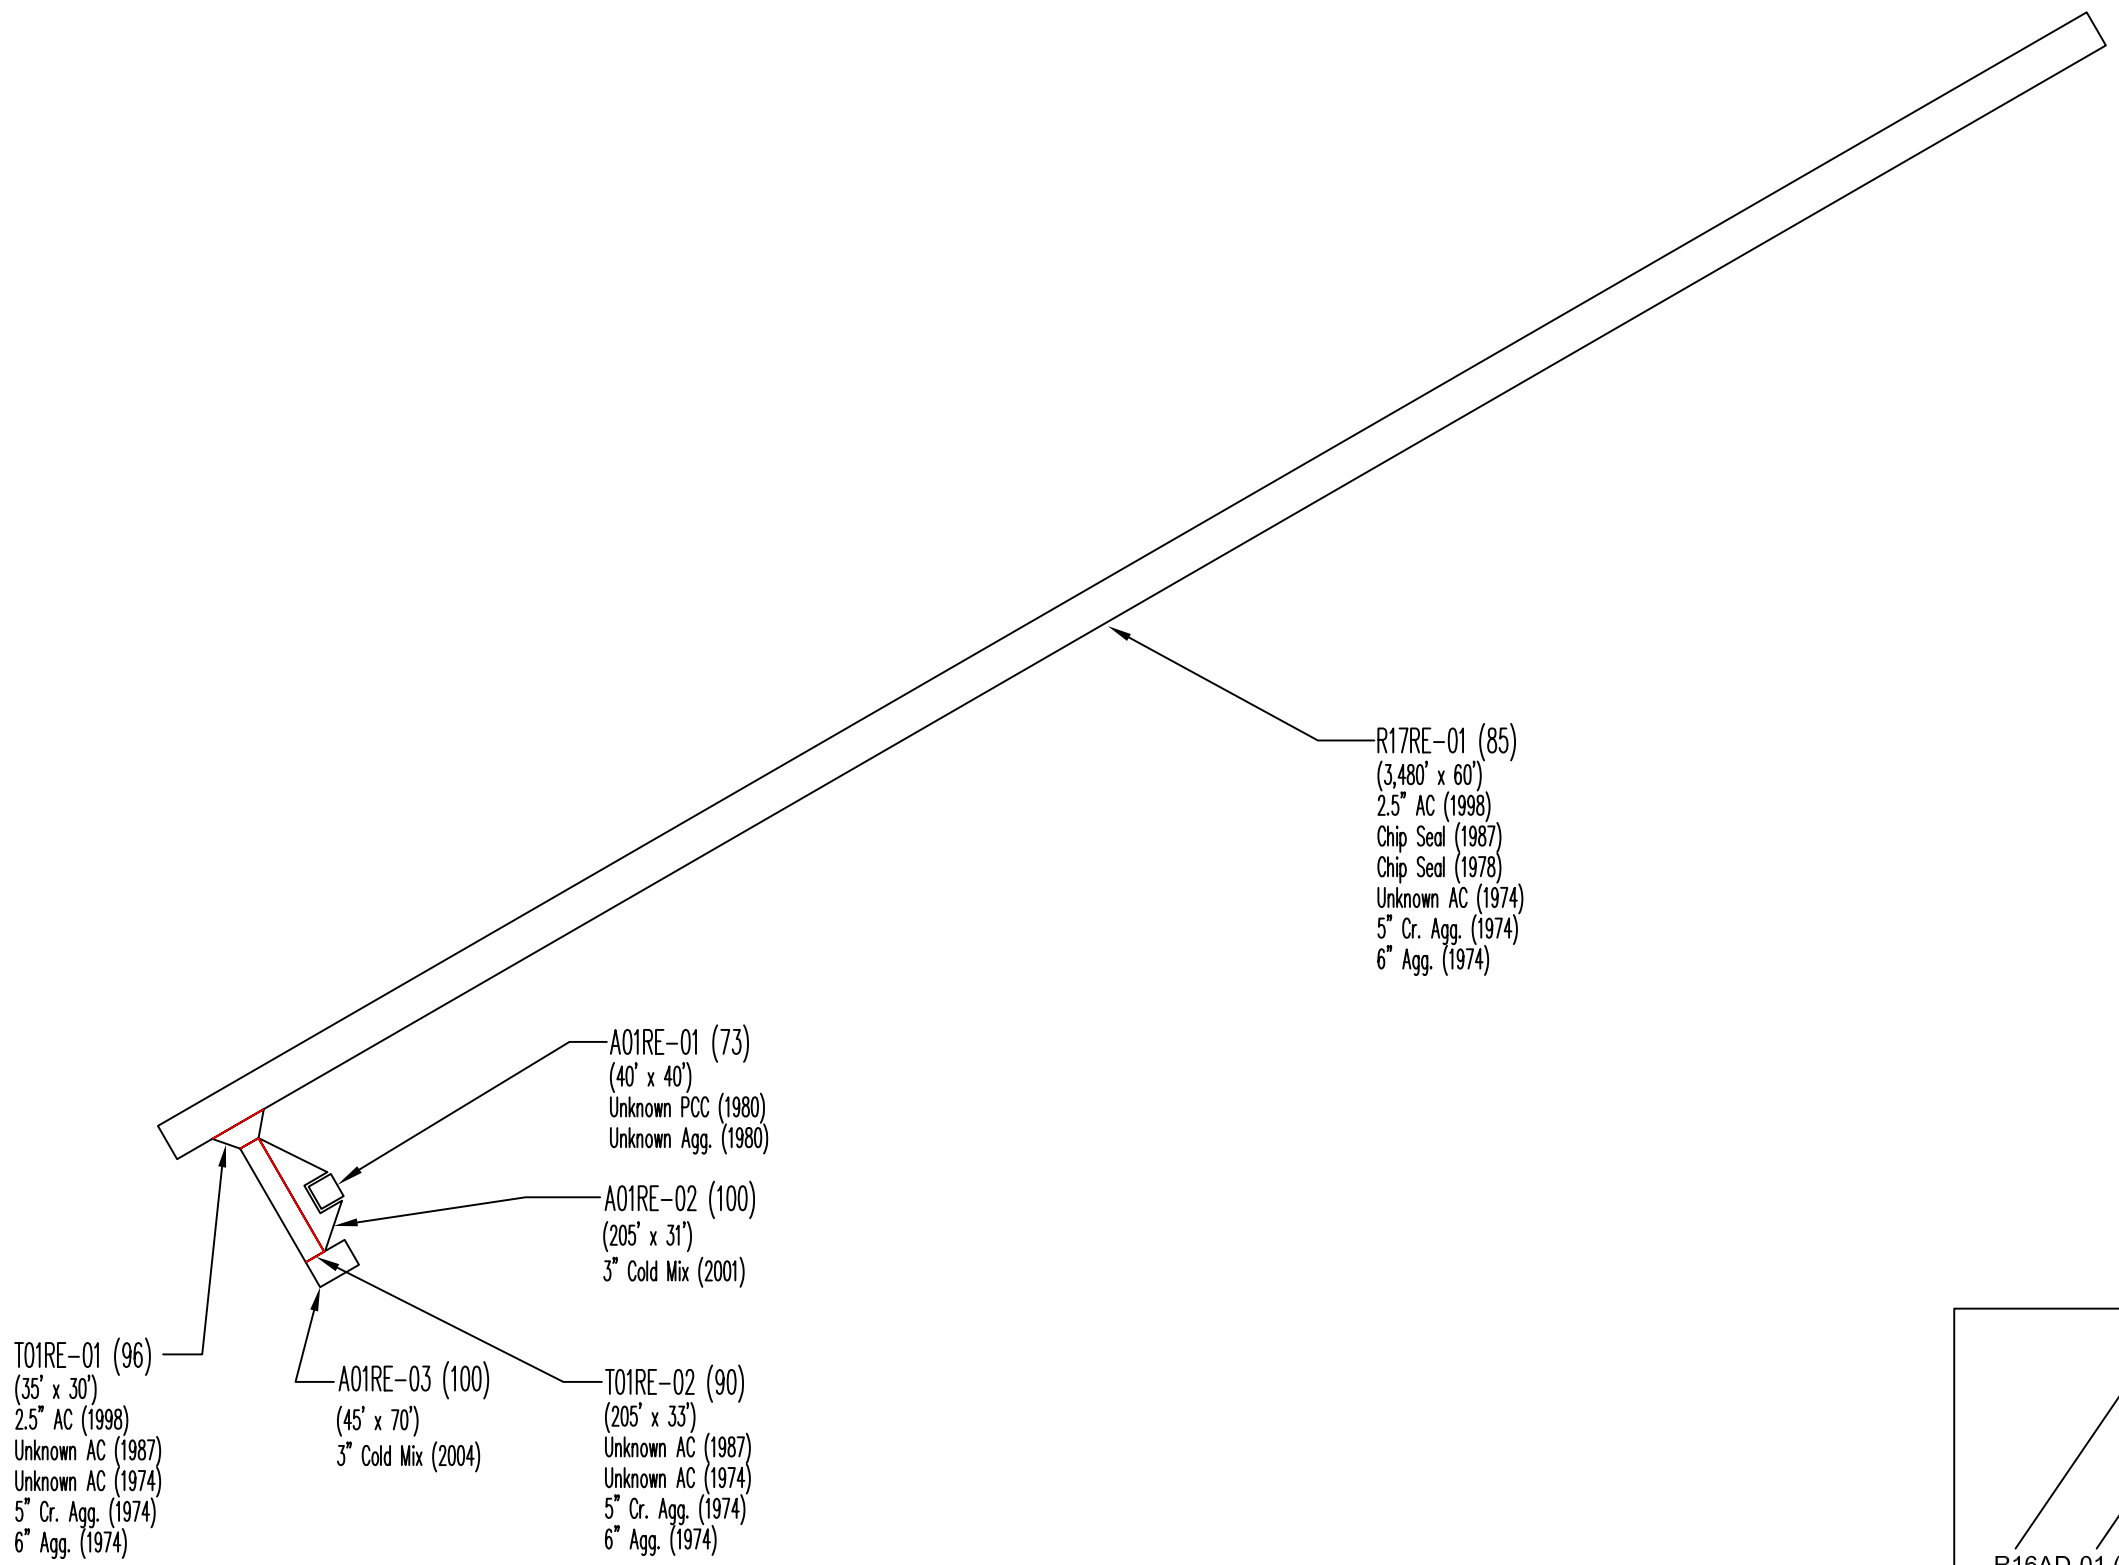
LOCATION: Ferry County Airport, Republic, Washington			
PAGE TITLE: 2005 Work History Map			
DRAWING SCALE: 1" = 300'	DATE: February 2006	REVISED BY: TJS	DRAWN BY: JR
FILENAME: Republic.dwg	AIRPORT ID: R49	LAYOUT NAME/NUMBER: Republic (WH)	PAGE NUMBER: 4

Figure 3 presents the records review results in the form of a work history map. The Micro PAVER database (see the inside back cover of this report) contains detailed inventory information about the pavement system at the airport.

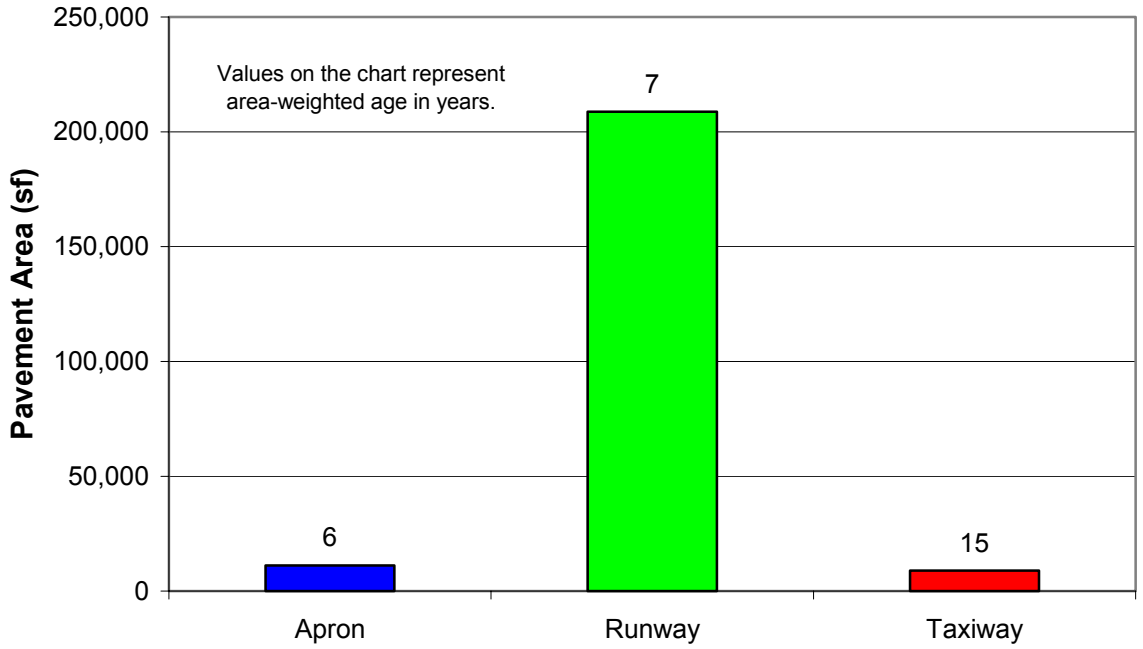
Figure 2. Ferry County Airport pavement inventory.

The review concluded that approximately 228,927 square feet of runway, taxiway, and apron pavements exist at Ferry County Airport, as shown in Figure 2. This figure also shows the average age of the pavements.

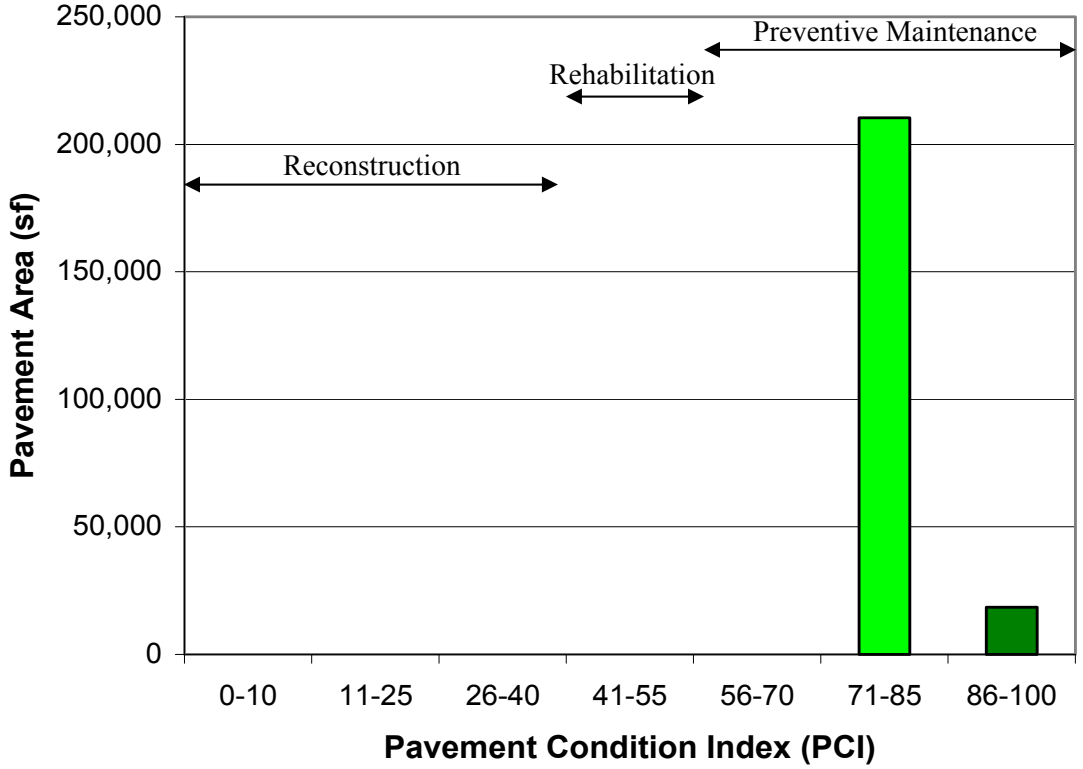
Figure 6. Ferry County Airport overall condition.

The pavements at Ferry County Airport were inspected on June 17, 2005. The 2005 area-weighted condition of Ferry County Airport is 86, with conditions ranging from 73 to 100 (on a scale of 0 [failed] to 100 [excellent]). During the previous inspection in 1999, the area-weighted condition was 94.

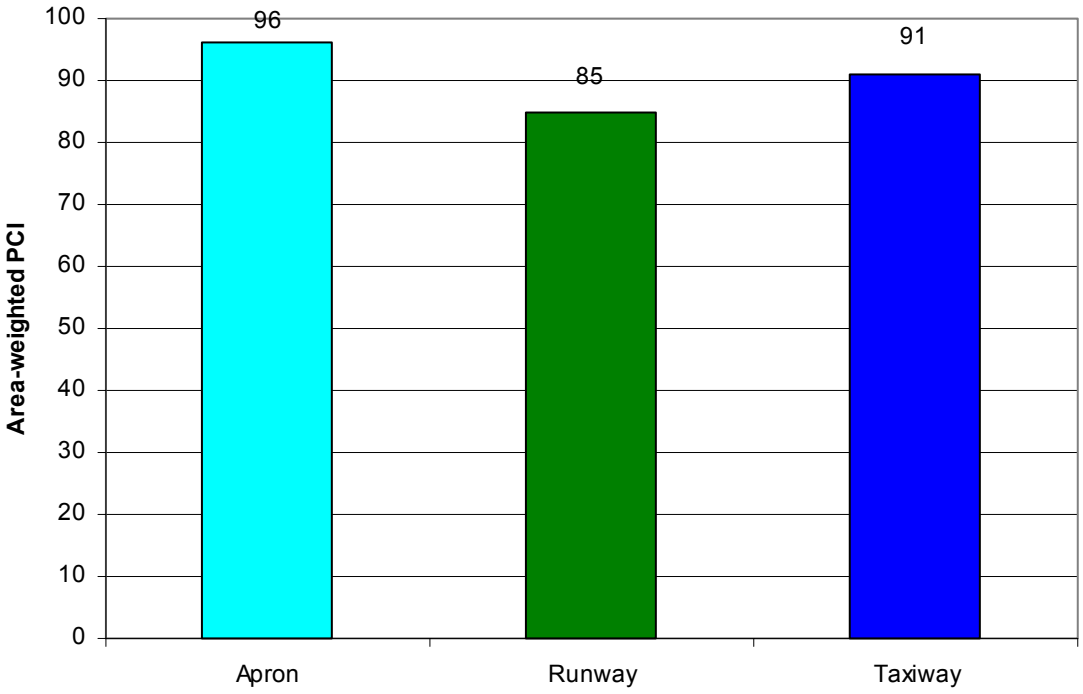
Figure 7. Ferry County Airport area-weighted PCI by use.

Figures 6 and 7 summarize the overall condition of the pavements at the Ferry County Airport. Figure 8 displays the condition of the pavements evaluated. Table 1 summarizes the results of the pavement evaluation. Appendix C presents photographs taken during the PCI inspection and Appendix D details the distresses observed during the visual survey.

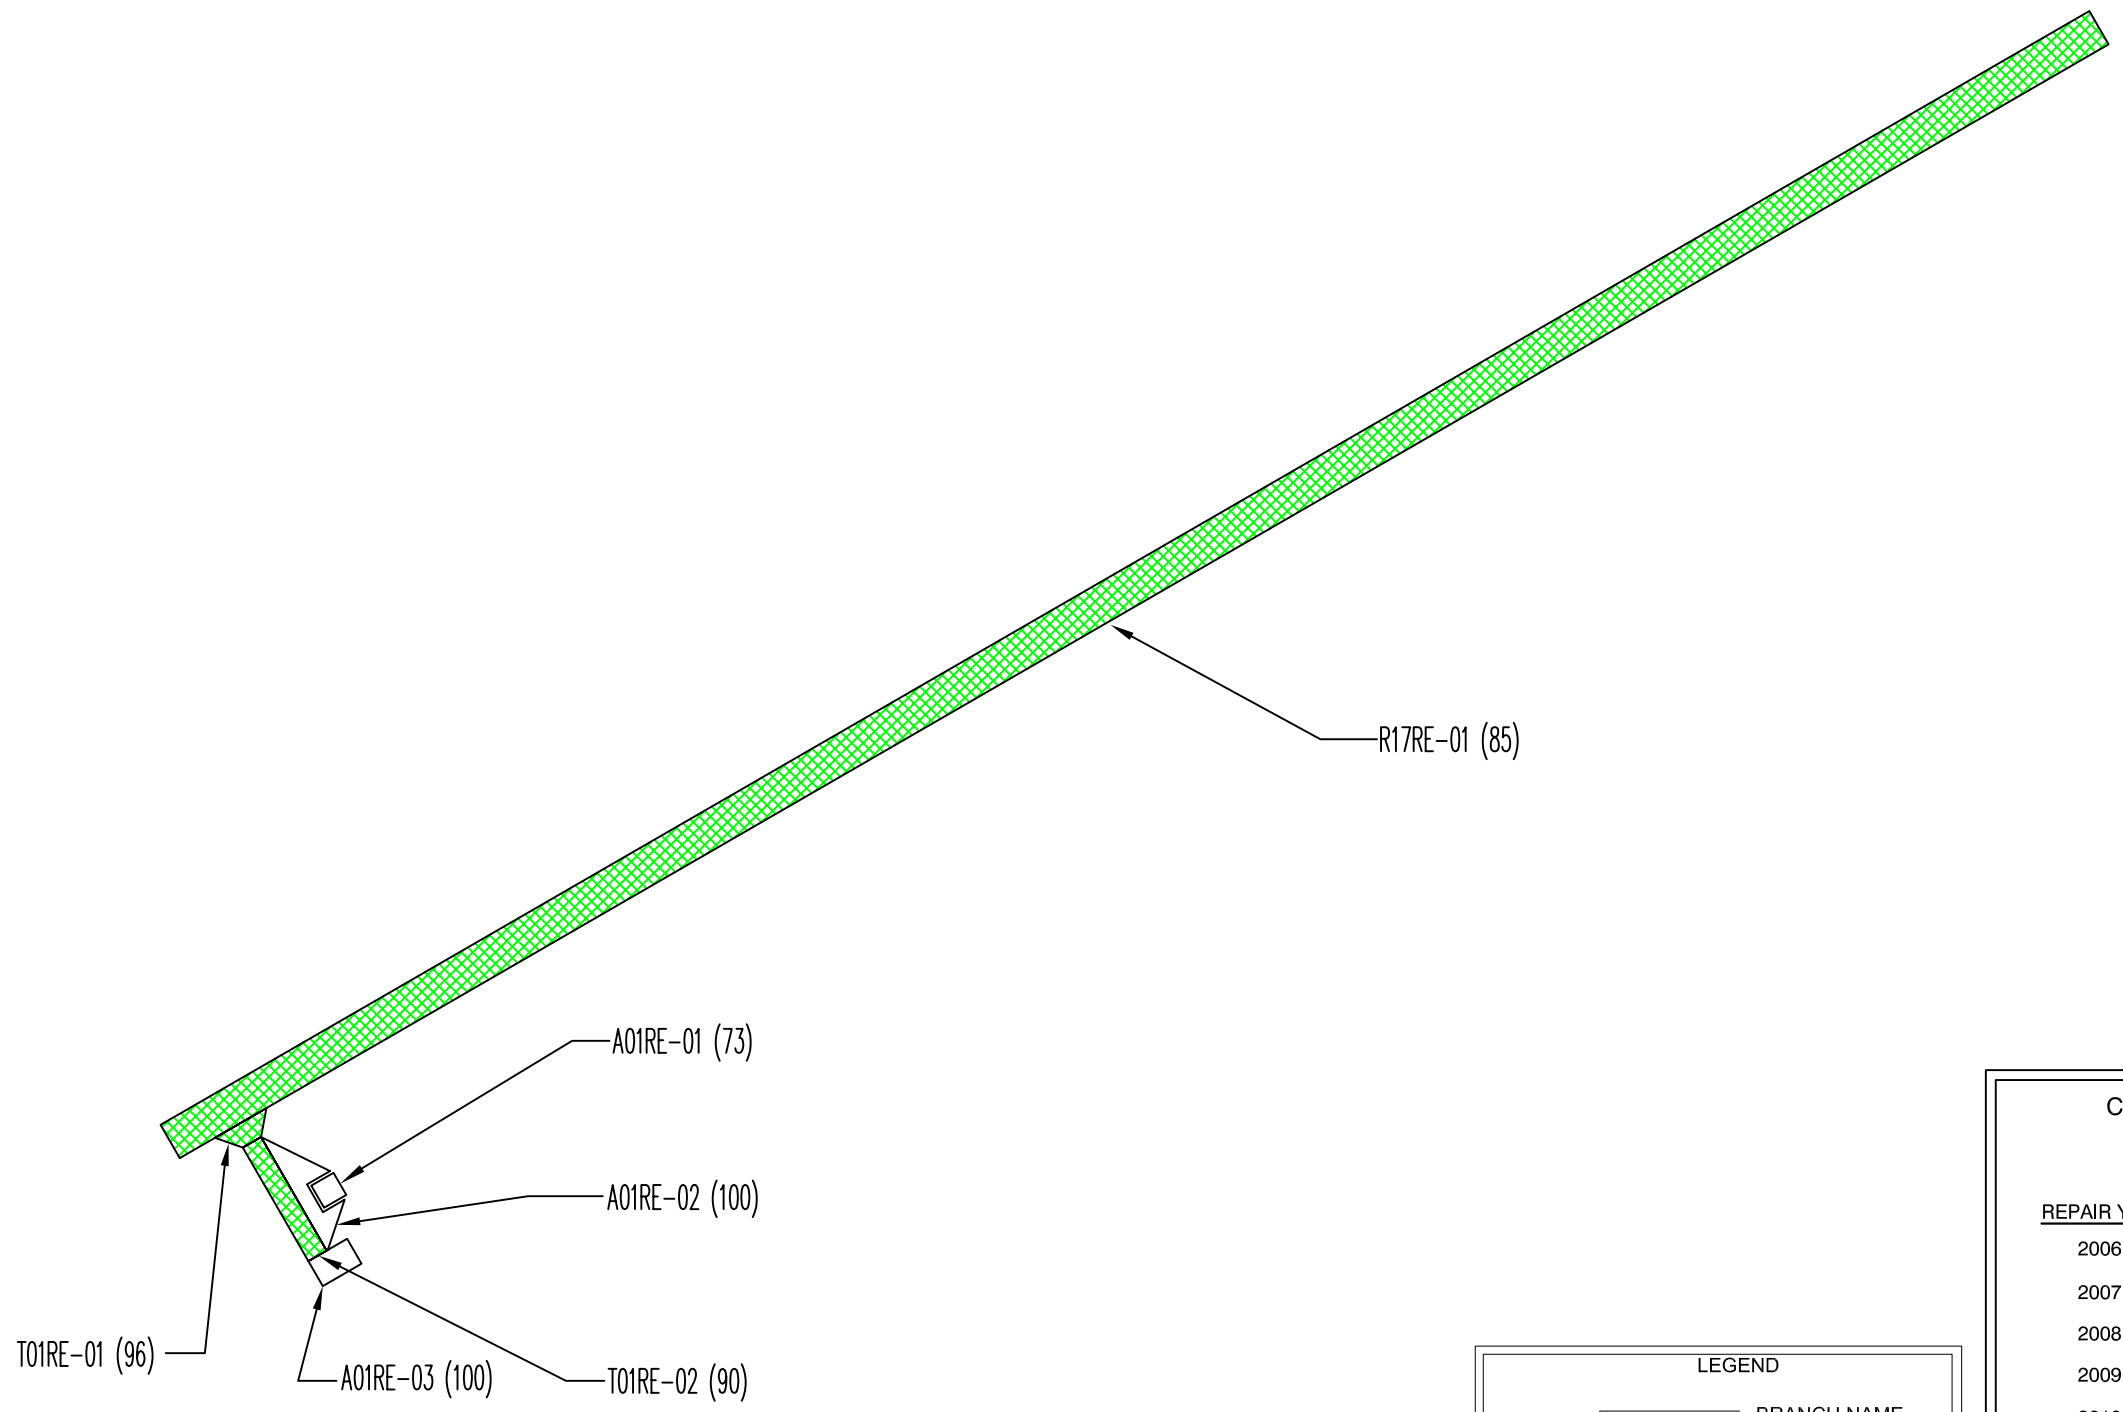
A summary of the pavement repair program for Ferry County Airport is presented in Table 4 and in Figure 9. Detailed information on the localized maintenance plan for 2006 is contained in Appendix F.

REPAIR YEAR	REPAIR TYPE
2006	FOG SEAL
2007	SLURRY SEAL
2008	REHABILITATION
2009	RECONSTRUCTION
2010	
2011	
2012
