WESTPORT AIRPORT
2005 PAVEMENT MANAGEMENT REPORT

February 2006

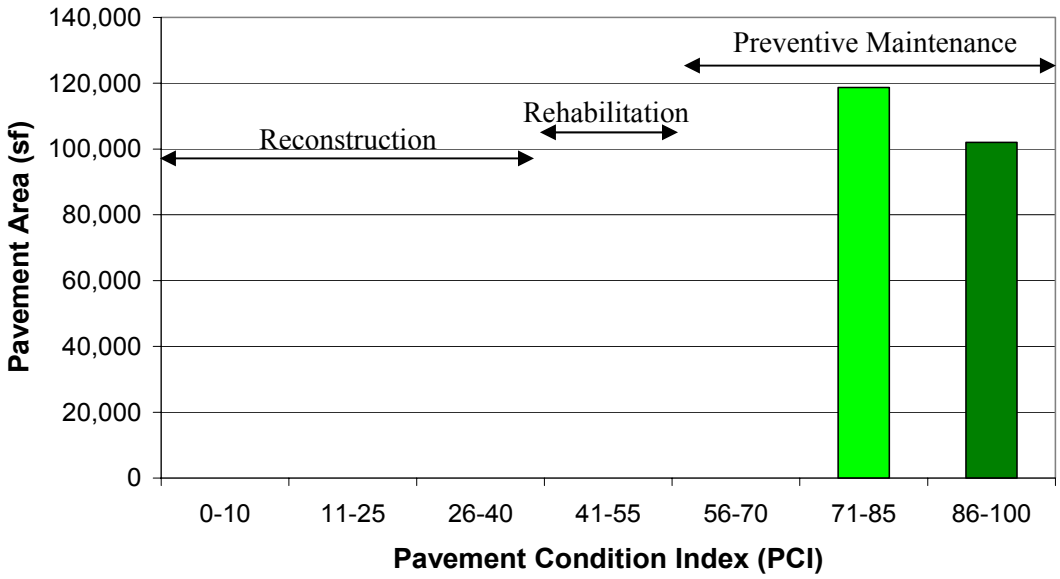
Figure 6. Westport Airport overall condition.

The pavements at Westport Airport were inspected on April 29, 2005. The 2005 area-weighted condition of Westport Airport is 85, with conditions ranging from 81 to 92 (on a scale of 0 [failed] to 100 [excellent]). During the previous inspection in 1999, the area-weighted condition was 62.

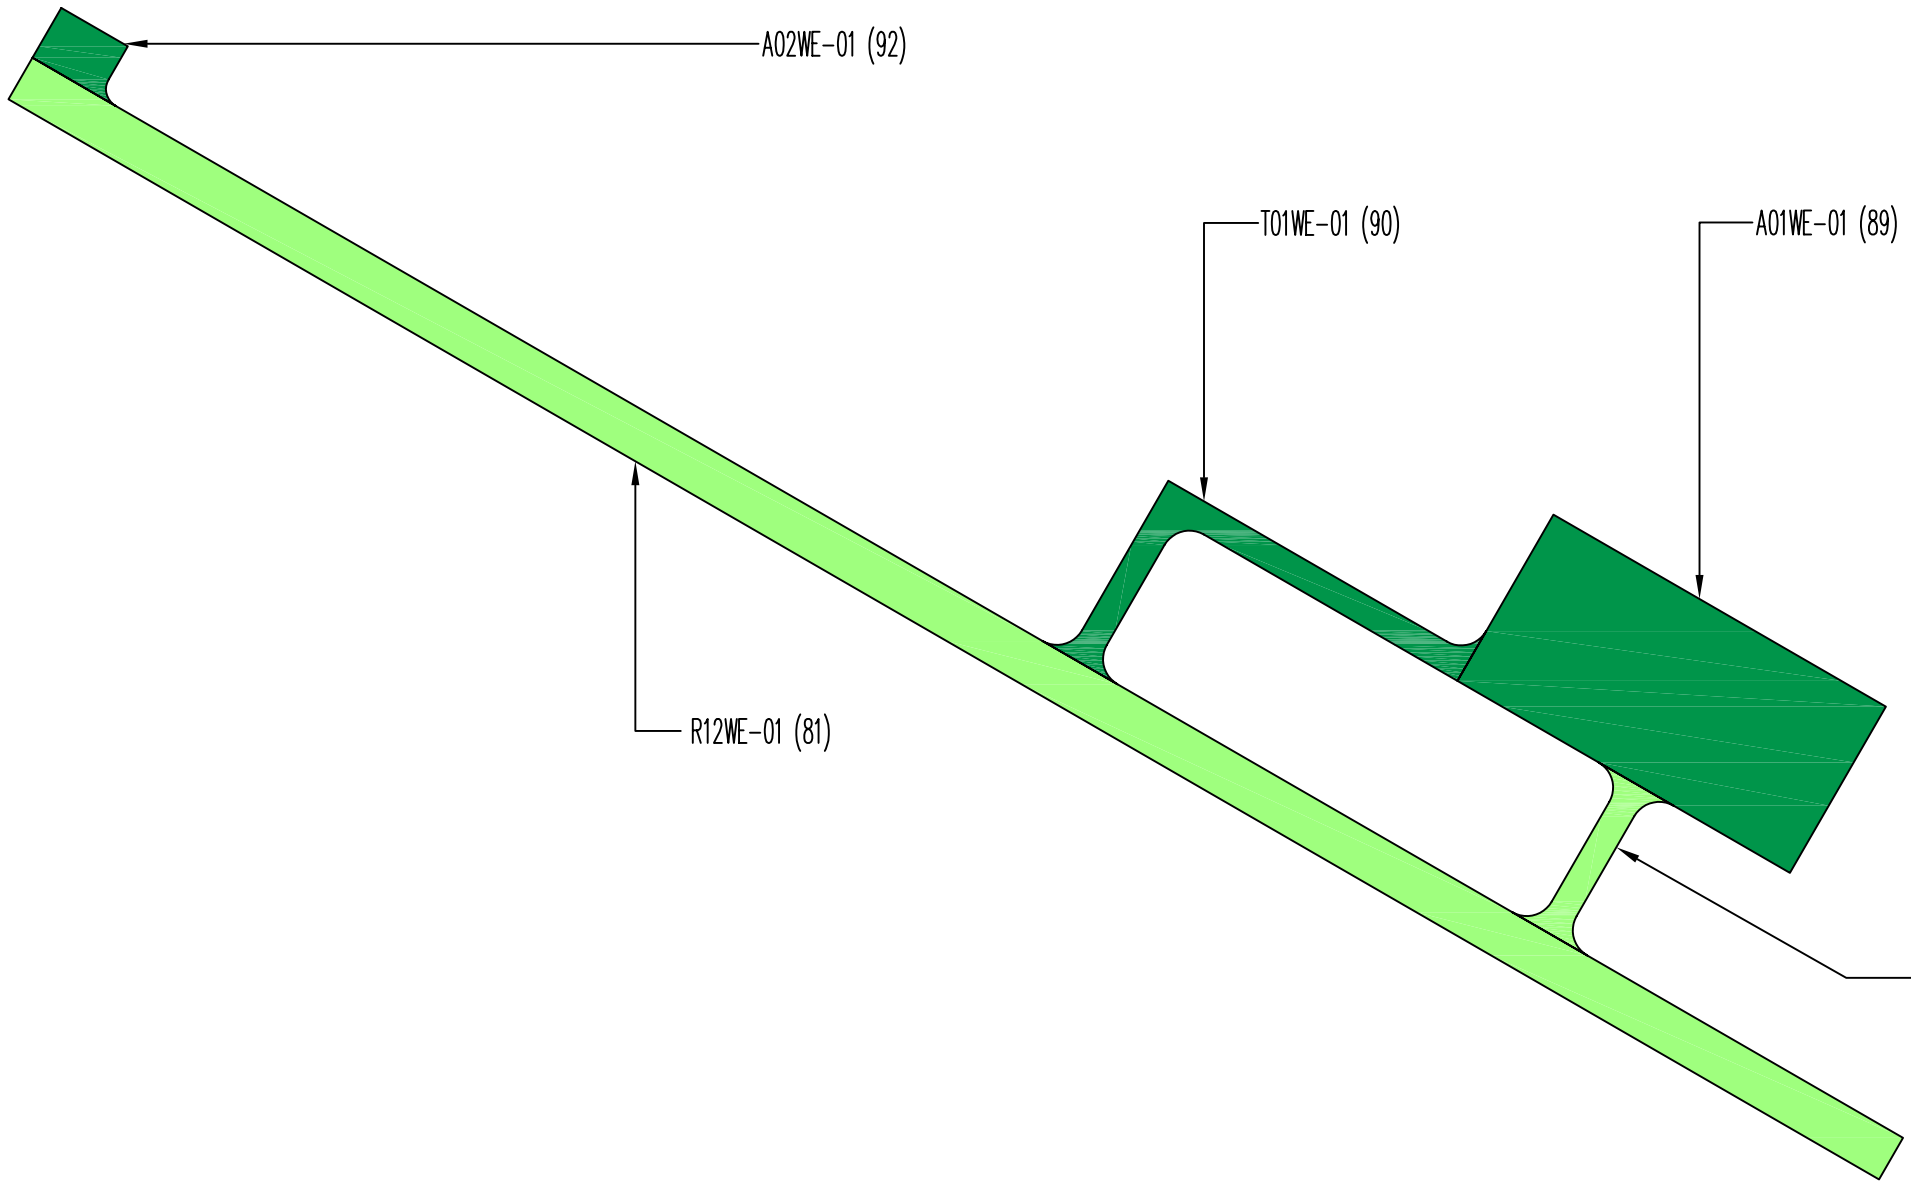
2005 PAVEMENT CONDITION INDEX

Figures 6 and 7 summarize the overall condition of the pavements at the Westport Airport. Figure 8 displays the condition of the pavements evaluated. Table 1 summarizes the results of the pavement evaluation. Appendix C presents photographs taken during the PCI inspection and Appendix D details the distresses observed during the visual survey.

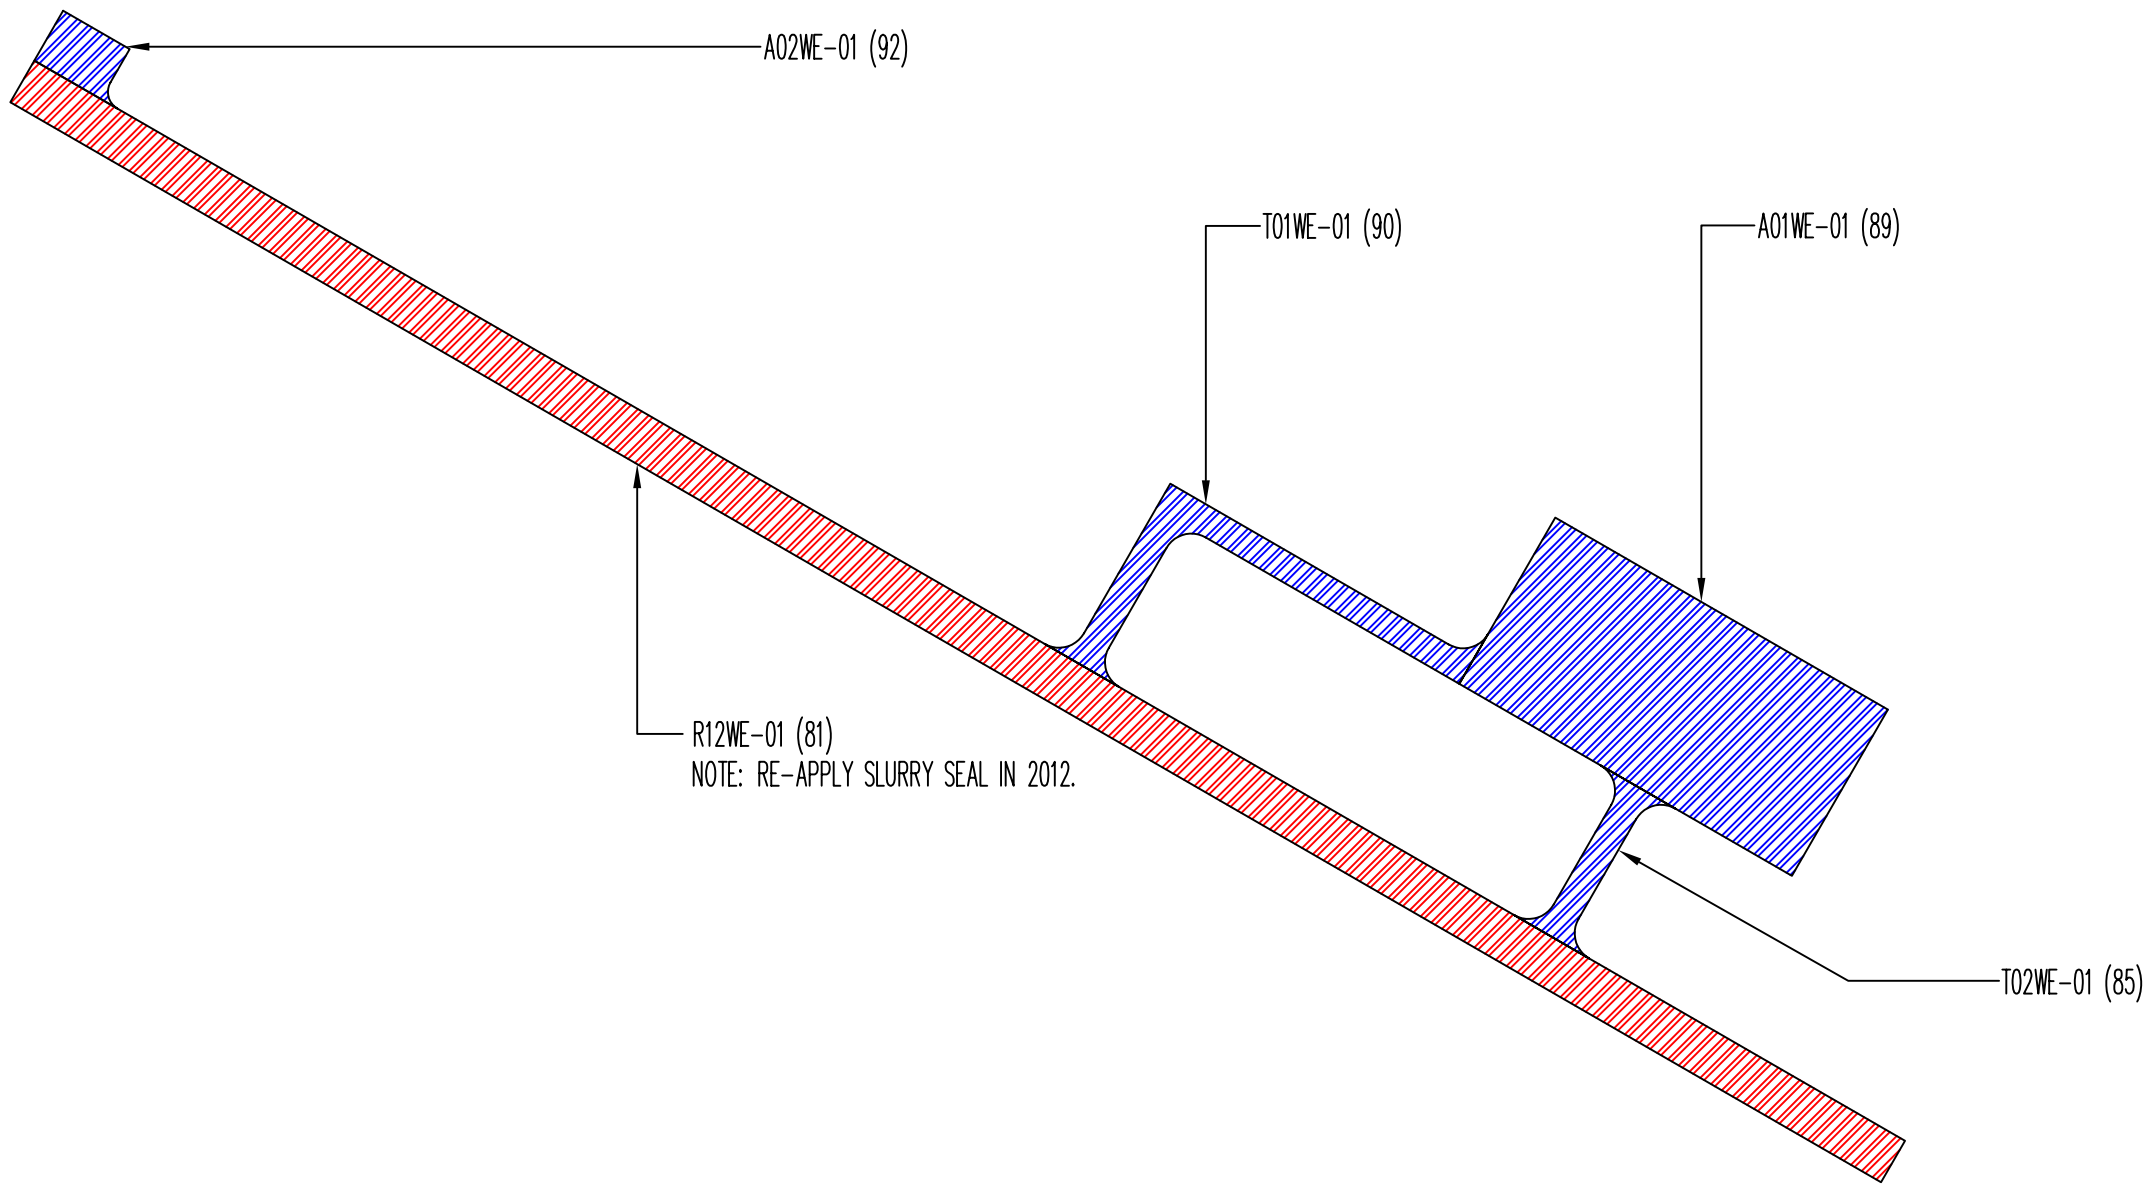
CAPITAL IMPROVEMENT PROGRAM
2006 THROUGH 2012

A summary of the pavement repair program for Westport Airport is presented in Table 4 and in Figure 9. Detailed information on the localized maintenance plan for 2006 is contained in Appendix F.

REPAIR YEAR	REPAIR TYPE
2006	FOG SEAL
2007	SLURRY SEAL
2008	REHABILITATION
2009	RECONSTRUCTION
2010	
2011	
2012
