OCEAN SHORES MUNICIPAL AIRPORT
2005 PAVEMENT MANAGEMENT REPORT

February 2006

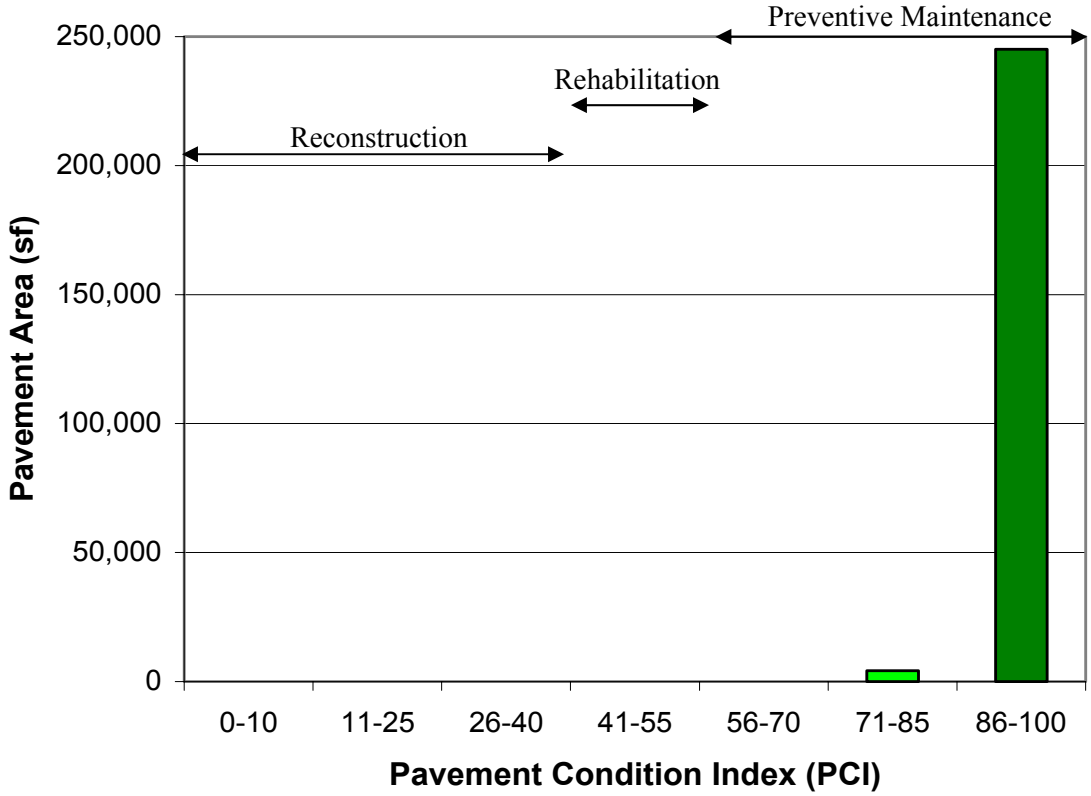
Figure 6. Ocean Shores Municipal Airport overall condition.

The pavements at Ocean Shores Municipal Airport were inspected on April 28, 2005. The 2005 area-weighted condition of Ocean Shores Municipal Airport is 98, with conditions ranging from 80 to 99 (on a scale of 0 [failed] to 100 [excellent]). During the previous inspection in 1999, the area-weighted condition was 91.

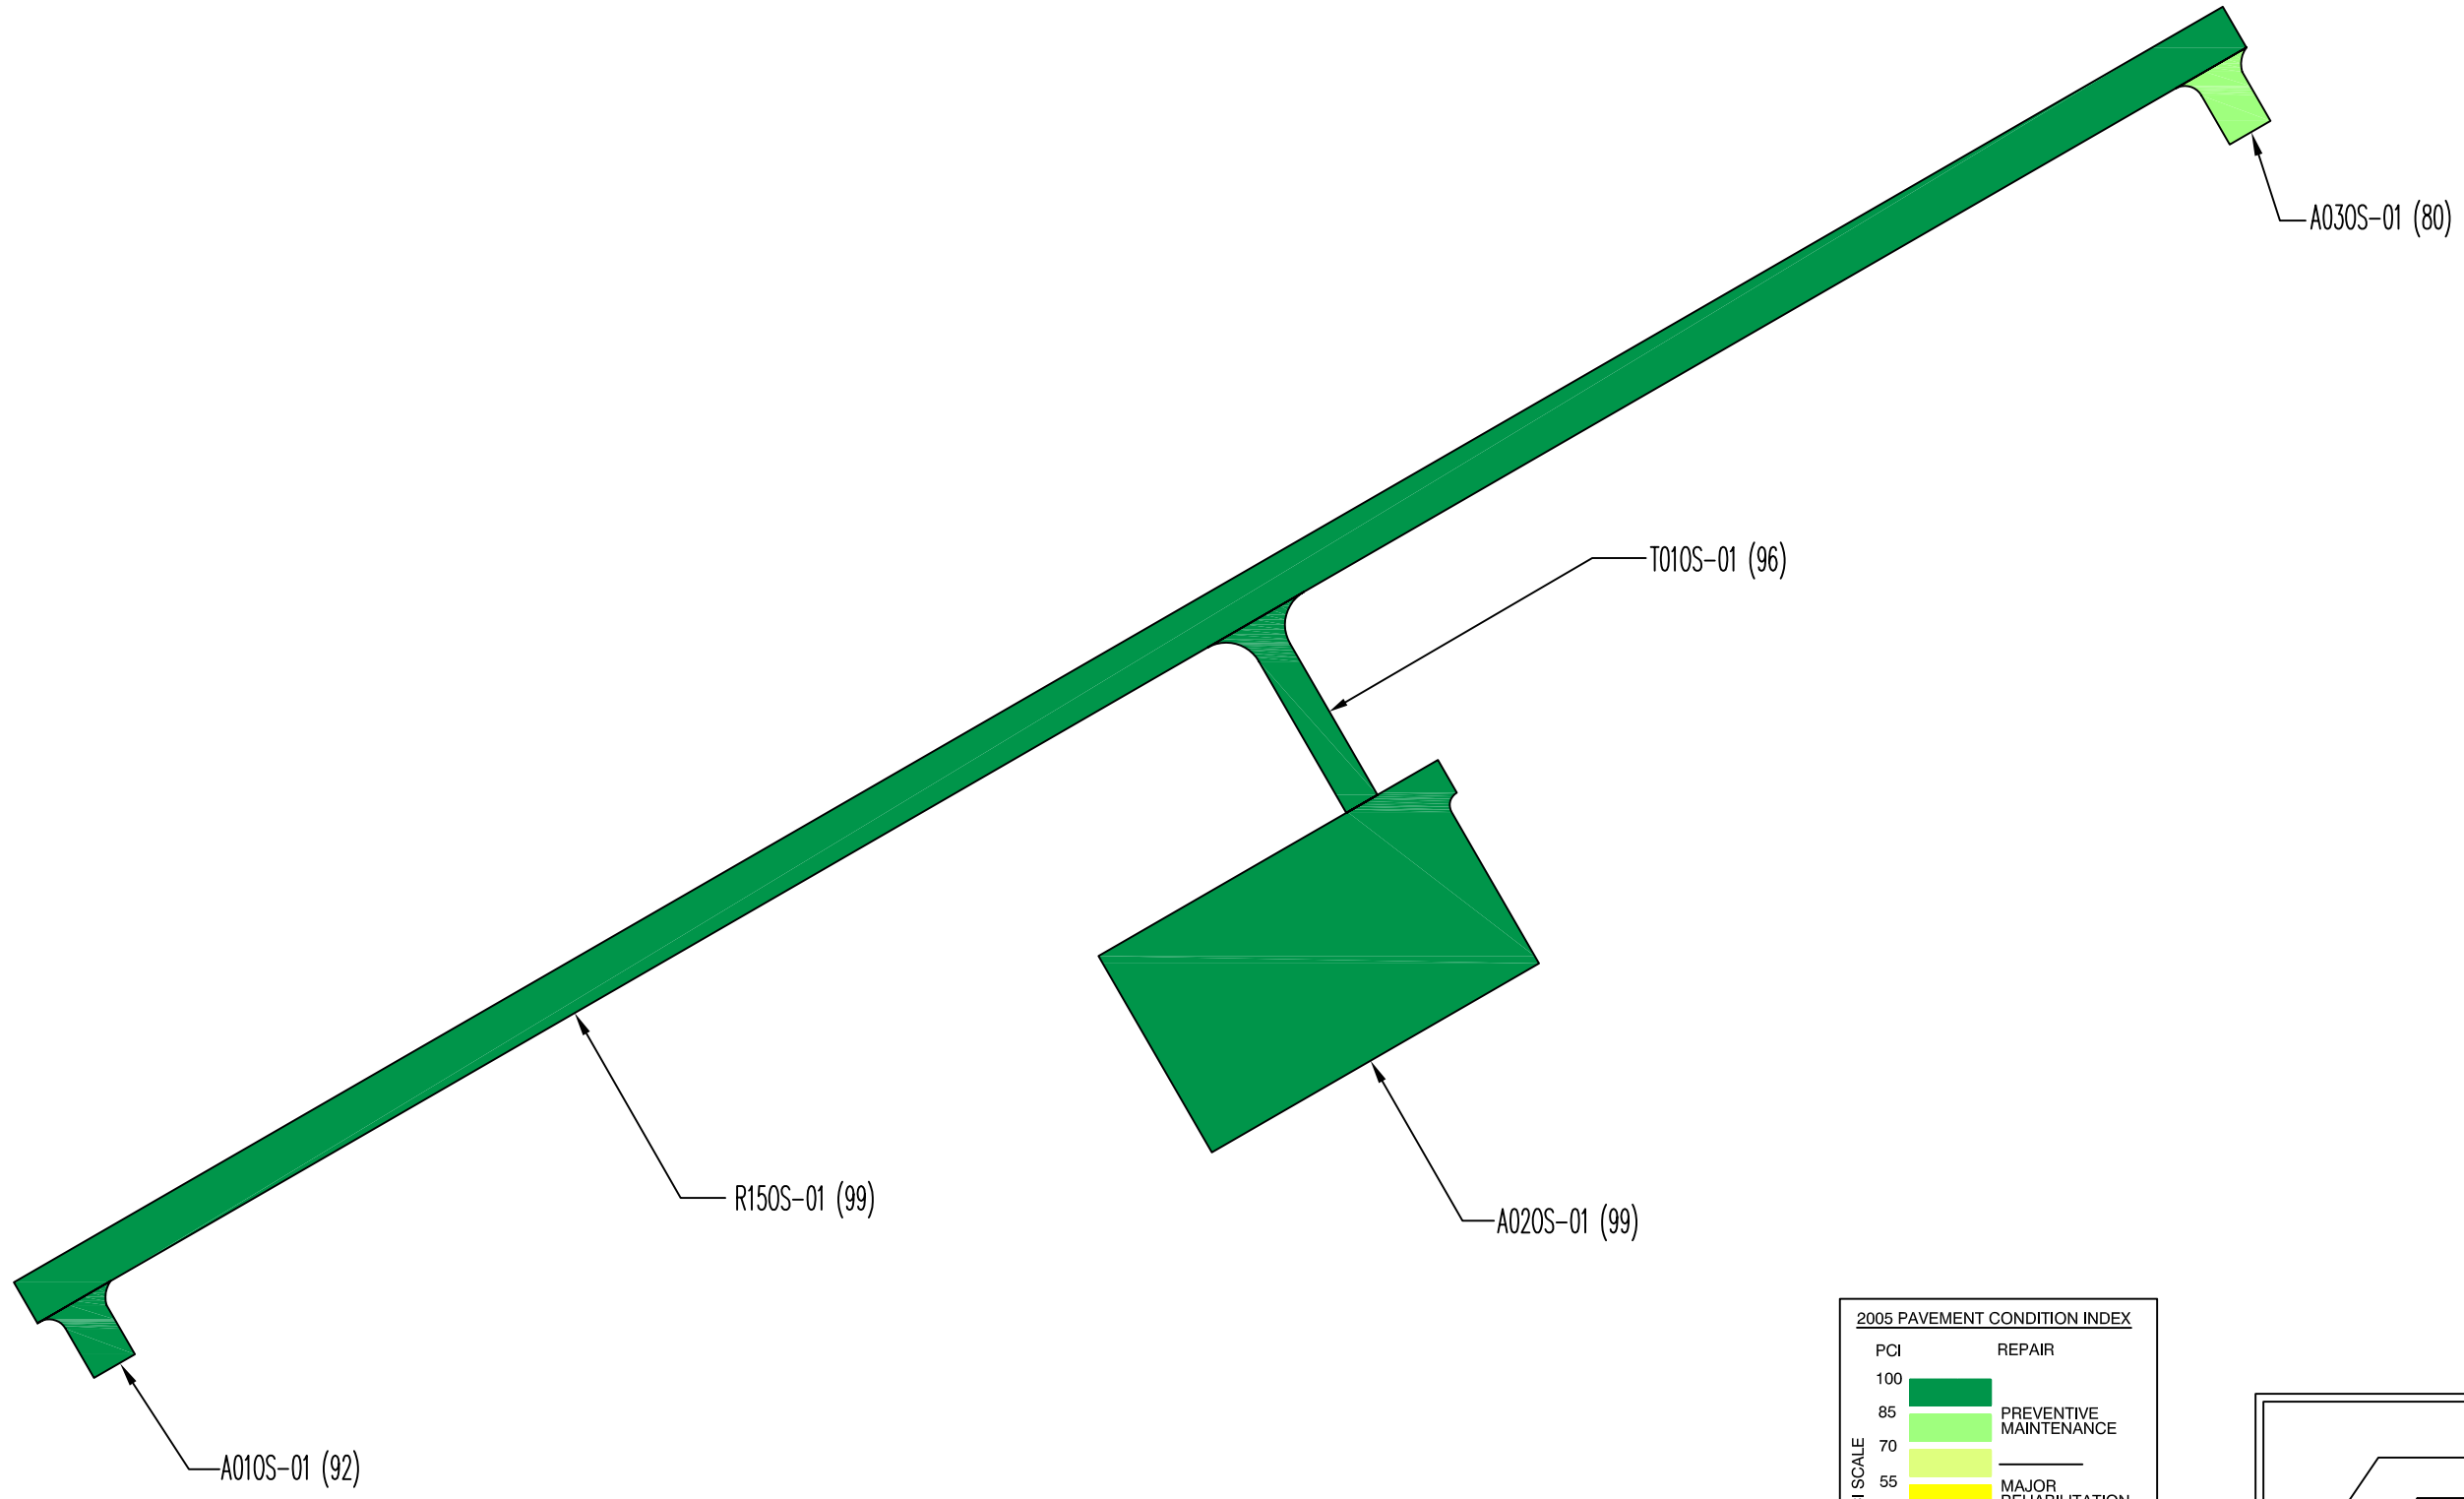
LOCATION: Ocean Shores Municipal Airport, Ocean Shores, Washington			
PAGE TITLE: 2005 Pavement Condition Index Map			
DRAWING SCALE: 1" = 200'	DATE: February 2006	REVISED BY: MK	DRAWN BY: MK
FILENAME: Monroe.dwg	AIRPORT ID: W04	LAYOUT NAME/NUMBER: OS (PCI)	PAGE NUMBER: 9

Figures 6 and 7 summarize the overall condition of the pavements at the Ocean Shores Municipal Airport. Figure 8 displays the condition of the pavements evaluated. Table 1 summarizes the results of the pavement evaluation. Appendix C presents photographs taken during the PCI inspection and Appendix D details the distresses observed during the visual survey.

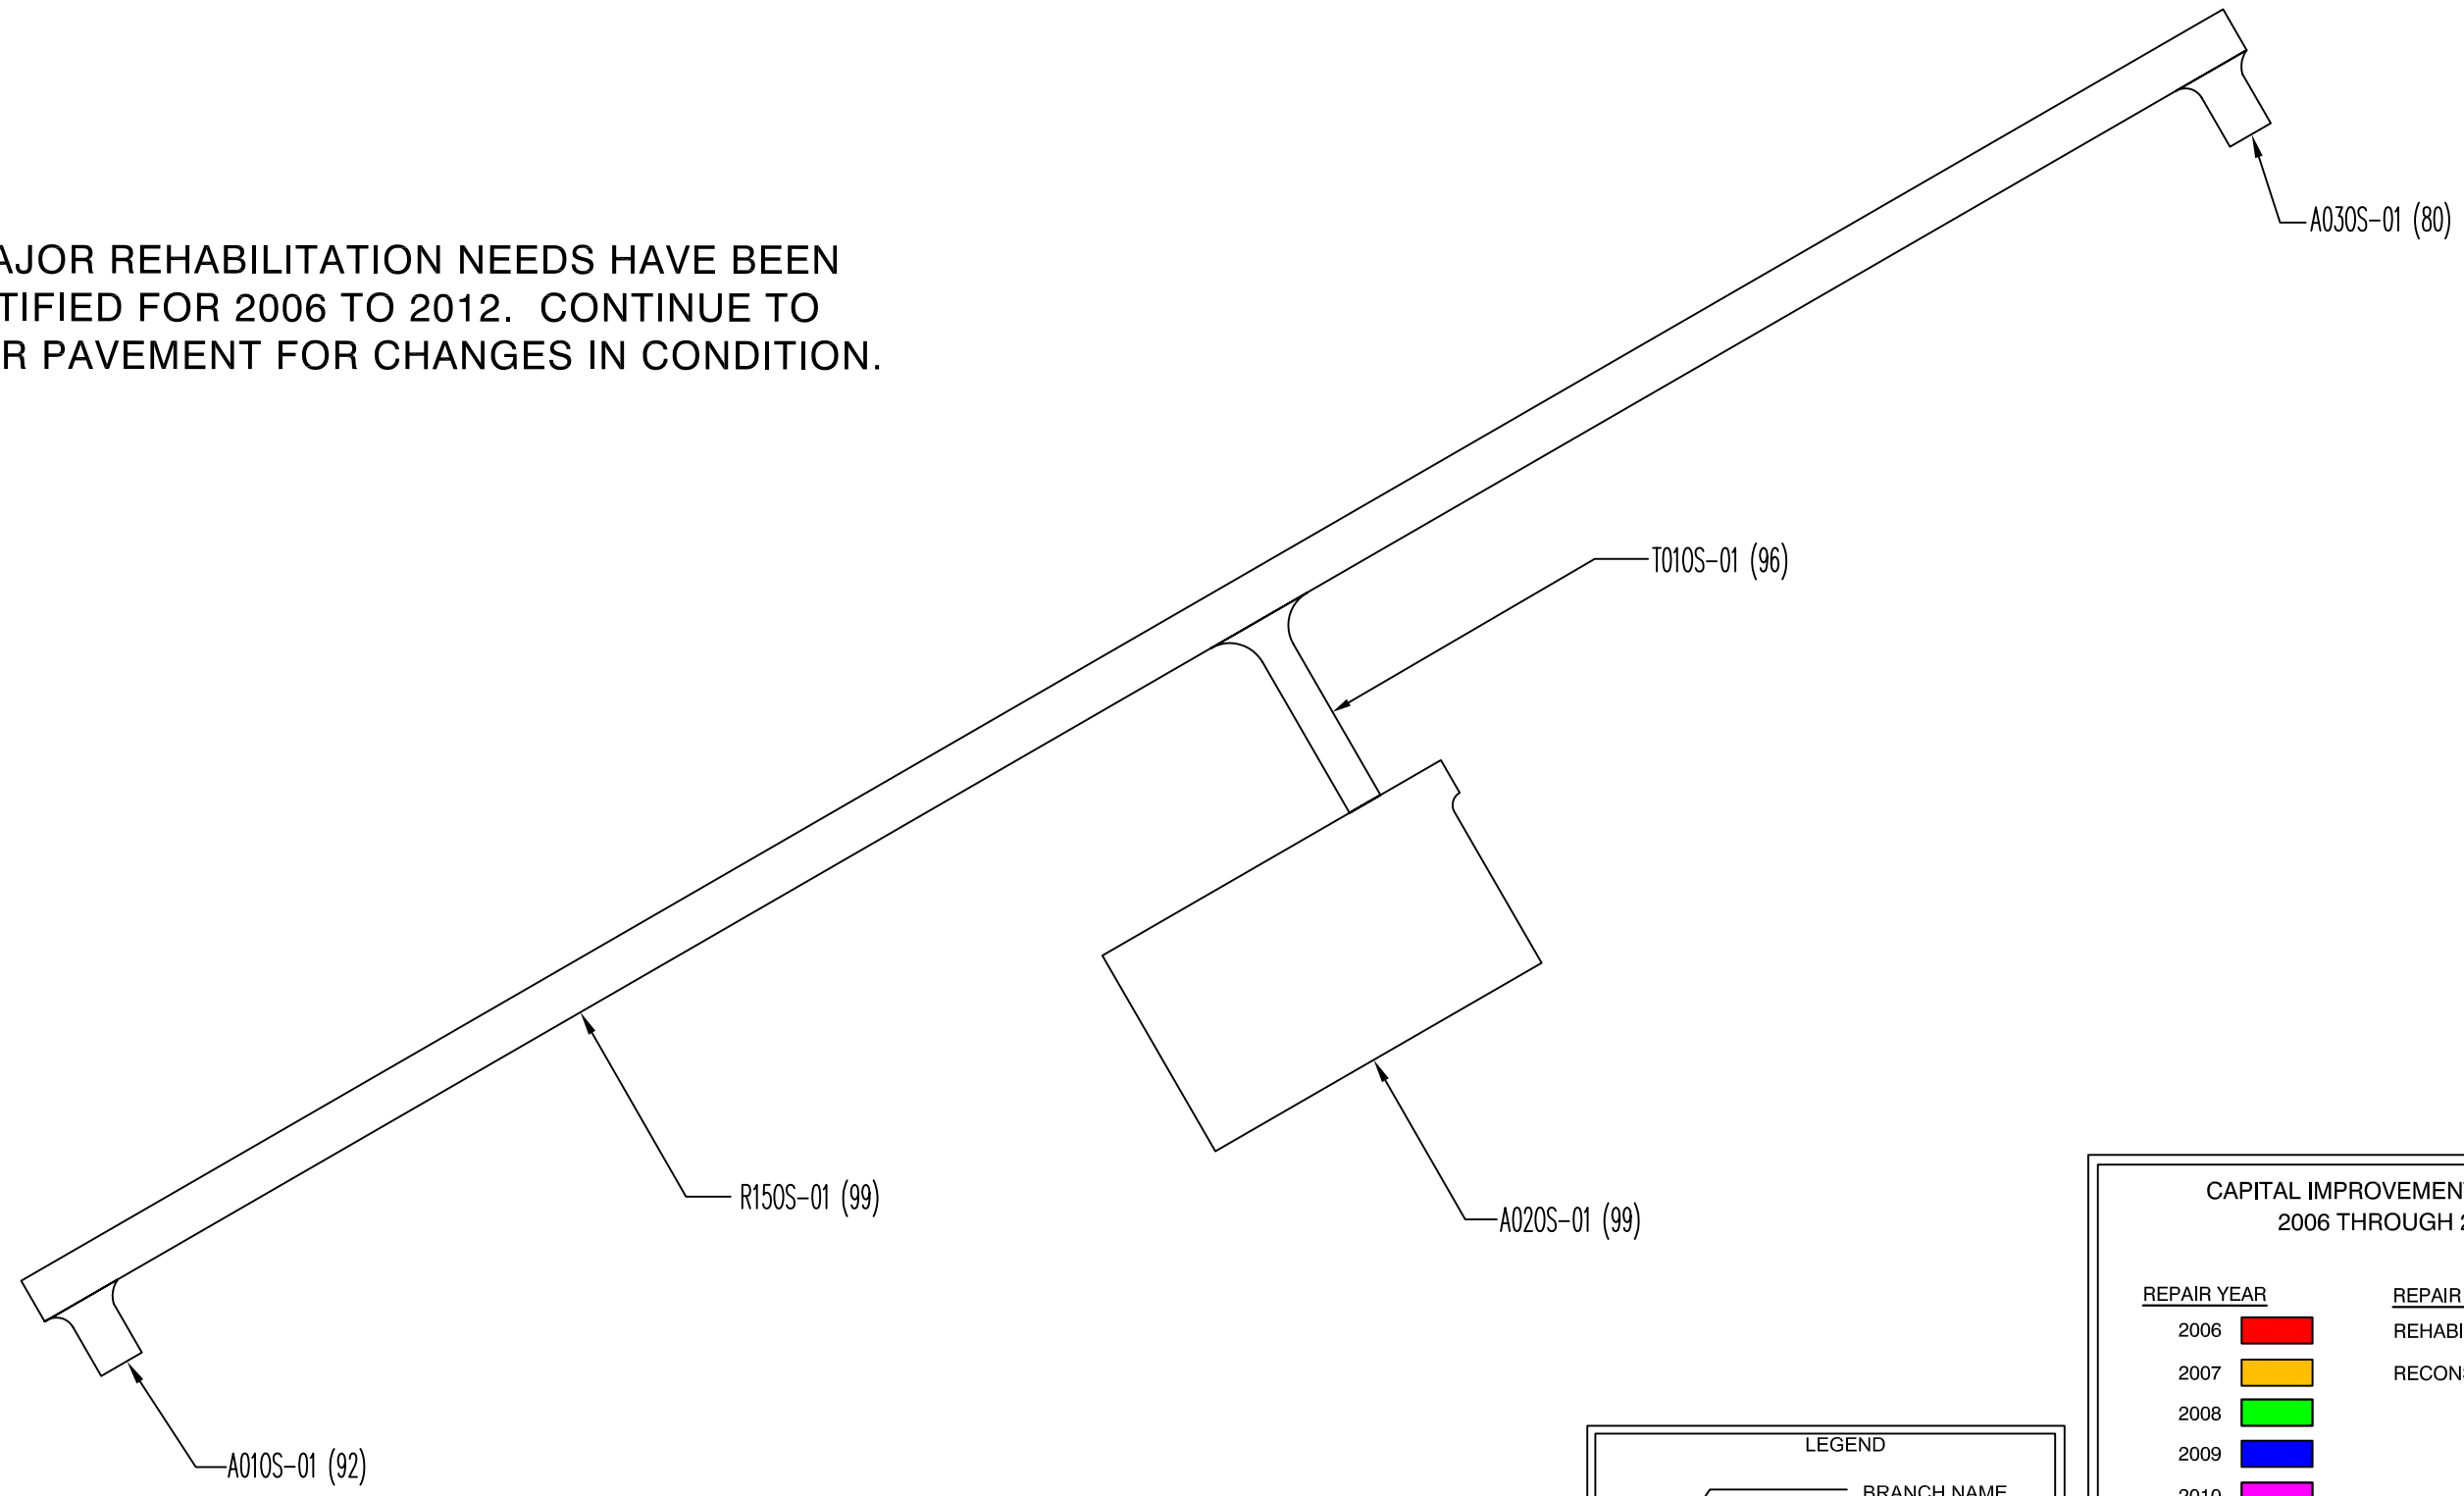
NO MAJOR REHABILITATION NEEDS HAVE BEEN IDENTIFIED FOR 2006 TO 2012. CONTINUE TO MONITOR PAVEMENT FOR CHANGES IN CONDITION.
