GROVE FIELD AIRPORT
2005 PAVEMENT MANAGEMENT REPORT

February 2006

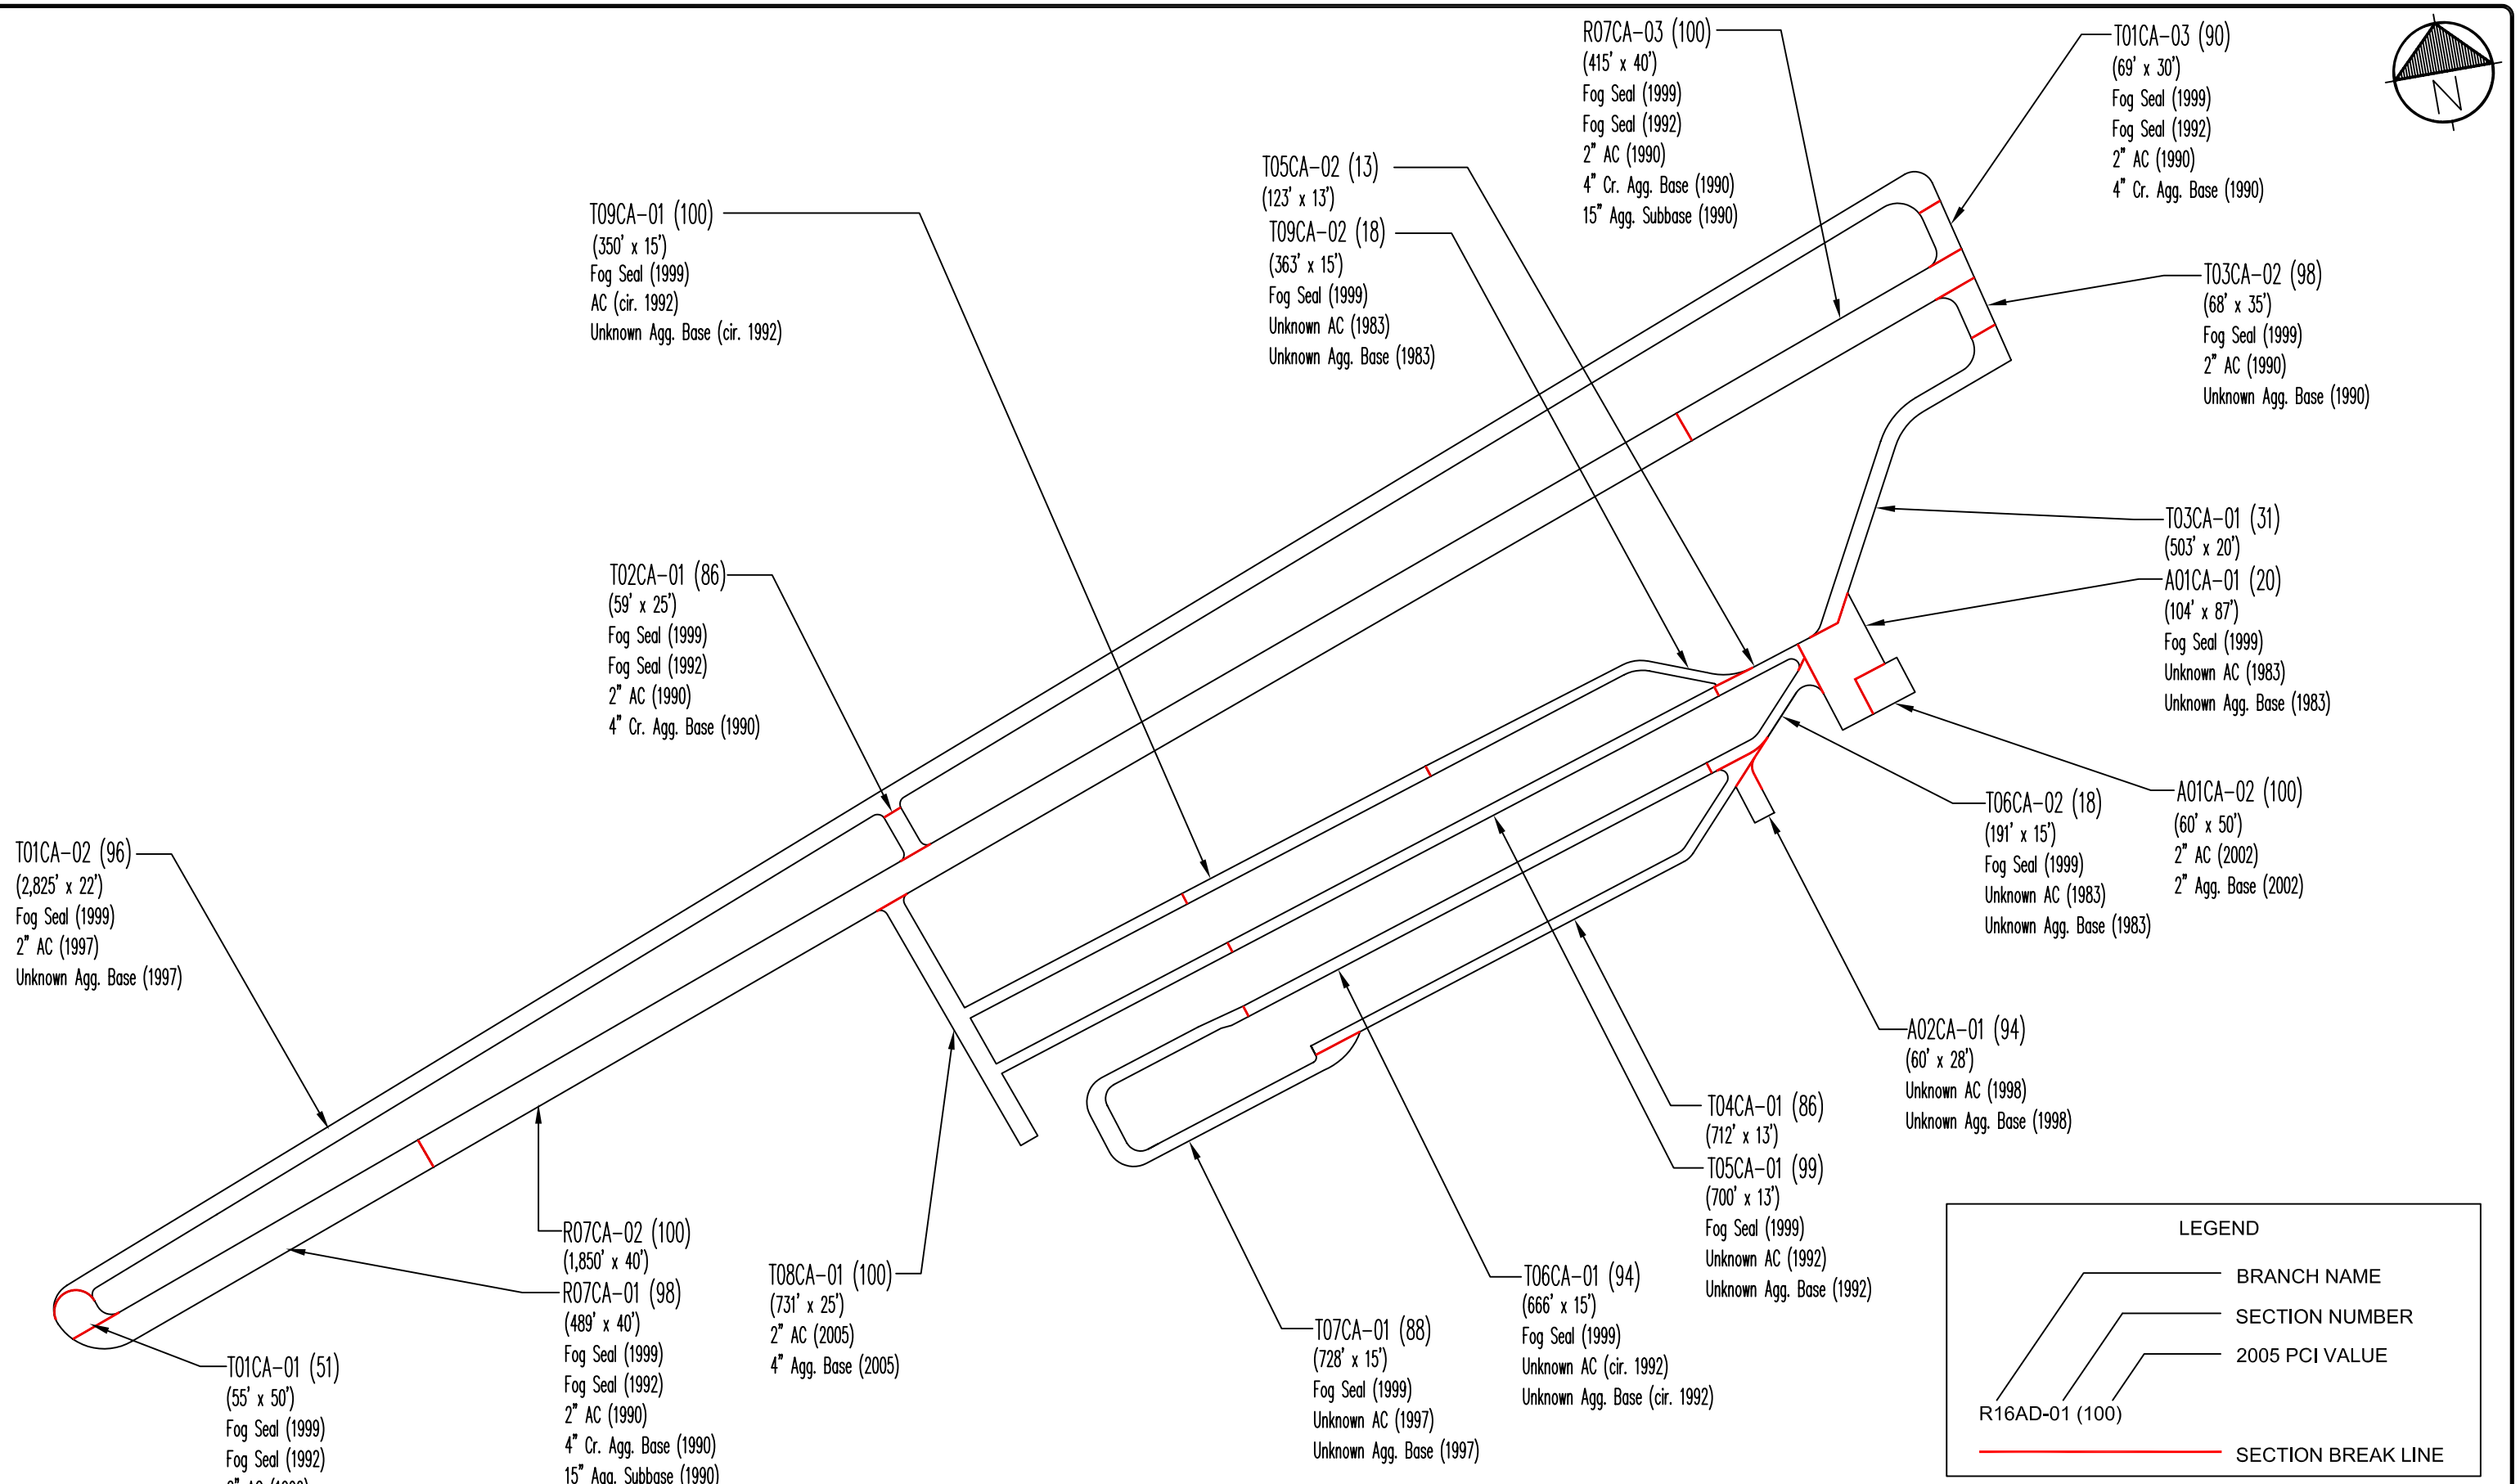
LOCATION: Grove Field Airport, Camas, Washington			
PAGE TITLE: 2005 Work History Map			
DRAWING SCALE: 1" = 200'	DATE: February 2006	REVISED BY: AM	DRAWN BY: AM
FILENAME: Camas.dwg	AIRPORT ID: S50	LAYOUT NAME/NUMBER: Camas (WH)	PAGE NUMBER: 4

Figure 3 presents the records review results in the form of a work history map. The work history information and the Micro PAVER database (see the inside back cover of this report) ensure that your airport complies with the "pavement inventory" and "record keeping and information retrieval" requirements of FAA Grant Assurance 11 (discussed later in the section of this report entitled *Public Law 103-305*).

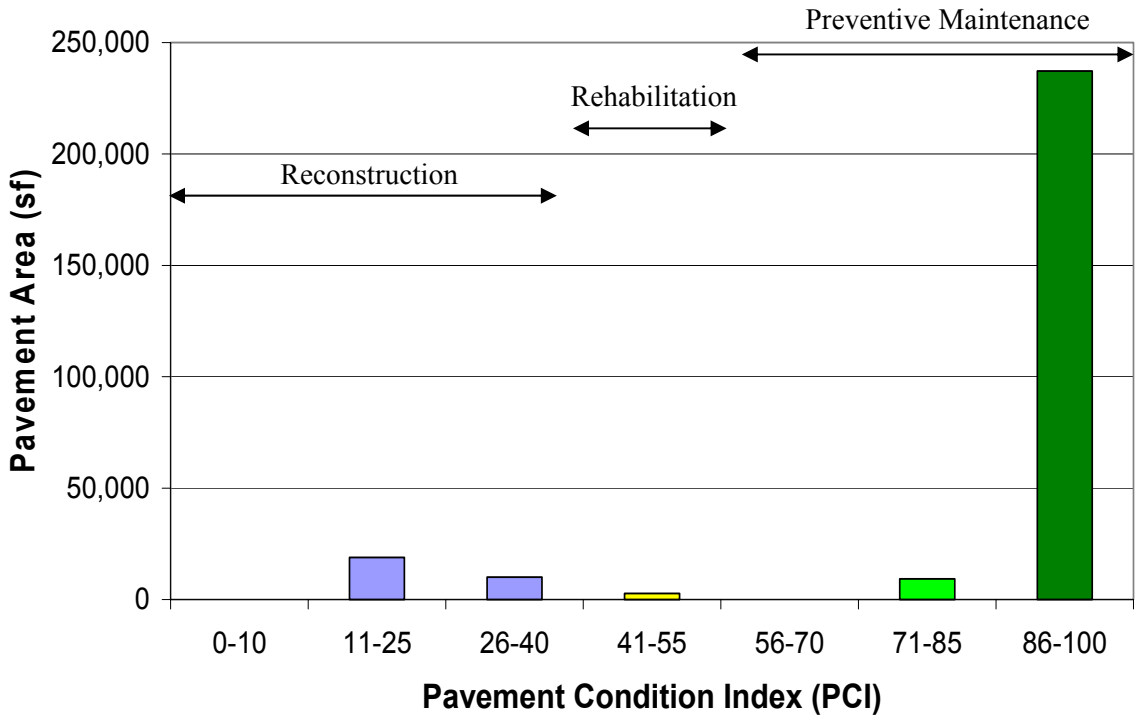
Figure 6. Grove Field Airport overall condition.

The pavements at Grove Field Airport were inspected on April 27, 2005. The 2005 area-weighted condition of Grove Field Airport is 89, with conditions ranging from 13 to 100 (on a scale of 0 [failed] to 100 [excellent]). During the previous inspection in 1999, the area-weighted condition was 91.

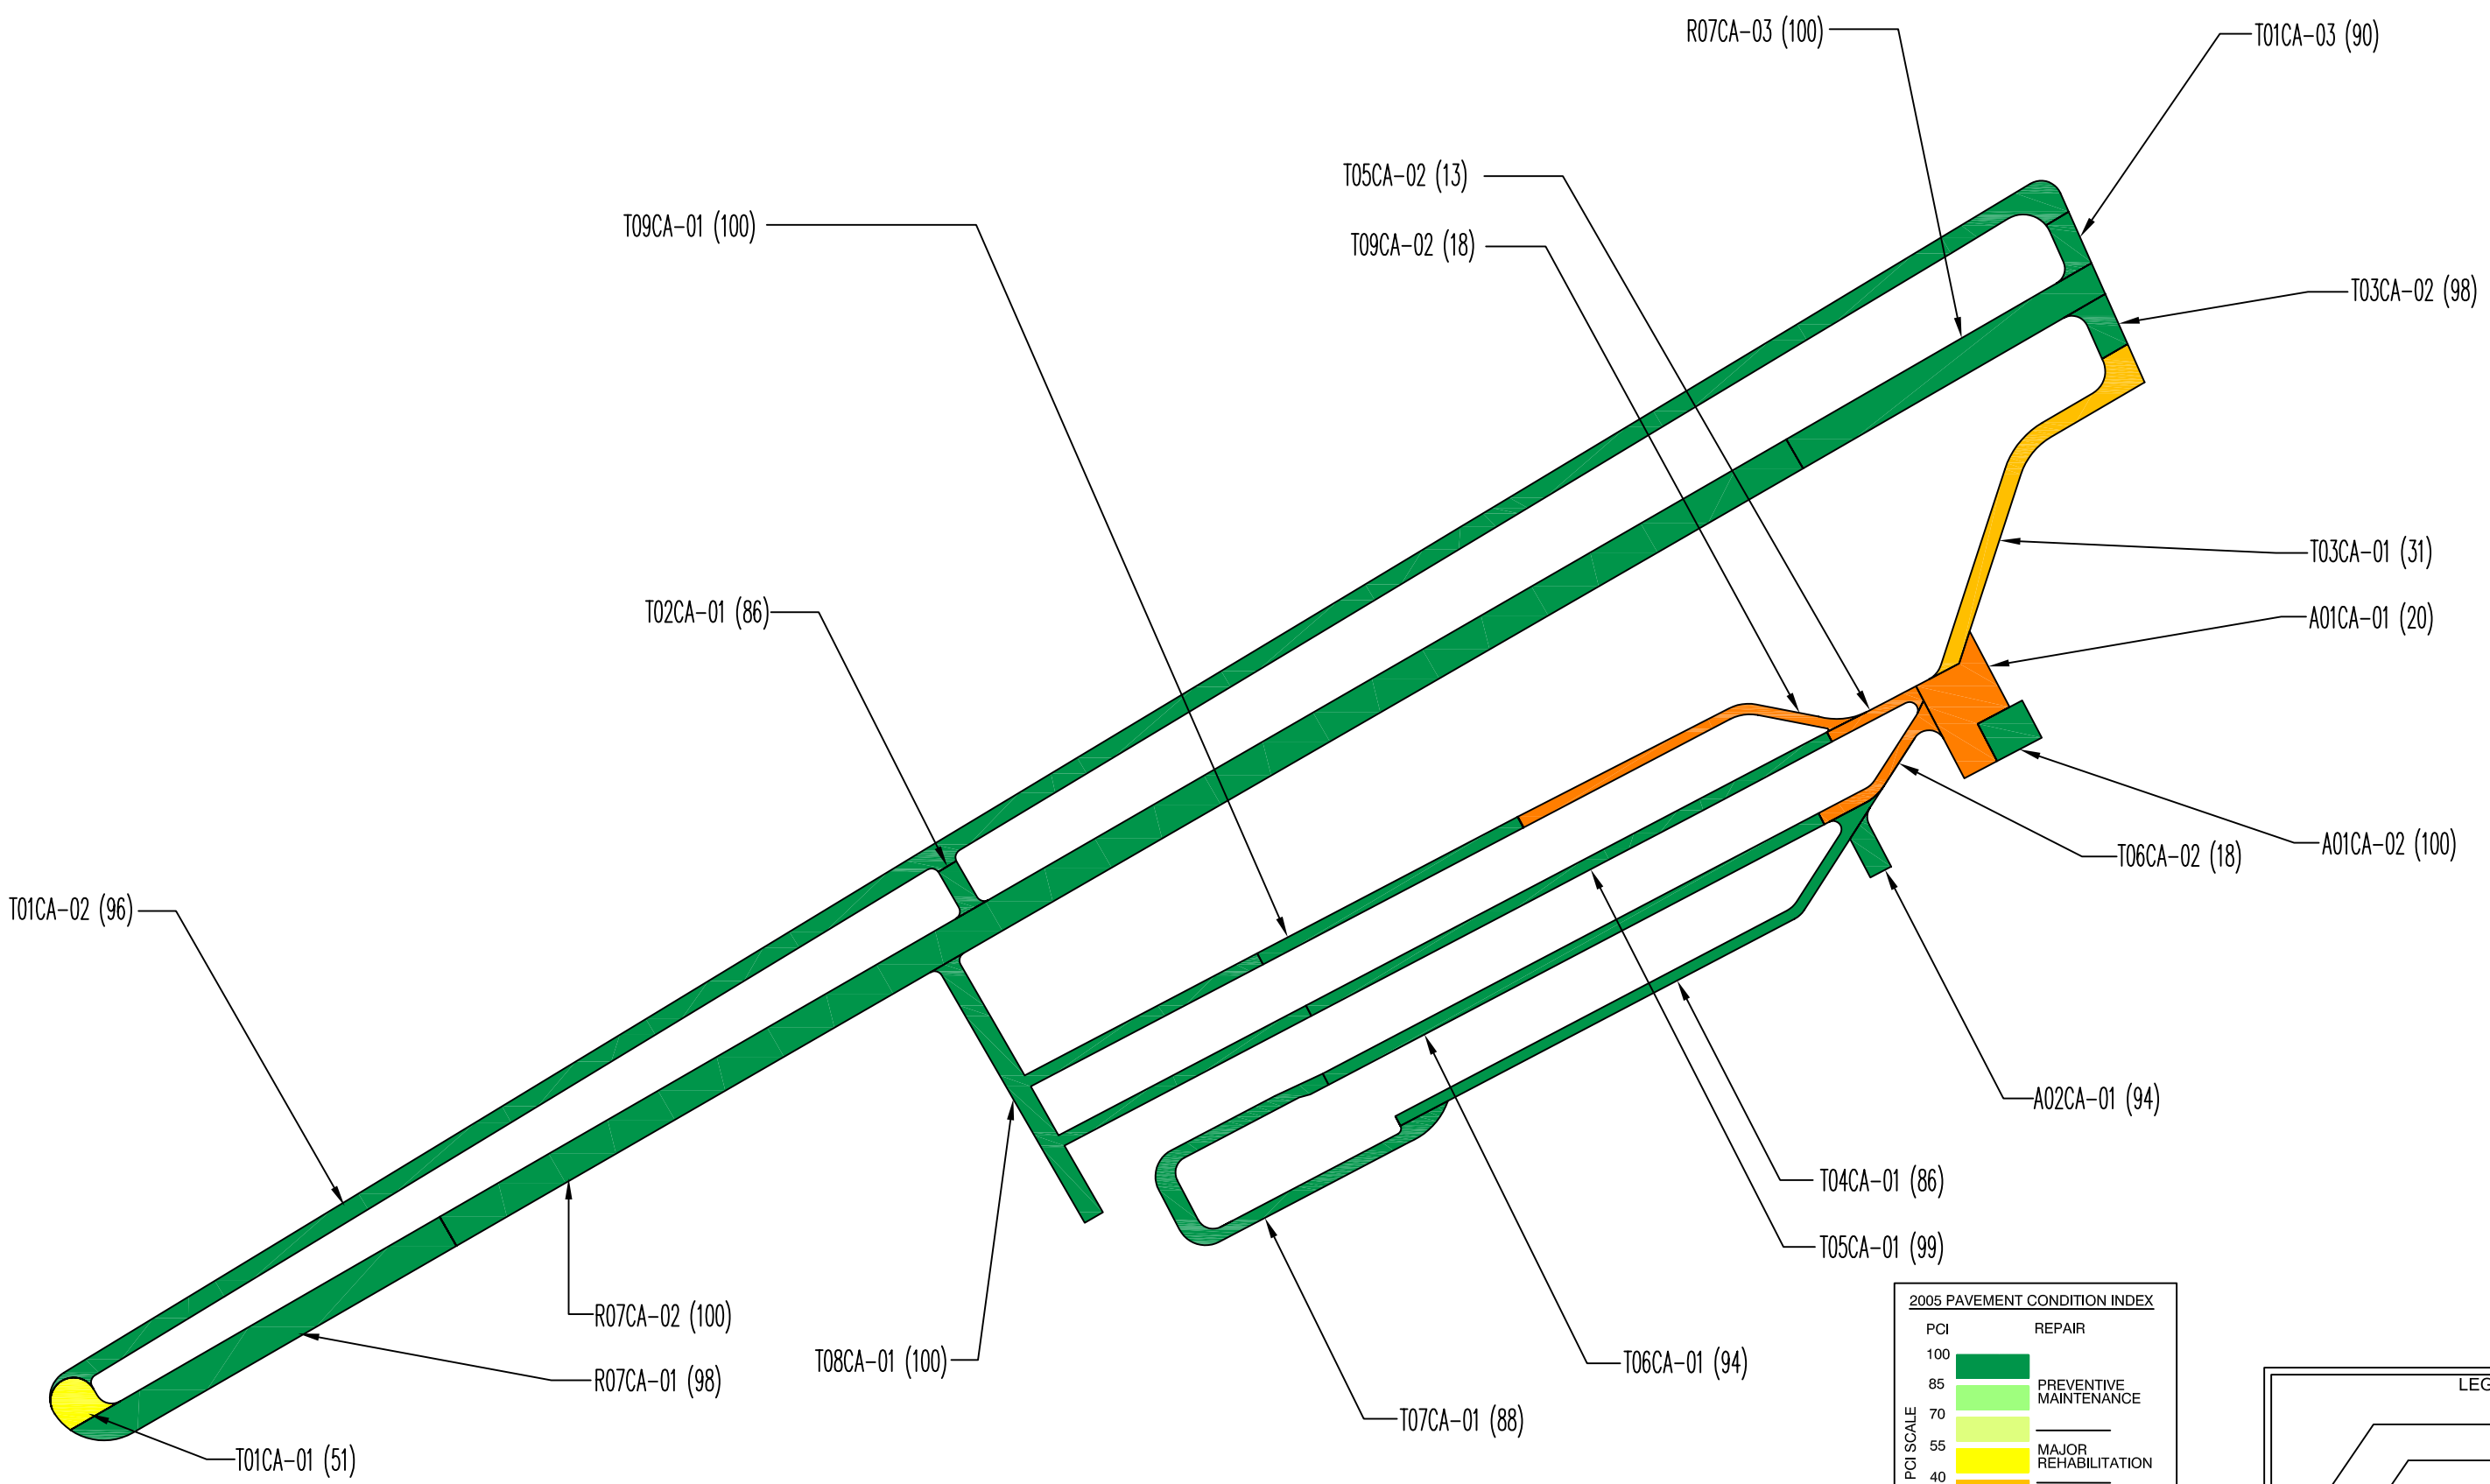
2005 PAVEMENT CONDITION INDEX

Figures 6 and 7 summarize the overall condition of the pavements at the Grove Field Airport. Figure 8 displays the condition of the pavements evaluated. Table 1 summarizes the results of the pavement evaluation. Appendix C presents photographs taken during the PCI inspection and Appendix D details the distresses observed during the visual survey.
