Vulnerable Points of the Existing Evergreen Point Floating Bridge and Approach Spans

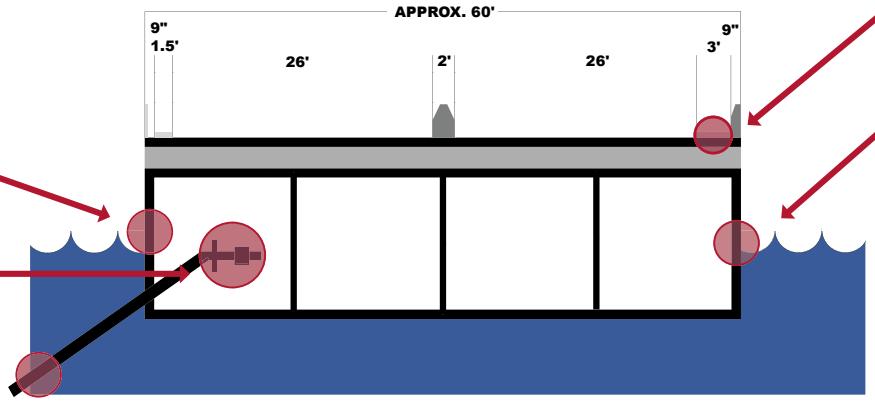
Floating Bridge/Pontoons

Exterior walls may crack and leak

Weak drawspan, cross pontoons, anchor galleries

Near shore anchor cables

Maintenance hatches difficult to access

Added weight makes bridge float low in the water

Waves crash over low roadway

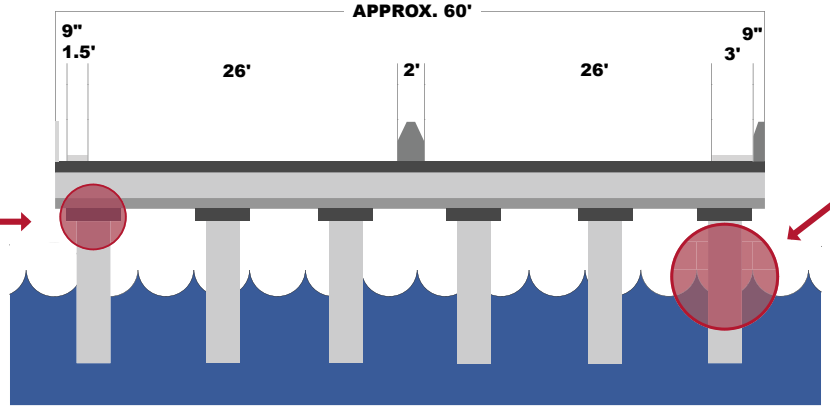
Approach Span

Earthquake Vulnerability for Approaches

Pile cap to hollow pile connection

Hollow piles may implode during earthquake
